Nathaniel “Nat” Washington Power Plant G21 Turbine Runner Cavitation Resistant Coating Field Trial

Interim Report No. ST-2023-20024-02

Technical Memorandum No. 8540-2023-12

**Columbia Basin Project, Washington
Columbia-Pacific Northwest Region**

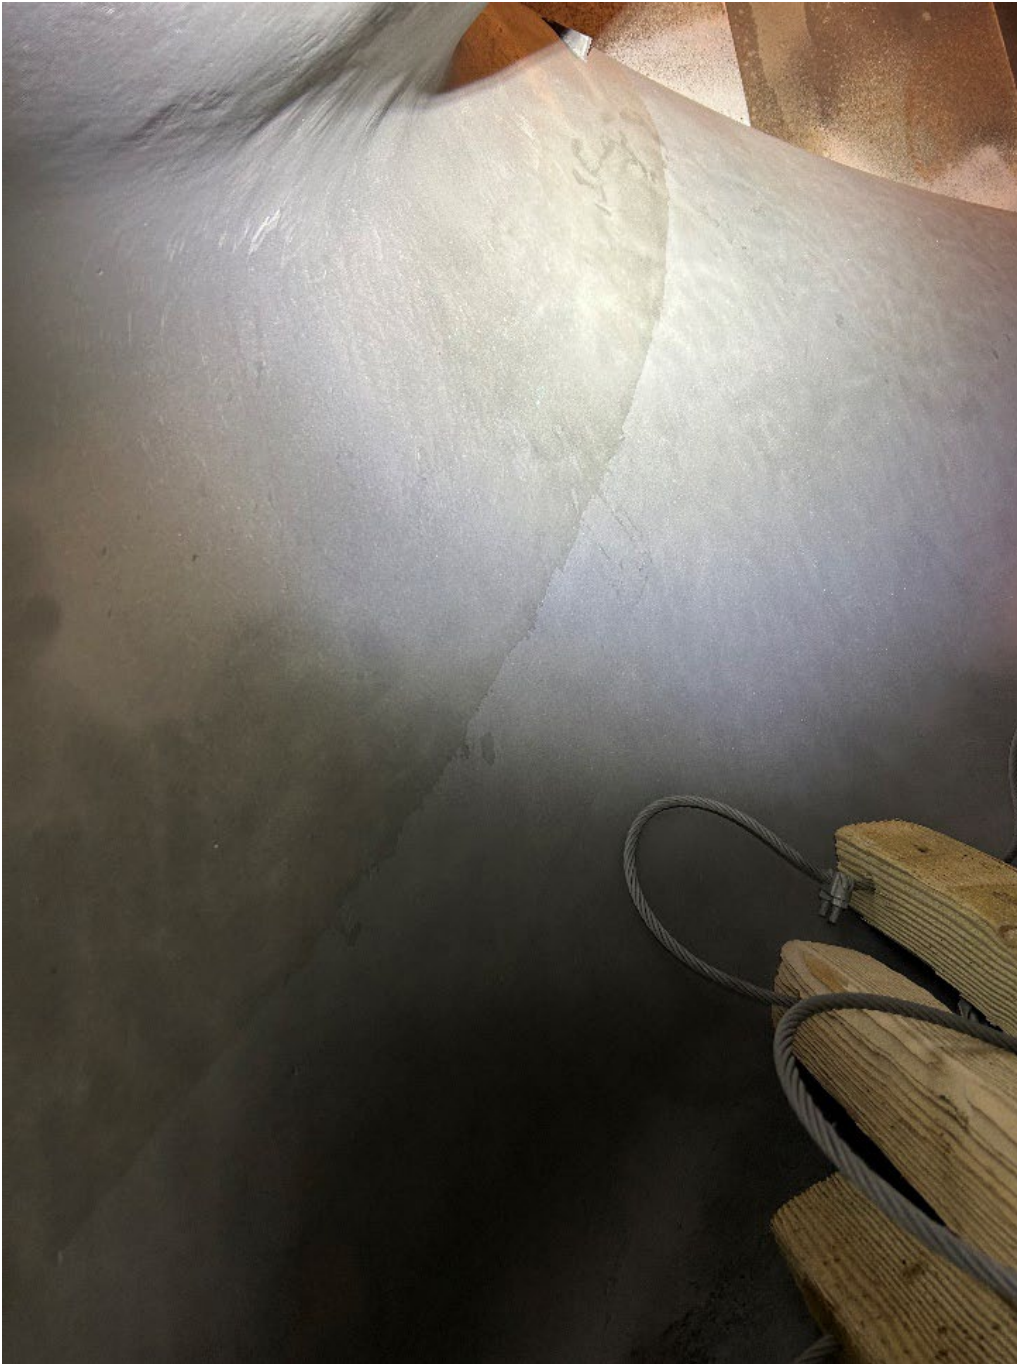
The turbine runner of Unit G21 was abrasive blast cleaned to white metal, NACE 1/SSPC-SP5, using 16-grit Kleen Blast® abrasive [2]. After cleaning, the surface profile averaged 3.7 mils (mil) on the mild steel areas and 3.6 mil on the stainless steel weld overlay. The manufacturers of

PE1 and PE2 specify a minimum 3.0-mil profile. The cleaned surface of the turbine runner is shown in Figure 1.

Figure 1.—Typical condition of surface preparation at 308 stainless steel weld overlay/mild steel transition.

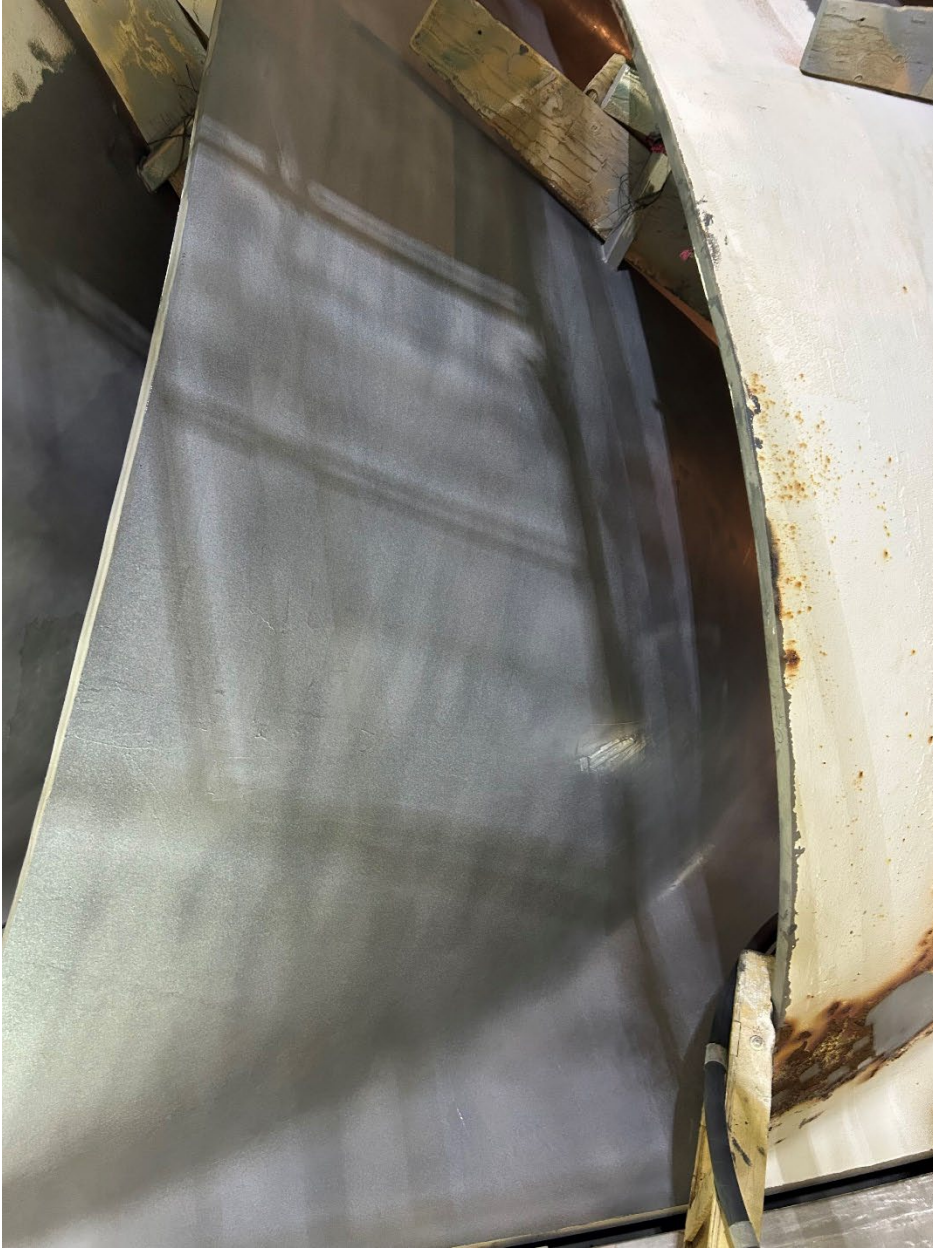
Using 16-grit Kleen Blast[®] abrasive, the primer was sweep blast cleaned to SSPC-SP7, which removed all gloss [3]. The measured surface profile averaged 5.2 mil, exceeding the manufacturer's 2-mil profile requirement. A higher profile in the primer surface could increase mechanical adhesion for the elastomer and decrease the chance of delamination. The sweep blasted primer surface is shown in Figure 2.

Figure 2.—The surface of Blade 13 primed with ceramic-filled epoxy, shown after sweep blasting.

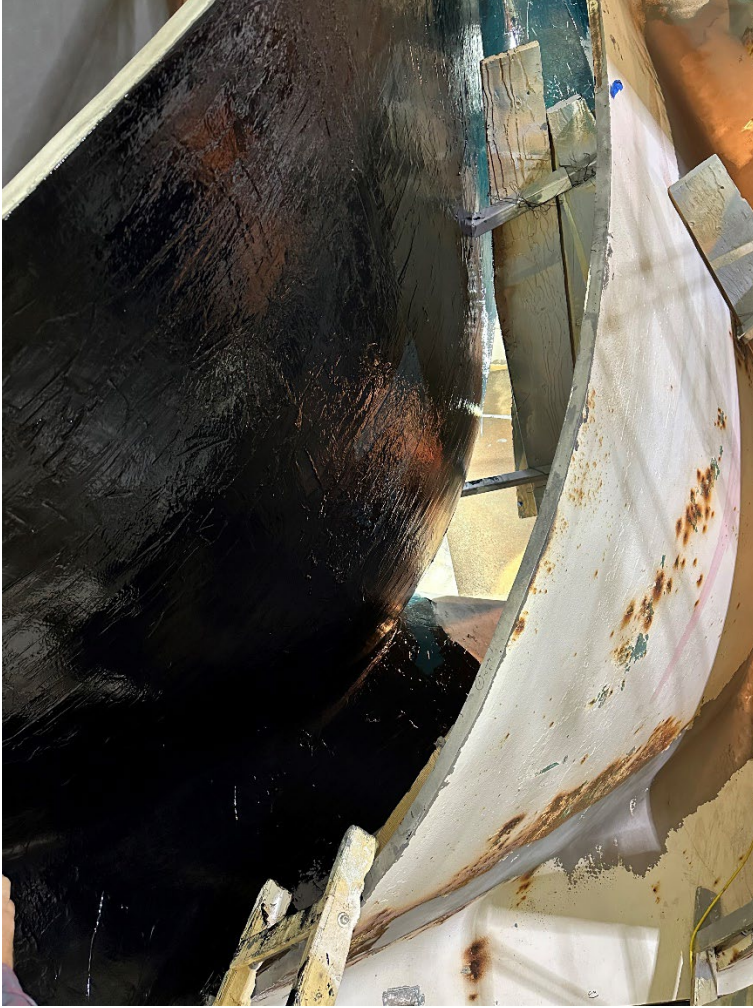
A visual inspection was performed the following day, February 8. Most of the newly coated area was fully cured, but some areas remained tacky, which prompted inspection of the used product containers. Some of the remaining material at the bottom of a mixing container was not solid, and a few Part B containers had 5–10 milliliters left in the bottom. This suggests some kits were not mixed with the full amount of Part B, resulting in improper mix ratios. Skaja advised the team to wait seven days to allow for complete curing and then conduct a sweep blast over the entire surface to find and remove incompletely cured areas, which would require spot repair following the manufacturer’s instructions.

On February 10, the team performed holiday and DFT testing. Holiday testing found no defects in the coating. The coating thickness averaged 46.3 mil with a maximum of 79.3 mil and a minimum of 12.3 mil. Figure 6 shows Blade 13 after PE1 application was finished.

Figure 6.—Blade 13 shown coated with PE1.

On February 16, the prescribed sweep blast revealed seventeen small spots (3 x 3 inches) that needed repair. Three of the areas were within the cavitation zone and were repaired with PE1 on March 15. The areas outside the cavitation zone were repaired with three coats of solvent-borne epoxy.

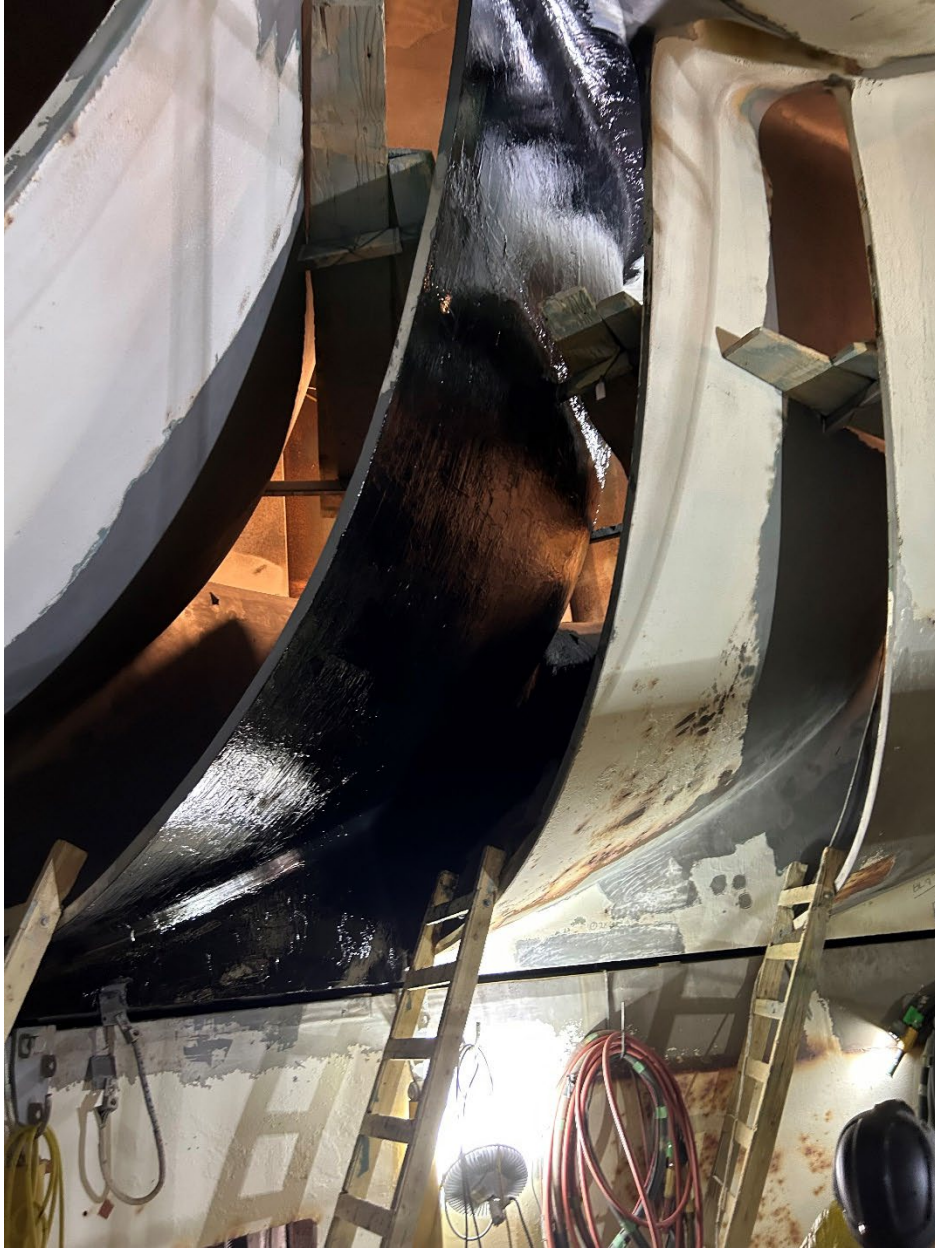
On February 10, the team performed holiday and DFT testing. Three pinholes were found on Blade 7 and repaired using one kit of PE2. The kit was heated in a warm water bath for 15 minutes to reliquefy Part A. The final coating thickness averaged 38.7 mil with a maximum of 79.0 mil and a minimum of 9.1 mil. All areas hardened as expected without any tackiness observed. Figure 8 shows Blade 7 fully coated with PE2.

Figure 8.—Blade 7 shown coated with PE2.

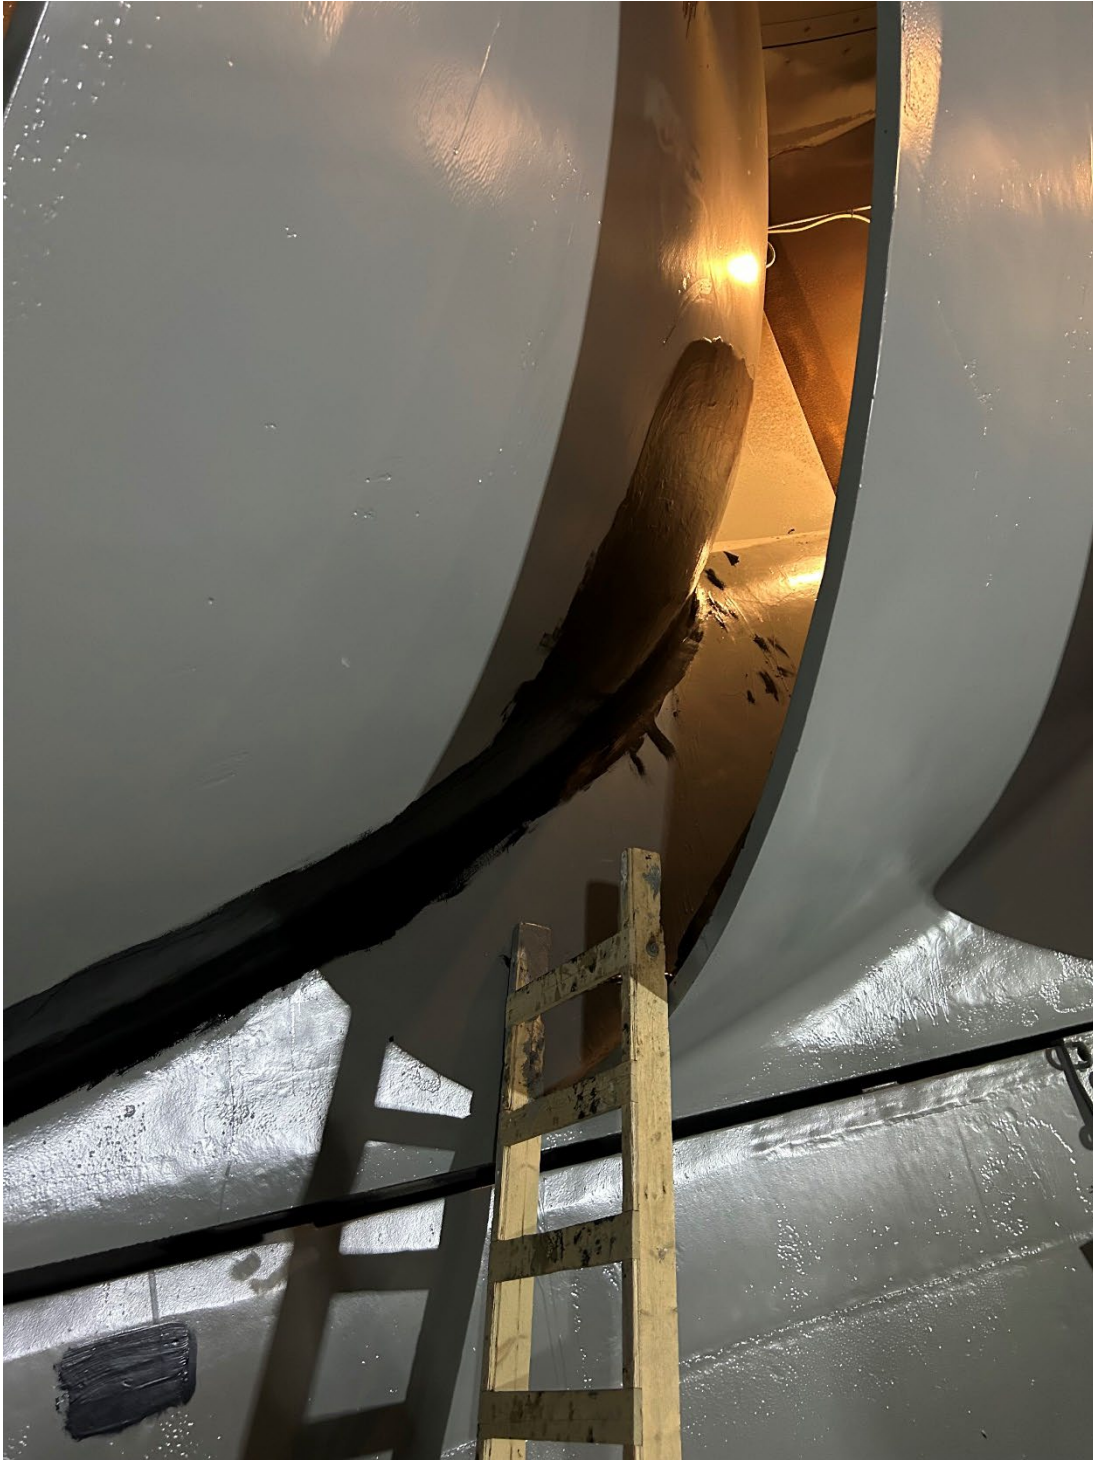
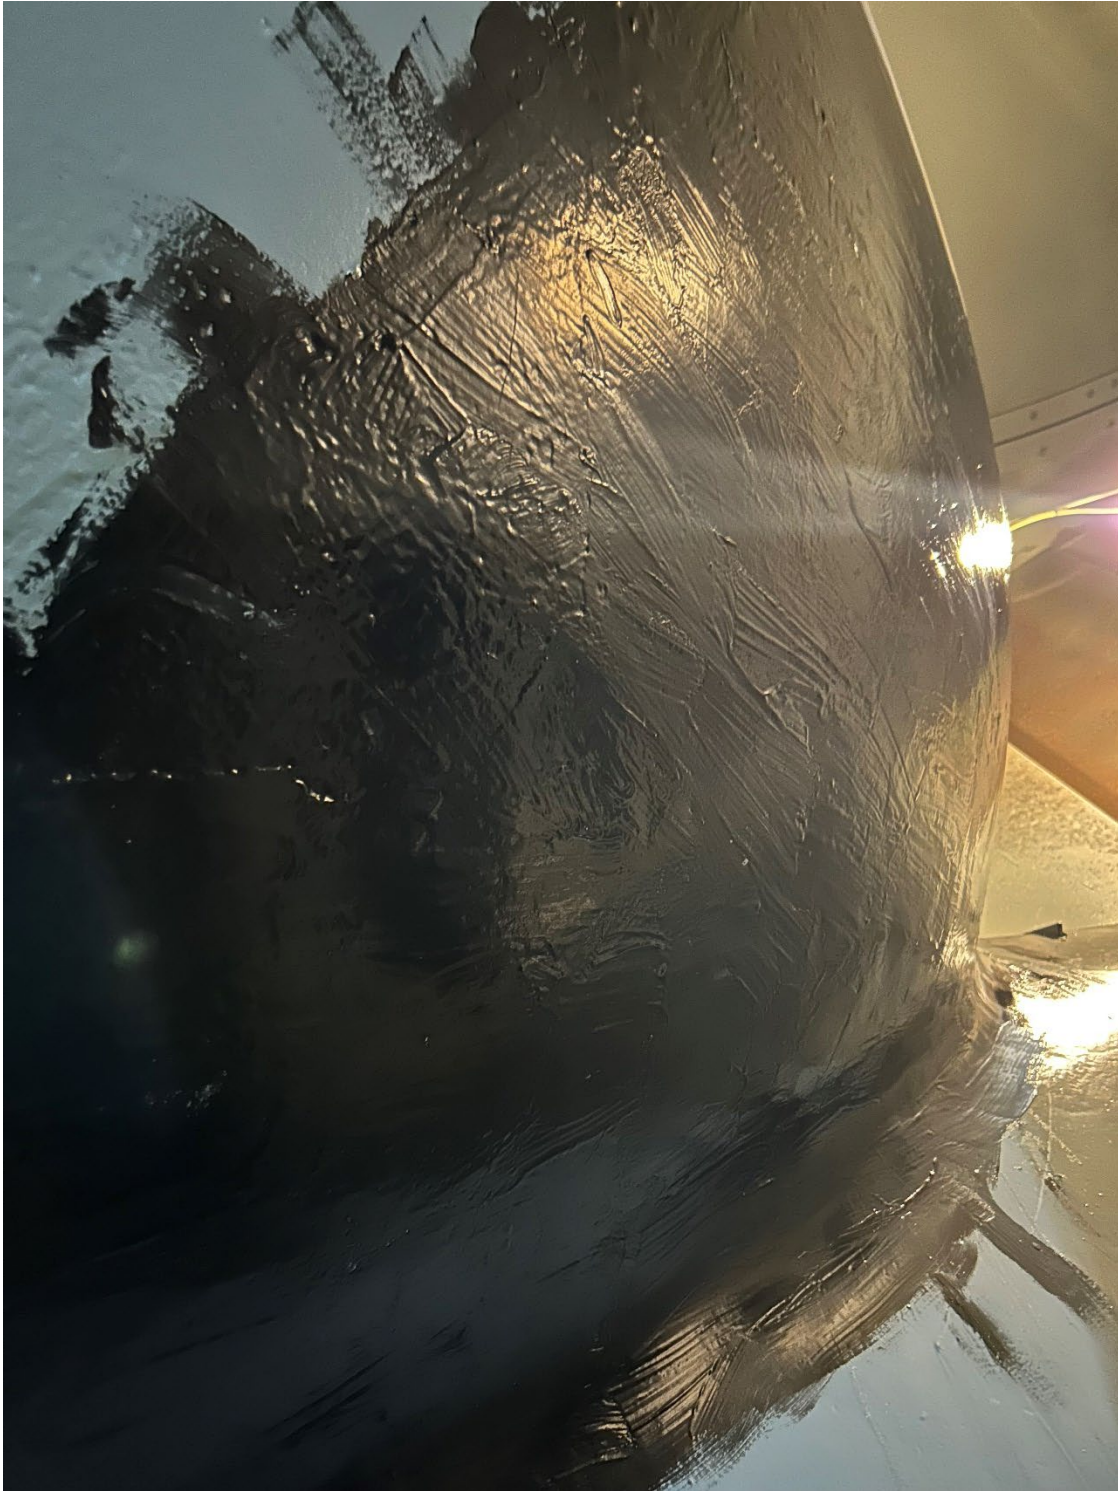
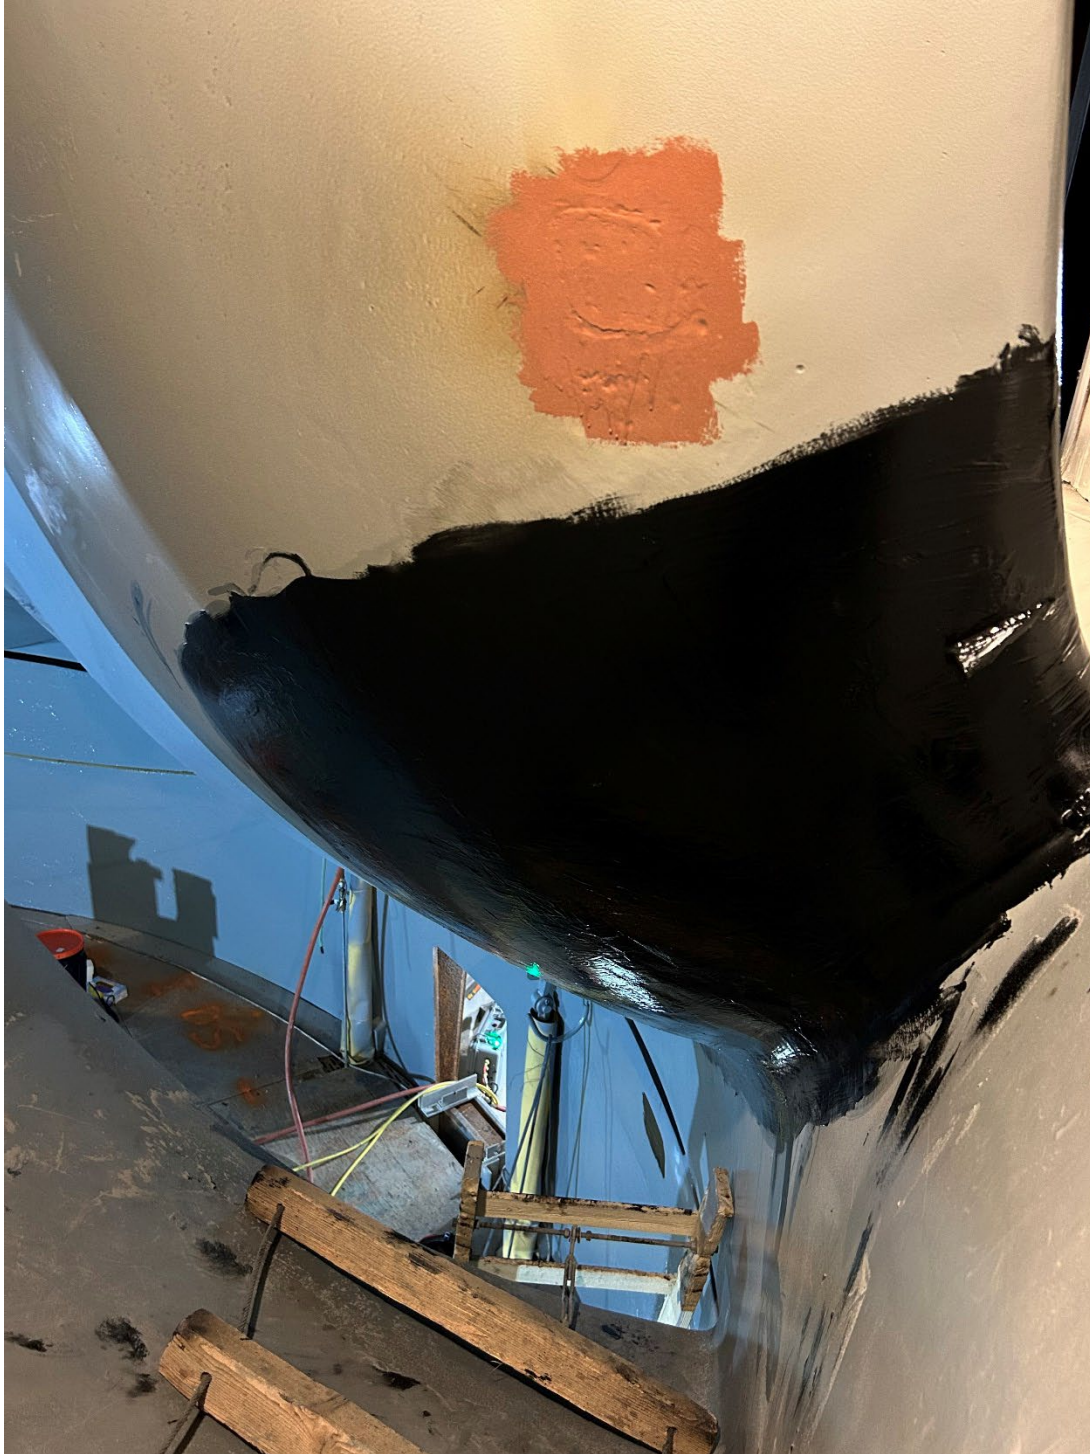
On March 22, Skaja inspected Blade 8, documented DFT measurements, and took photos. The DFT of the epoxy adjacent to the cavitation zone was 13 mil average. The final coating thickness of PE2 averaged 40.6 mil with a maximum of 81.0 mil and a minimum of 16.1 mil. All areas hardened as expected without any tackiness observed. Figures 9–11 show Blade 8 coated with epoxy and PE2 coated in the cavitation zone.

Figure 9.—The cavitation zone of Blade 8 shown coated with solvent-borne epoxy and PE2.

Figure 10.—The cavitation zone of Blade 8 shown coated with solvent-borne epoxy and PE2.

Figure 11.—The cavitation zone of Blade 8 shown coated with solvent-borne epoxy and PE2 before exposure.

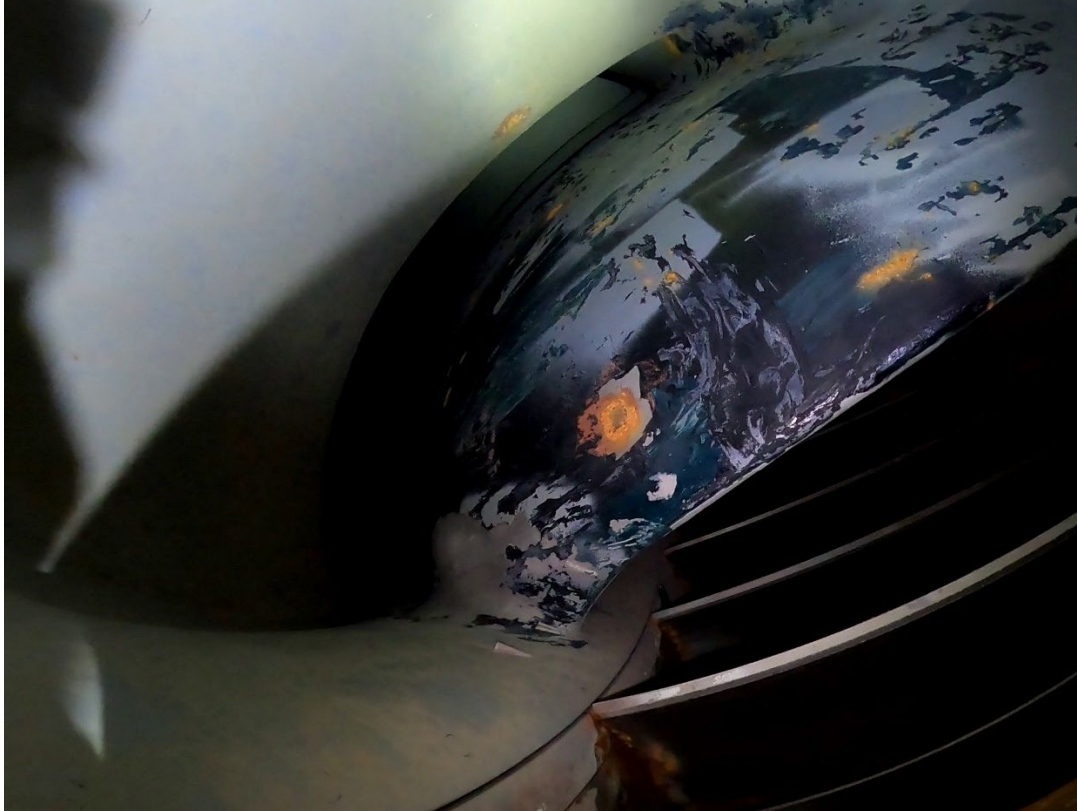
In mid-August, the G21 transformer experienced a failure, and there was a stop in power generation. On October 18, 2023, Grand Coulee staff inspected the PE1 and PE2 cavitation resistant coatings after approximately 1,000 hours of operation. The inspection showed PE1 providing adequate cavitation performance on most of the turbine blade, with approximately 1 square foot of coating damage exposing stainless steel weld overlay in the most severe cavitation zone. This location is near the leading edge on the suction side of the blade, as shown in Figure 12. The few corrosion spots are likely from spot repairs of the application defects and inability to control the coating thickness due to brush and trowel application.

First, for Blade 13, improper mixing ratios of PE1 Parts A and B resulted in areas of incompletely cured product. This was likely due to the relatively short, 13-minute pot life of the system, which presents a challenge for field application. This may have been exacerbated by the exposure assessment requirements—such as wearing full PPE and additional monitoring equipment—which were time consuming and cumbersome. The trial for PE2 did not result in areas of incompletely cured product, which has nearer to a 45-minute pot life. Additionally, PE1 was applied late in the afternoon, requiring the team to work past normal business hours, which increased the stress on individuals to get the materials applied. To improve results in future application, some suggestions are:

Figure 12.—Cavitation damage on leading edge suction side of PE1, approximately 1 square foot of damage. The gray color is from application defects that were repaired with an epoxy.

- provide a demonstration on how to handle quickly-curing coatings,
- allow team members to perform/witness practice applications and discuss feedback and what can be improved,
- and begin application early enough in the day so that work can be completed within normal business hours.

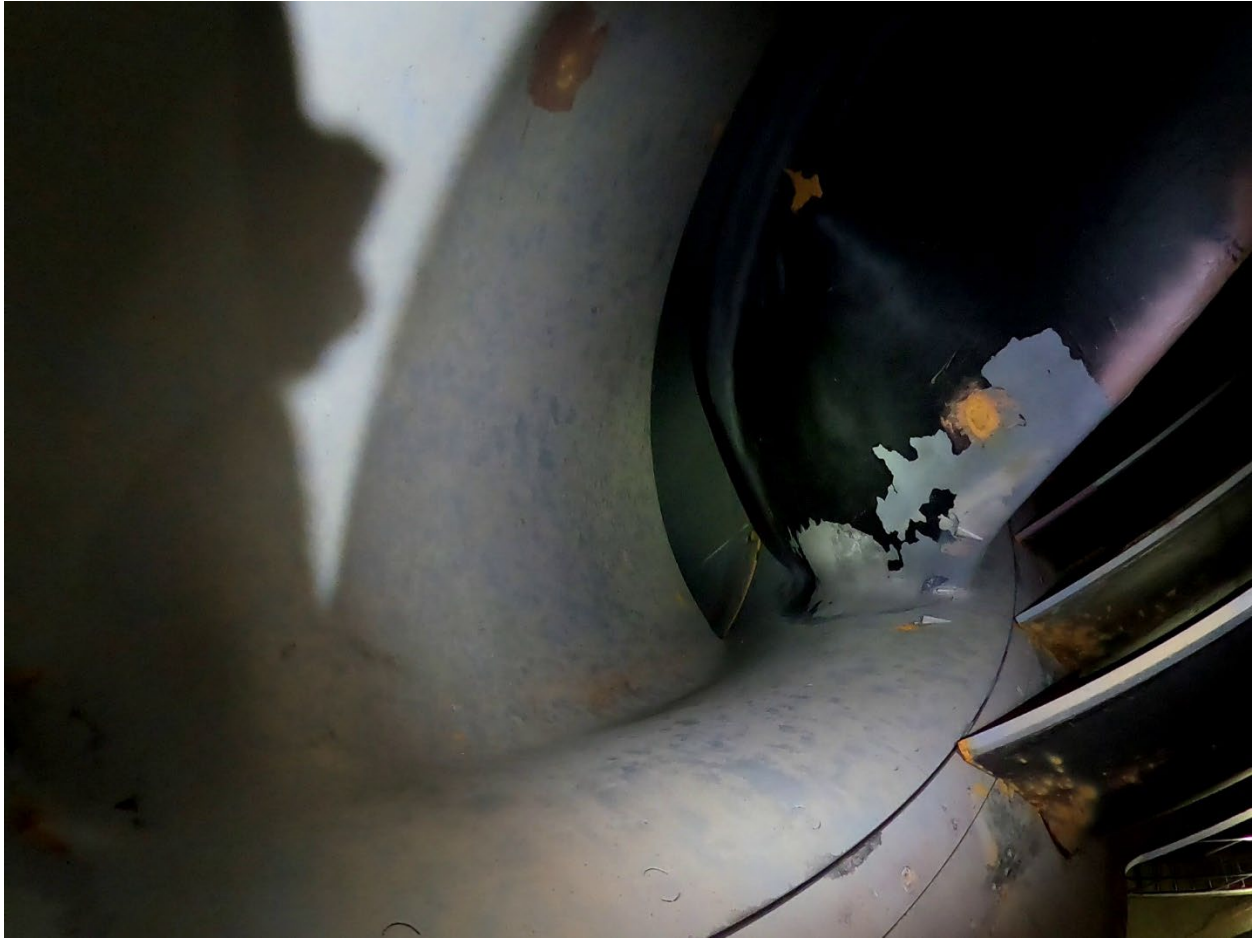
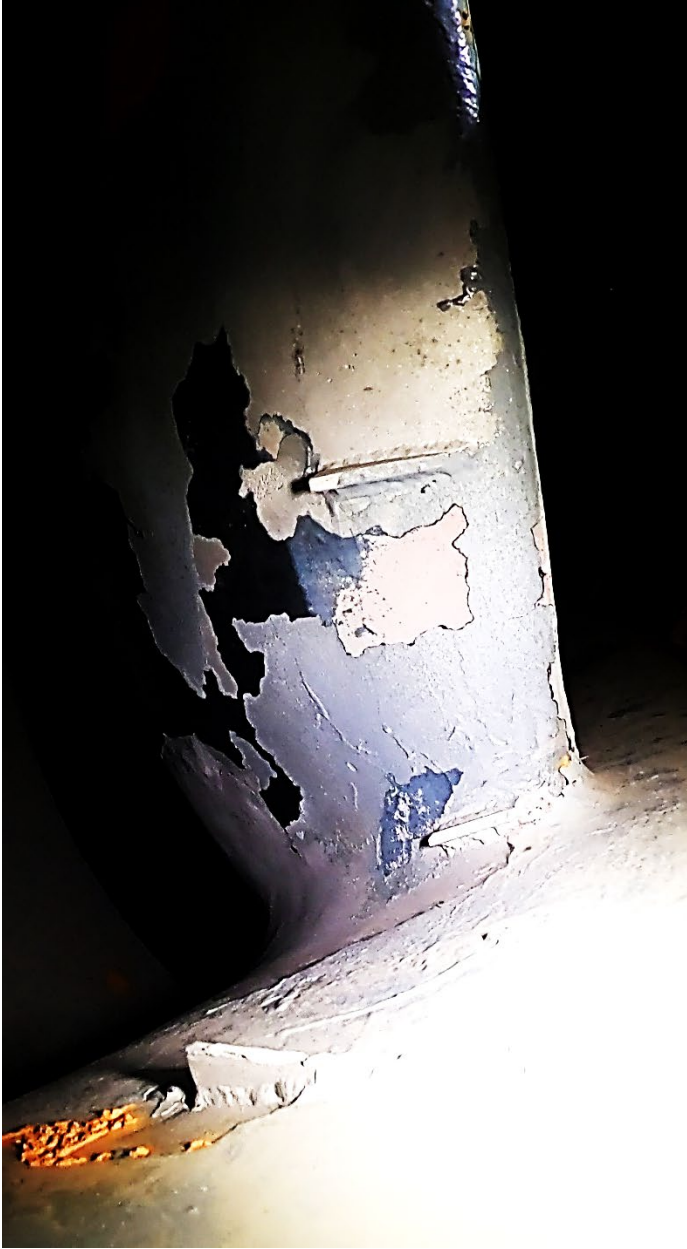
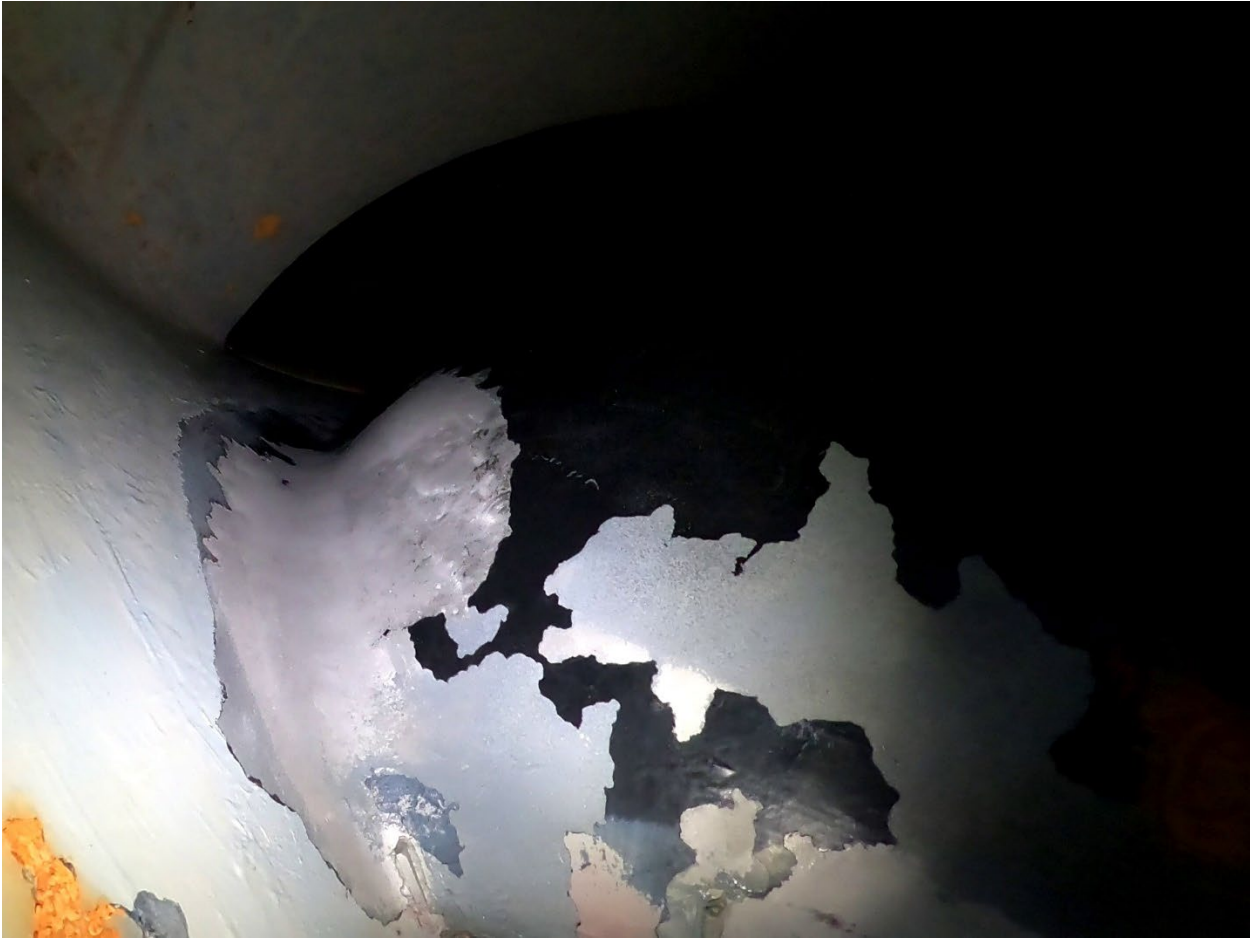
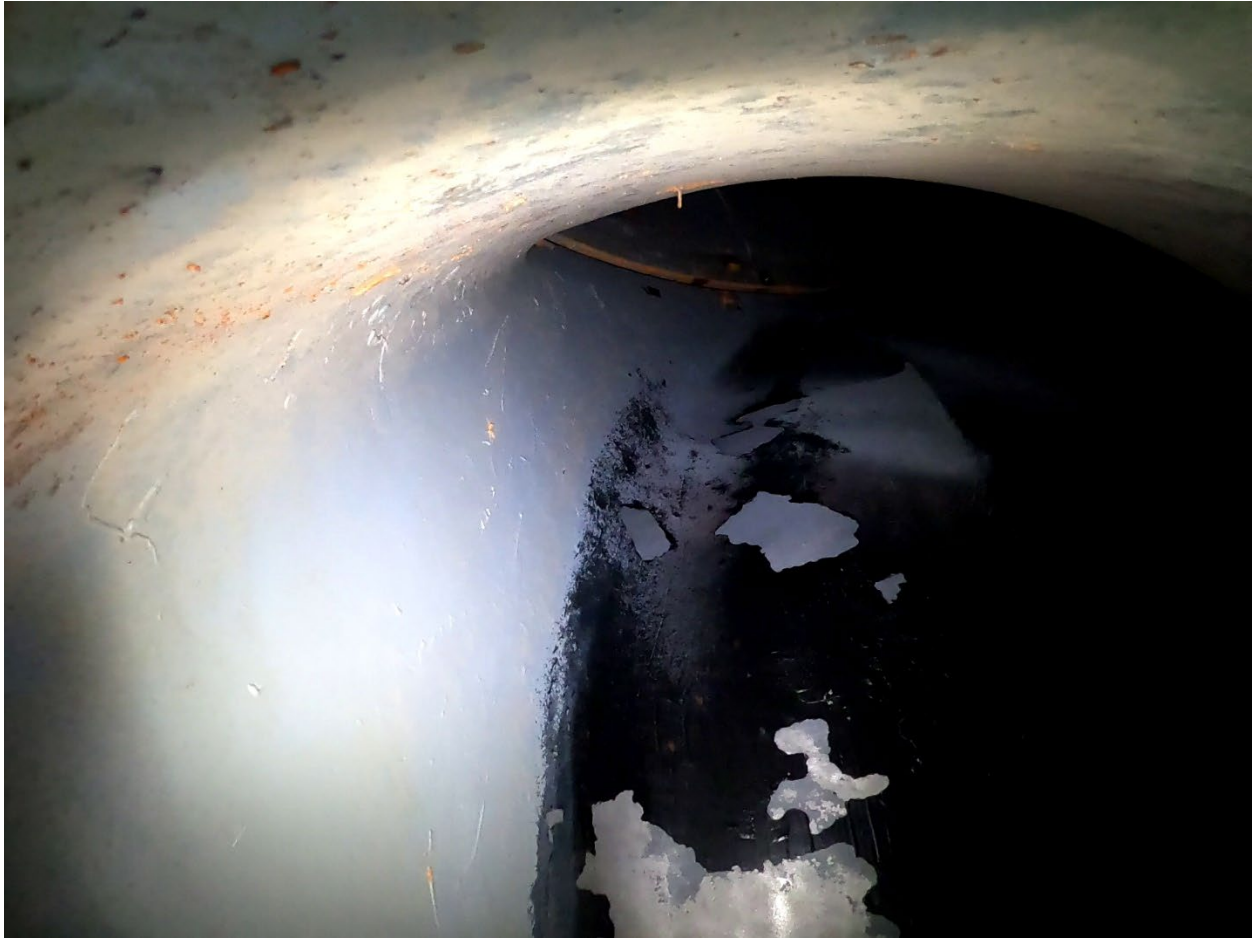
The inspection on October 18, 2023, showed approximately 10 square feet of coating damage in the PE2 repair due to cavitation and delamination between coats, with some areas exposing stainless steel weld overlay in the severe cavitation zone near the leading edge on the suction side of the blade as shown in Figures 13–16.

The second challenge, shown on the Blade 7 application, was that the team had not considered the crystallization temperature of PE2 Part A. It is possible that the use of two coats of adhesive on Blade 7 due to the initial crystallization of PE2 Part A contributed to the disbonded coating. This challenge was overcome by warming up the materials to 85F overnight or by reliquefying for 15 minutes in a warm water bath. An additional solution could be to place the materials in heating blankets prior to use. Future applications can utilize heating blankets or 5-gallon pails of warm water to keep the product components at an appropriate temperature for application.

- Blade 7 showed the most damage, approximately 10 square feet, possibly due to having two adhesive coats because of the PE2 Part A crystallization delaying the application one day to re-warm. Blade 13 showed approximately 1 square foot of damage. The damage location was consistent for both and in the severe cavitation zone near the blade leading edge.

Figure 13.—Blade 7 after 1,000 hours of operation. The PE2 failed by cavitation and delamination on leading edge with approximately 10 square feet of damage. The rust spot near the center of the blade is from the welded brace that was removed for the platform and repaired using an unknown procedure.

Figure 14.—Close-up of Blade 7 after 1,000 hours of operation. The PE2 failed by cavitation and delamination on leading edge.

Figure 15.—Close-up of Blade 7 after 1,000 hours of operation. The PE2 failed by cavitation and delamination.

Figure 16.—Close-up of Blade 7 after 1,000 hours of operation. The PE2 failed by cavitation and delamination.

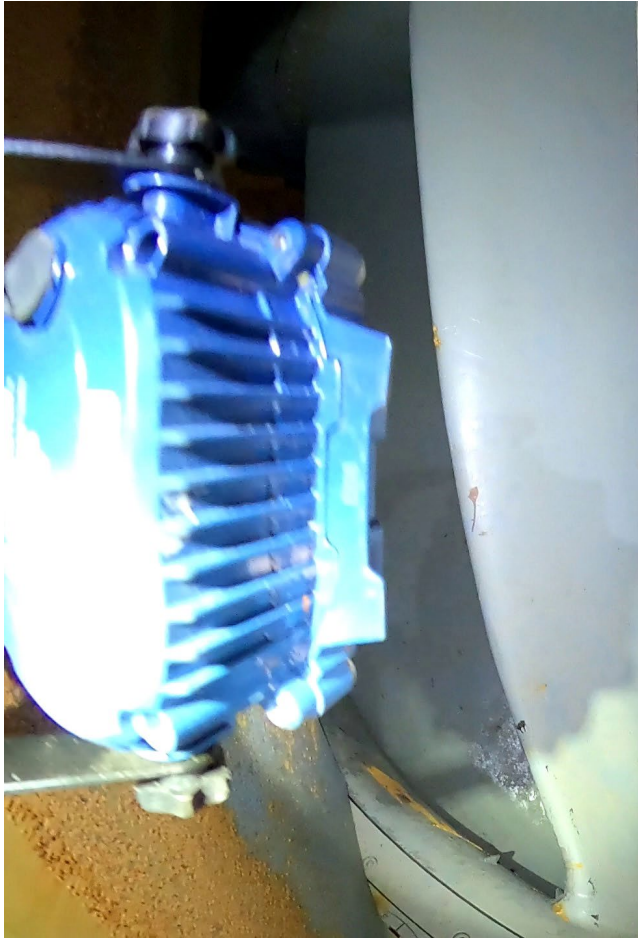
The inspection on October 18, 2023, accidentally omitted Blade 8 so there is no data at 1,000 hours of operation. The only documentation is showing the leading edge on the upstream side of the blade, with small black specks of coating remaining, shown in Figure 17. Blade 8 will be inspected during the next outage.

The application of PE2 on Blade 8 was installed by field personnel with a corrosion resistant primer. The exact details of the application were not documented, and the inspection at 1,000 hours of operation omitted Blade 8. Thus, the outcome is unknown at this time. More information on results, challenges, and lessons learned from the Blade 8 application of PE2 can be determined after the next inspection.

Figure 17.—Leading edge of Blade 8 showing the applied PE2 almost completely gone, with only a few specks of the black coating still remaining after 1000 hours. No photos are available of the downstream side of the blade shown in Figure 11.
