Flatiron Powerplant Unit 2 Butterfly Valve Cavitation Resistant Coating Field Trial

Interim Report No. ST-2023-20024-03
Technical Memorandum No. 8540-2023-34

Big Thompson Project, Colorado
Missouri Basin Region

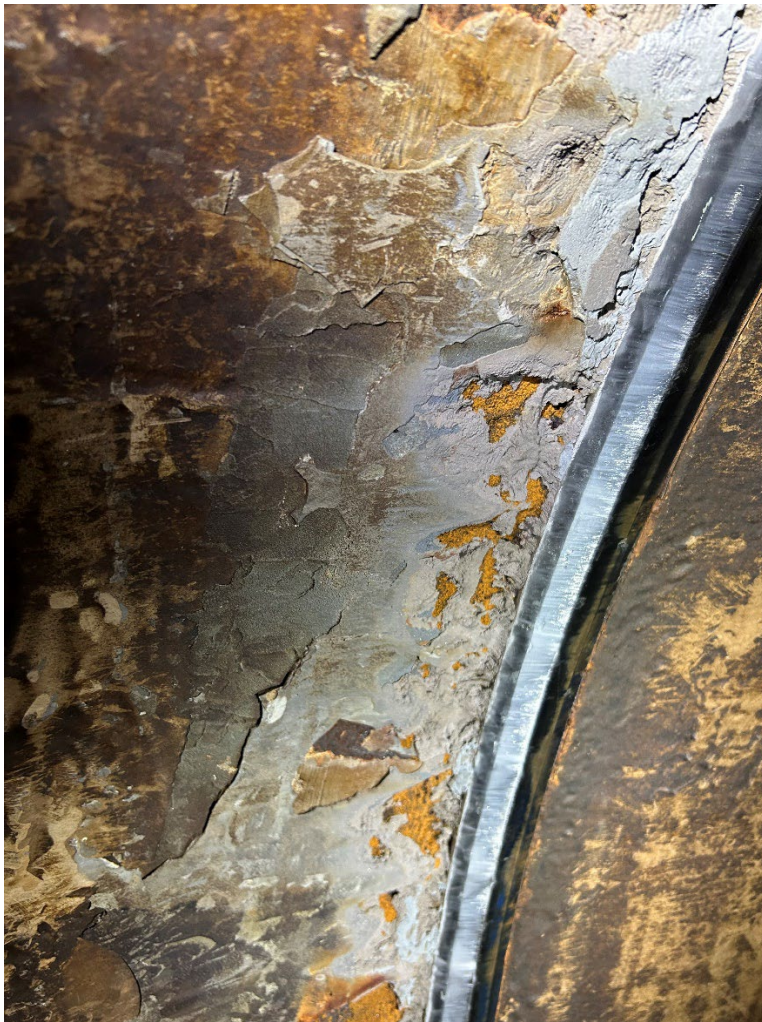
The downstream side of the valve body, shown in Figure 1–Figure 2, exhibited 3/8-inch-deep cavitation pits, resulting from the 500-pound-per-square-inch (psi) pressure drop caused by water seeping around the seats when the valves are in the closed position. On the morning of March 28, 2023, the area was cleaned with needle guns and a bristle blaster to prepare the cavitated areas of the butterfly valve body to bare metal conditions per SSPC-SP11, as shown in Figure 3–Figure 5 [2].

Figure 1.—Condition of the cavitation damage downstream of the butterfly seat (left side of stainless steel seal) prior to surface preparation.

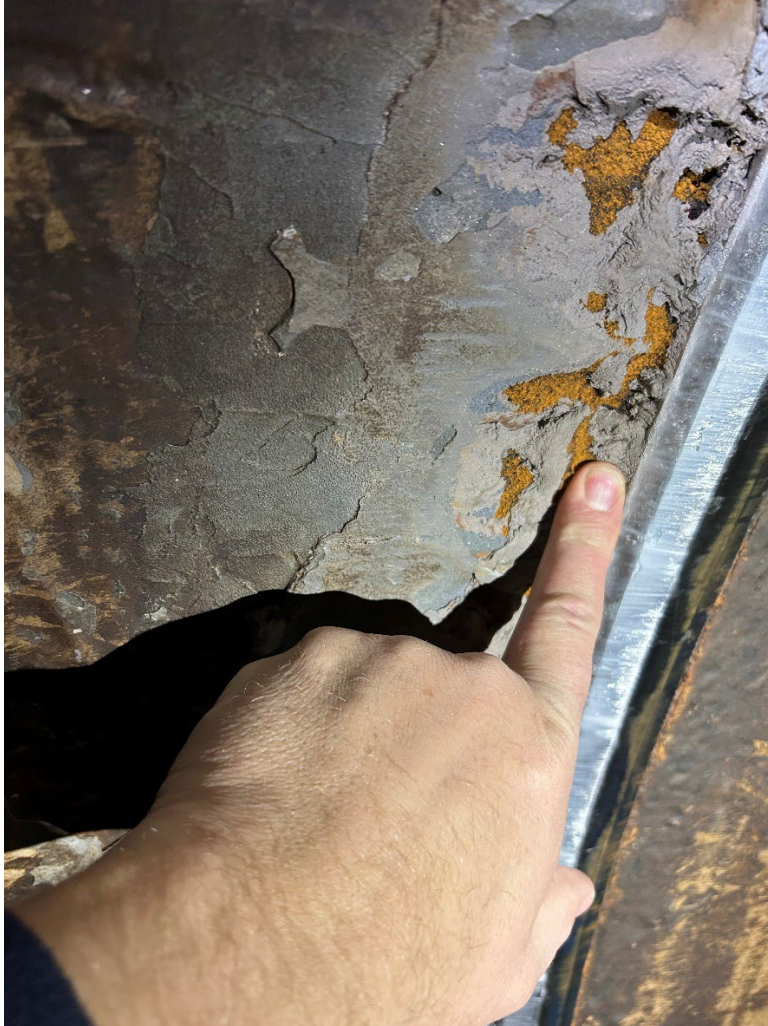
Figure 2.—Condition of the cavitation damage downstream of the butterfly seat prior to surface preparation.

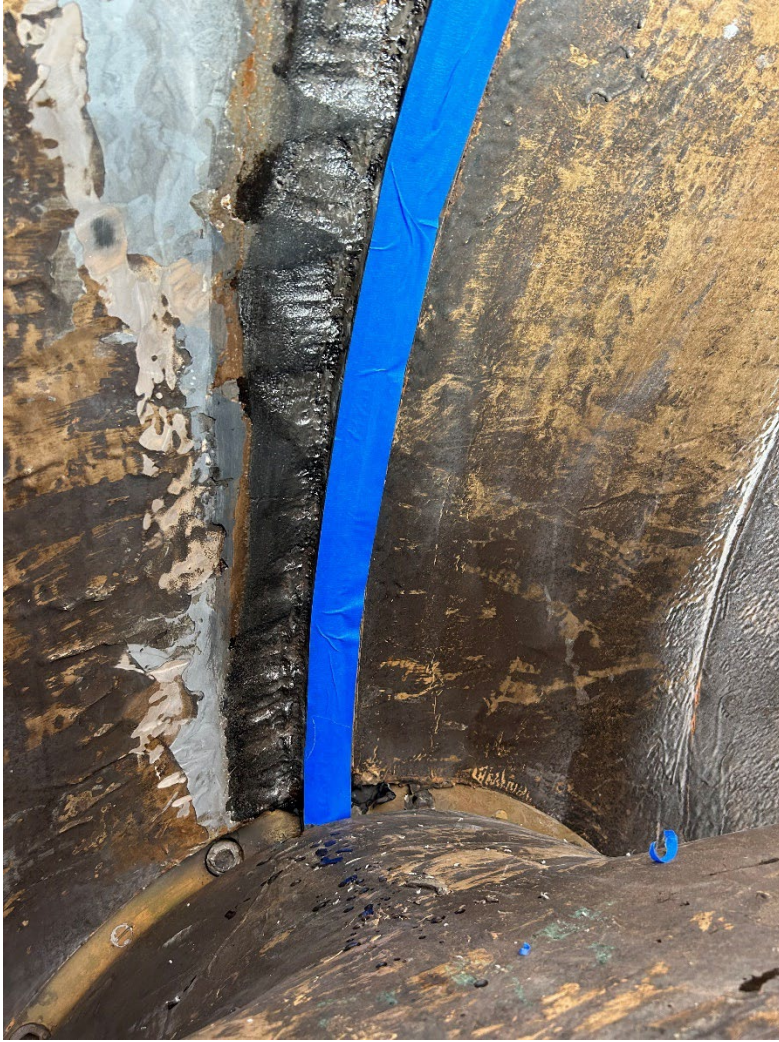
Figure 3.—Power tool cleaning to metal of the cavitation damage downstream of the butterfly seat. The blue tape is protecting the stainless steel seat. The 3/8-inch-deep cavitation damage is to the left of the tape.

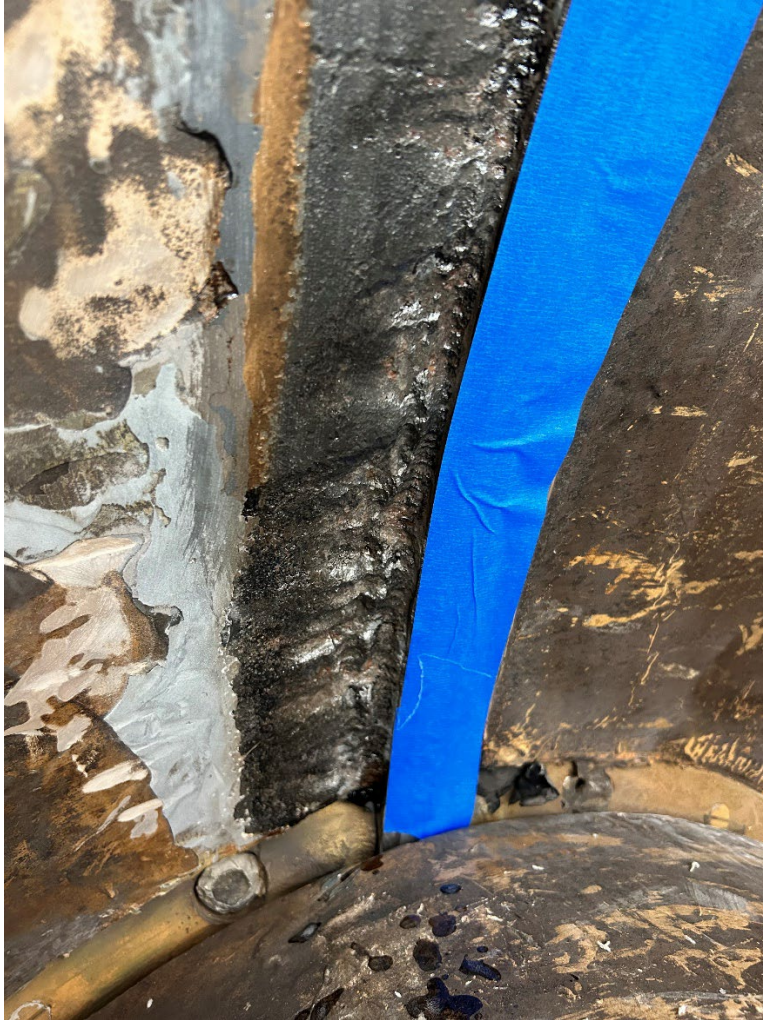
Figure 4.—Powertool cleaning to metal of the cavitation damage downstream of the butterfly seat. The blue tape is protecting the stainless steel seat. The 3/8-inch-deep cavitation damage is to the left of the tape.

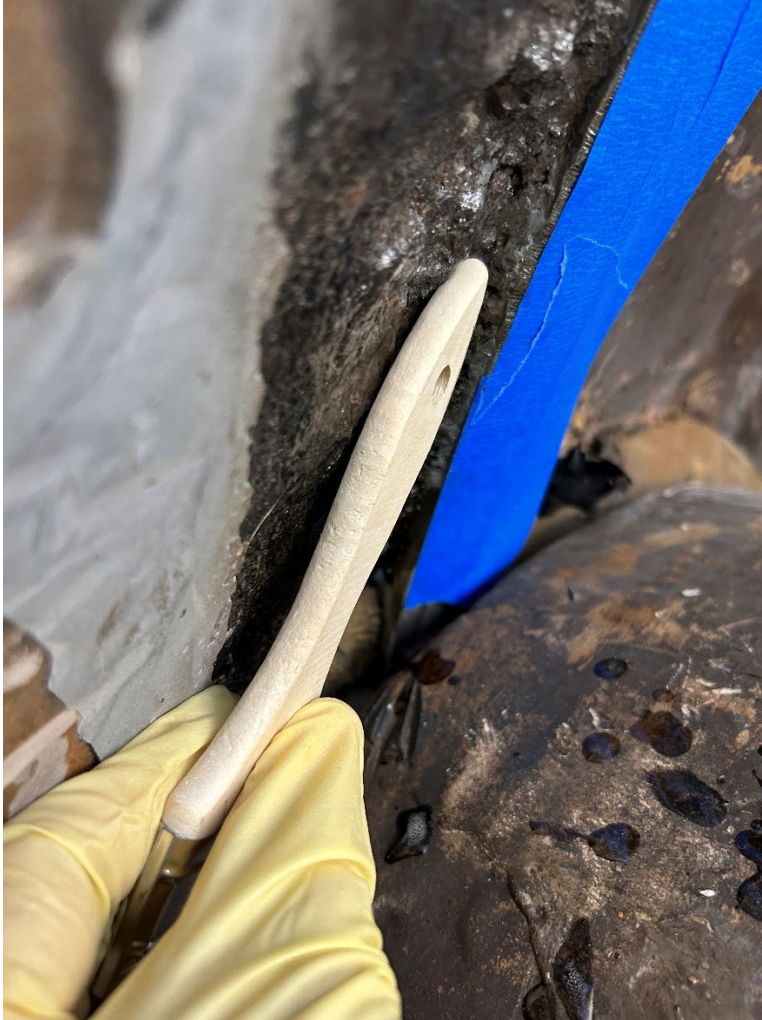
Figure 5.—Cavitation damage downstream of the butterfly seat shown after power tool cleaning exposed pits up to 3/8 inches deep.

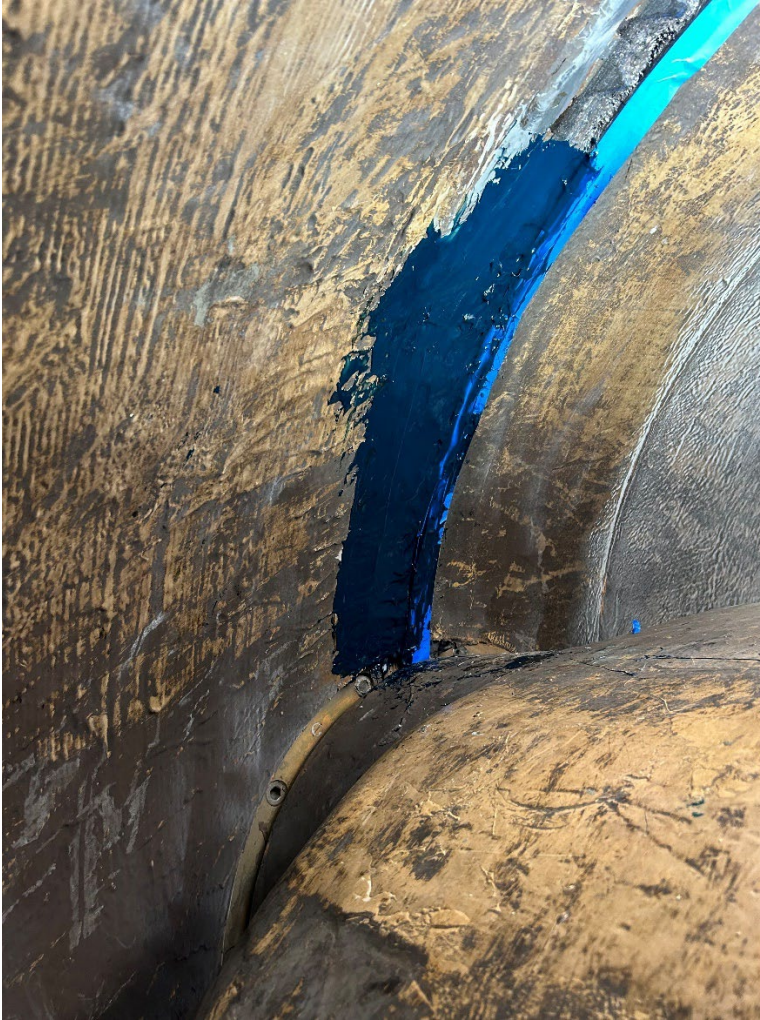
Figure 6.—PE1 is shown applied between the 9 o'clock and 11 o'clock positions.

PE1 was mixed for three minutes and applied to its test area between the 8 o'clock and 11 o'clock positions, and across the trunnion at the 9 o'clock position. The lining was worked into the surface profile and cavitation pits with a thin initial layer using brushes. The lining was applied in layers until all pits were filled. A trowel was used to periodically smooth any sags until the viscosity held the elastomer in place and no further sags formed. Figures 6–7 show the PE1 test area after the final application.

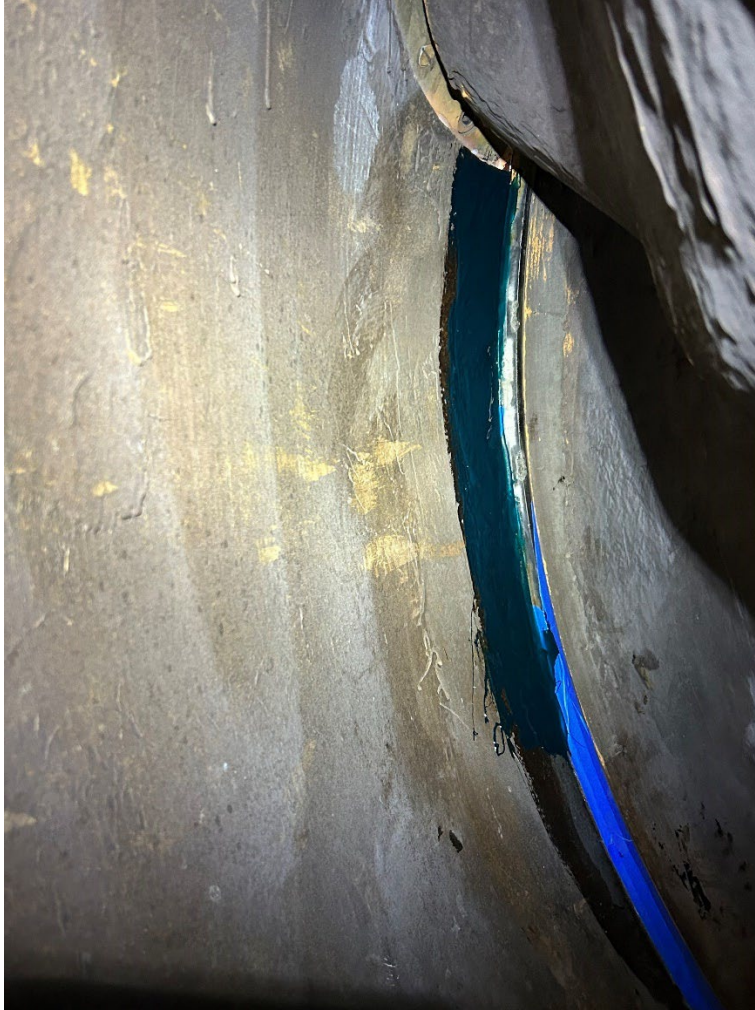
Figure 7.—PE1 is shown applied between the 8 o'clock and 9 o'clock positions.

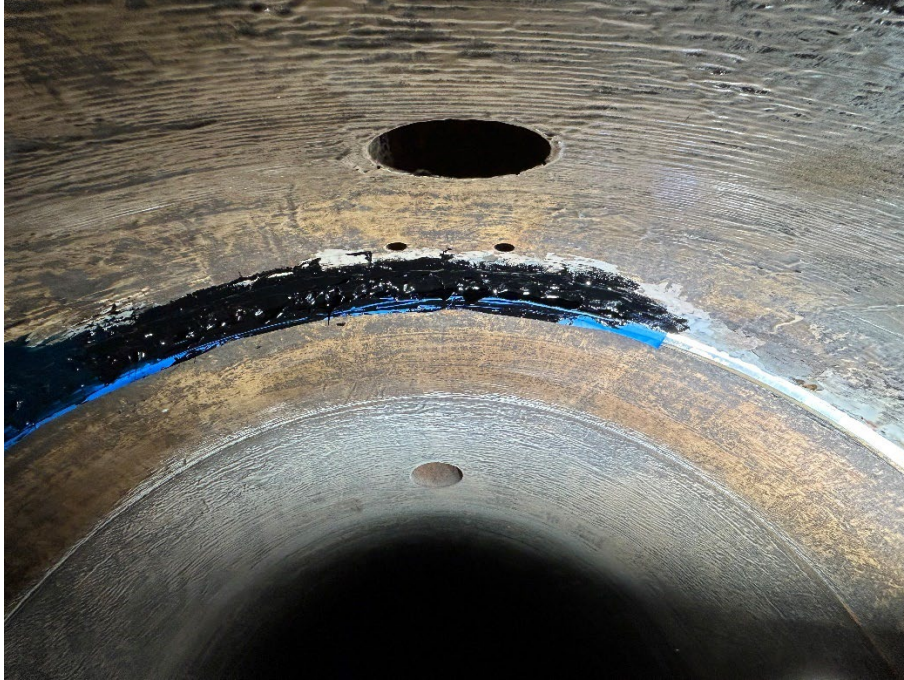
Figure 8.—PE2 is shown applied between the 11 o'clock and 1 o'clock positions.

PE2 was mixed for three minutes and applied to its test area between the 11 o'clock and 1 o'clock positions and between the 7 o'clock and 8 o'clock positions. The lining was worked into the surface profile and cavitation pits with a thin initial layer using brushes. The lining was applied in layers until all pits were filled. A trowel was used to periodically smooth any sags, but sags continued to form, as the viscosity of this coating was lower than PE1 and it never increased to a point where it would stay entirely in place. Figures 8–10 show the test area after application of the first coat. A second coat was applied on March 29, 2023. Once the second coat had cured, remaining drips and sags were ground smooth with an angle grinder. Figure 11 shows the completed field trial cavitation repair area.

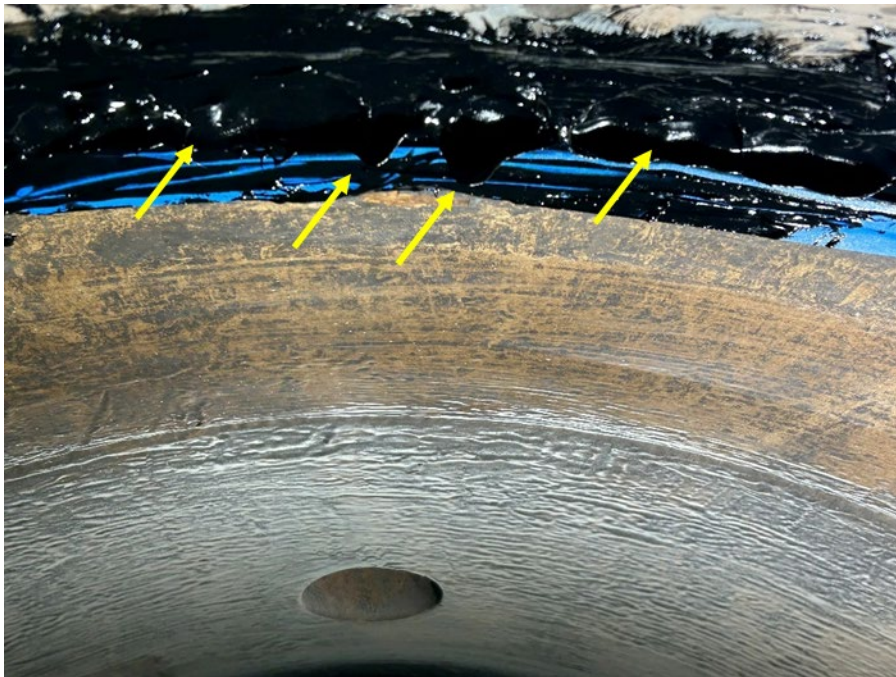
Figure 9.—PE2 is shown applied between the 11 o'clock and 1 o'clock positions. The lower viscosity resulted in sags and drips, noted with arrows.

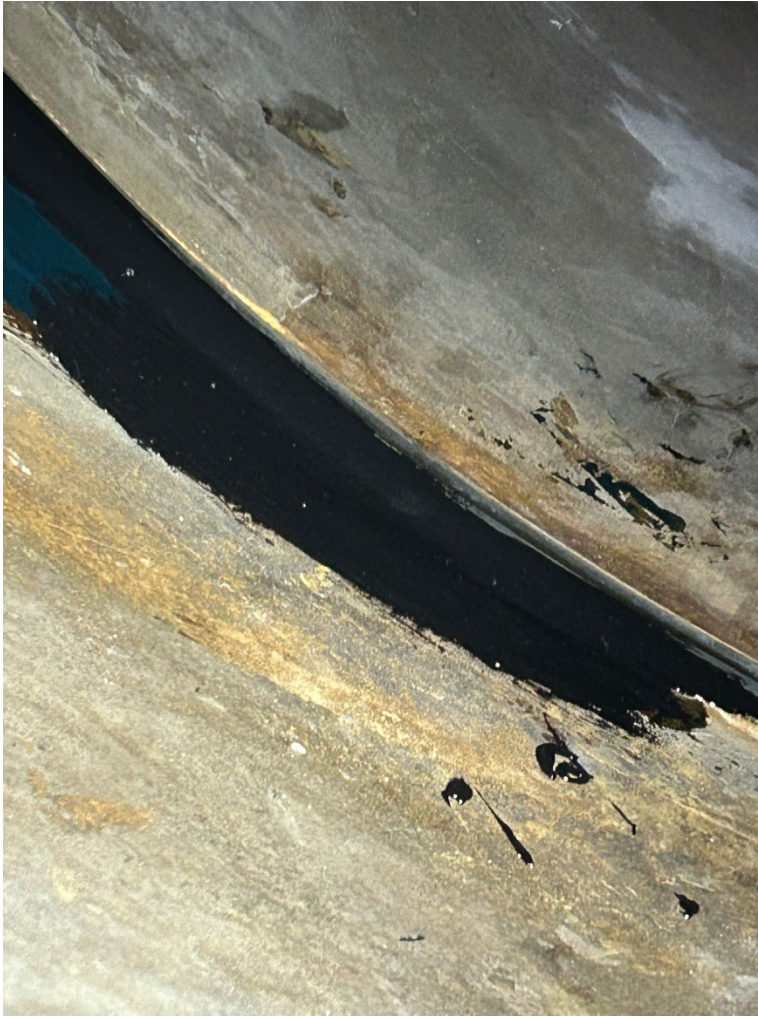
Figure 10.—PE2 is shown applied between the 7 o'clock and 8 o'clock positions.

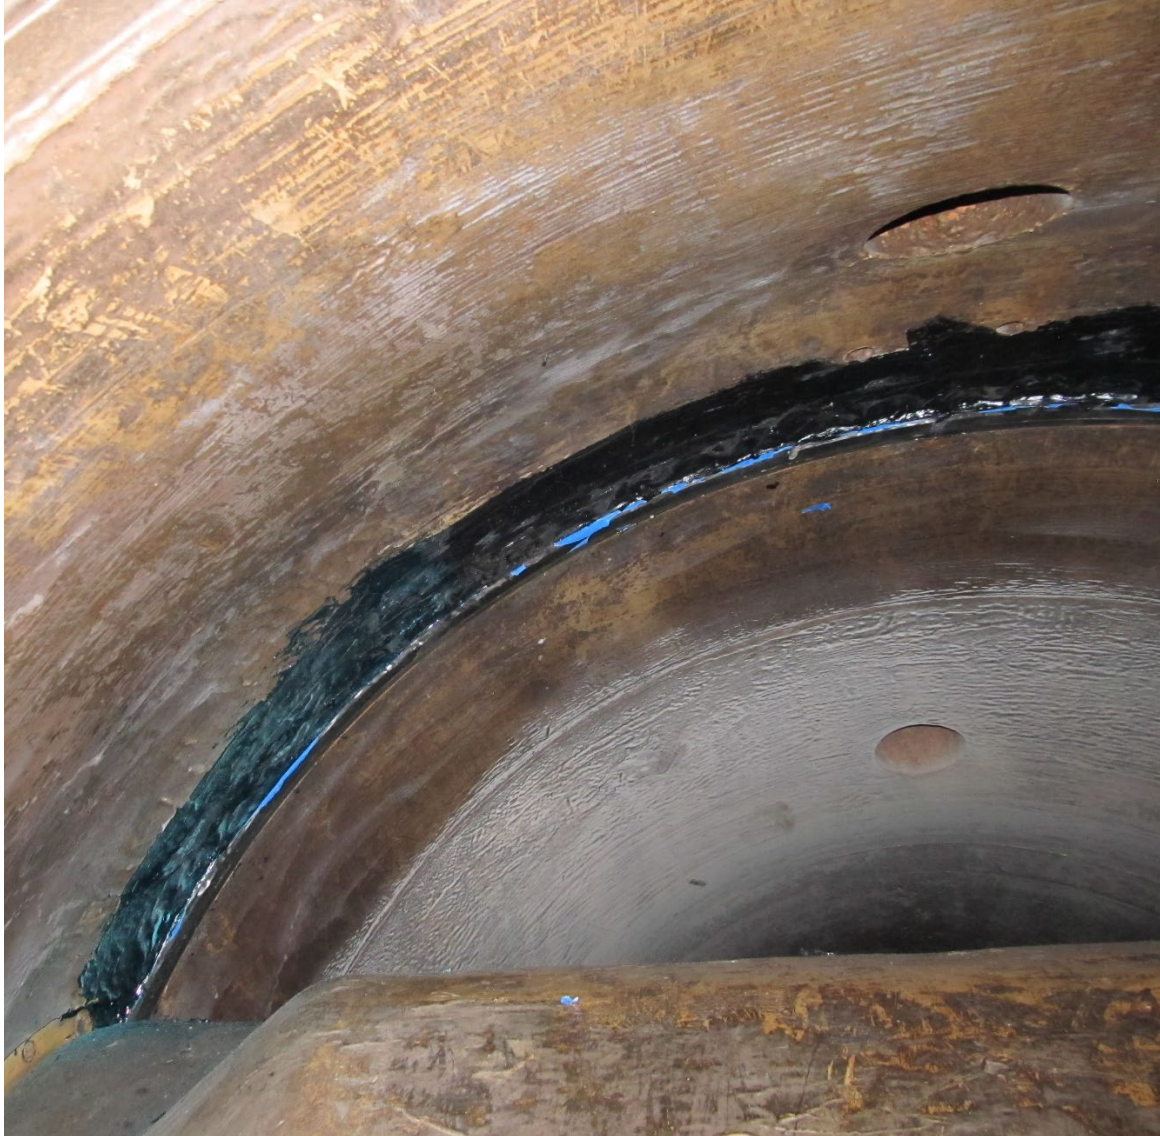
Figure 11.—Test area is shown prior to recommissioning Unit 2 penstocks. Drips and sags had been smoothed, but a few areas still needed to be sanded down to allow for proper operation of the butterfly valve.
