Shasta Dam Unit 5 Penstock – Historic Linings Field Test Site

Science and Technology Program
Research and Development Office
Interim Report No. ST-2022-22024-01
Technical Memorandum No. 8540-2023-42

Interim Report ST-2023-22024-01

Technical Memorandum No. 8540-2023-42

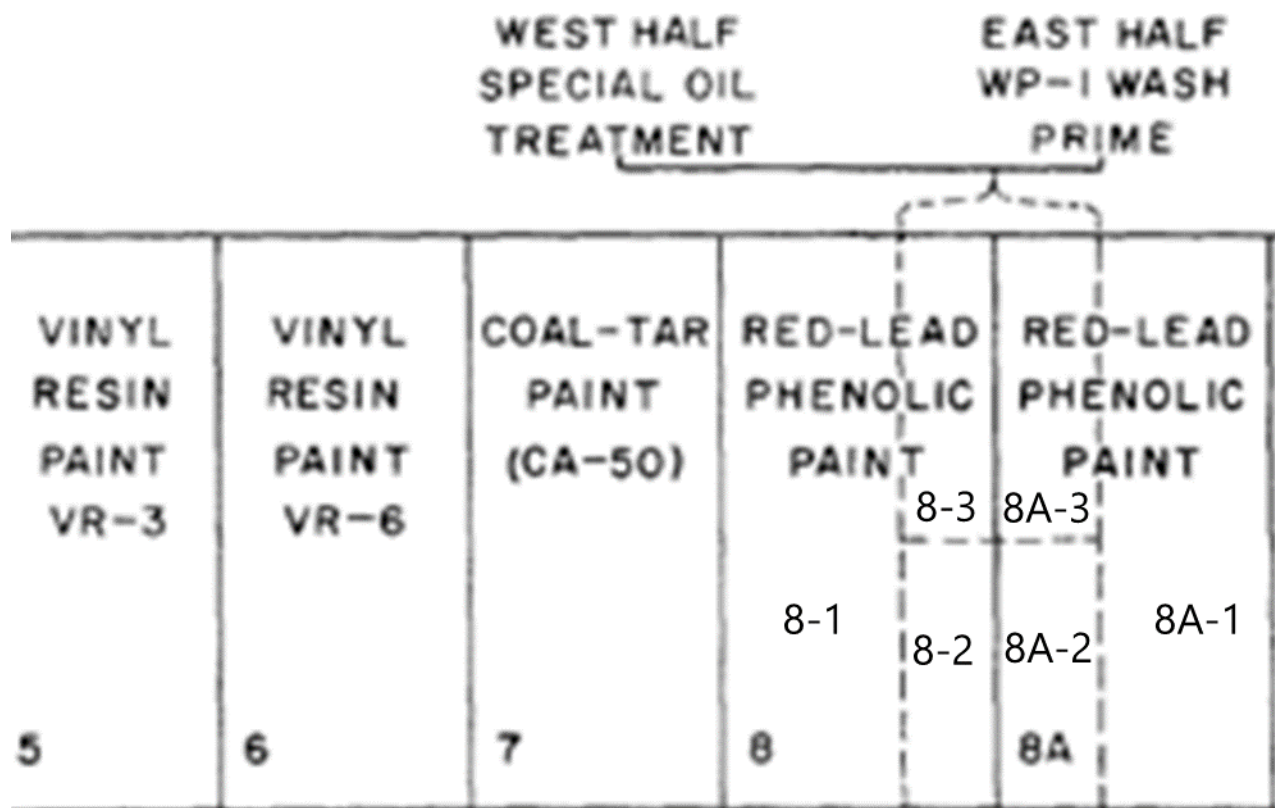
Sometime after the 15-year inspection the linings in test sections 1-4 and 9-20 failed and were relined or were relined in 2009 during a maintenance contract. In 2009, repairs were made to the coal tar enamel lining throughout the penstocks using 100-percent solids epoxy. During this construction project, the contractor found the 1949 study was still on-going. In 2019, Reclamation coatings inspectors performed visual inspection of the remaining test linings and collected field electrochemical impedance spectroscopy (EIS) data on the remaining experimental linings and the 10-year-old 100-percent solids epoxy repair lining. Nine experimental linings remained in the study, [2] the visual inspection report stated they were in poor condition by visual inspection and as no longer providing adequate corrosion protection by EIS in 2019 [3]. However, the photos showed the linings to be in good condition, with minimal corrosion, no blisters, or flaking paint. Following the 1949 rating, the author would have given several of them a B rating, “Essentially performing the intended function, but showing slight deterioration and/ or minor defects.” The remaining test linings in Figure 2 account for 55 ft of length within the original 160-ft test section.

Figure 2. Remaining test sections: System 5 VR3, system 6 VR 6, system 7 CA-50 or CTE with red lead primer (uncertain if this was repaired after the other test materials 1-4, and 9-20 failed), red lead with chromate pigments system 8 was divided into 3 separate systems, and labeled ((8-1) direct to metal, (8-2) right side (west side) oil based primer, and (8-3) left side (East side) vinyl wash primer, and moving right phenolic red lead system 8A was divided into 3 separate systems, and labeled (additionally contains chromate inhibitor pigments) ((8A-3) left side (East side) vinyl wash primer, (8A-2) right side (west side) oil based primer, and, (8A-1) direct to metal).

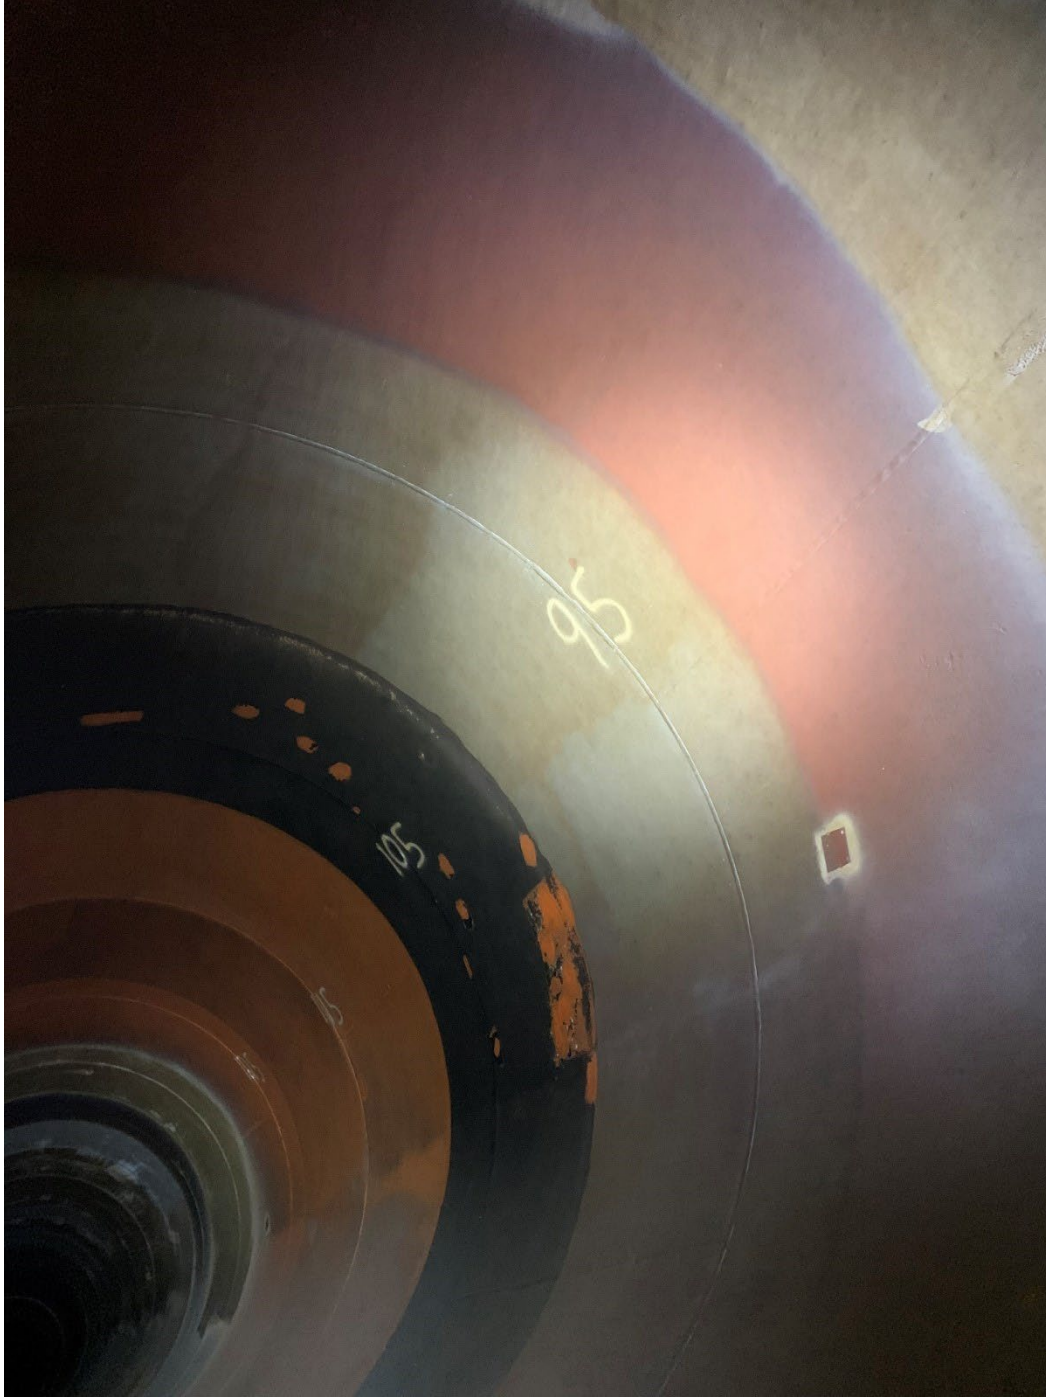
Visual inspections can be a useful method for quickly determine if a lining is providing corrosion protection. Note that silt accumulation tends to obstruct and obscure the lining appearance. Surface contaminants were cleaned and removed in EIS test locations and in spots in the lower 1/3 of the pipe for improved inspections. It was not possible to remove any surface contaminants above the spring line due to accessibility and inspectors had to make best judgement on lining condition in these areas. In addition, the inspectors noted that subsequent spot and zone repairs were made in the penstock, including repairs in the experimental test area. These factors and the overall condition of the experimental liners made it difficult to determine with certainty which product was which. Best efforts have been made to identify the linings remaining in the study by color, listed in Table 1. Figure 3 shows the field test area with multiple-colored linings which indicate a different coating system. Visual observations showed the VR-3 (red), and VR-6 (gray) vinyl linings were in good condition with no blisters or other defects within the test sections. The coal tar CA-50 (black) lining was in poor condition with significant delamination and the primer was exposed. The lead-based paint (red-orange color) linings were in good condition. The remaining Unit 5 penstock was coated with coal tar enamel (black) and spot repaired with 100% solids epoxy (light gray) and both linings were in good condition.

Based on visual observations and following industrial standard guidelines, the coal tar CA-50 lining was the only lining in the 1949 field trial that was in poor enough condition to justify removal and relining. However, the primer for CA-50 is still in acceptable visual condition and is likely providing some corrosion protection, thus maintenance could be deferred. The remaining linings were in good condition and deferred maintenance is recommended.

Figure 3. Visual condition of all test systems 5-8. Red lining system 5 VR3, (section 95 in photo) gray lining system 6 VR 6, (section 105 in photo) black lining system 7 CA-50 or CTE with red lead primer, (between sections 115 and 125) red lead systems 8 and 8A looking down the pipe ((8-1) direct to metal, (8-2) right side (West side) oil based primer), and (8-3) left side (East side) vinyl wash primer, and moving down the pipe red lead system 8A (additionally contains chromate inhibitor pigments) (8A-3) left side (East side) vinyl wash primer, (8A-2) right side (West side) oil based primer, and, (8A-1) direct to metal)

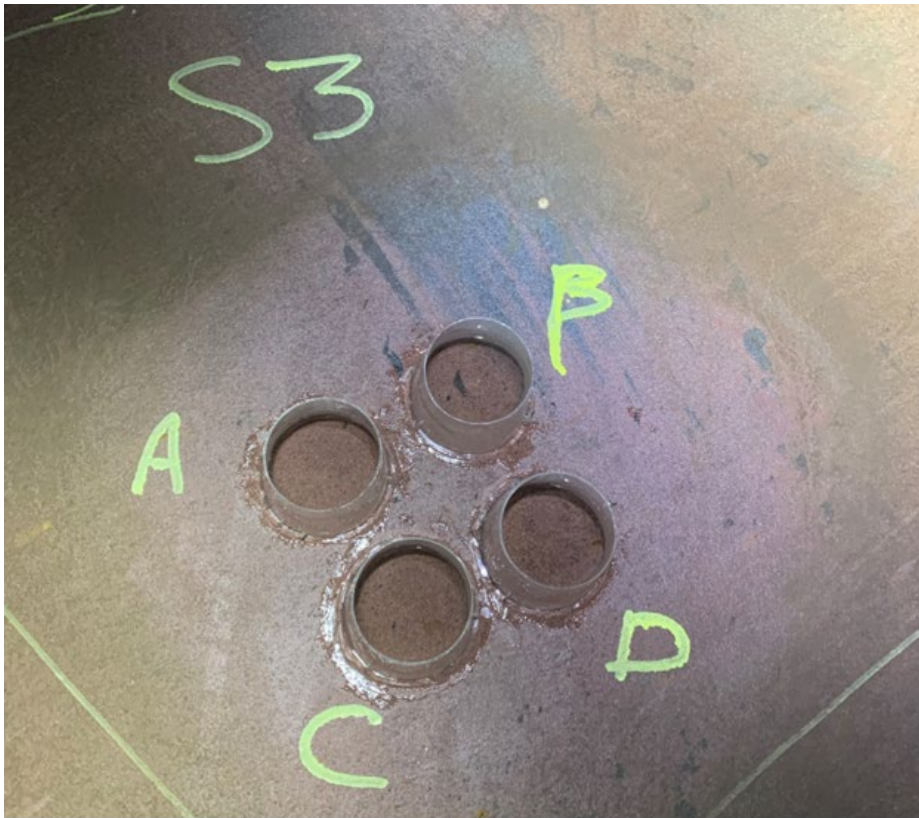
Vinyl lining VR3 (System 5) was evaluated using EIS with four different test cells as shown in Figure 4. The photo shows no visible signs of coating damage or corrosion. However, the Bode plot in Figure 5 shows VR3 was only 10^5 at 0.1 Hz after 70 years of service. The phase angle shows resistive behavior with two-time constants. The two-time constants may indicate corrosion or a stable oxide layer under the coating.

Figure 4. Visual assessment of VR3 (System 5) and EIS test setup. Notice no corrosion or blisters after 70 years of service in 18-20 ft/s flowing water conditions.

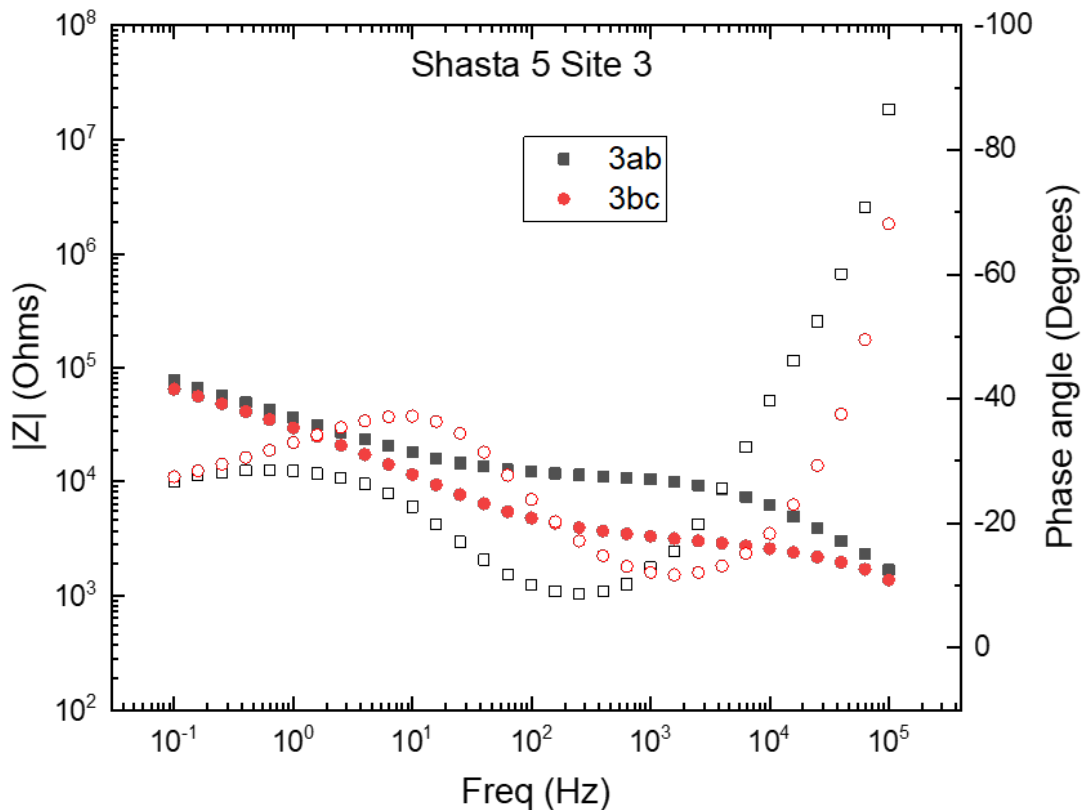
Figure 5. Typical EIS Bode plot of VR3 (System 5), the solid markers are the impedance magnitude.

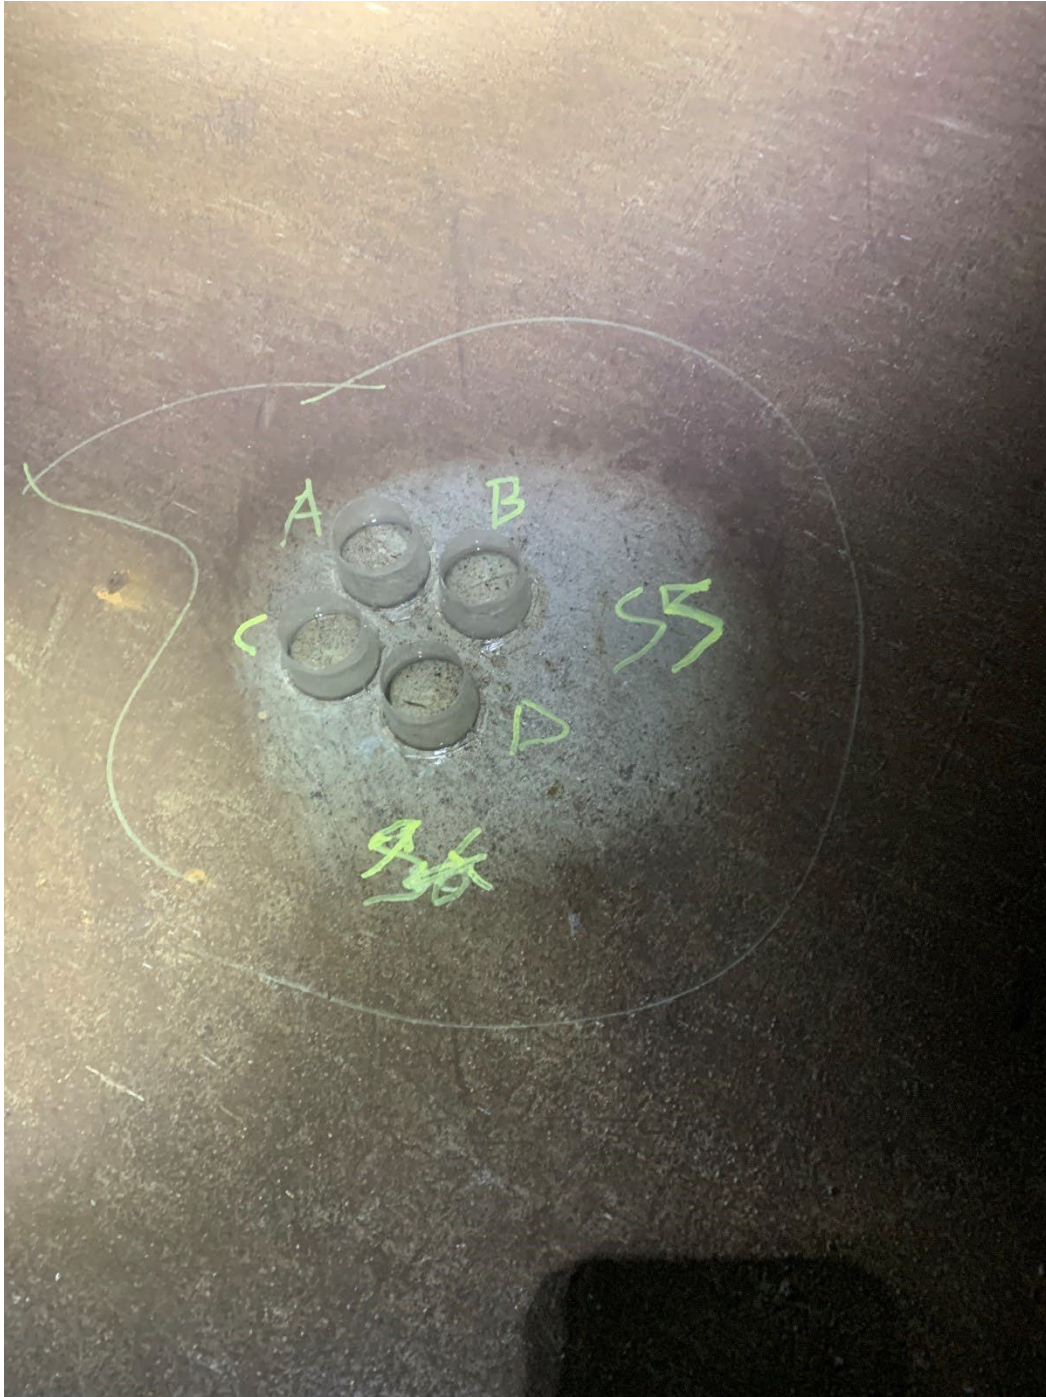
Figure 6. EIS location S5, VR6 (System 6).

Vinyl lining VR6 (System 6) was evaluated using EIS with four different test cells as shown in Figure 6. The photo shows no visible signs of coating damage or corrosion. However, the Bode plot in Figure 7 shows VR6 was only 10⁵ at 0.1 Hz after 70 years of service. The phase angle shows resistive behavior. The two-time constants may indicate corrosion or a stable oxide layer under the coating.

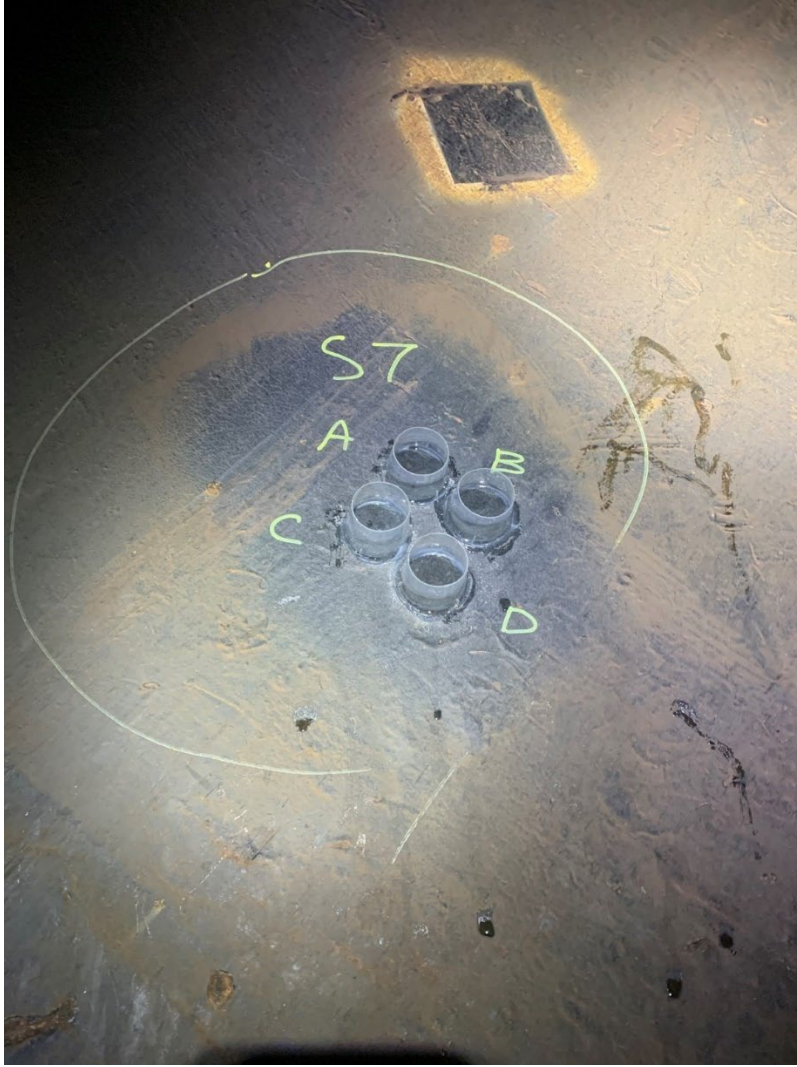
Figure 8. EIS location S7 coal tar CA-50 (System 7)

Coal tar CA-50 (System 7) lining was evaluated using EIS with four different test cells as shown in Figure 8. The photo shows no visible signs of coating damage or corrosion. However, the Bode plot in Figure 9 shows CA-50 was only 10^6 at 0.1 Hz after 70 years of service. The phase angle shows resistive behavior with two-time constants. The two-time constants may indicate corrosion or a stable oxide layer under the coating.

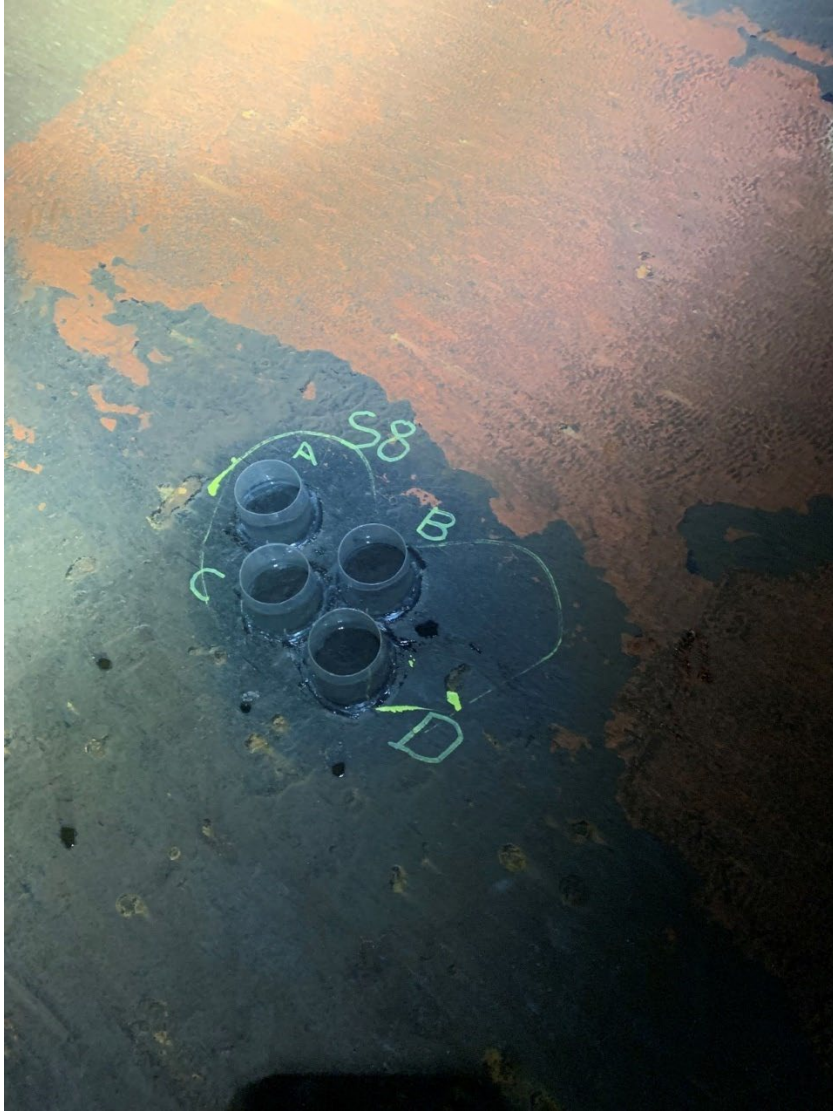
A second location of coal tar CA-50 lining was evaluated adjacent to the damaged area using EIS with four different test cells as shown in Figure 10. The photo shows exposed primer adjacent to the CA-50 lining. The Bode plot in Figure 11 shows CA-50 was 10^6 on one scan and two scans at 10^7 at 0.1 Hz after 70 years of service. The phase angle shows resistive behavior. CA-50 lining shows the highest impedance magnitude of all the linings from the 1949 field trial, while having the worst visual appearance. This may be since the EIS measurement was taken on an area where the coal tar lining was mostly intact. The two-time constants may indicate corrosion or a stable oxide layer under the coating.

Figure 10. EIS location S8, Coal tar CA-50 (System 7) with adjacent exposed primer.

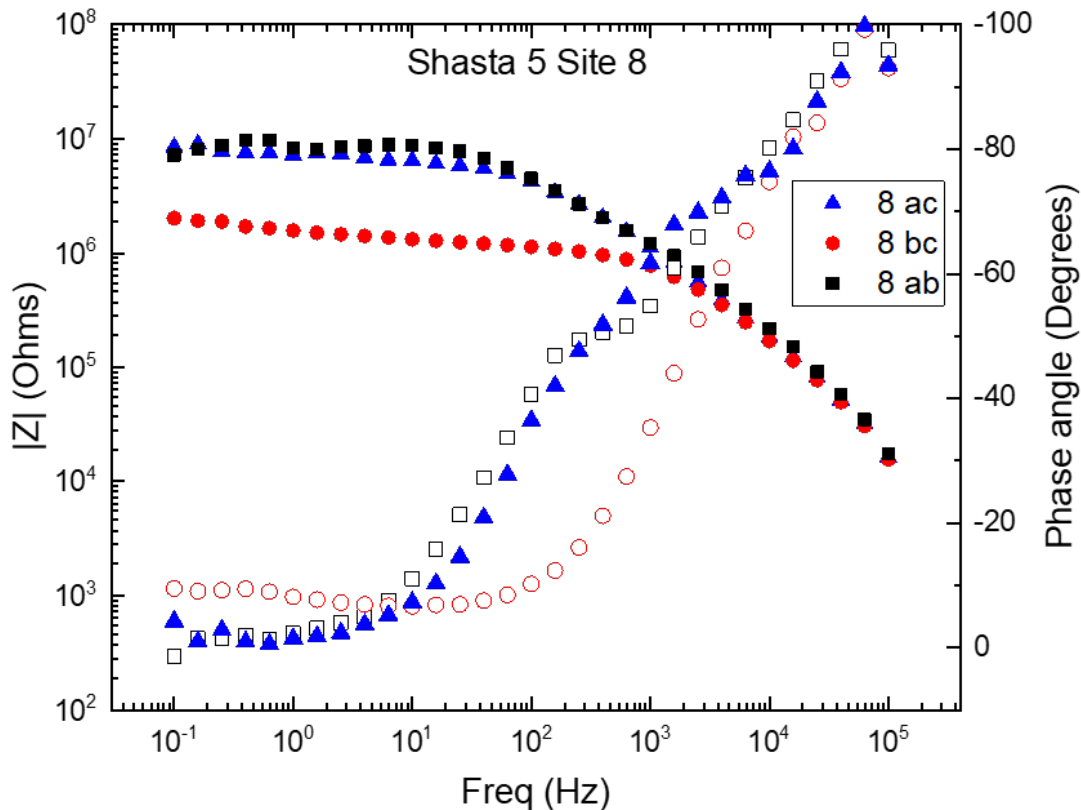
Figure 11. Bode plot of EIS location 8, coal tar CA-50 (System 7) adjacent to damaged coating with exposed primer.

The data shows that EIS is a valuable tool to do a quantitative inspection, but caution should be used since the highest impedance magnitude from the 1949 field trial was CA-50, which had the worst visual appearance and should be recommended for complete replacement. The increase in capacitive behavior at lower frequencies shows the formation of a stable oxide layer only observed when lead-based primers were applied directly to metal. The increased capacitive behavior was not observed when an oil-based primer was used, only barrier properties were observed with resistive behaviors and some samples also showed two-time constants. The data shows that a stable oxide layer did not form at the steel interface, due to the lead pigments not being in close enough to the steel. Two-time constants usually mean there is corrosion occurring under the lining but could also mean that there's multiple layers of lining with different rates of diffusion.

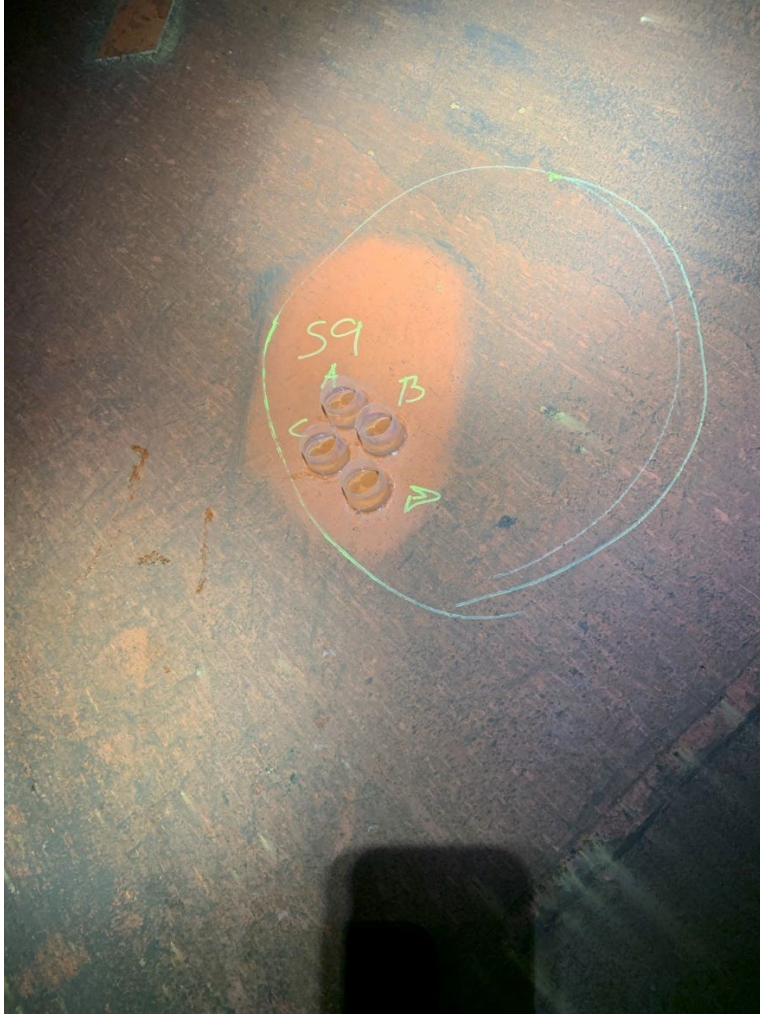
Figure 12. EIS location S9, red lead with chromate inhibitive pigments direct to metal (System 8-1)

Lead based paint lining with chromate inhibitive pigments (system 8-1) direct to metal was evaluated using EIS with four different test cells as shown in Figure 12. The photo shows no visible signs of coating damage or corrosion. However, the Bode plot in Figure 13 shows the system had one scan with 10^5 and two scans at 10^6 at 0.1 Hz after 70 years of service. The phase angle shows resistive behavior and the 10^5 scan also had two-time constants. The two-time constants may indicate corrosion or a stable oxide layer under the coating.

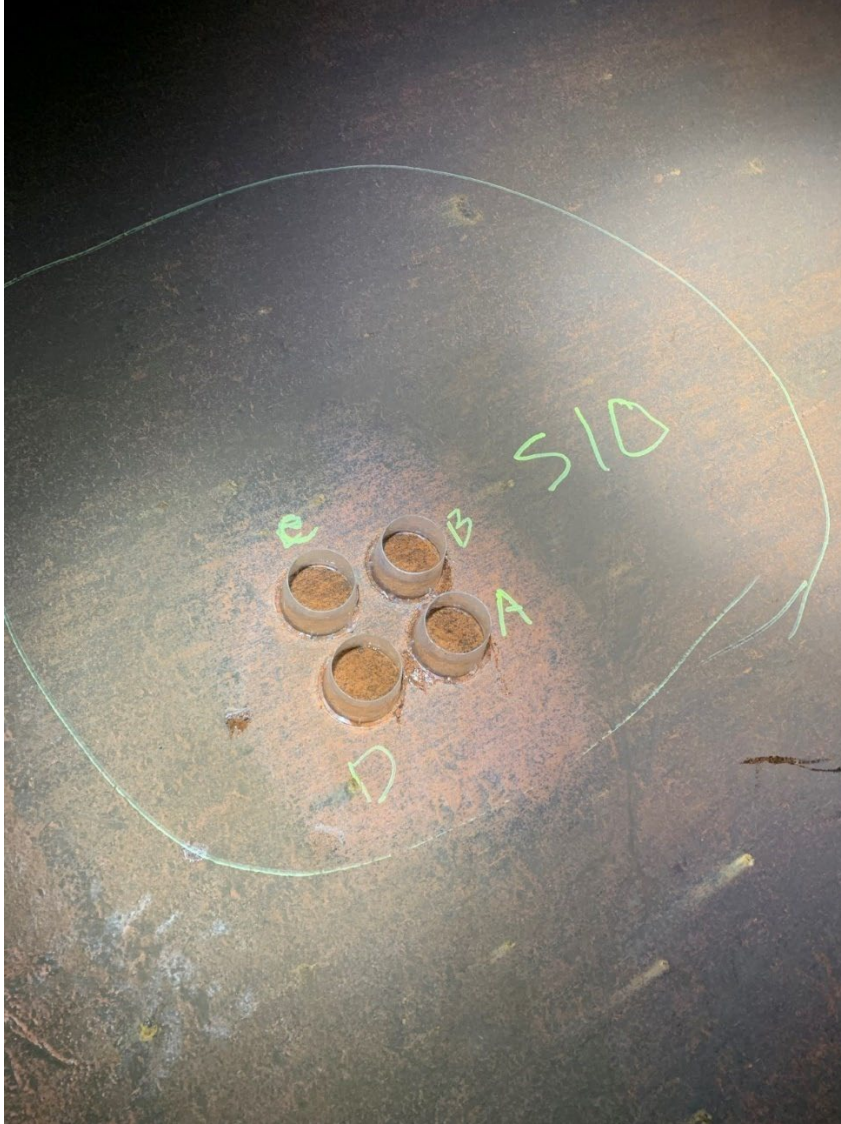
Lead based paint lining with oil-based primer was evaluated using EIS with four different test cells as shown in Figure 14. It was too difficult to determine the exact location to determine if the topcoat was System 8 or 8A. The photo shows no visible signs of coating damage or corrosion. However, the Bode plot in Figure 15 shows the system was the lowest of all linings from the 1949 field trial at 10^4 at 0.1 Hz after 70 years of service. The phase angle shows resistive behavior with two-time constants. The two-time constants may indicate corrosion or a stable oxide layer under the coating.

Figure 14. EIS Location 10 red lead with oil-based primer, West side of pipe. It was too difficult from photos to determine if the topcoat was System 8 or 8A.

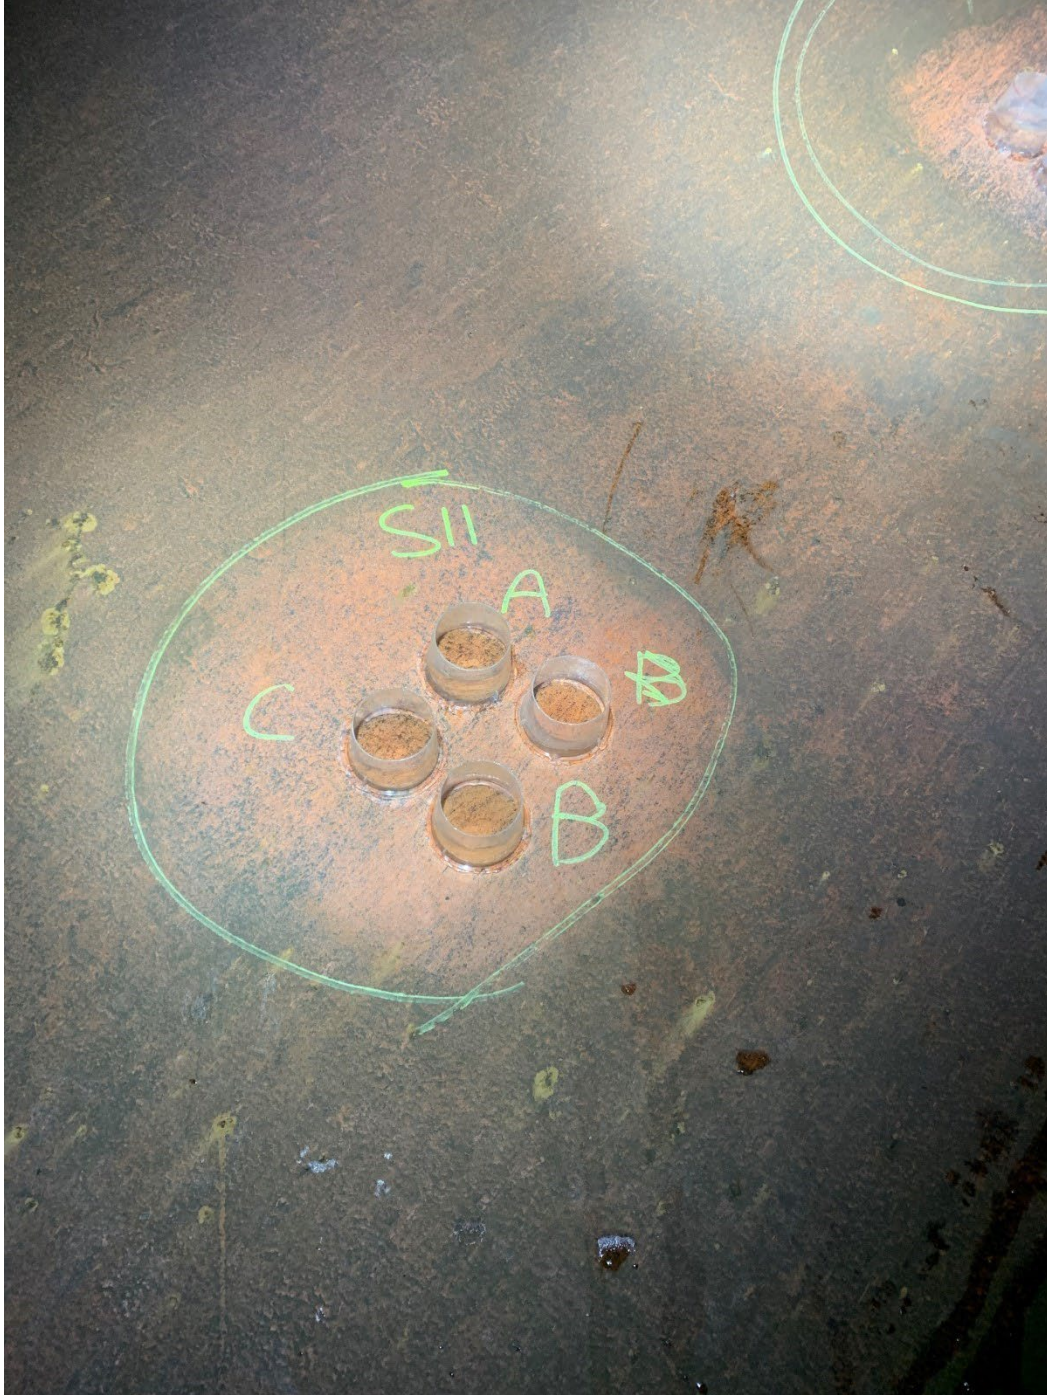
Figure 16. EIS Location 11, System 8A-1 Direct to metal

Lead based paint lining applied direct to metal (System 8A-1) was evaluated using EIS with four different test cells at location S11 as shown in Figure 16. The photo shows no visible signs of coating damage or corrosion. However, the Bode plot in Figure 17 shows the system was the lowest of all linings from the 1949 field trial at 10^4 at 0.1 Hz after 70 years of service. However, the phase angle increases to more capacitive behavior to -45 or -50 degrees at low frequency with multiple-time constants. The increase in capacitive behavior may be the result of the formation of a stable oxide layer under the lead-based primers. The exact mechanism of how lead-based paints provided the stable oxide layer are debatable. Some of the most probable hypothesis is the formation of lead azelate salts which inhibits steel from corroding, or the deposition of metallic lead and will maintain the growth of the ferric oxide layer, the metallic lead acts as a catalyst [5][6].

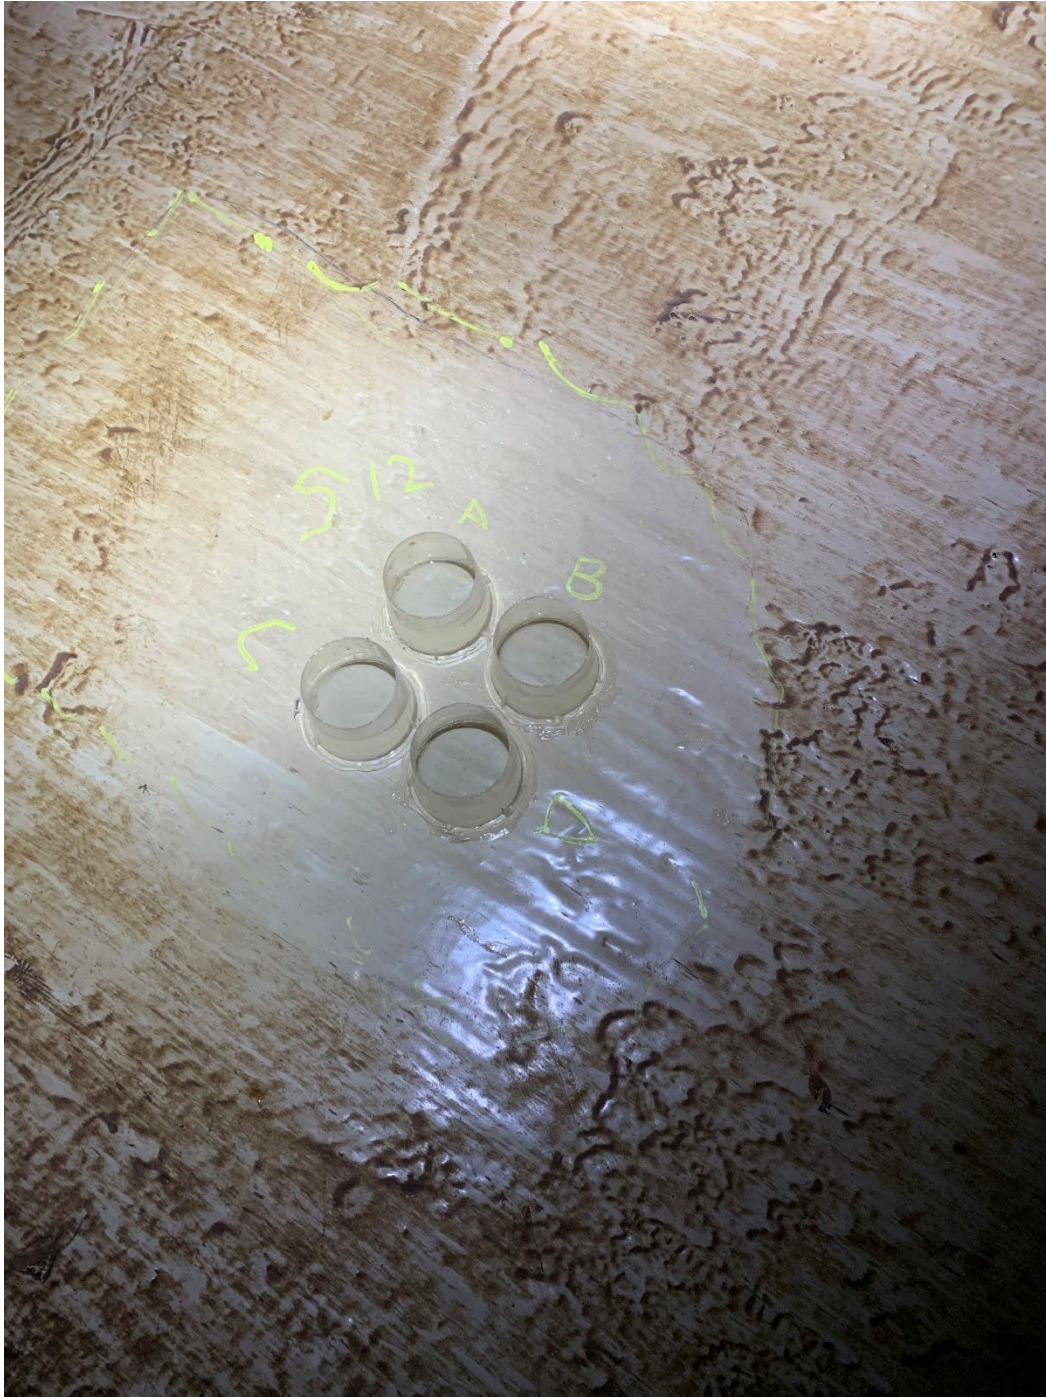
Figure 18. EIS location S12, 100-percent solids epoxy.

The 100-percent epoxy was a repair area during the 2009 contract. The 100-percent solids epoxy was evaluated using EIS with four different test cells as shown in Figure 18. The photo shows no visible signs of coating damage or corrosion. The Bode plot in Figure 19 shows the system has excellent barrier properties at 10¹⁰ at 0.1 Hz after 10 years of service. The phase angle shows capacitive behavior as its stays near -90 degrees. The noise in the plot is due to the lining barrier properties exceeding the limitations of the instrument.

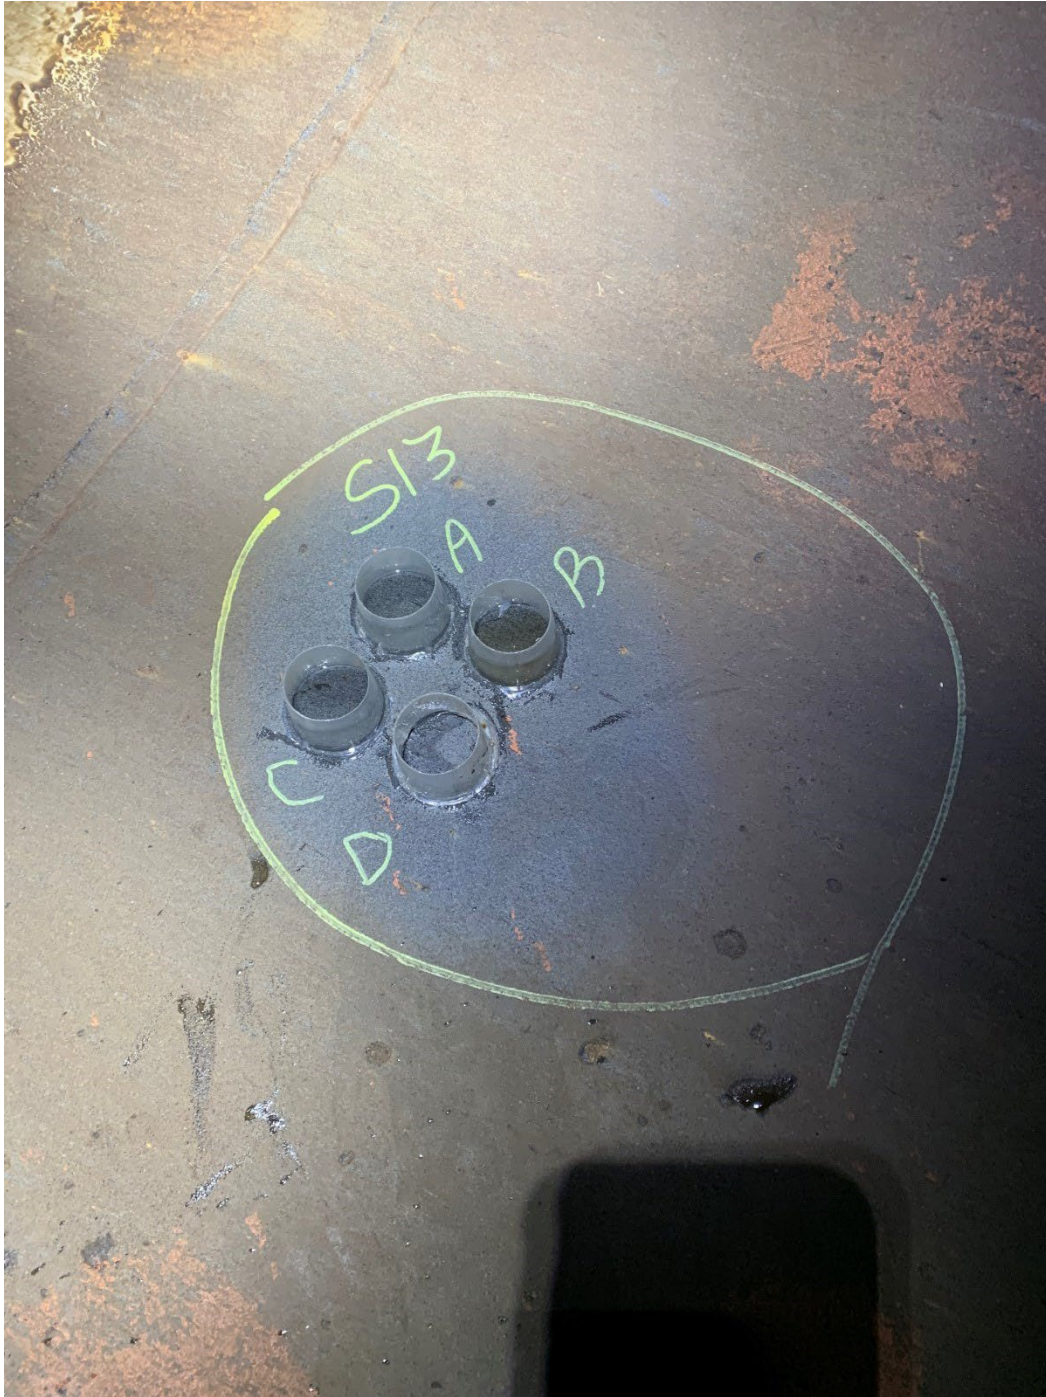
Coal tar enamel with a lead-based primer lining system was evaluated using EIS with four different test cells as shown in Figure 20. The photo shows some coal tar lining damage exposing the lead-based primer in some locations. The Bode plot in Figure 21 shows the system has low impedance magnitude at 10^4 at 0.1 Hz after 70 years of service. The phase angle increases to more capacitive behavior to -45 or -50 degrees at low frequency. The increase in capacitive behavior most likely is a result from the formation of a stable oxide layer under the lead-based primers. Even today, the exact mechanism of how lead-based paints provided the stable oxide layer is unknown. Some of the most probable hypothesis is the formation of lead azelate salts which inhibits steel from corroding, or the deposition of metallic lead and will maintain the growth of the ferric oxide layer, the metallic lead acts as a catalyst [5] [6].

Figure 20. EIS location S13, coal tar enamel with lead-based primer
