# Learning from Historic Lining Field Trials at Shasta Dam and Collbran Project

Science and Technology Program  
Research and Development Office  
Final Report No. ST-2023-22024-02  
Technical Memorandum No. 8540-2023-43

# **Learning from Historic Lining Field Trials at Shasta Dam and Collbran Project**

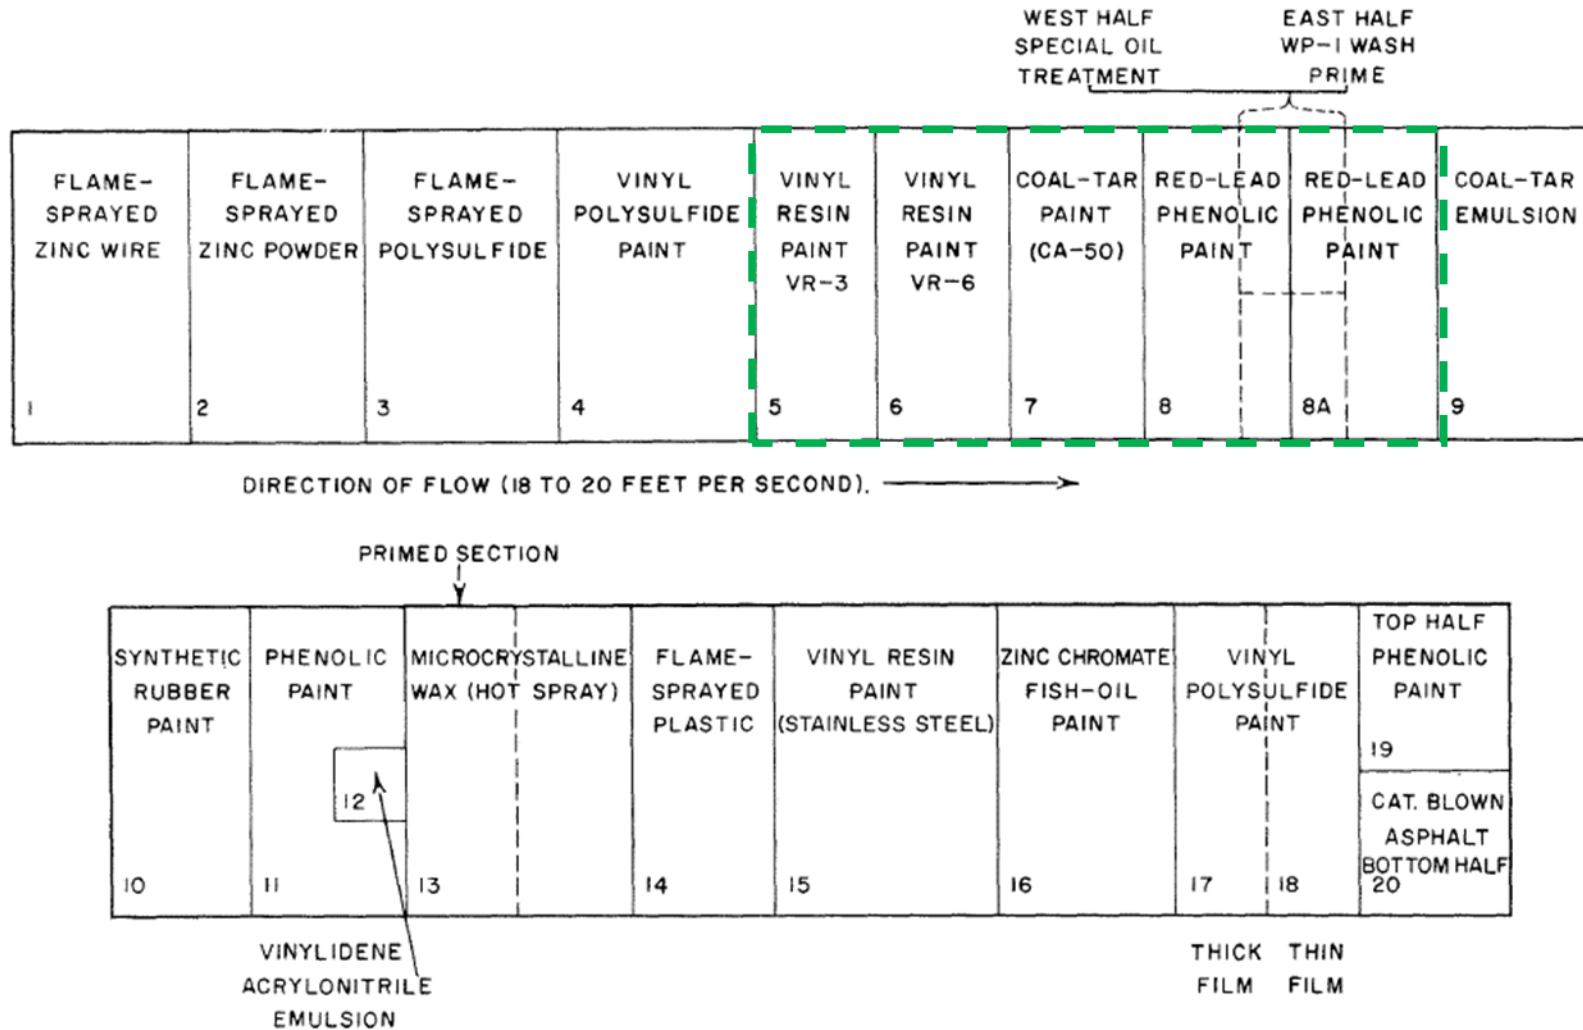
In 2009, contractors applied 100 percent (%) solids epoxy repairs to the original CTE lining. The work led to the discovery that some of the test linings from the 1949 study were still in place. The surviving areas of test linings are outlined within the original layout with a green dashed box in Figure 1 and noted with an asterisk in Table 2 [13].

Figure 1.—Shasta test section layout. The test sections remaining in the 2019 inspection are noted with a dashed green border.

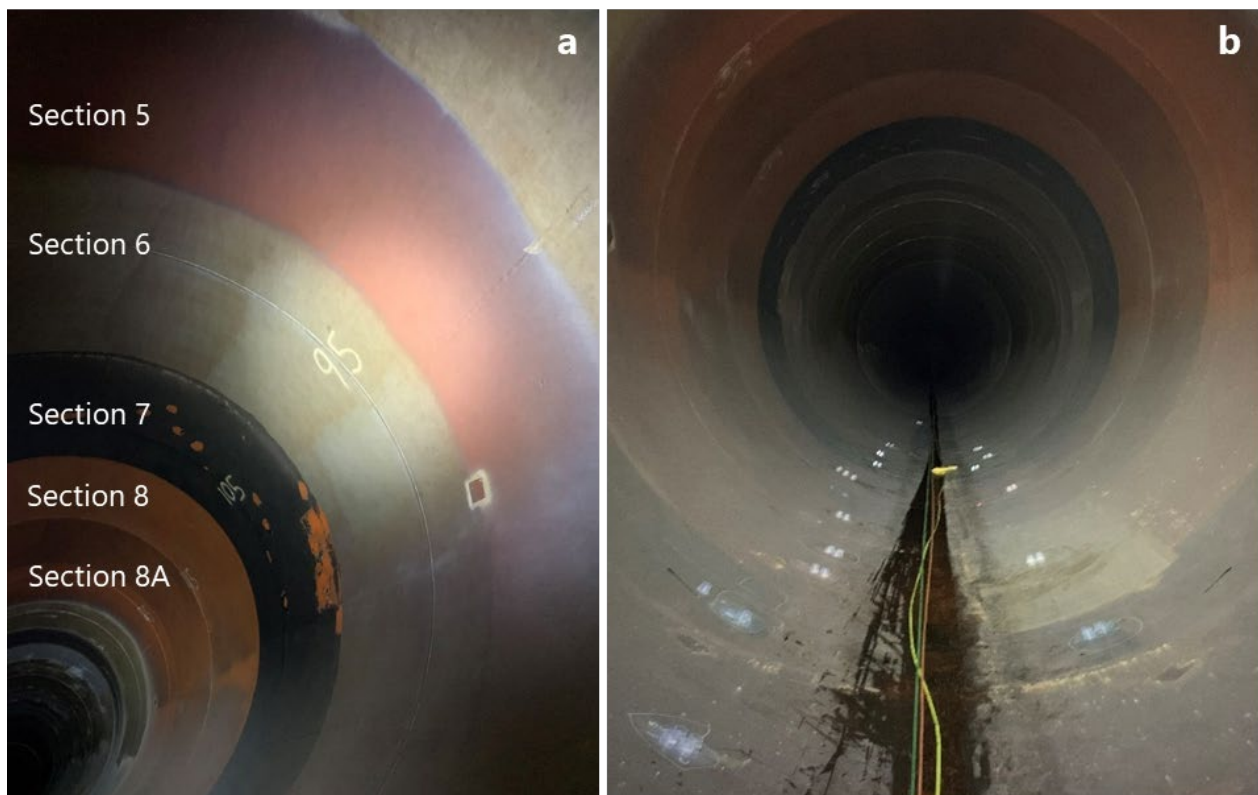
Figure 2.—The test linings section of the Shasta Unit 5 Penstock looking (a) downstream with labels of the surviving test lining section IDs, and (b) upstream with EIS test cells in place.

The 2019 inspection report noted that all linings in the test section were in poor condition with several spots of spalled or missing coating and substrate corrosion present [14]. A recent assessment of the 2019 inspection report, conducted as part of the Historic Linings research, closely examined the images of each EIS test cell location, and concluded the appearance of many of the surviving coatings could be consistent with a Class B rating and did not warrant immediate maintenance [13]. The report also noted that it was not clear whether the lining in Section 7 was the original CA-50 test lining system, or whether it had been repaired with CTE. Additionally, the process of correlating inspection images with the original lining system descriptions could not differentiate the identity of the 8-2 and 8A-2 test locations.

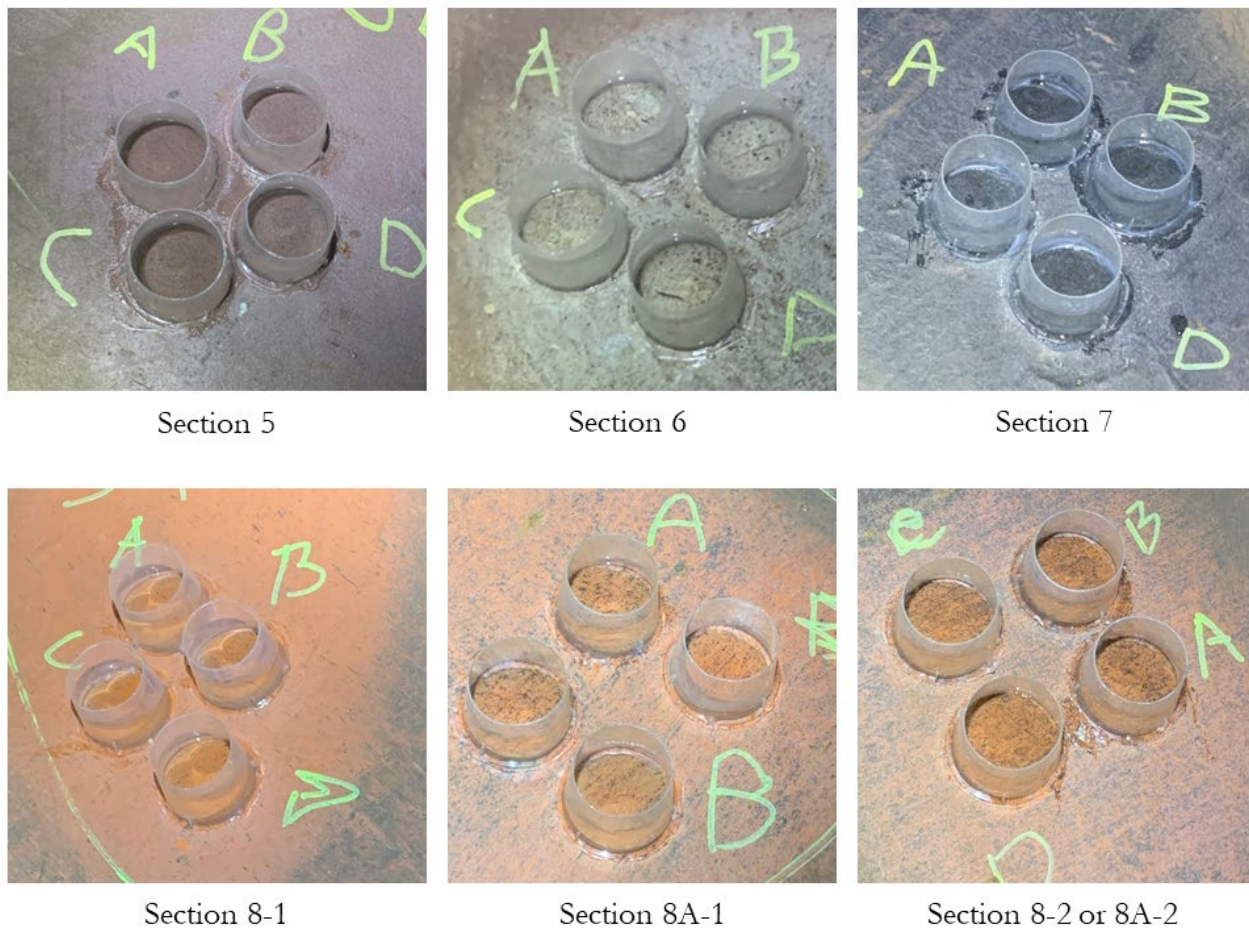
Figure 3.—Field EIS test cells of the surviving test lining sections at Shasta. Each cup is roughly 5 cm in diameter.

Shasta test section was not sufficient for a thorough visual assessment, limiting the visual assessment to the images of each EIS test cell location. Photos show the EIS evaluation areas are in good condition, prompting a general recommendation that maintenance be deferred [13]. However, the overall poor visual appearance of the entire test lining areas reported in 2019 and low  $|Z|$  values measured with field EIS, suggest the linings are degraded and may no longer be providing ample corrosion protection to the underlying steel. This highlights some key takeaways.

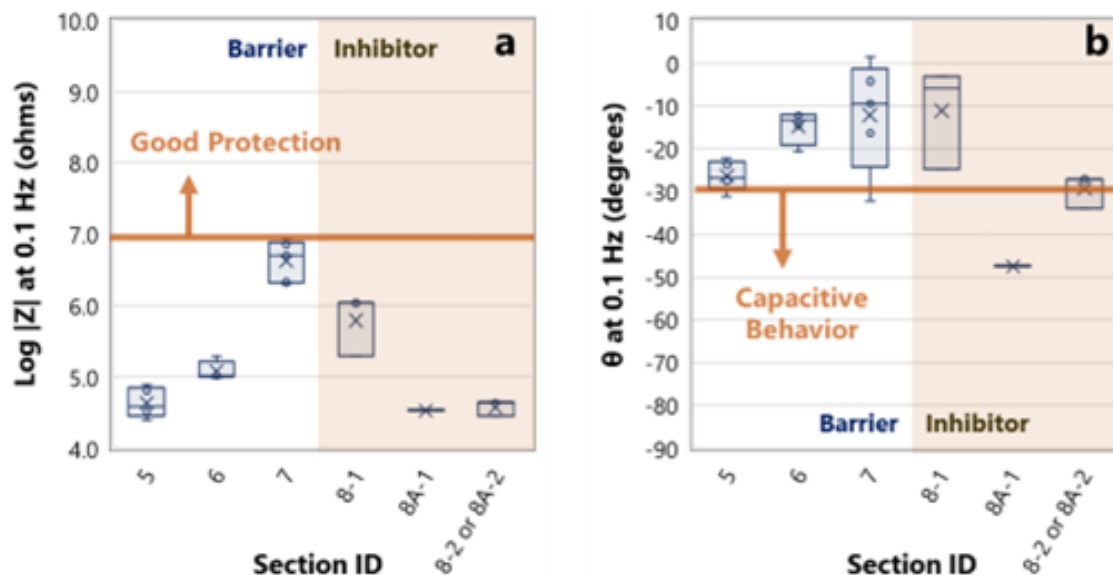
Figure 4.—Shasta test linings data for a) Log  $|Z|$  and b)  $\theta$ ; data is shown in an inclusive median box and whisker plot of all replicates at 0.1 Hz; inner data points and outliers are designated with open circles.

Figure 4a includes a line at  $10^7$  ohms. Above this value, lining systems provide good barrier protection against corrosion. Based on this analysis alone, the highest performing linings are Systems 7 and 8-1. Most systems show a narrow data range, especially those with  $|Z|$  near  $10^4$  to  $10^5$  ohms. This low  $|Z|$  is typical of bare steel, oxides, or other unintended current pathways. Further, the steel surface temperature, if warmer than typical laboratory temperatures, will show a decreased  $|Z|$  because  $|Z|$  has an inverse relationship with temperature [15].

Figure 4b includes a line at -30 deg to aid in interpretation of this plot. Near 0 deg the resistive elements dominate EIS data at 0.1 Hz. As  $\theta$  values become more negative, capacitive behavior has an increasing influence. At -45 deg, diffusion-limited corrosion typically occurs, known as Warburg diffusion, and as  $\theta$  approaches -90 deg, capacitive behavior dominates the data. For EIS results showing a single RC pair for the coating, the capacitive behavior is an indication of good barrier protection. However, this analysis becomes more complex when a second RC pair is needed to model the interface because oxides and/or corrosion reactions are significant contributors.

All Shasta test linings evaluated showed low barrier protection, indicated by low  $|Z|$  values. System 7 exhibited the highest values near  $10^7$  ohms followed by System 8-1 near  $10^6$  ohms (where  $10^7$  ohms or greater indicates good corrosion protection). All systems showed some capacitive behavior that would require ECM to further characterize. Due to close test cell placement, Shasta field EIS data may not accurately represent the actual impedance of the test lining sections.

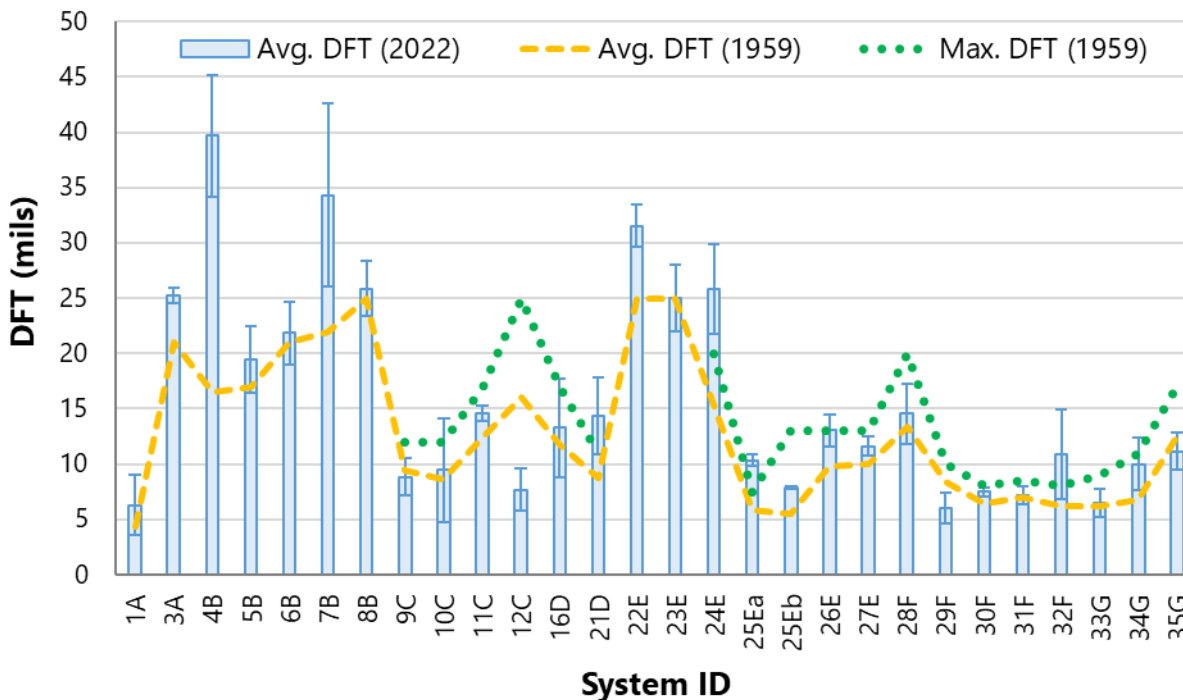
DFT results are reported as averages in Figure 6, shown with the originally reported average coating thicknesses. Average DFT values of Collbran linings measured in 2022 are plotted with the original average and maximum DFT values recorded in 1959. Error bars represent the standard deviation of the data. System 36G was beyond the limit of the DFT gauge, over 100 mils.

Figure 6.—Average DFT values of lining thickness measured in 2022 plotted with the original average (avg.) and maximum (max.) DFT values recorded in 1959. Error bars represent the standard deviation of the data. 36G was beyond the limit of the DFT gauge.

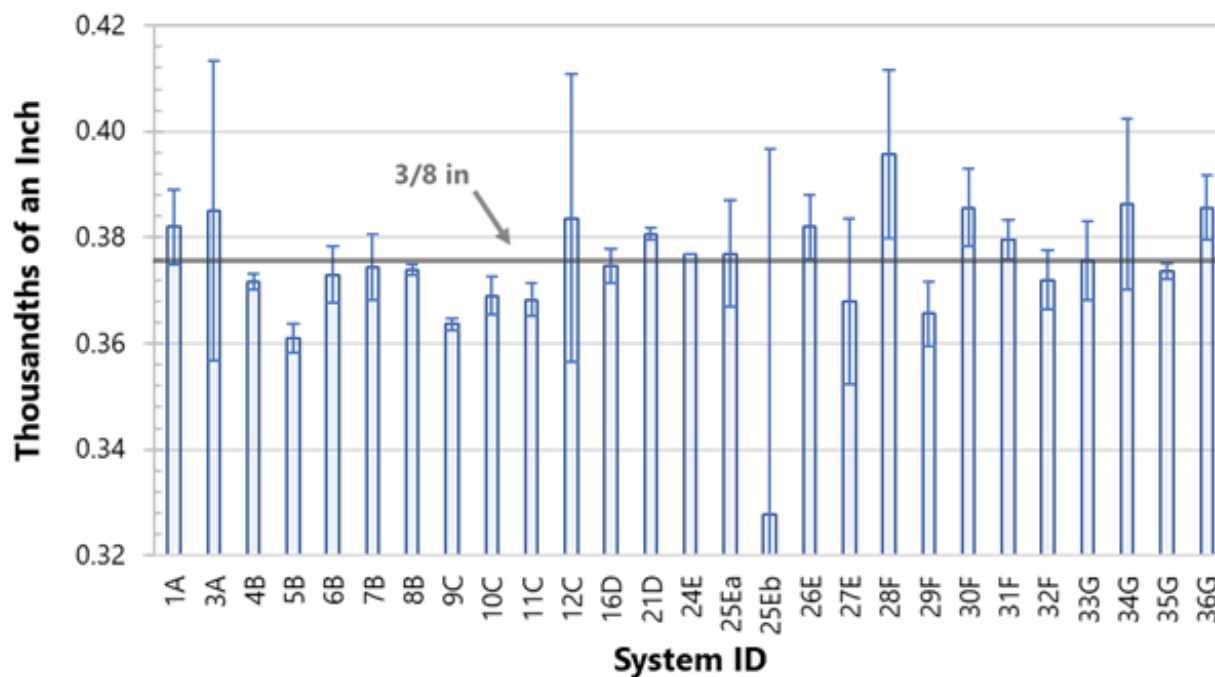
Ultrasonic thickness measurement results are reported as averages in Figure 7. The historic reports do not make note of the original wall thickness, but drawings suggest it is 3/8 in. It is common for the manufactured pipe as received to exceed the specified value. Several results have large error bars and a mean value greater than the assumed original thickness. Others have small error bars and suggest metal loss may have occurred, such as for System 5B and 9C. The large variability in wall thickness data from each section suggests significant irregularity in the original wall thickness. Without knowing the as-manufactured dimensional tolerance of the pipe, interpretation base metal loss is not possible without further physical assessments. Thus, no conclusions are drawn from the UT data.

Figure 7.—Average steel thickness at Collbran test lining areas, as measured with UT, marked with the original wall thickness of 3/8 in. No data was collected for Systems 23E and 22E.

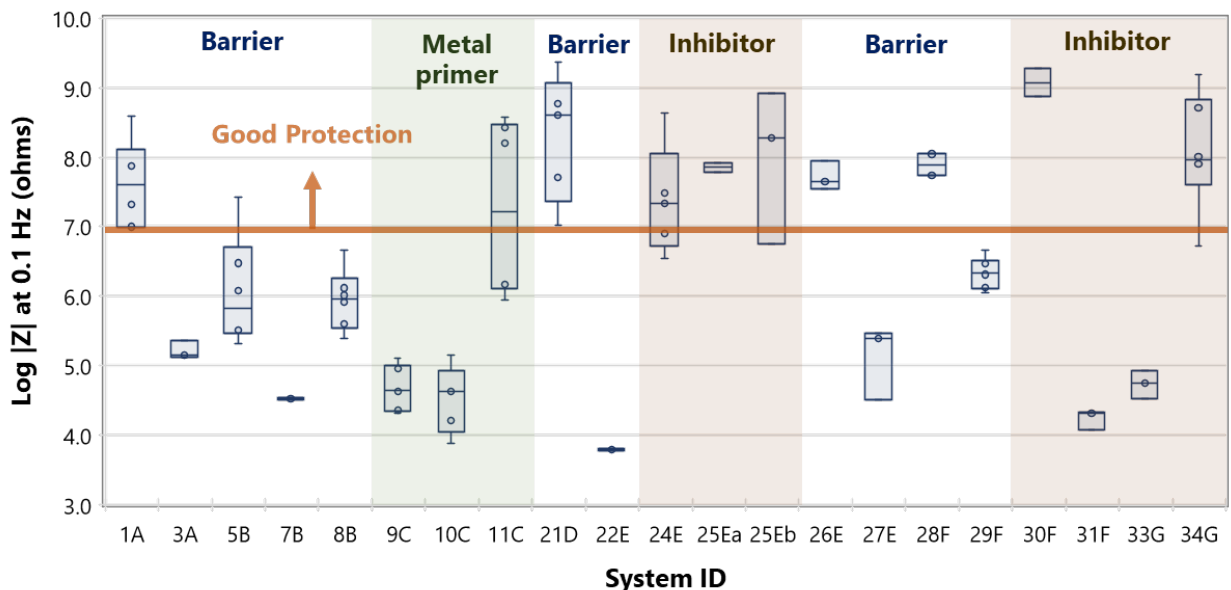
Figure 8.—Log  $|Z|$  measurements of Collbran test linings shown in an inclusive median box and whisker plot of all replicates at 0.1 Hz; inner data points and outliers are designated with open circles.

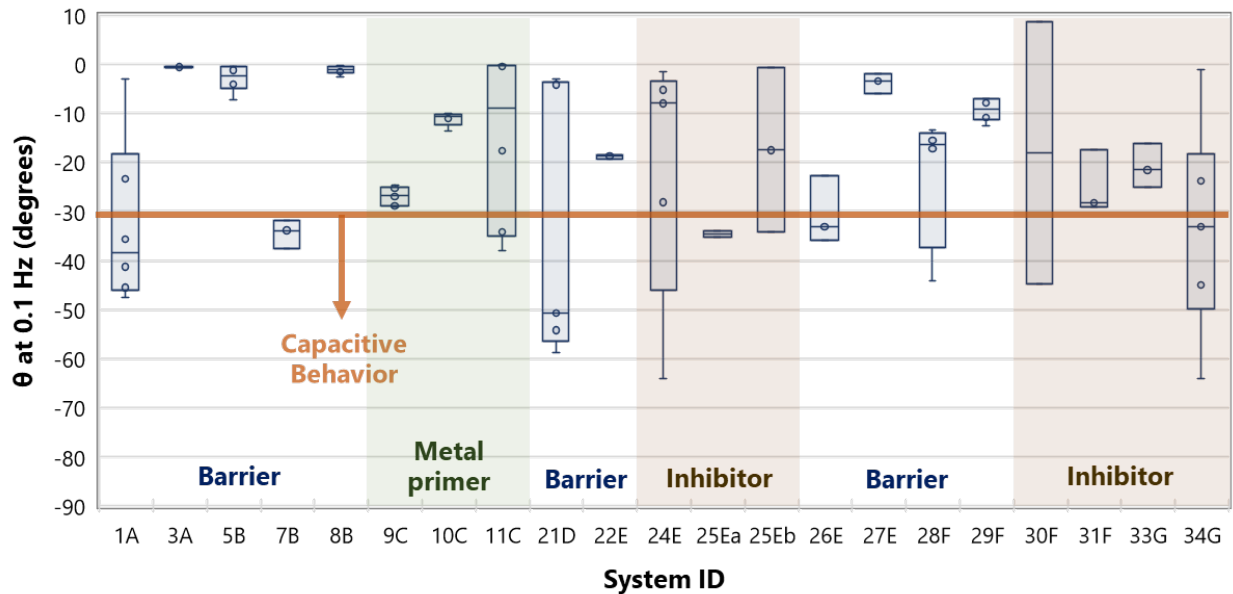
Figure 9.— $\theta$  measurements of Collbran test linings shown in an inclusive median box and whisker plot of all replicates at 0.1 Hz; inner data points and outliers are designated with open circles.

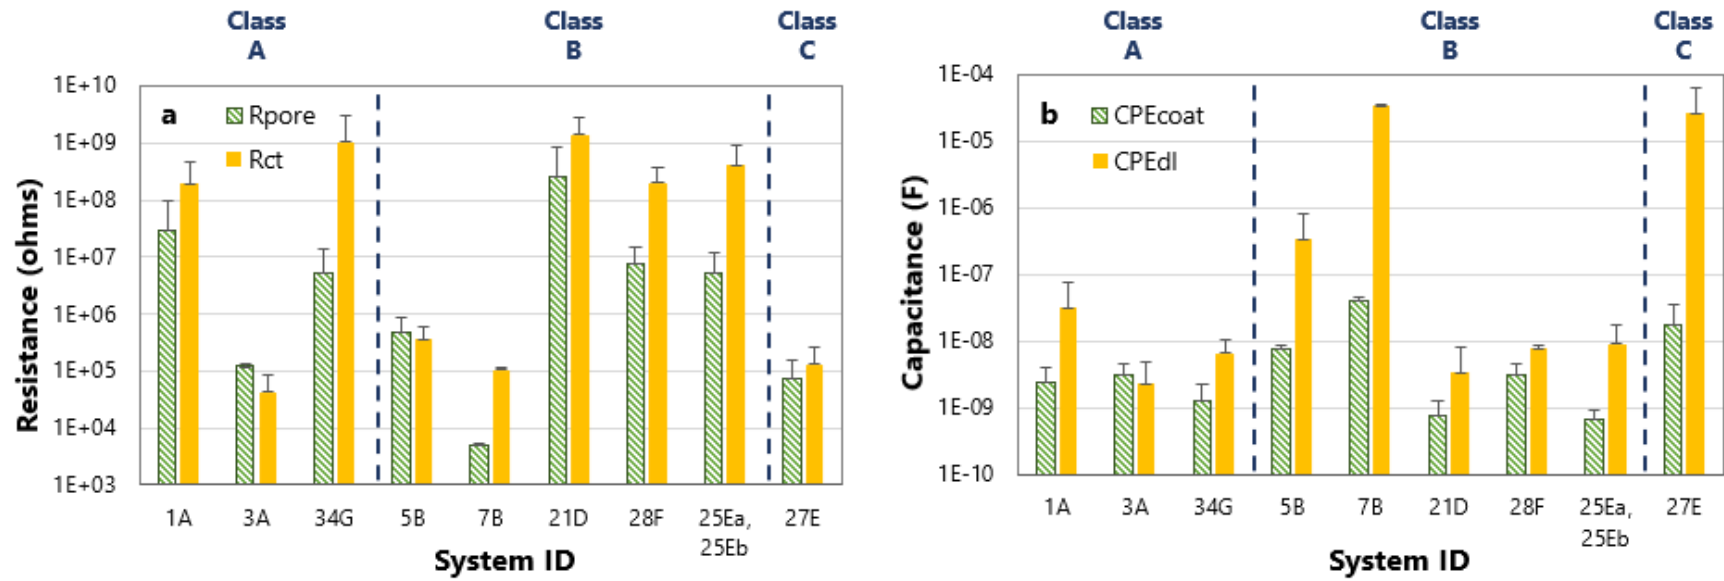
Figure 11 provides the mean and standard of the model resistors and capacitors for Class A systems 1A, 3A, and 34G (plotted at left), Class B systems 5B, 7B, 21D, 28F, and 25Ea/25Eb combined, and Class C system 27E. All systems are barrier coatings except for 34G and 25Ea/25Eb, which are inhibitors. The reported values are not normalized for 20-cm<sup>2</sup> sample surface area.

Figure 11.—Equivalent circuit modeling (ECM) results for select lining systems plotted for the mean and standard deviation of the system a) resistors and b) capacitors. The coating elements are represented with hashed bars and the interface elements as solid bars. \*ECM for System 3A utilized a capacitor element for the double layer instead of a CPE. Results are not normalized for the 20-cm<sup>2</sup> test cell area.

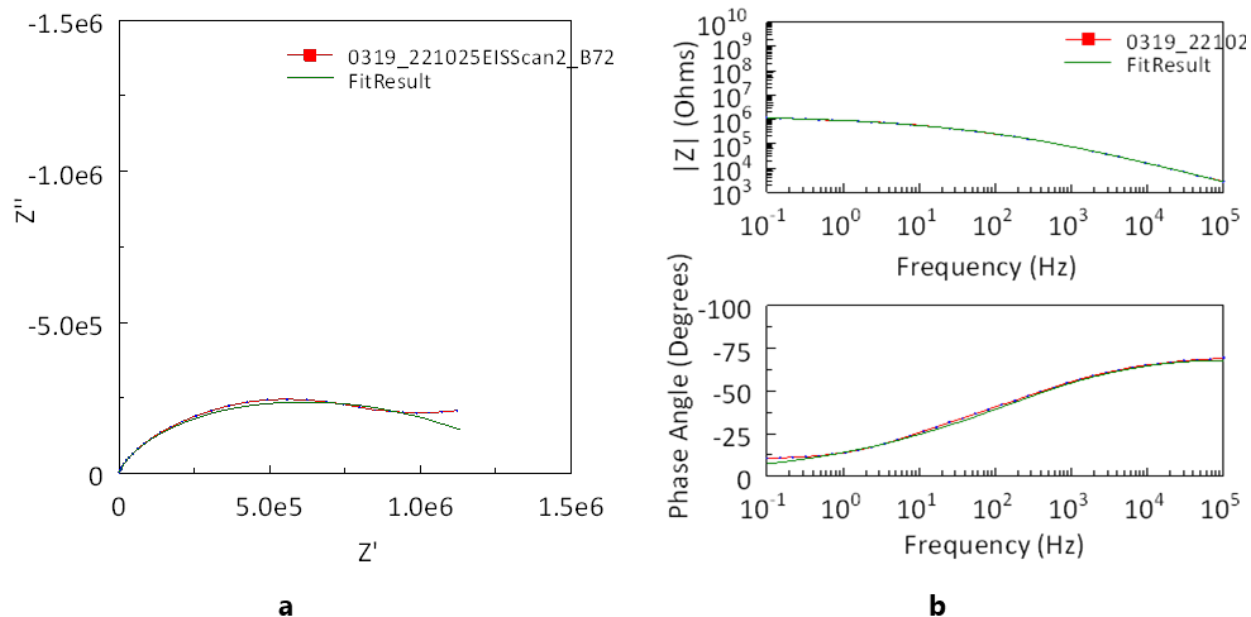
Attempts were made to perform ECM on Systems 8B, 22E, 29F, and 30F. Each system requires a different ECM than the two RC pairs utilized in the previous examples. Therefore, results provide less direct comparison and were excluded. Systems 8B (Class B) and 22E (Class D) can be modeled using a single RC pair and appeared to be modeling the corrosion cell with no influence from a barrier lining, i.e., a achieves a good fit with only  $R_{ct}$  and  $CPE_{dl}$ . For System 8B, this could be a result of the microcracking reported from the visual inspection. System 29F (Class C) appeared to be a single RC pair needing a Warburg element to model diffusion-controlled reactions at the interface. This is shown in Figure 12 with Nyquist and Bode plots for System 29F using an ECM containing two RC pairs. The good overall fit except for the low frequency “tail” suggests that a single RC pair and Warburg element would provide an improved fit.

Figure 12.—Example ECM showing data and fit results for System 29F via a) Nyquist and b) Bode plots using two RC pairs. The Nyquist plot shows real impedance ( $Z'$ ) on the x-axis and imaginary impedance ( $Z''$ ) on the y-axis. The good overall fit except for the low frequency “tail” suggests that a single RC pair and Warburg element would provide an improved fit.

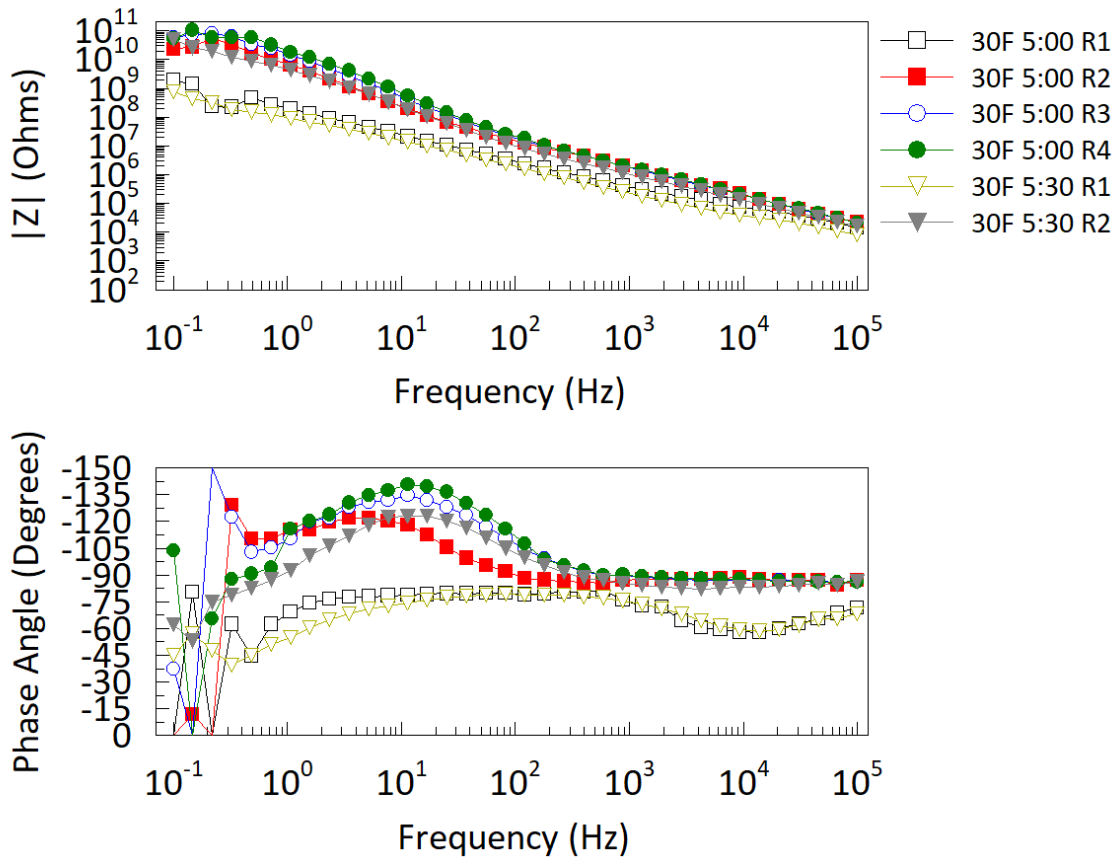
System 30F (Class B) is an inhibitor system and required a single capacitor-resistor pair that appeared to be dominated by the protective coating ( $R_{\text{pore}}$  and  $CPE_{\text{coat}}$ ) as opposed to the corroding interface shown by Systems 8B and 22E. The ECM observations utilized the two measurements made at the 5:30 position. As shown in Figure 13, System 30F was unique in the EIS testing results in that it produced multiple spectra with non-typical data and noise at the lower frequencies. Specifically, the  $\theta$  values less than  $-90$  deg cannot be modeled with physical electrical elements. No cause was identified for these spectra features. Inspectors made multiple attempts to collect data absent of these features.

Figure 13.—EIS Bode plot results for System 30F demonstrating values less than -90 that were not modeled because an appropriate physical electrical element does not exist. The y-axes were expanded to show all data for this system.
