# Laboratory Evaluation of Field Repairable Materials and Techniques for Cavitation Damage: Phase II

Science and Technology Program  
Research and Development Office  
Final Report No. ST-2023-20024-01

**Technical Service Center  
Materials and Corrosion Laboratory Group  
Allen Skaja, Ph.D., Protective Coatings Specialist**

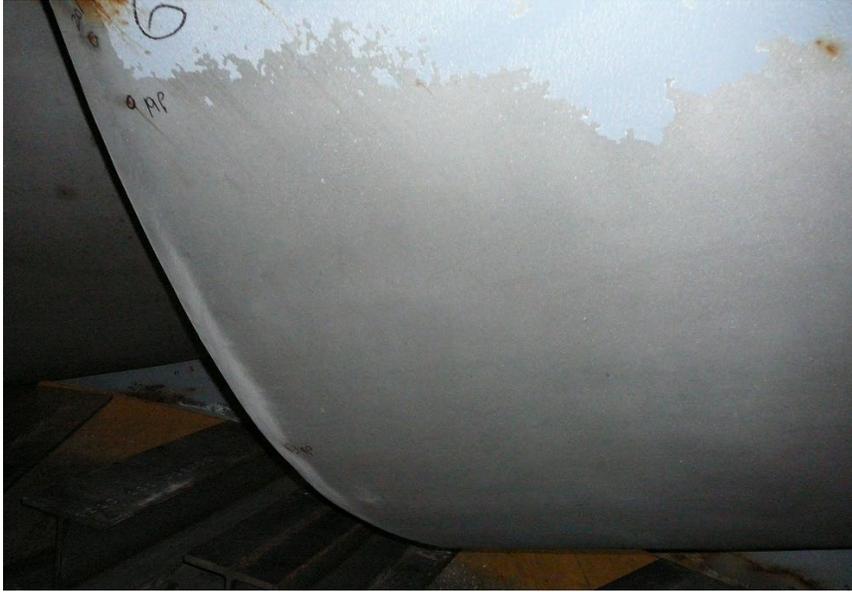
Figure 2.—Nathaniel “Nat” Washington Power Plant Unit G22 turbine runner with minimal damage to the Type 309 stainless steel weld overlay and some galvanic corrosion. The epoxy coating system failed due to cavitation. This blade location is a moderate cavitation environment.

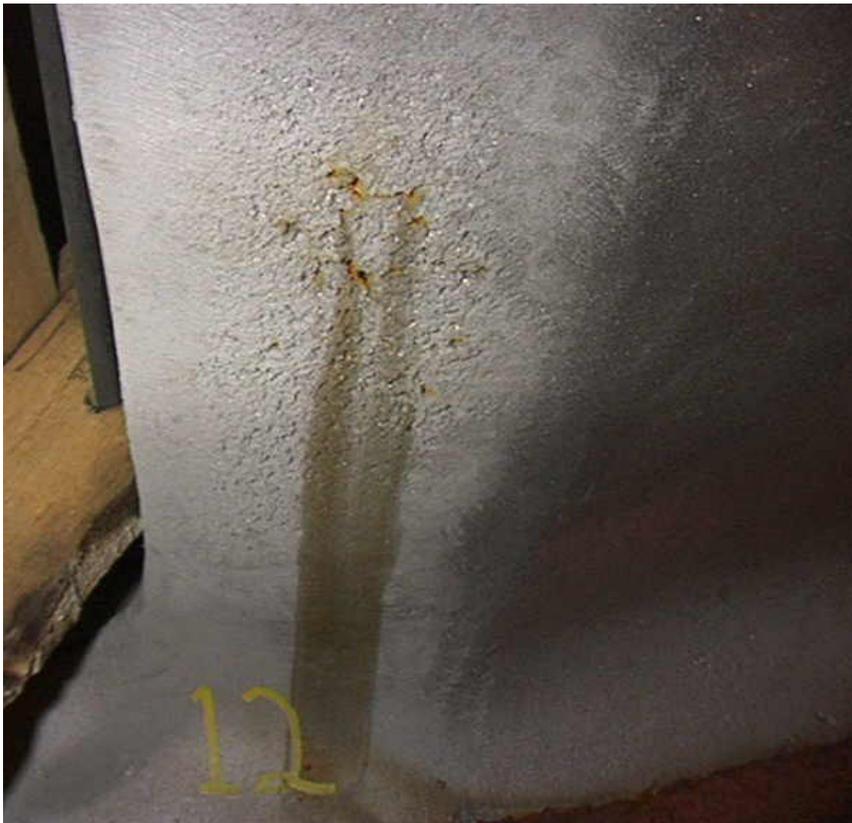
Figure 3.—Nathaniel “Nat” Washington Power Plant Unit G21 turbine runner with cavitation pitting damage on the Type 309 stainless steel weld overlay penetrating through to the mild steel substrate. This blade location is a severe cavitation environment.

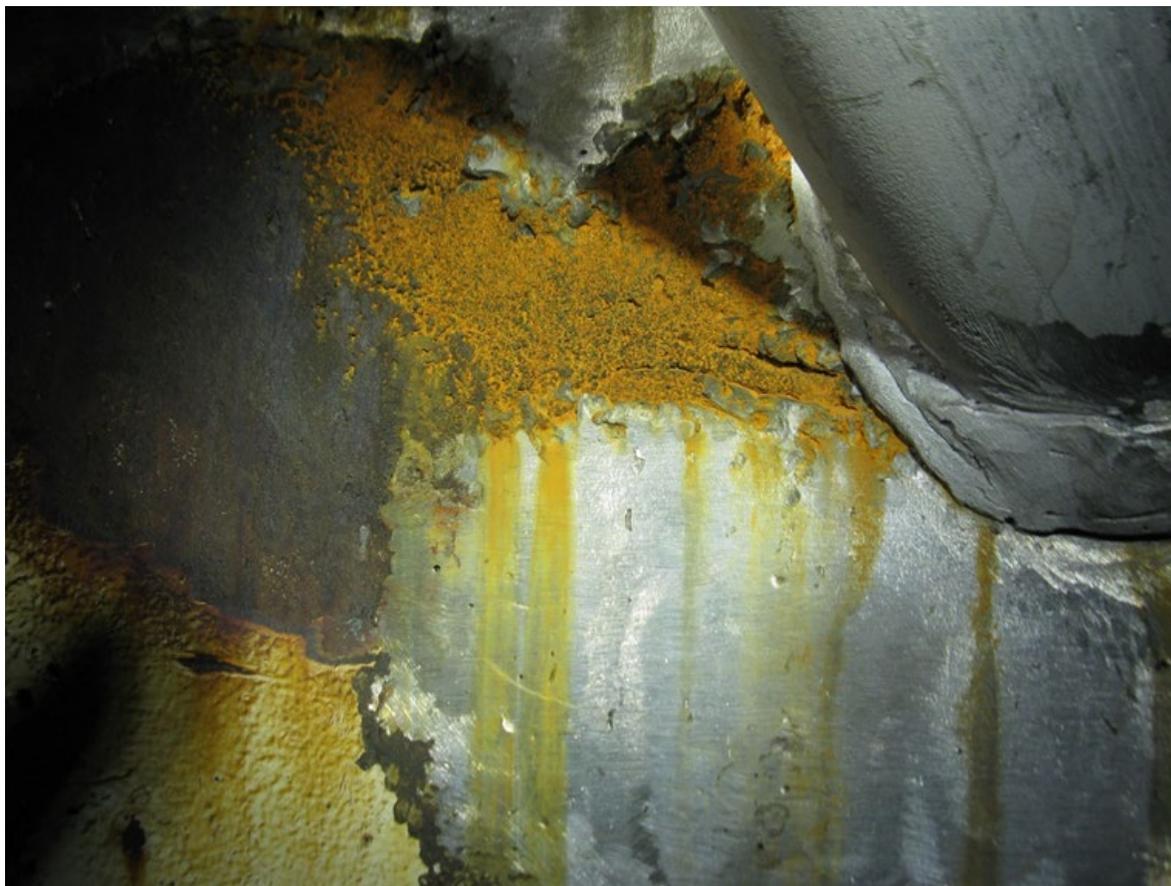
Figure 4.—Image of a Type 308/309 stainless steel weld overlay on cast steel in a draft tube that has failed by galvanic corrosion; cavitation damage is observed on the mild steel substrate.

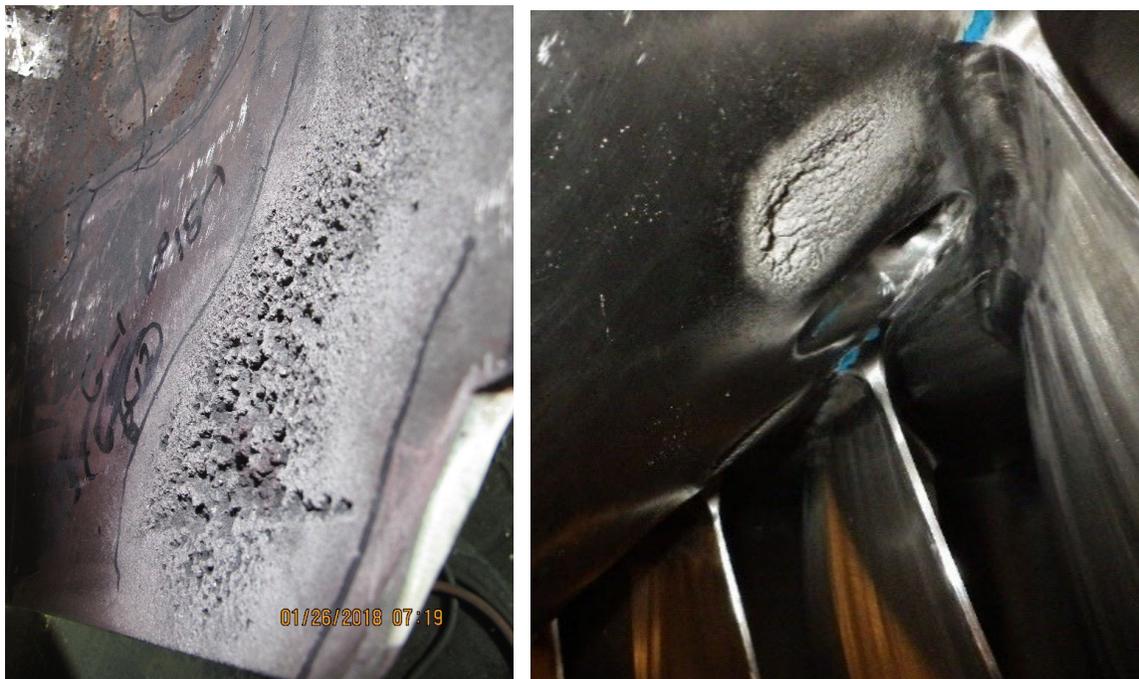
Severe cavitation conditions can cause damage to Type 308/309 stainless steel weld overlay and under extreme conditions damages 316 stainless steel. An example of severe cavitation damage on stainless steel is shown in Figure 5. Different levels of cavitation severity are defined for this research and summarized in Table 1 below and include in the Definitions section of this report.

Figure 5.—Examples of extreme cavitation damage on Type 316 (left) and 304 (right) stainless steel turbine runners.

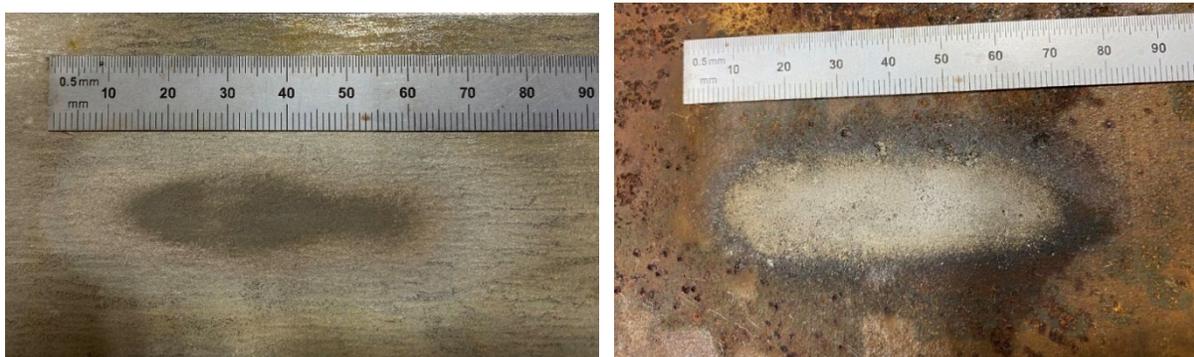
Figure 8.—Type 316 stainless steel (left) and mild steel (right) after 40 hours exposure to submerged jet testing. Notice pitting caused by cavitation in the mild steel. Ruler tick marks are in millimeters.

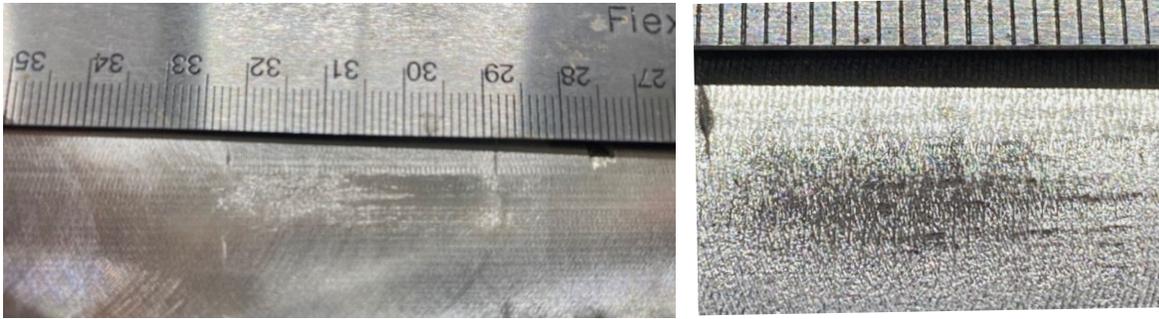
Figure 9.—Photo of Type 308/309 stainless steel weld overlay after 40 hours of exposure to the submerged jet testing (left) and close-up image (right). The damaged area is significantly less than mild steel. Ruler tick marks are in millimeters.

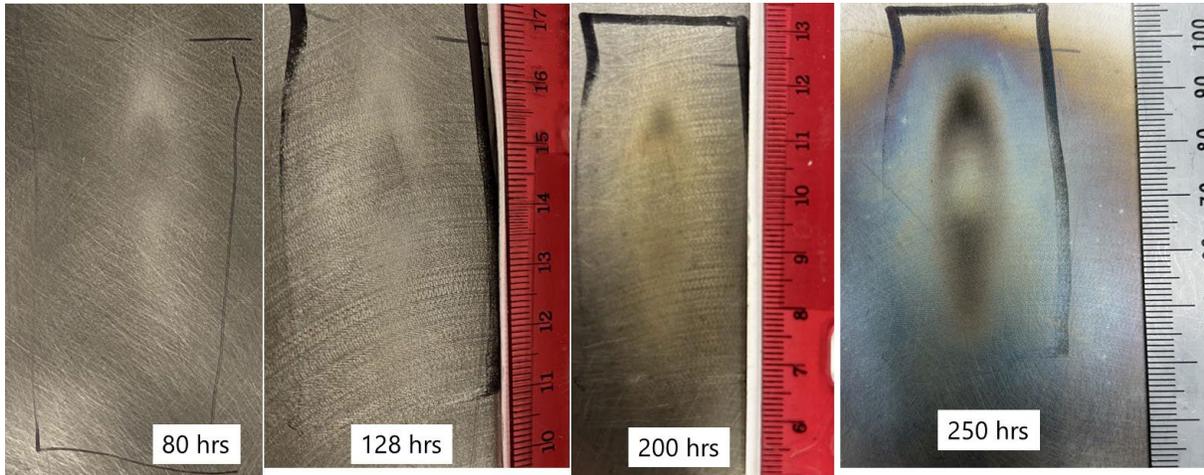
- Type 316 stainless steel exhibited no measurable metal loss with only light frosting after 250 hours.
- Type A36 mild steel exhibited initial signs of pit formation at 16 hours and accumulated 180 cubic millimeters (mm<sup>3</sup>) of material loss at 250 hours.

Figure 16.—Type 316 stainless steel long-term cavitation testing results: visible frosting, but no measurable material loss was observed. Ruler tick marks are in millimeters.

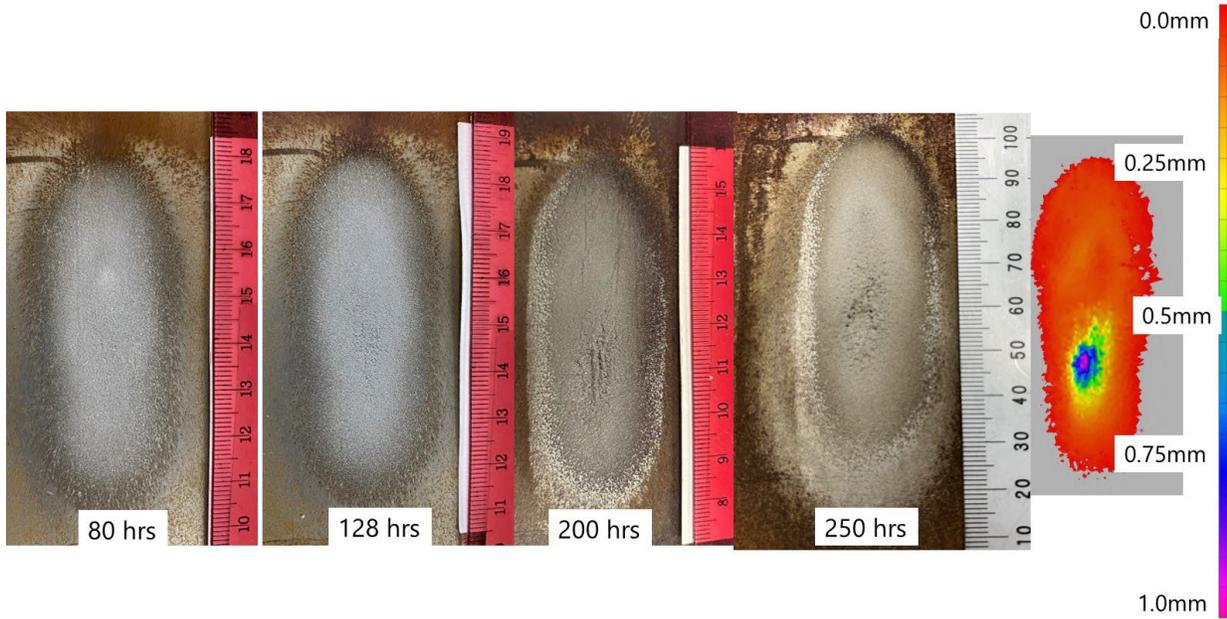
Figure 17.—A36 mild steel long-term cavitation testing results: visible pitting and metal loss was observed. The image to the right was developed from the laser scanner to show the volume and depth loss at 250 hrs. Ruler tick marks are in millimeters.

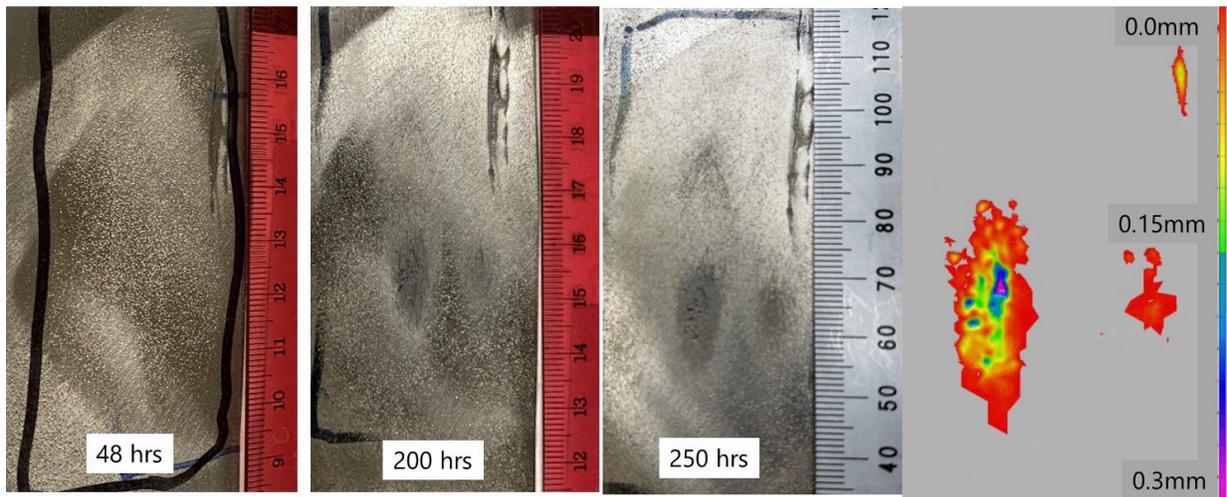
- Type 308/309 stainless steel weld overlay exhibited initial signs of pit formation at 40 hours and accumulated 6 mm<sup>3</sup> of material loss at 250 hours.

Figure 18.—Type 308/309 stainless steel weld overlay long-term cavitation testing results. The image to the right was developed from the laser scanner to show the volume and depth loss at 250 hrs. Ruler tick marks are in millimeters.

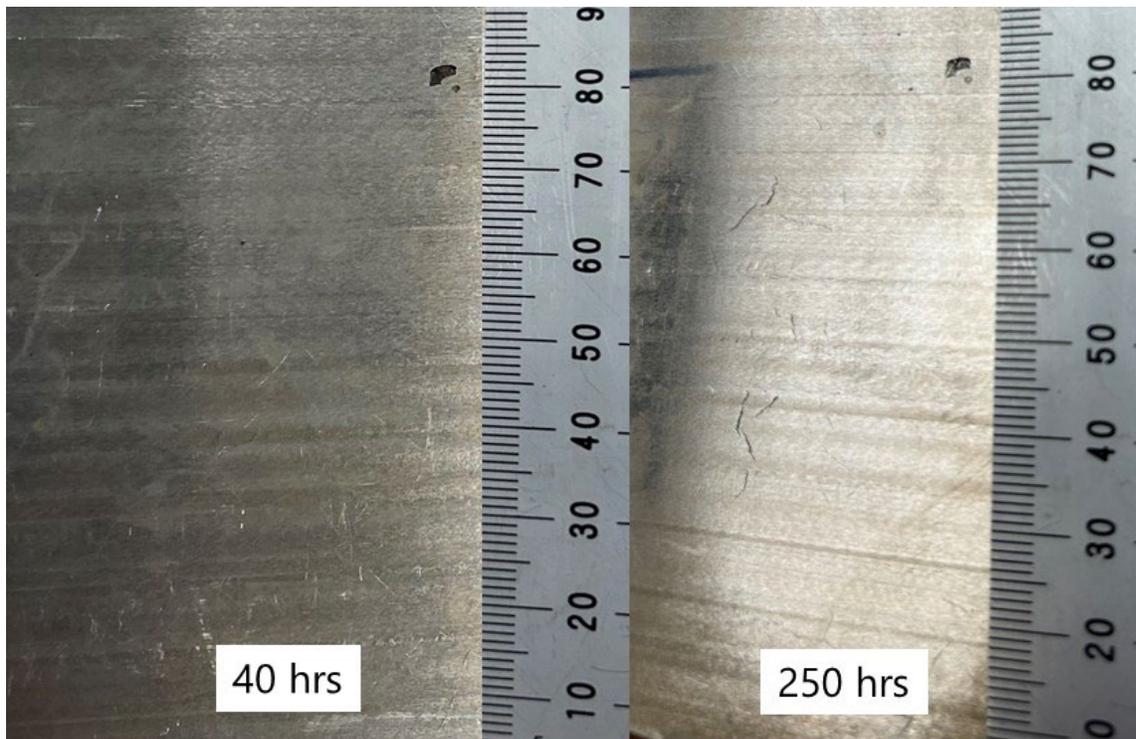
- Cavitec, a proprietary stainless steel alloy, showed no metal loss at 250 hours, but cracked in the cavitation and impact zone. Cracking is an unacceptable result as it can cause an electrolytic pathway to the substrate and result in galvanic and crevice corrosion of the mild steel substrate.

Figure 19.—Cavitec shown after 40 hours (hrs) and 250 hrs of long-term cavitation testing. Cracking is evident despite no measured metal loss. Ruler tick marks are in millimeters.

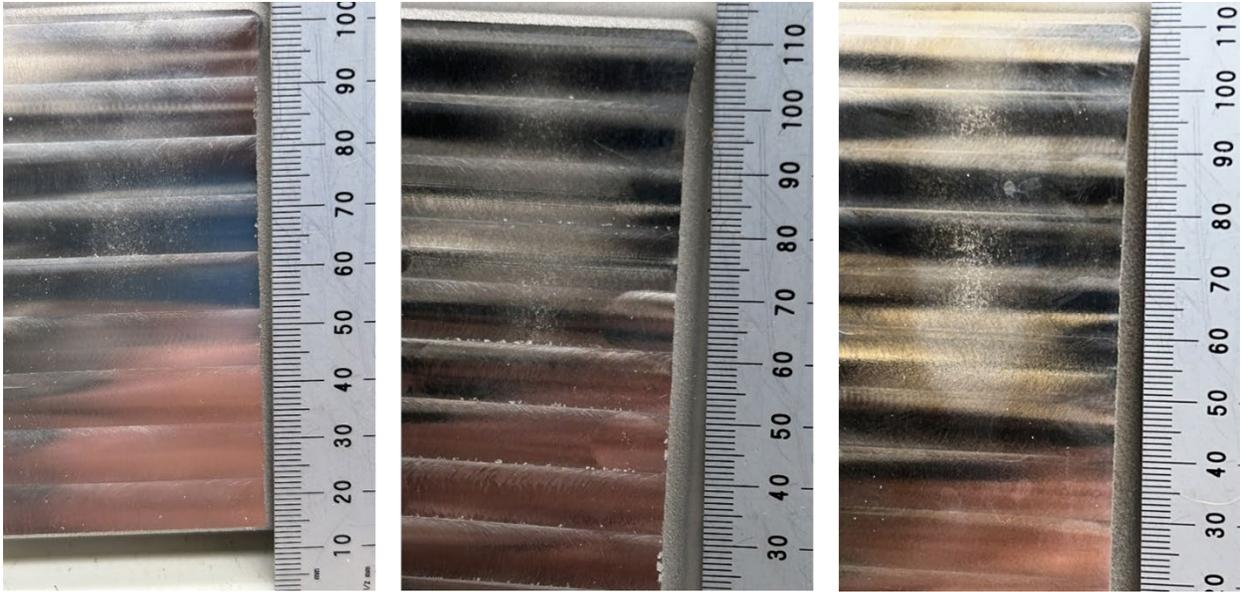
- Cold spray-applied Inconel 425 and CRC-410-1 chromium carbide tested with three different application parameters exhibited no metal loss at 250 hours, performing better than Type 308/309 stainless steel and showing less frosting than Type 316 stainless steel.

Figure 20.—Inconel 625/CRC-410-1 chromium carbide blend shown after 250 hours cavitation testing. Left: Cold Spray 2.1. Middle: Cold Spray 2.2. Right: Cold Spray 2.3. Ruler tick marks are in millimeters.

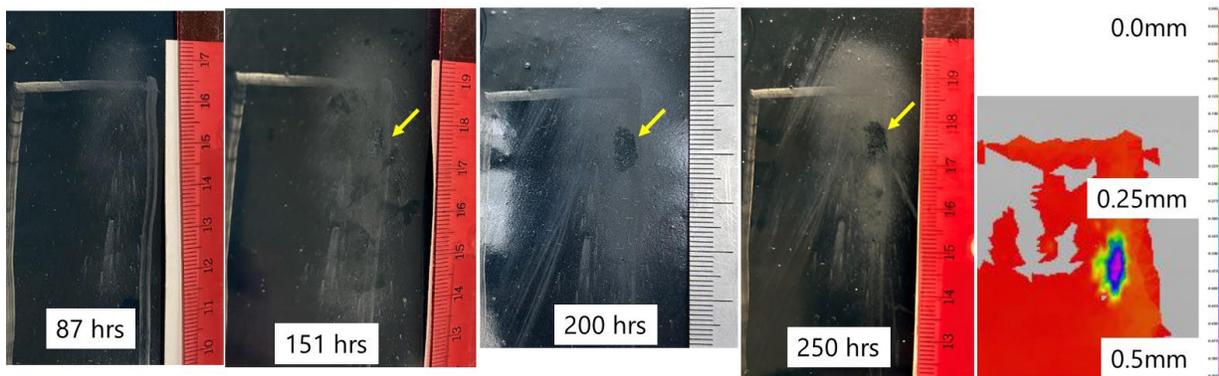
Figure 21.—PE 1-1 cavitation damage in long-term testing over four exposure times noted in hours (hrs). The image to the right was developed from the Laser scanner to show the volume and depth loss at 250 hrs. Ruler tick marks are in millimeters.

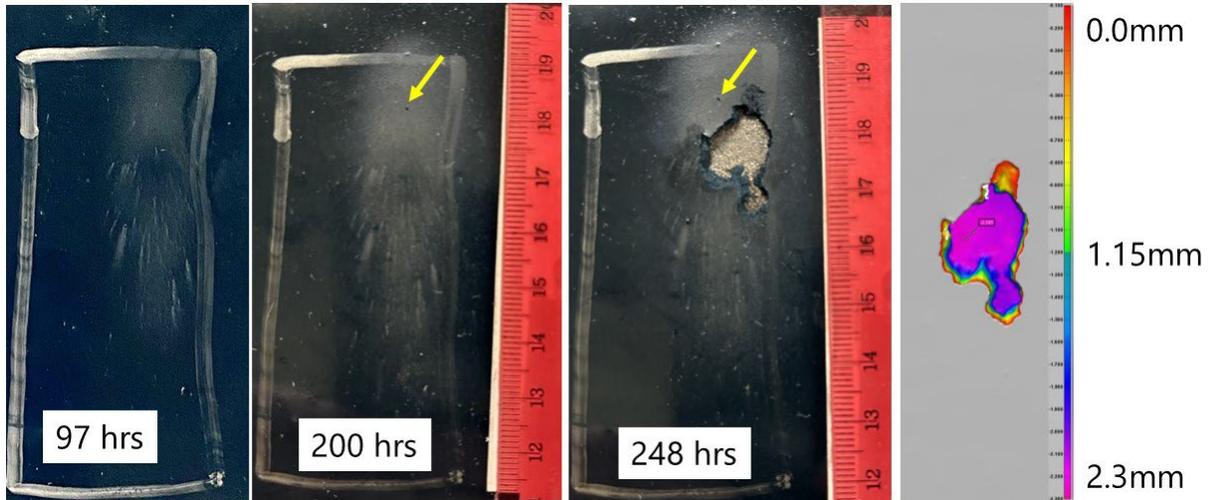
Figure 22.—PE 1-2 cavitation damage over three exposure times noted in hours (hrs). The image to the right was developed from the laser scanner to show the volume and depth loss at 248 hrs. Yellow arrows point to what appeared to be a point of failure initiation at 200 hrs but was still visible after failure at 248 hrs. Ruler tick marks are in millimeters.

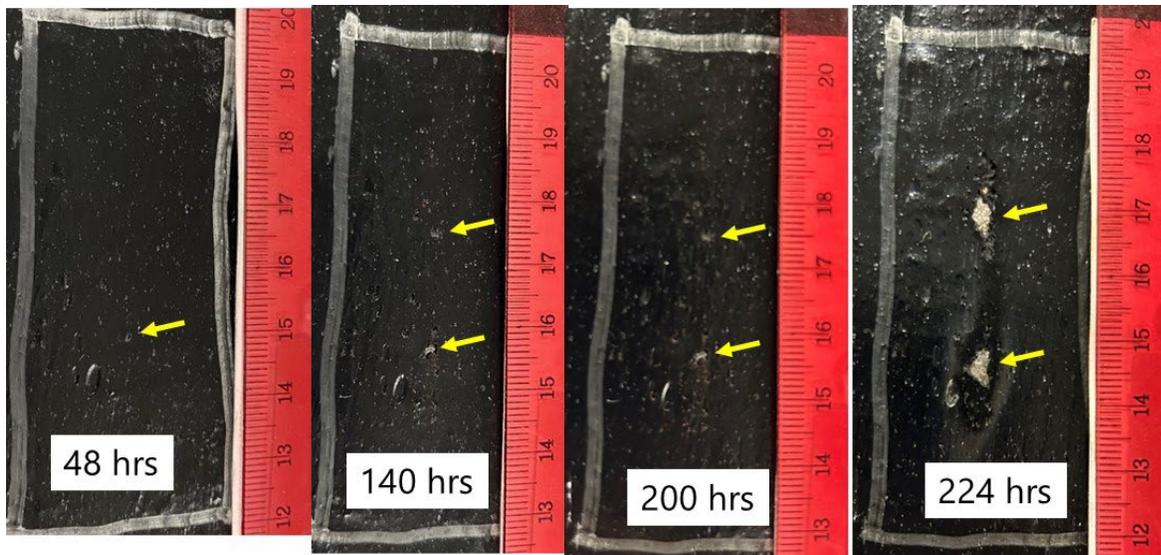
Figure 25.—PE 2-2 long-term cavitation testing over time, reported in hours (hrs). The top arrow shows the damage in the impact zone and the bottom arrow shows the damage in the pure cavitation zone. Ruler tick marks are in millimeters.

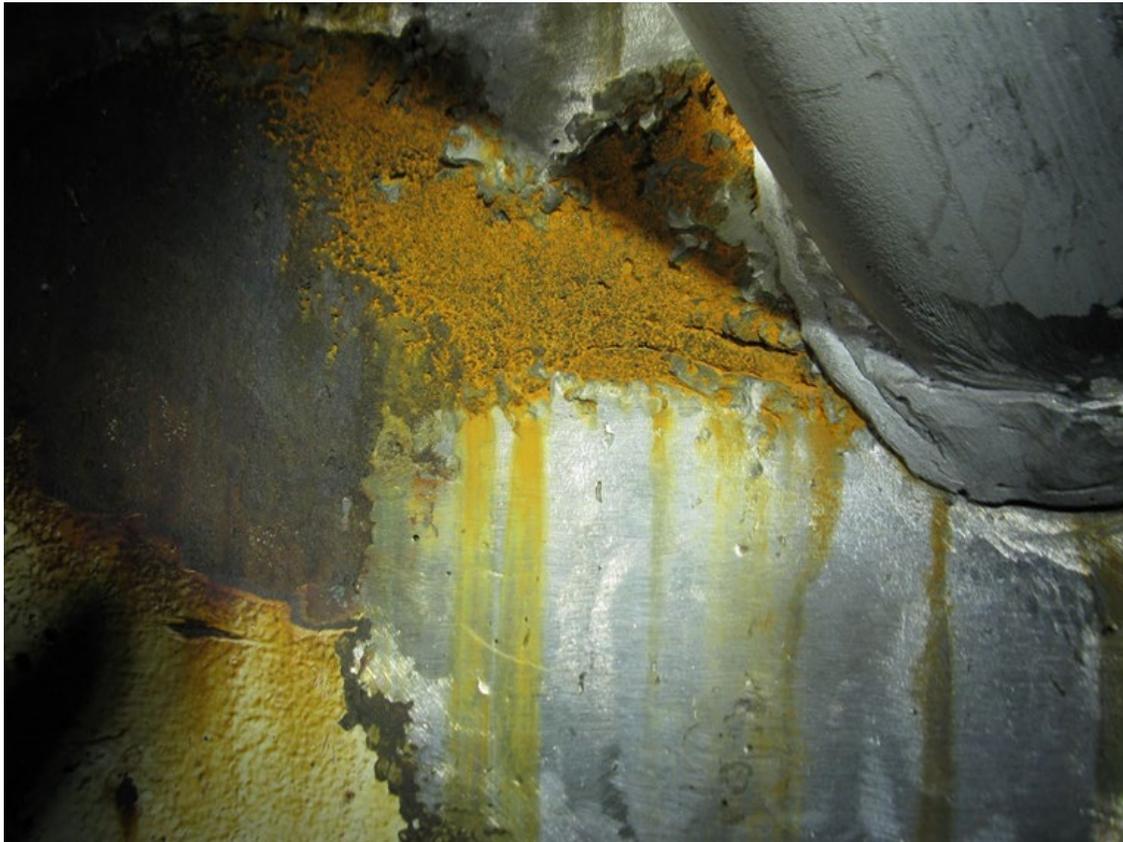
**Figure 1: Image of a stainless-steel weld overlay failure in a draft tube. Galvanic corrosion and cavitation damage is observed in the mild steel.**

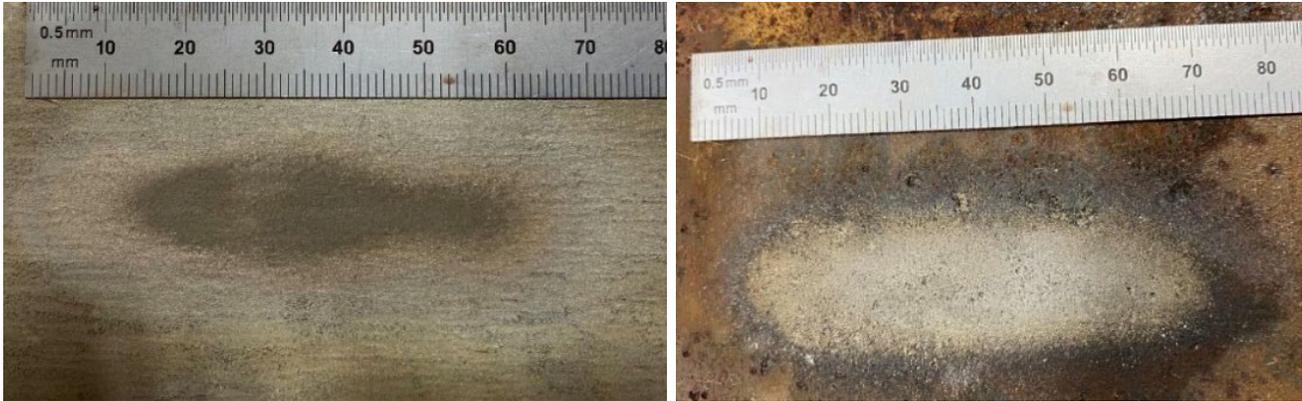
**Figure 3: Stainless steel 316L (left) and mild steel (right) after 40 hours exposure to submerged jet cavitation apparatus. Notice pitting caused by cavitation in the mild steel.**

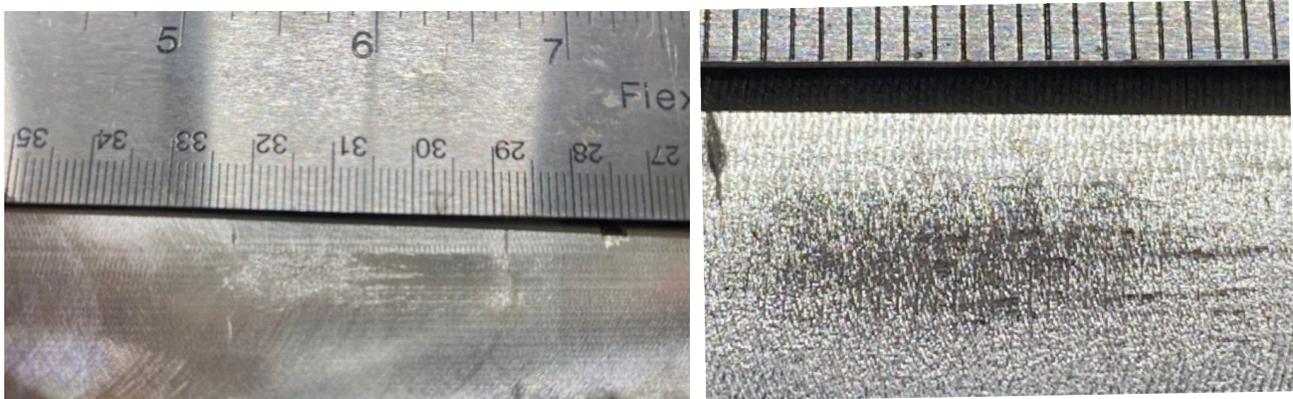
**Figure 4: Photo of ER308/309 stainless steel weld overlay after 40 hours exposure to cavitating jet apparatus. The damaged area is significantly less than mild steel.**

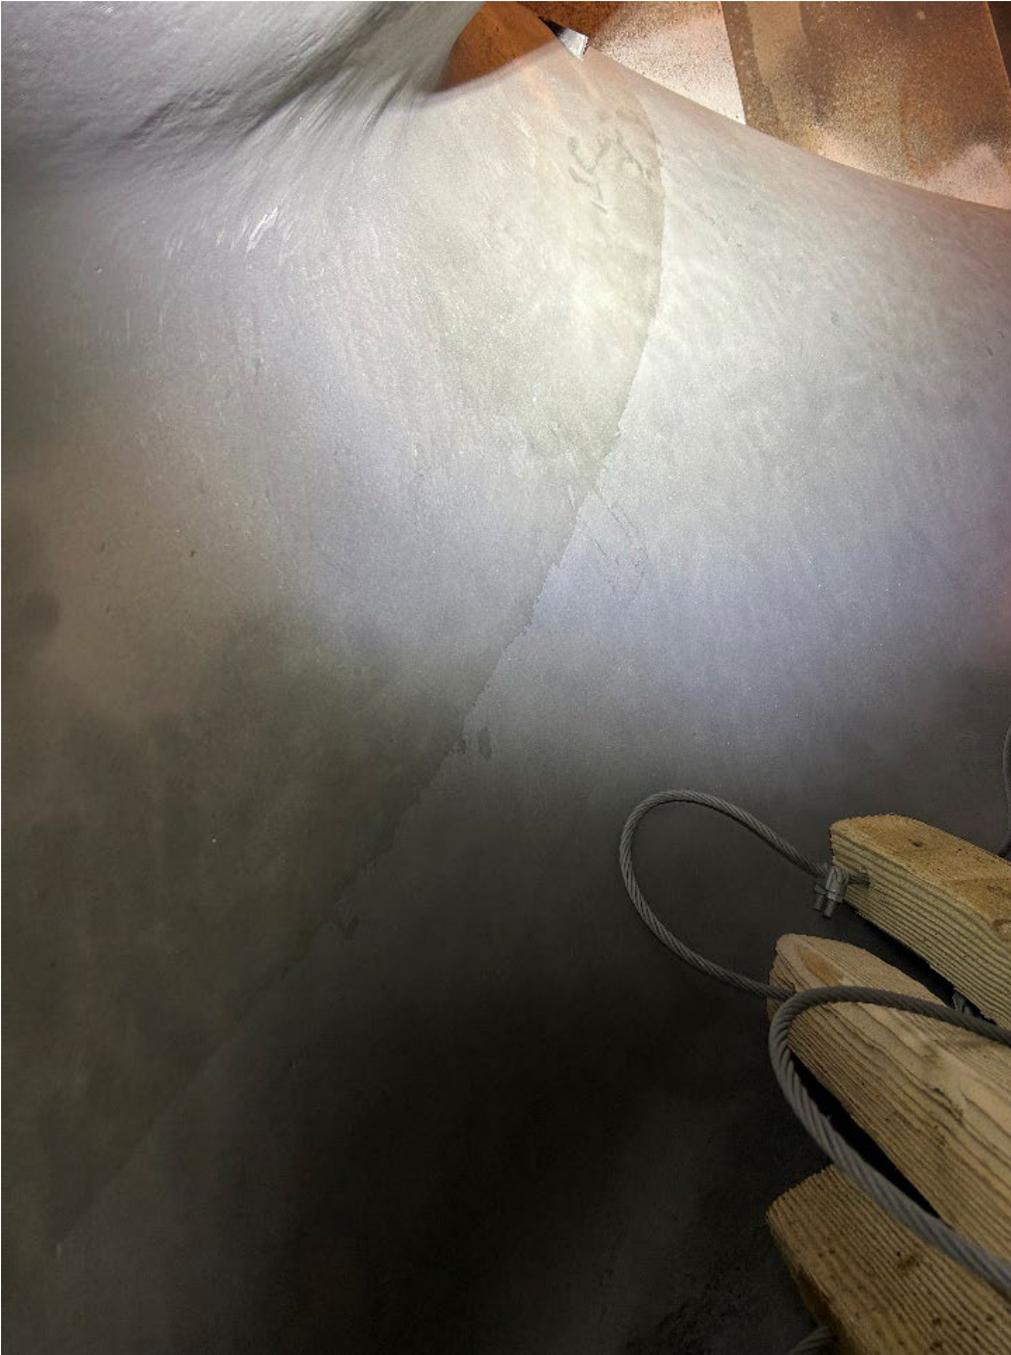
Figure 1.—Typical condition of surface preparation at 308 stainless steel weld overlay/mild steel transition.

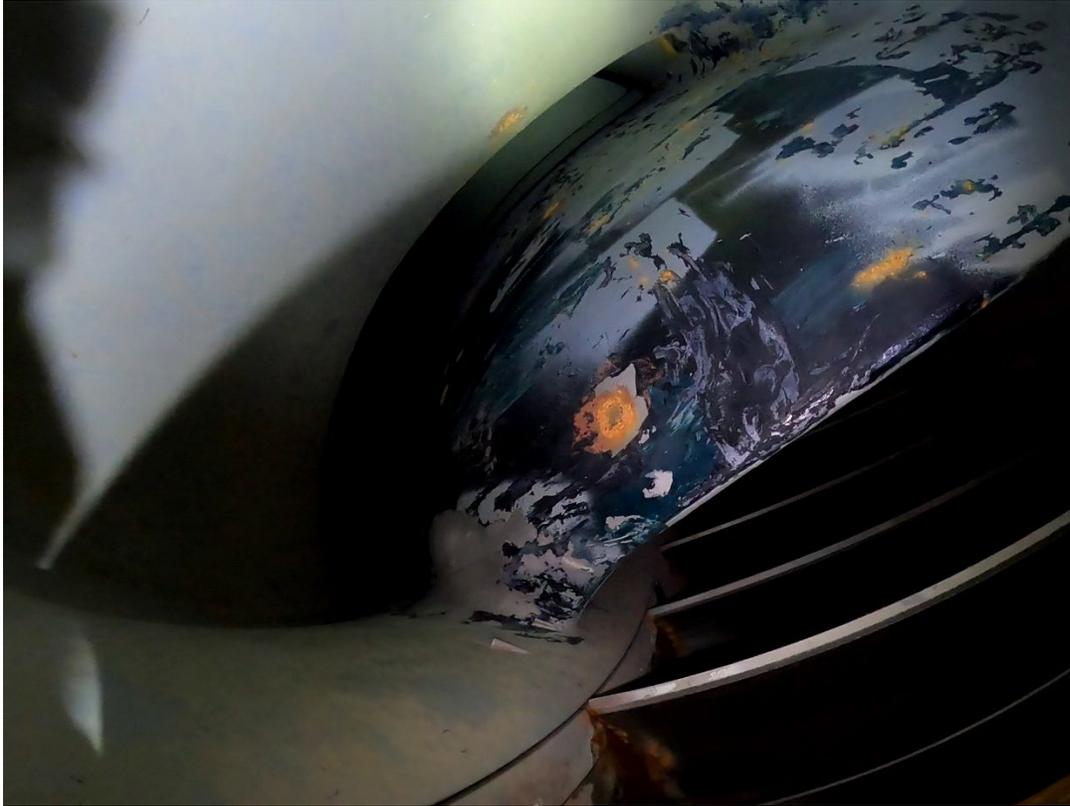
Initial field trials of PE 1 and PE 2 at the Nathaniel “Nat” Washington Power Plant Unit G21 turbine runner resulted in a small region of elastomer failure after less than 1,000 hours of operation near the inlet on the suction side of the blade. This is the most severe cavitation zone of the runner, and estimated damage area for PE 1 and PE 2 were about 1 square foot (sq ft) and 10 sq ft, respectively. The field trials showed the PE coatings are difficult to apply and require pre-heating to lower the viscosity for mixing. The materials must also be hand-applied by trowel quickly after mixing. The pot life for PE 1 and PE 2 is 13 and 45 minutes, respectively. Spray-applied PE materials would provide an opportunity to improve application quality and reduce labor.

Figure 12.—Cavitation damage on leading edge suction side of PE1, approximately 1 square foot of damage. The gray color is from application defects that were repaired with an epoxy.

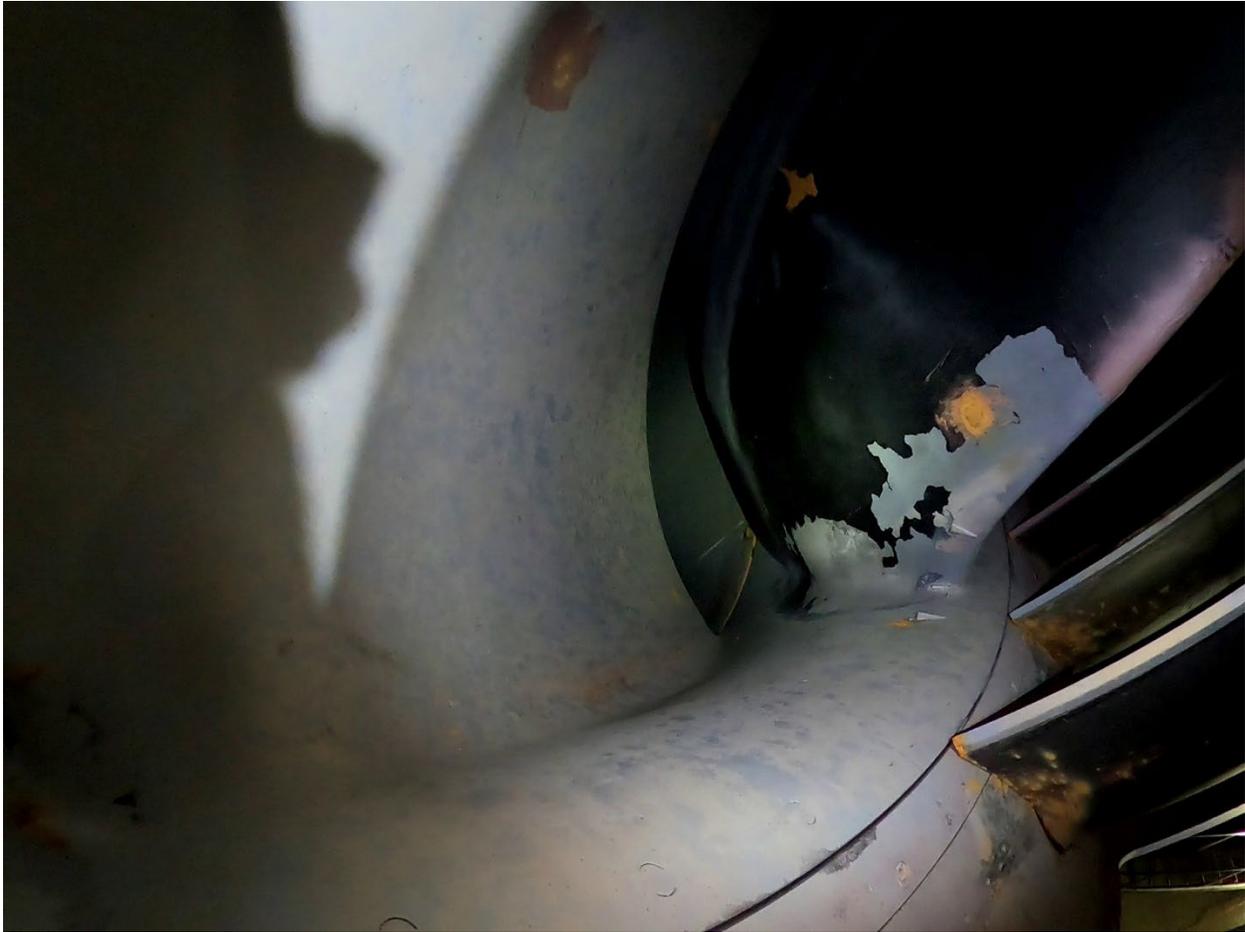
Figure 13.—Blade 7 after 1,000 hours of operation. The PE2 failed by cavitation and delamination on leading edge with approximately 10 square feet of damage. The rust spot near the center of the blade is from the welded brace that was removed for the platform and repaired using an unknown procedure.

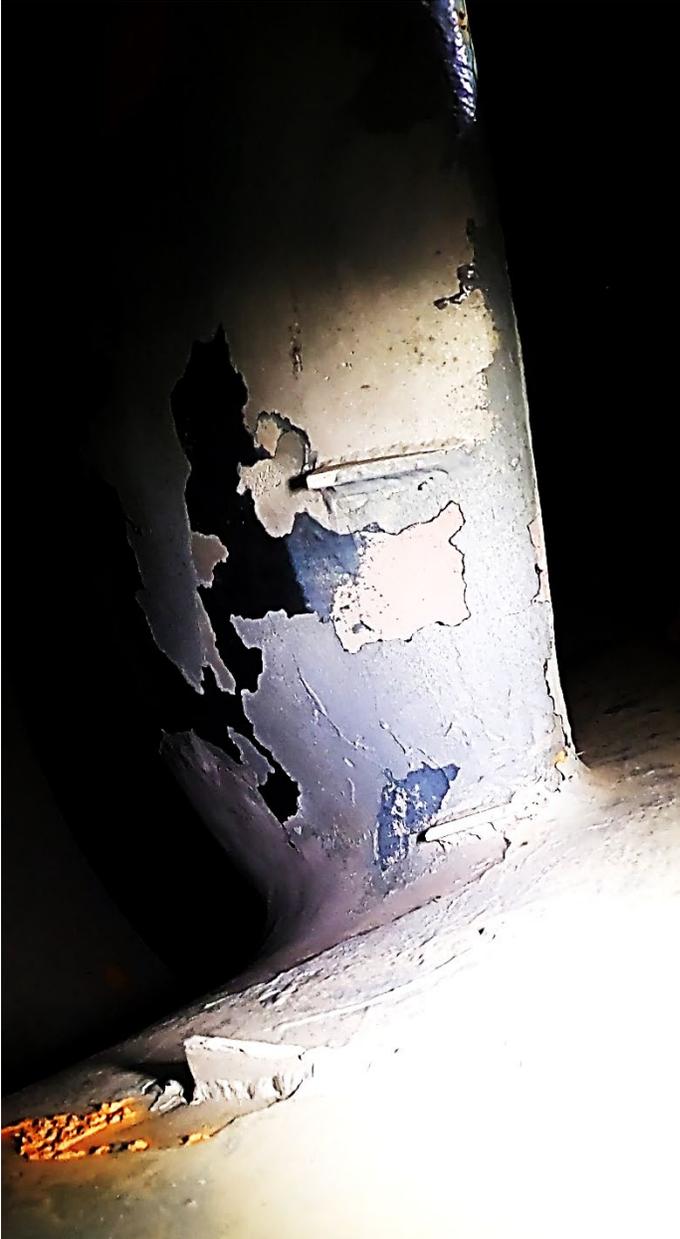
Figure 14.—Close-up of Blade 7 after 1,000 hours of operation. The PE2 failed by cavitation and delamination on leading edge.

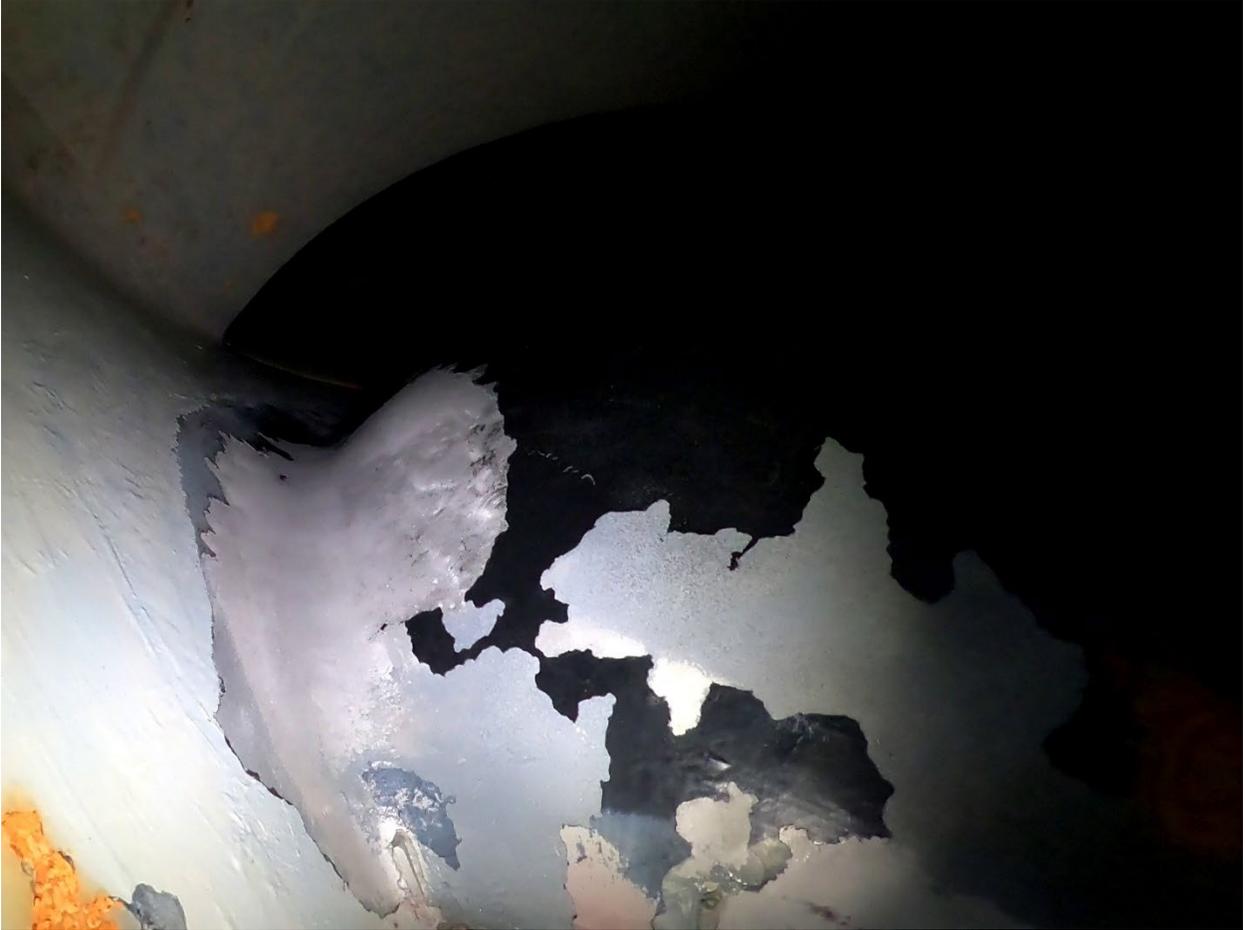
Figure 15.—Close-up of Blade 7 after 1,000 hours of operation. The PE2 failed by cavitation and delamination.

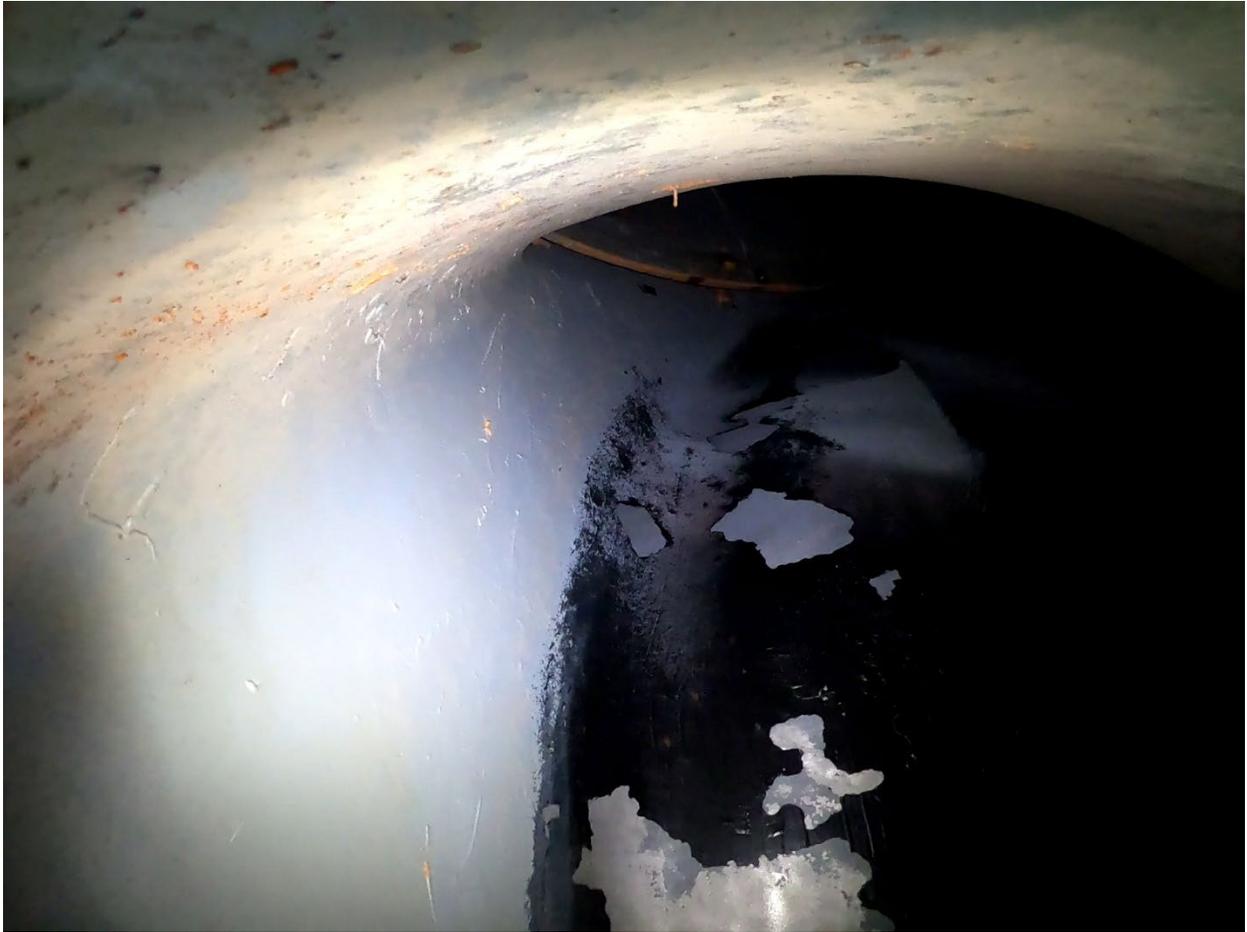
Figure 16.—Close-up of Blade 7 after 1,000 hours of operation. The PE2 failed by cavitation and delamination.

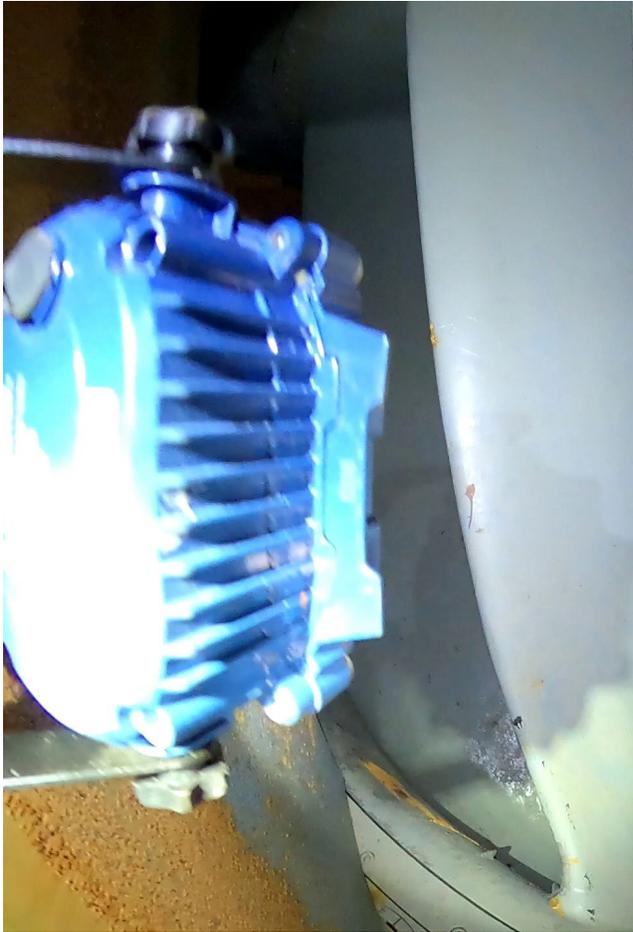
Figure 17.—Leading edge of Blade 8 showing the applied PE2 almost completely gone, with only a few specks of the black coating still remaining after 1000 hours. No photos are available of the downstream side of the blade shown in Figure 11.

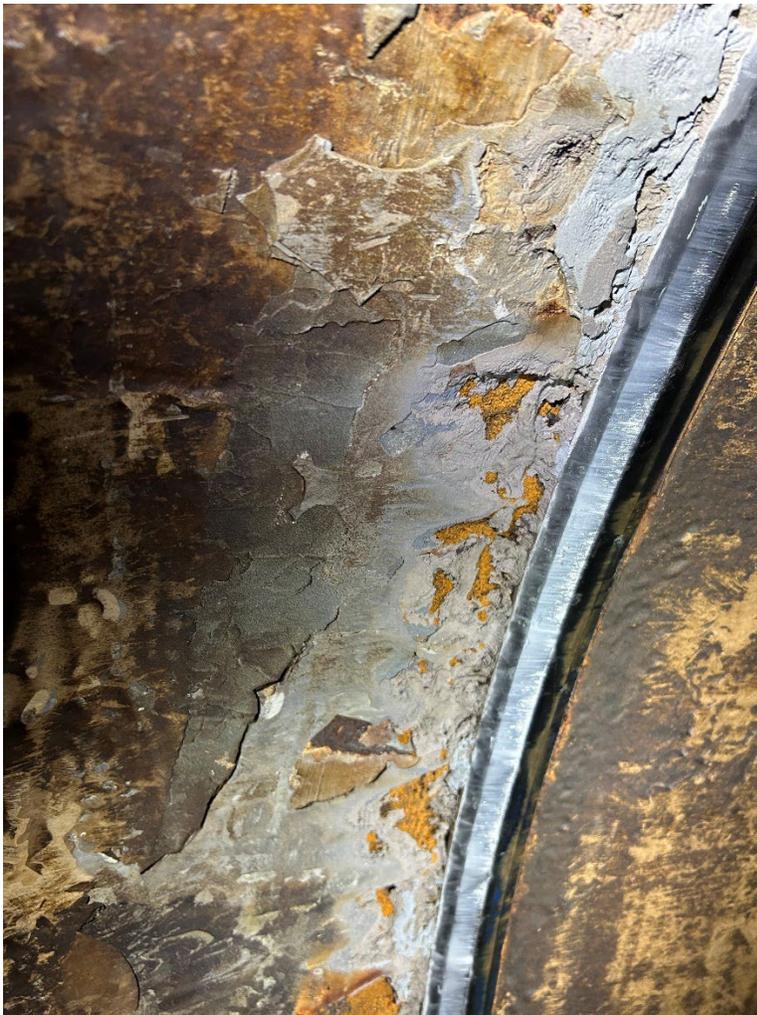
Figure 1.—Condition of the cavitation damage downstream of the butterfly seat (left side of stainless steel seal) prior to surface preparation.

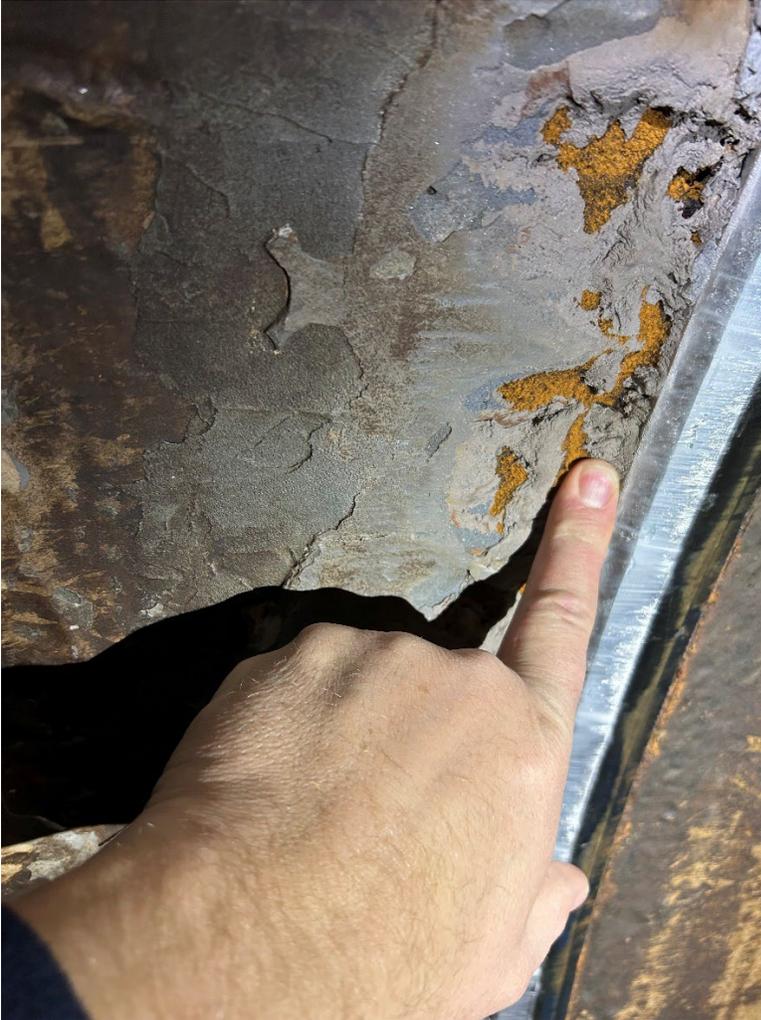
Figure 2.—Condition of the cavitation damage downstream of the butterfly seat prior to surface preparation.

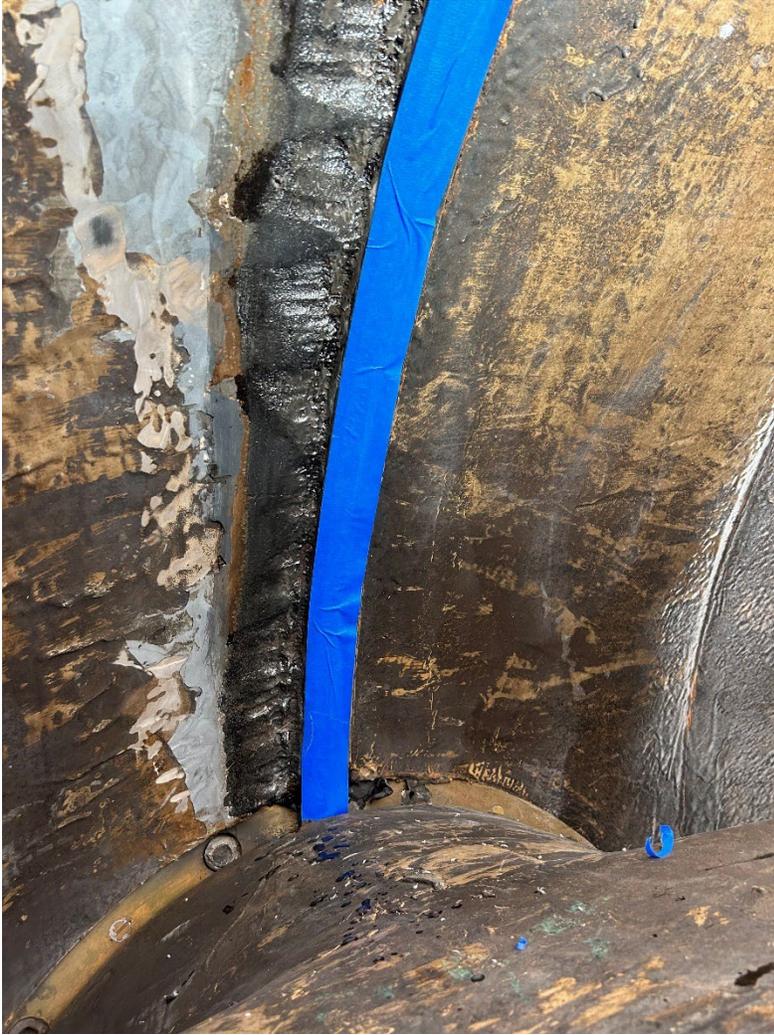
Figure 3.—Power tool cleaning to metal of the cavitation damage downstream of the butterfly seat. The blue tape is protecting the stainless steel seat. The 3/8-inch-deep cavitation damage is to the left of the tape.
