# Laboratory Evaluation of Field Repairable Materials and Techniques for Cavitation Damage: Phase II

Science and Technology Program  
Research and Development Office  
Final Report No. ST-2023-20024-01

**Technical Service Center  
Materials and Corrosion Laboratory Group  
Allen Skaja, Ph.D., Protective Coatings Specialist**

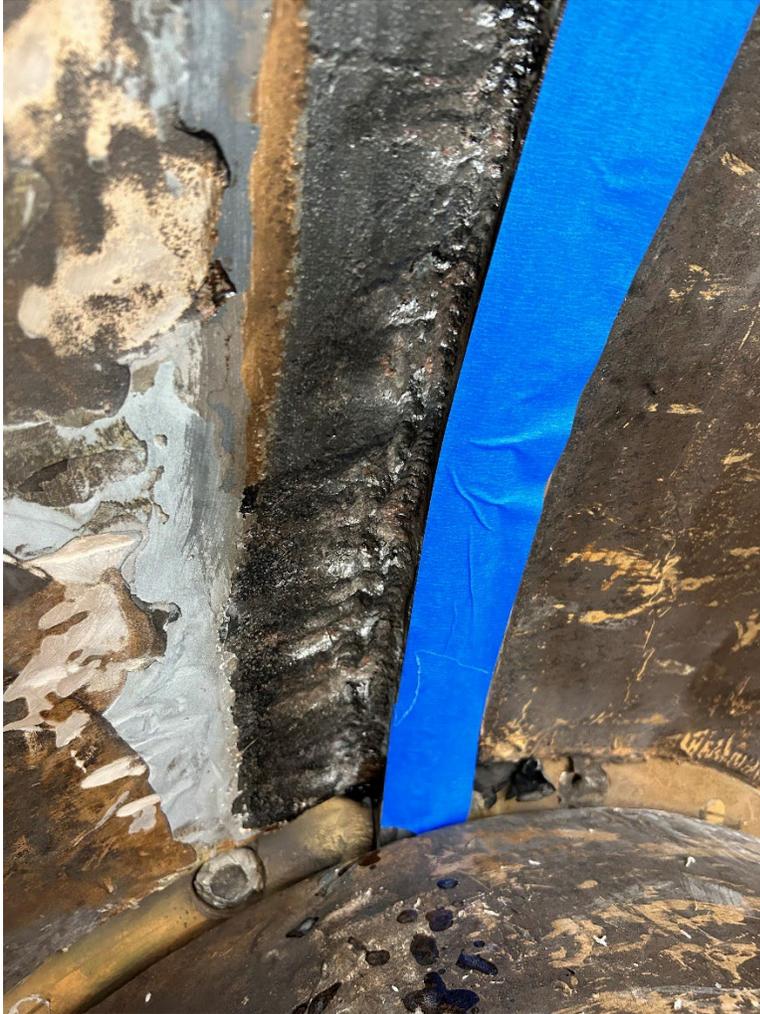
Figure 4.—Powertool cleaning to metal of the cavitation damage downstream of the butterfly seat. The blue tape is protecting the stainless steel seat. The 3/8-inch-deep cavitation damage is to the left of the tape.

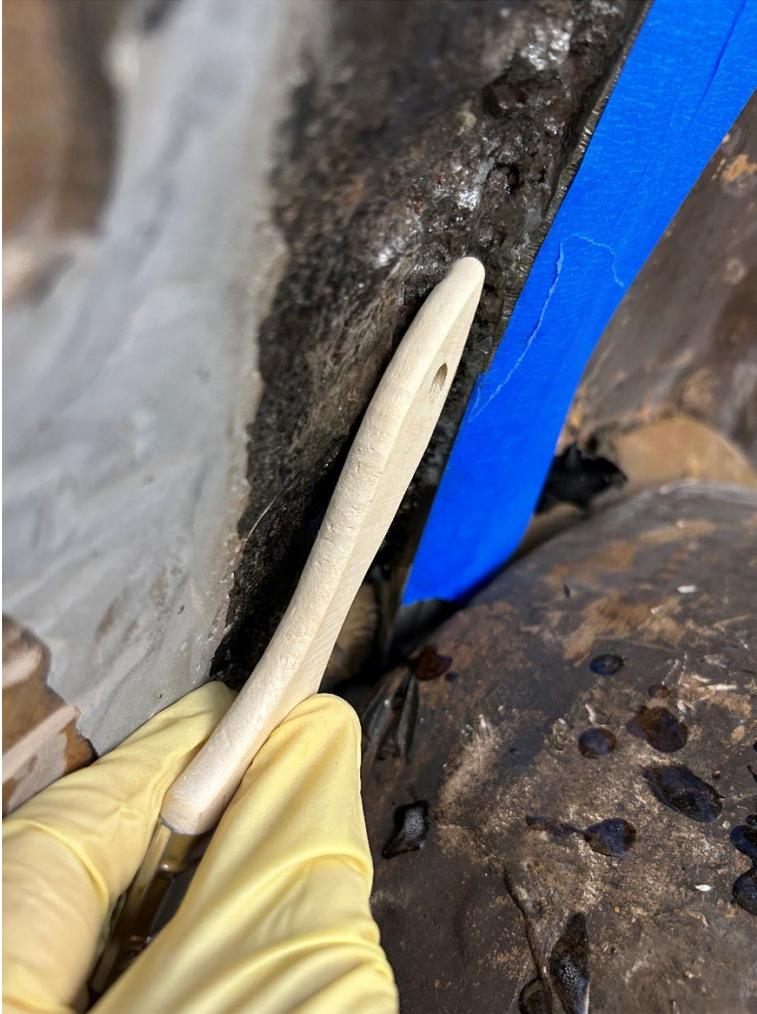
Figure 5.—Cavitation damage downstream of the butterfly seat shown after power tool cleaning exposed pits up to 3/8 inches deep.

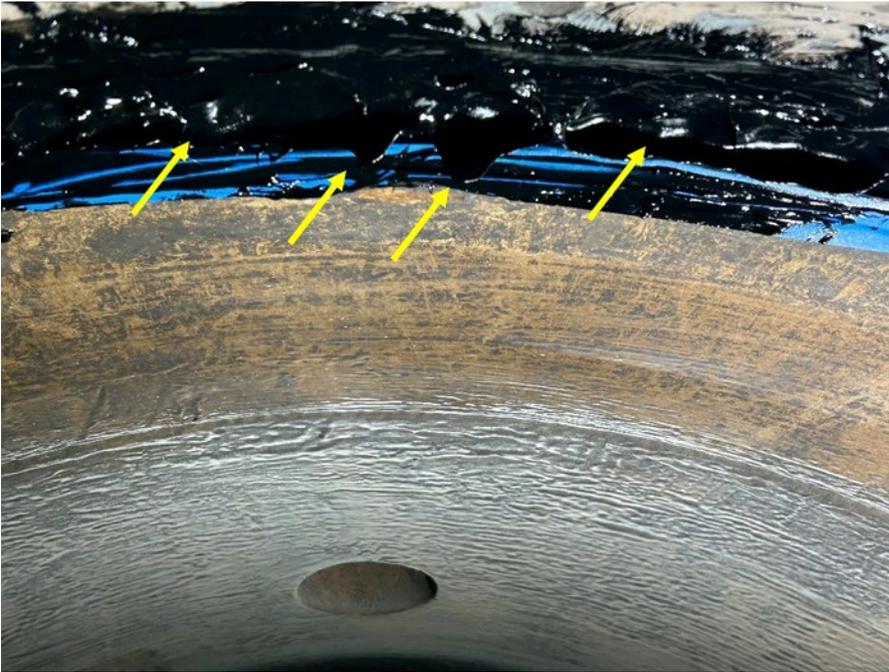
Figure 9.—PE2 is shown applied between the 11 o'clock and 1 o'clock positions. The lower viscosity resulted in sags and drips, noted with arrows.

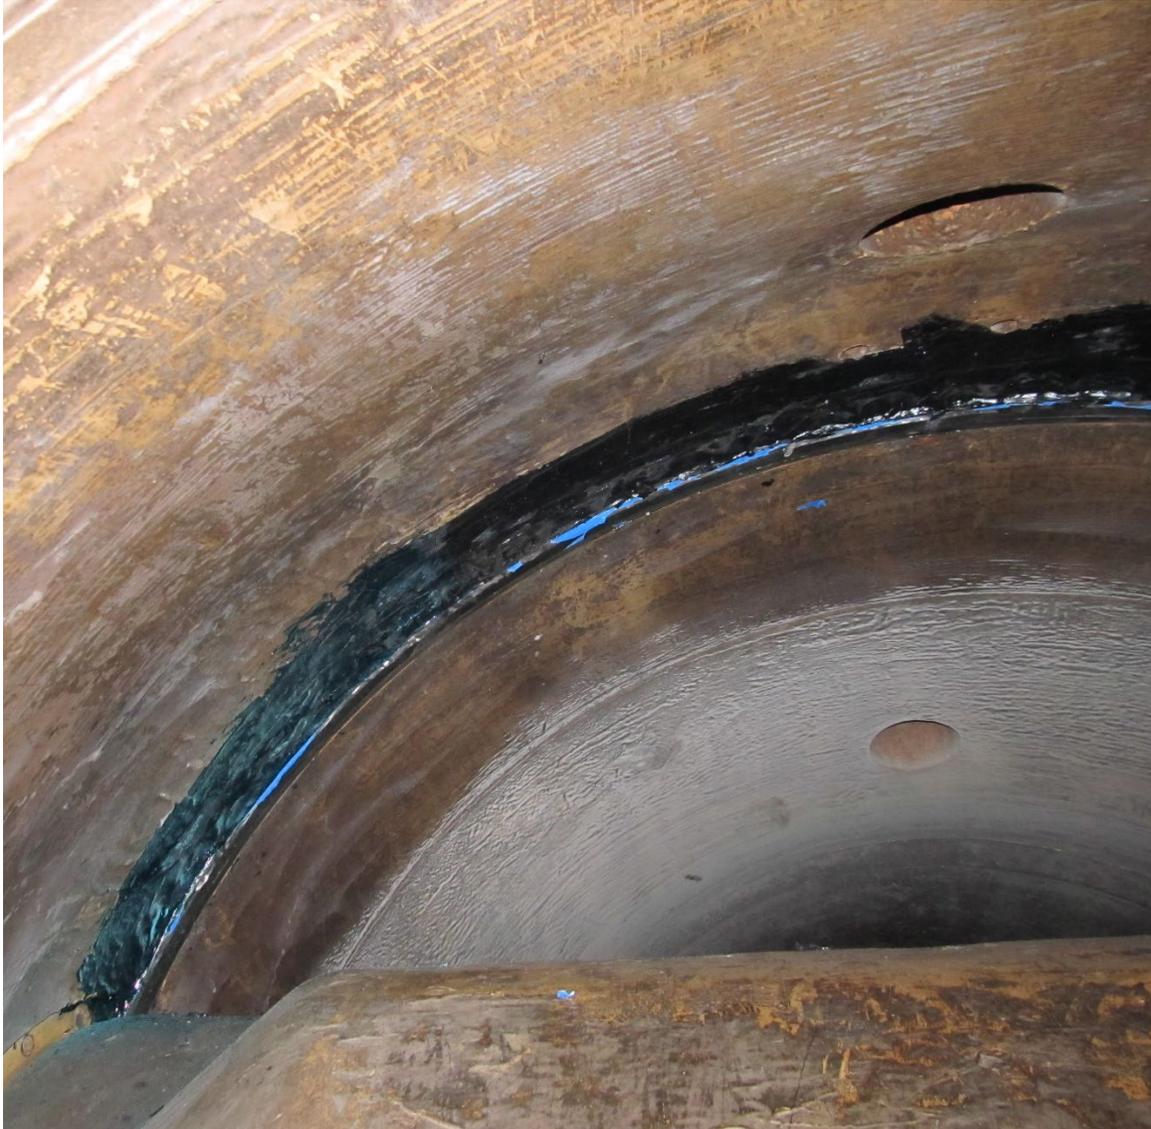
Figure 11.—Test area is shown prior to recommissioning Unit 2 penstocks. Drips and sags had been smoothed, but a few areas still needed to be sanded down to allow for proper operation of the butterfly valve.
