PCCP Inspection Truthing and Education Demonstration

Science and Technology Program
Research and Development Office
Final Report No. ST-2022-19275-01

**Final Report No. ST-2022-19275-01
8540-2022-74**

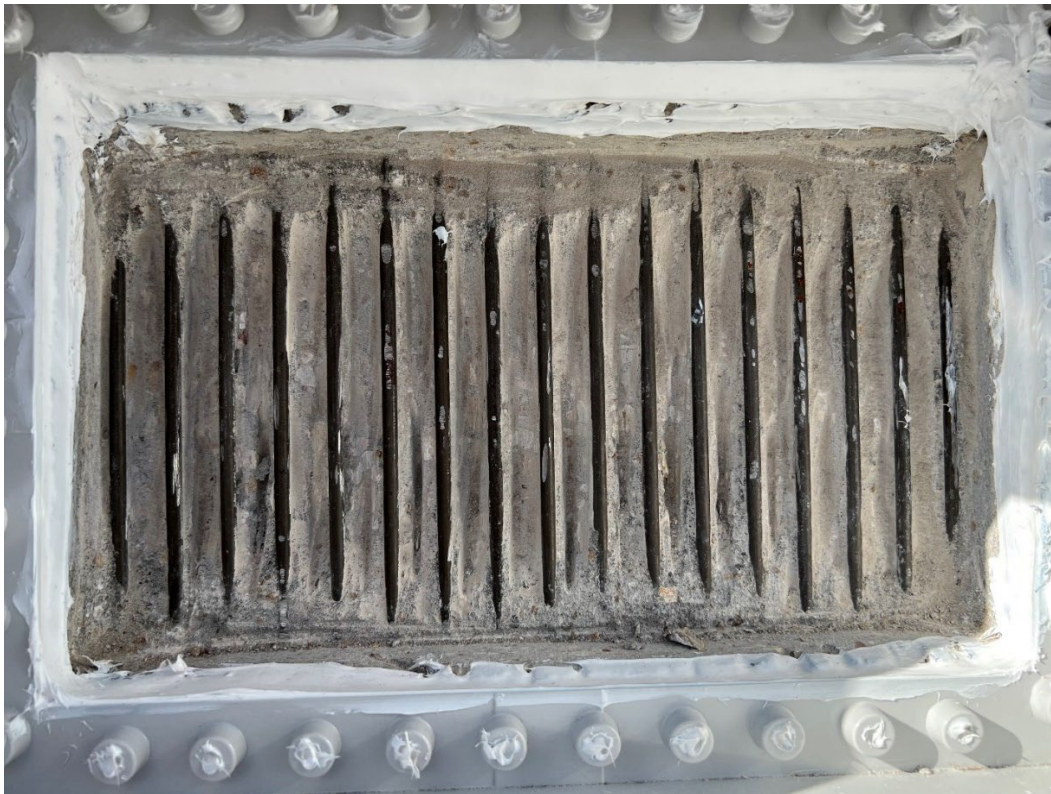
Figure 5. Exposed prestressing wires used for EC inspection demonstration.

A small portion, roughly 12in by 6in, of the exterior mortar coating was removed to expose prestressing wires for the EC testing. A weather enclosure was added to protect the exposed wires from further corrosion. An image of the portion tested and intended for use in educational demonstrations is shown in Figure 5, with the corresponding results are provided in Table 1 where wires were numbered sequentially from left to right. Testing revealed that all exposed prestressing wires were electrically continuous indicating that no wires were broken. To provide learning opportunities for student inspectors, wires 5 and 6 were later cut with an angle grinder to provide discontinuous readings.

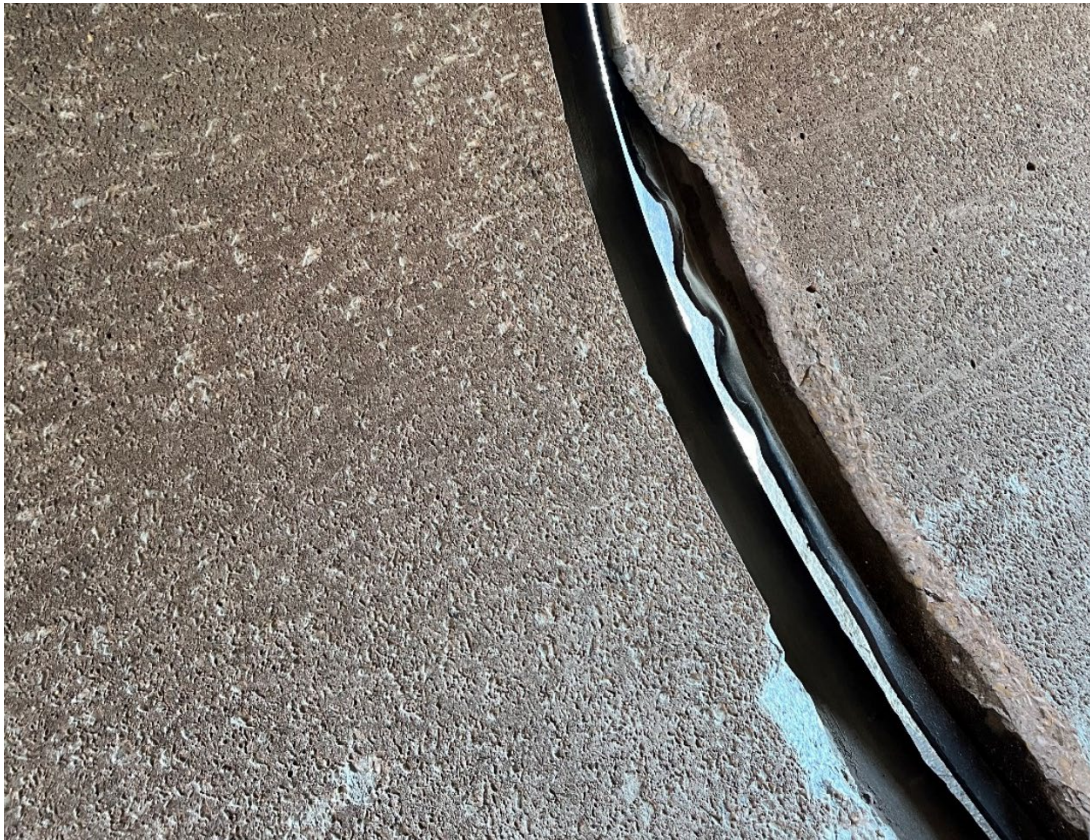
Visual inspection was completed on the distressed PCCP sections after installation. Severe cracking was observed around all bell and spigot joints and the metallic ring was severely bent; an example of bending in the joints can be seen in Figure 7. This damage likely occurred as the pipe sections were being removed from service.

Figure 7. Example of damage found on joints

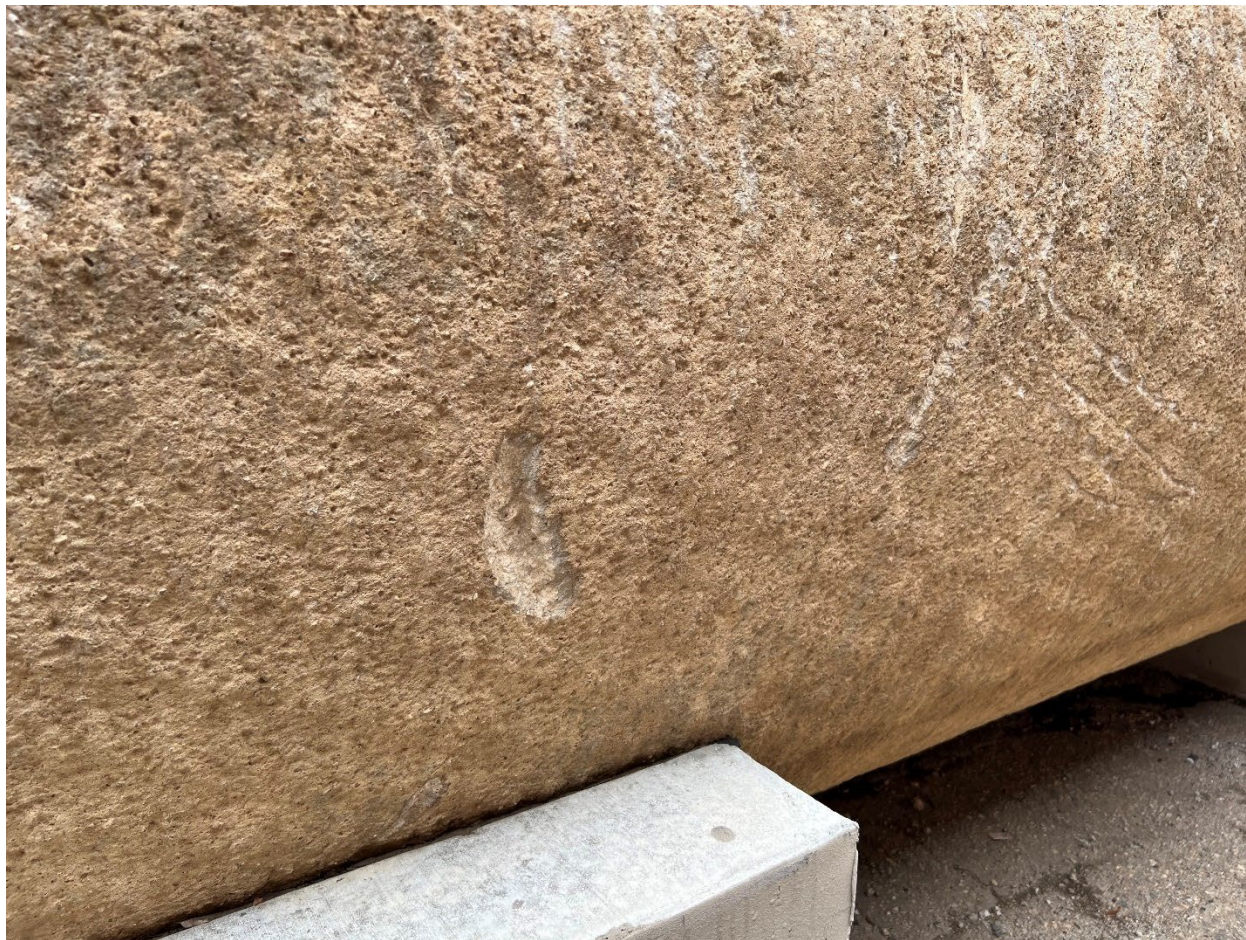
Severe gouge marks were found in the exterior mortar coating indicating transport by heavy machinery, an example of which is shown in Figure 8. While the damage likely occurred during removal from service, it was not possible to determine if the damage occurred at the initial placement or after removal from service.

Figure 8. Example of Gouging found on exterior of PCCP sections.

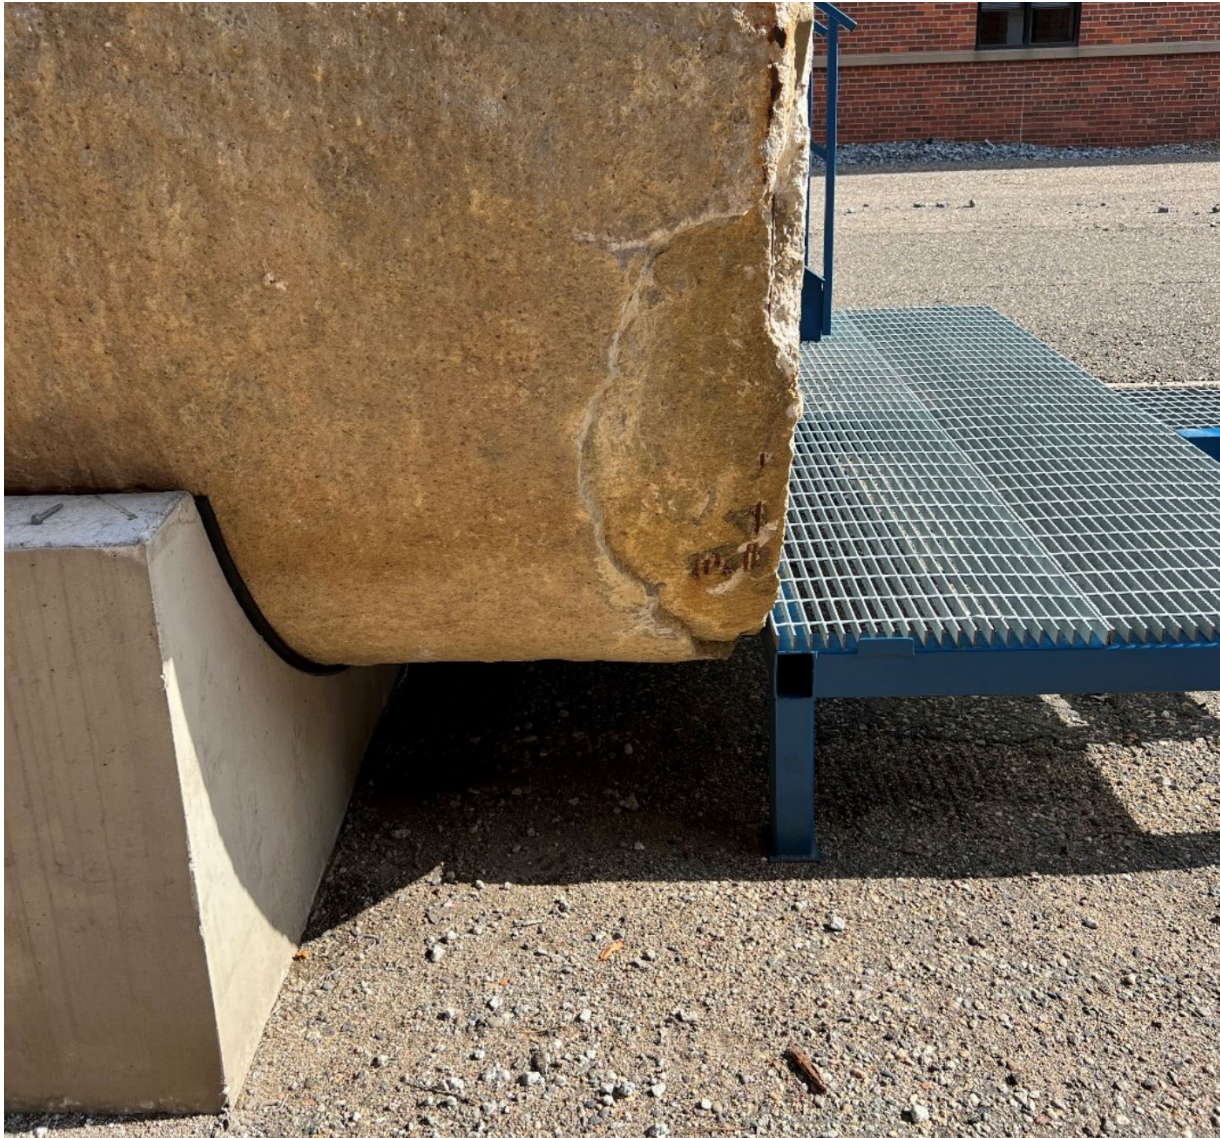
Mortar delamination and exposed prestressing wires were found near both joints on the West PCCP section, shown in Figure 9. It was not possible to determine if this damage occurred in service or during the removal process.

Figure 9. Mortar delamination is visible on the West PCCP section.

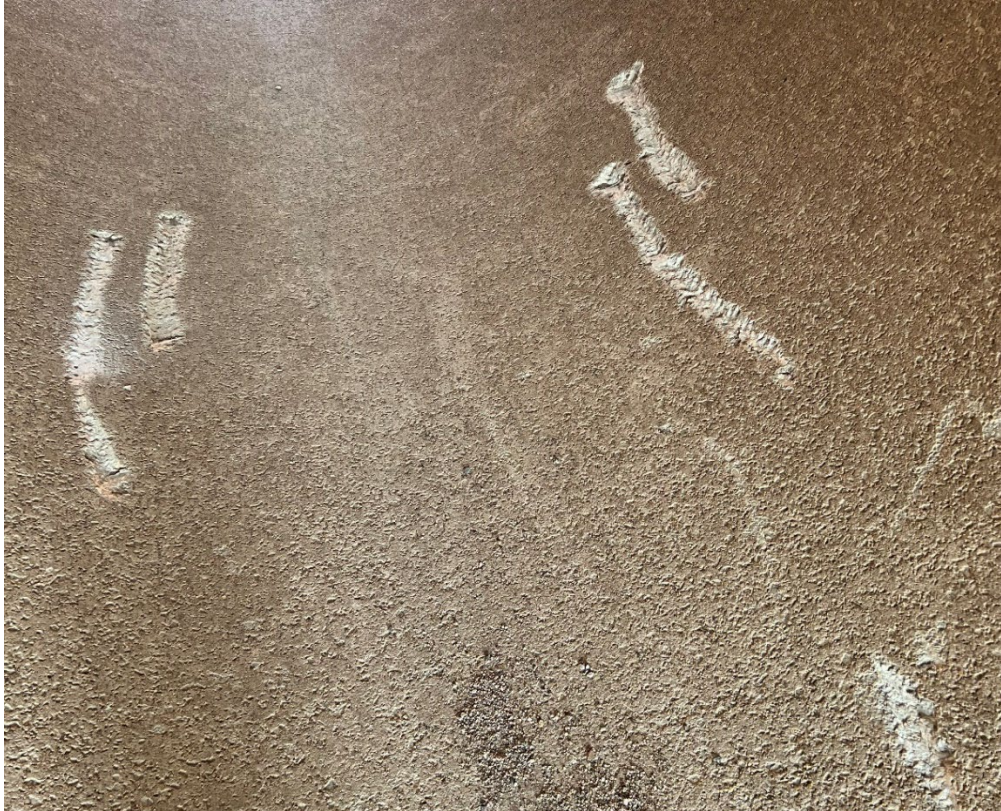
Gouges like those shown in Figure 10 were found in the interior of the East PCCP section. Interior gouges can be caused of number of factors, including debris; however, the clean surface of these marks and presence of drill holes indicates this damage likely occurred during or after removal of the section from service.

Figure 10. Example of gouges found on the interior of PCCP sections.
