— BUREAU OF —
RECLAMATION

Development and Field Research on Next Generation Coatings for Mussel Mitigation on Infrastructure

Science and Technology Program
Research and Development Office
Final Report No. ST-2021-19196-01
Technical Memorandum No. 8540-2022-56

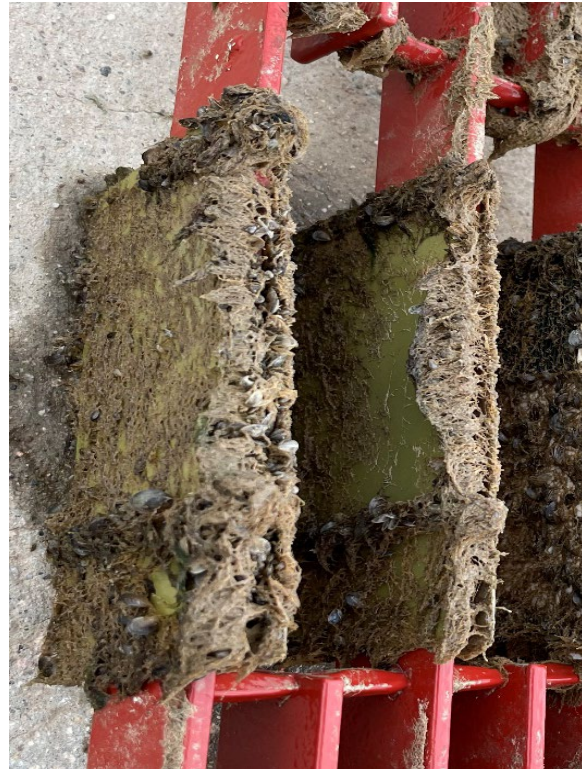
Figure 3: Popspeed after six months in dynamic testing condition. Some accumulation of the colonial hydroid on surface. Mussels are attached to zip ties and not adhered to coated surface.

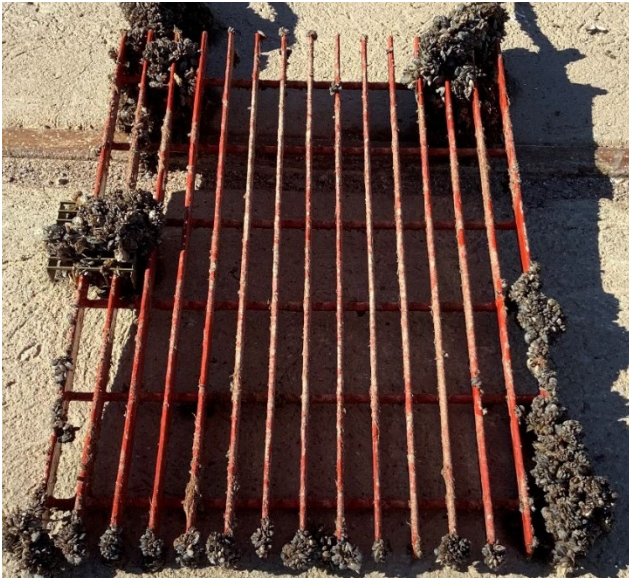
Figure 4: Jotun Sealion Repulse flowing water test grate during January 2022 inspection. No fouling except for areas of damaged coating.

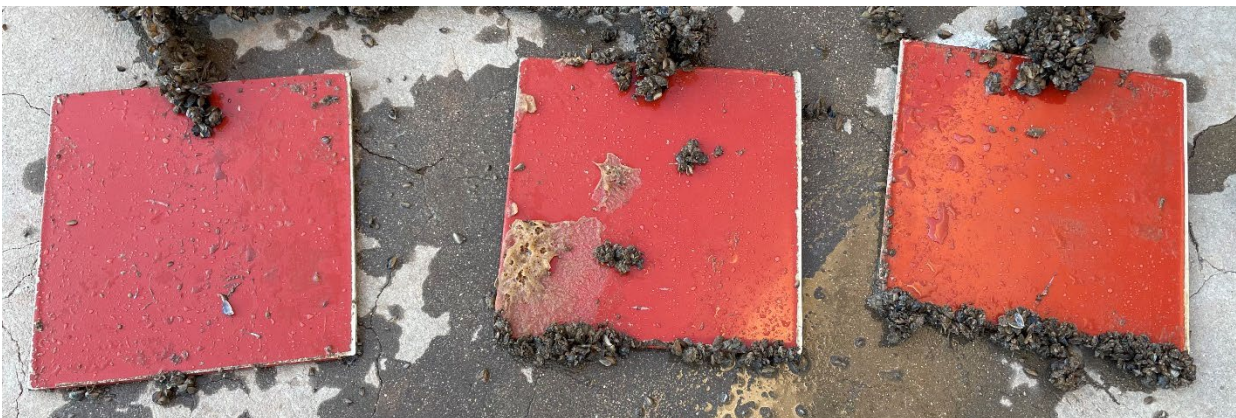
of the grate. During the 2022 inspections it was observed that the static test panels had light fouling on the bottom edge of the panels where the coating had become damaged and/or missing. This damage was likely caused by the scrapping of the panels on the dam as they were pulled and reinstalled during inspections for data collection. Damage could also be caused by nearby flowing water causing the panels to move and rub against the dam during testing. Figure 5 shows the light fouling on the damaged areas of the static test panels.

Figure 5: Quasi-static test plates for Jotun Sealion Repulse. Fouling only on edges due to damaged coating.

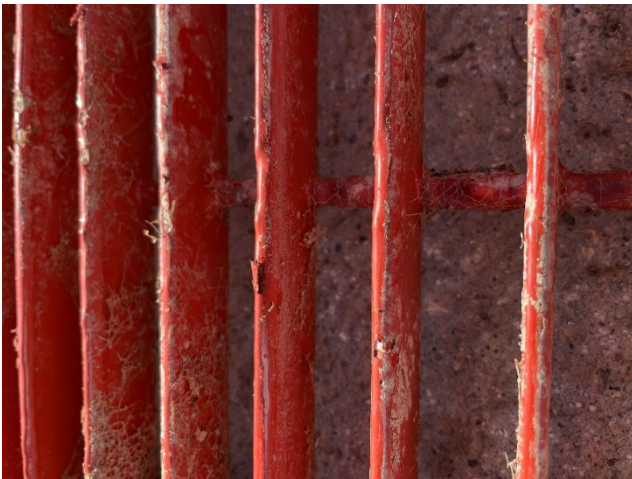
Jotun has two products in testing. Product one, Sealion Repulse, is a soft-silicone coating that is biocide free. The coating system utilizes nanotechnology to create the surface properties that provide foul release. This system was installed in 2013 and remains effective in preventing mussel attachment with zero mussel fouling in both flowing and static water conditions shown in Figure 4 and Figure 5. The test grate in flowing water did have an accumulation of the colonial hydroid on the surface during the July 2022 inspection, shown in Figure 6, but was easily cleaned. During the January 2022 inspection, it was observed that minor damaged had occurred to the coating on the flowing test grate shown in Figure 7 and Figure 8. The damage was primarily on the upstream side

Figure 7: Damage on upstream side of Jotun Sealion Repulse test grate.

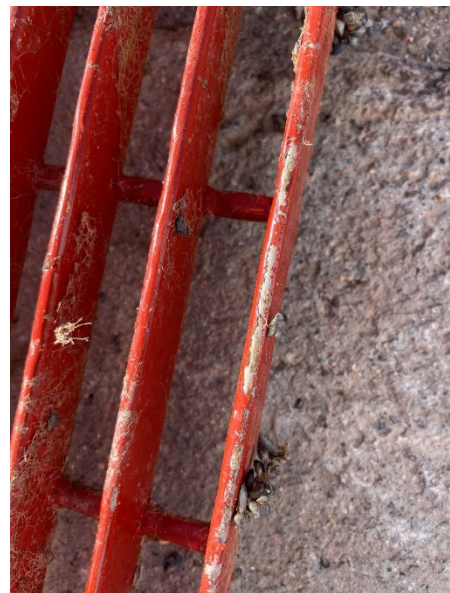
Figure 8: Abrasion style damage of Jotun Sealion Repulse test grate.

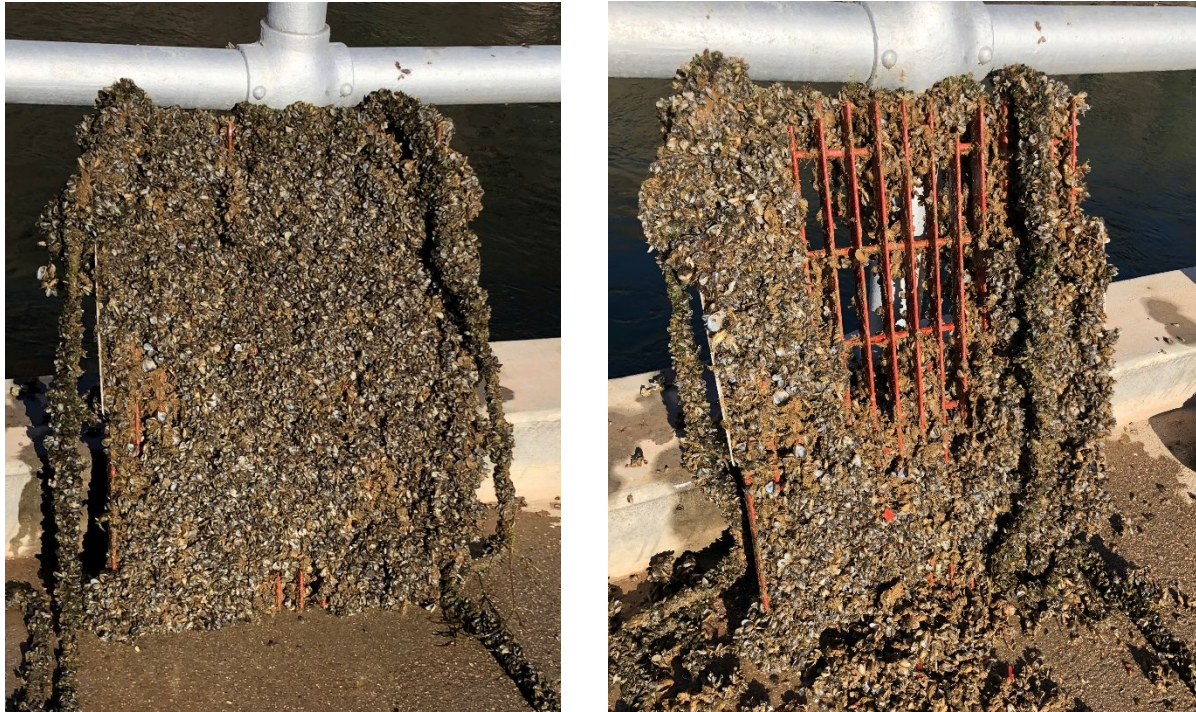
Figure 9: Jotun Sealion Resilient During 2019 inspection. 100% fouled before cleaning (left) and partially cleaned (right).

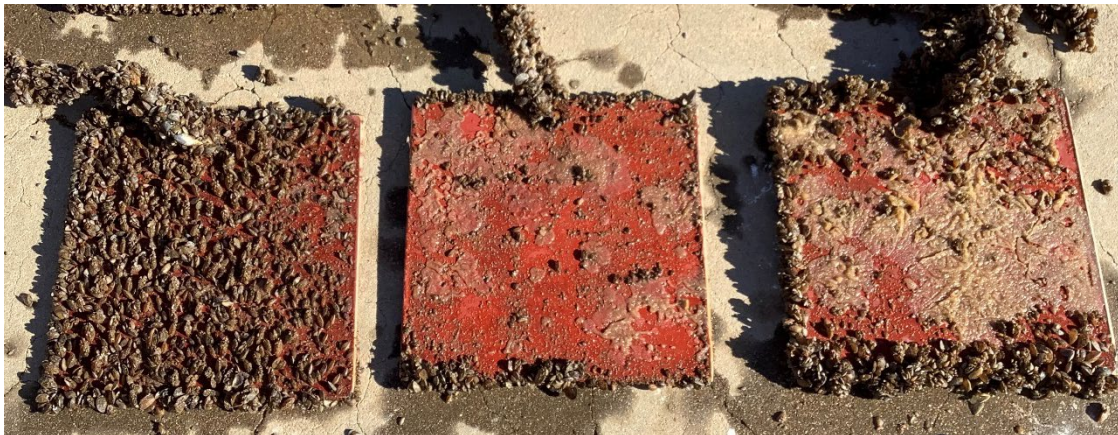
Figure 11: Jotun Sealion Resilient quasi-static test plates with mussel and sponge organism fouling during January 2022 inspection.

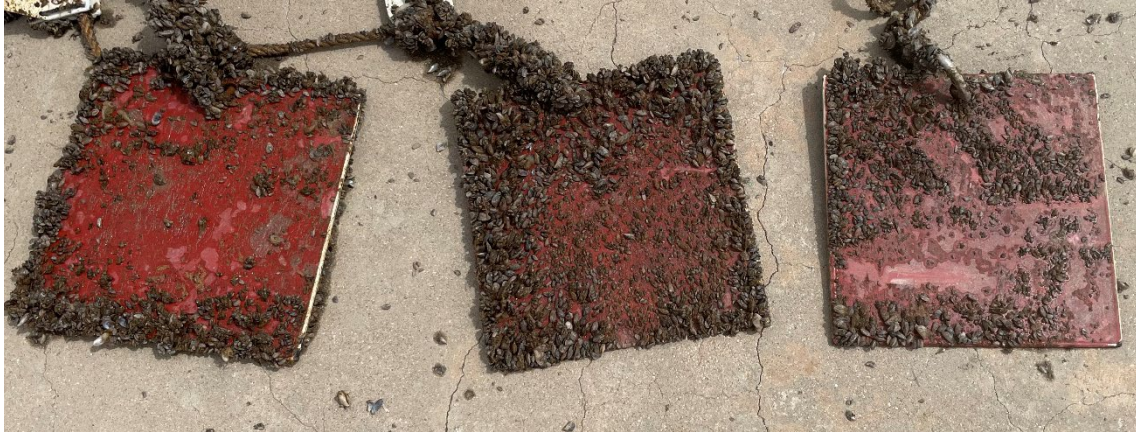
Figure 12: Jotun Sealion Resilient static test plates during July 2022 inspection with the surface partially fouled with mussels.

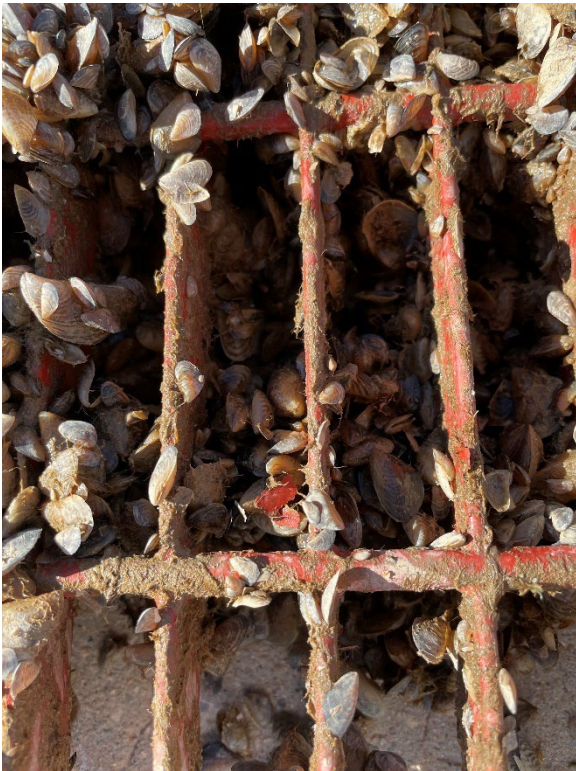
During an inspection in 2014 it was observed that the topcoat was delaminating on the dynamic test grate. Figure 13 and Figure 14 which were taken during the January 2022 inspections, but no corrosion was present. This defect only seemed to affect the topcoat of the coating system until the inspection in July 2022 when some of the primer had become exposed shown in Figure 15. No corrosion was present at any of the damaged areas during the July 2022 inspection.

Figure 13: Damage to *Jotun Sealion Resilient* with topcoat flaking off.

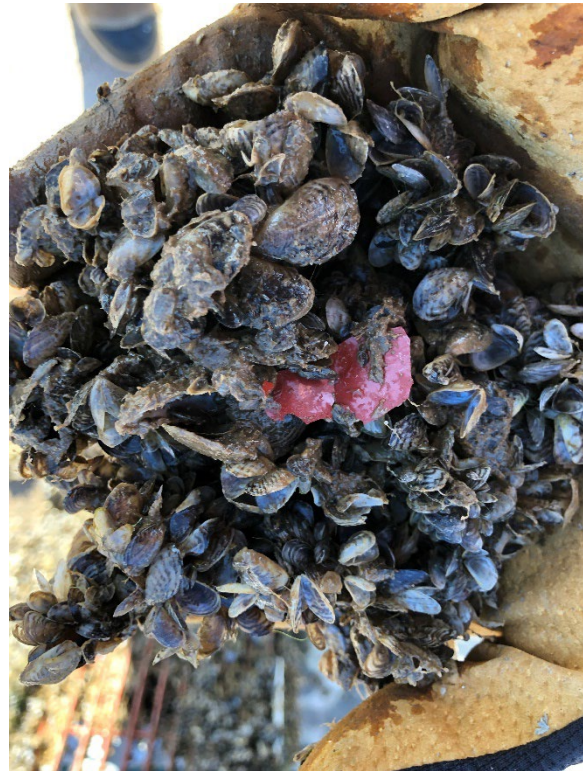
Figure 14: Piece of topcoat of *Jotun Sealion Resilient* that has flaked off.

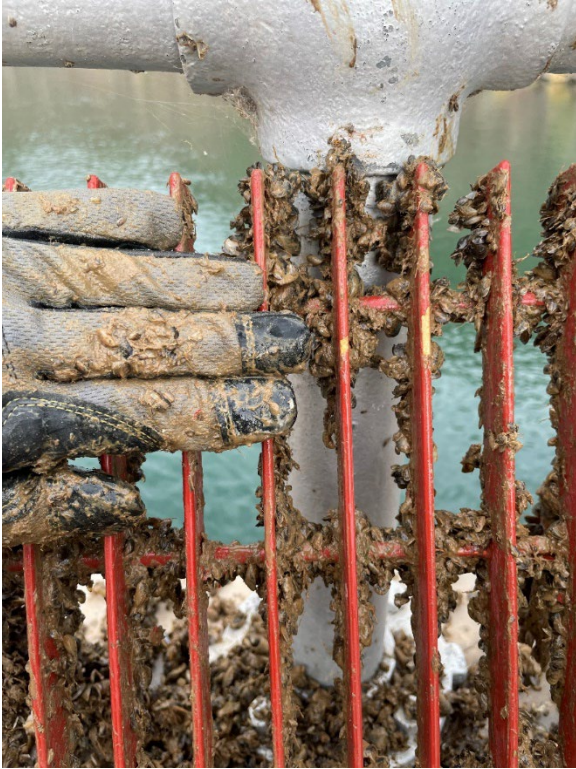
Figure 15: Damage in the upstream side of the Jotun Resilient exposing primer during July 2022 inspection.

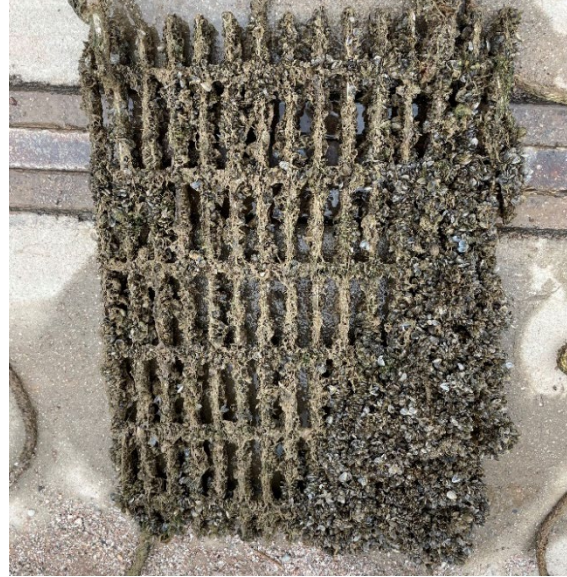
Figure 20: Silicone Solutions 5000A dynamic test grate during July 2022 inspection. Part of the grate is densely fouled with mussels and the remainder of the grate is fouled with mussels and the colonial hydroids.

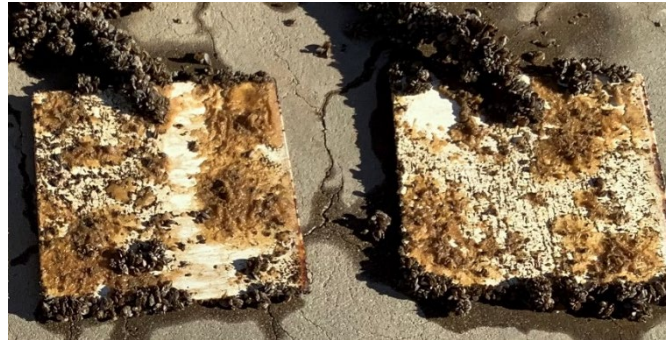
Figure 22: NuSil 9707 static plates during January 2022 inspection. Surface is fouled with sponge organism and mussel fouling is only at edges where coating is damaged.

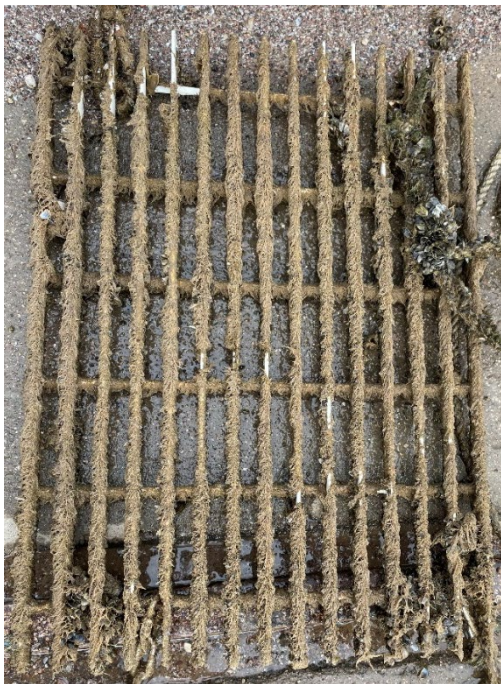
Figure 23: NuSil 9707 test grate during July 2022 inspection. Surface is 100% covered with colonial hydroid but no mussel fouling.

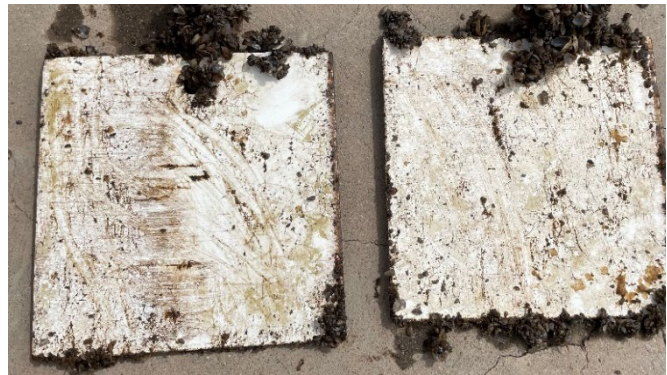
Figure 24: NuSil 9707 static plates during July 2022 inspection. Surface is free of fouling except for edges where coating is damaged.

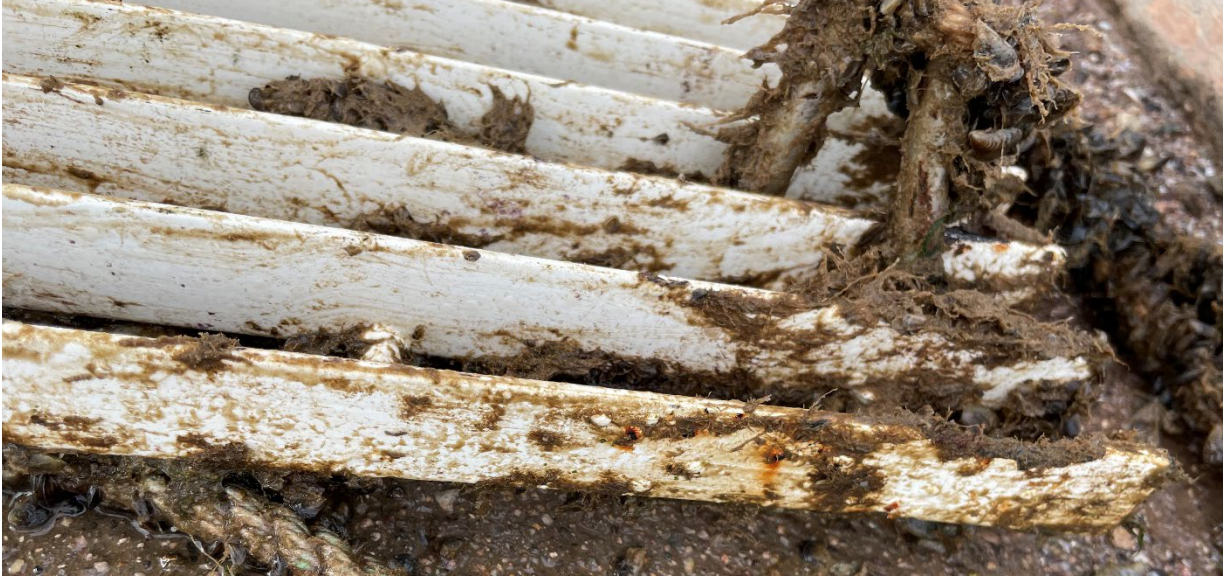
Figure 25: Corrosion present on edge of NuSil 9707 test grate, likely from damage.

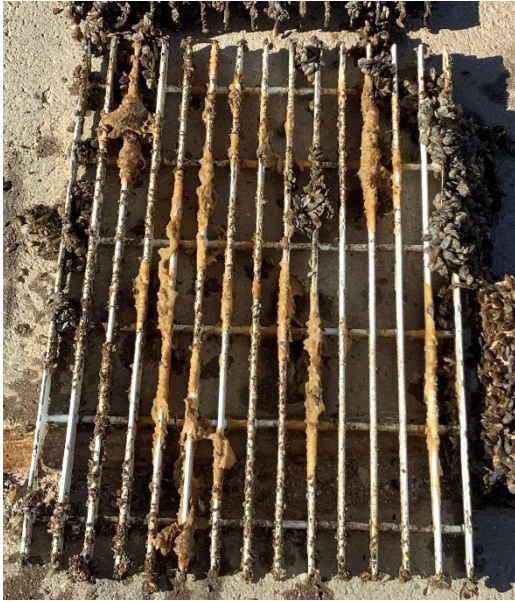
Figure 26: Sigmaglidle 890 during January 2022 inspection. Surface is lightly fouled with mostly a sponge organism and minimal mussel fouling.

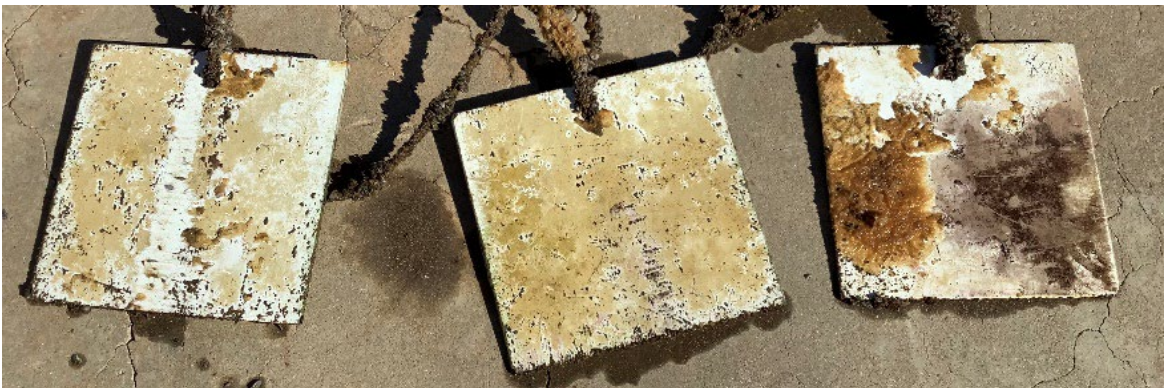
Figure 27: Static test plates Sigmaglidle 890. Fouled with sponge organism over most of the surface and one plate is stained with a dark color from an unknown source.

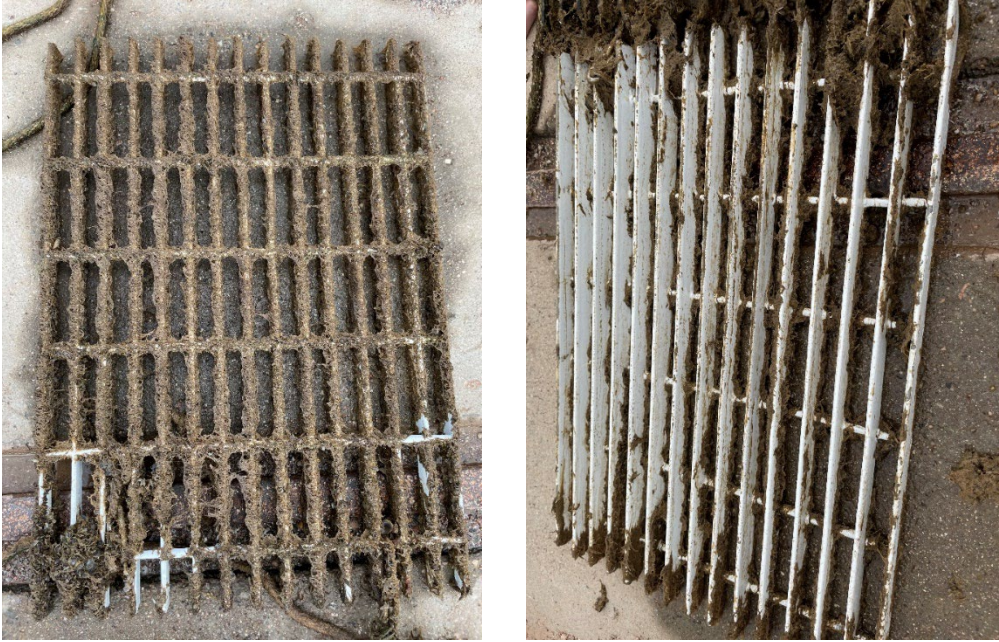
Figure 29: Before and after cleaning photos of Sigmaglide 890 dynamic test grate during July 2022 inspection. No mussel fouling but surface covered in colonial hydroid.

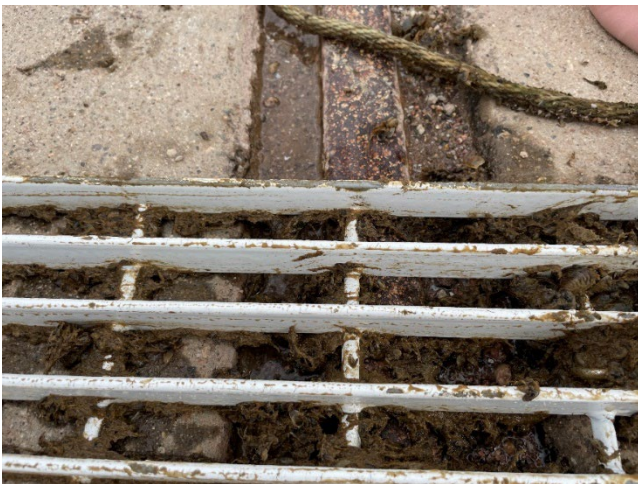
Figure 30: Damage and missing coating observed on edge of Sigmaglide 890 grate during July 2022 inspection.

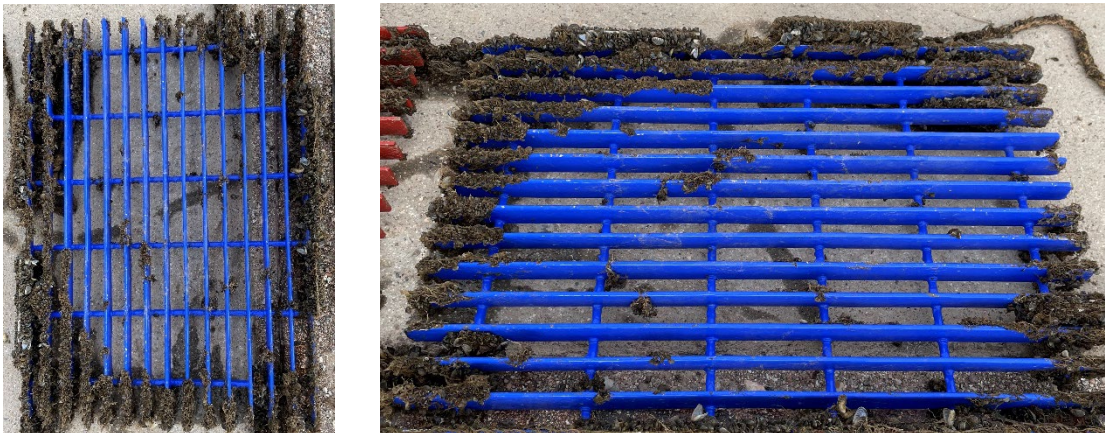
Figure 36: Intersleek 970 test grate during July 2022 inspection. Mussels have attached to around the edge where the coating has become damaged or is missing. Where the coating is intact there is no damage to the coating.

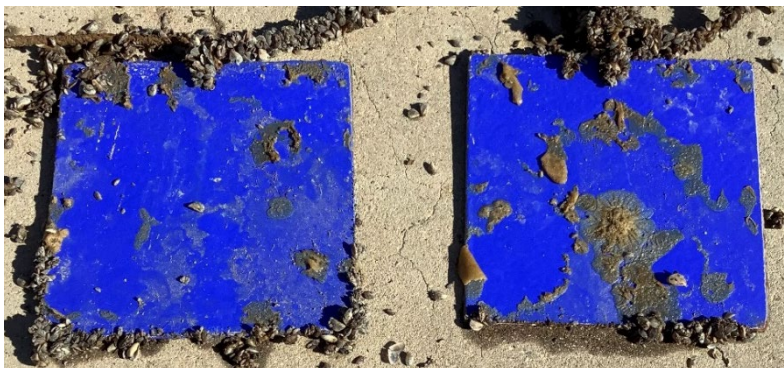
Figure 37: Intersleek 970 test plates lightly fouled with sponge organism and around edges due to damage during 2019.

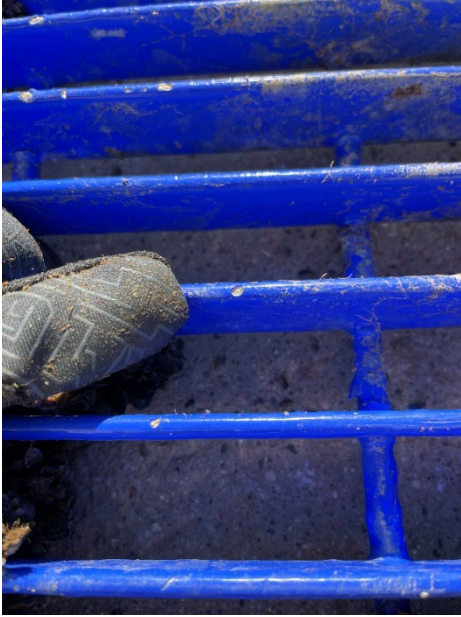
970 continues to retain its foul release properties. During the January 2022 inspection, small areas of chipped and missing coating were observed on the upstream side of the dynamic test grate seen in Figure 38 and Figure 39. It was also observed that the coating at the edges on the static test plates were damaged as well. These areas of damaged or missing coatings allowed for mussel attachment. At the July 2022 inspection, blisters were observed along the top edge of both static test plates which are shown in Figure 40 and Figure 41.

Figure 38: Damage to flowing water InterSleek 970 test grate in the form of small chips.

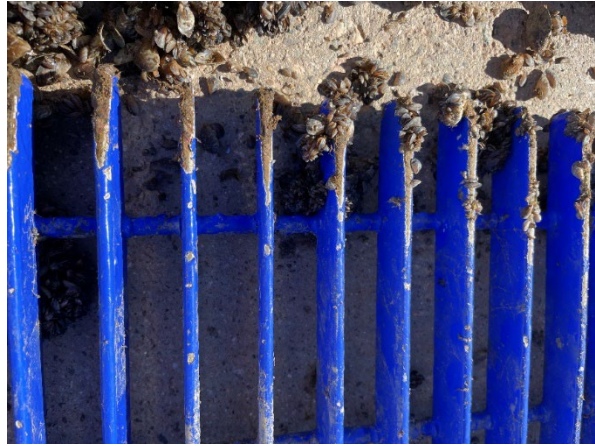
Figure 39: Damage to InterSleek 970 test grate on the edge of the grate, observed during January 2022 inspection.

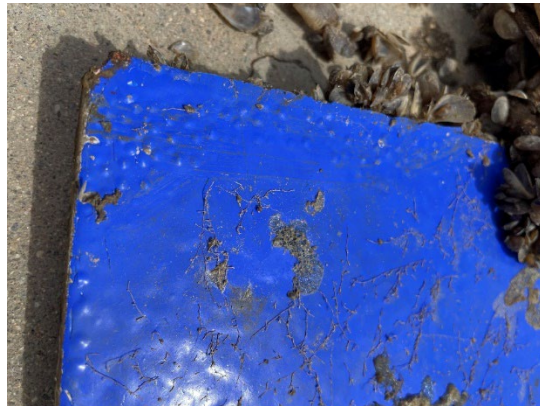
Figure 41: InterSleek 970 static plates during the July 2022 inspection with blistering observed around the edges.

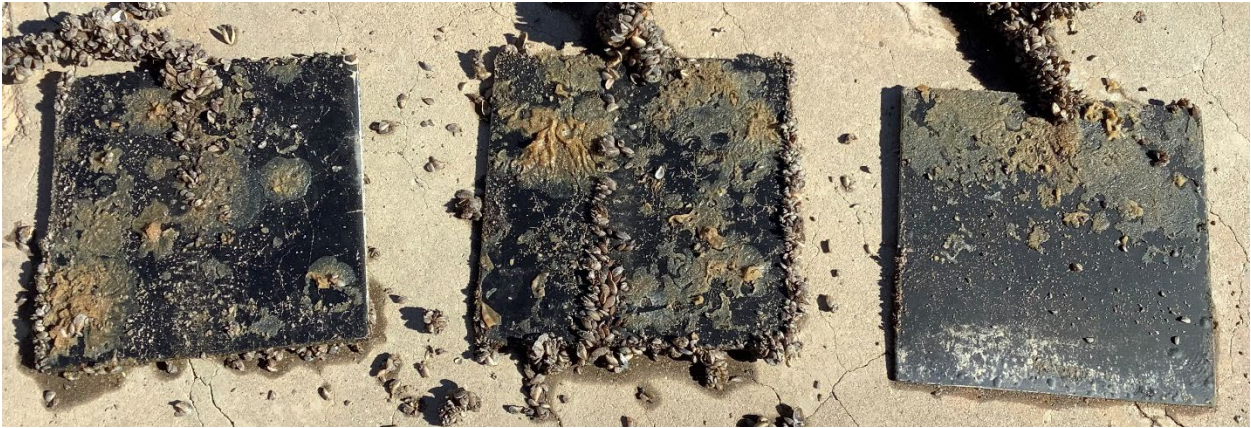
Figure 45: BioClean quasi-static test panels that are slightly fouled with both mussels and sponge organism during January 2022 inspection.

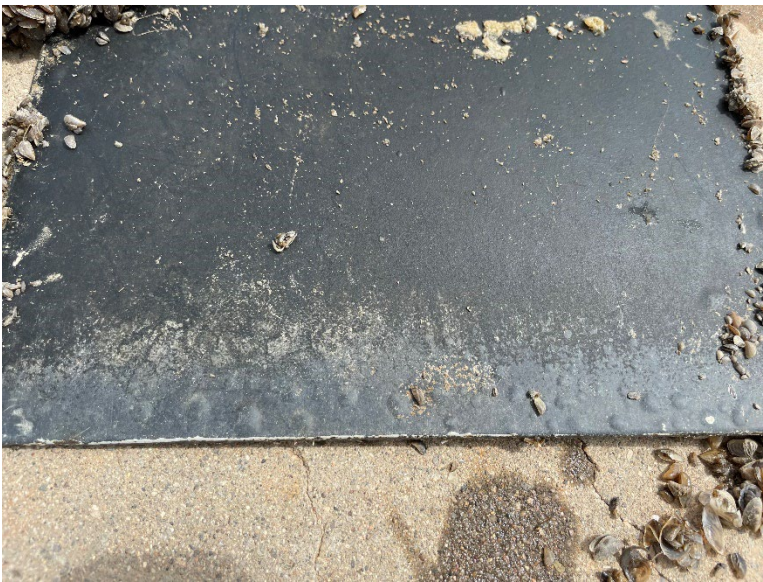
Figure 48: Blister on bottom of BioClean static plate which were observed during July 2022 inspection.

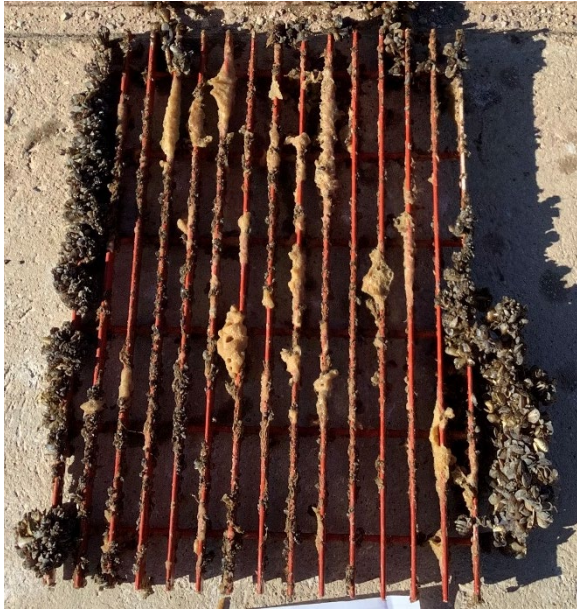
Figure 49: Hempel X3 test grate that is fouled with some mussels and sponge organism during January 2022 inspection.

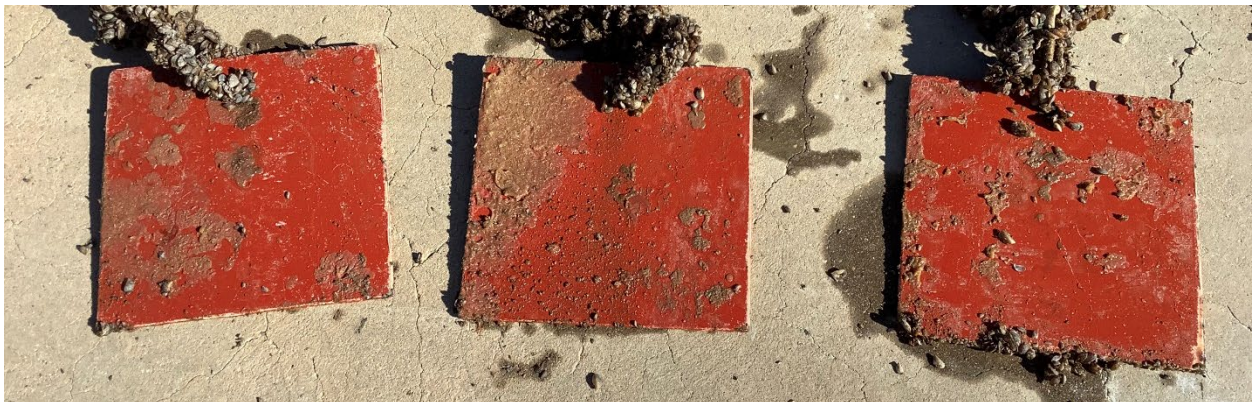
Figure 50: Hempel X3 Quasi-static test plates with fouling around damaged edges and fouled with sponge organism during January 2022 inspection.

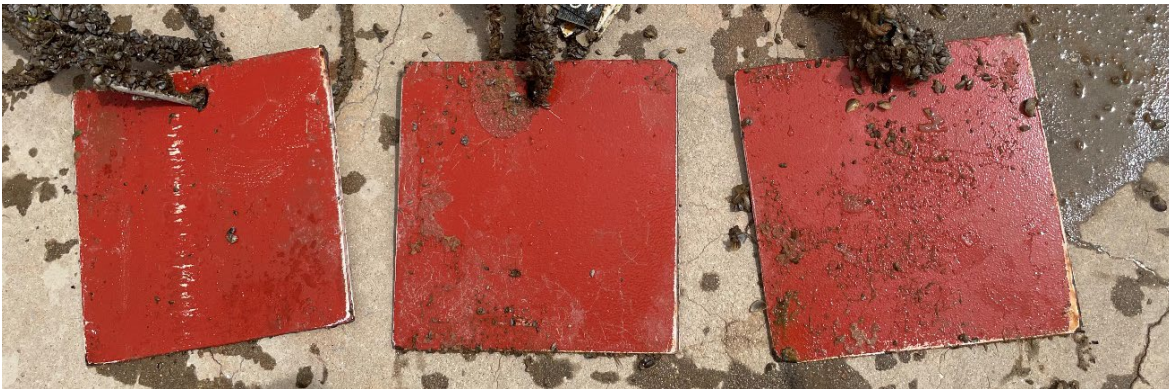
shown in Figure 53. This damage did not appear to worsen when inspected at the following inspection. The static test plates also had coating damage around the edges of the plates caused by abrasion from rubbing on the dam. During the July 2022 inspection, new rope damage to one of the static plates was evident. The damage presented itself as missing coating down the middle of one plate that likely caused by abrasion from the rope, shown in Figure 52.

Figure 52: Hempel X3 static test plates during July 2022 inspection. One plate appears to have abrasion damage in the center of the plate caused by the rope it suspends from.

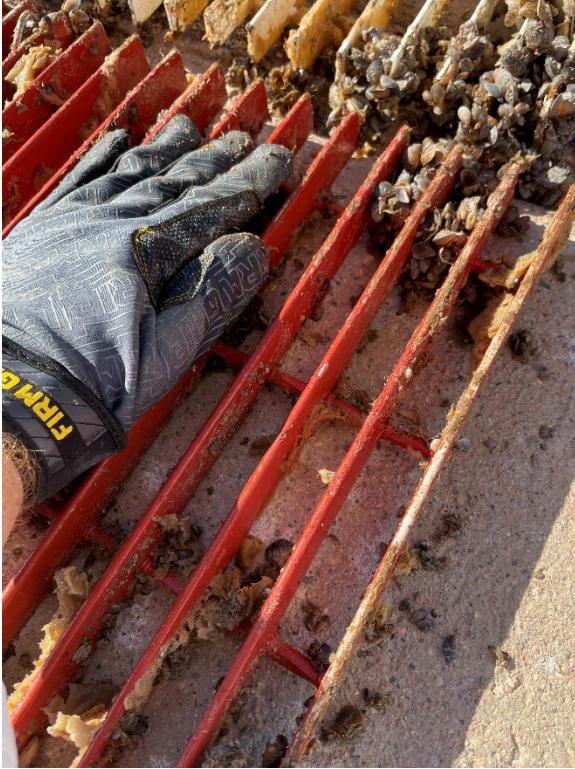
Figure 53: Damage to Hempel X3 flowing water test grate taken during July 2022 inspection.

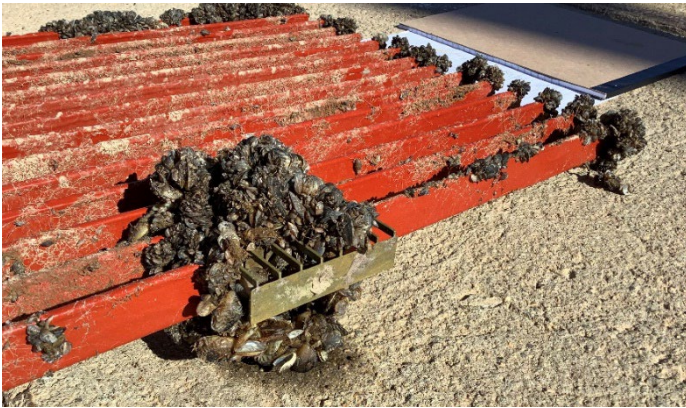
Z Alloy is a fish screen made from a copper alloy. This was the only antifouling system that was evaluated. It was installed in 2015. This product was only evaluated in dynamic water conditions. All fouling appeared to be localized to the zip-ties that were securing the test screen to a larger test grate and there was no fouling on the Z-alloy fish screen during both 2022 inspections. Figure 54 and Figure 60 show the test sample and the fouling on the zip-ties.

Figure 54: Z-Alloy fish screen during January 2022 inspection. All fouling appeared to be attached to zip-ties securing screen to larger test grate.

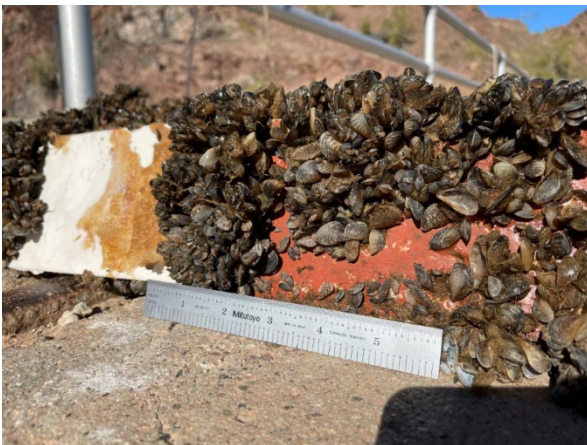
Figure 56: NDSU 8 (left) NDSU 9 (right) test panels in dynamic conditions. NDSU 8 remained free of fouling since the January inspection. NDSU 9 was fouled but easily cleaned. NDSU 9 also had some damage to the topcoat.

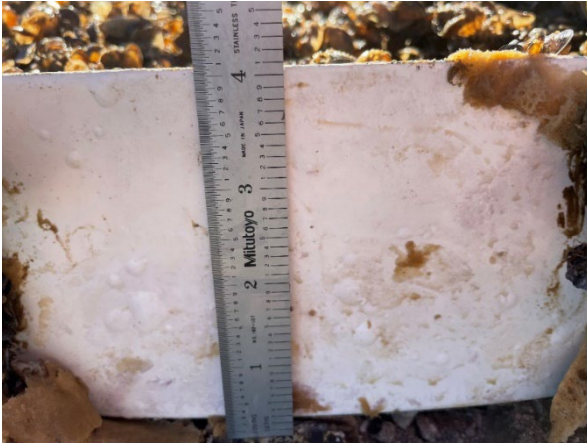
Figure 58: Blisters on NDSU 8 flowing water panel during January 2022 inspection.

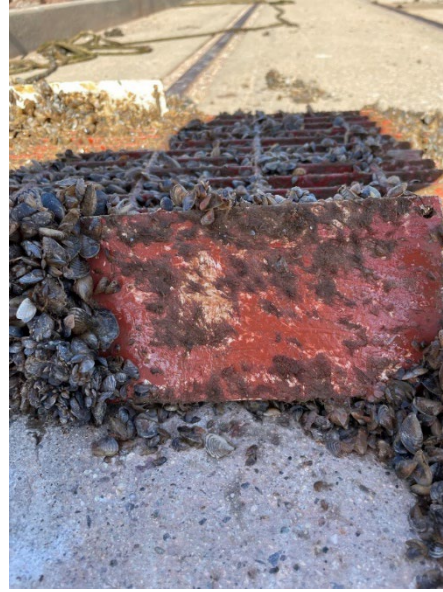
Figure 59: Close up of damage on NDSU 9 dynamic panel after cleaning during January 2022 inspection.

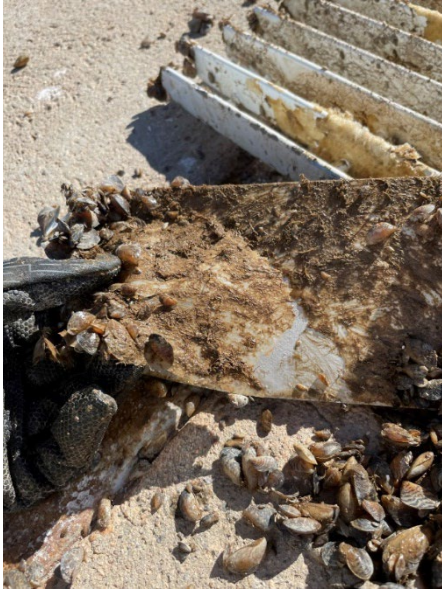
NDSU 8, C20, and C4-20% had the best results in flowing water testing. These formulations had little to no fouling and were easily cleaned. Figure 56 through Figure 59 show the dynamic panels for NDSU 8 and NDSU 9 formulations. NDSU 8 had blisters form and NDSU 9 is damaged with some of the topcoat missing. The other noticeable observation during the January 2022 inspection was a large section of topcoat on NDSU 3 had delaminated in as a single piece shown in Figure 60 through Figure 62.

Figure 61: NDSU 3 panel where large portion of topcoat has delaminated in one piece.

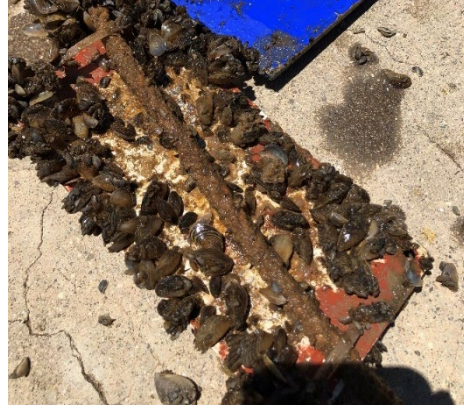
NDSU 9 was the only formulation to prevent fouling in static testing. The back side of the panel had become damaged with part of the topcoat missing, allowing for mussel attachment as shown in Figure 66. All other formulations did not prevent mussels from adhering to the surface and 50% to 80% of the surfaces were fouled; requiring a light force to clean the surfaces. Figures 67 through Figure 71 show NDSU formulations during testing. Blisters were observed on the surface of NDSU 5 in static testing.

Figure 66: NDSU 9 quasi-static plate with damaged backside allowing for mussel fouling.

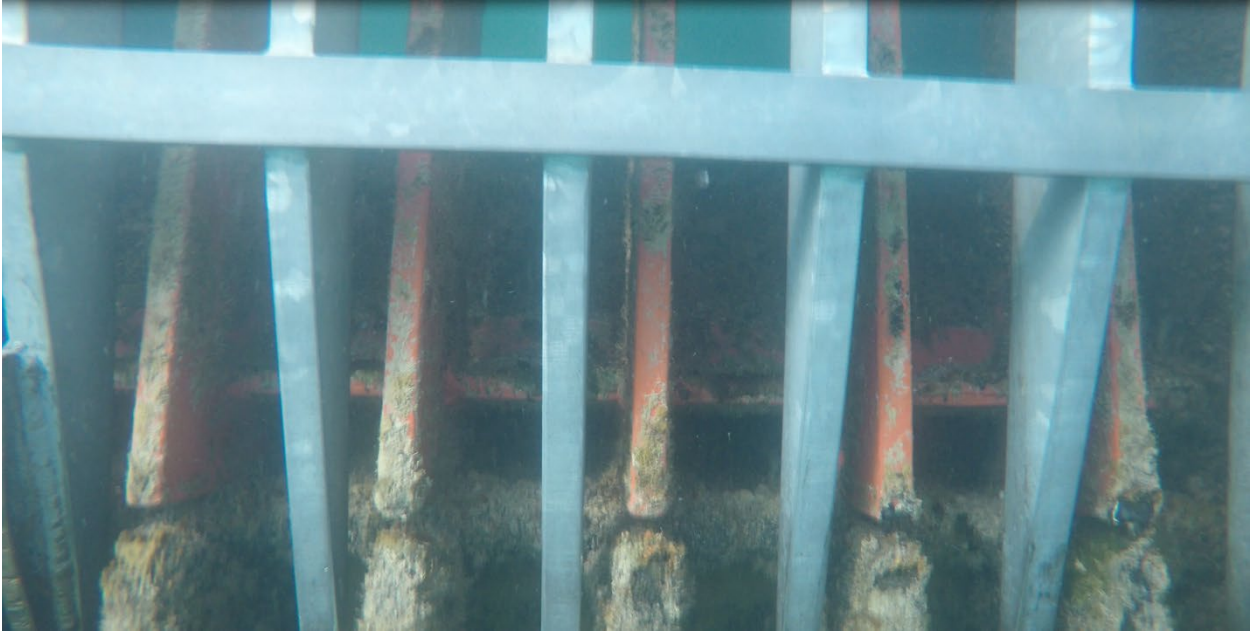
Figure 105: Bottom section of trashrack coated with Sigmaglide 890. Some missing coating at the bottom of the grate likely damaged by the rake system.

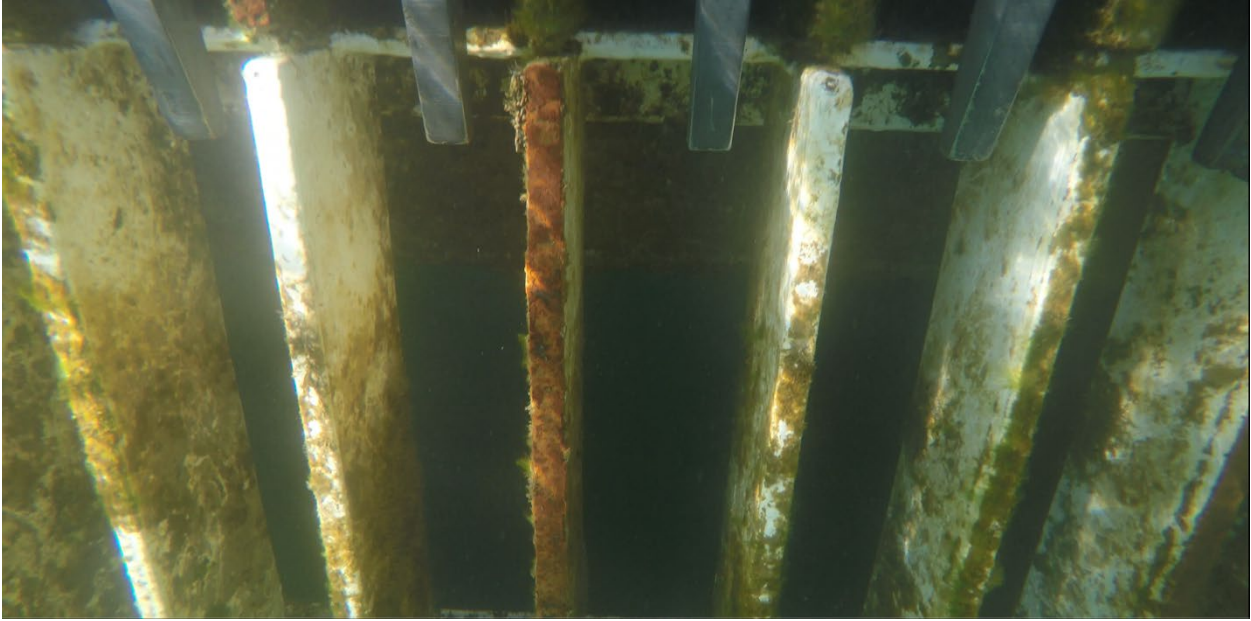
Figure 107: Sher-release coated section of trashrack. Can see one of the bearing bars is damaged caused by wear from abrasion forces caused by the rake cleaning system.

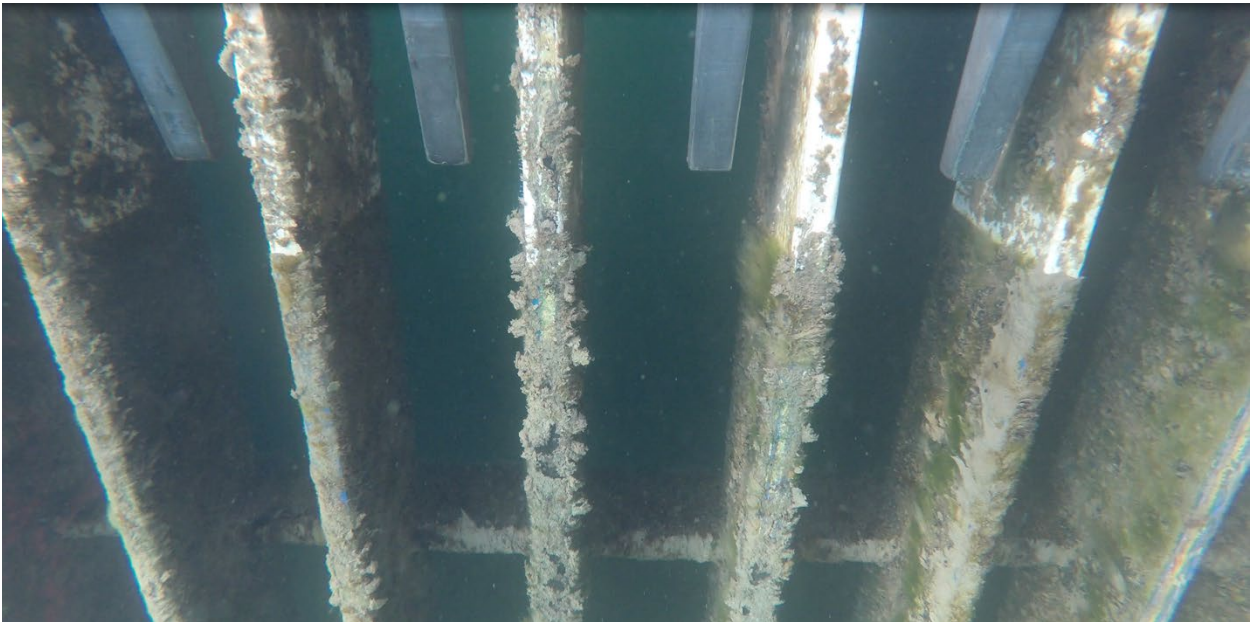
Figure 108: Sher-release and Seaspeed V5 interface. The bearing bars for the Seaspeed have abrasion damage and the coating has allowed for more accumulation of algae.

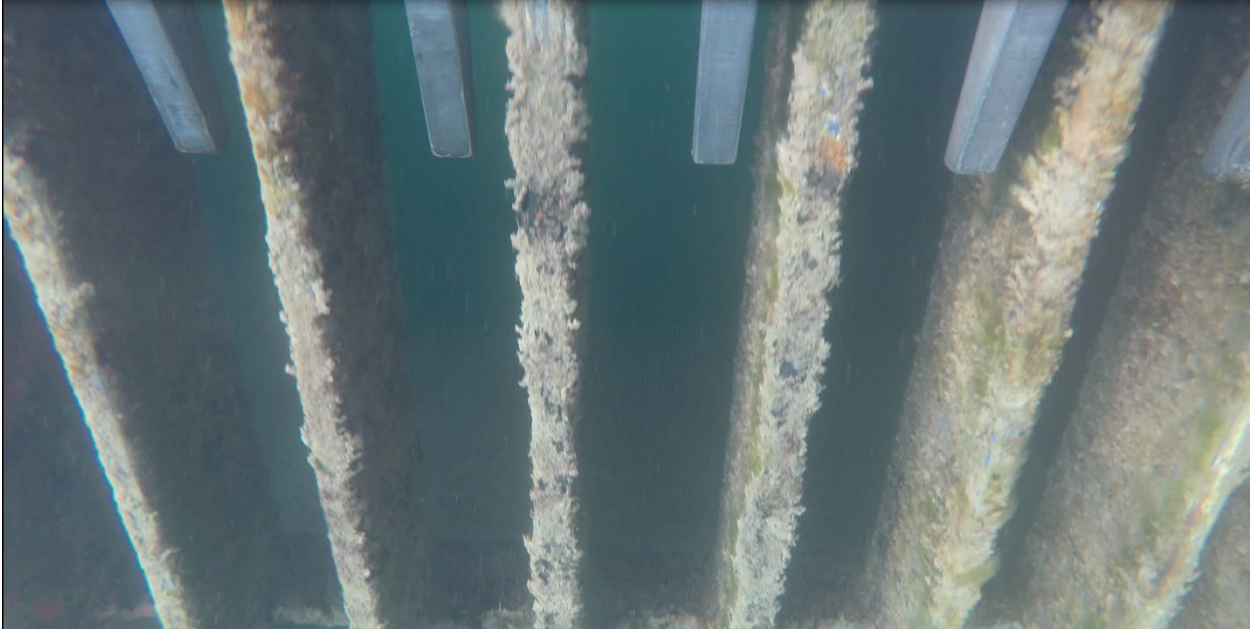
Figure 109: Seaspeed V5 which has become covered in algae but still prevents mussel attachment. The coating is damaged with missing spots of coating and corrosion present.

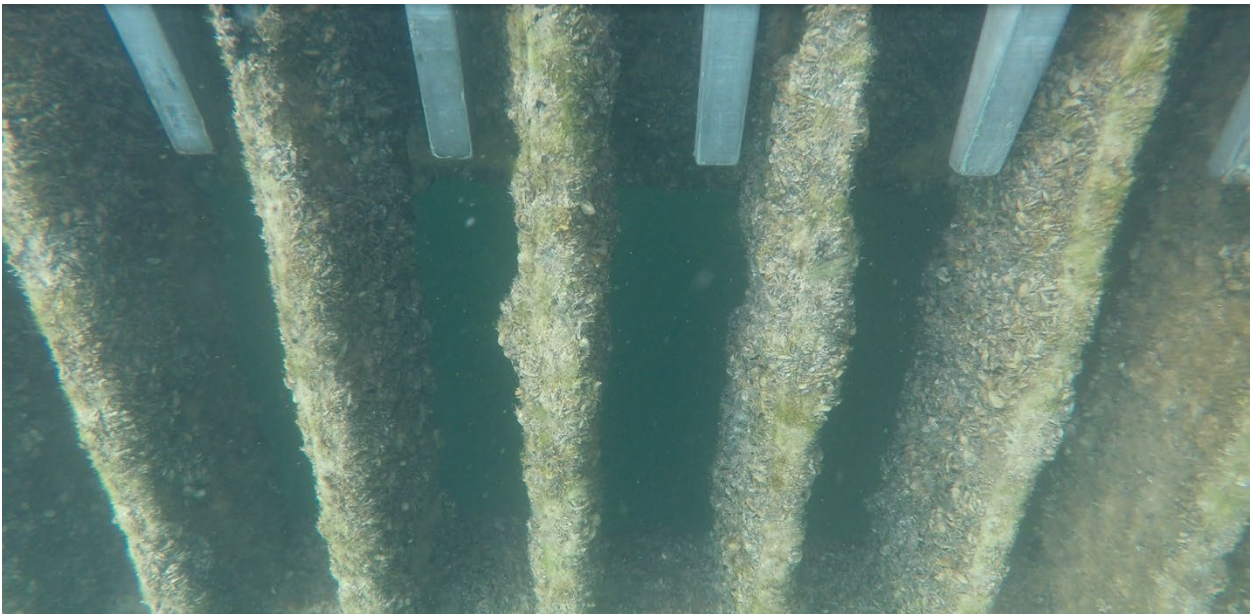
Figure 110: Section of trashrack not coated with FRC that is 100% fouled with mussels.
