— BUREAU OF —  
RECLAMATION

# Field Validation of Impedance Spectroscopy Coating Assessments

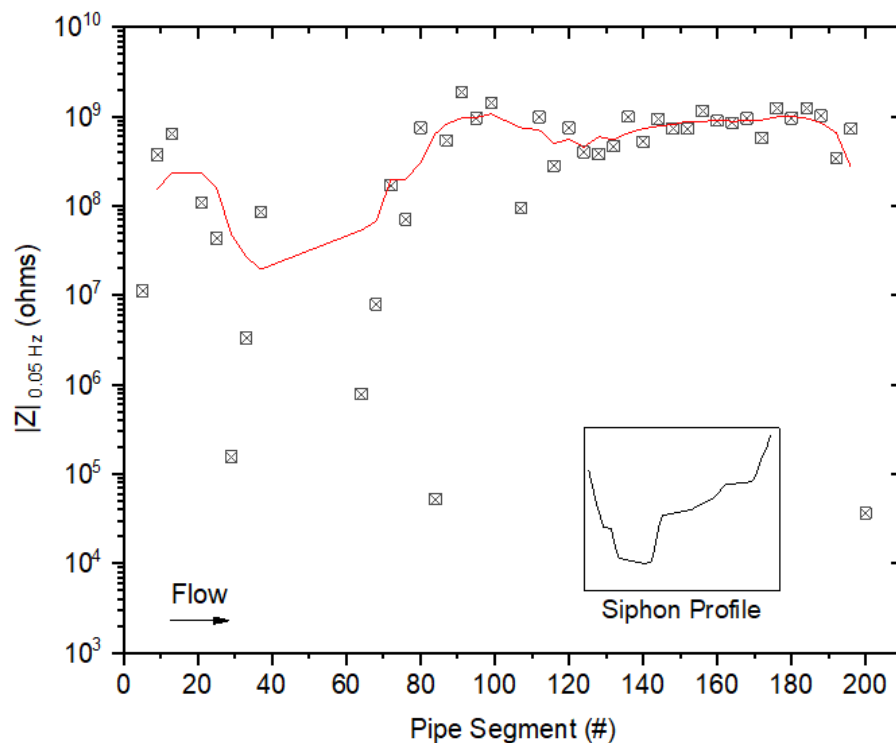
Figure 6. Low frequency  $|Z|$ , adjacent-averaging trendline, and siphon profile versus pipe segment at the Agua Fria Siphon.

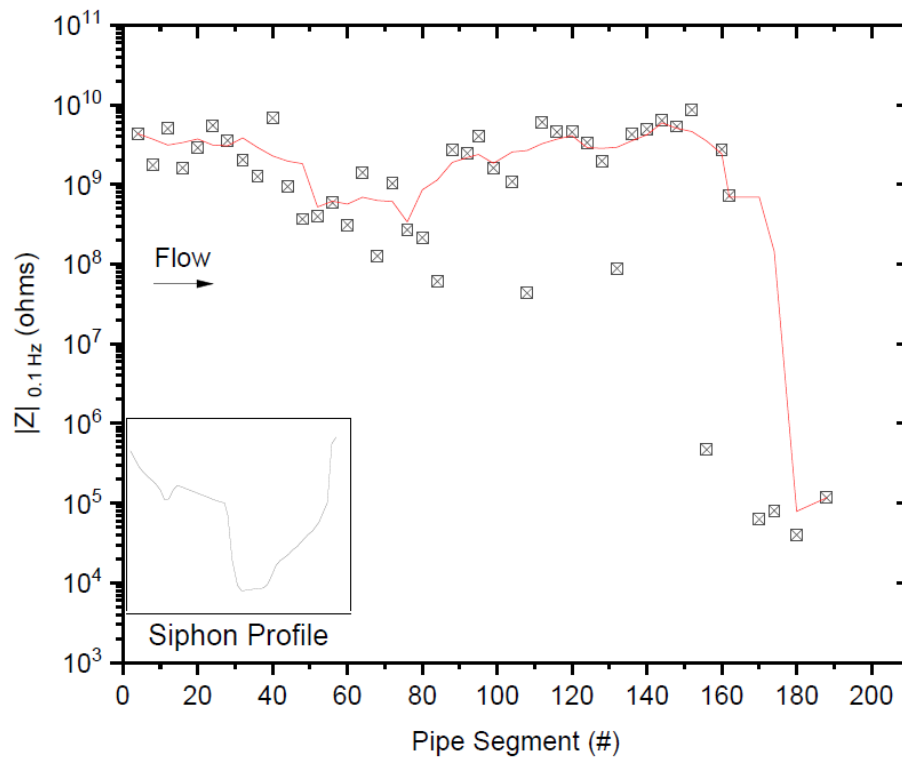
Figure 7. Low frequency  $|Z|$ , adjacent-averaging trendline, and siphon profile versus pipe segment at the Salt River Siphon.

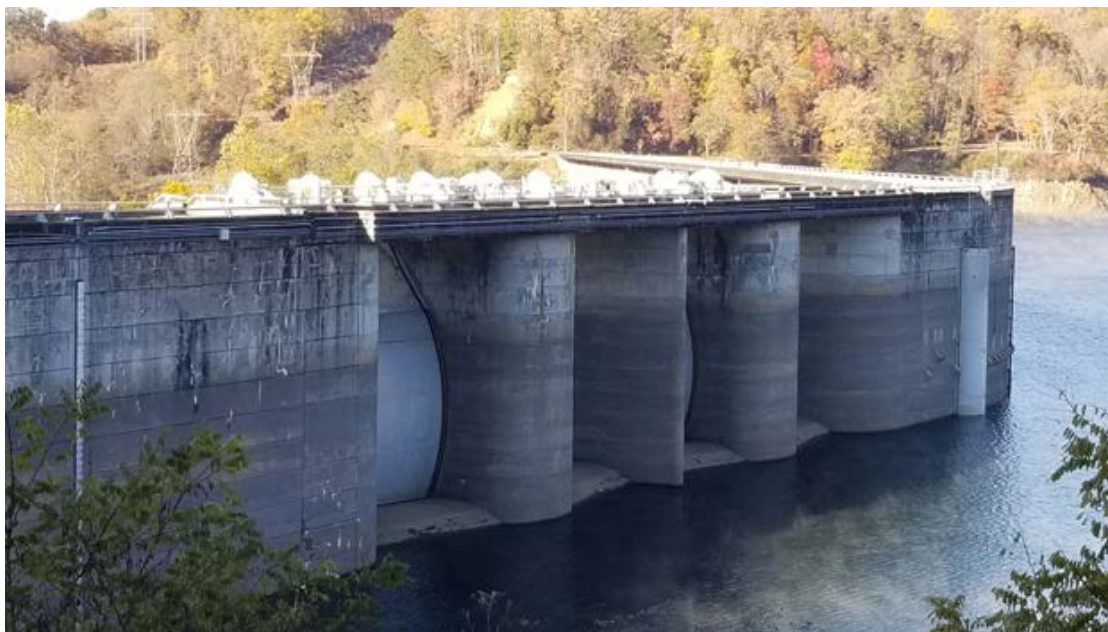
Figure 8. Fontana Dam radial gates accessed by boat to evaluate polysiloxane coating.

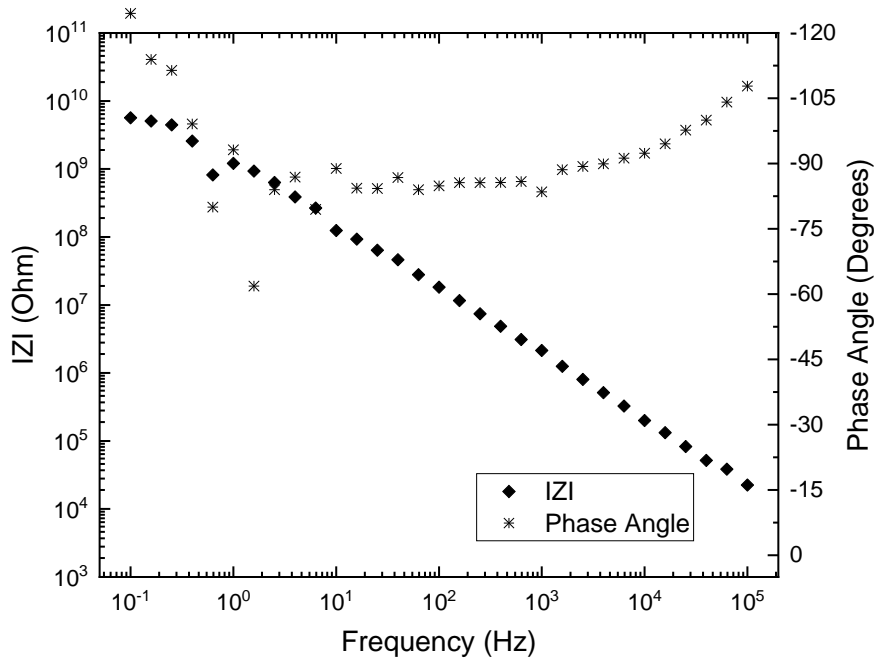
Figure 9. EIS Bode plot results for vertical test cell set-up at Fontana Dam Gate 3, Location 2.

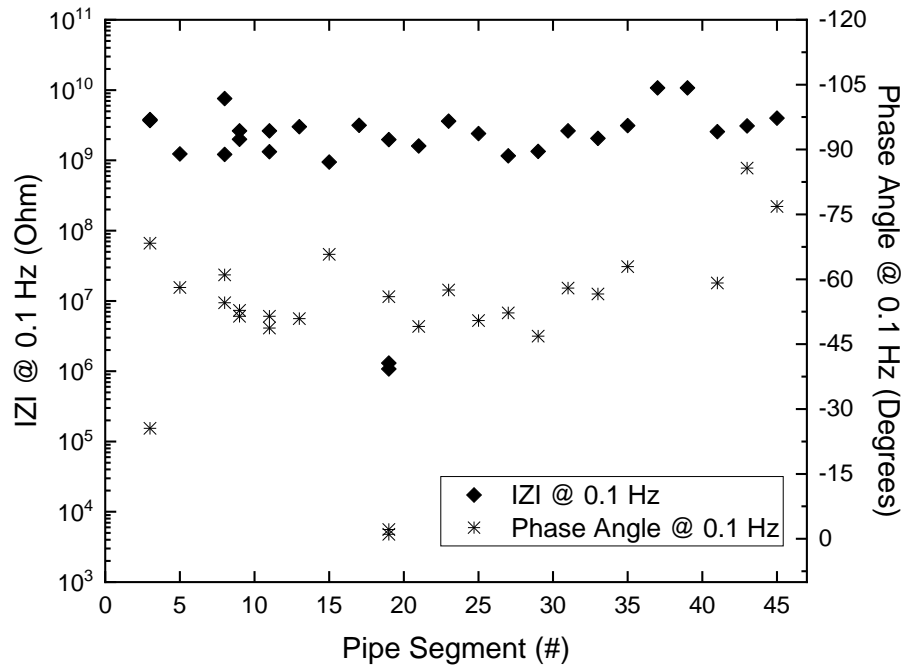
Figure 10. Low frequency  $|Z|$  and phase angle versus pipe segment for overhead testing of the pipe crown at the Salt River Siphon.

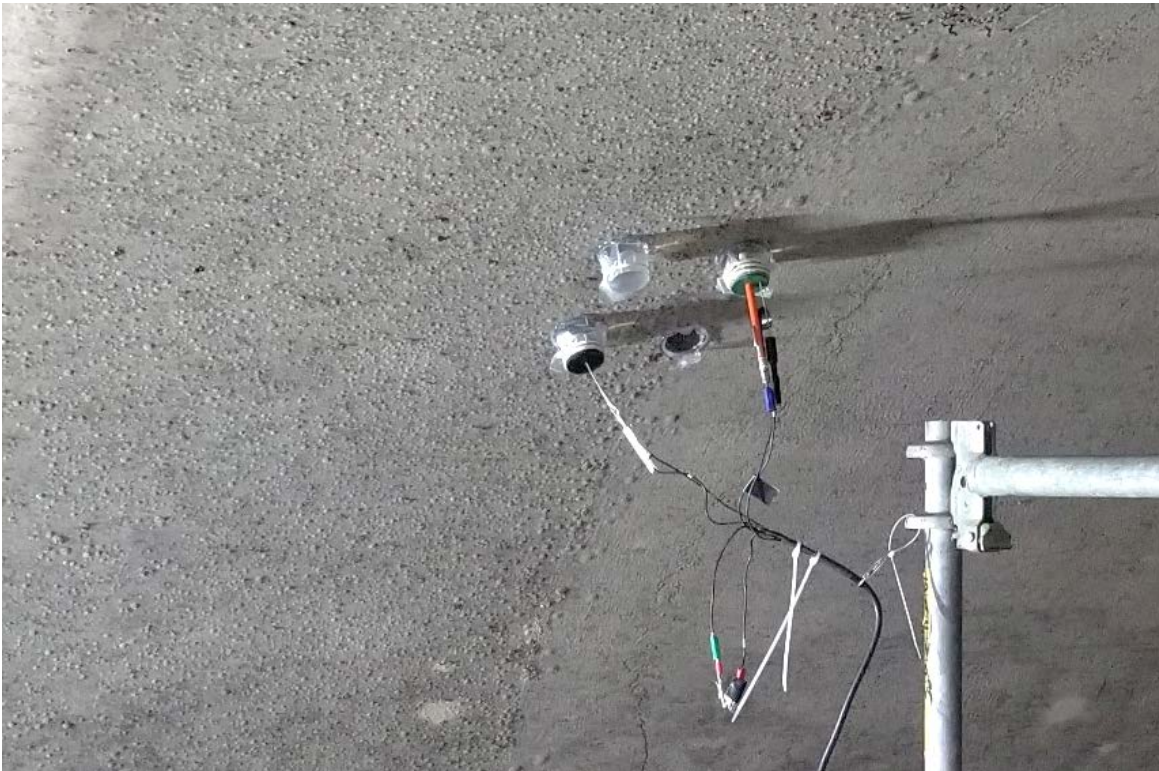
Figure 11. Blistering observed at the 10:30 pipe position in pipe segment 19 of the Salt River Siphon and non-horizontal EIS test set-up.

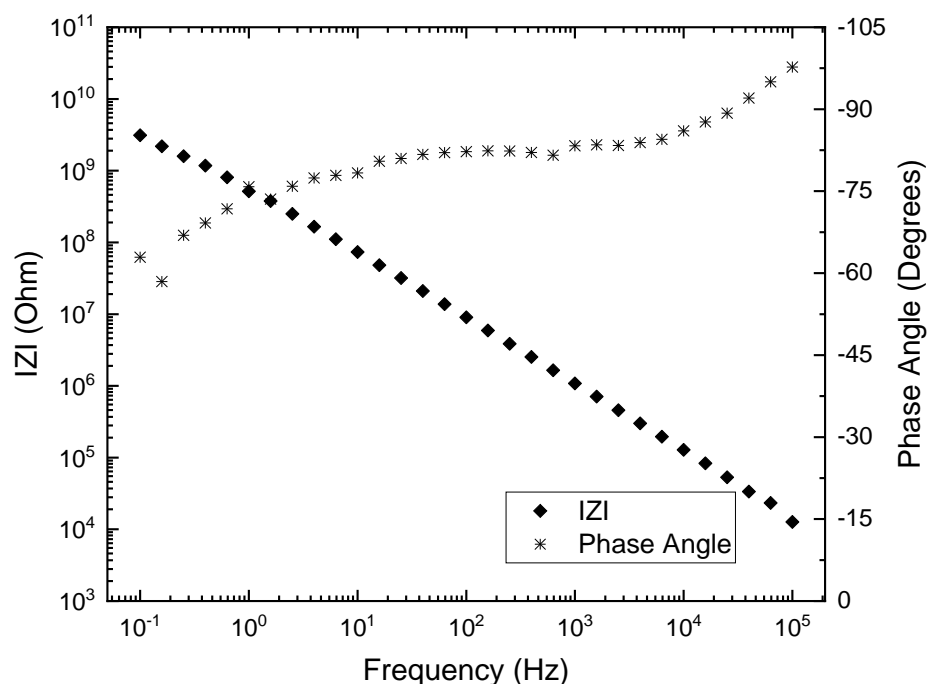
Figure 12. Representative EIS Bode plot from the 10:30 pipe position in pipe segment 35 of the Salt River Siphon.

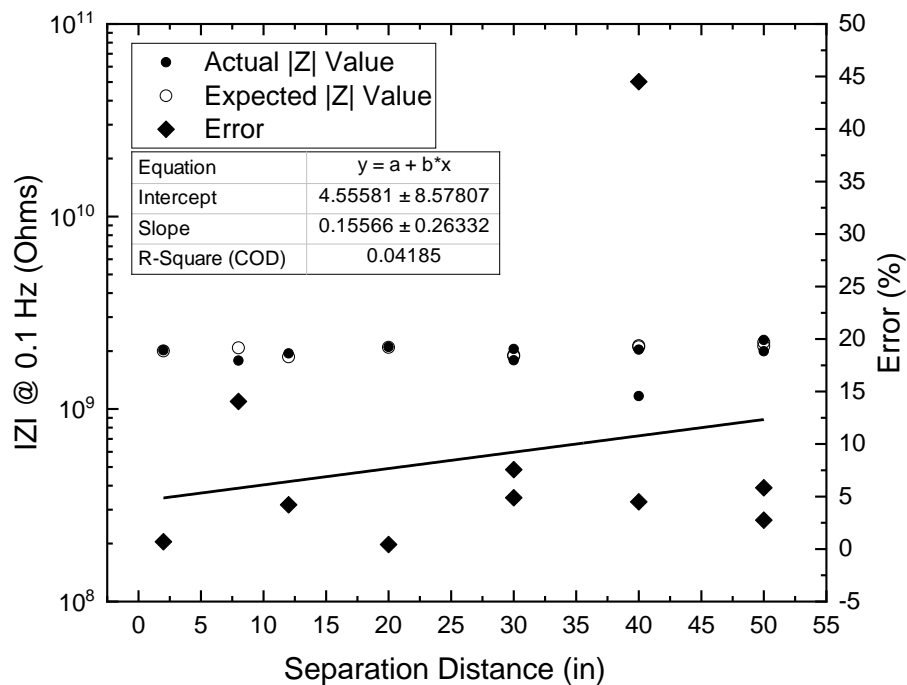
Figure 15. Effect of test cell separation distance on the accuracy of EIS measurements.

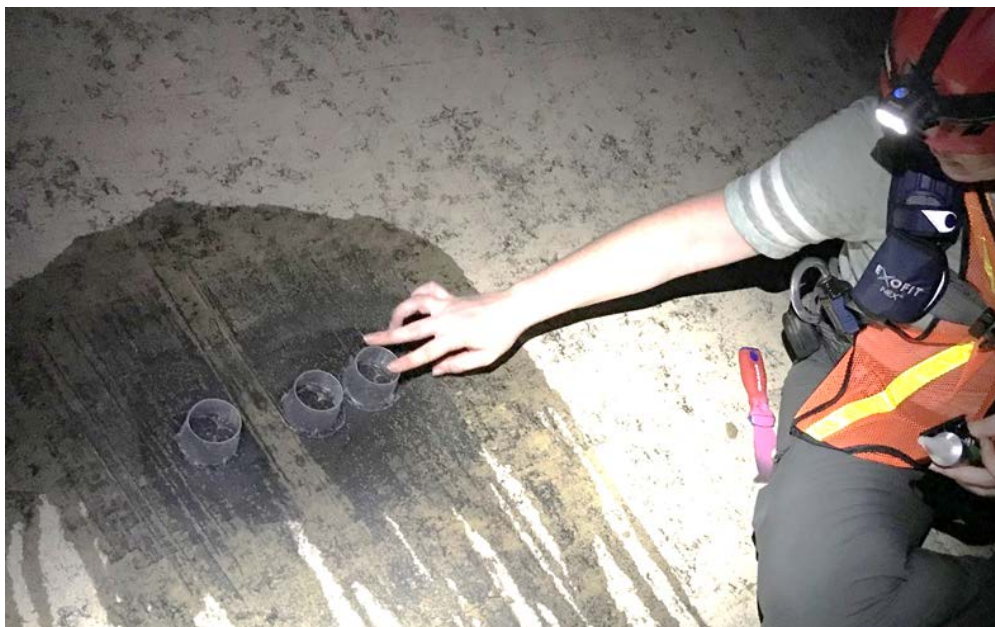
**Figure 1. Surface preparation and application of three temporary EIS test cells along lower pipe wall.**

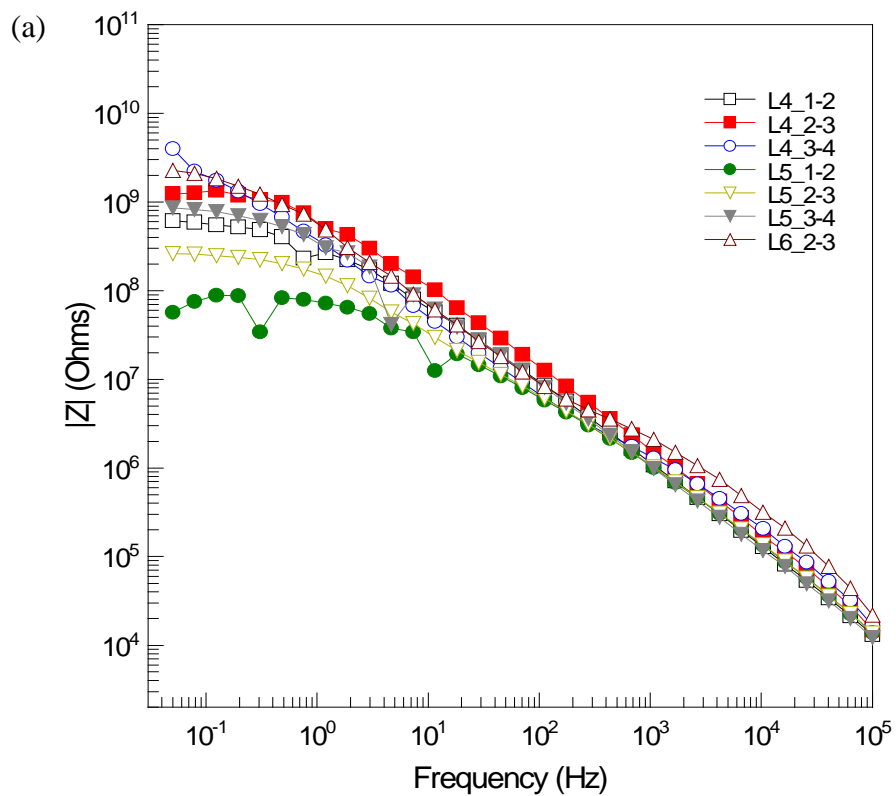
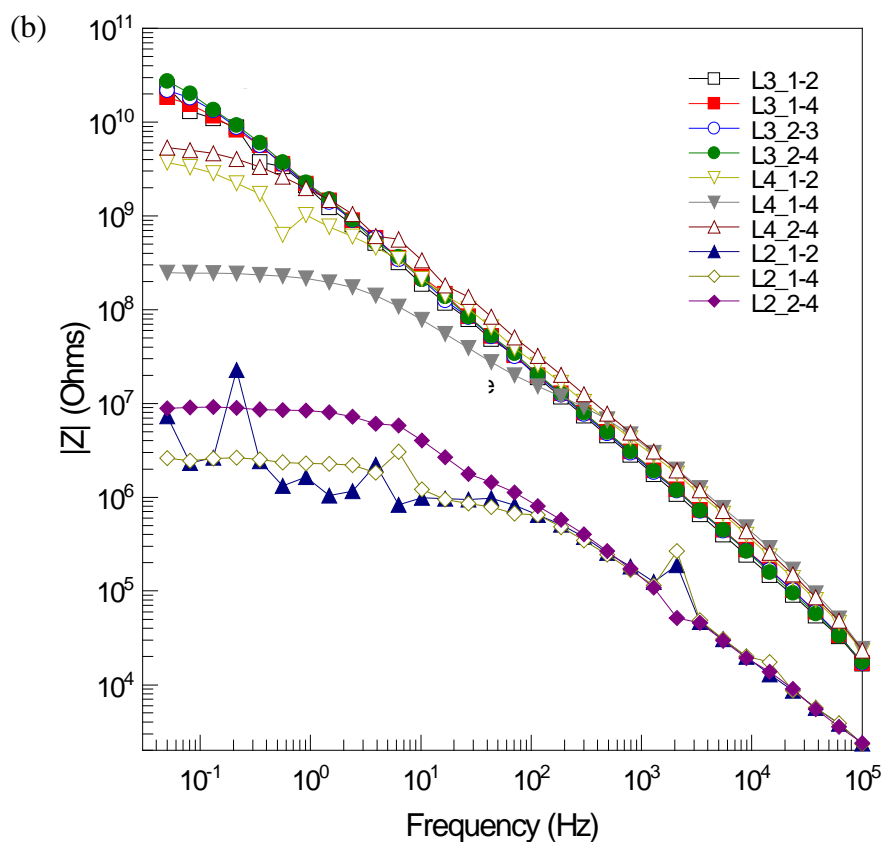
Figure 3 provides field EIS Bode plots of coal tar enamel, polyurethane, and coal tar epoxy linings, respectively, showing  $|Z|$  versus frequency only. The low frequency is 0.05 Hz, which extends slightly beyond the 0.1 Hz threshold value discussed above. Each dataset represents an EIS test measurement. Figure 3(a) and 3(b) include data for three test locations within the pipe, defined as  $L\#$ , whereas Figure 3(c) shows a unique test location for each dataset. The test location characterizes a distinct area of the coated structure, often several hundred feet from the next location, while the test cells evaluated are separated by several inches. Similarly, as shown in Figure 3(a) legend, L4\_1-2 and L4\_2-3 both evaluated test cell #2. The former did so in combination with test cell #1, while the latter used test cell #3.

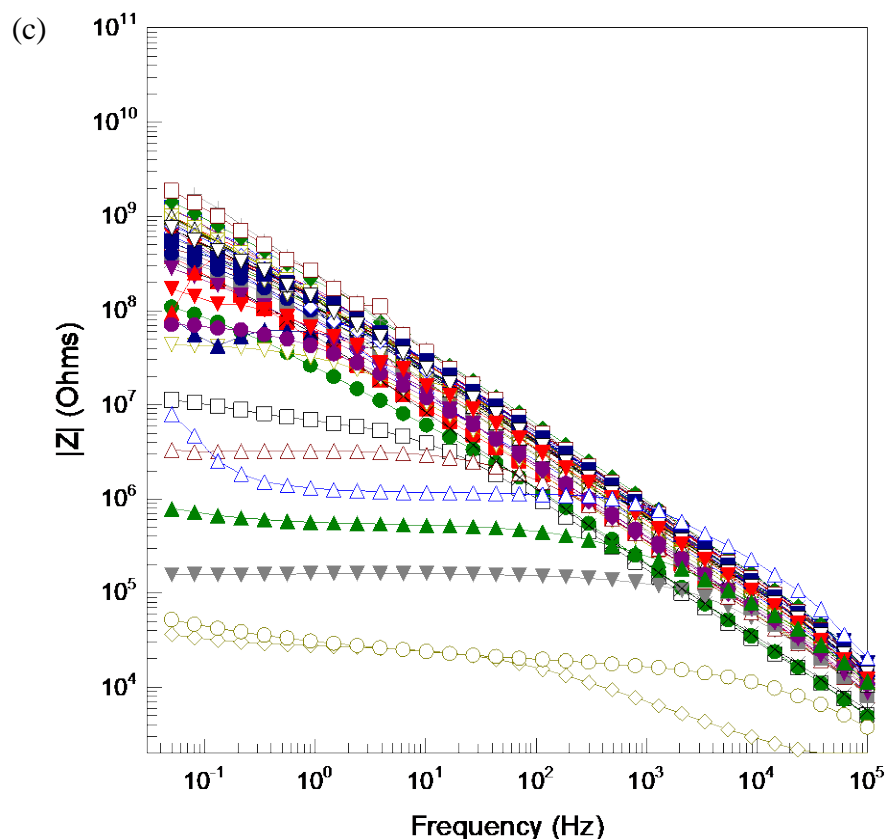
**Figure 3. Field EIS data showing impedance magnitude,  $|Z|$ , versus measurement frequency for (a) coal tar enamel, (b) polyurethane, and (c) coal tar epoxy linings.**

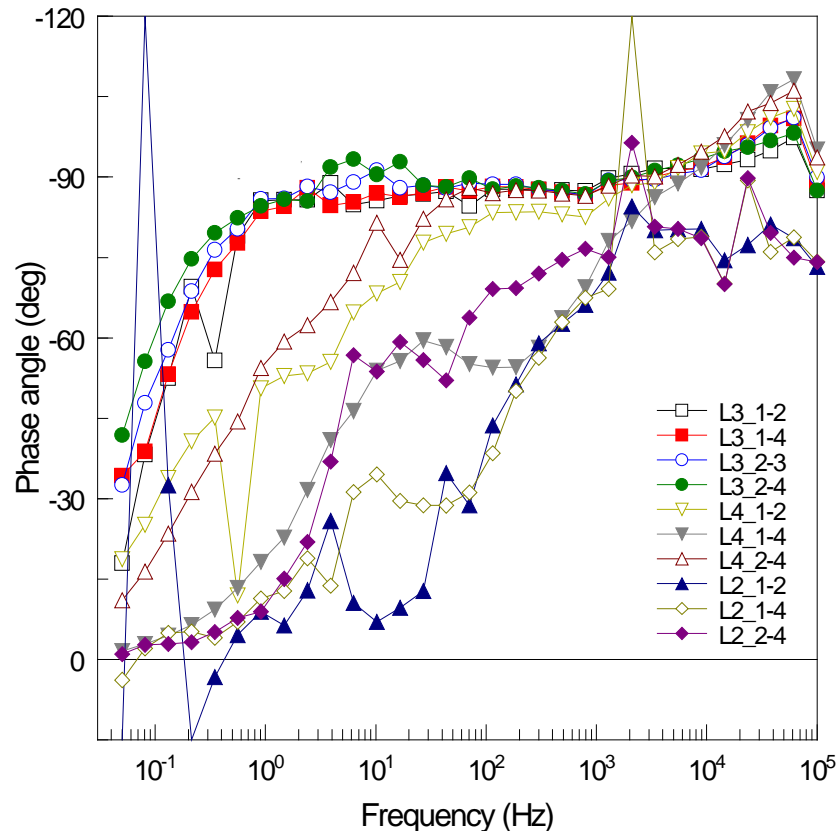
**Figure 4. Field EIS data showing phase angle versus measurement frequency for the polyurethane lining.**

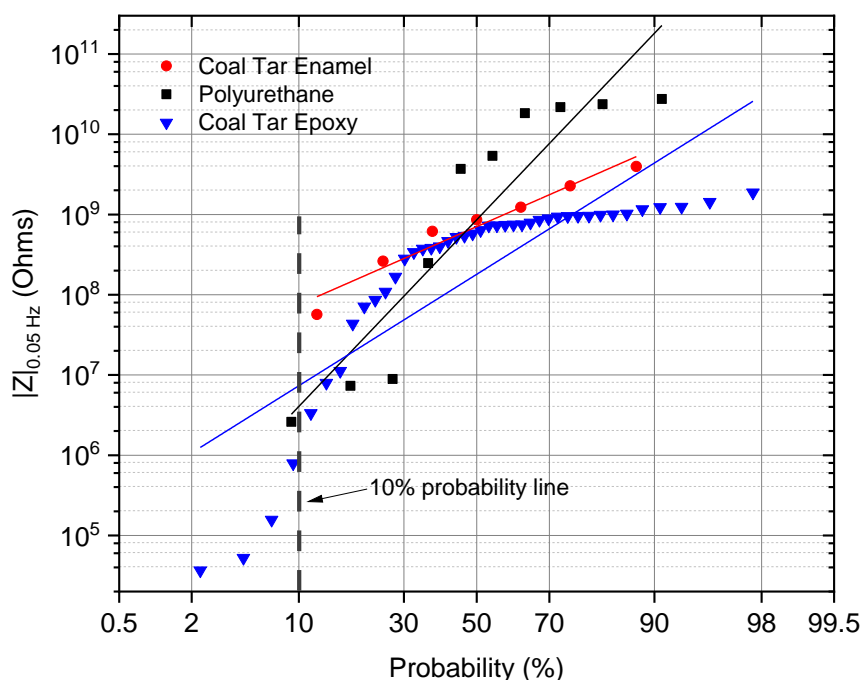
**Figure 5. Probability plot of  $|Z|_{0.05 \text{ Hz}}$  for field EIS data.**

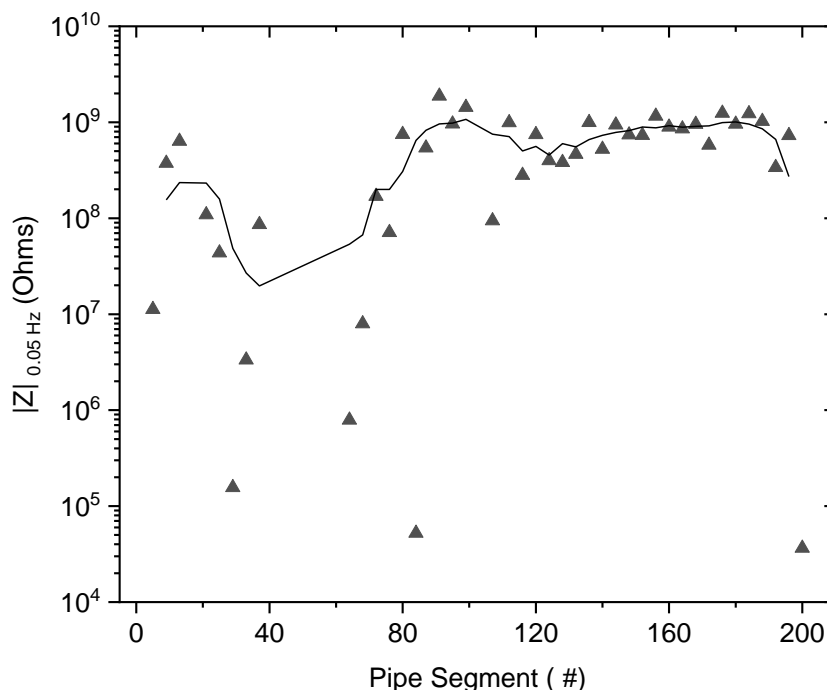
**Figure 6. Field EIS  $|Z|_{0.05 \text{ Hz}}$  results versus test location for coal tar epoxy along 10,000 foot long coated structure.**

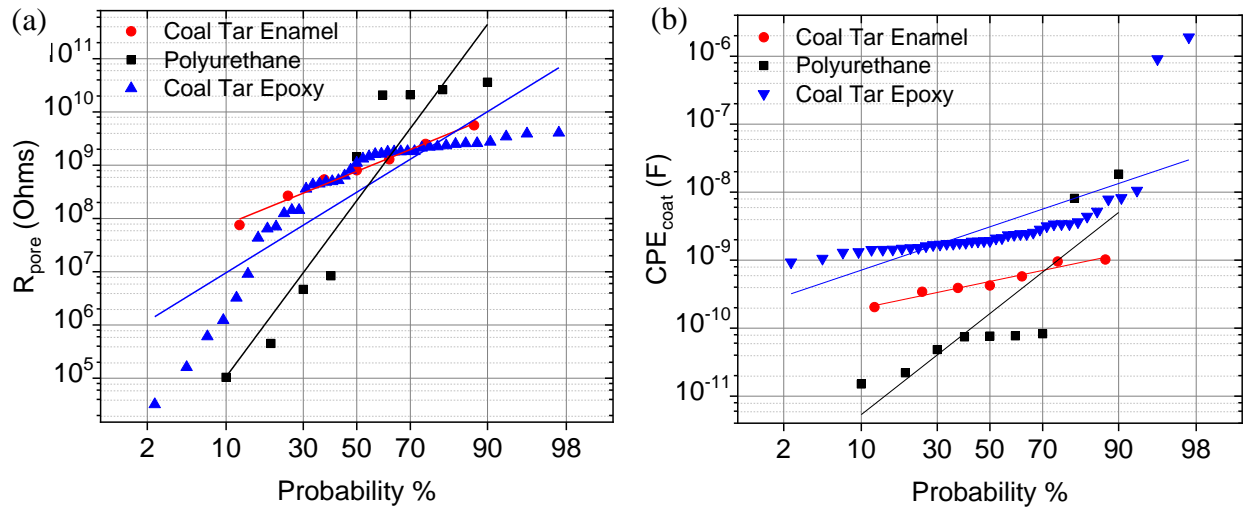
**Figure 8. Probability plot of (a)  $R_{pore}$  and (b)  $CPE_{coat}$  for field EIS data.**

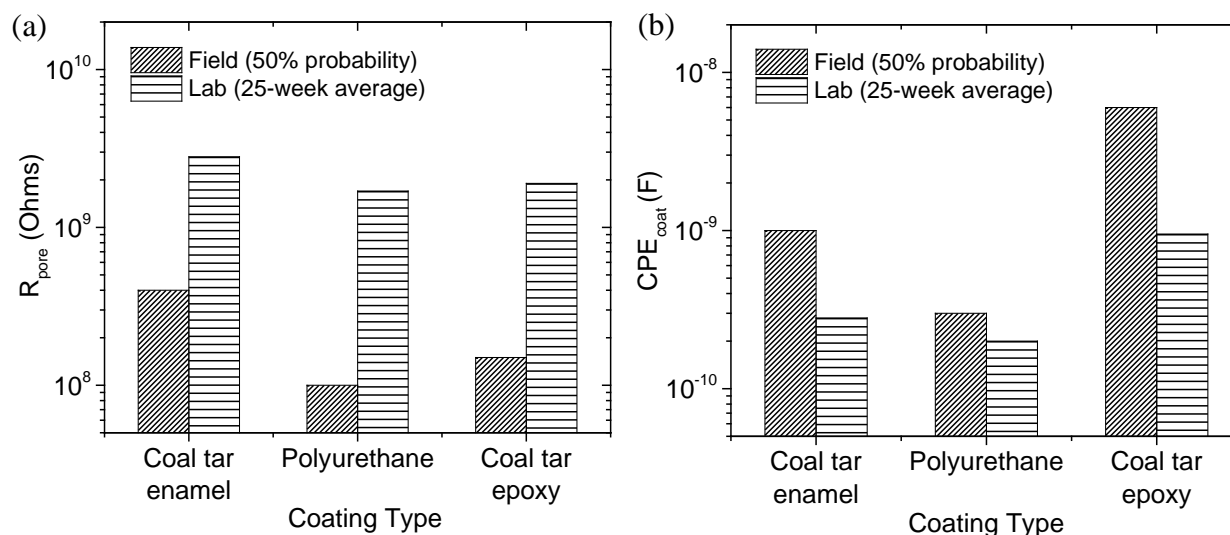
**Figure 9. Comparison of field EIS data to laboratory coupons for (a)  $R_{pore}$  and (b)  $CPE_{coat}$ .**

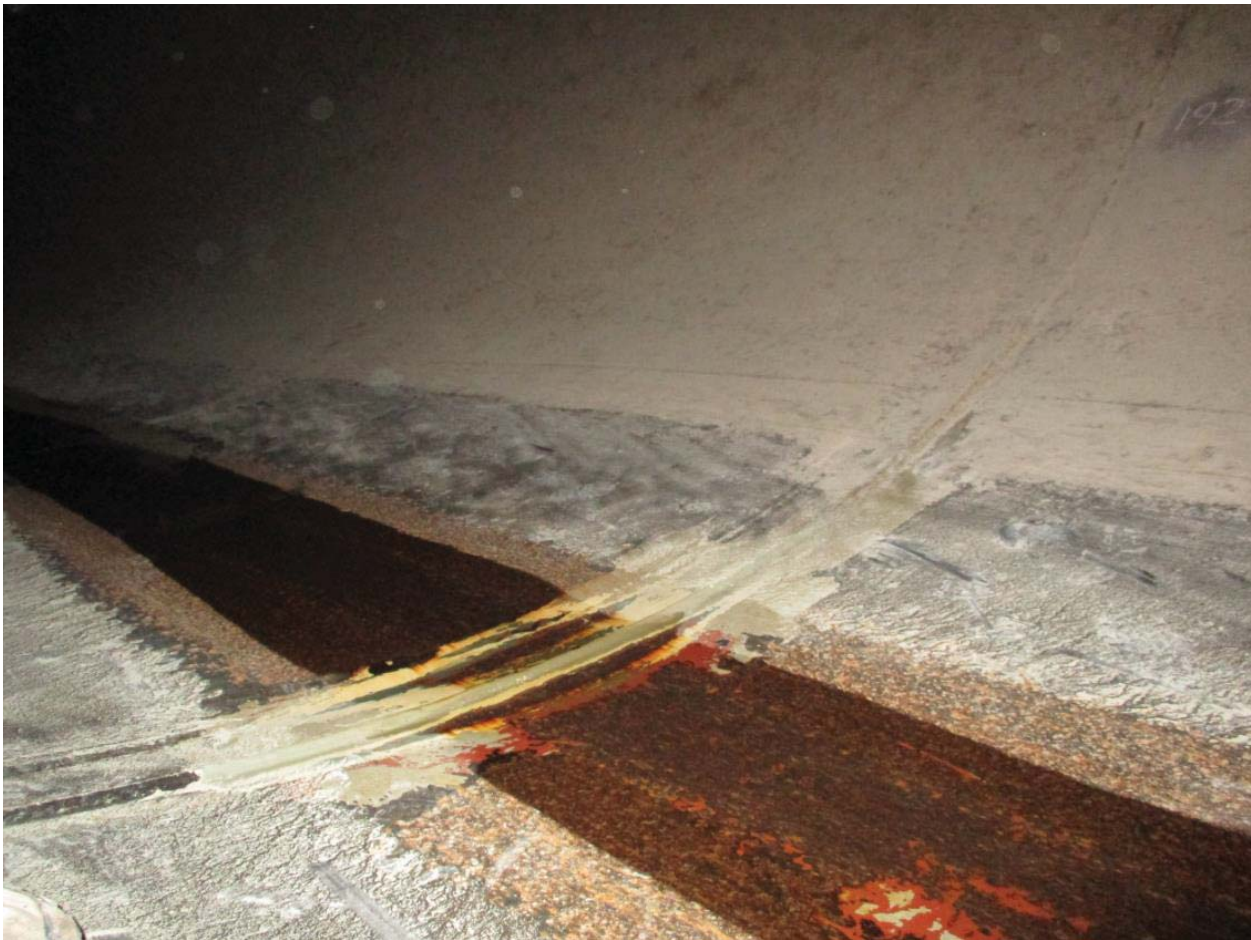
U.S. Department of the Interior  
Bureau of Reclamation

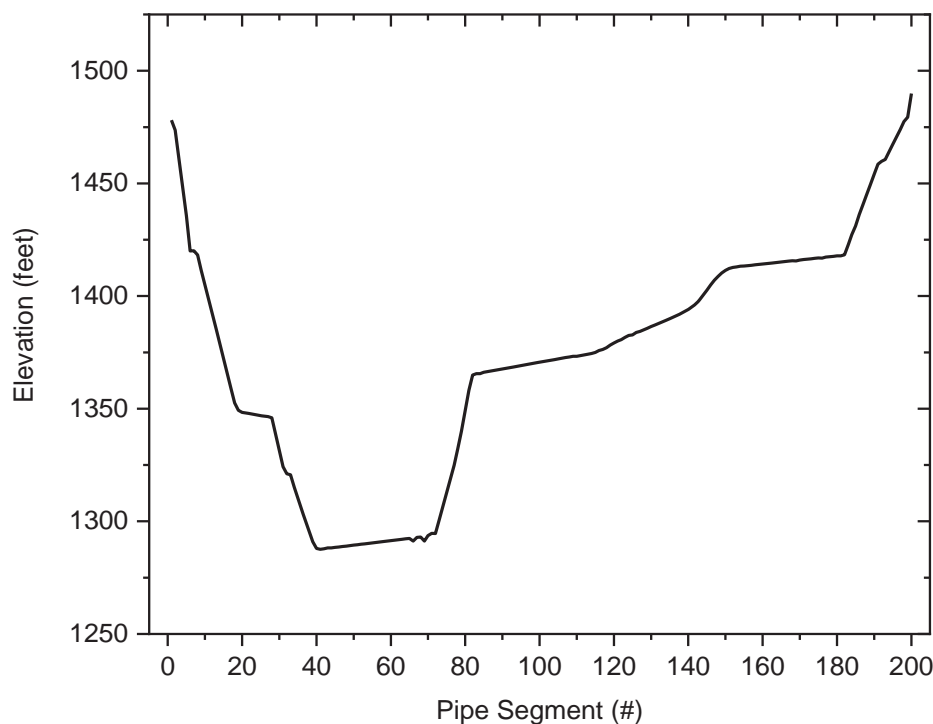
**Figure 2. Siphon elevation profile.**

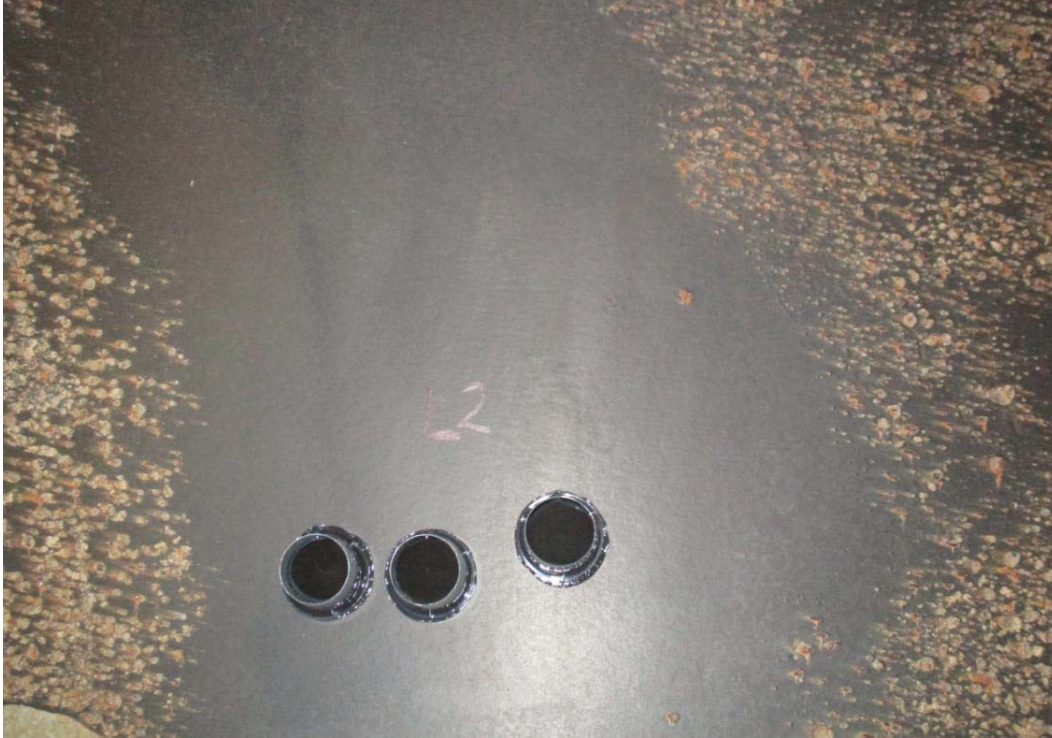
**Figure 3. Test cell set-up and coating condition at pipe segment 9.**

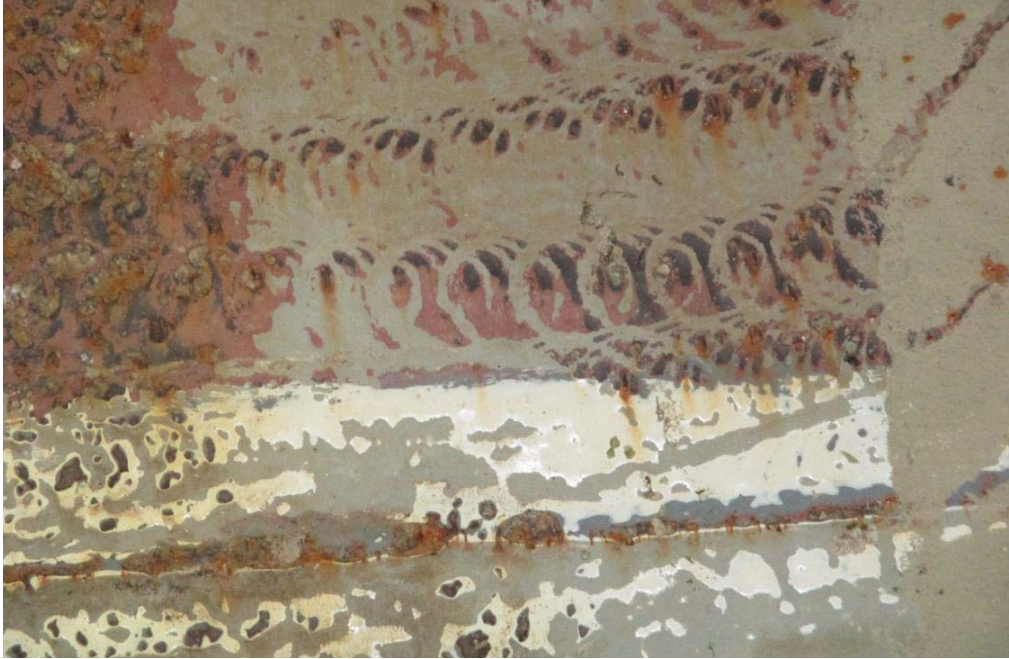
**Figure 4. Repair area in the invert of pipe segment 21.**

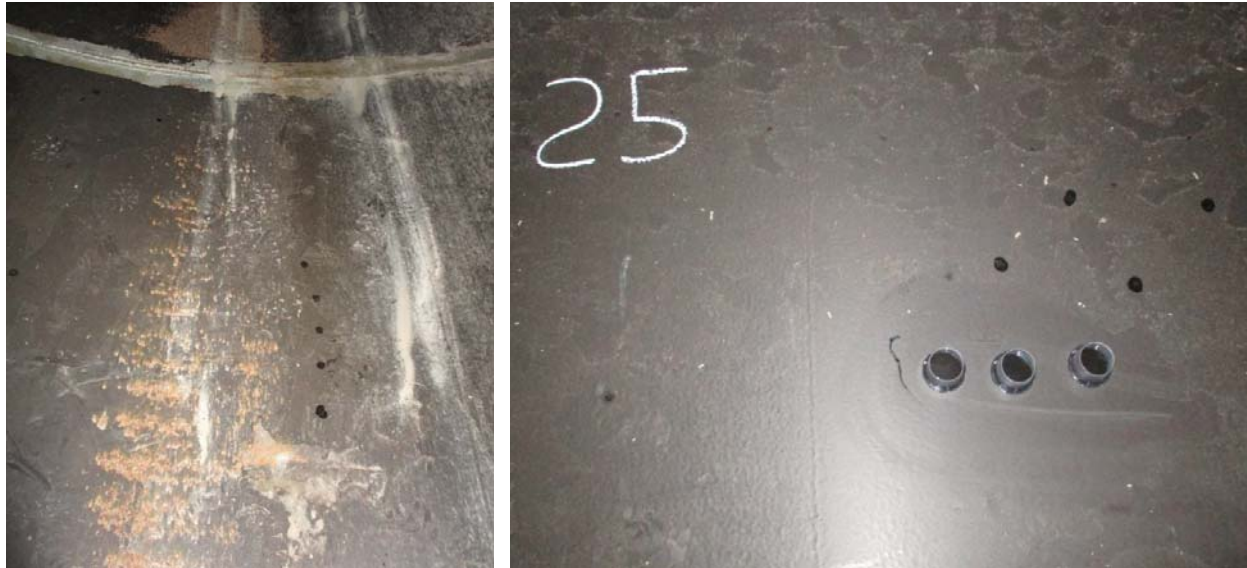
**Figure 5. Coating condition in pipe segment 25 at (left) the pipe invert and (right) at side wall where quantitative measurements occurred.**

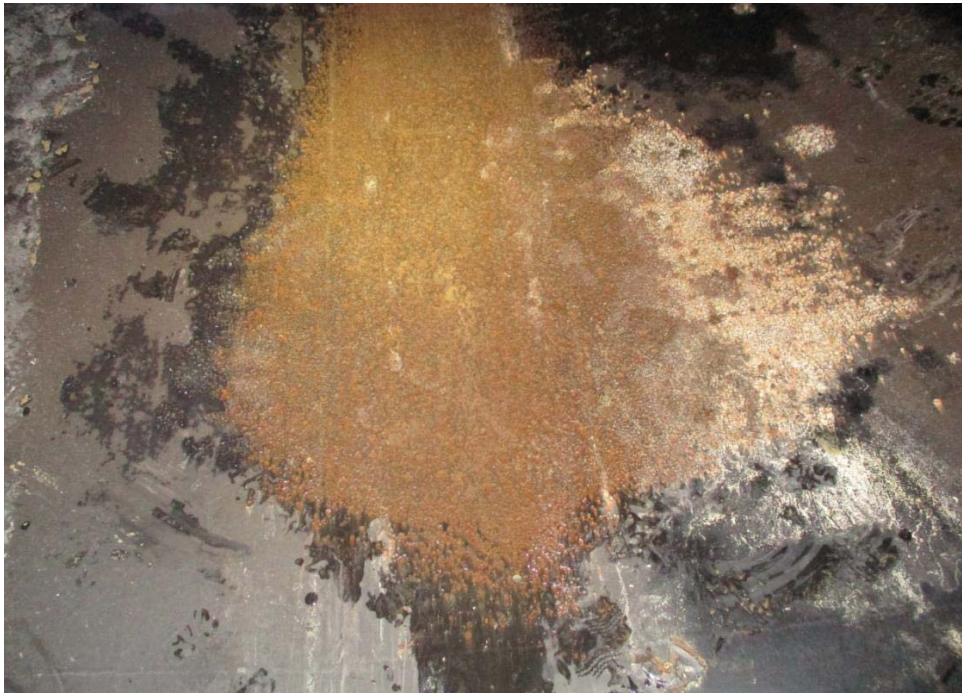
**Figure 6. Large area of corrosion in the invert near pipe segment 37.**

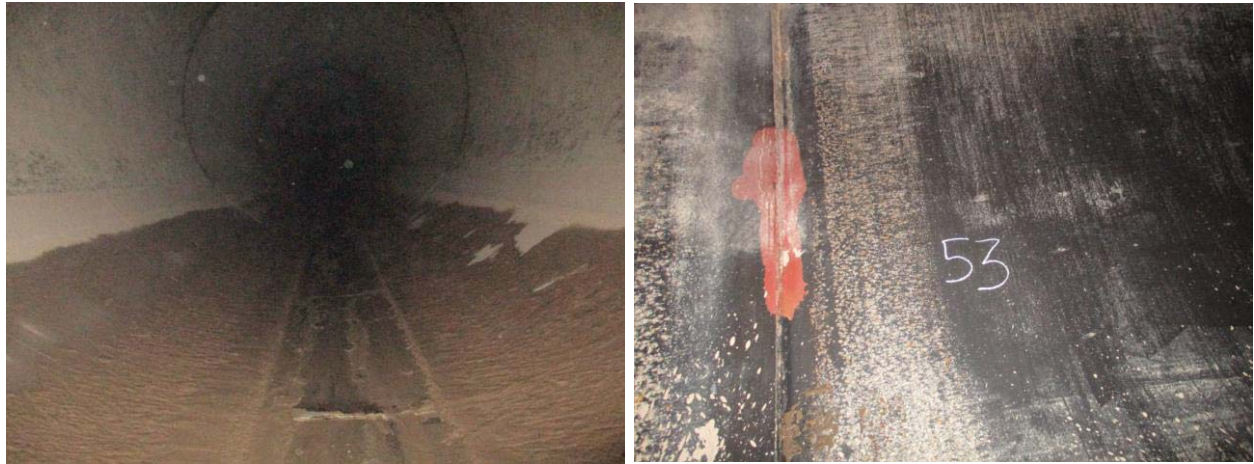
**Figure 7. Typical pipe condition (right) between pipe segments 37 and 67 with thick mud in the pipe invert and (left) along pipe walls, shown up close for pipe segment 53.**

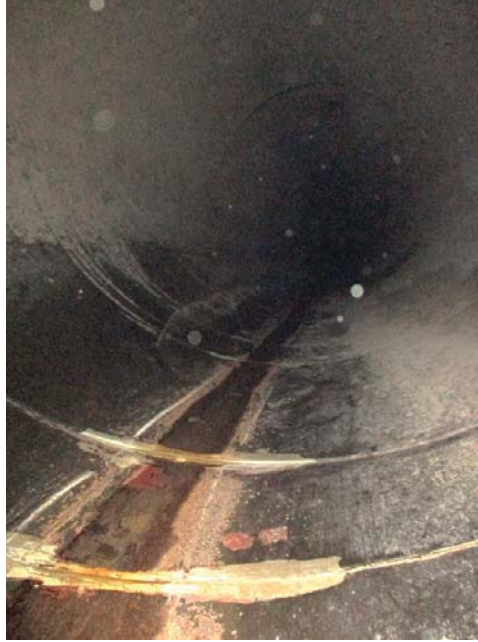
**Figure 8. Coating condition of the invert and pipe joints near pipe segment 84A.**

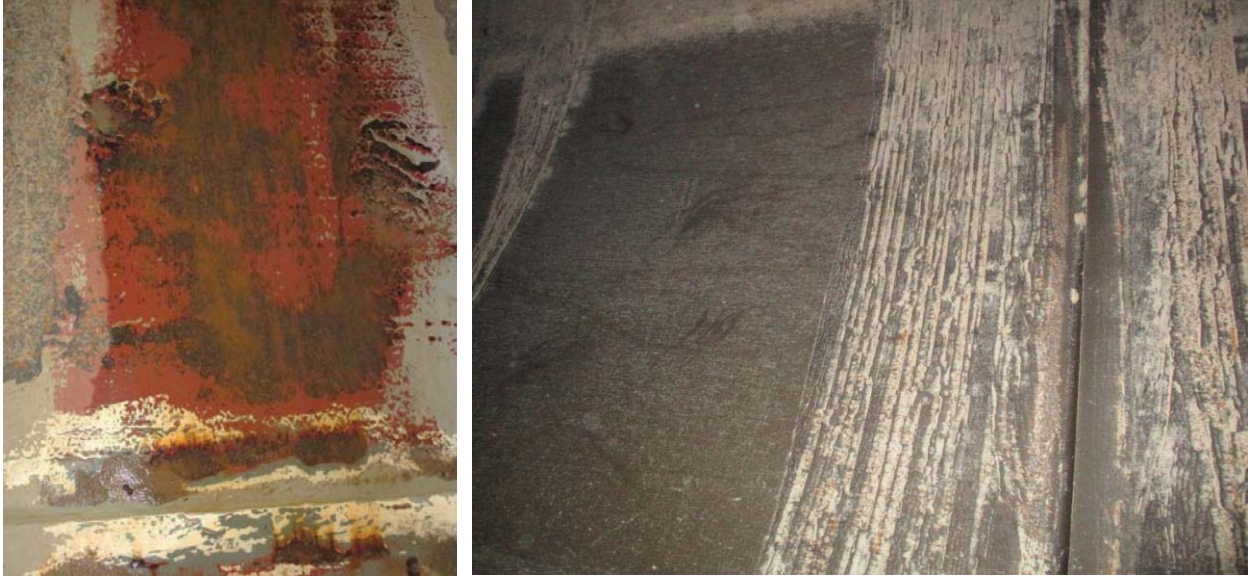
**Figure 9. Typical condition of (left) invert and joint repair near pipe segment 116 and (right) application defects from brush application of coating near pipe segment 136.**

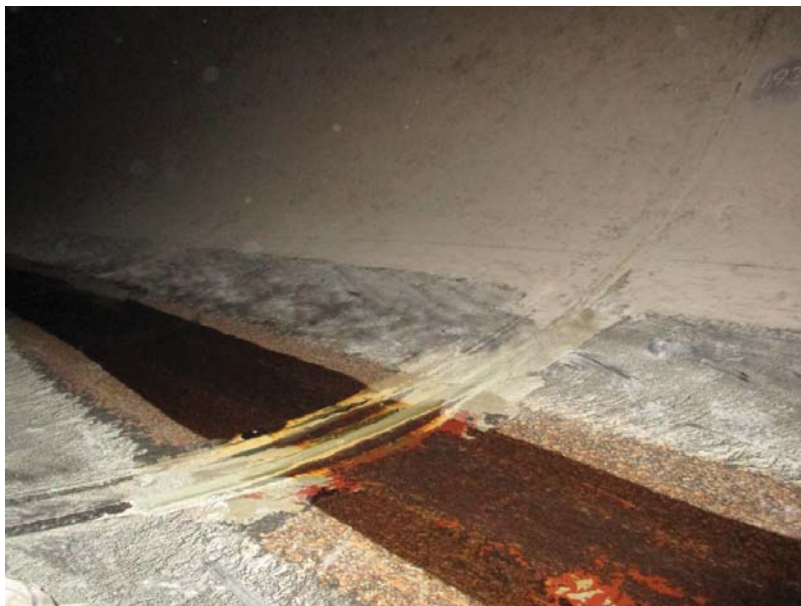
**Figure 10. Typical joint and invert condition at pipe segment 192.**

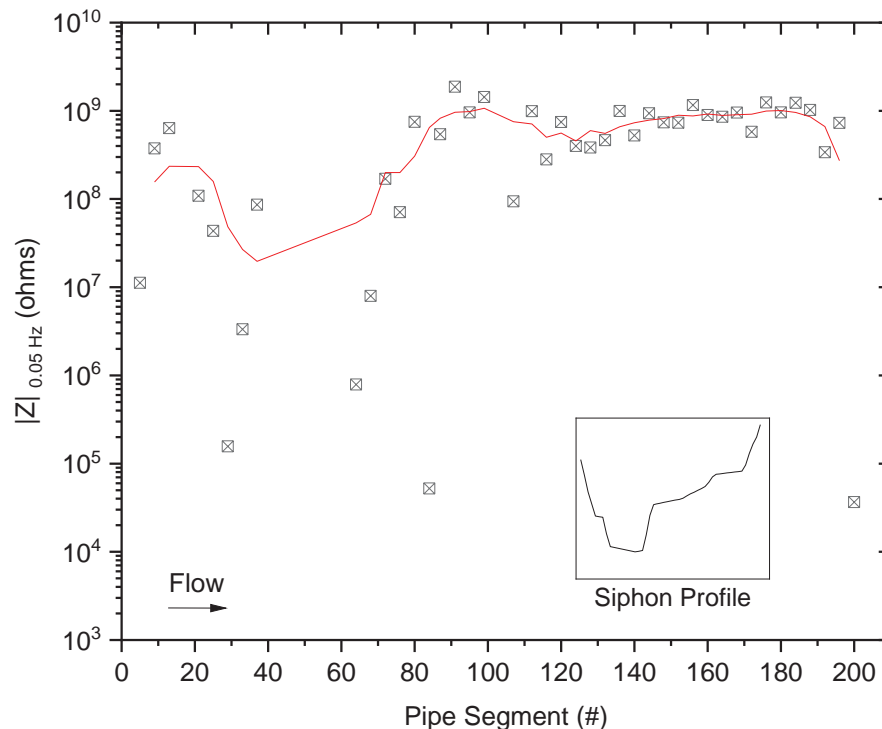
**Figure 11. Overall corrosion protection at each pipe segment per EIS testing results with a 5-point adjacent averaging trendline included and siphon elevation profile inset.**

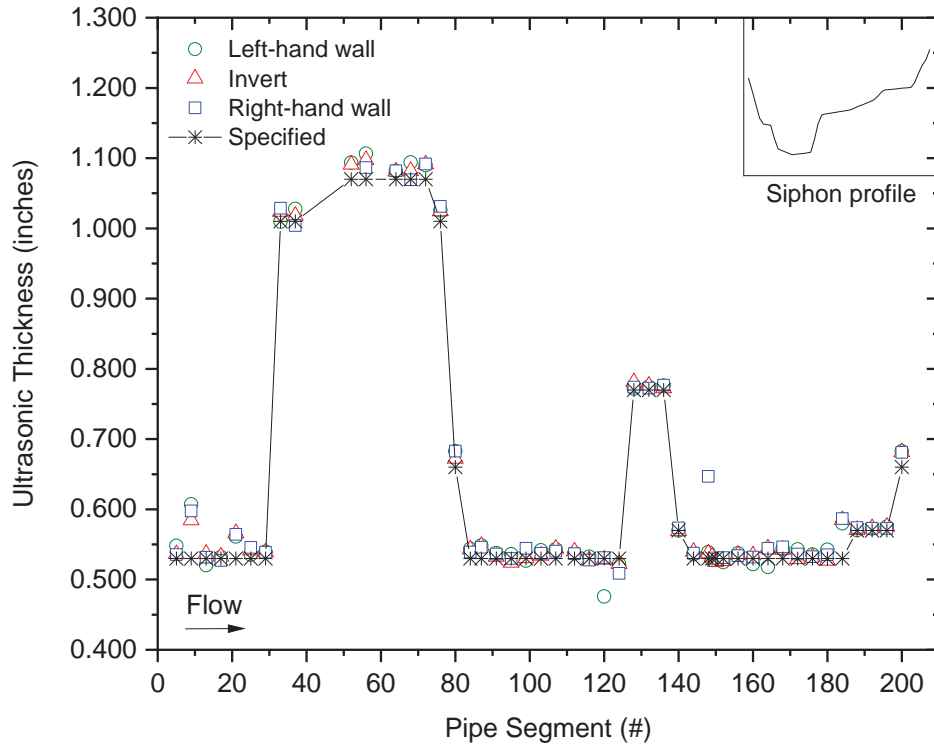
**Figure 13. Average UT at each pipe segment, measured at invert and each wall, with specified values also shown and the siphon elevation profile inset.**

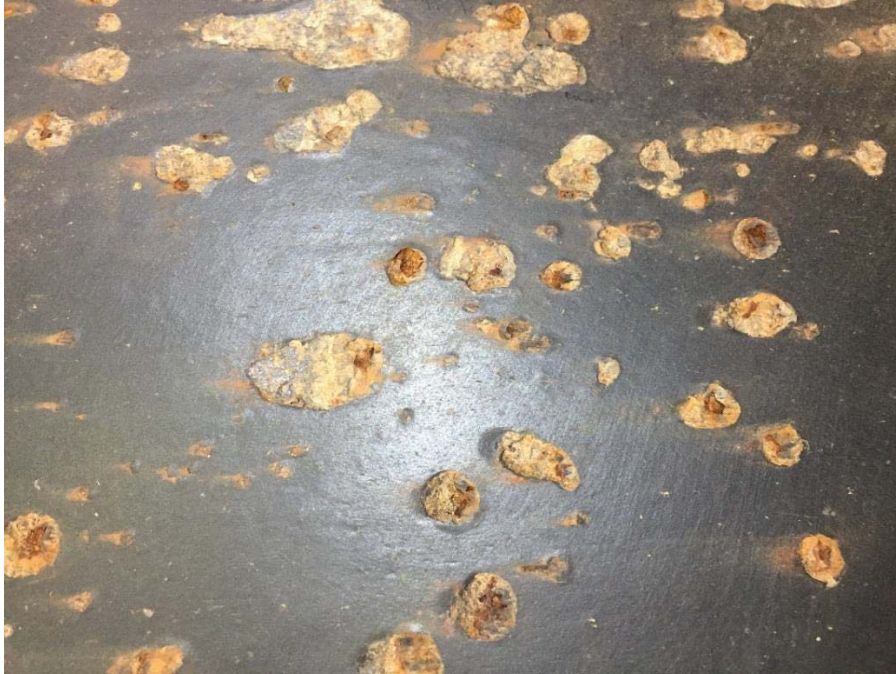
**Figure 14: Severe pitting at pipe segment 10.**

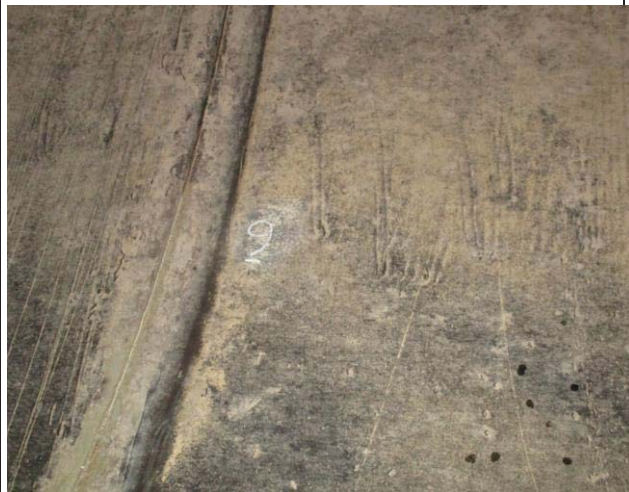
Figure D-2: Pipe wall condition at pipe segment 9. UT test locations visible at lower, right.

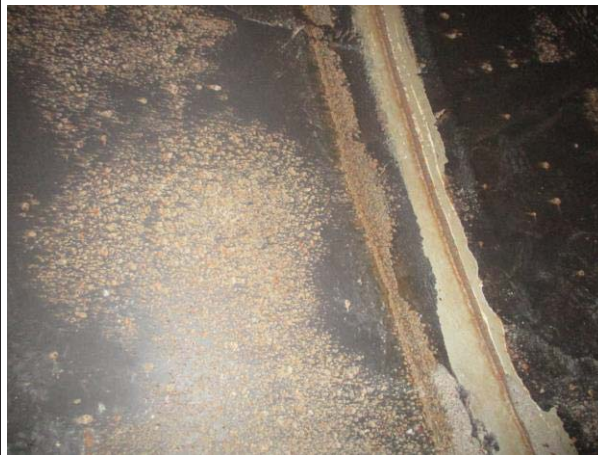
Figure D-3: Corrosion near a joint at pipe segment 9.

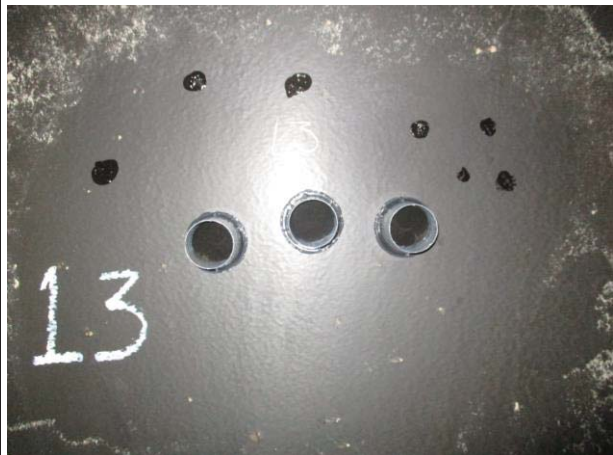
Figure D-4: EIS test cell set-up at pipe segment 13. UT test locations are visible above test cells.

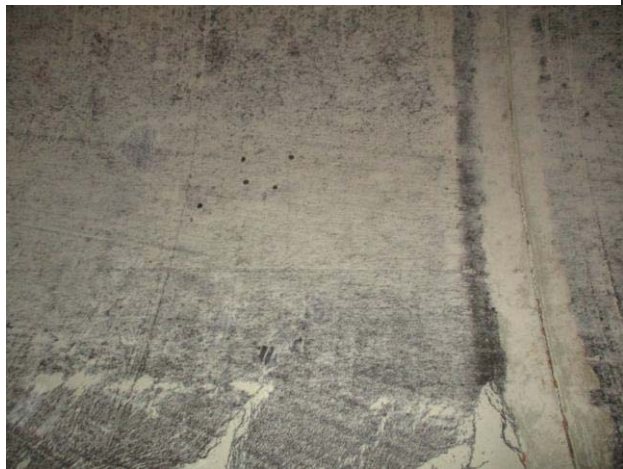
Figure D-5: Wall condition near pipe segment 13. UT test locations are visible.

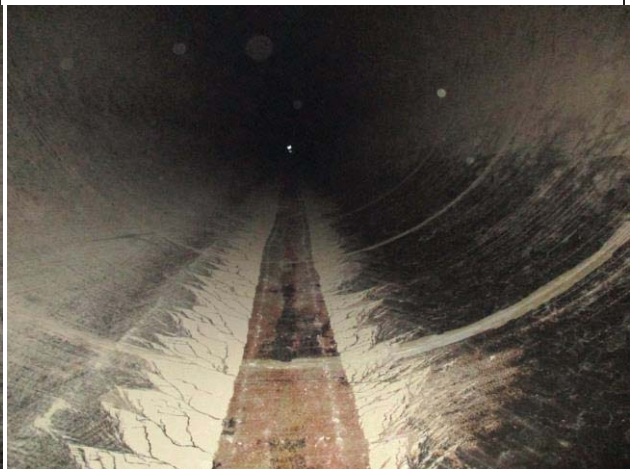
Figure D-6: Condition of invert near pipe segment 13. Rust-through and remnants of repair materials are visible.

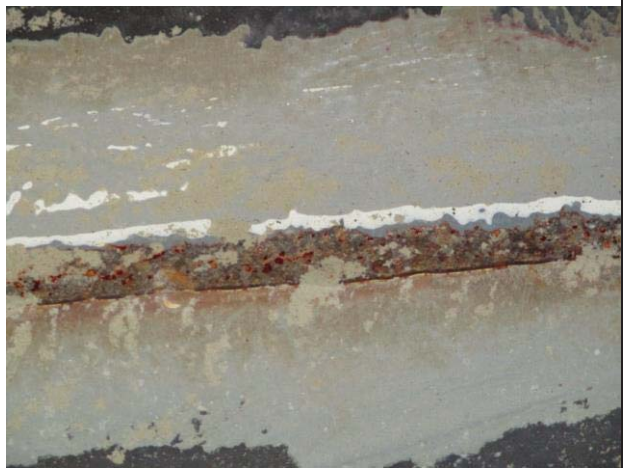
Figure D-7: Close-up of rust-through in a joint near pipe segment 13.
