— BUREAU OF —  
RECLAMATION

# Field Validation of Impedance Spectroscopy Coating Assessments

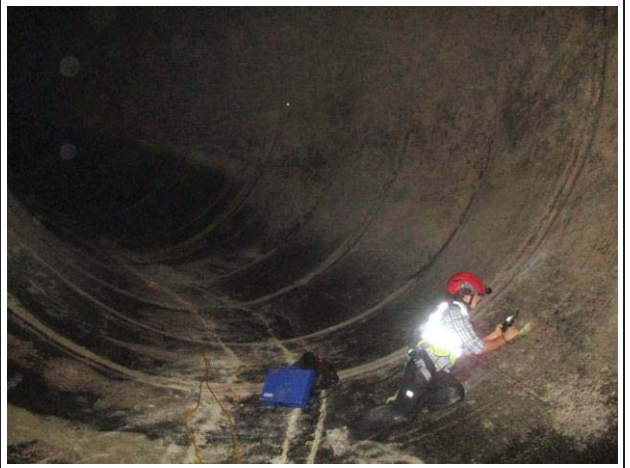
Figure D-8: Reclamation inspector performing UT measurements near pipe segment 13.

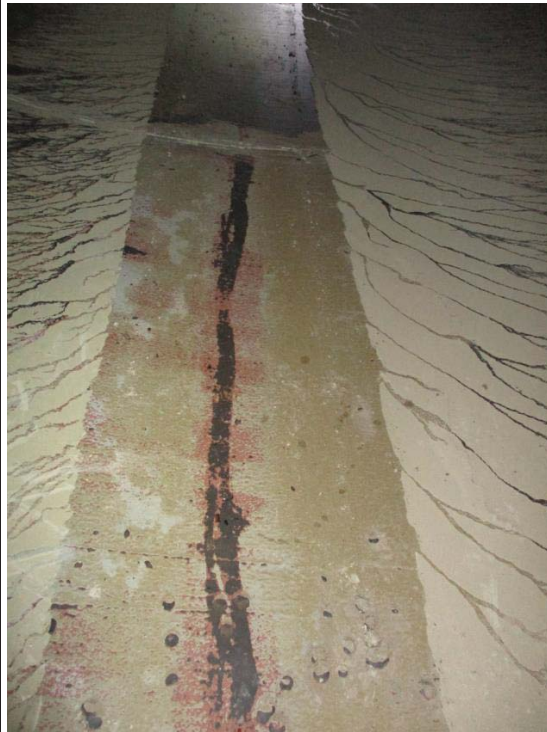
Figure D-10: Condition of invert near pipe segment 17. Coating appears to be intact. Sediment is visible to the left and right of invert.

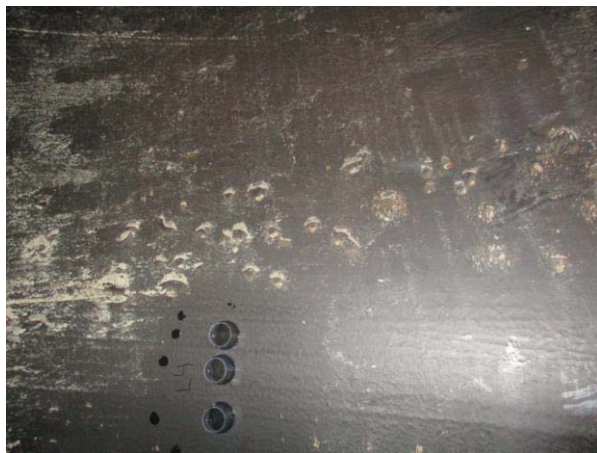
Figure D-11: Defects in the lining at pipe segment 17. Lining appears to be pockmarked with some corrosion within the indentations.

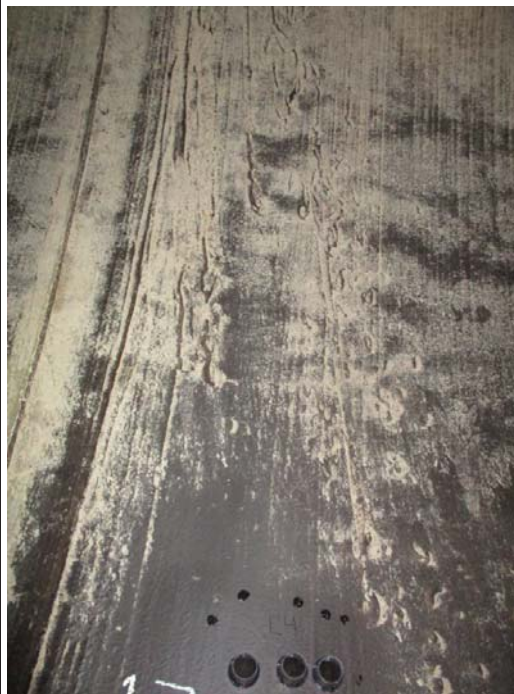
Figure D-12: Defects in the lining at pipe segment 17. Lining appears to be wrinkled near the joint.

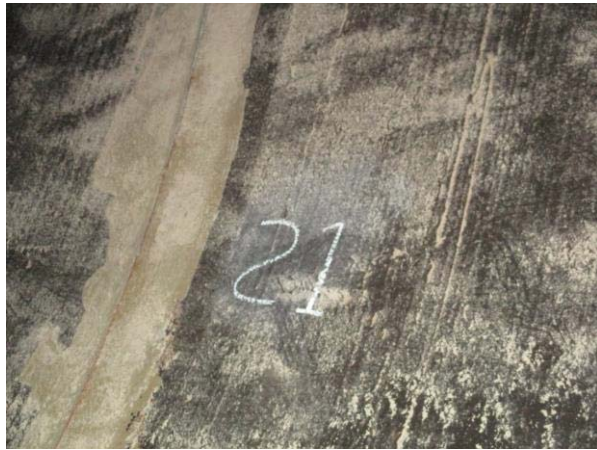
Figure D-13: Condition of coating at pipe segment 21. Concentric stripes or wrinkles (fingering) were commonly found near the pipe field joints.

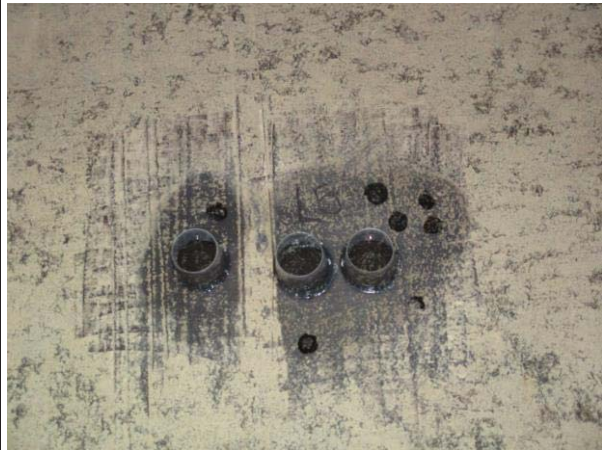
Figure D-14: EIS test cell set-up and UT test location at pipe segment 21. Pipe walls in some areas were covered in thick, dried mud that needed to be scraped away before testing.

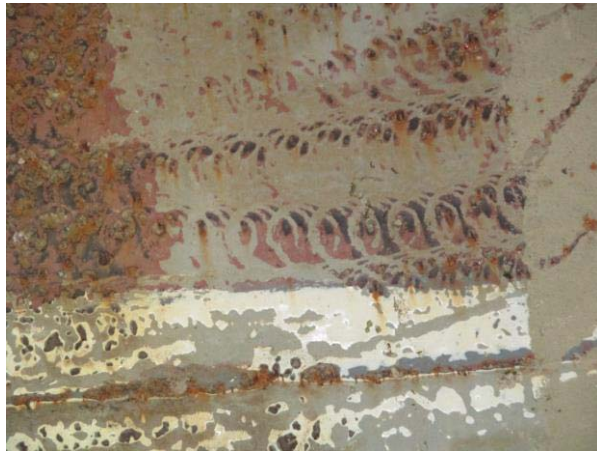
Figure D-15: Close up of invert repair. The surface preparation was reported by CAP staff to have been done with water jetting, which resulted in the circular pattern.

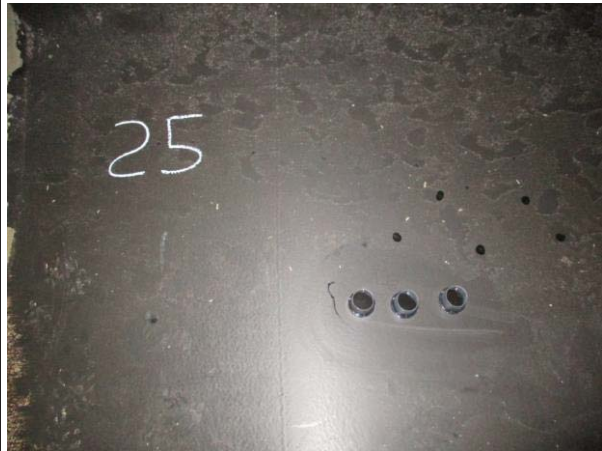
Figure D-16: EIS test cell set-up and UT test location at pipe segment 25.

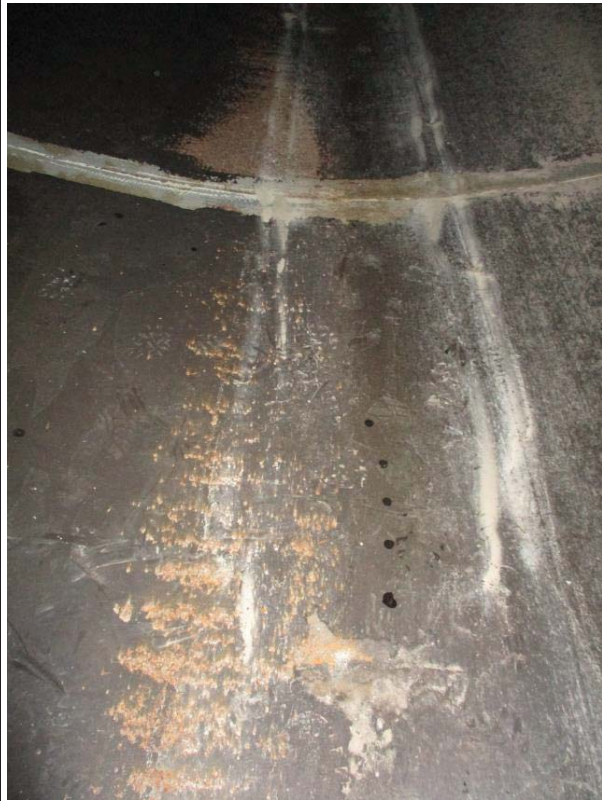
Figure D-18: Visible corrosion along the invert of pipe segment 25.

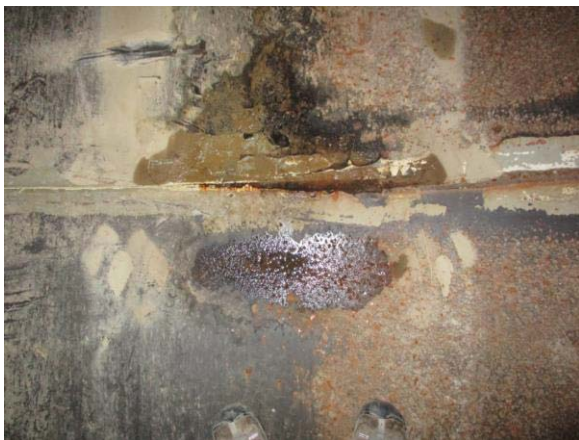
Figure D-19: Corrosion and rust-through near a joint at pipe segment 25.

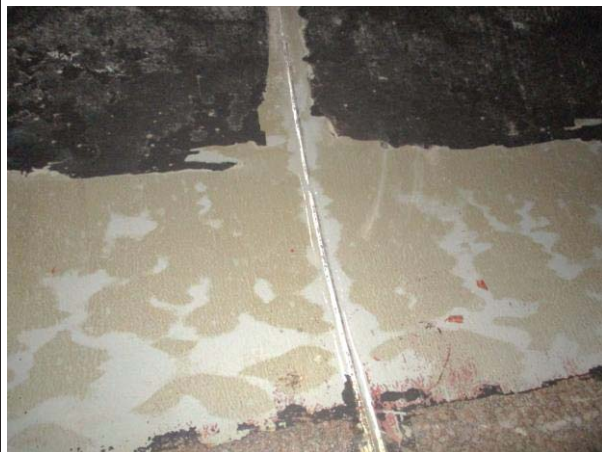
Figure D-20: A coating repair area in the invert of pipe segment 25. The repair in this area looks to be in good condition, but corrosion is visible adjacent to the repaired area.

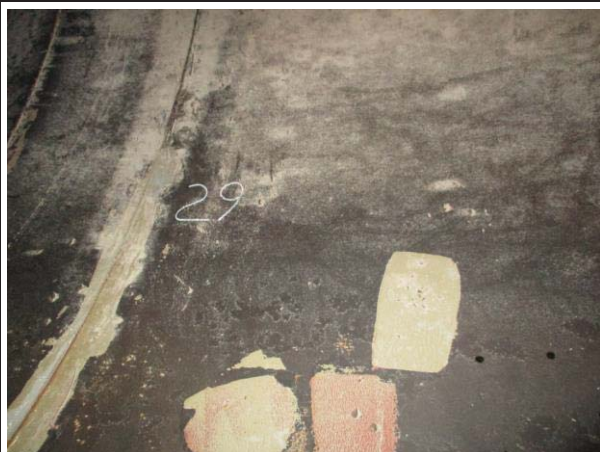
Figure D-21: Repaired spots on pipe segment 29.

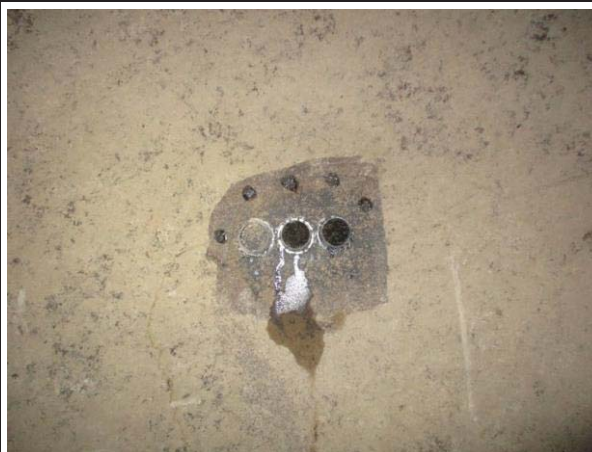
Figure D-22: EIS test cell set-up and UT test location at pipe segment 29.

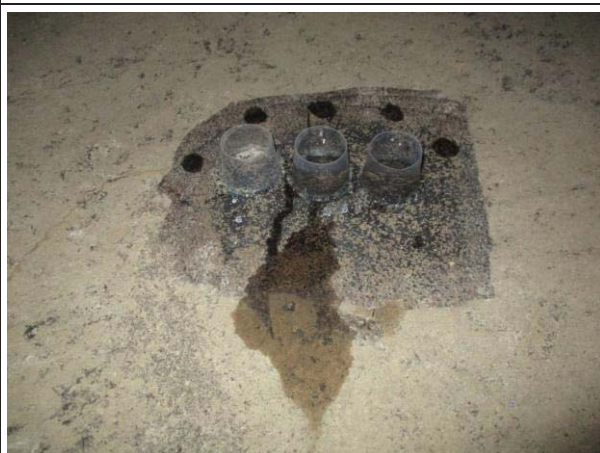
Figure D-23: Close-up of EIS test cell set-up and UT test location at pipe segment 29. The center test cell leaked water and could not be used.

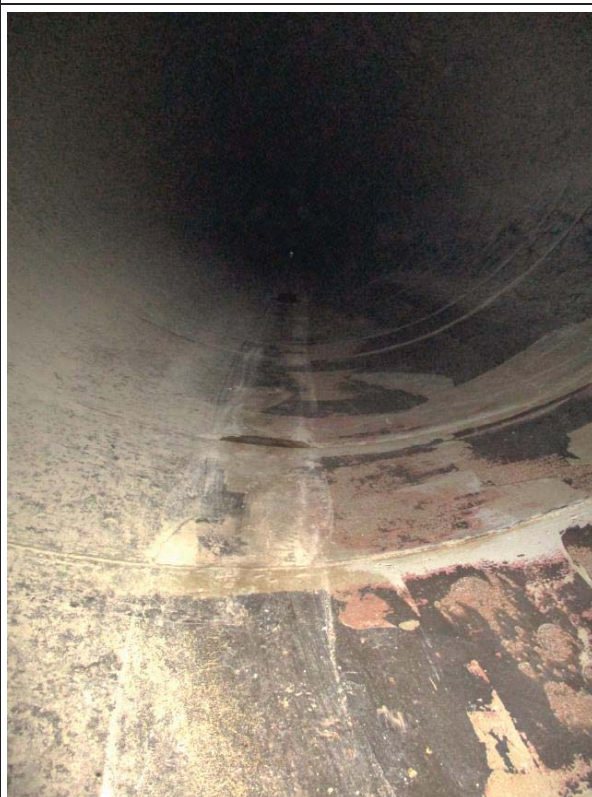
Figure D-24: General condition of pipe segment 29. Areas of corrosion and areas of repair are visible throughout.

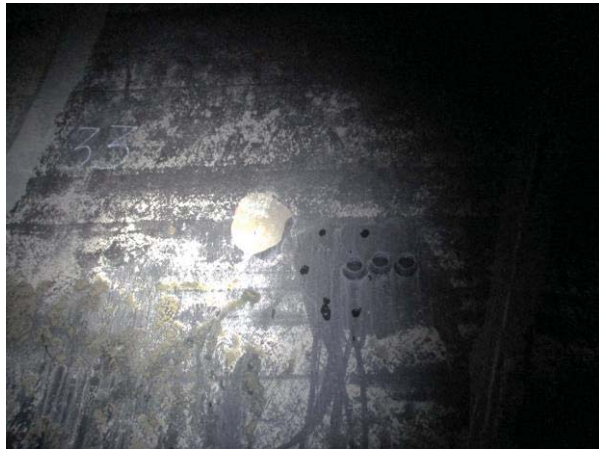
Figure D-25: Condition of the EIS test cell set-up at pipe segment 33.

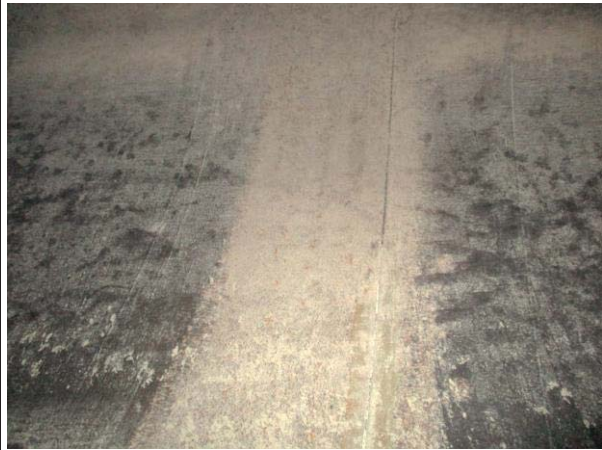
Figure D-26: Condition of the wall near pipe segment 33.

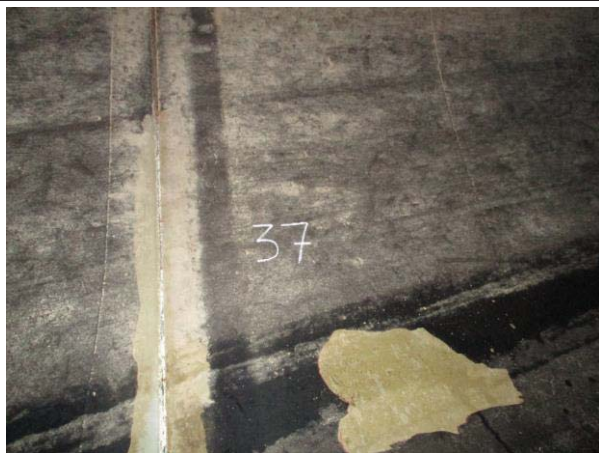
Figure D-27: Condition of the wall at pipe segment 37. A small amount of rust-through is visible within the field joint repair area.

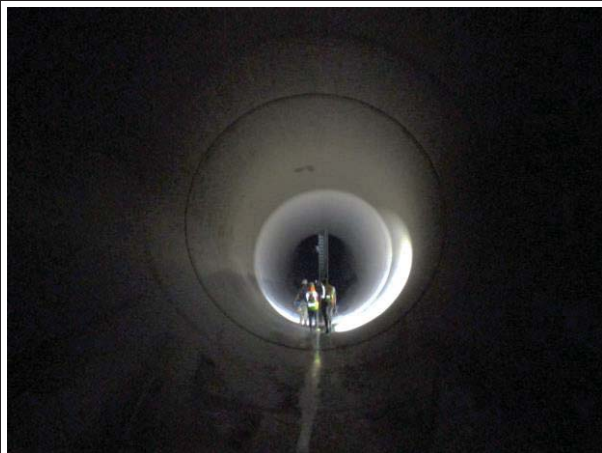
Figure D-28: The inspection team working near pipe segment 37.

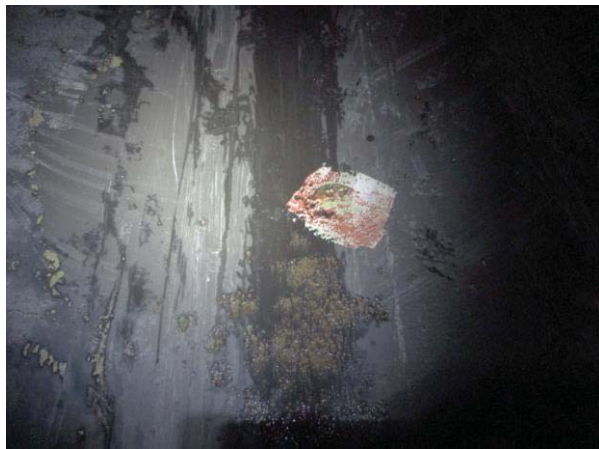
Figure D-29: A small repair patch near pipe segment 37. Mud is visible on the pipe wall.

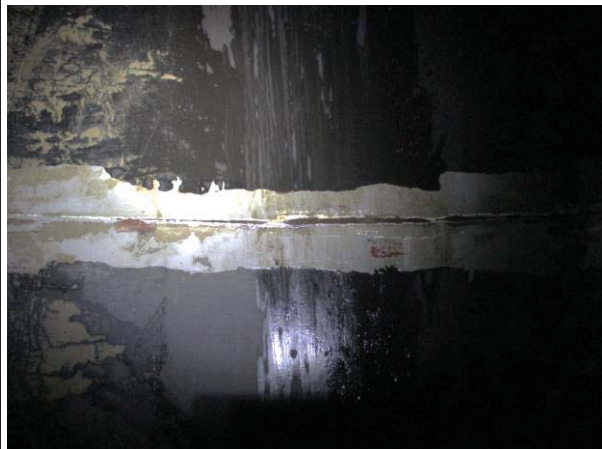
Figure D-30: A field joint repair near pipe segment 37.

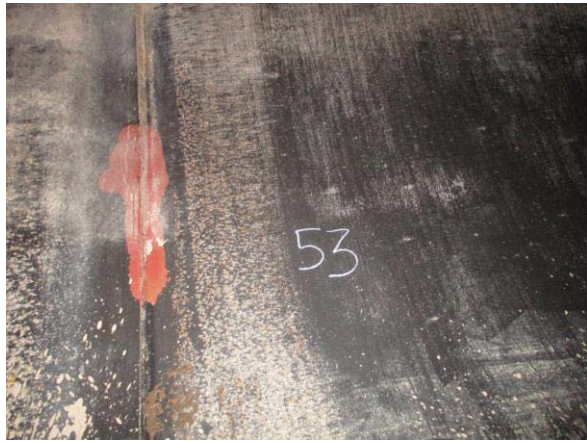
Figure D-31: Condition of the wall of pipe segment 53. Large areas of corrosion are visible. The failed field joint repair shows rust-through.

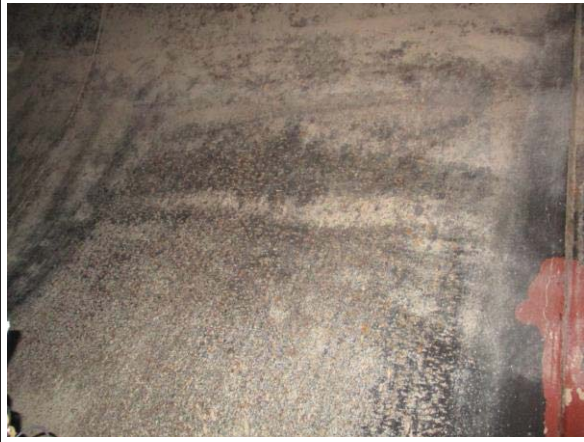
Figure D-32: Condition of the wall near pipe segment 53. This area represented one of the largest areas of widespread corrosion rust-through found in the siphon.

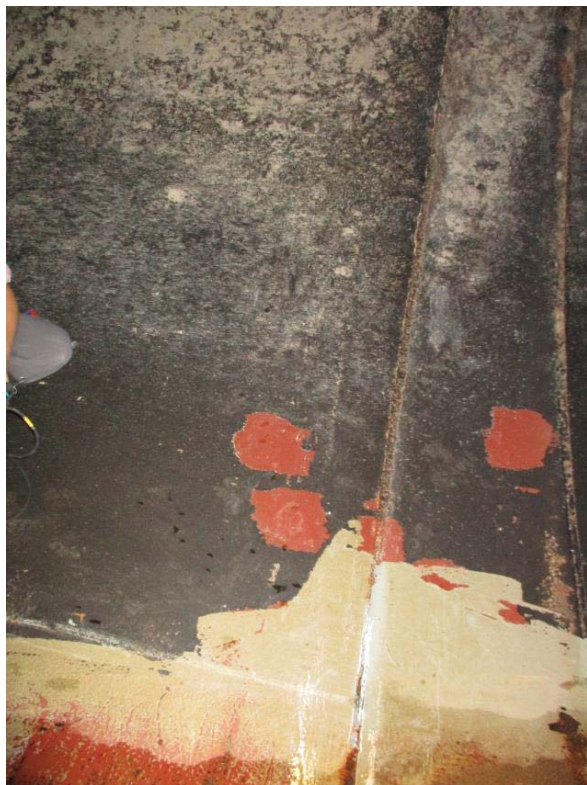
Figure D-33: Wall condition of pipe segment 84A.

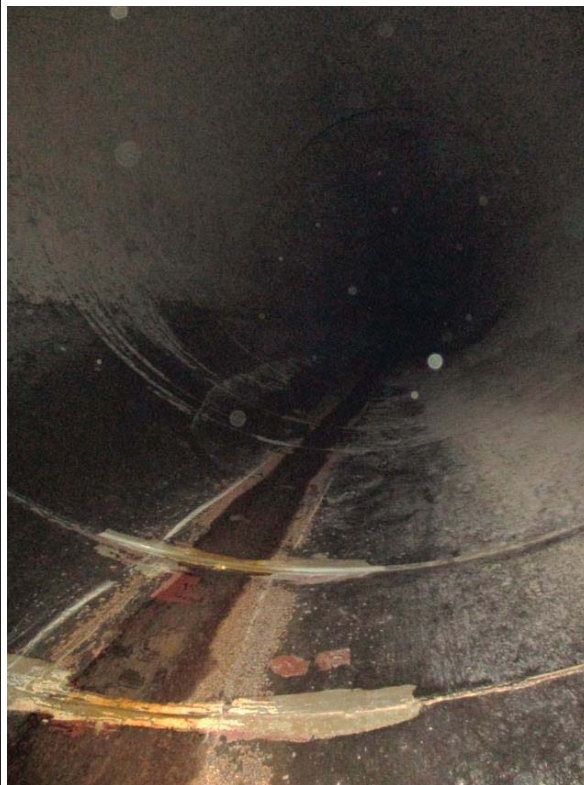
Figure D-34: Condition of the siphon near pipe segment 84A. Joint and invert repairs have failed and rust-through and corrosion are visible.

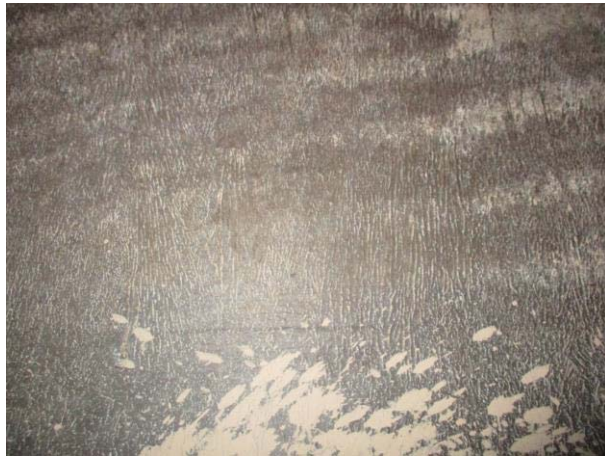
Figure D-35: Condition of the wall near pipe segment 84A. Coating wrinkles and potential cracks are abundant.

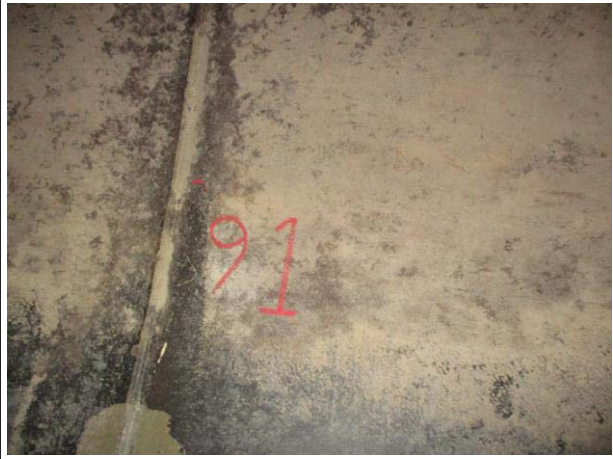
Figure D-36: Condition of the pipe wall of segment 91.

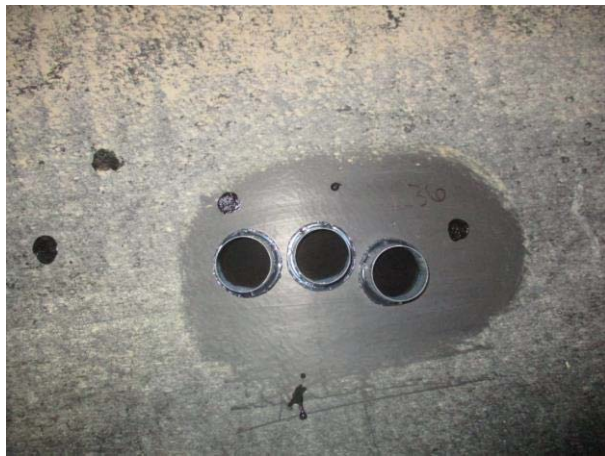
Figure D-37: EIS test cell set-up and UT test location at segment 91. Dried mud covered both sides of the wall and needed to be scraped away to perform testing.

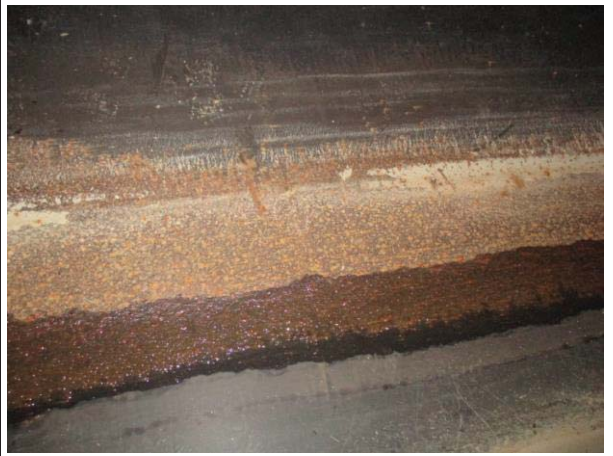
Figure D-38: Condition of the pipe invert near segment 91. An area of severe corrosion extends nearly three feet wide across the invert.

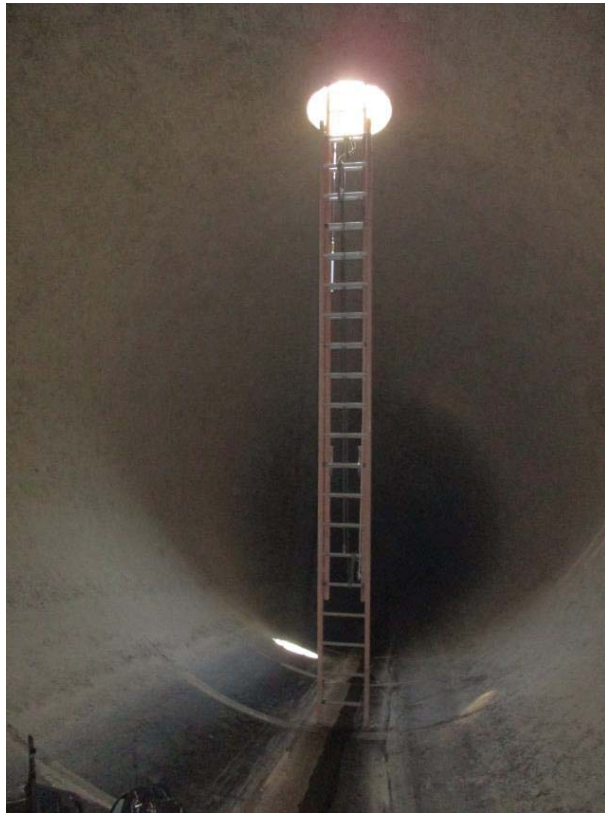
Figure D-39: An access point near pipe segment 91.

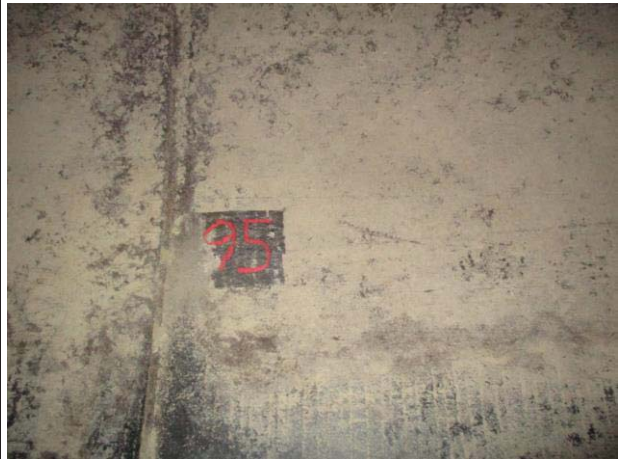
Figure D-40: Condition of the wall of pipe segment 95.

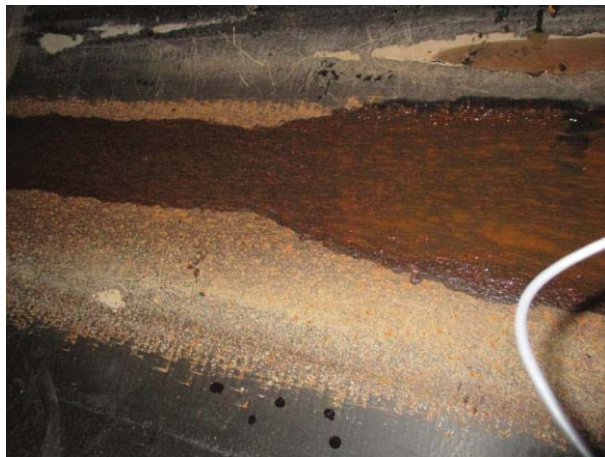
Figure D-41: Condition of the invert at pipe segment 95. Widespread corrosion is visible.

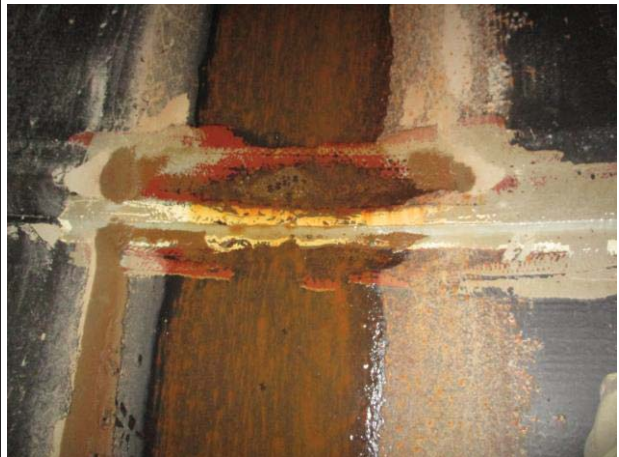
Figure D-42: Condition of a previously-repaired joint at pipe segment 95. The repair material has been abraded in some areas to reveal multiple layers of coating. Rust-through and evidence of water jetting are visible.

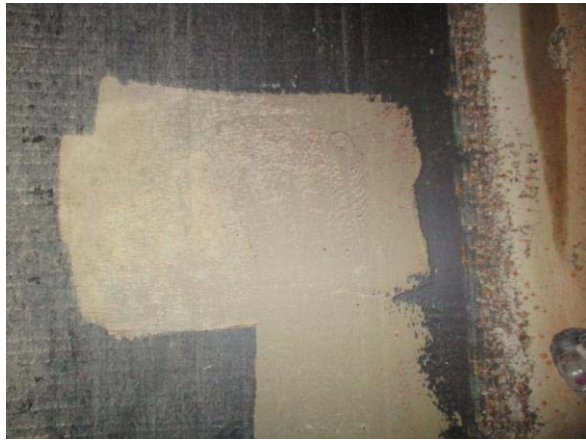
Figure D-43: An area of repair on the pipe wall near segment 95 that appears to be in good condition.

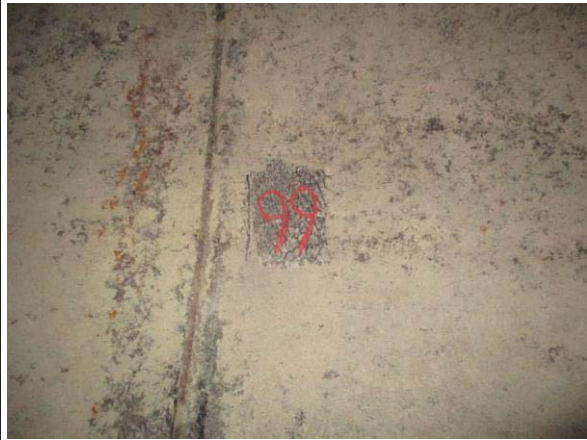
Figure D-44: Condition of the wall at pipe segment 99.

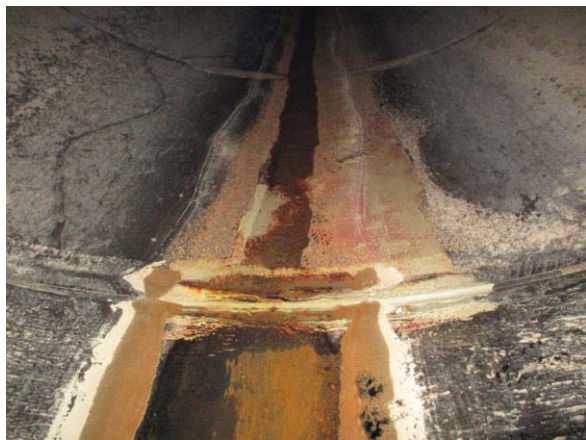
Figure D-45: Condition of the invert at pipe segment 99. Corrosion and rust-through are prevalent throughout.

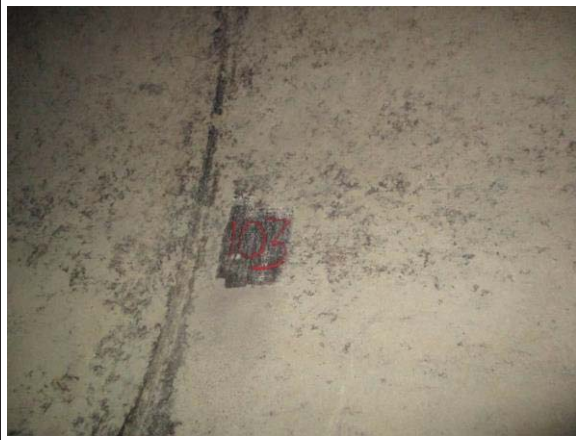
Figure D-46: Condition of the wall at pipe segment 103. Dried mud and sediment on the walls were almost plaster-like.

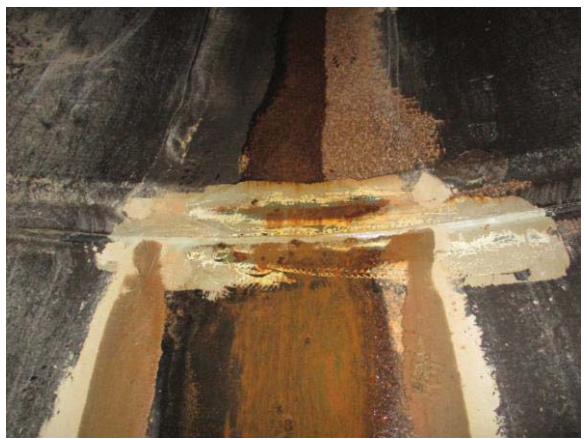
Figure D-47: Condition of the invert at pipe segment 103.

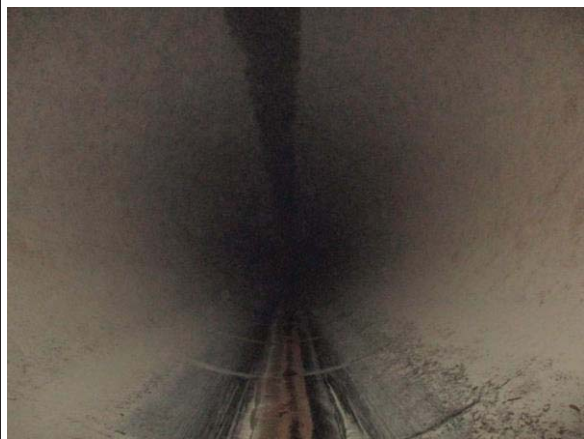
Figure D-48: Condition of the walls near pipe segment 103. Both sides were covered in difficult-to-remove dried mud.

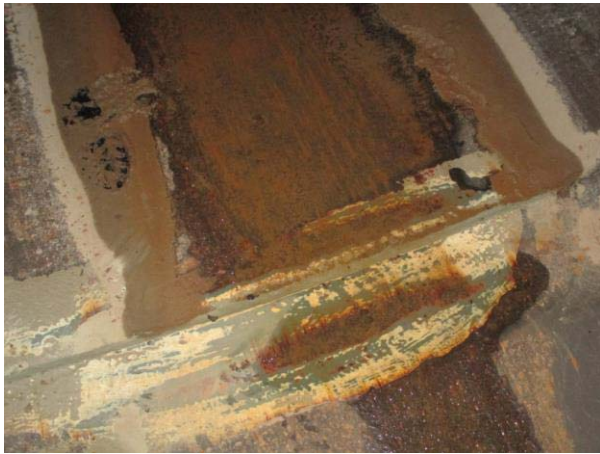
Figure D-49: Condition of the invert and pipe joint at segment 107. Coating repair has failed and significant rust-through and corrosion is visible.

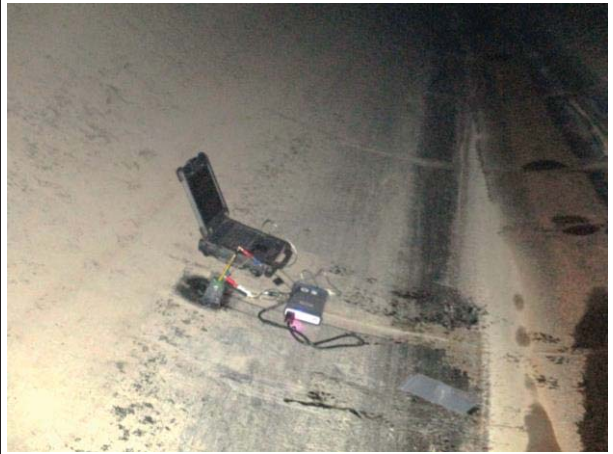
Figure D-50: EIS test set-up at segment 107. The siphon's curvature was shallow enough to allow for the equipment to be set directly onto the pipe wall.

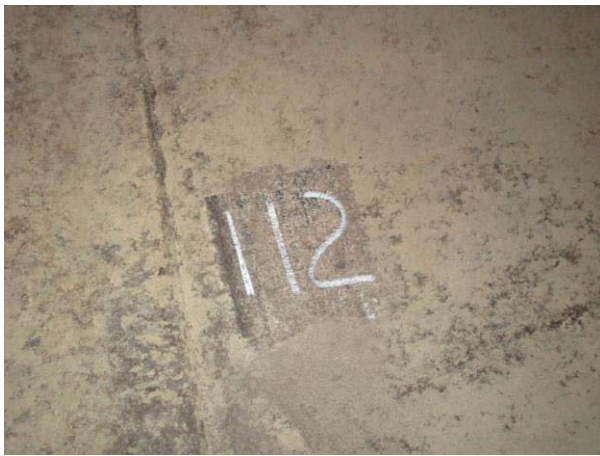
Figure D-51: Condition at pipe segment 112.

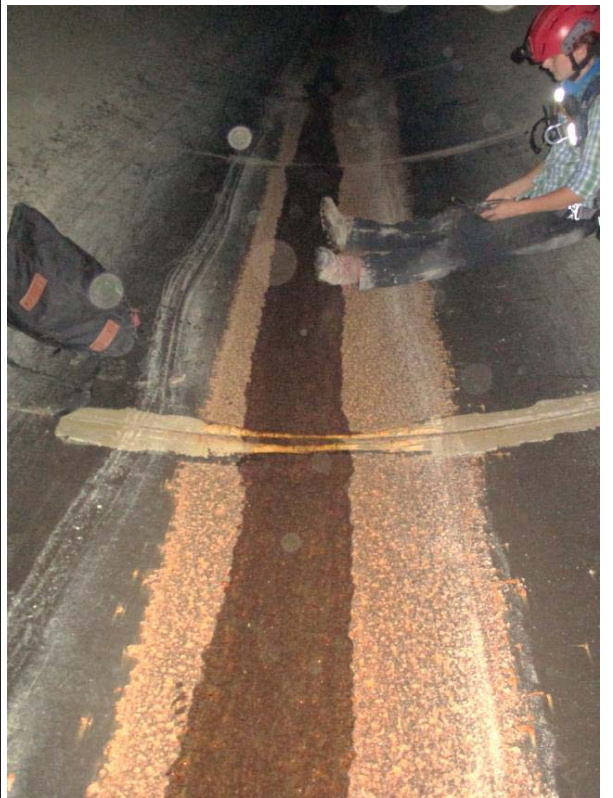
Figure D-52: Reclamation inspector programming UT gage while waiting for EIS to finish. Each test took between 2 and 3 minutes to complete.

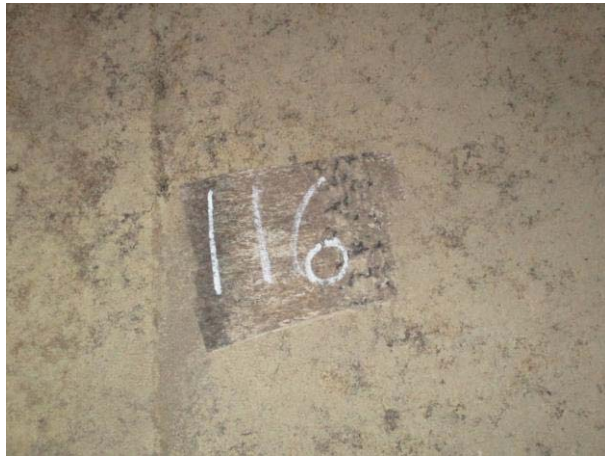
Figure D-53: Condition of pipe segment 116.

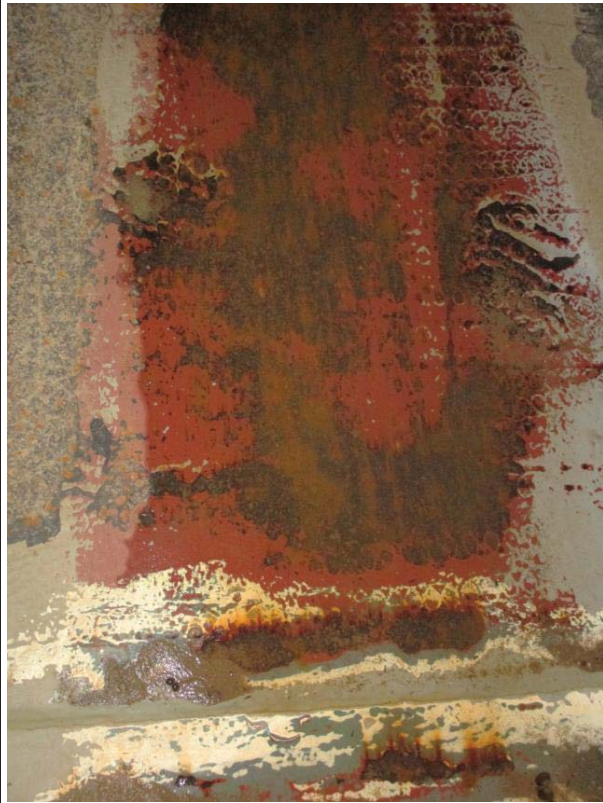
Figure D-54: Condition of the invert at pipe segment 116. A large coating repair area has been abraded away to reveal evidence of water jetting. Corrosion and rust-through is also visible.

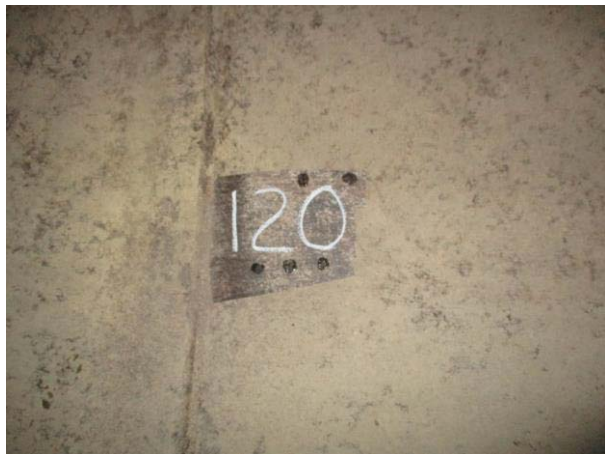
Figure D-55: Condition of pipe segment 120.

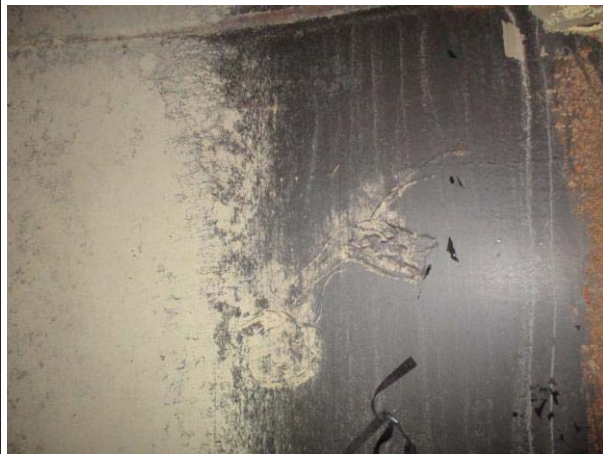
Figure D-56: An area of mud accumulation (left), cleaned coal tar enamel (center), and corrosion within invert (far right) near pipe segment 120.

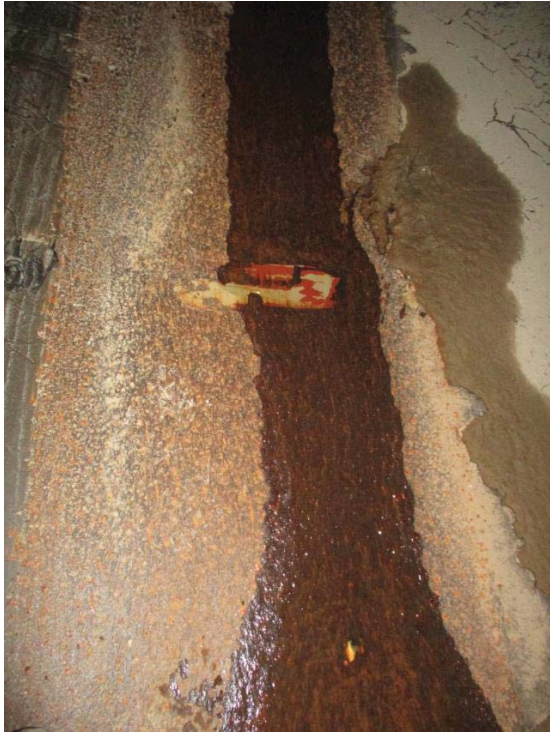
Figure D-57: Severe corrosion in the invert near pipe segment 124.

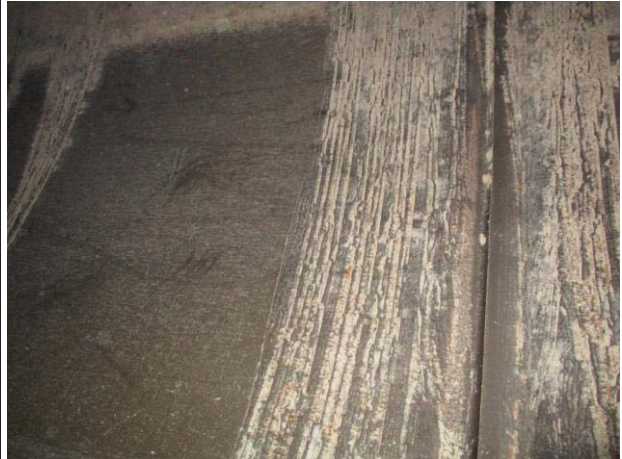
Figure D-58: Brush marks from application defects around joints near segment 132.

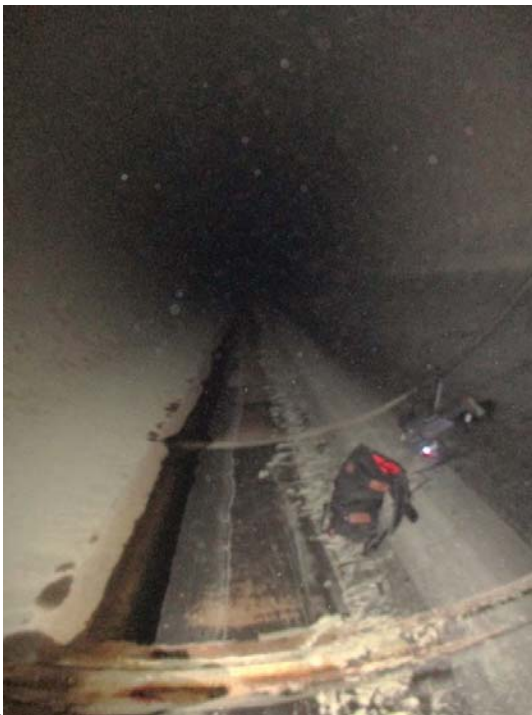
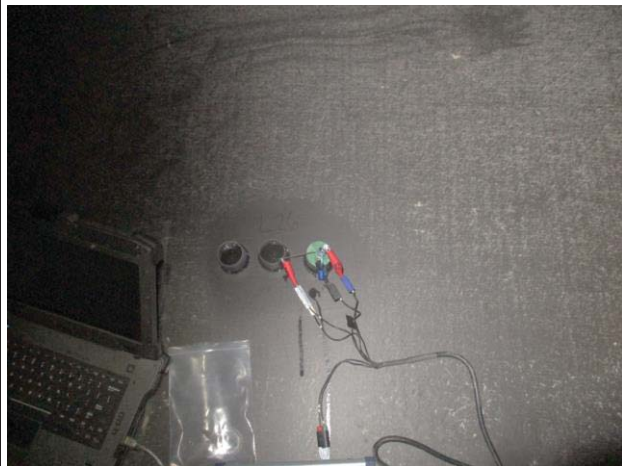
Figure D-59: General condition of the pipe near segment 136 within EIS test equipment and measurement in progress at right.

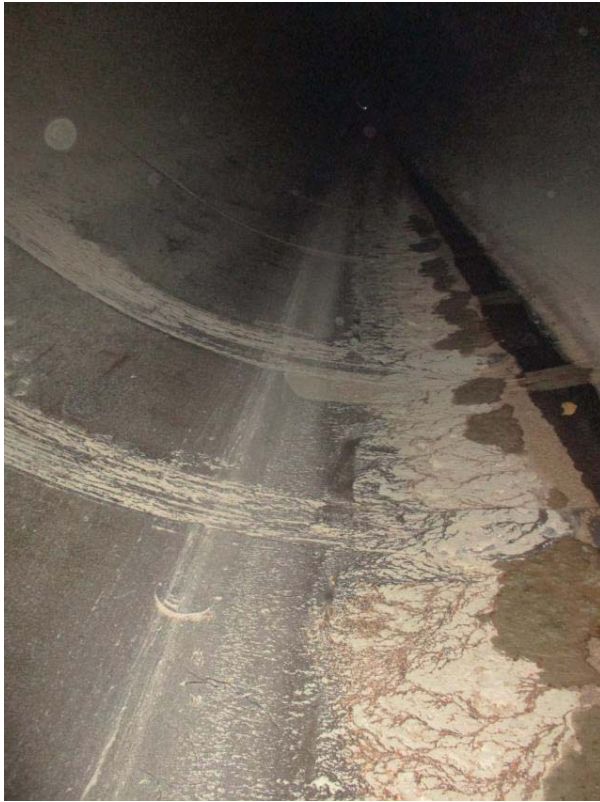
Figure D-60: Close-up of EIS test cell set-up at pipe segment 136.

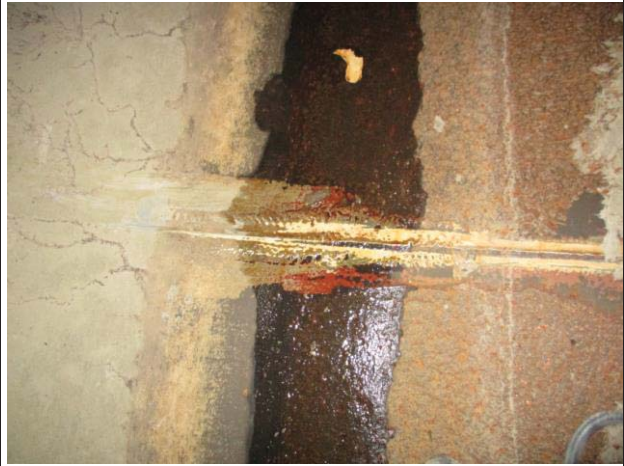
Figure D-61: General condition of pipe wall and invert near pipe segment 140.

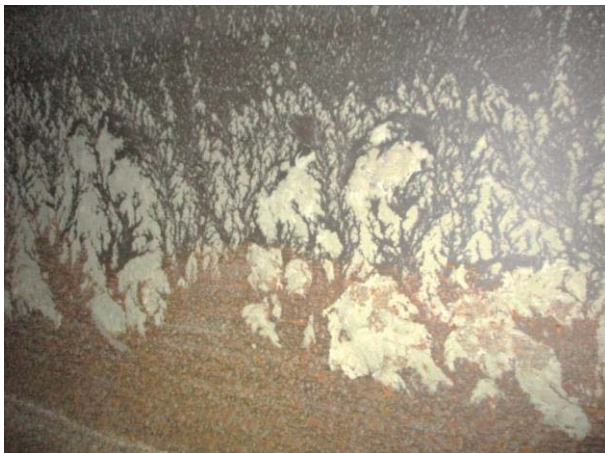
Figure D-62: Failed field joint repair near pipe segment 140. Multiple layers of coating material are visible and evidence of water jetting is present.

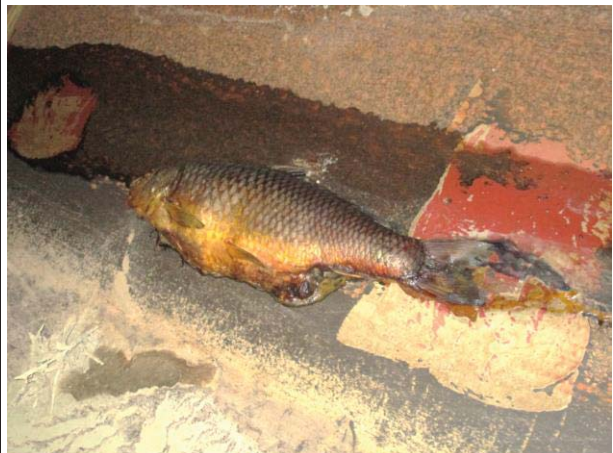
Figure D-63: Invert and wall condition near pipe segment 140.

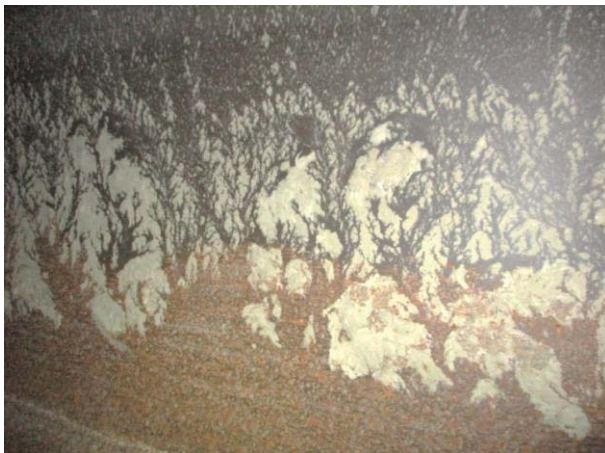
Figure D-64: Pipe invert condition near pipe segment 148.

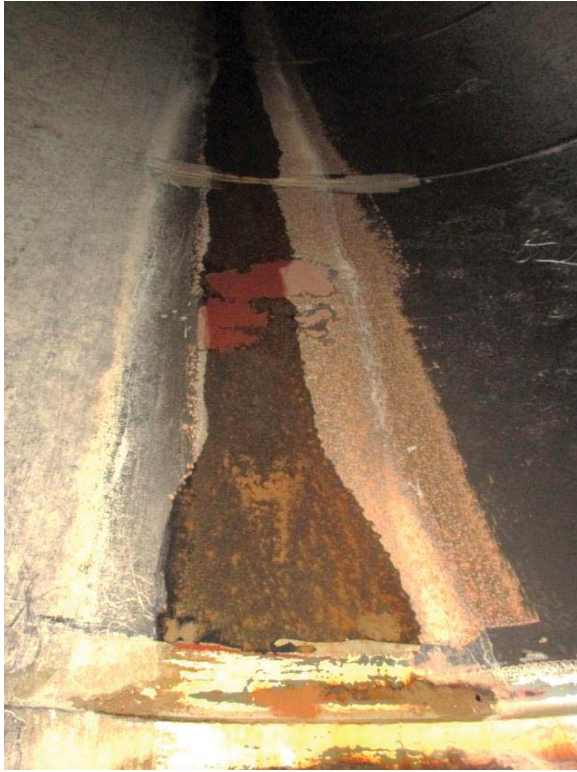
Figure D-65: General condition of the pipe walls and invert near segment 152. Commonly, one side of the wall would be covered with much more dried mud than the other.

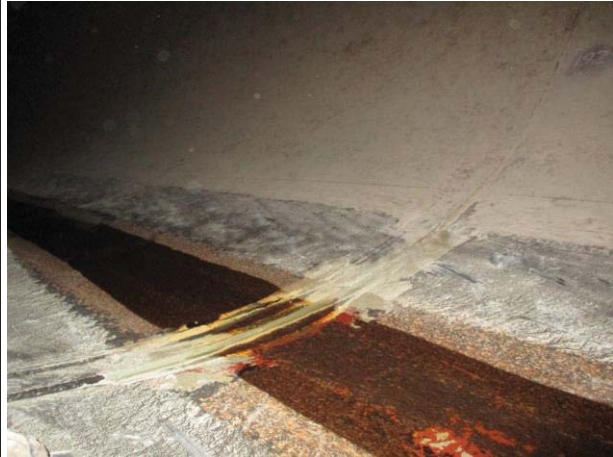
Figure D-66: General condition of the invert and walls near pipe segment 192. Severe corrosion and rust-through is visible in the invert.

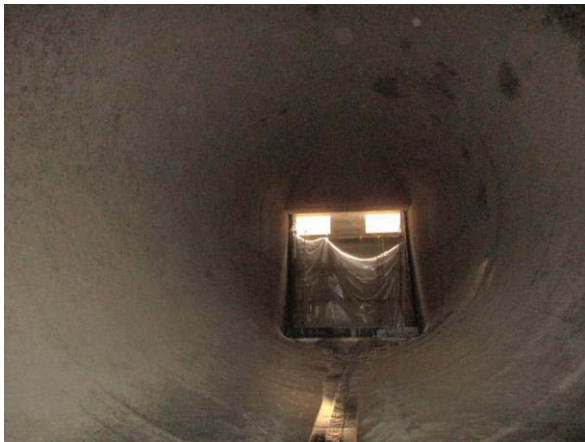
Figure D-67: View of the outlet from pipe segment 200.

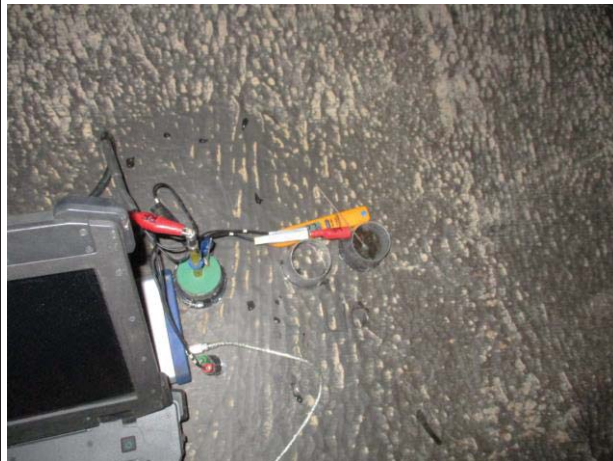
Figure D-68: EIS test cell set-up at pipe segment 200. The coating is riddled with defects, visible at right. Segment 200 had among the worst EIS results of all tested segments.

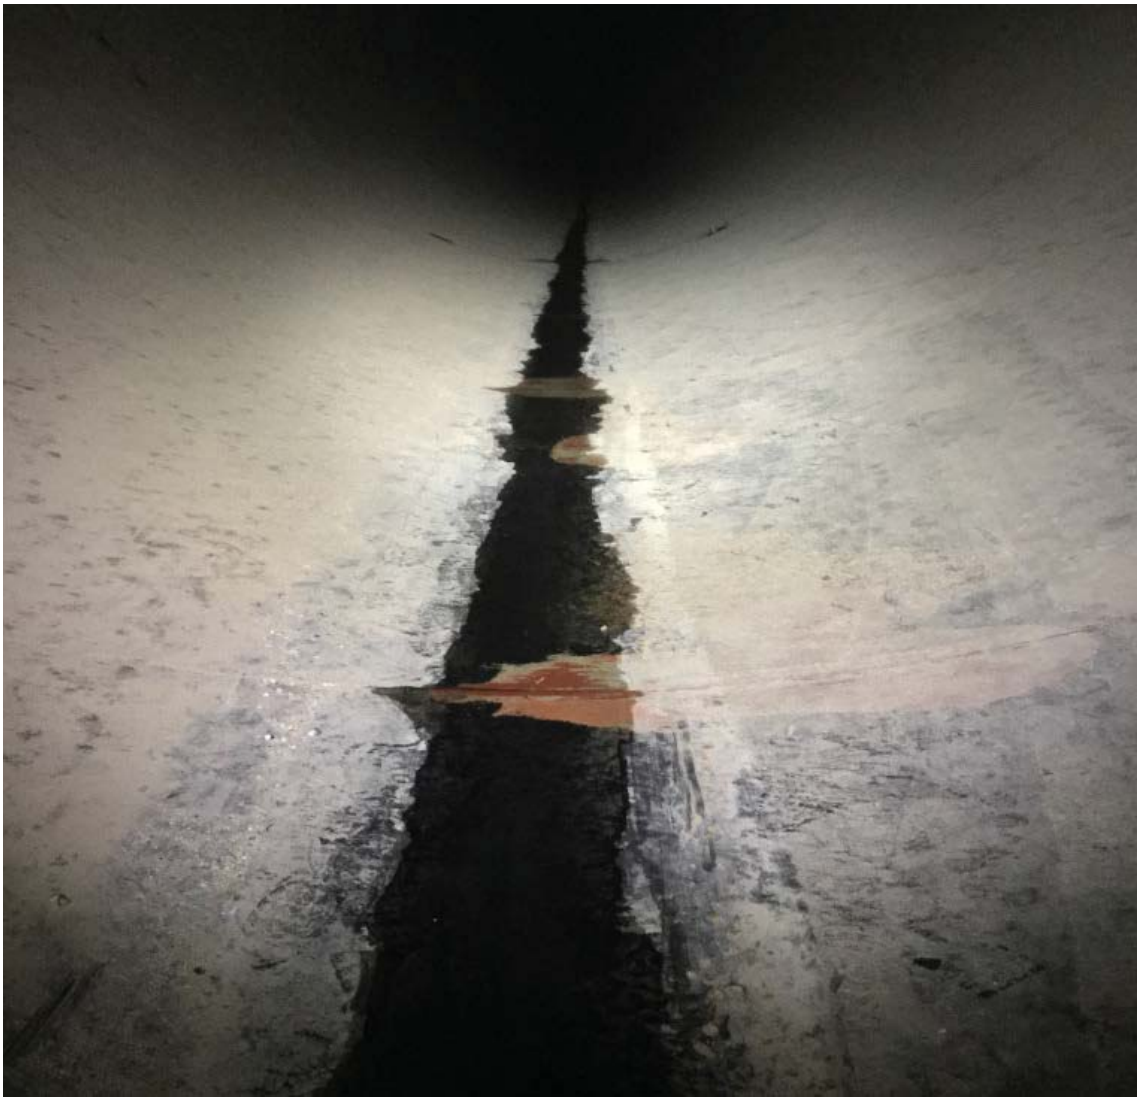
U.S. Department of the Interior  
Bureau of Reclamation

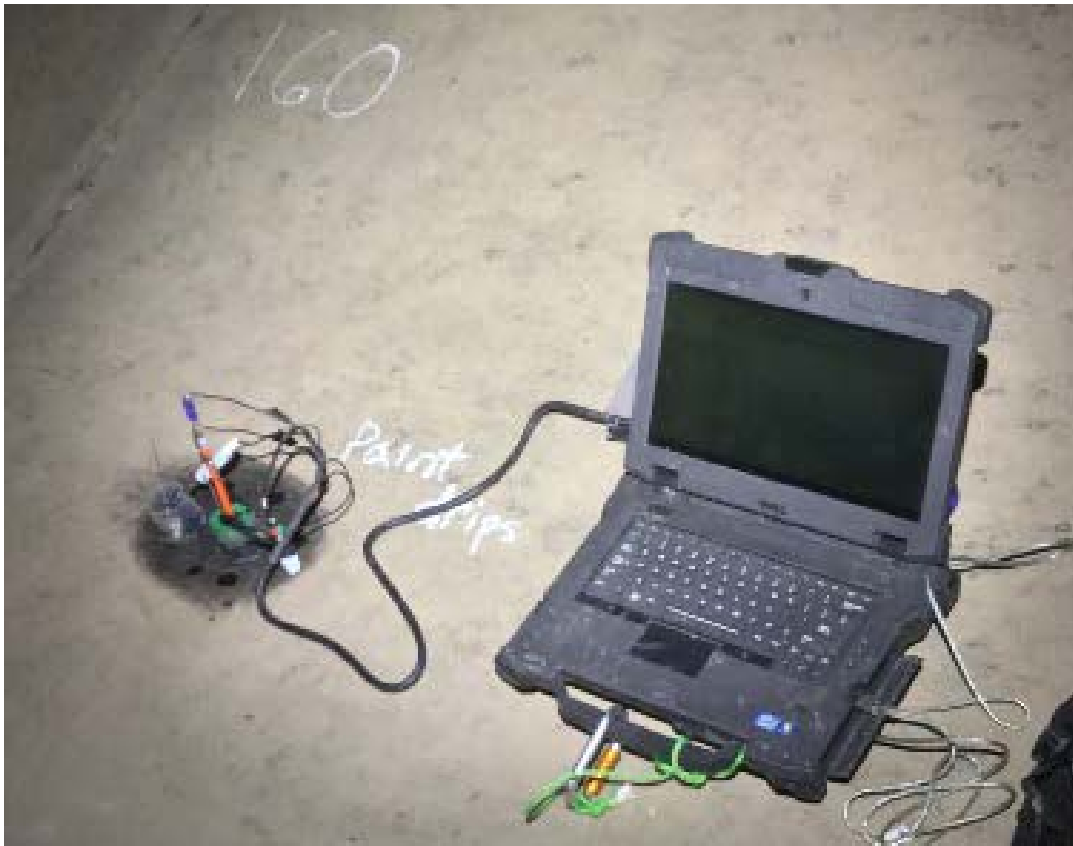
**Figure 1. Typical EIS set-up during measurement at pipe segment 160 with ruggedized laptop connected to a portable potentiostat (not shown, behind the laptop).**

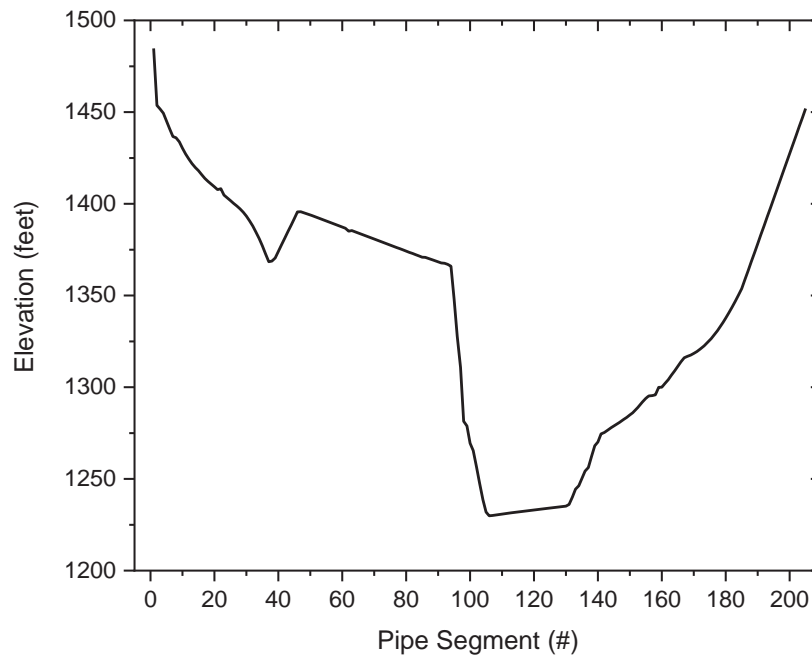
**Figure 2. Siphon elevation profile.**
