— BUREAU OF —  
RECLAMATION

# Field Validation of Impedance Spectroscopy Coating Assessments

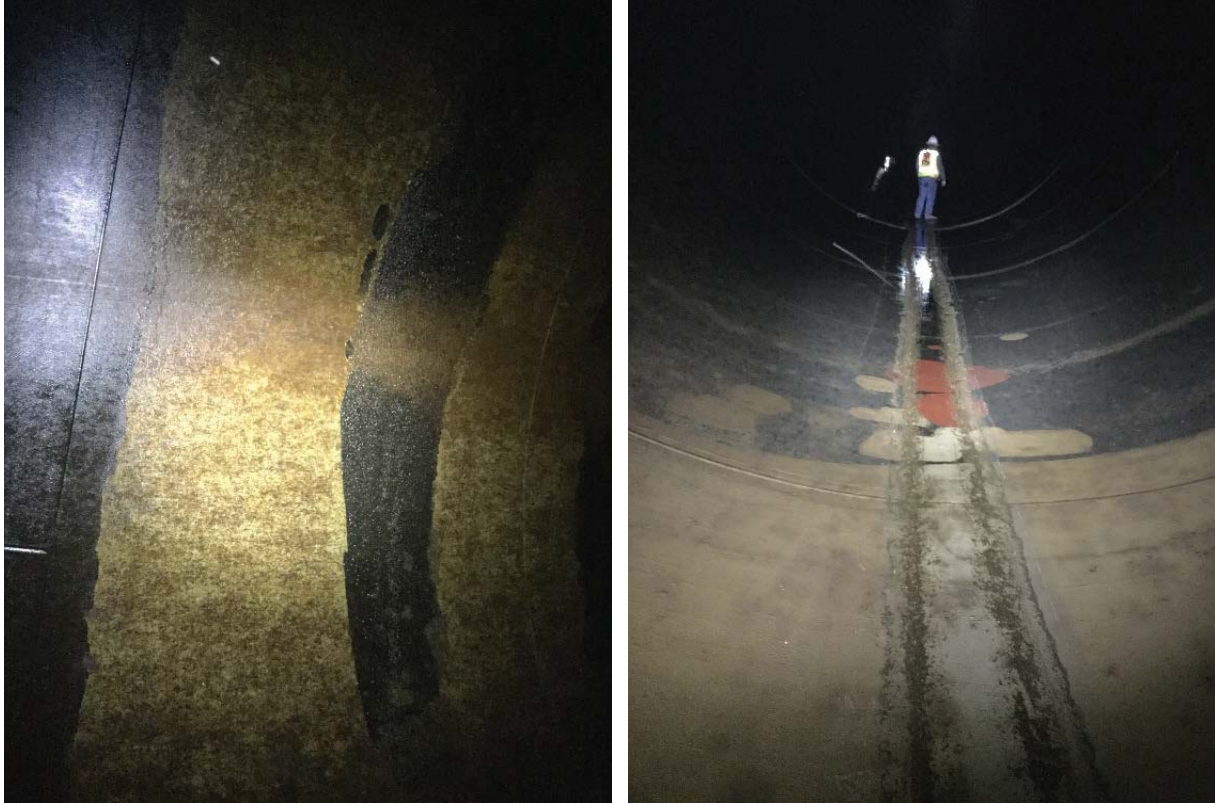
**Figure 3: Pipe wall and joint repairs near pipe segment 4 are in good condition (left). Abrasion of repair material in the invert was commonly found throughout the siphon (right).**

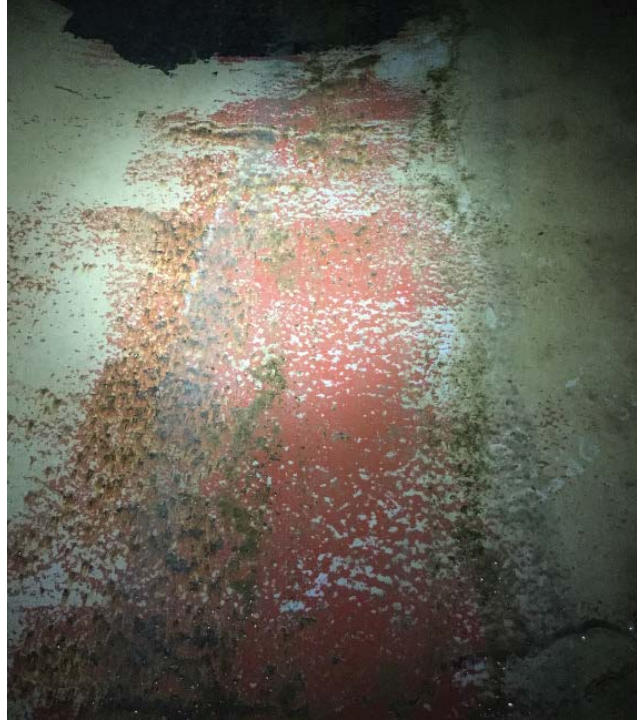
**Figure 4: Large area of abraded repair material and corrosion in the invert near pipe segment 12.**

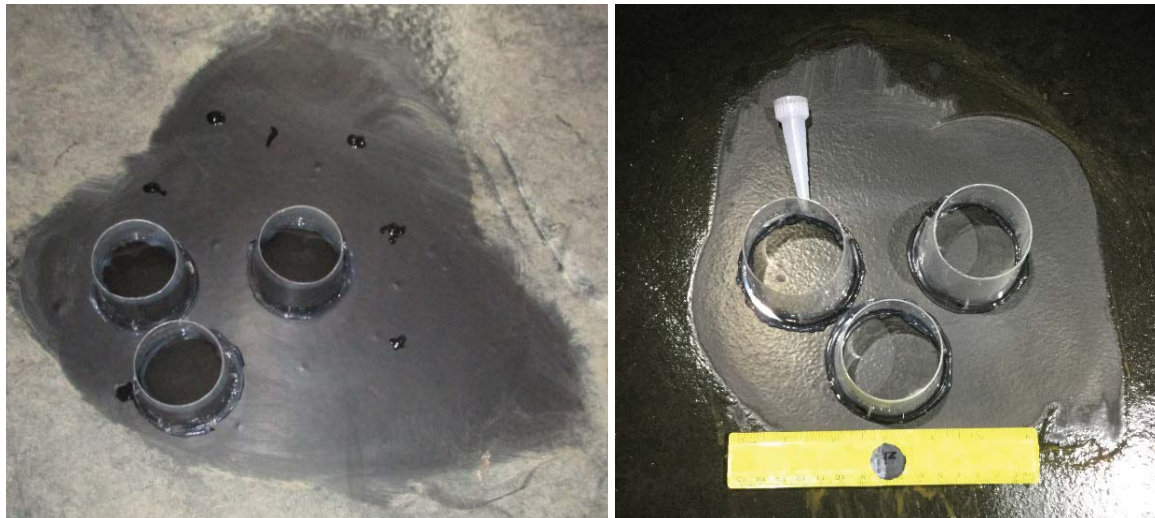
**Figure 5: Coating condition at pipe segment 40 (left) and 48 (right). Small blisters are visible in the coating around the test cells at segment 40. UT coupling fluid is seen around the blisters.**

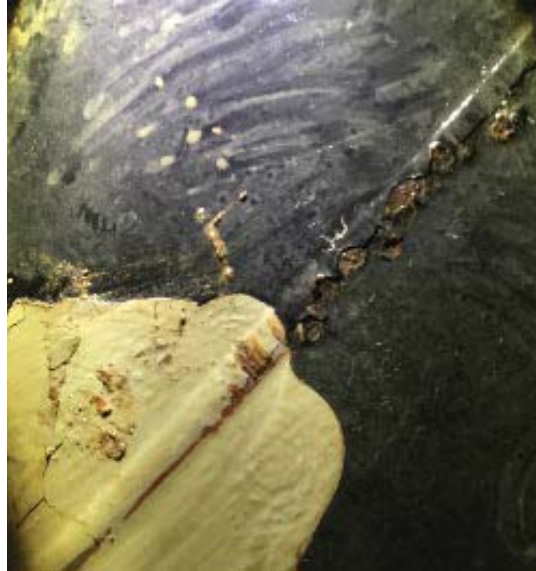
**Figure 6: Corrosion near pipe segment 80 at a joint interface directly above repair material (white).**

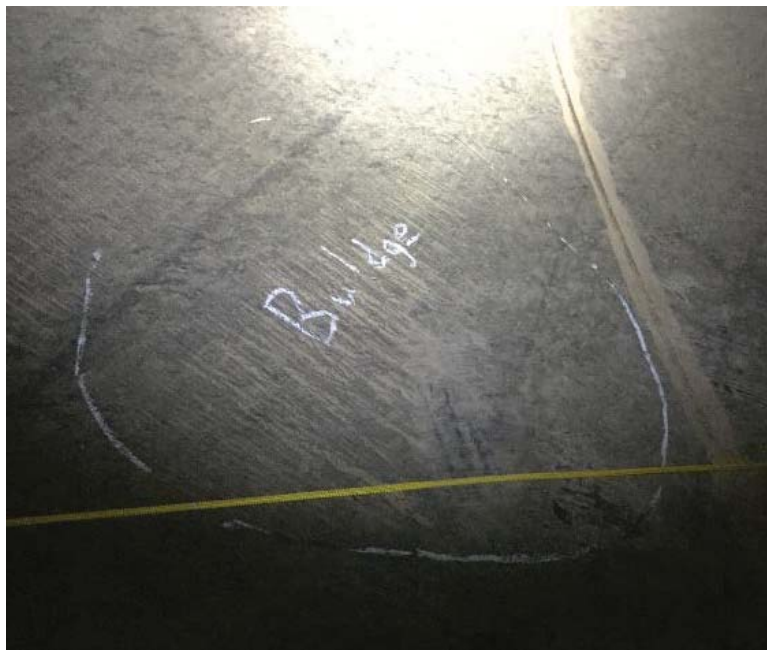
**Figure 7: 2'x2'x6" bulge found on the left-hand wall of pipe segment 95.**

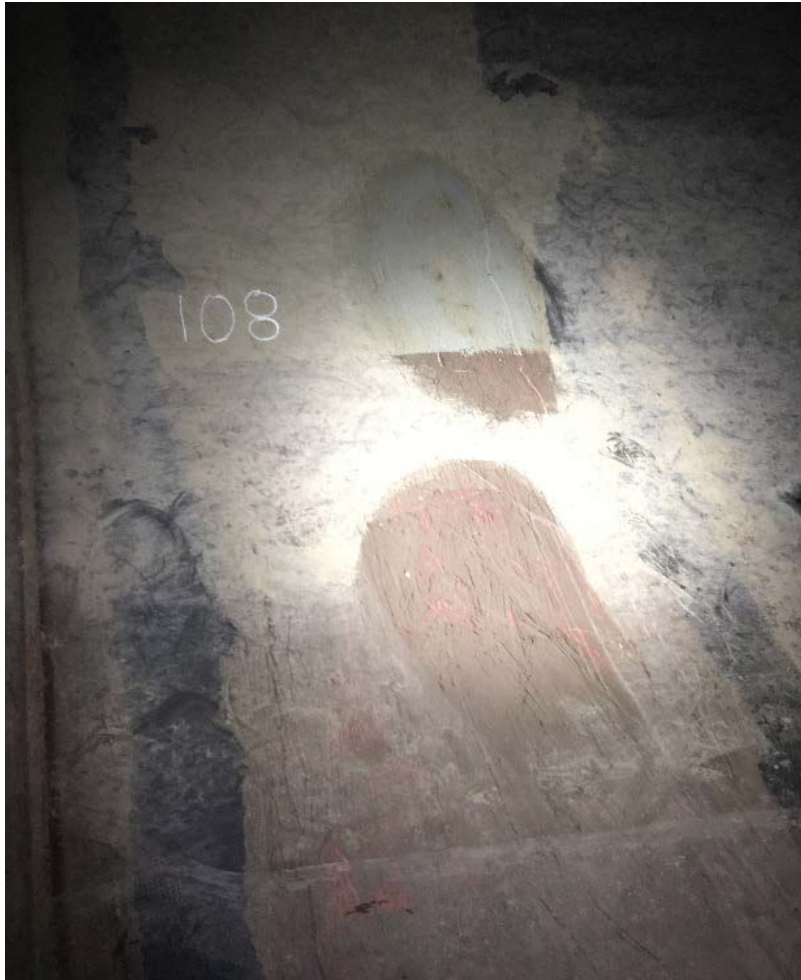
**Figure 5: Intact repair material at pipe segment 108.**

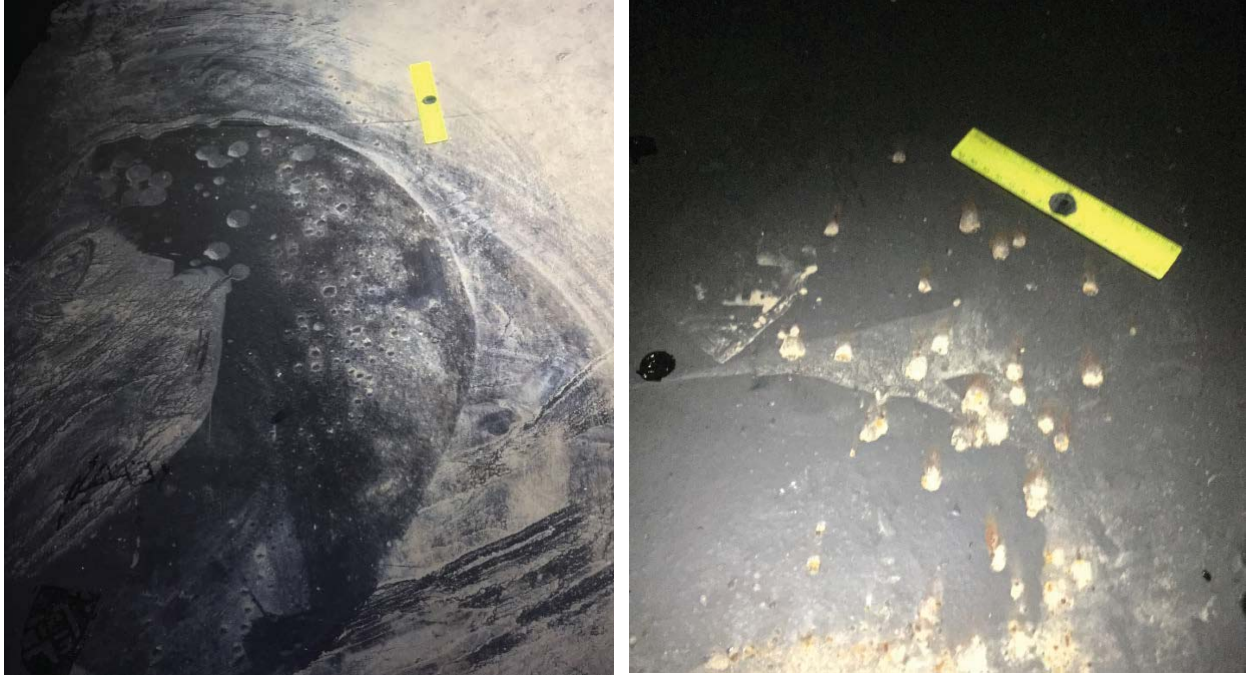
**Figure 6: Large blisters near pipe segment 136 (left) and pitting near pipe segment 140 (right).**

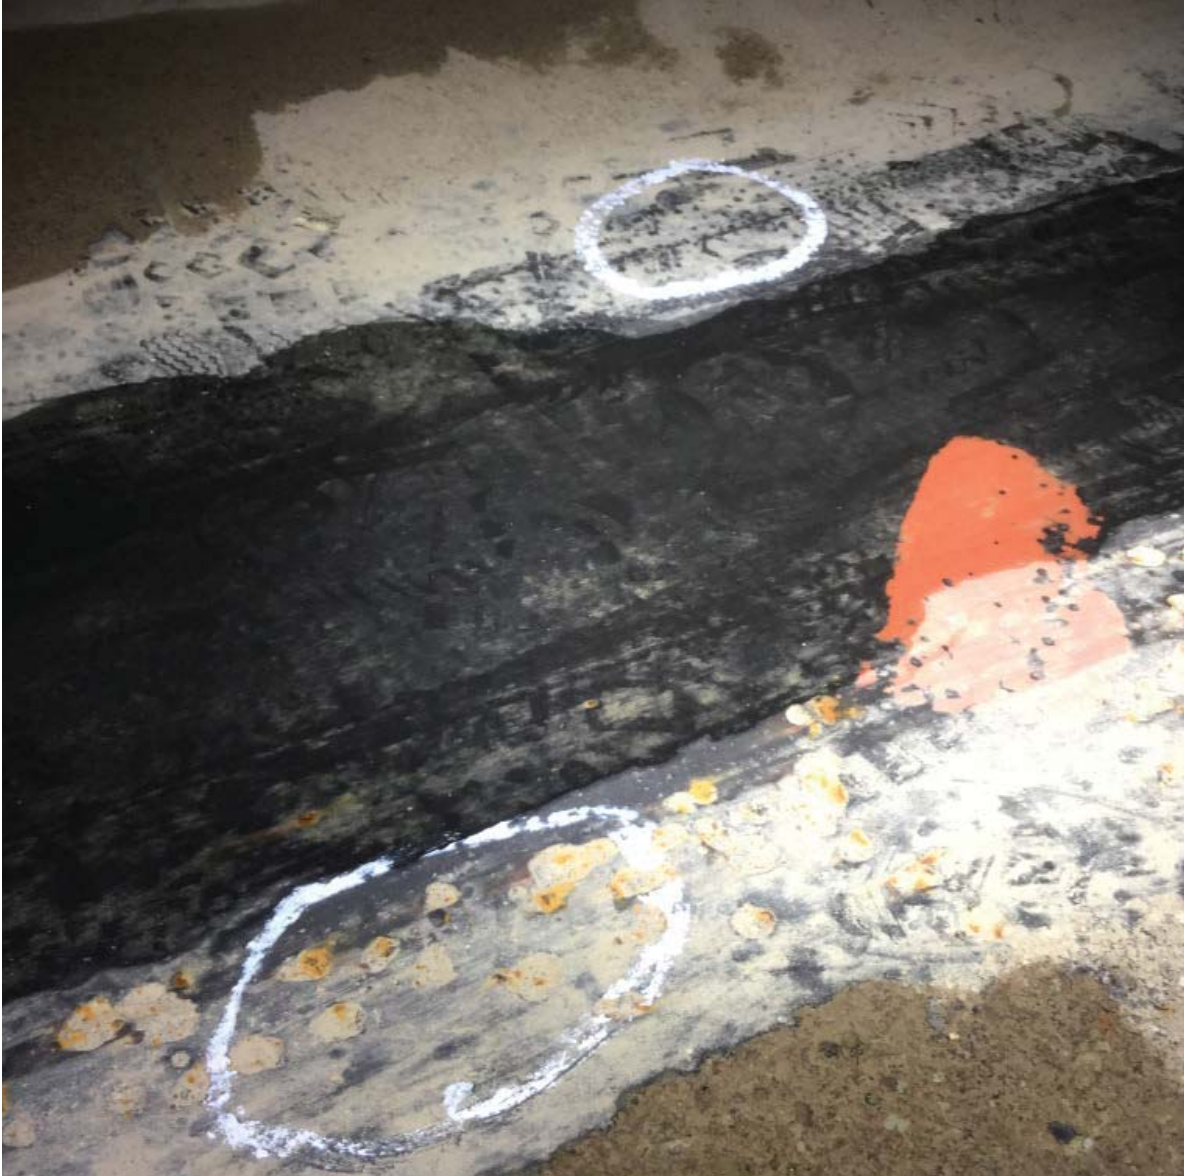
**Figure 7: Highly abraded repair material on either side of the invert near pipe segment 144. Pitting is on the left and blisters are on the right of the invert.**

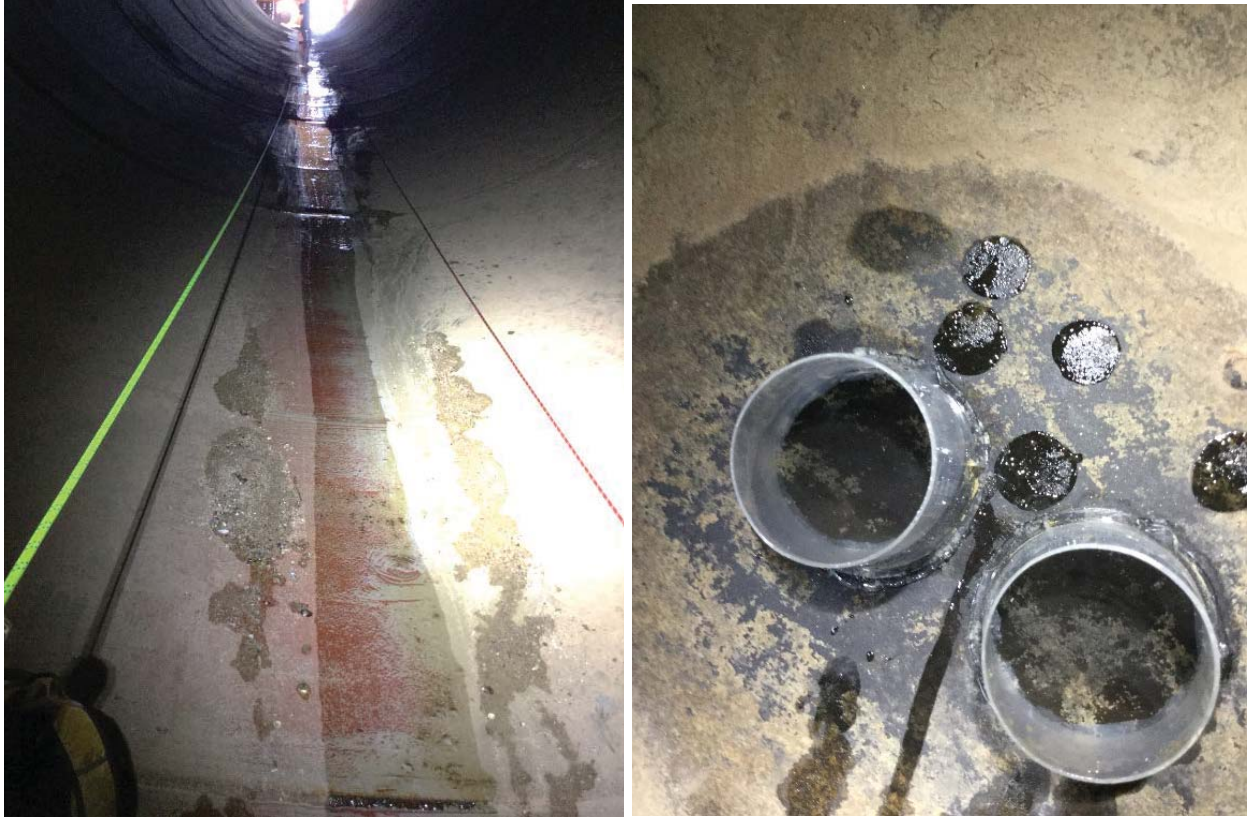
**Figure 8: Abraded repair coating visible in the invert with mud and sediment nearby (left). Rough coating visible with tightly adherent mud at an EIS test location at pipe segment 180 (right).**

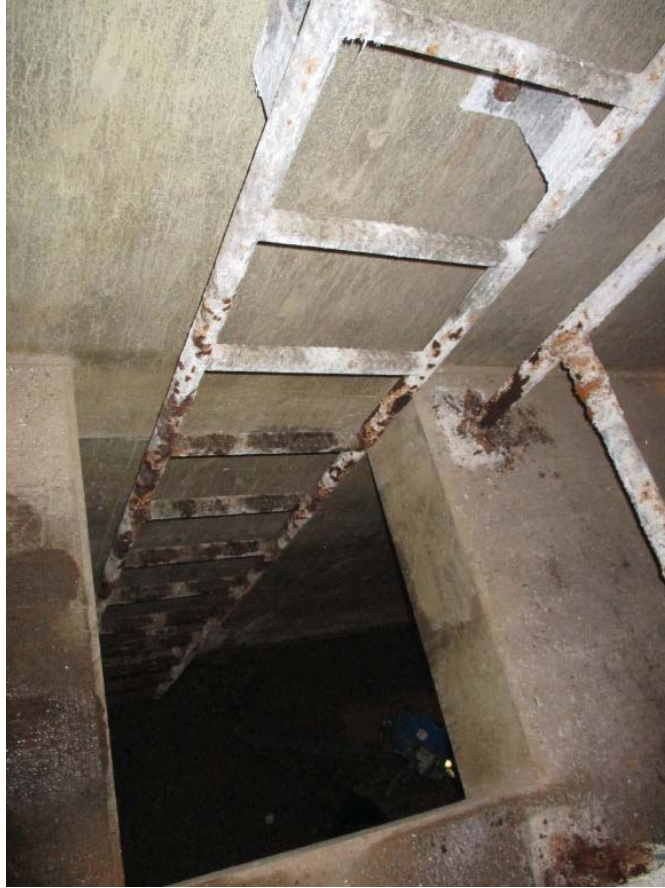
**Figure 9: Severe corrosion on the ladder, bolts, and guardrail in the access point leading to the deep well.**

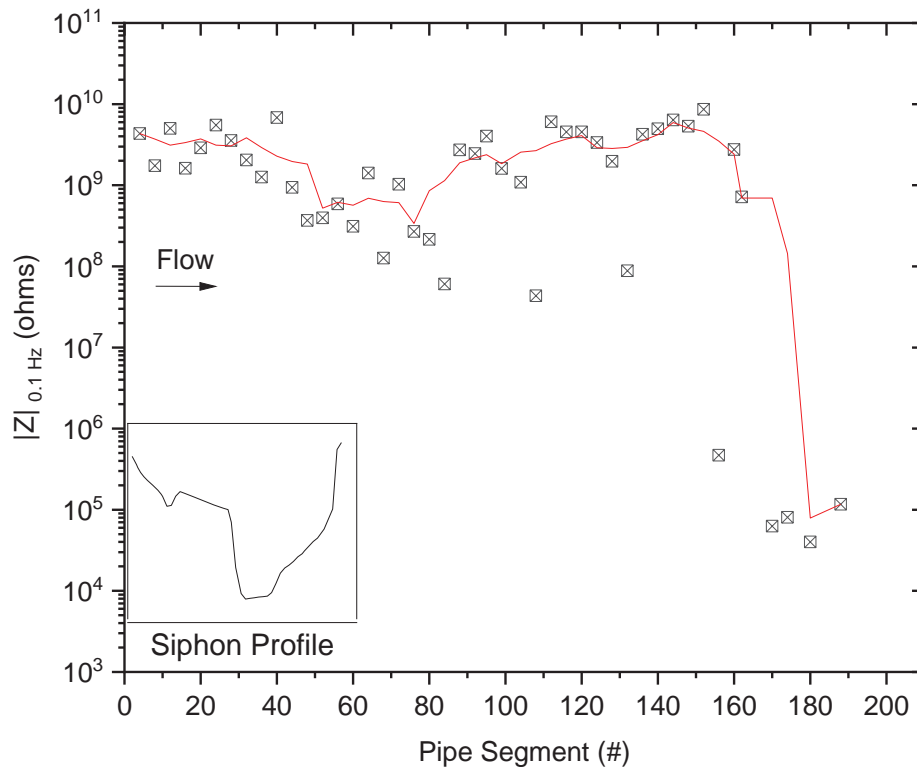
**Figure 10. Overall corrosion protection at each pipe segment per EIS testing results with a 5-point adjacent averaging trendline included and siphon elevation profile inset.**

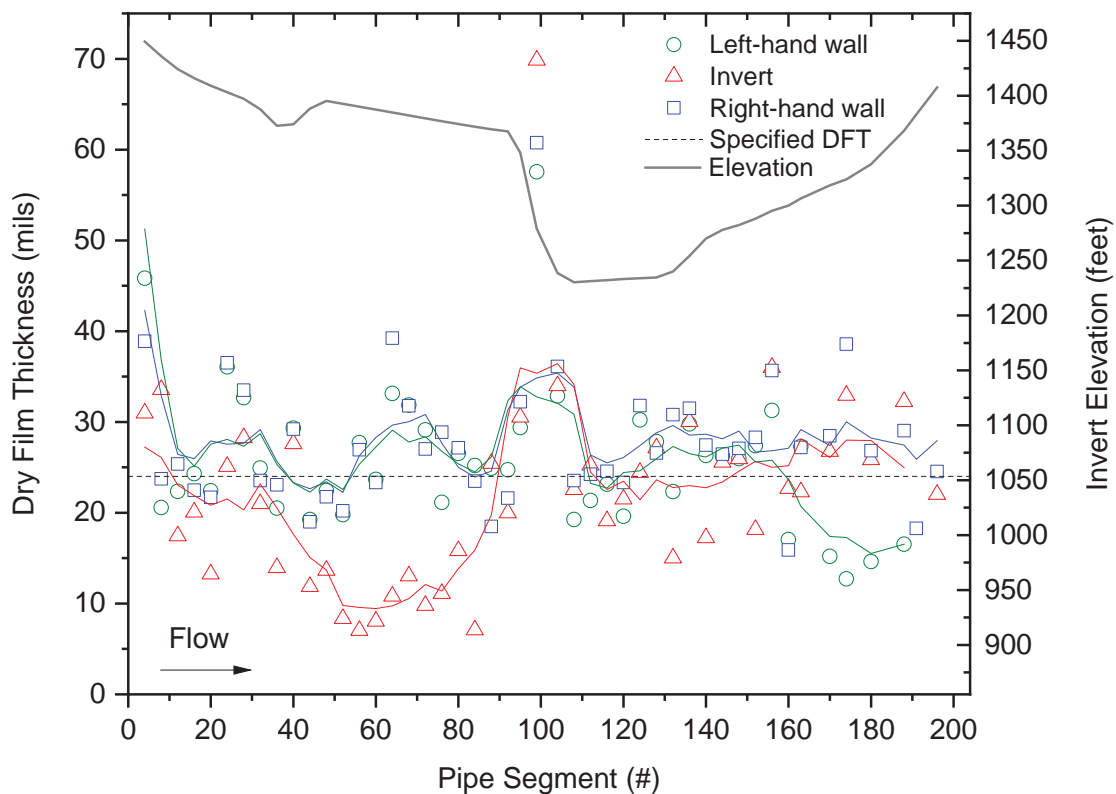
Figure 11. Average DFT at each pipe segment, measured at invert and each wall with a line indicating 80% of the specified DFT and siphon invert elevation profile inset.

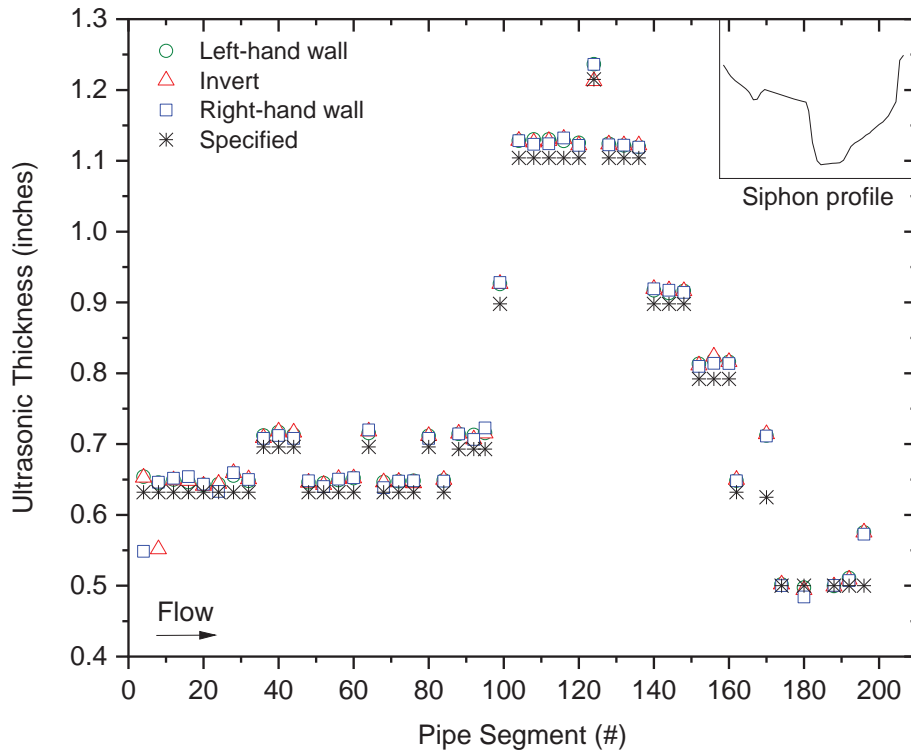
**Figure 12. Average UT at each pipe segment, measured at invert and each wall, with specified values also shown and the siphon elevation profile inset.**

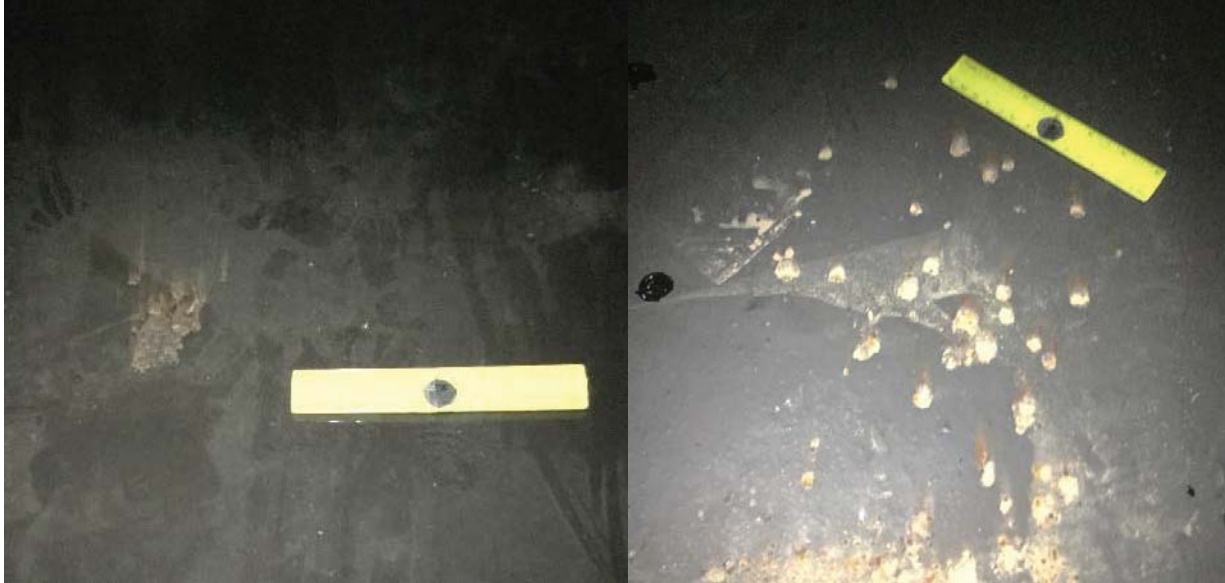
**Figure 13: Areas of pitting near pipe segment 60 (left) and 140 (right).**

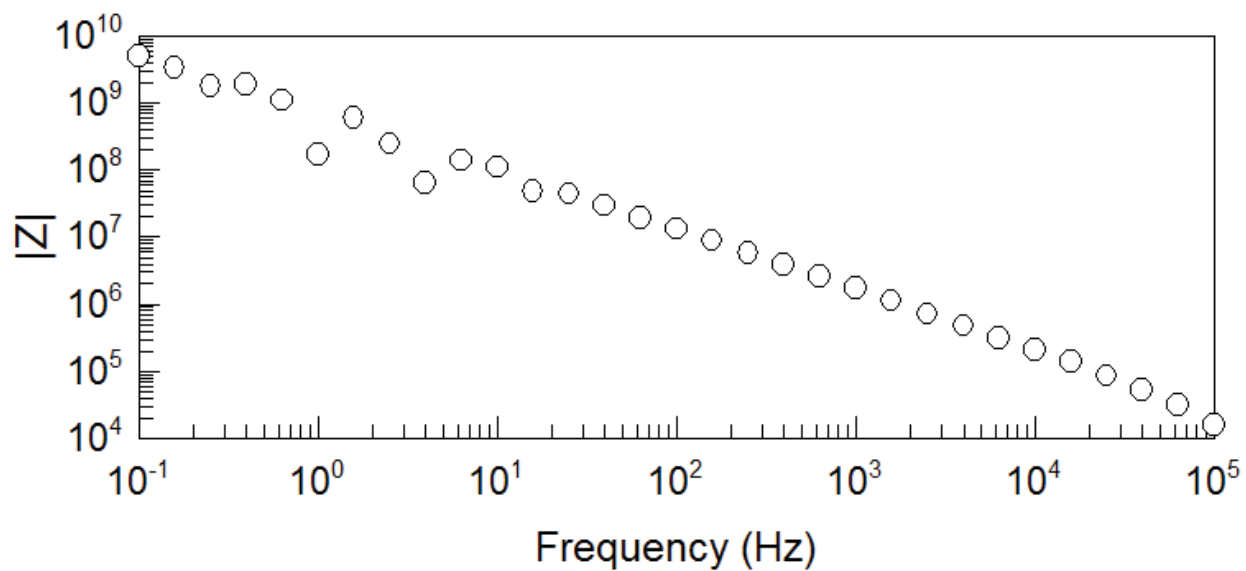
Figure A-3: EIS Bode plot from pipe segment 12, coal tar epoxy.

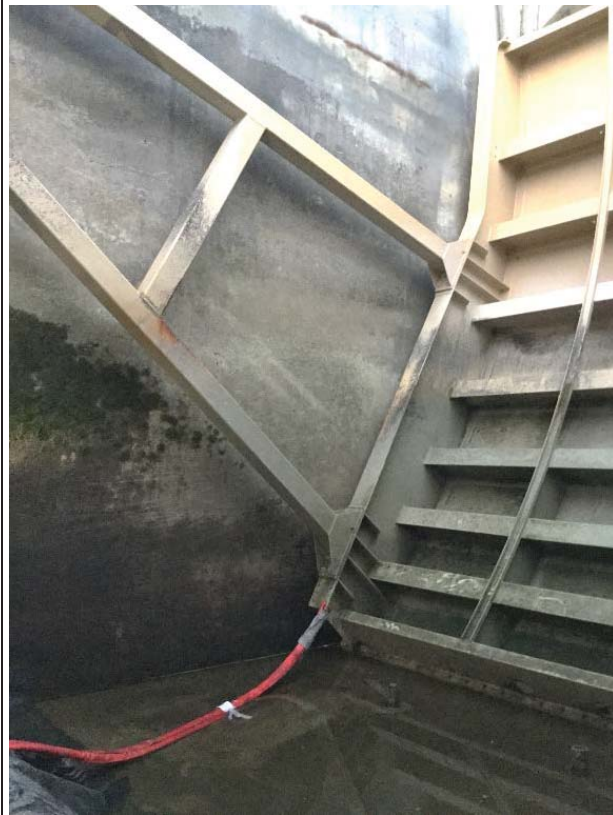
Figure D-3: Small amounts of corrosion visible on the radial gate arm near the inlet of the [redacted]

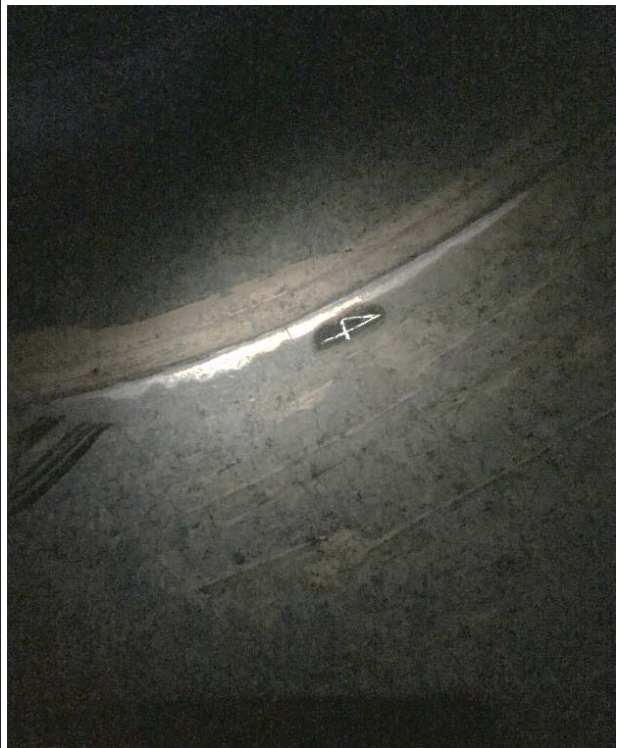
Figure D-4: Pipe segment 4. Image of pipe wall and joint; joint contains repair material.

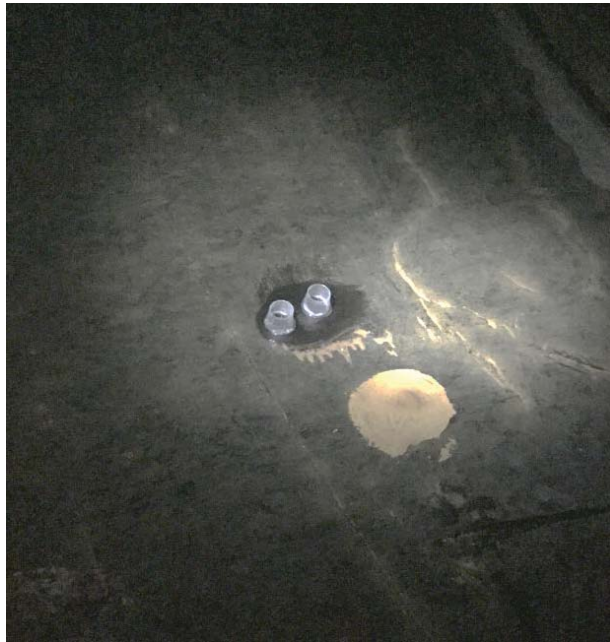
**Figure D-5: Pipe segment 4. EIS cups set above a circular area of Devgrip 238 repair.**

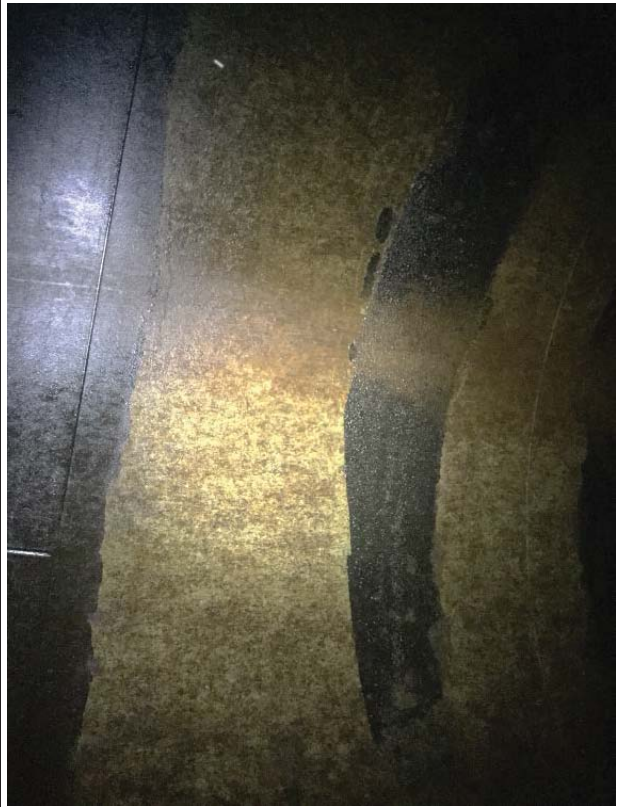
**Figure D-6: Near pipe segment 4. Image of pipe joints repaired with Devgrip 238. Repair material appears to be in good condition.**

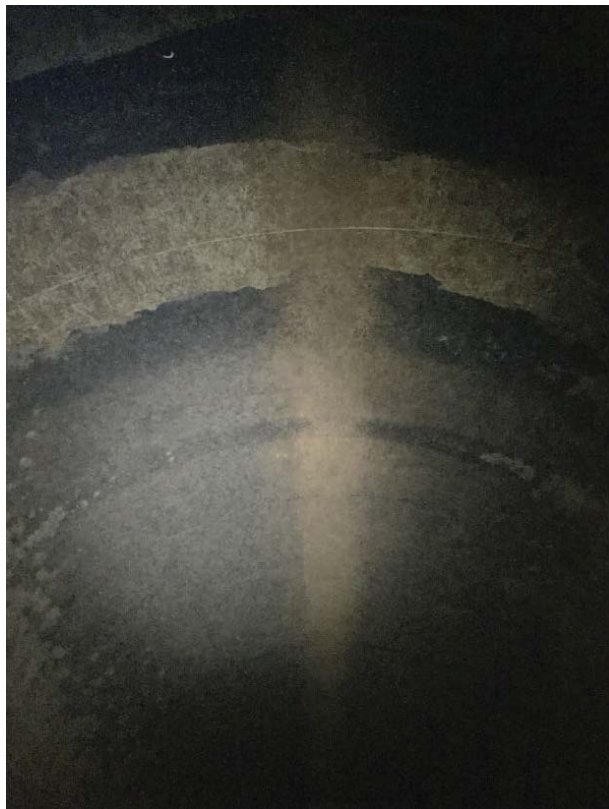
**Figure D-7: Near pipe segment 4. Image shows repair material along the pipe joint in the pipe's crown.**

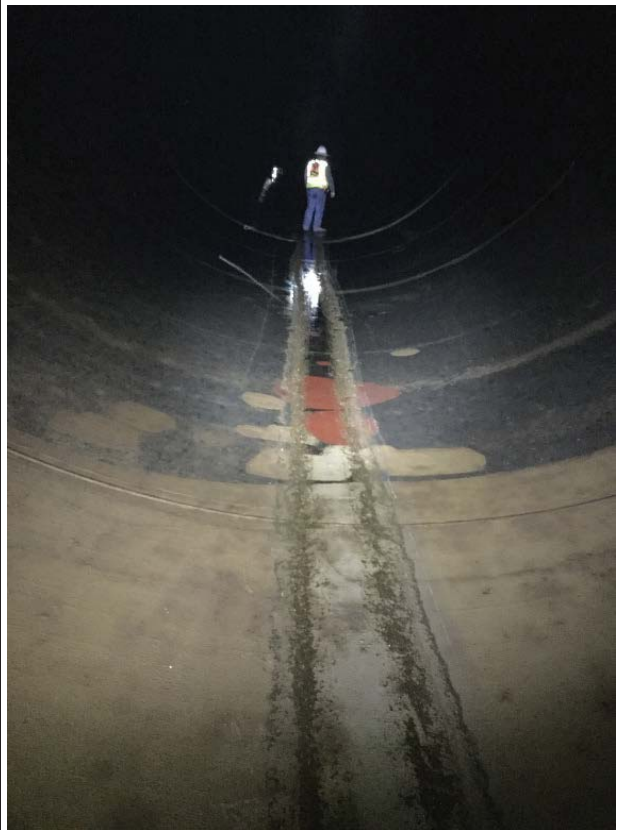
**Figure D-8: Near pipe segment 4. Image of repairs in the invert. In some areas, the top coat (grey) of the repair material had been omitted when doing the repair.**

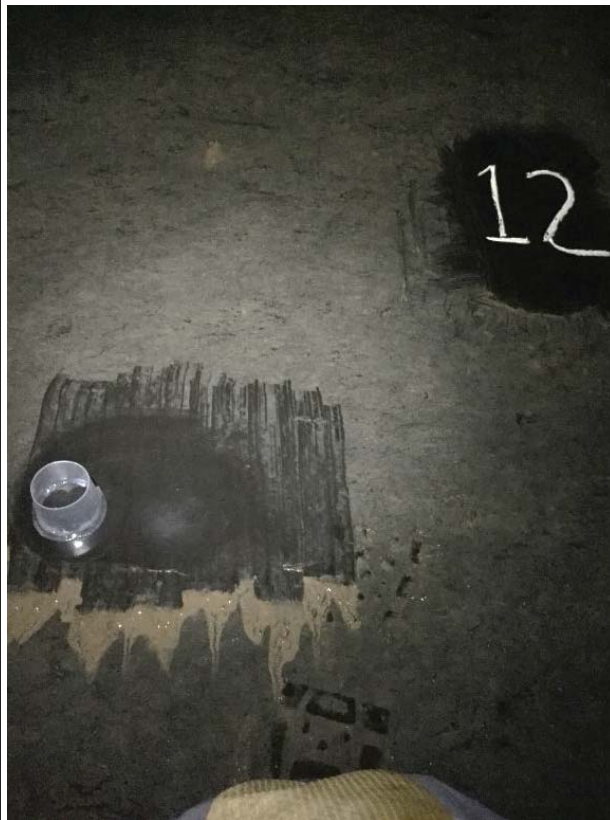
**Figure D-9: EIS test cell set-up at pipe segment 12.**

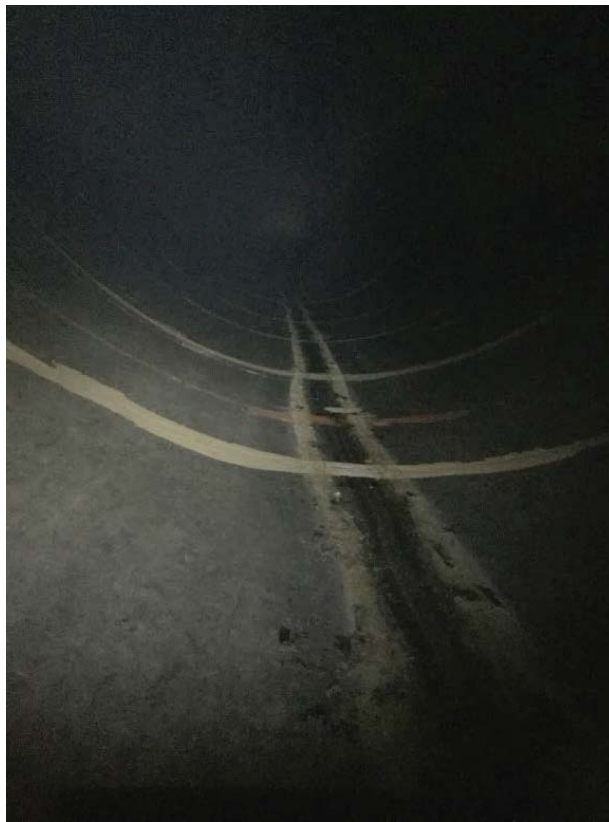
**Figure D-11: Pipe segment 12. Image of the invert and pipe wall. Joint and invert repairs are visible.**

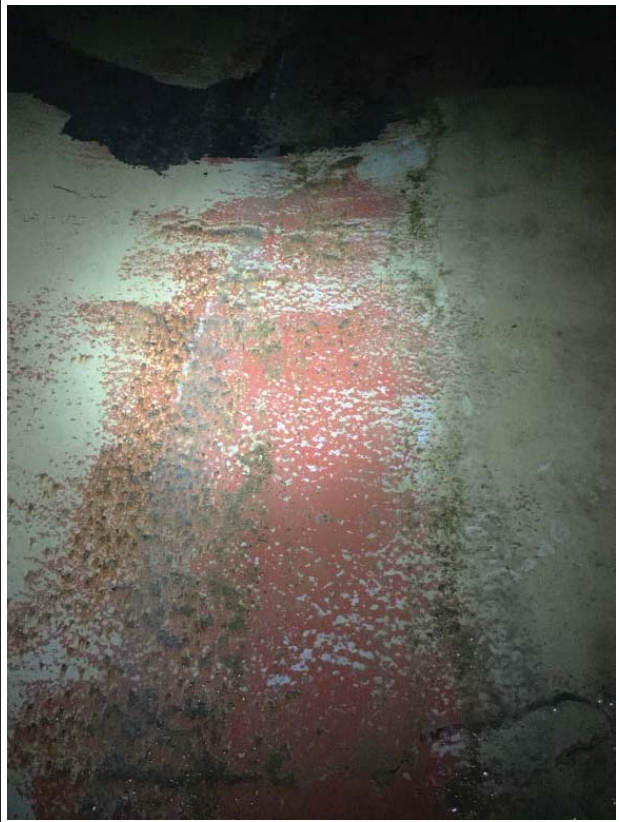
**Figure D-12: Area of abraded repair material and corrosion in the invert near pipe segment 12.**

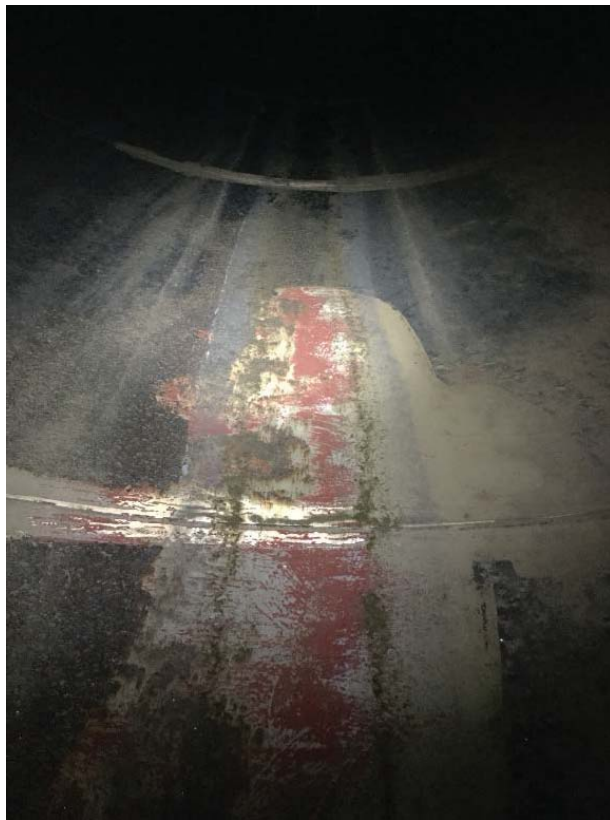
**Figure D-13: Area of abraded repair material and corrosion in the invert near pipe segment 12.**

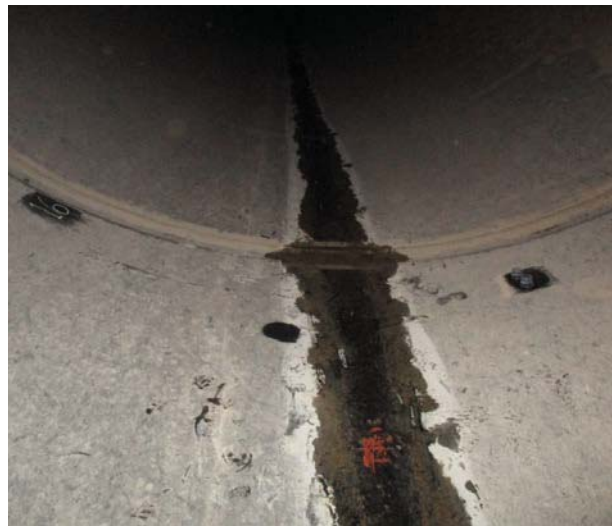
**Figure D-14: Pipe segment 16. Image of the invert and EIS test cell set-up.**

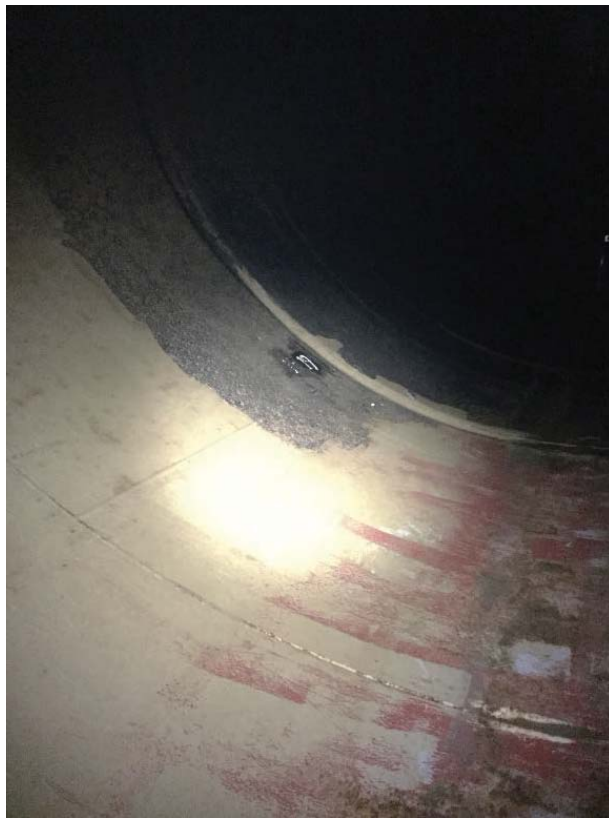
**Figure D-15: Invert and wall condition near pipe segment 19. Abraded Devgrip 238 is seen near the invert**

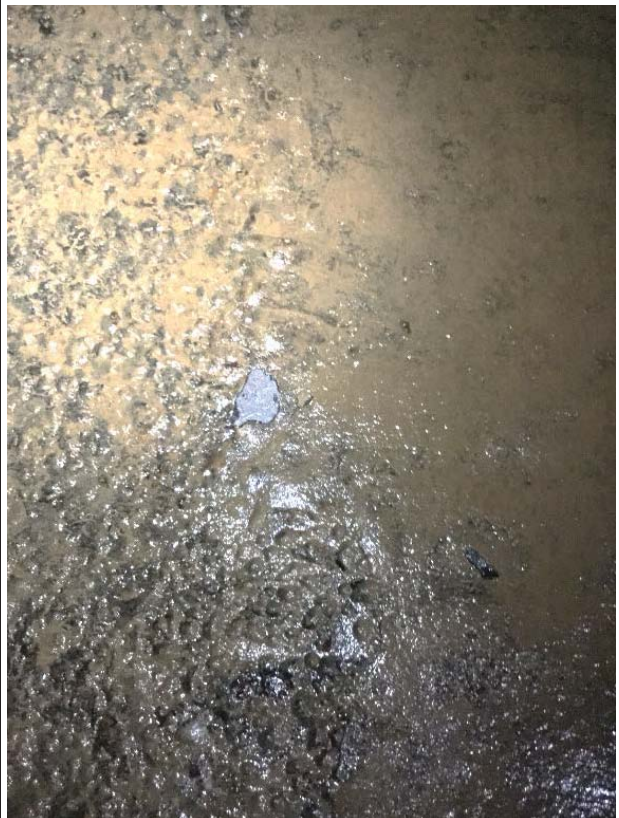
**Figure D-16: Bare steel visible in a portion of coal tar epoxy near pipe segment 19. Steel does not appear to be corroded.**

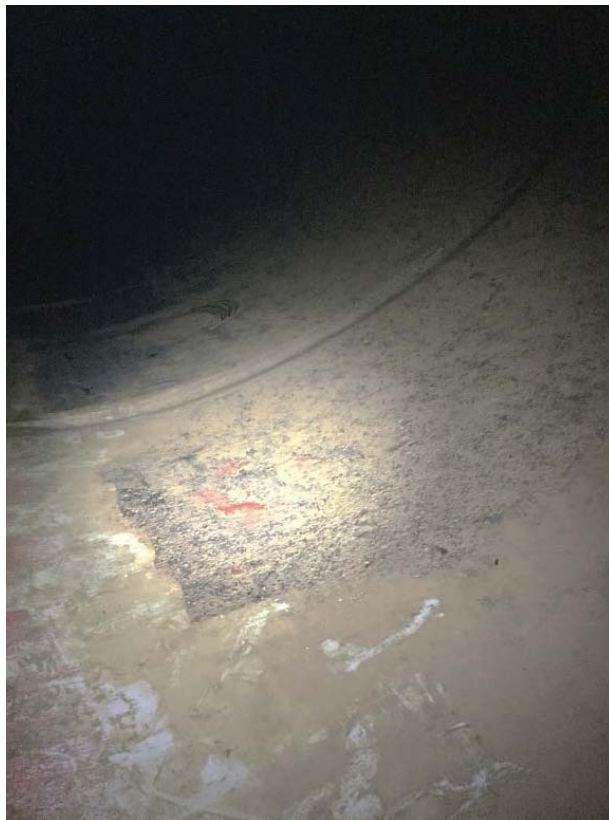
**Figure D-17: Pipe wall near segment 19. Repair material, mud, and coal tar epoxy are all visible.**

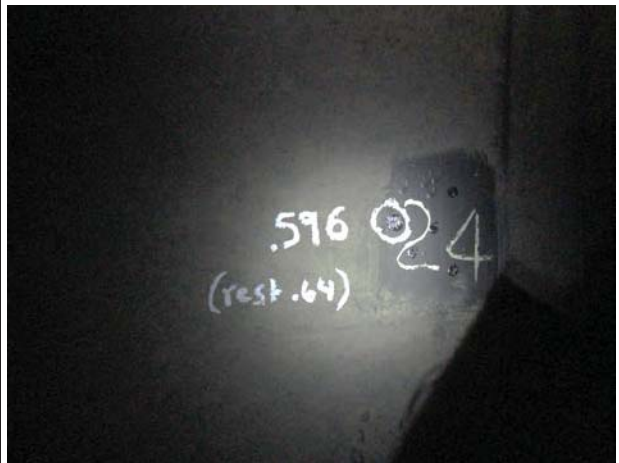
**Figure D-18: Record of UT measurements at pipe segment 24 highlighting one area of lower-than-expected wall thickness, 0.596-inch instead of 0.640-inch.**

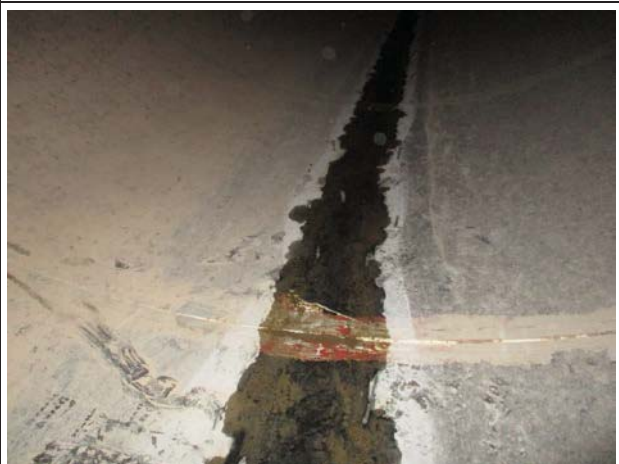
**Figure D-20: Near pipe segment 24. Image of a pipe joint as it crosses the invert. Repair material is abraded in the very center of the invert.**

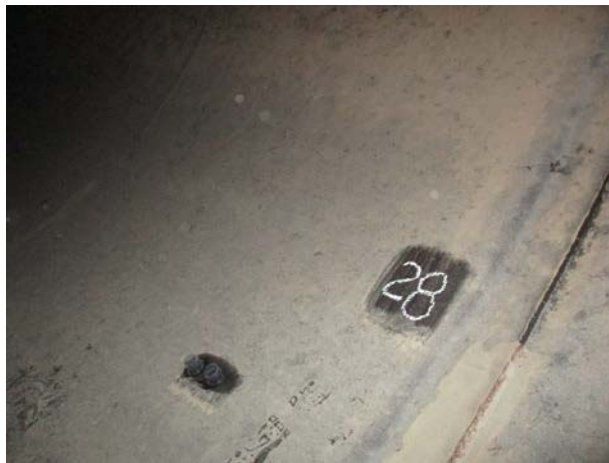
**Figure D-21: Pipe segment 28. Image of pipe wall, including joint. EIS test cell set-up is at bottom left.**

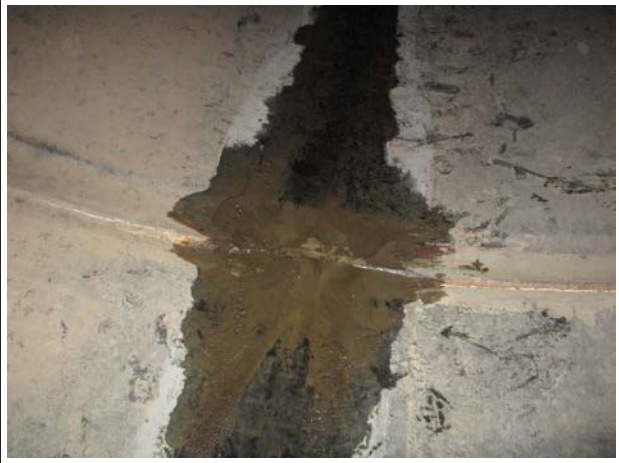
**Figure D-22: Near pipe segment 28. Image of a pipe joint crossing the invert. Mud and other sediment has accumulated in the joint resulting in abrasion to the repair material.**

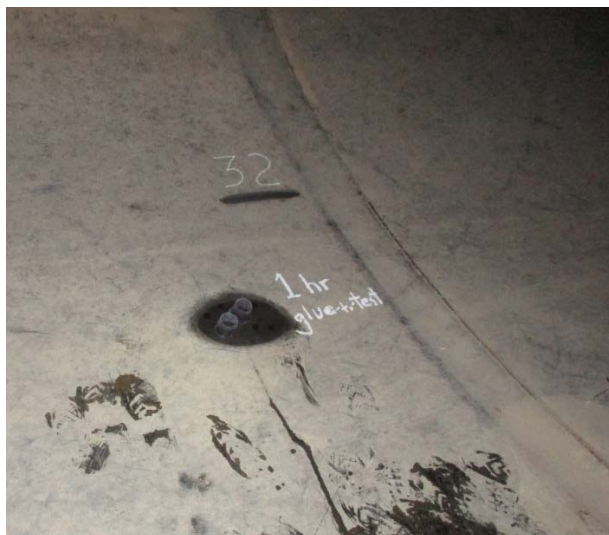
**Figure D-23: Pipe segment 32. Image of pipe wall and EIS test cell set-up. At this location, the EIS test time was 1 hour, from gluing the test cells to test completion.**

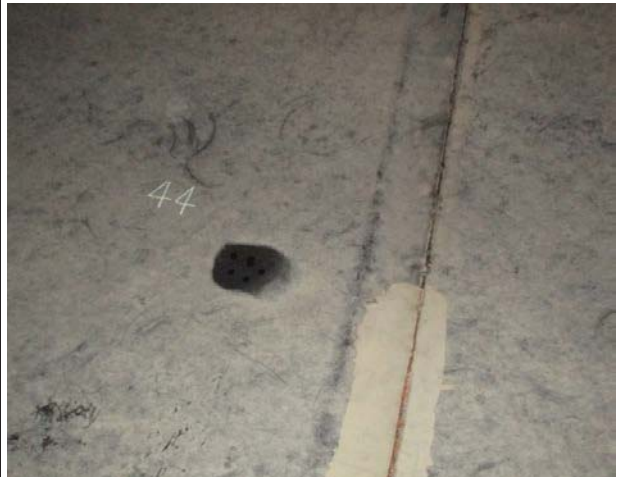
**Figure D-28: Wall and joint condition of pipe segment 44. Repair material is seen a few feet up the wall of the pipe. Corrosion is visible in the interface between the two pipe sections.**

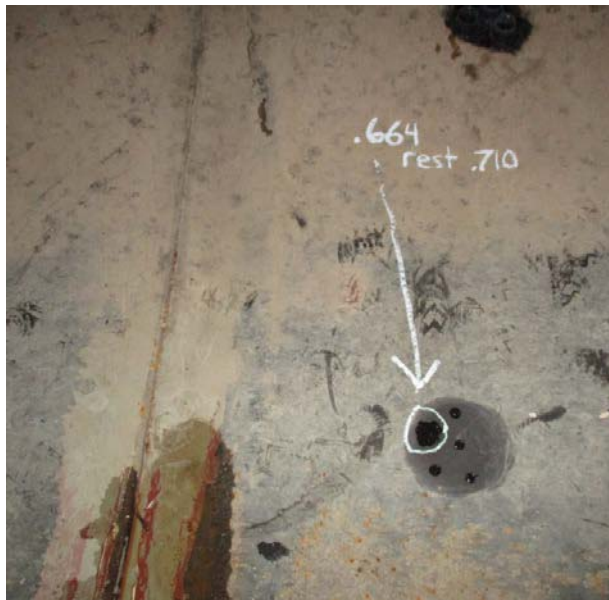
Figure D-29: UT measurements near pipe segment 44; circled measurement area is 0.664 inch and all others are 0.710. Abraded repair coating is visible at the pipe joint at bottom left.

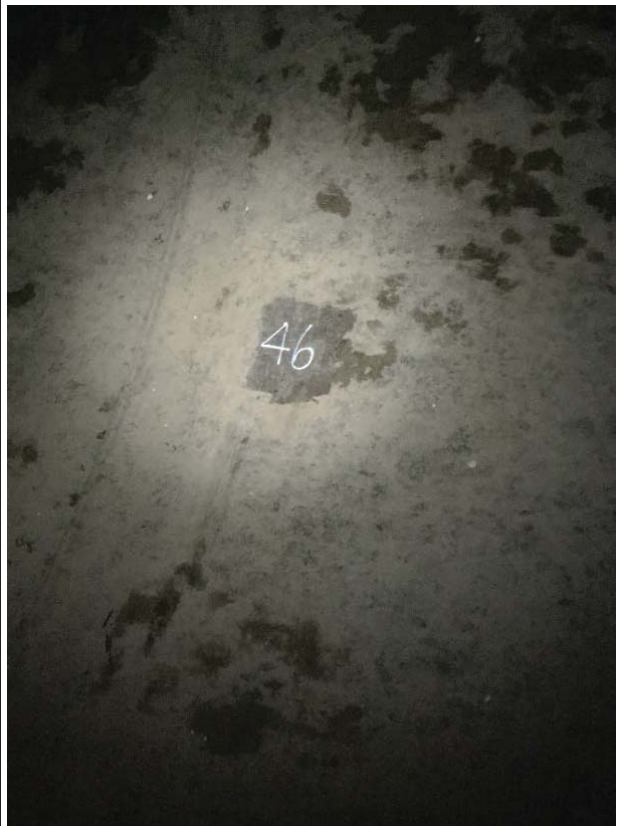
Figure D-30: Pipe segment 46. Pipe wall is covered with mud and sediment.

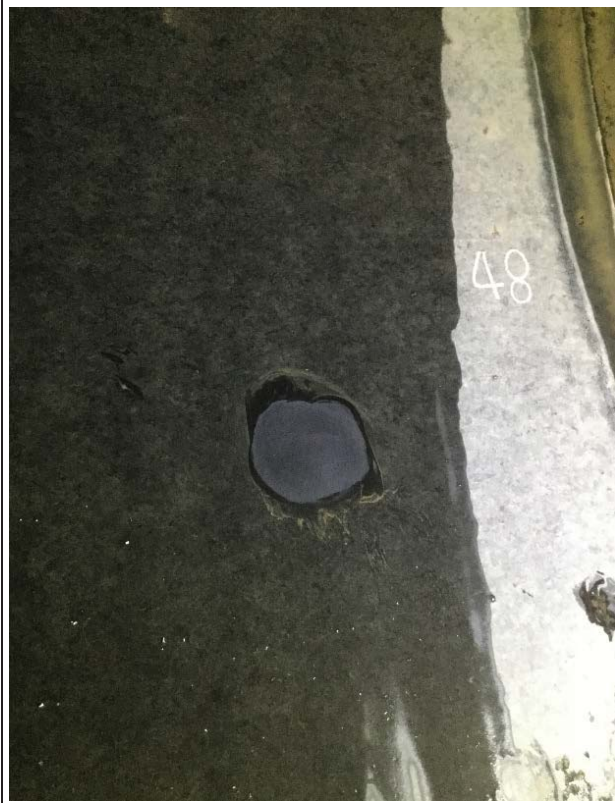
**Figure D-31: Pipe segment 48. Coal tar epoxy looks to be in excellent condition.**

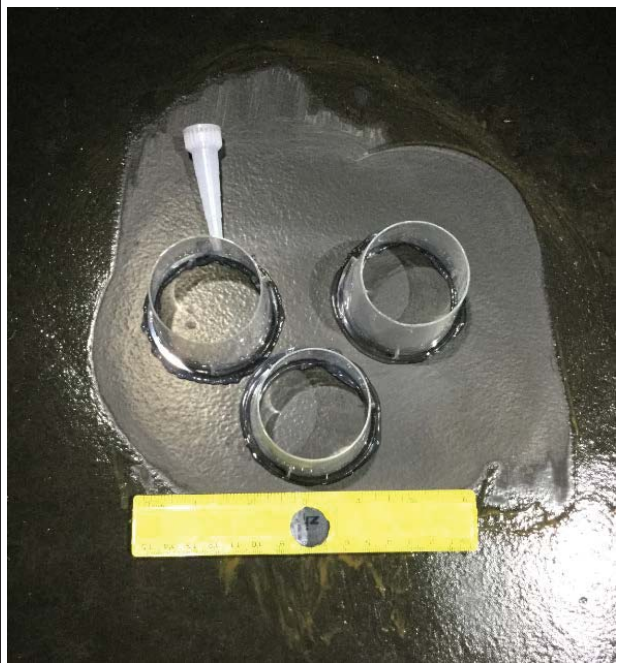
**Figure D-32: EIS test cell set-up at pipe segment 48. Coal tar epoxy has an orange-peeled surface.**

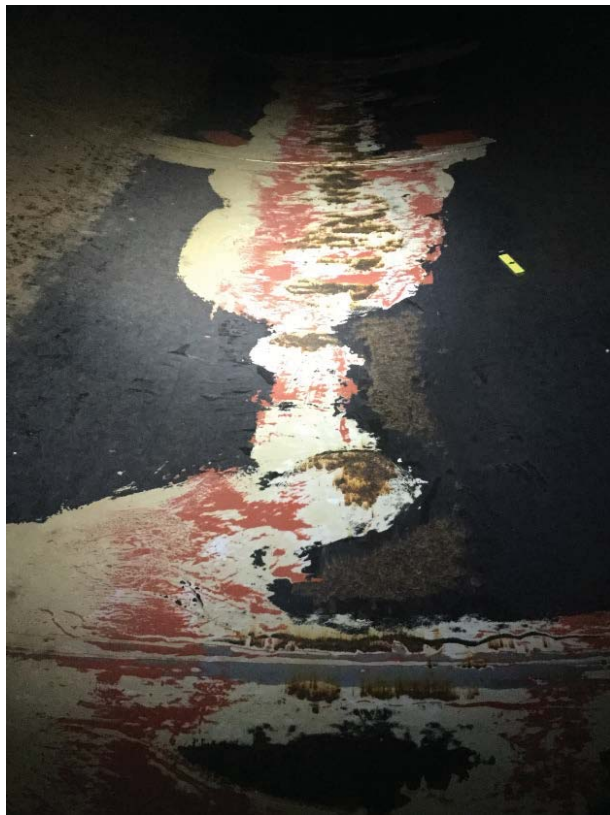
**Figure D-33: Near pipe segment 48. Image of pipe invert. The repair material is highly abraded with areas of corrosion throughout the invert.**
