— BUREAU OF —  
RECLAMATION

# Field Validation of Impedance Spectroscopy Coating Assessments

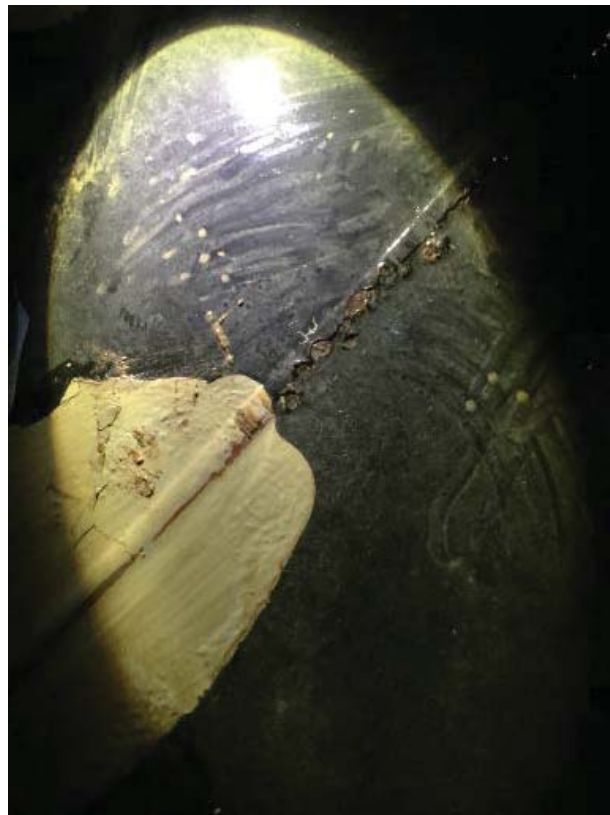
**Figure D-34: Areas of corrosion adjacent to repair material on a pipe joint near pipe segment 48.**

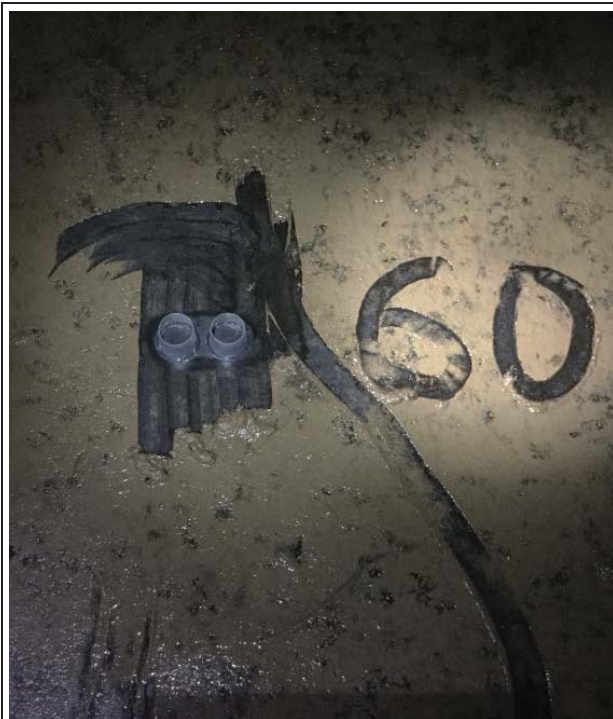
**Figure D-35: EIS test cell set-up at pipe segment 60. Thick mud was prevalent through this area.**

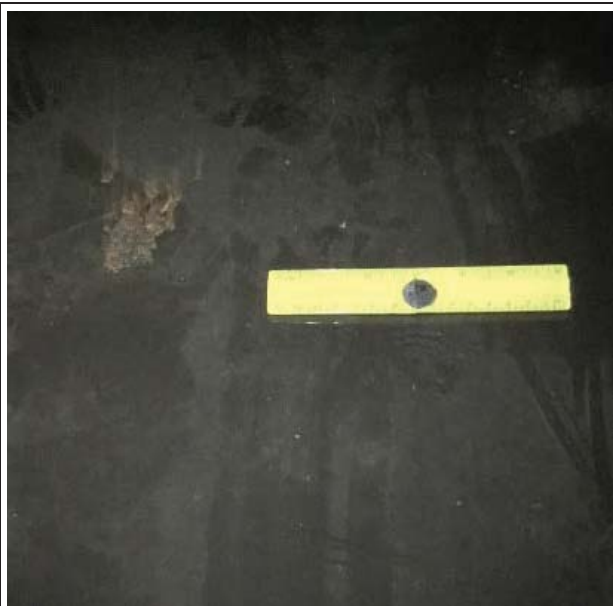
**Figure D-36: Isolated area of corrosion near pipe segment 60.**

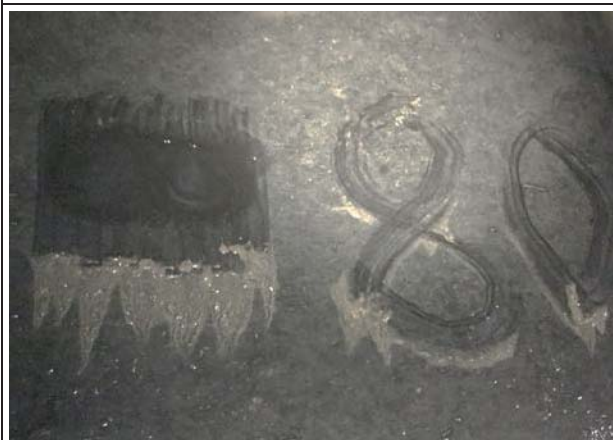
**Figure D-37: Pipe segment 80. Coal tar epoxy is in visually good condition.**

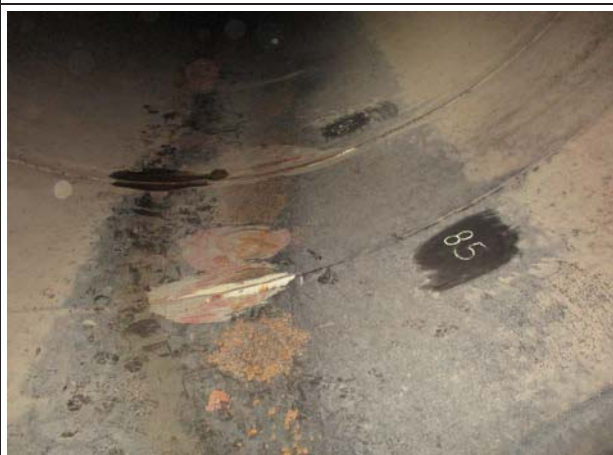
**Figure D-38: Pipe segment 85. Image of invert and pipe wall. Repair material is abraded and corrosion is prevalent throughout the invert.**

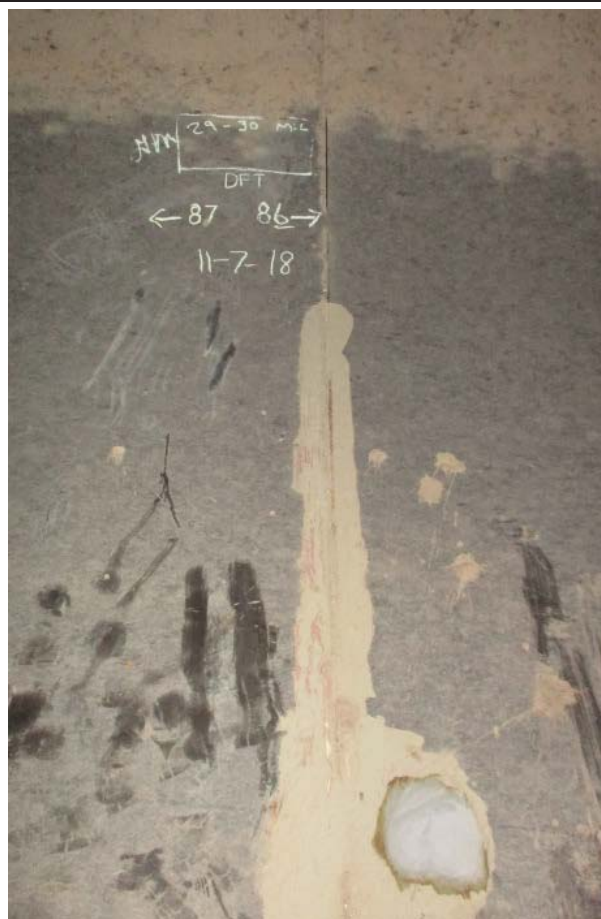
**Figure D-39: Repair material at a pipe joint between pipe segments 86 and 87. Repair material is lightly abraded.**

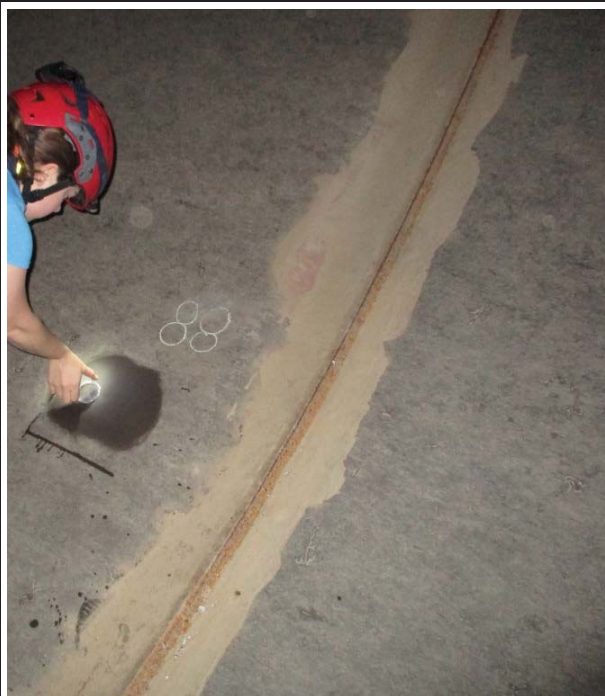
**Figure D-40: Inspector affixing EIS test cell to the pipe wall at pipe segment 88. Adjacent joint has abraded repair material and light corrosion at interface of pipe segments.**

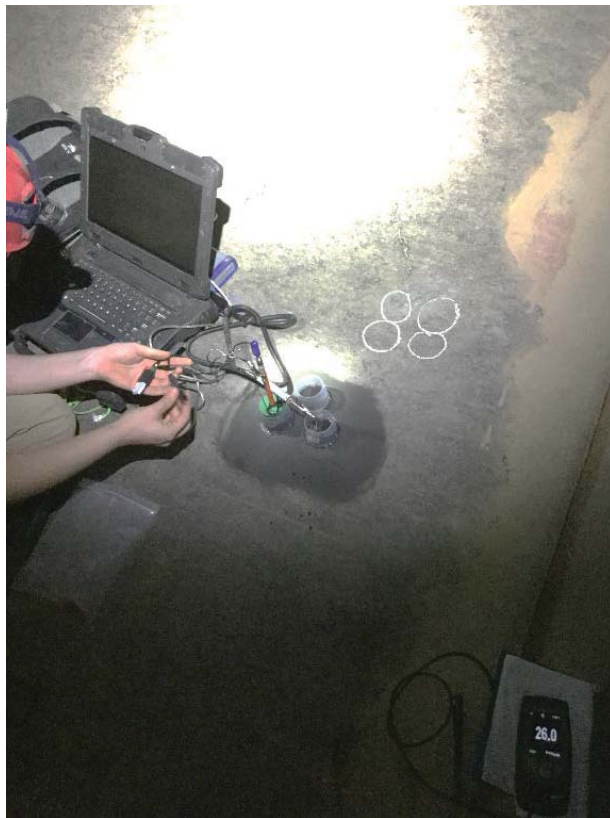
**Figure D-41: EIS set-up at pipe segment 88.**

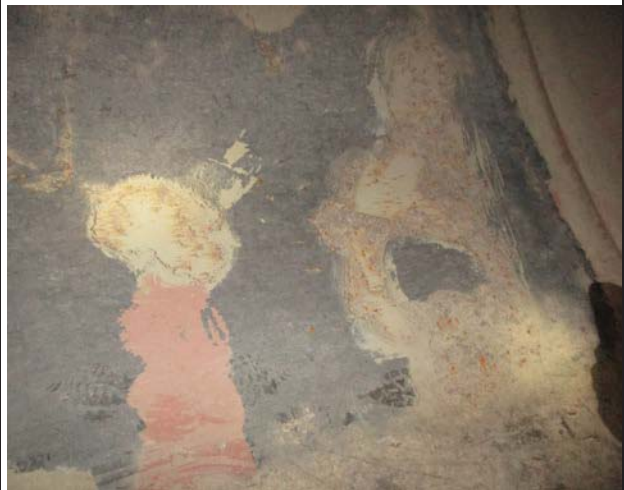
**Figure D-42: Abraded repair area near pipe segment 88. Grey top coat has been abraded away to reveal the red mid-coat.**

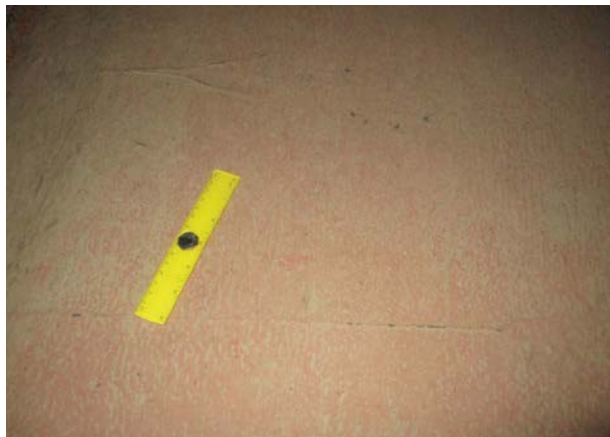
**Figure D-43: A large area of abraded repair material near pipe segment 88.**

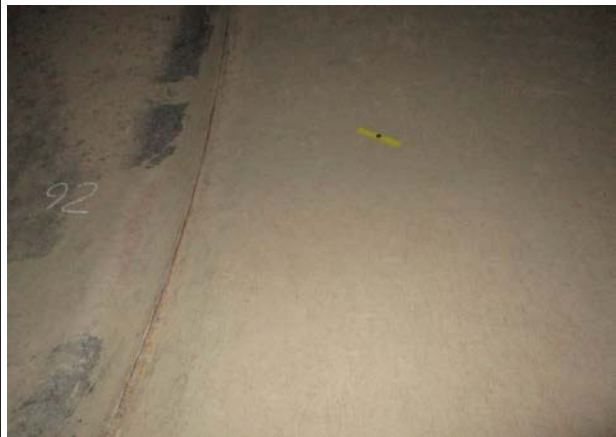
**Figure D-44: Pipe segment 92. A large area of repair material is lightly abraded through the topcoat to the midcoat.**

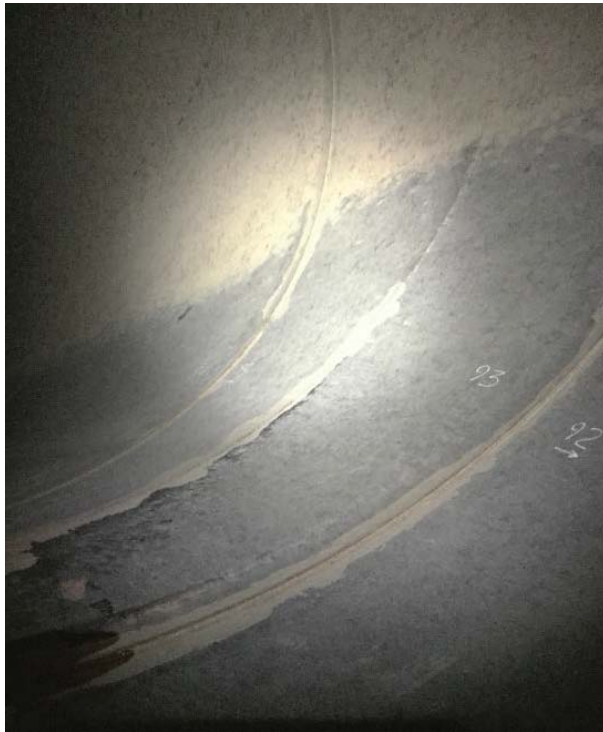
**Figure D-45: Pipe segments 92 and 93. Image of a bend in the pipe near a point of elevation change.**

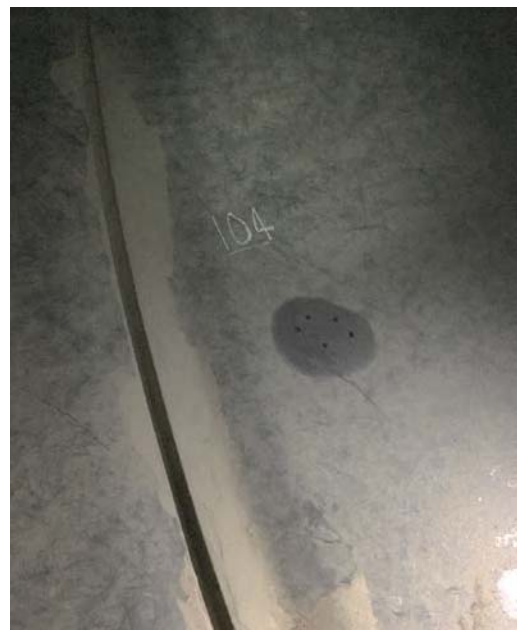
**Figure D-50: Pipe segment 104. Image of pipe wall, UT measurement test location, and pipe joint. Pipe joint has been repaired.**

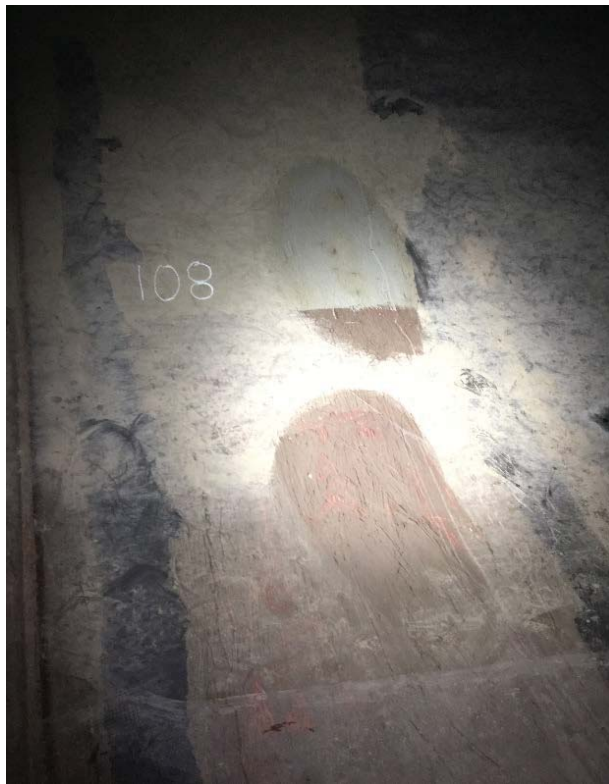
**Figure D-51: Pipe segment 108. Image of abraded repair material and repair material in good condition a few feet up the pipe wall.**

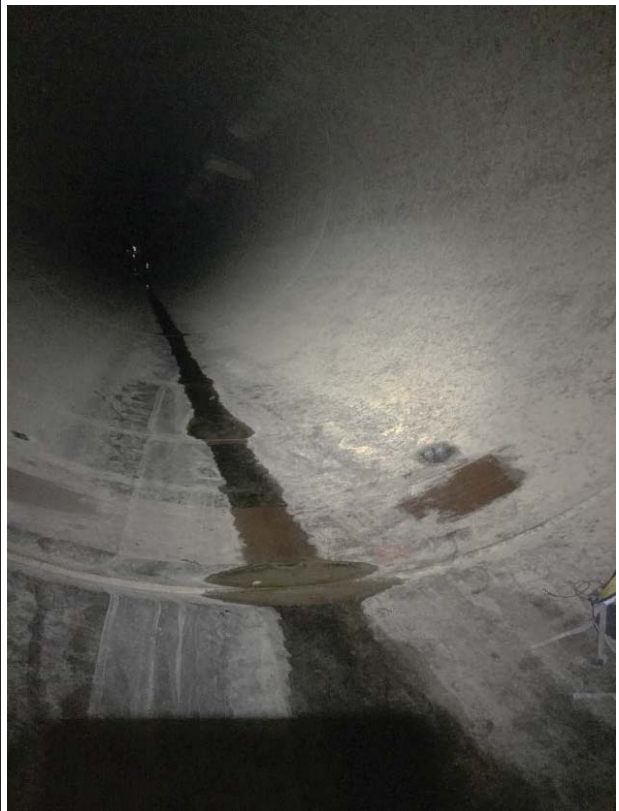
**Figure D-52: Near pipe segment 108. Image of invert and pipe walls. EIS test cells are visible on right.**

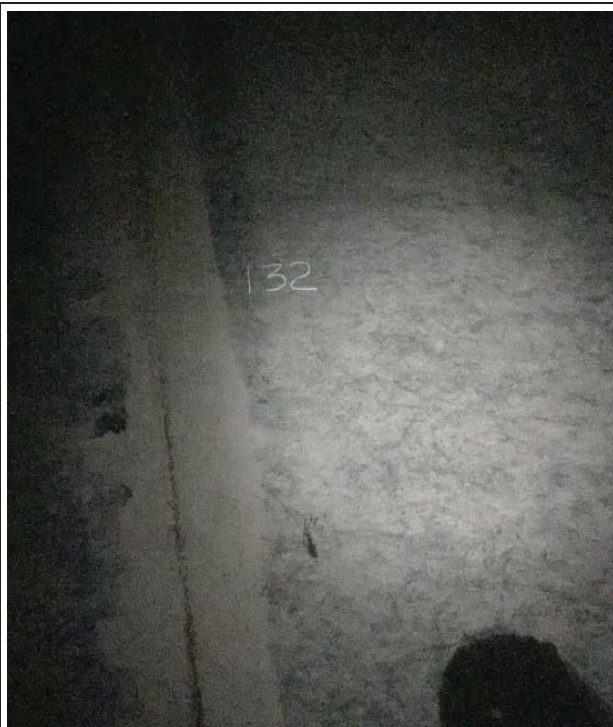
**Figure D-58: Pipe segment 132. Image of wall and repaired joint.**

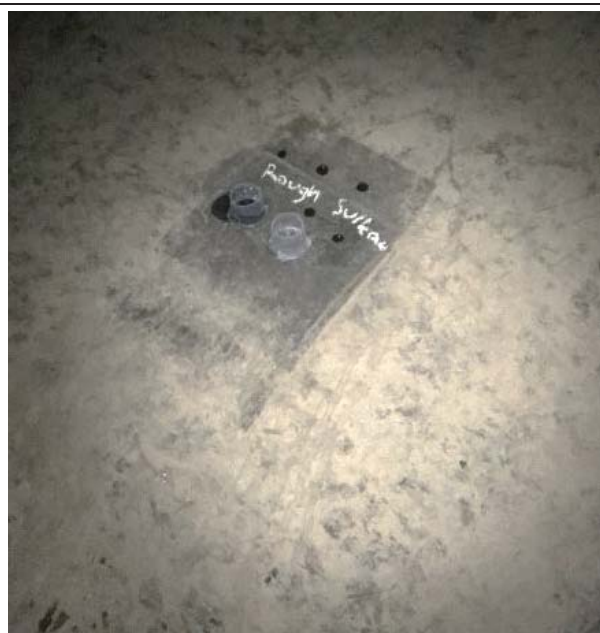
**Figure D-59: EIS test cell set-up at pipe segment 132. The coating at the test location had a notably rough surface.**

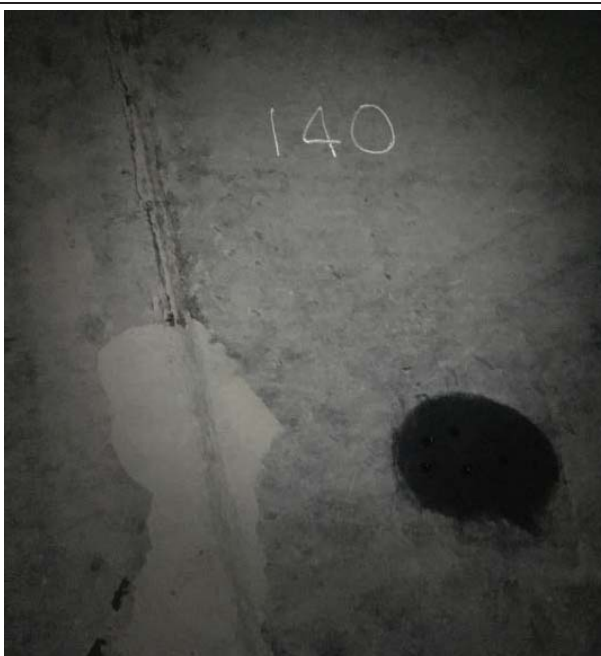
**Figure D-63: Pipe segment 140. Image of pipe wall and joint with joint repair material.**

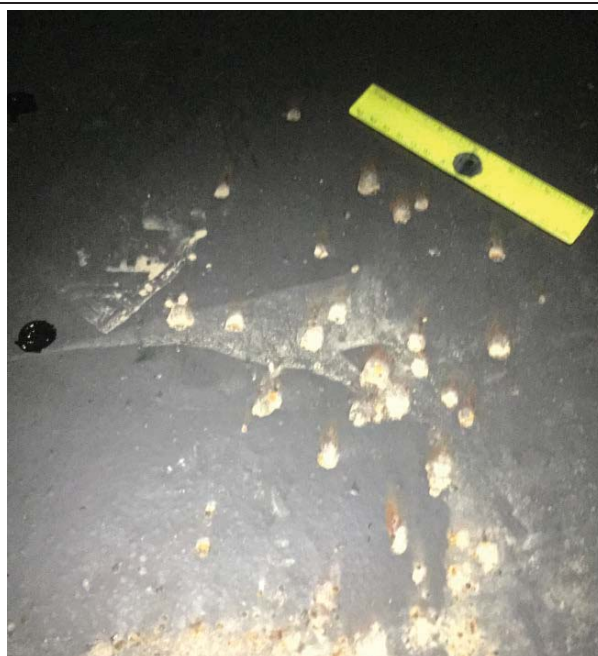
**Figure D-64: Large area of pitting and blistering near pipe segment 140.**

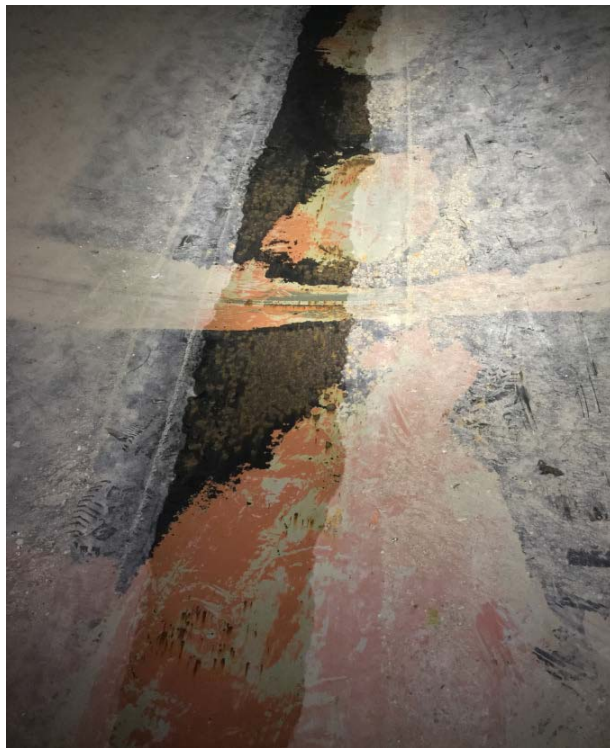
**Figure D-65: Near pipe segment 140. Image of invert with abrasion of repair material topcoat.**

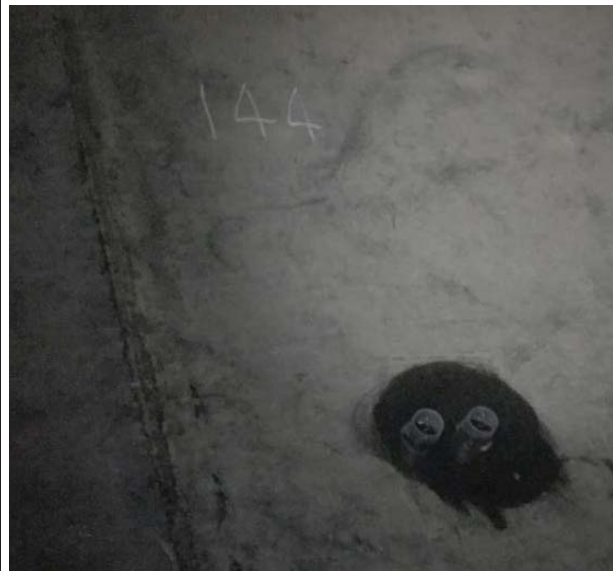
**Figure D-66: Pipe segment 144. Image of pipe wall and EIS test cell set-up.**

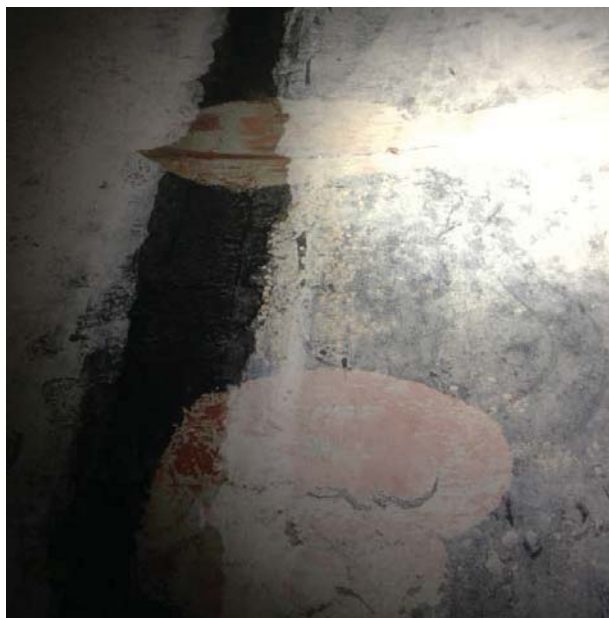
**Figure D-75: Near pipe segment 156. Areas of abraded repair coating are visible at and around the joint and at the invert.**

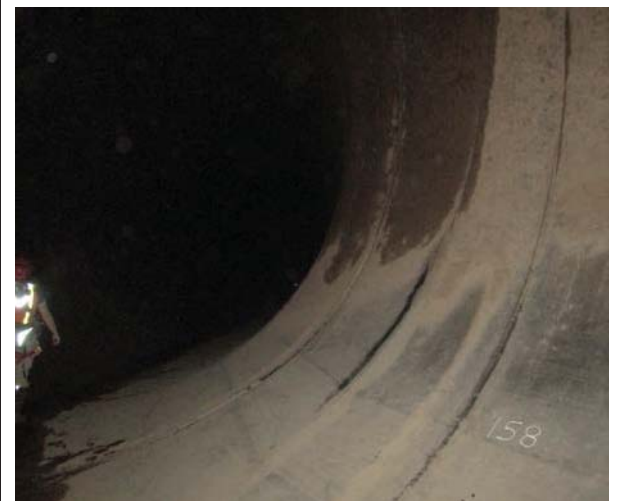
**Figure D-76: Near pipe segment 158. Image of pipe wall and bend in pipe.**

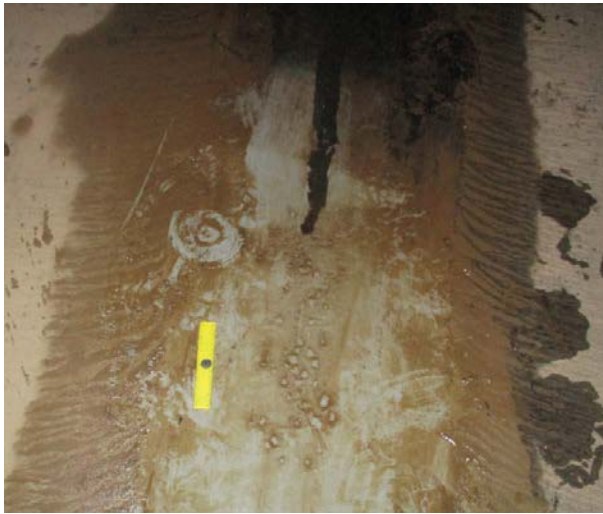
Figure D-81: Blistering of the repair material in the invert near pipe segment 162.

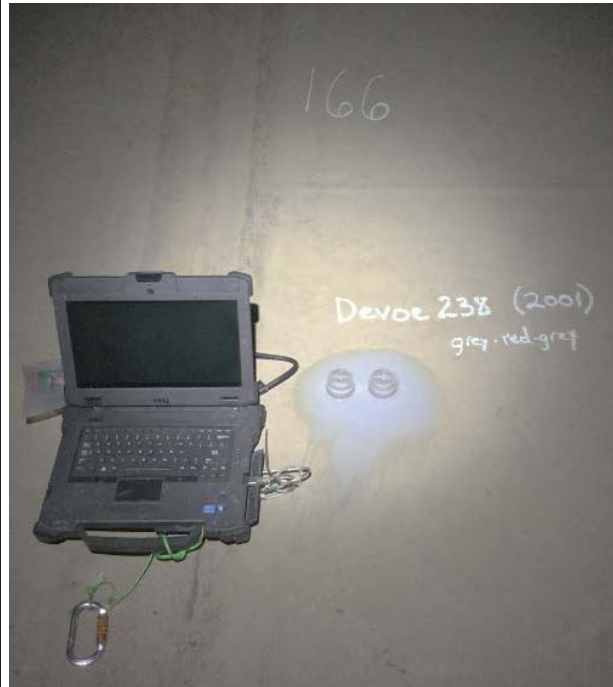
Figure D-82: EIS test cell set-up at a repair material location at pipe segment 166.

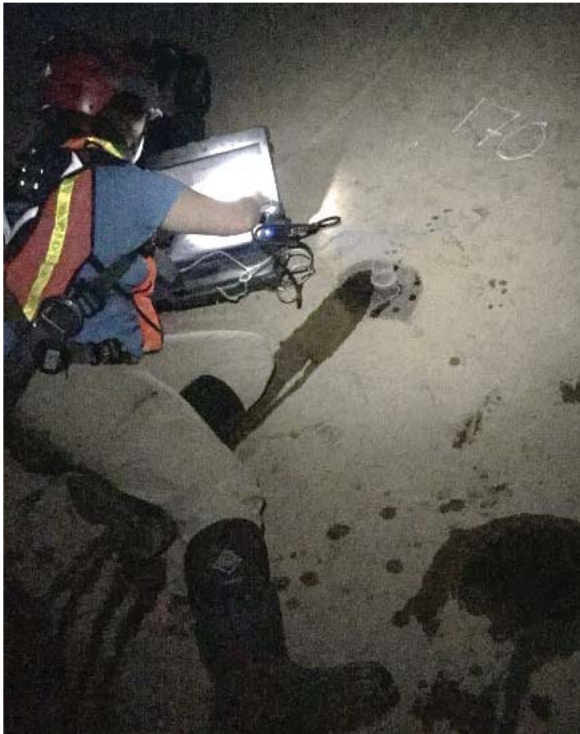
Figure D-83: EIS set-up within 30° slope at pipe segment 170.

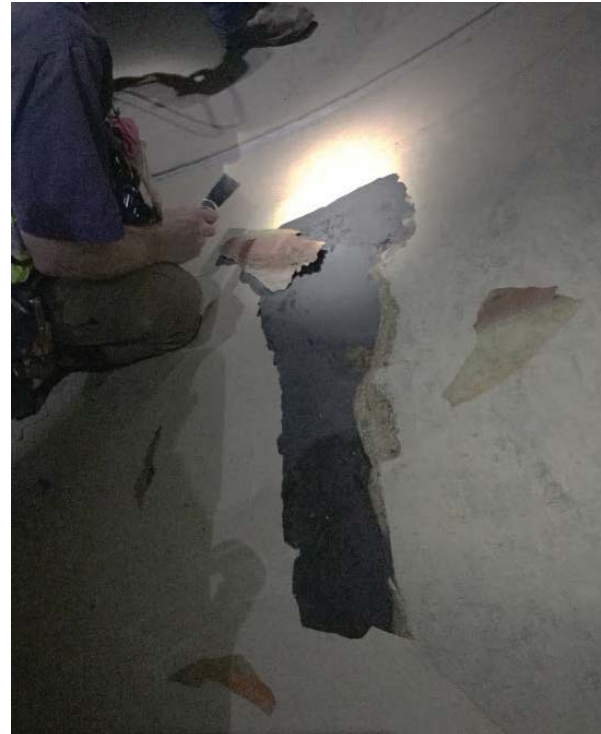
Figure D-84: Delaminated repair material with underlying coal tar epoxy in good condition near pipe segment 170.

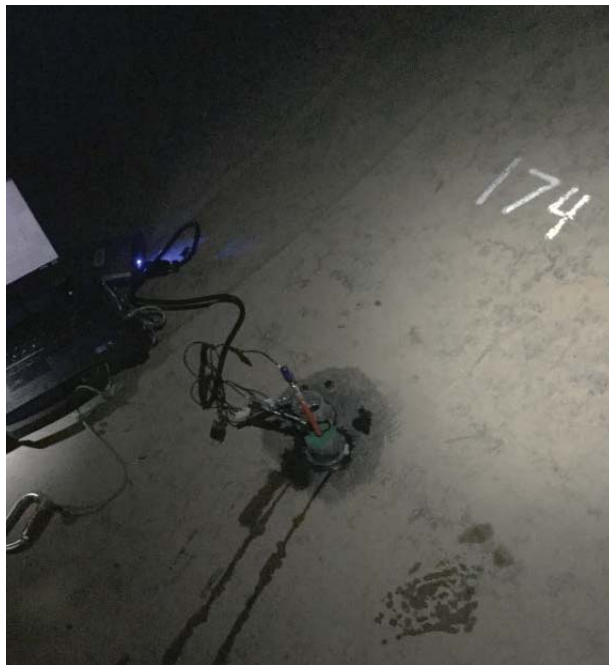
**Figure D-85: EIS in progress at pipe segment 174.**

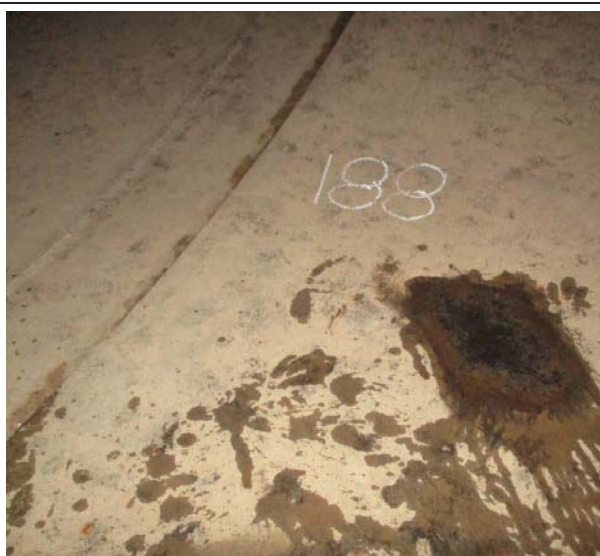
**Figure D-90: Pipe segment 188. Coal tar epoxy was found to be rough.**

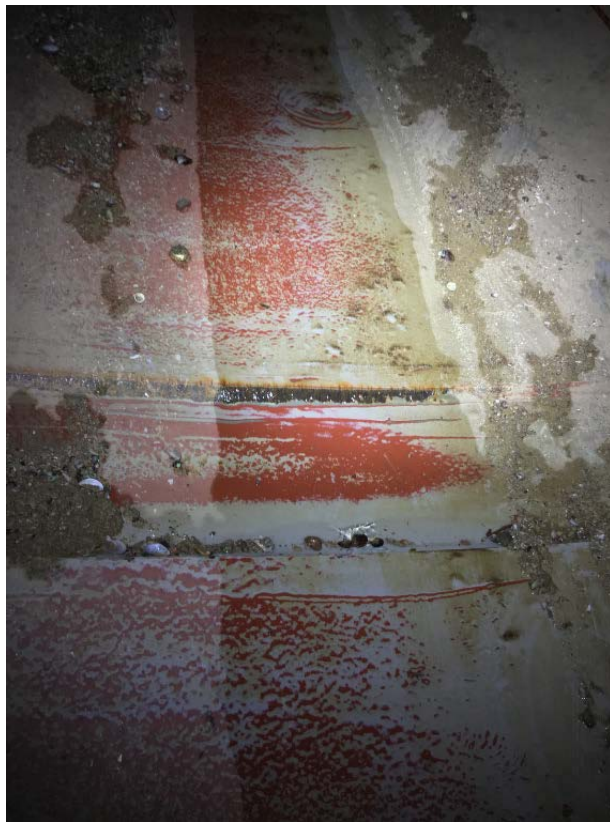
**Figure D-91: Near pipe segment 188. Image of the invert. Repair coating was heavily abraded and mud and sediment were present.**

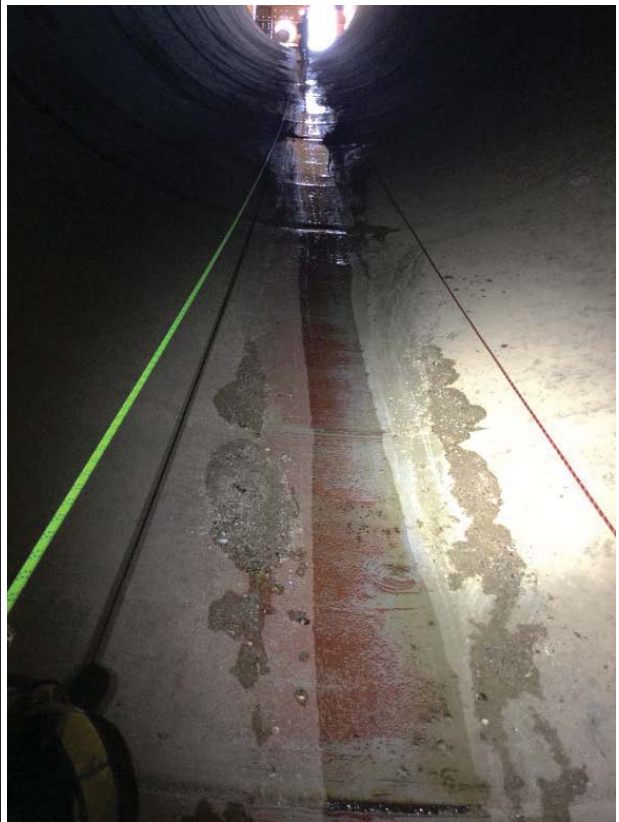
**Figure D-92: Near pipe segment 194. Mud and sediment in the invert coupled with the extreme slope made the inspection difficult.**

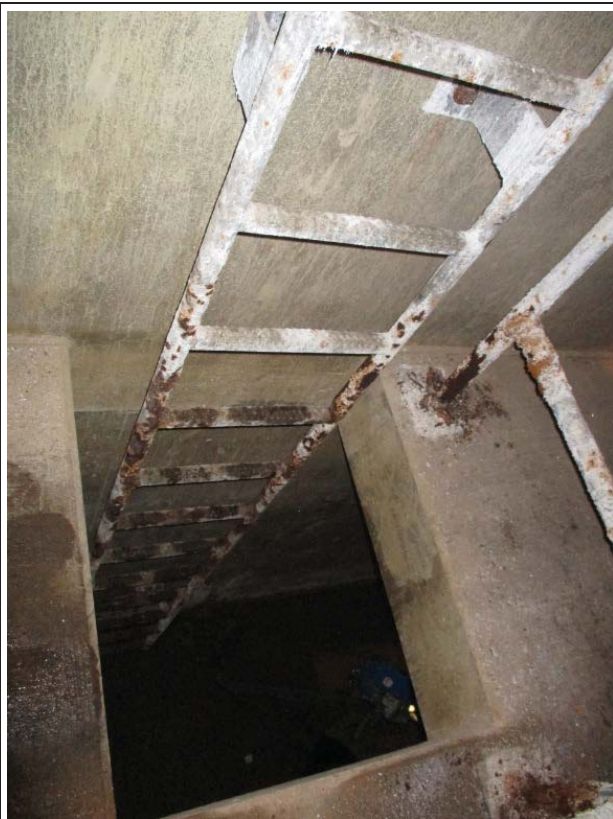
**Figure D-96: Corroded ladders and railings at the deep-well access point.**

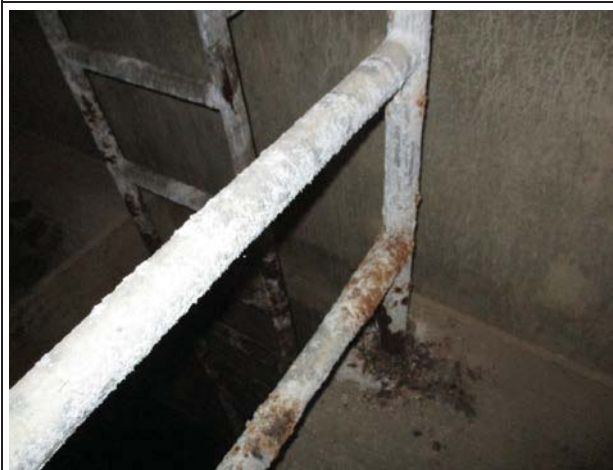
**Figure D-97: Corroded ladders and railings at the deep-well access point.**

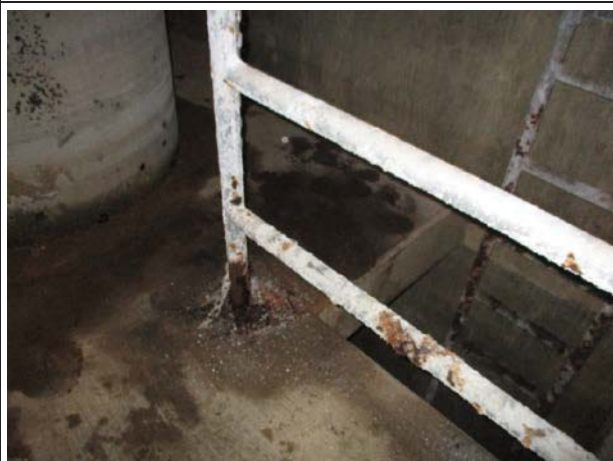
**Figure D-98: Corroded ladders and railings at the deep-well access point.**

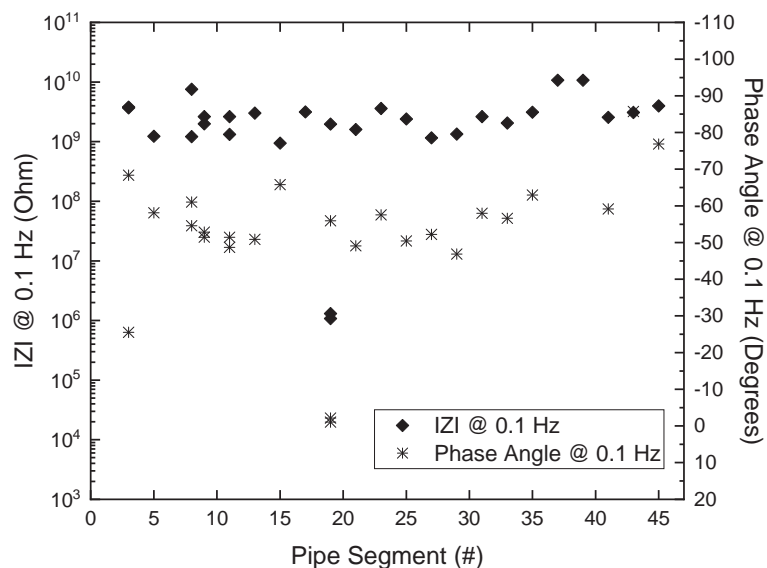
**Figure 1 Impedance magnitude and phase angle at low frequencies versus pipe segment.**

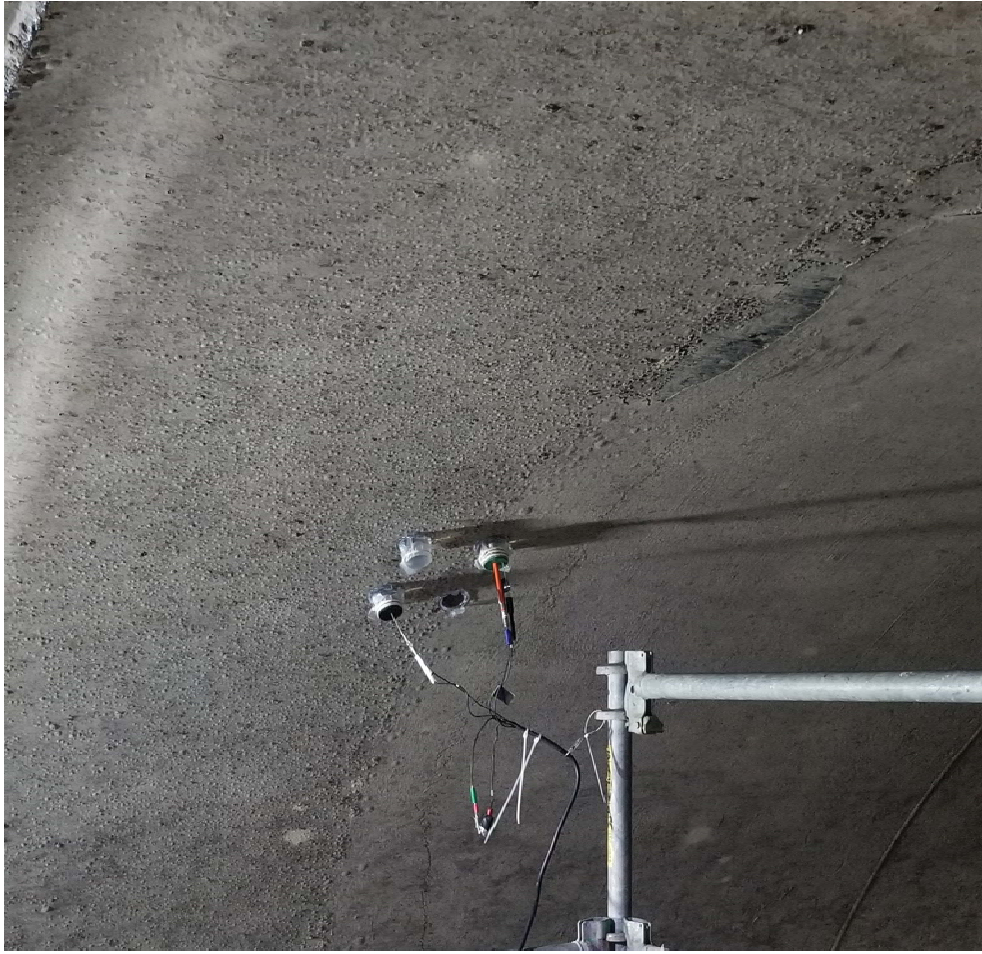
**Figure 2 Blistering observed at EIS test cell location on pipe section#19 at 10:30 position.**

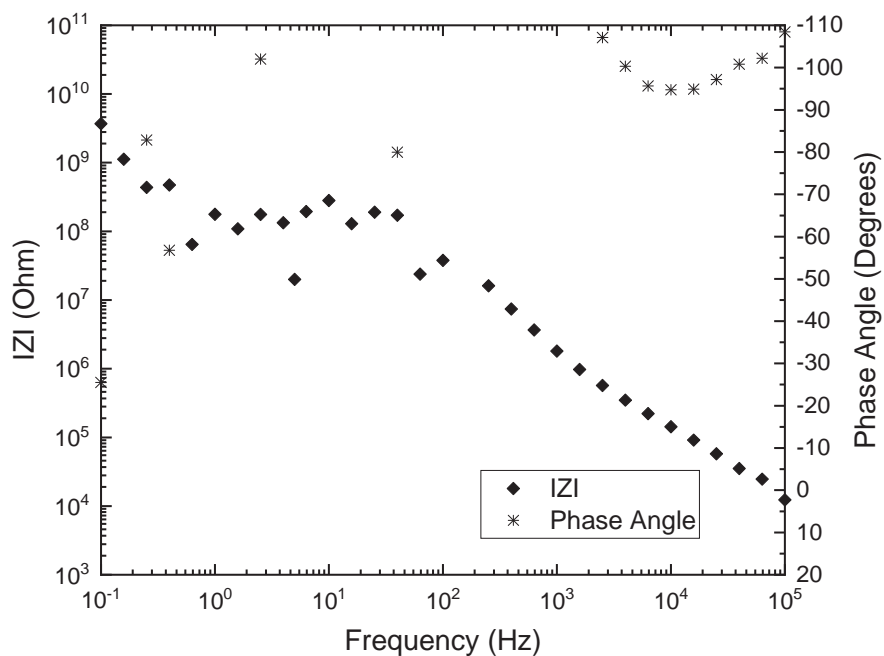
Figure 3 Pipe segment #3 EIS results at the 1:30 position.
