Leak Repair Demonstrations for Pressurized Mechanical Systems

Science and Technology Program
Research and Development Office
Final Report No. ST-2023-20074-01
8540-2023-78

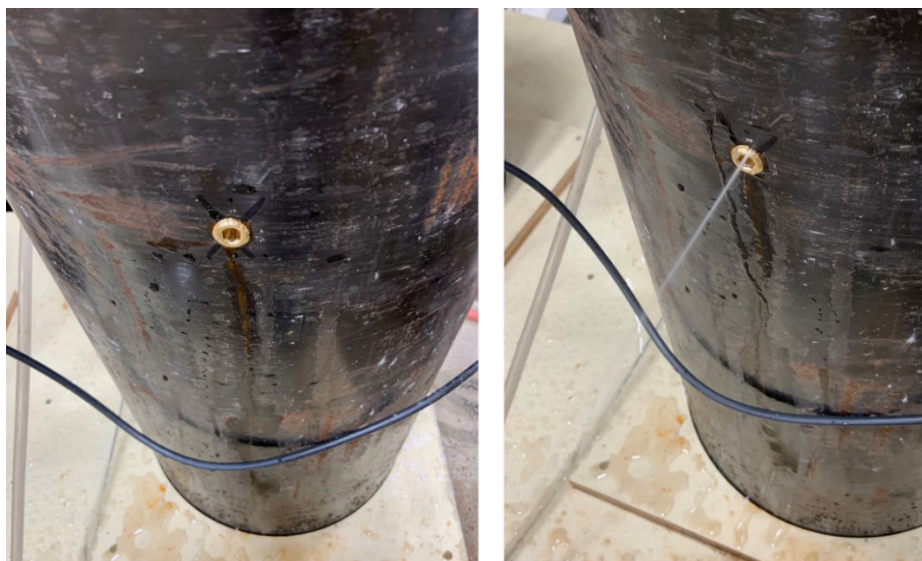
Figure 4.—Brass plugs providing different leak conditions. Left: weeping leak with water running down the surface of the pressure vessel. Right: spraying leak with water shooting out from the plug.

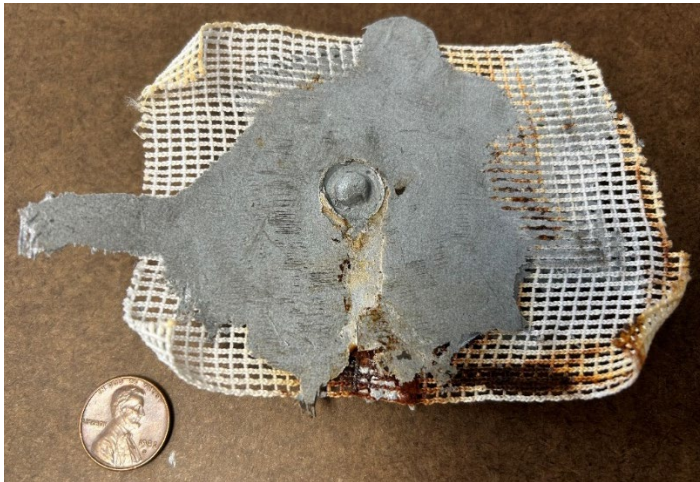
Similar to Product C, the weeping trial for Product D was extended to two weeks to see if the pressure vessel would begin leaking. Leakage remained negligible for the second week, and the test was ended. Removal of the repair and inspection of the underside showed a channel below the plug where leaking water prevented the repair from curing flush against the pressure vessel (Figure 10).

Figure 10.—Underside of Product D repair after weeping trial. The circle at the center of the repair is where it contacted the plug. Below this point, there is a visible channel where the weeping leak prevented the repair from curing flush against the pressure vessel.

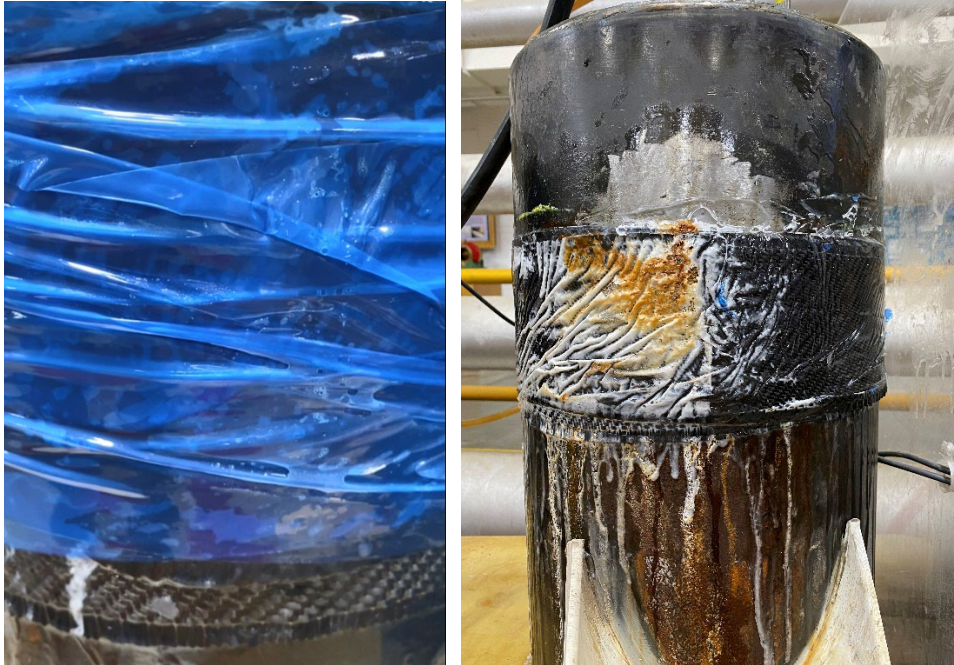
Data for Product E is not included for the weeping trials. This is because Product E was unable to cure properly with the pressure vessel in the active leaking, pressurized condition. Product E consisted of a carbon fiber composite which was wrapped with a compression film. During testing, researchers discovered that there was water seeping underneath the compression film (Figure 11, left). This water was not being collected in the spout and measurement bucket, making it impossible to determine the full volume of leaked water. This invalidated the data, and as such, the trial was ended on Day 5. Upon removal of the repair, corrosion was visible within and underneath the repair product, indicating that the repair was not successful in stopping water or further corrosion from occurring on the pressure vessel (Figure 11, right).

Figure 11.—Photographs of Product E at the end of the Weeping Trials. Left: water seeping underneath the compression film. Right: Corrosion product visible within the Product E repair.

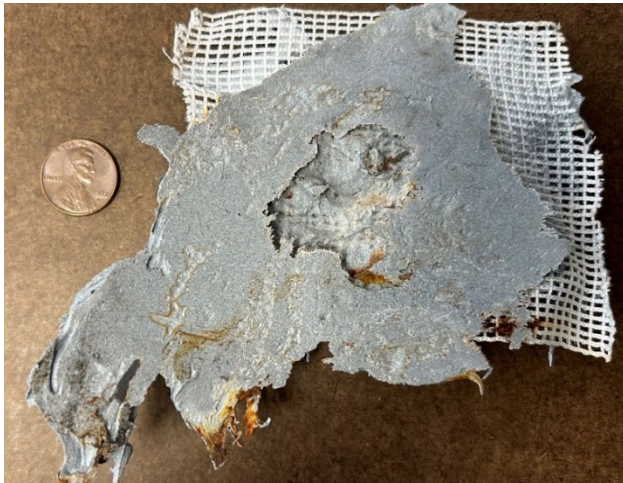
After completing the trial, removal of the repair product showed a void in the repair material around the plug (Figure 13). This indicates that the active leak prevented the repair material from curing properly around the plug where water was present. It was also noted that the repair was easily removed from the surface, and that surface preparation (such as a rotary bristle tool to add a surface profile) could possibly improve adhesion.

Figure 13.—Void in Product D repair material around the plug where leaking water prevented the material from curing properly.

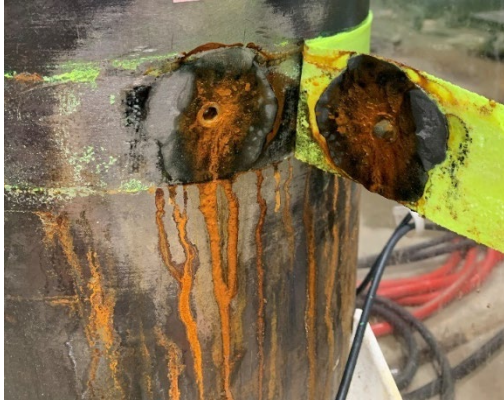
Like the intermediate trial, after ending the test, the epoxy was removed in a single piece with the wrap, indicating that it was not adhered to the pressure vessel surface and no longer effective in reducing leakage once water got through. Extensive corrosion was visible underneath the repair, suggesting corrosion damage continued to occur underneath the repair (Figure 15).

Figure 15.—Removal of repair Product B after Spraying Trial showing extensive corrosion underneath the repair.

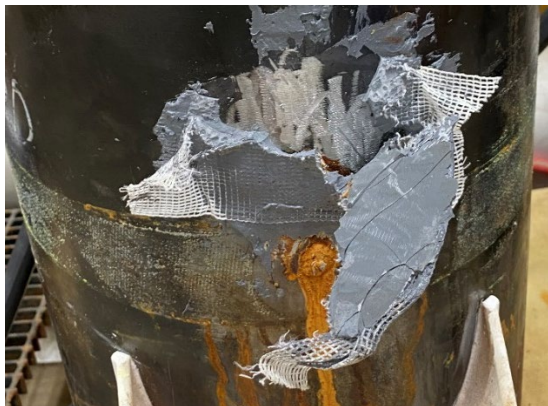
The spraying trial for Product C was stopped after two days because of overflow of the measurement bucket on both days, which indicated that the repair was not reducing water leakage from the pressure vessel. There were clear lines of corrosion streaking the pressure vessel exterior where water continued to leak from the repair (Figure 16). Corrosion was visible beneath the repair.

Figure 16.—Removal of repair Product C after Spraying Trial showing corrosion streaking the pressure vessel exterior where water continued to leak from the repair.

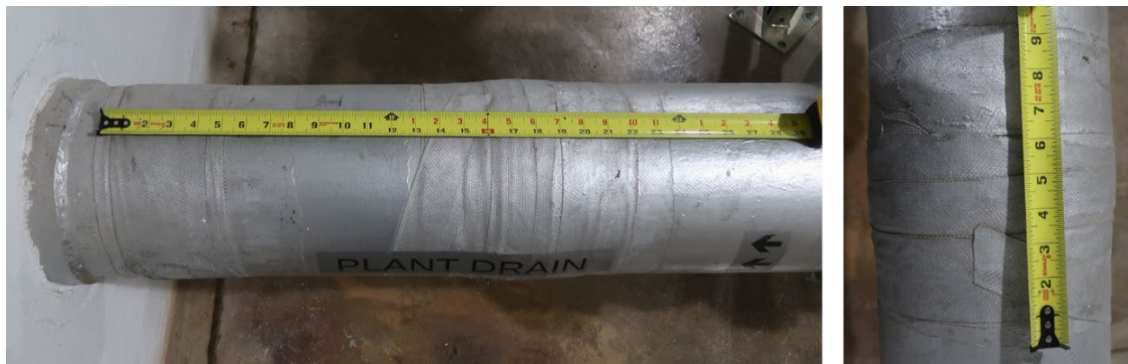
The facility has an 8-inch diameter unwatering piping with a typical flow rate of 800 gallons per minute. A pinhole leak formed on the pipe. No information was available on what caused the leak. In 2001, the facility maintenance crew applied a fiberglass wrap to the active leak as a temporary repair (Figure 17). In 2021, the facility installed valves to allow for isolation of the line and future replacement or permanent repair. No replacement or additional repair work has been performed as of February 2023, which indicates that the fiberglass wrap repair has been successful since its application.

Figure 17.—Fiberglass wrap repair on 8-inch diameter unwatering piping.

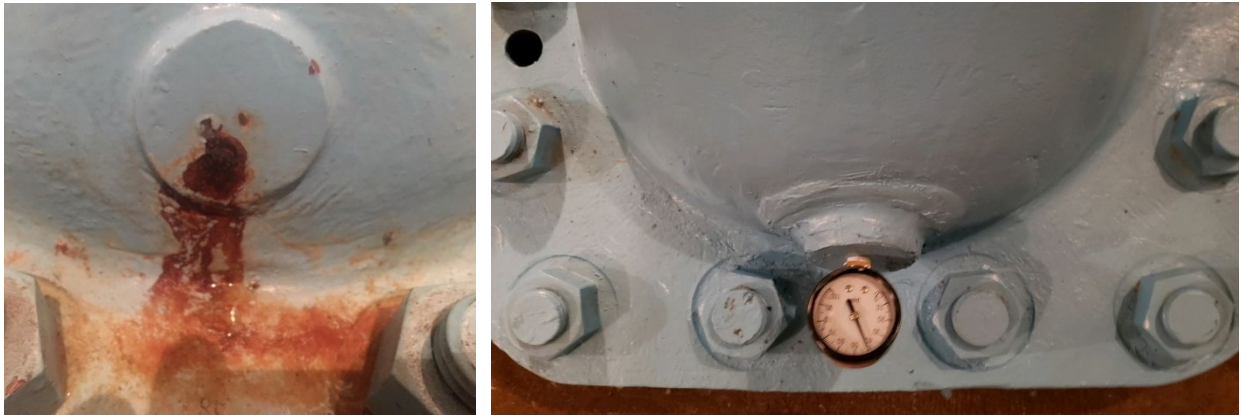
Figure 18.—Left: Photograph of pinhole leak in gate bonnet cover prior to repair. Right: Photograph of bonnet after repair showing the pressure gage and repair cap installed on the gate bonnet cover.

Facility staff cleaned the repair area and roughed the surface using a 24 grit wheel. They then fabricated a cap with a threaded relief valve on top to vent the water. This cap was then installed atop the damaged weep hole while the repair material was applied. The finished repair was then permitted to dry and a pressure gauge was threaded into the threaded connection used to vent the water (Figure 18, right).

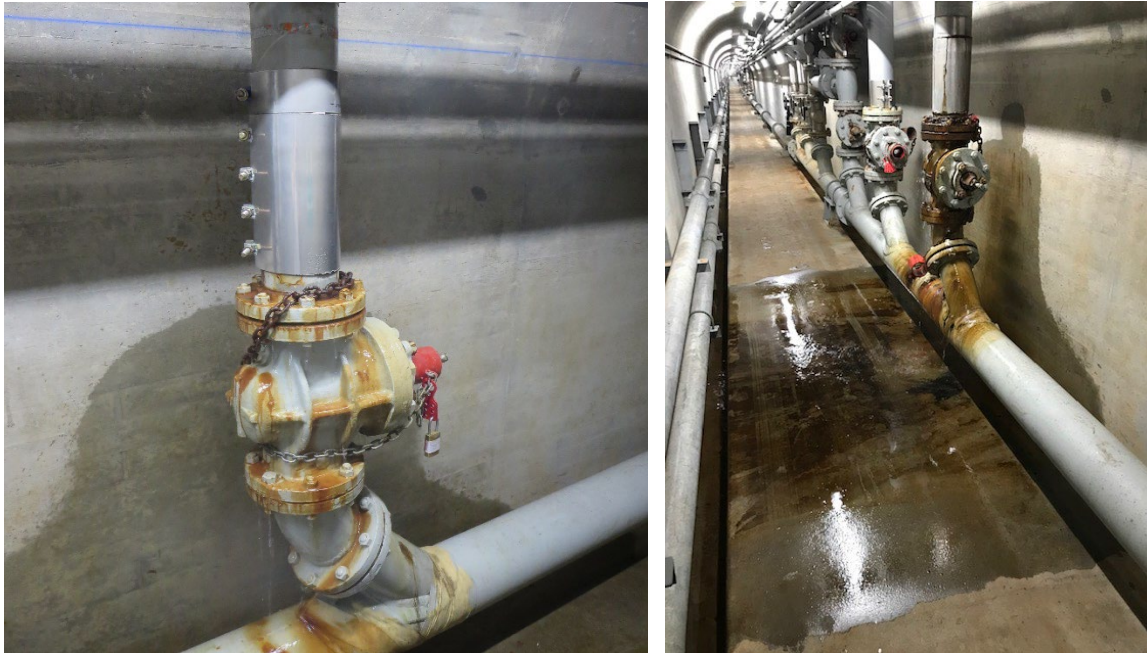
Leakage is occurring on a 16-inch unwatering pipe that is embedded in concrete (Figure 19). The leak is located at the first joint, which remains under pressure from the tailbay. At full pool, the leak is under 123 psig. The wall across from the leak shows erosion from leakage. The facility has attempted to stabilize the leak without depressurizing the system. The facility has only seen marginal success. Ultimately, the piping needs to be dewatered for permanent repairs.

Figure 19.—Leak on 16-inch unwatering pipeline.

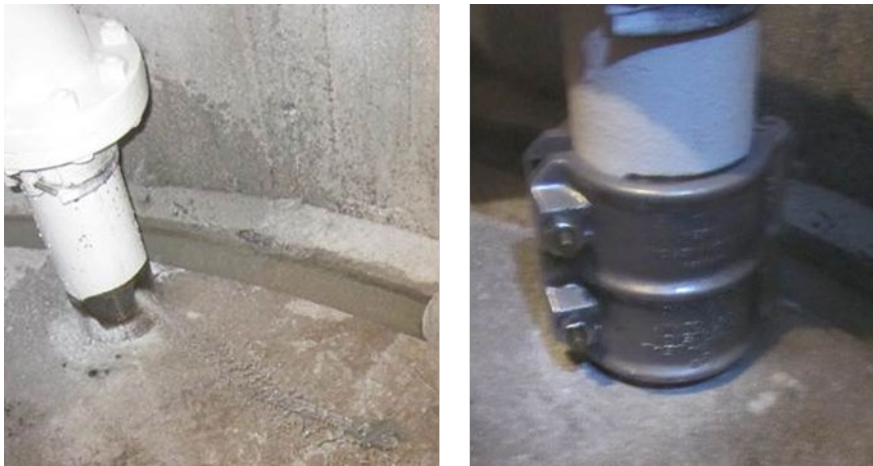
The 4-inch bypass pipe first began leaking in September 2018 after abrasive blasting (for coating repair work) caused a pinhole leak in the corroded pipe at a location that is upstream of the isolation valves. The facility applied a clamp repair, which has since been used to prevent active leakage. However, the facility has some concern regarding the ability of the repair to hold over time, as well as concern about continued degradation of the pipe. The leak and the clamp repair are shown in the figure below.

Figure 20.—Left: photograph of leaking pressurized pipe at a field partner facility. Right: photograph of the temporary clamp repair immediately after installation.
