Test Method Development for Adhesion Strength of Protective Coatings under Real-Life Hydraulic Conditions

**Science and Technology Program
Research and Development Office
Final Report No. ST-2020-19122
Hydraulics Laboratory Report No. HL-2020-06**

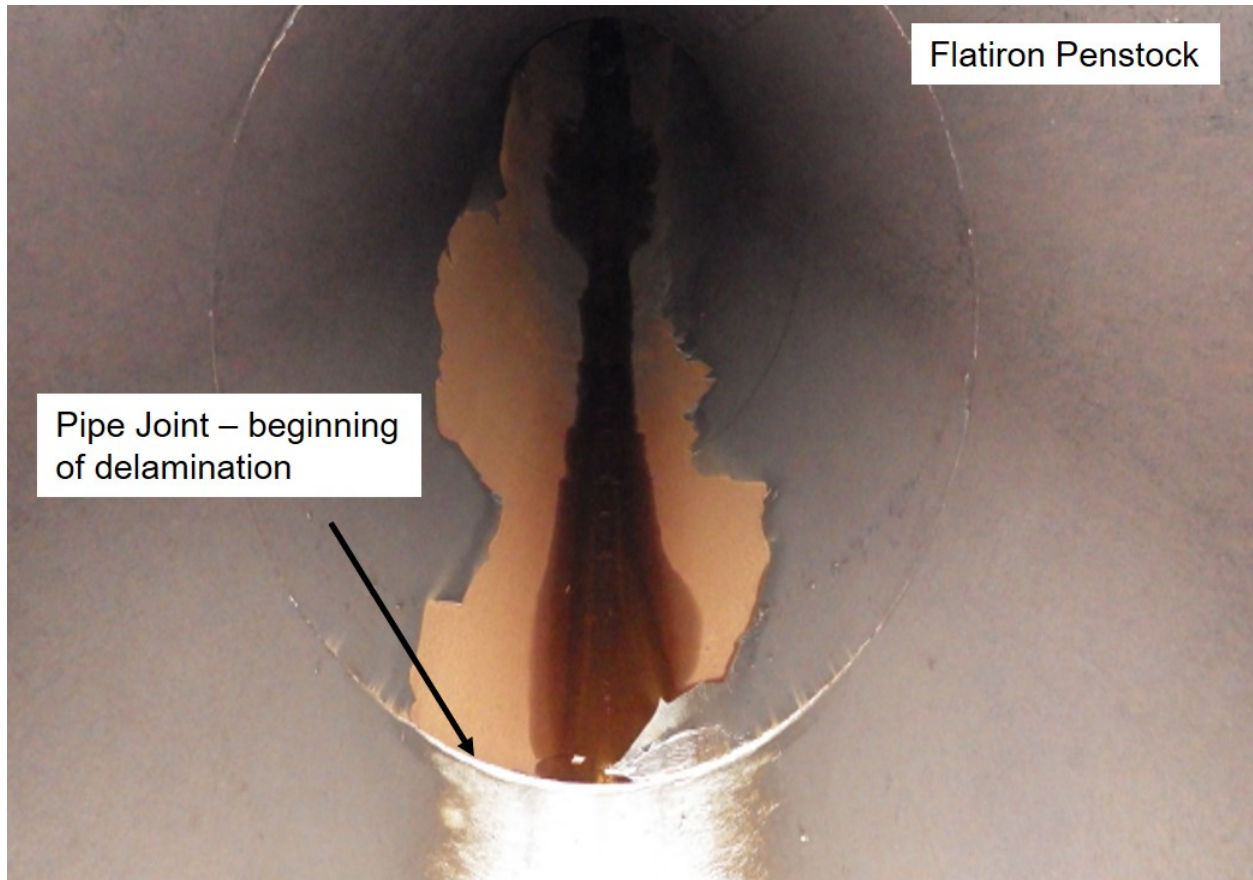
Recent experience with new coating systems in the field also showed the need for an improved adhesion test method. In 2015 failure of the penstock lining occurred at Flatiron hydropower plant where approximately 40 ft of the coating delaminated (Figure 1) and caused major issues for the downstream hydropower unit [3]. The coating system had only been in service for four years. Similar incidents of delaminated coatings occurred for the same coating system at Enders Dam in 2016 (Figure 2) and Platoro Dam in 2019 (Figure 3). At Enders coating delamination began at a few locations, namely the connection between the outlet pipe and the downstream control valve. For Platoro [4], delamination initiated at a pipe joint in the left bifurcation of the outlet works about five feet upstream of the control gate. Fortunately, in both cases initial delamination was caught before major damage occurred. Upgrades to lining systems in penstocks and outlet pipes are expensive (2-5 million dollars) due to large surface areas to be prepared and lined, as well as extra safety precautions for working in confined space with steep slopes.

While the extent of damage in these cases varied significantly, the common factor was that hydraulic uplift forces appeared to be the dominant factor leading to delamination of the coatings. In each case the delamination initiated at a discontinuity of the inner pipe wall, generally at a pipe joint. Water flow entered beneath the lining and pressures between the coating and pipe wall caused the coating to peel away from the pipe wall. This is the same physical process that can lift concrete slabs at joints in spillways and cause catastrophic damage like the Oroville Dam incident in 2017 [5]. The root cause of initial flow penetration beneath the coating is not known but could be due to a variety of factors (i.e. underlying corrosion, defect due to offset geometry, movement or vibration of offset, etc). While all these factors cannot be accounted for in the laboratory the dominant physical processes that cause the coatings to delaminate from the pipe wall can be simulated at field-scale in the laboratory.

Figure 1 Photo of the 2015 polyurethane lining failure at Flatiron penstock, looking downstream.

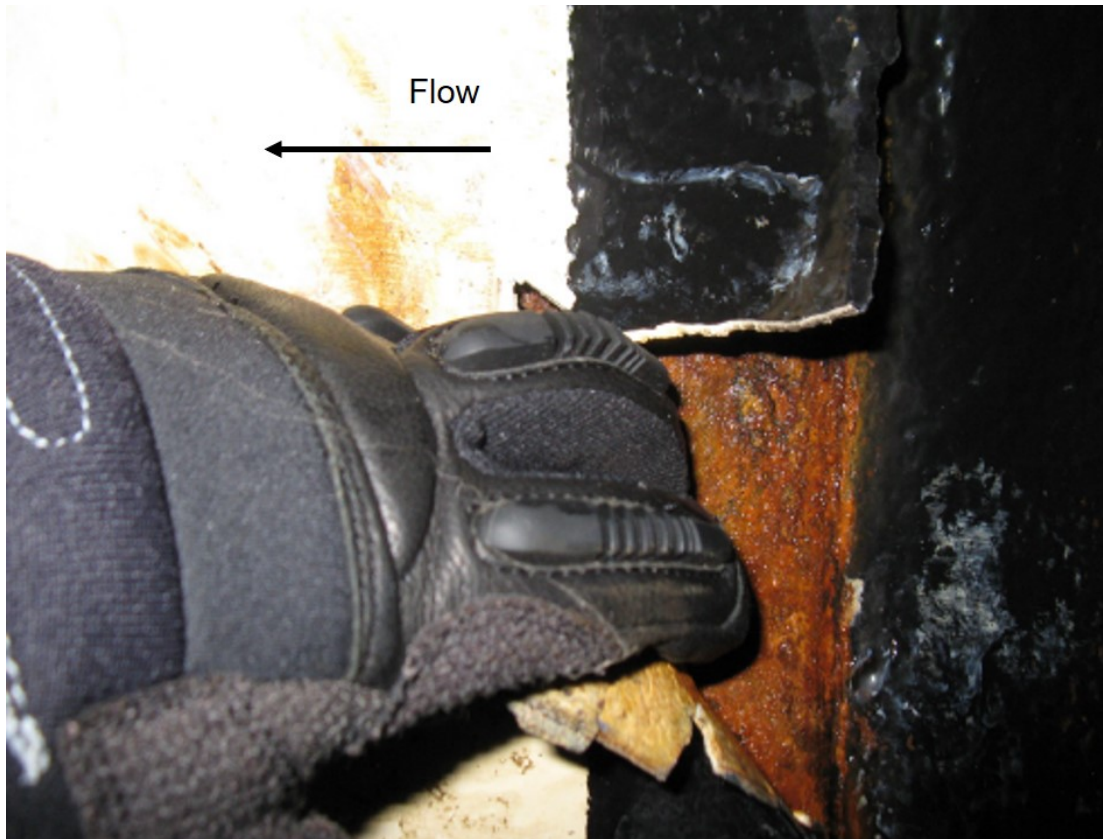
Figure 2 Polyurethane lining delamination at connection of outlet works pipe and control valve at Enders Dam in 2016. Flow is right to left.

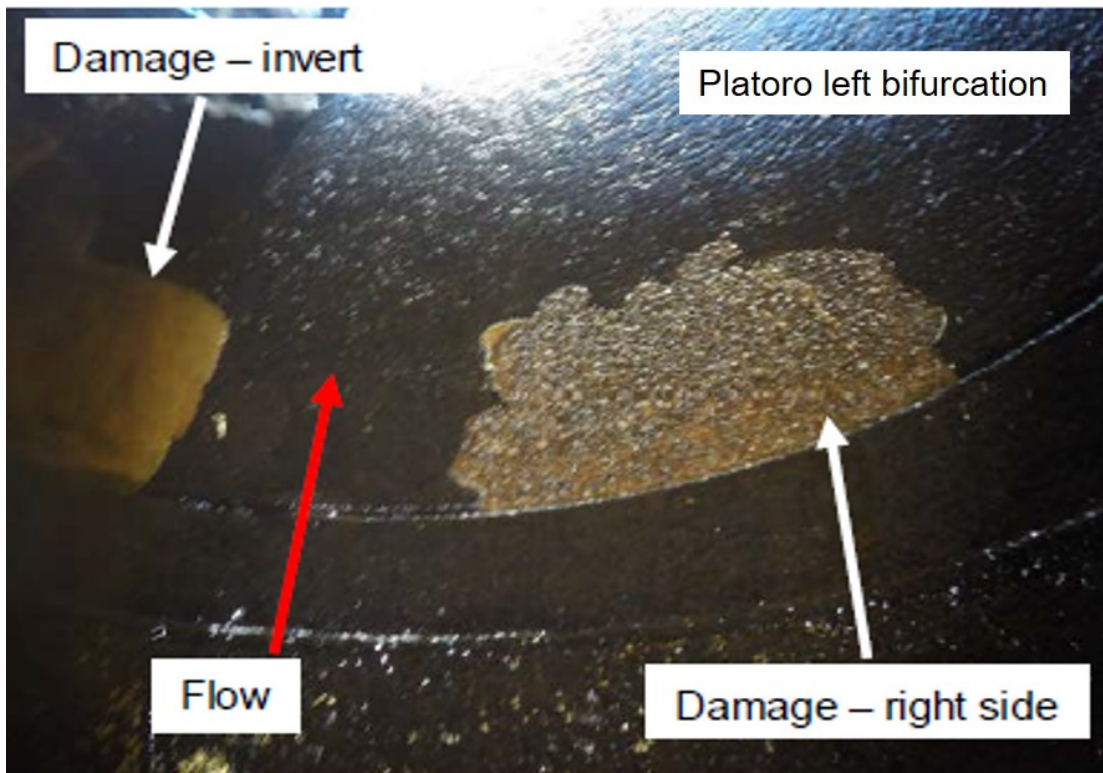
Figure 3 Polyurethane lining delamination at a pipe joint in the left bifurcation of the outlet works at Platoro Dam, 2019. Looking downstream.

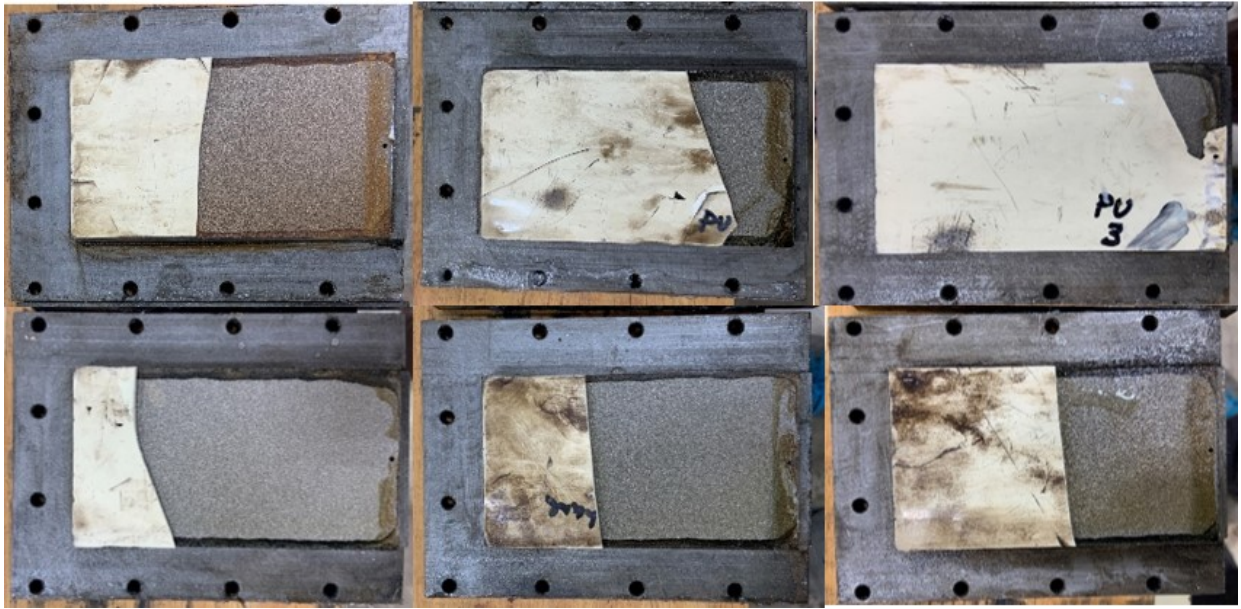
Twelve trial coating samples were tested in the facility with the same test procedure. As shown in Table 2, only the Polyurethane coating failed under the conditions produced by the test facility. Due to issues with the existing pumping system the maximum approach velocity was limited to 55 ft/s and could not be held at that setting for more than five minutes. Polyurethane samples failed consistently in the range of 40-50 ft/s under different uplift pressures that were dependent on the extent the delaminated coating protruded into the flow field. Delamination generally began at the upstream corners of the coating and would extend downstream until the delaminated coating detached and was swept downstream. Post-test photographs are shown in Figure 9.

Figure 9 The six failed Polyurethane samples, increasing in sample number from left to right top to bottom. Polyurethane number three folded over from a corner and failed in a slightly different manor than the other five.

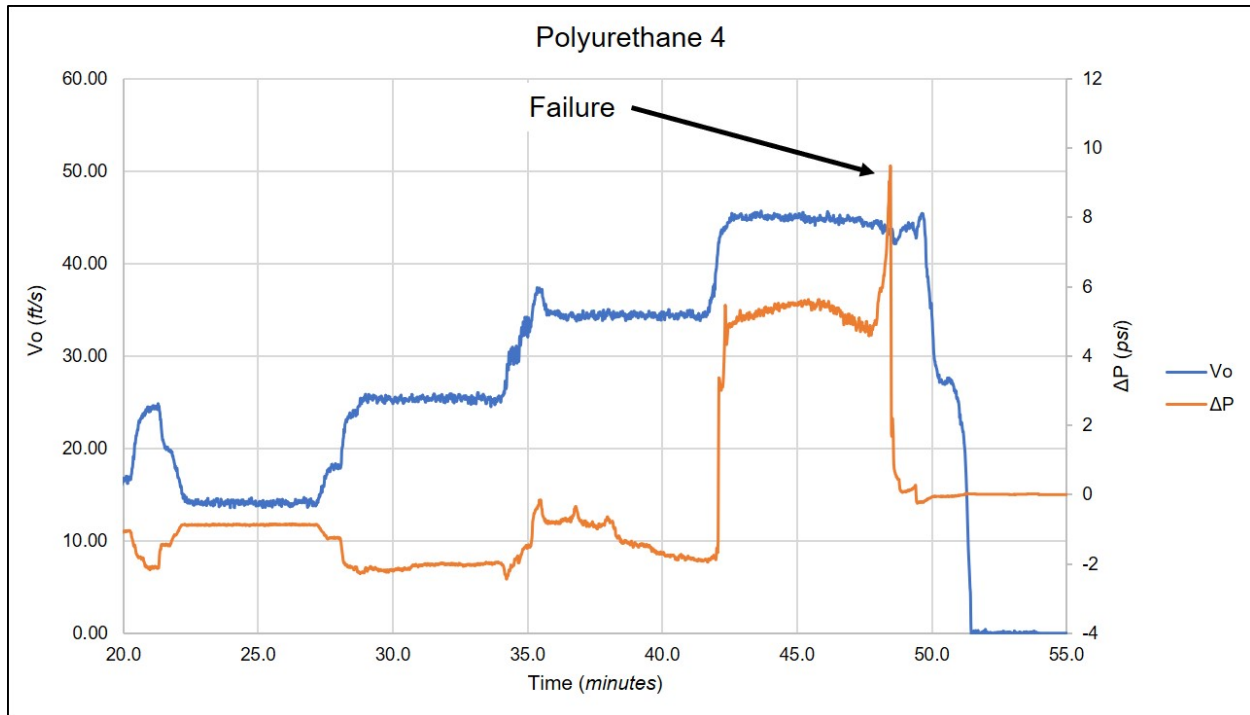
Uplift pressure measurements were useful in further understanding the behavior of the Polyurethane coating samples during delamination and failure. Figure 10 shows an example time series of approach velocity and uplift pressure. The uplift pressure, which is measured using a pressure tap under the upstream flap, did not follow the velocity as expected until it exceeded 40 ft/s. This may have occurred because the flap was still covering the pressure tap near the center of the sample until the approach velocity was high enough to lift the flap at that location. The sudden spike and drop of uplift pressure indicate the point at which the coating was lifted into the flow and then detached, alleviating the uplift pressure.

Figure 10 Time series approach velocity and uplift pressure acting on trial sample Polyurethane #4.

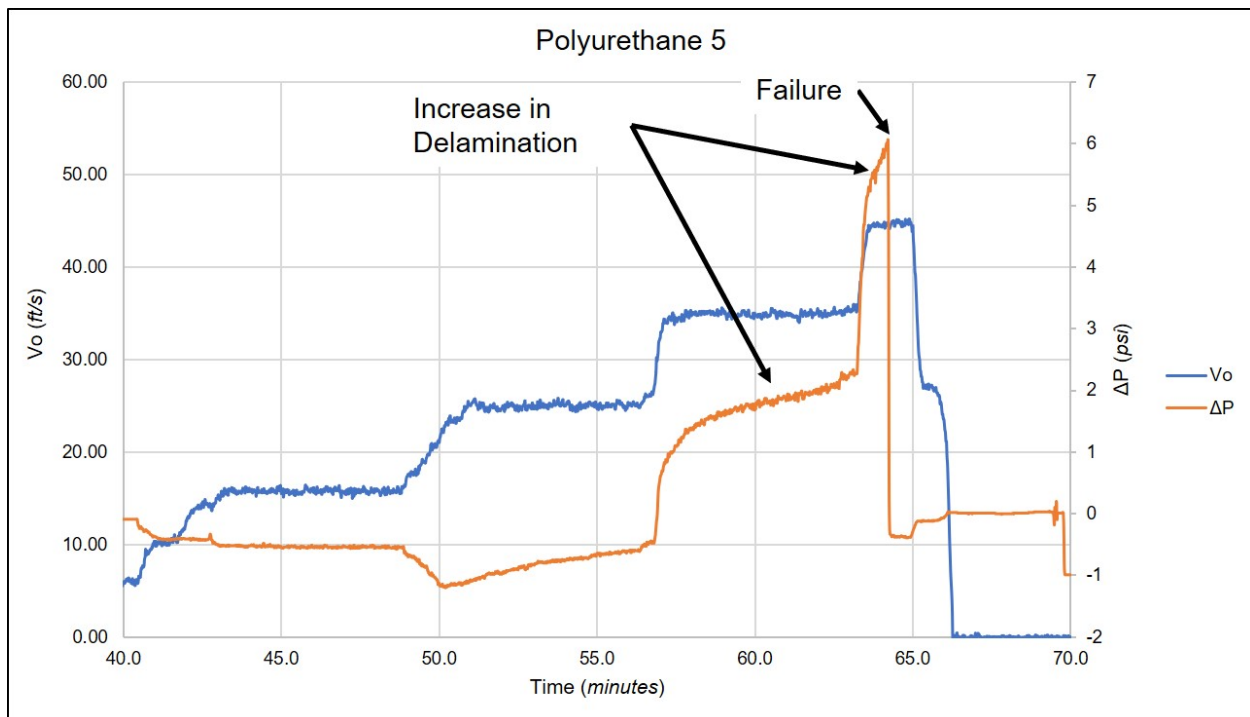
A similar trend is shown for a different sample in Figure 11. However, at constant approach velocities of 35 and 45 ft/s the uplift pressure gradually increased which corresponds to visual observations of the coating slowly delaminating from the base plate. As delamination continued the extent that the upstream flap protruded into the flow field grew until failure finally occurred as shown by the sudden spike and drop in uplift pressure. The delamination and failure process of the Polyurethane samples is shown visually in Figures 12 through 14.

Figure 11 Time series approach velocity and uplift pressure acting on trial sample Polyurethane #5.

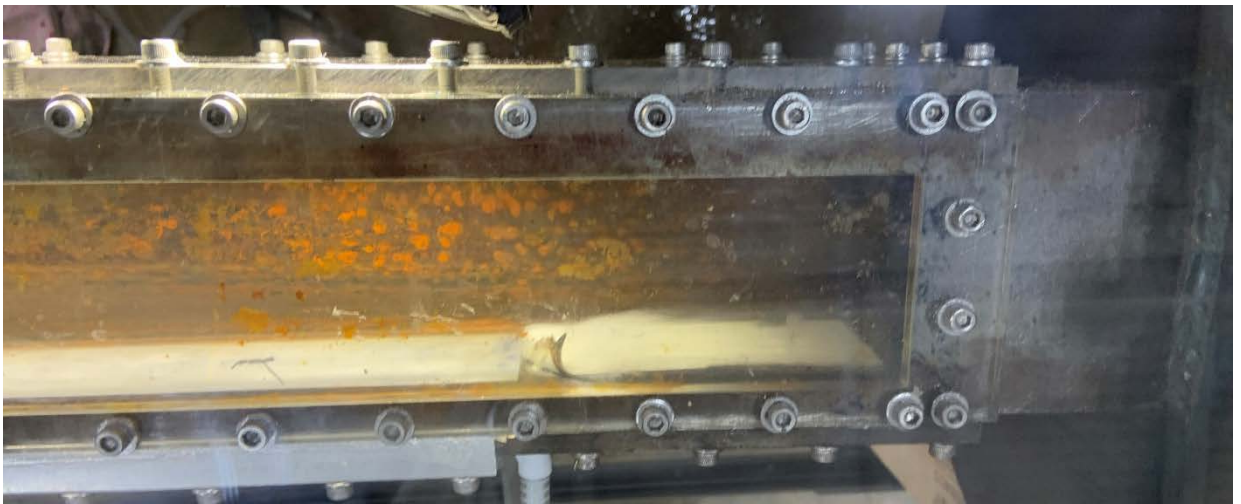
Figure 13 Photo of Polyurethane sample at high approach velocity, delamination beginning at upstream corners of the coating. Flow is left to right.

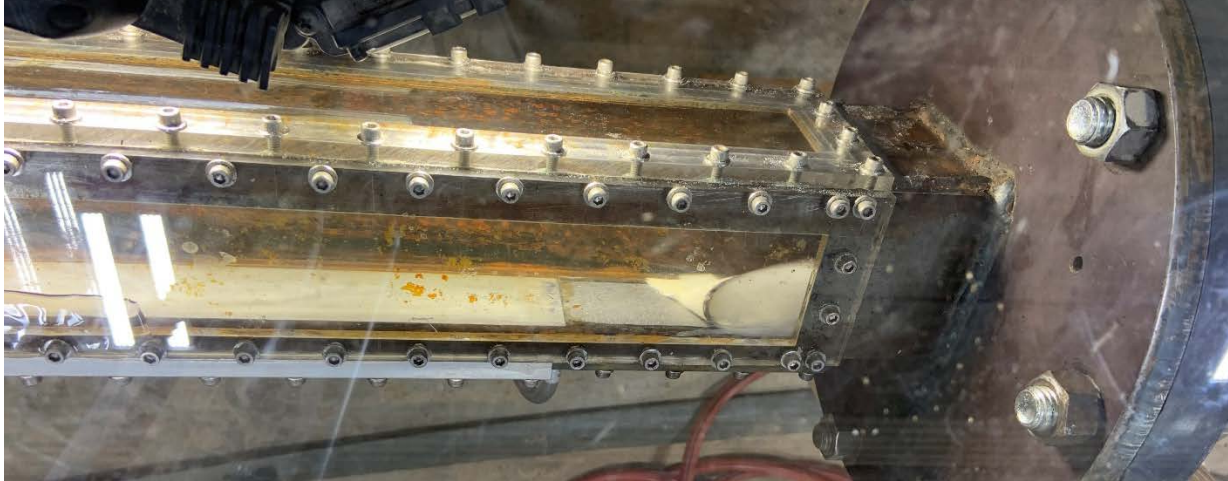
Figure 14 Photo of Polyurethane sample at high approach velocity, near complete failure. Flow is left to right.

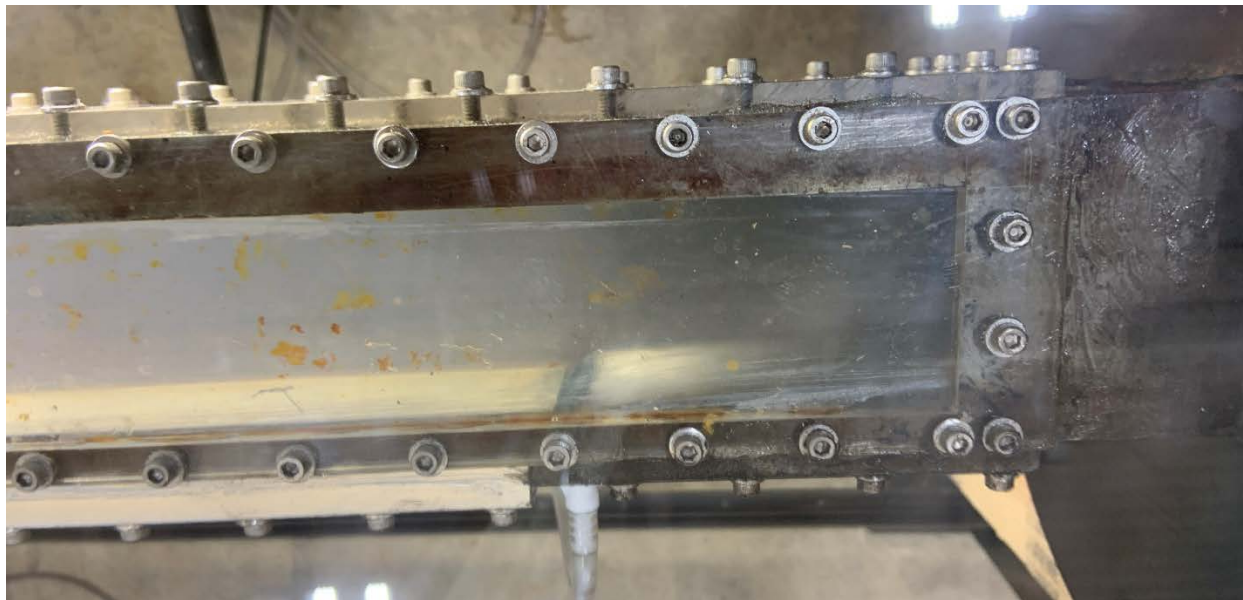
Test results of the Cavitation resistant lining samples showed better performance than the Polyurethane samples under the same test conditions without failure or any indications of delamination. Each sample was exposed to maximum uplift pressures of approximately 6 psi at approach velocities near 55 ft/s. Unfortunately, velocity profiles near the boundary were not able to be measured to compare calculated stagnation pressure with measured uplift pressure. The time series in Figure 15 shows that uplift pressures directly corresponded with approach velocities over the full range. Also, there was little variation in uplift pressure at each flow setting suggesting that gradual delamination did not occur. A longer exposure time at each setting in future tests would help confirm this finding. Visually, the upstream flap appeared to be very flexible (Figure 16) and not prone to cracking or detachment as seen with the Polyurethane coatings.

Figure 16 Photo of Cavitation resistant lining sample at high approach velocity. The upstream flap is bent backward and caused cavitation as seen by the white cloud of bubbles formed off the top edge of the coating flap. Flow is left to right.

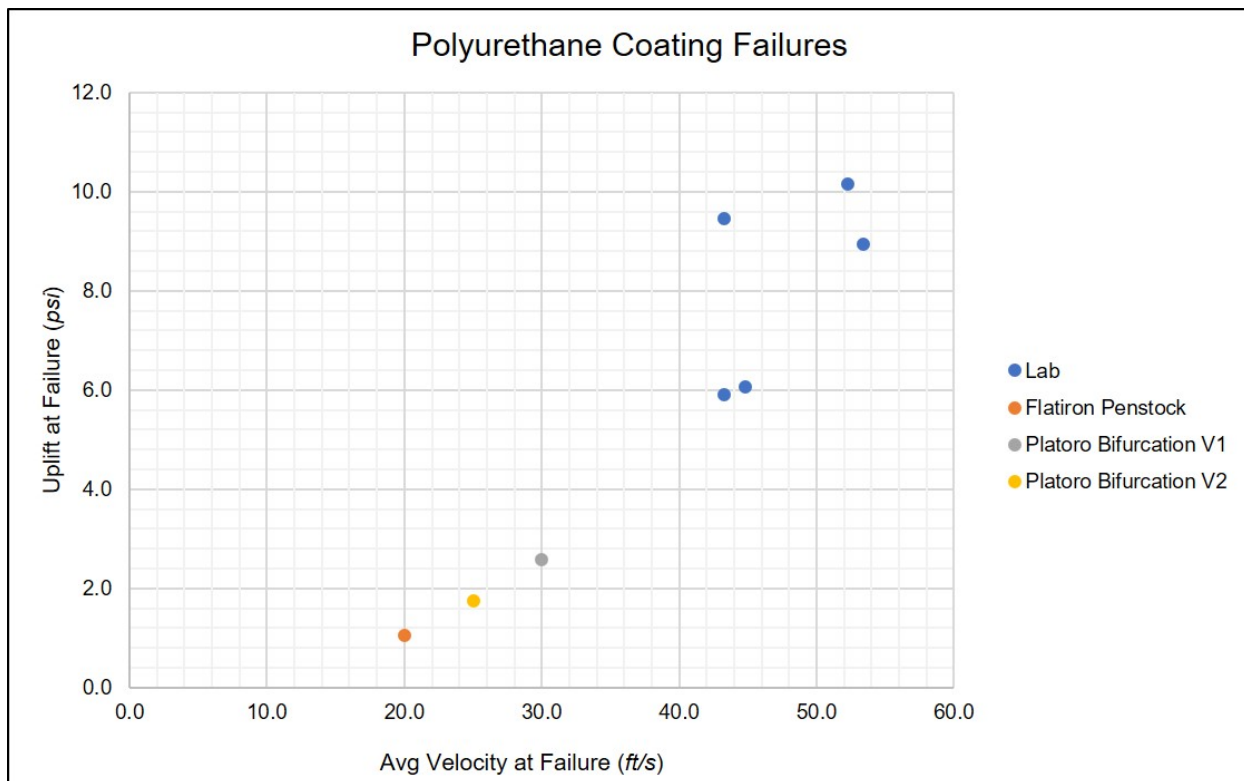
Failures in the laboratory occurred at higher uplift pressures and approach velocities compared to those in the field which could be due to several factors. First, actual uplift pressures were not measured in the field and ideal fully developed flow conditions were assumed to predict boundary layer velocities and stagnation pressures. More detailed analyses or numerical simulations may improve the accuracy of the fluid dynamics acting on the coating. Also, boundary layer velocities acting at the mid-height of the coating thickness were assumed in field uplift predictions. As shown in the laboratory tests the upstream edge of the Polyurethane coatings (same thickness in lab and field) would lift into the flow where it was exposed to higher velocities than those estimated at the coating mid-height. In some cases, the coating slowly peeled away, and the height of the upstream edge grew further increasing the measured uplift until the coating finally failed. A similar process likely happened in the field where the upstream edge of the coating lifted into the flow causing the actual uplift force to be significantly greater than what was predicted by the boundary layer velocity at the mid-height of the coating thickness.

Figure 17 Comparison of uplift pressures at failures for laboratory and field case results from Flatiron and Platoro dams.
