# Methods of Relining Penstocks and Pipe Structures: Summary of Collaborative Efforts

Science and Technology Program  
Research and Development Office  
Final Report No. ST-2022-19188-02  
Technical Memorandum No. 8540-2022-01

# **Methods of Relining Penstocks and Similar Structures: Summary of Collaborative Efforts**

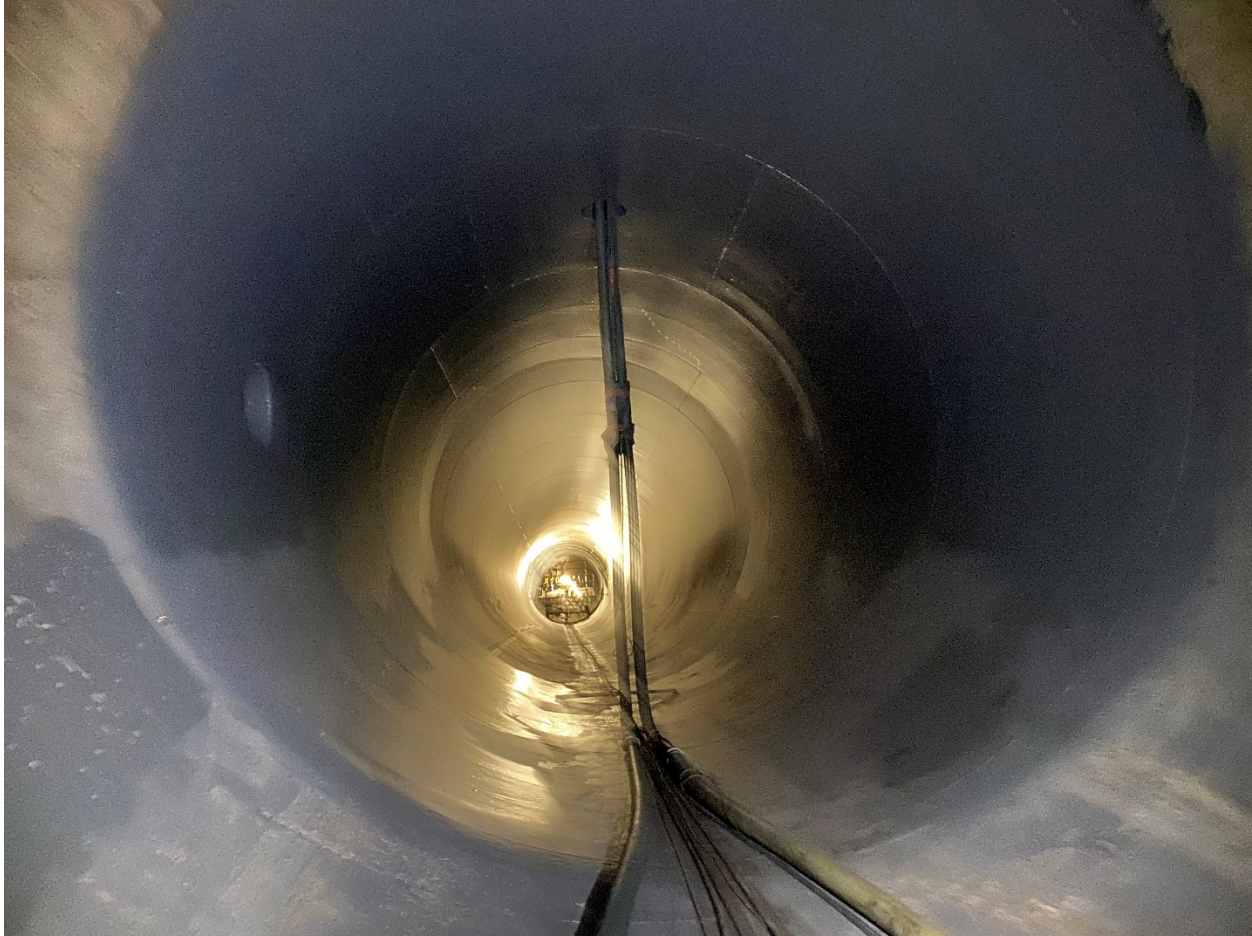
Figure 1. Grand Coulee Unit G8 penstock newly applied lining, from the concrete/steel transition to scroll case.

Two Reclamation relining projects have used manned robotics technologies: Grand Coulee G1-18 penstocks and the John W. Keys III Pump-Generating Plant (Keys PGP) P1-6 and PG7-12 discharge tubes. After relining, only a handful of coating defects (holidays) were found, the product was high quality, and the job was completed safely. Figure 1 shows the final product using robotics application equipment.

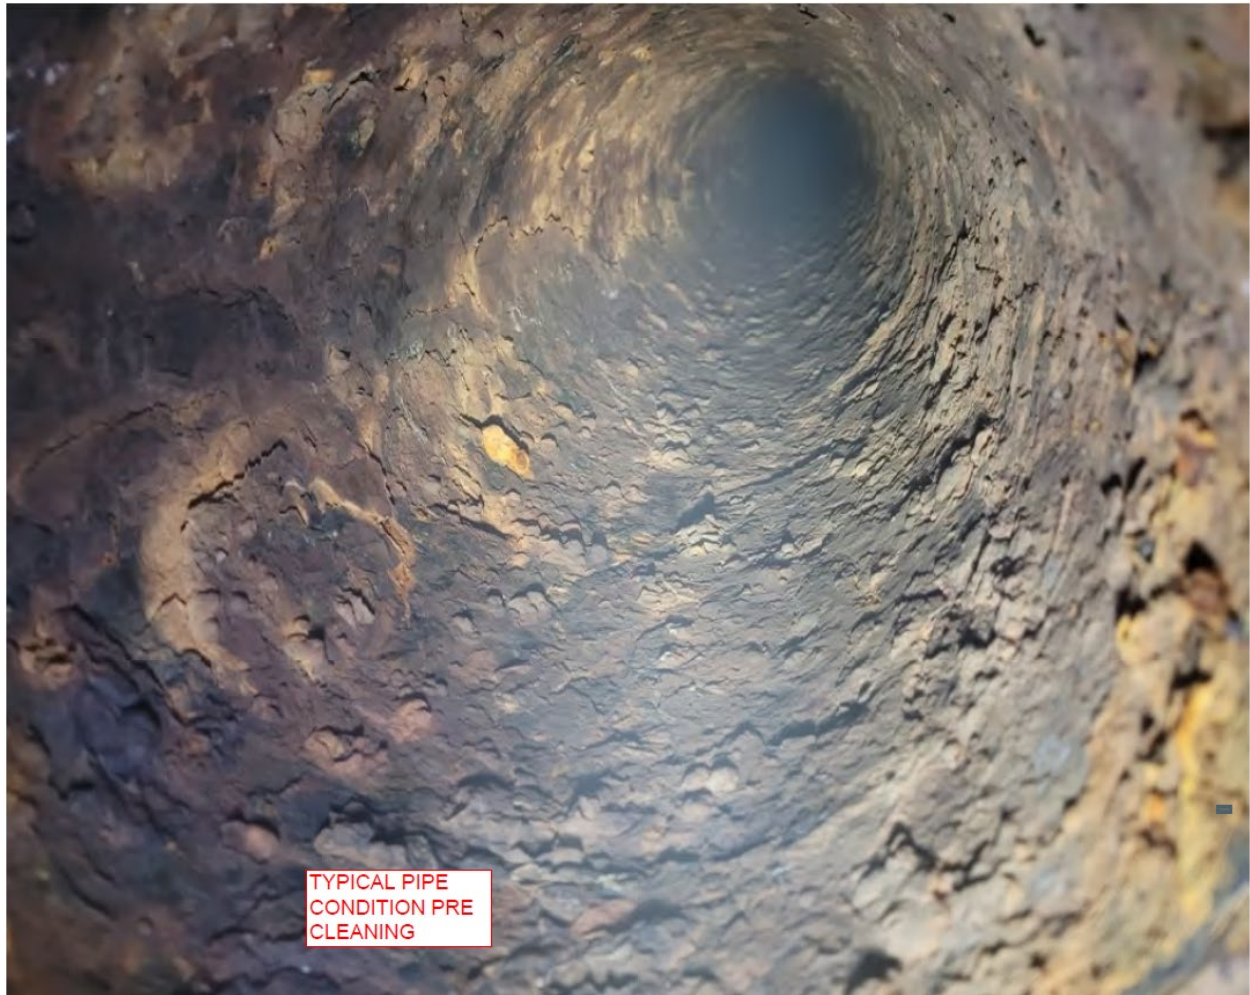
Figure 2. Typical small diameter pipe condition before cleaning at John W. Keys III. Pump-Generating Plant small diameter piping. (Image reprinted with the permission of Hartman Walsh Industrial Services)

For non-structural repairs, relining was selected as a proactive measure to mitigate the corrosion of the Keys PGP discharge tubes relining project small diameter piping. Figure 2 shows the condition before rehabilitation with significant rust blooms and scale on the interior pipe surfaces [8]. Waterjet cleaning using a small robot was performed and a surface-tolerant epoxy coating was applied using small robotic application equipment. Upon waterjet cleaning, some pipe sections looked fair (Figure 3) while other pipe sections had significant metal loss (Figure 4) [8]. Figure 5 shows the typical pipe section after recoating with the epoxy. Figure 6 shows a screen shot of the CCTV camera feed during inspection further into the small diameter pipes.

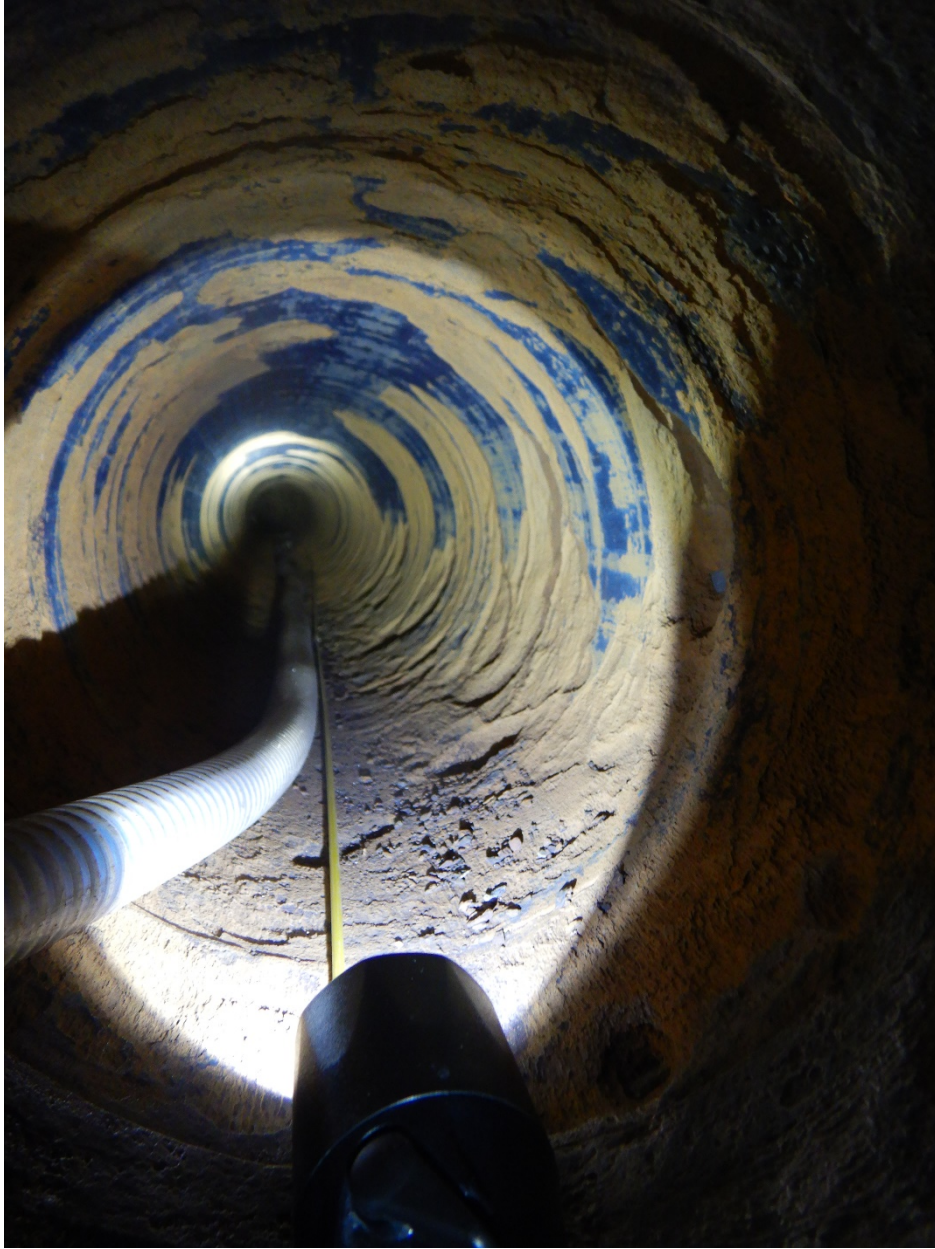
Figure 4. Significant metal loss of horizontal bypass filling piping at John W. Keys III. Pump-Generating Plant. (Image reprinted with the permission of Hartman Walsh Industrial Services)

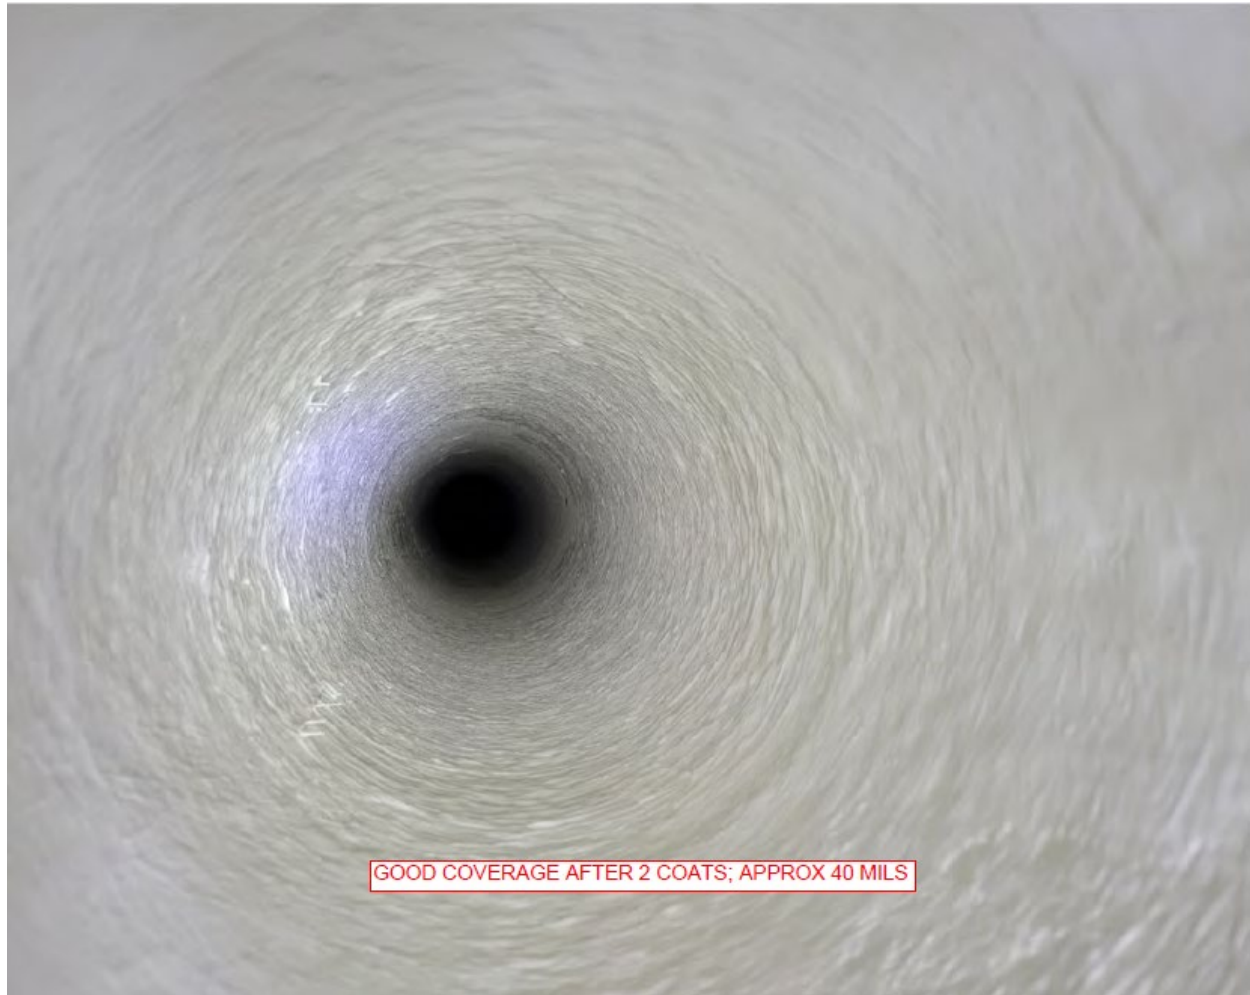
Figure 5. Typical condition after two coats of lining in the small diameter piping at John W. Keys III. Pump-Generating Plant. (Image reprinted with the permission of Hartman Walsh Industrial Services)

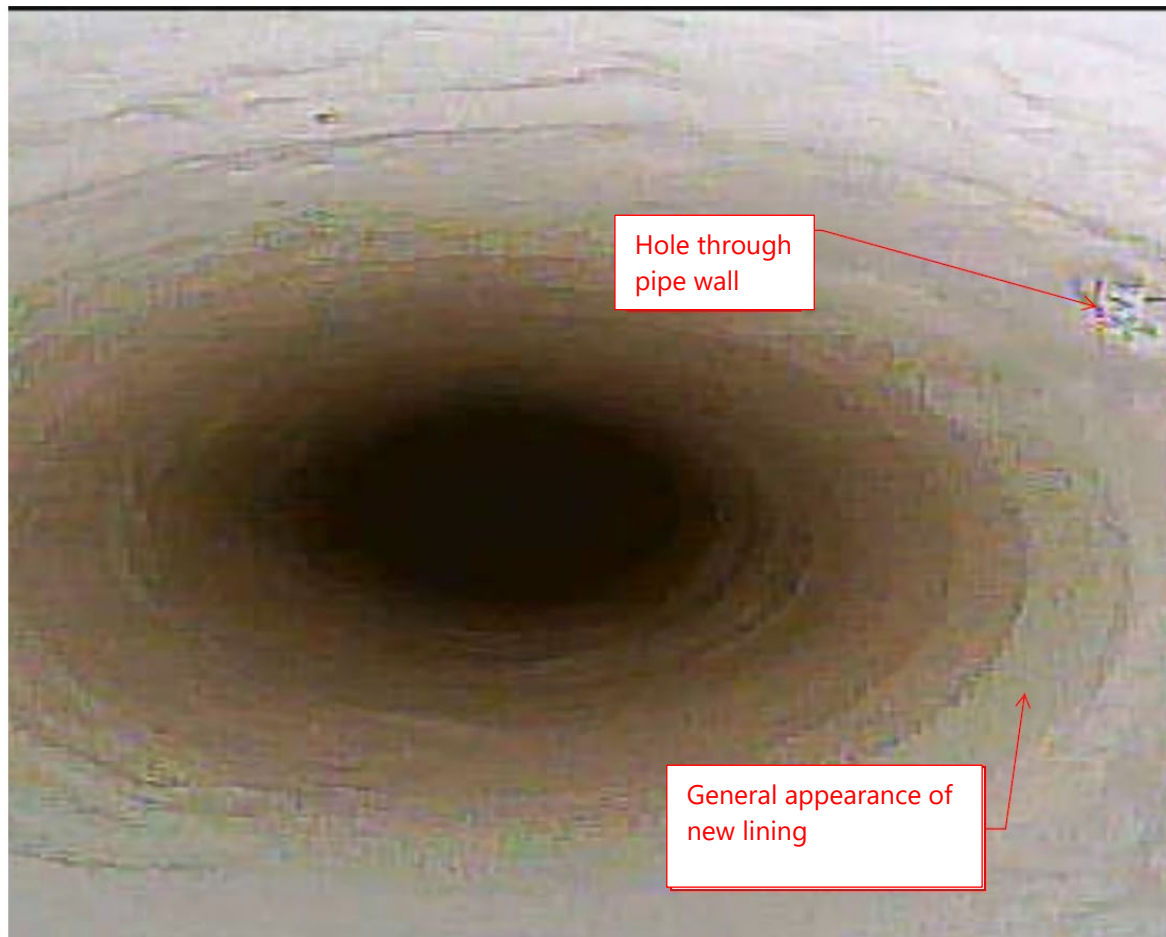
Figure 6. CCTV video feed after lining application at John W. Keys III Pump-Generating Plant of small diameter piping. (Image reprinted with the permission of Hartman Walsh Industrial Services)
