Appendix 1. Science & Technology #1751 Proposal

Impacts of Grade Control Structure Installations on Hydrology and Sediment Transport as an Adaptive Management Strategy during Climate Change

Appendix 4. Heard Scout Pueblo Site Conditions, Monitoring Installations and Field Activities

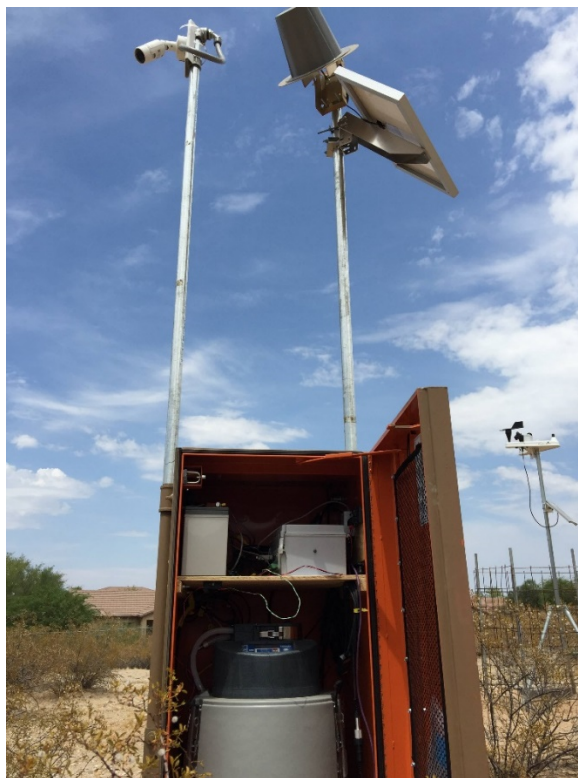
June 27, 2017 USGS install surface water monitoring station at HSP study area.

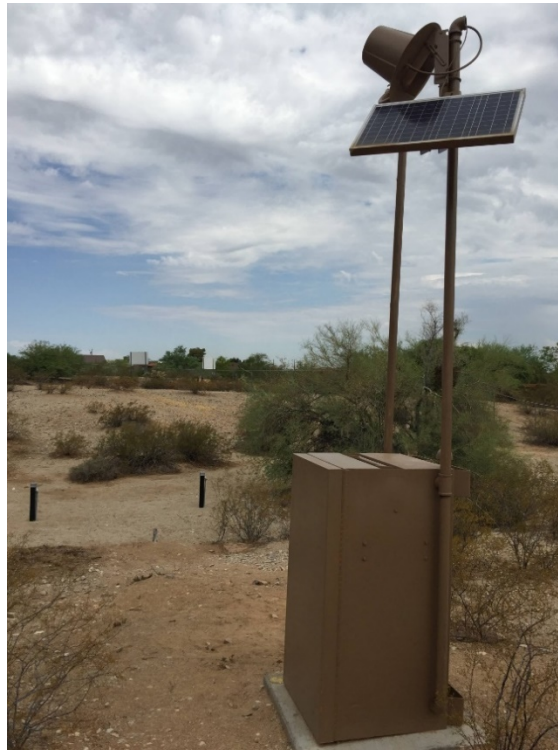
USGS surface water datalogger housing, a USGS surface water sensor at the edge of the channel, and groundwater wells HSP-1 and HSP-2. Photo looking north.

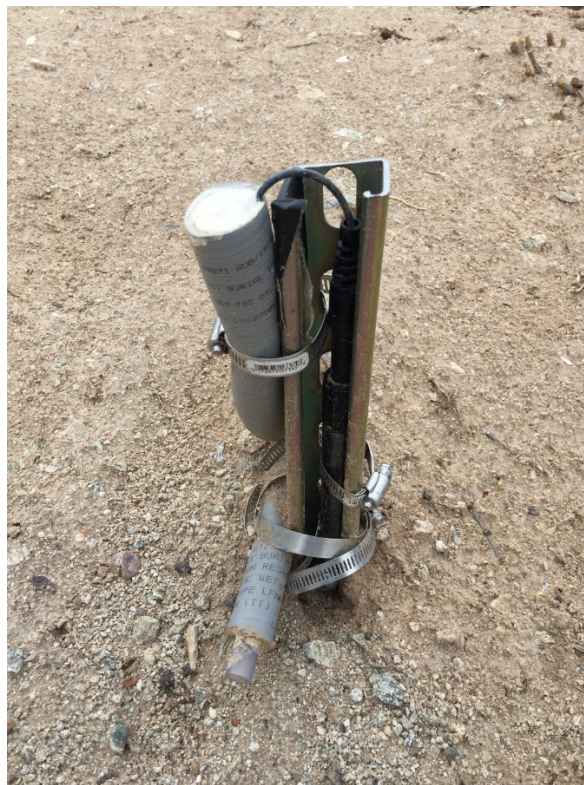
USGS main surface water sensor connected to water monitoring station.

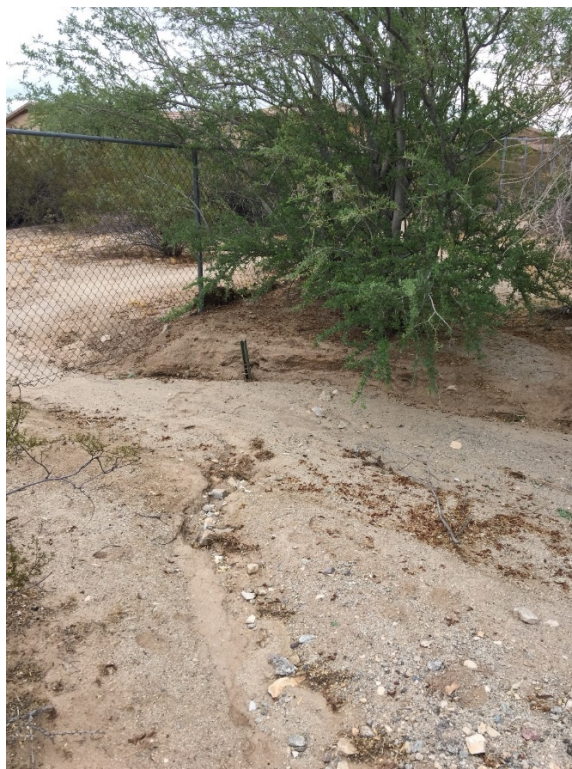
Location of USGS downstream surface water sensor, adjacent to HSP fence line.

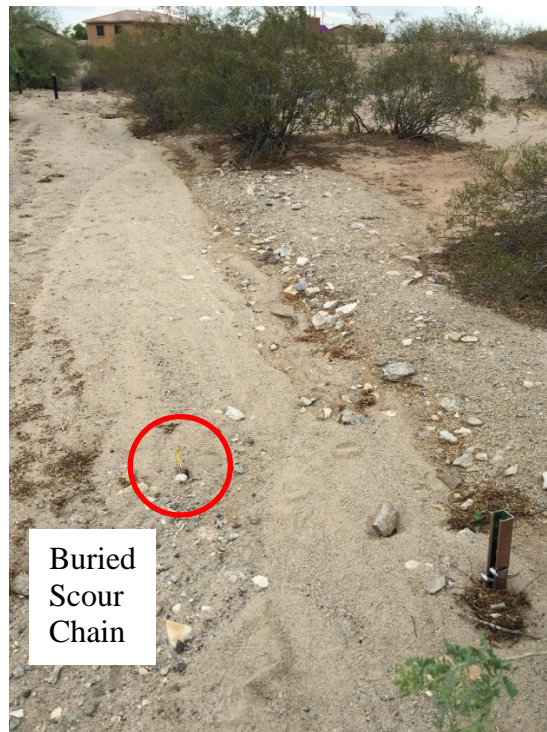
July 28, 2017 USGS Scour Chain location and upstream surface water monitoring sensor. Evidence of minor flow. See downstream HSP wells. Photo looking downstream and east.

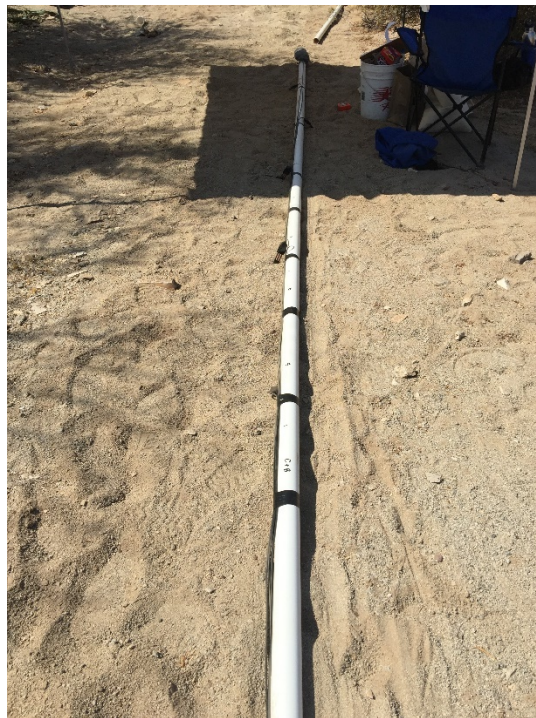
July 7, 2017 HSP-2 well casing with soil moisture sensors attached to casing before installation in the drill borehole.

Installed 2 in. dia. blank PVC from 0.0-19.0 ft.; slotted casing from 19.0-20.0 ft.; end cap from 20.0-20.5 ft. Six soil moisture sensors attached to the outside of the PVC at the following depths:

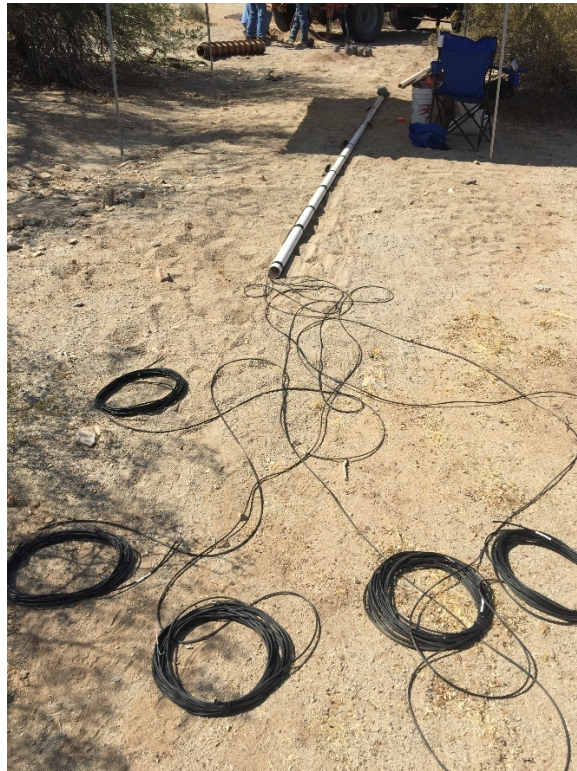
July 7, 2017 HSP-2 well casing with soil moisture sensor cables before installation in the drill borehole.

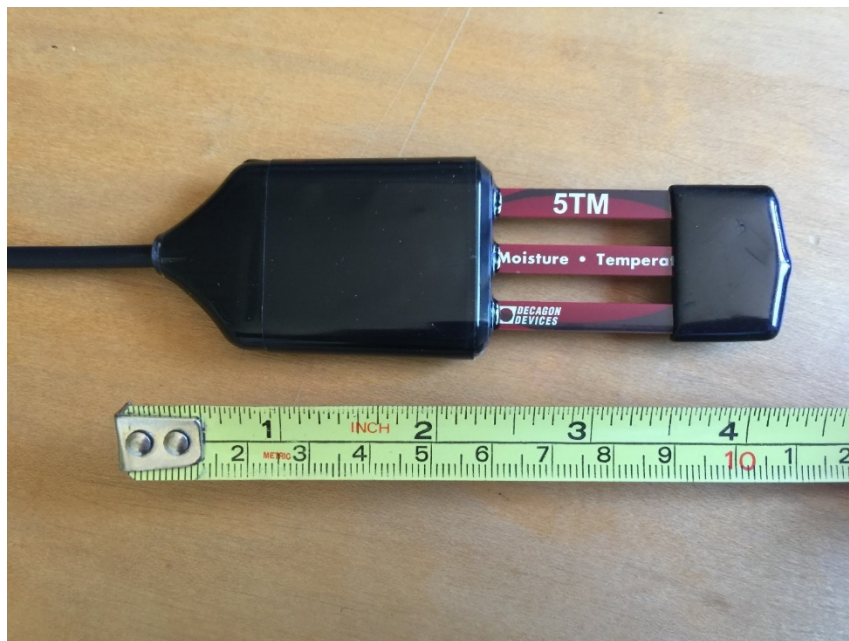
Soil moisture sensor installed outside of the HSP-2 well casing.

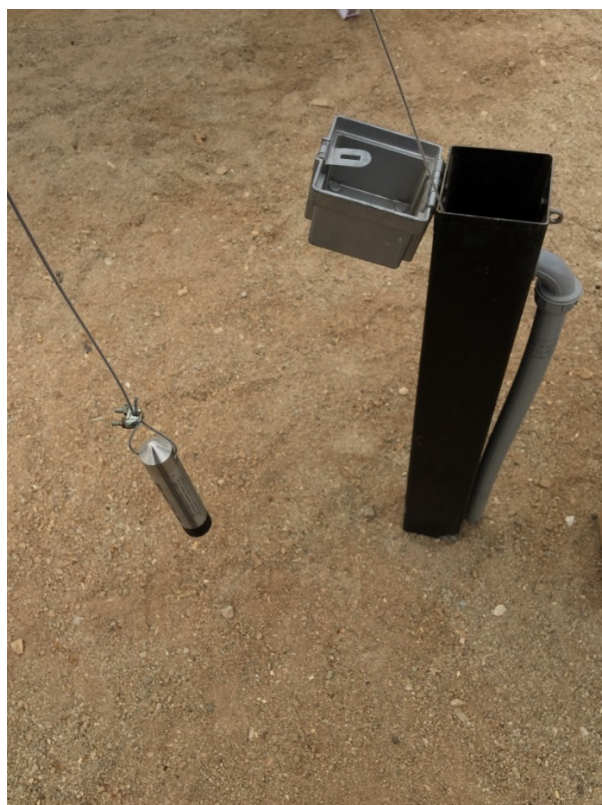
July 7, 2017 HSP-2 Transducer installation in monitor well HSP-2.

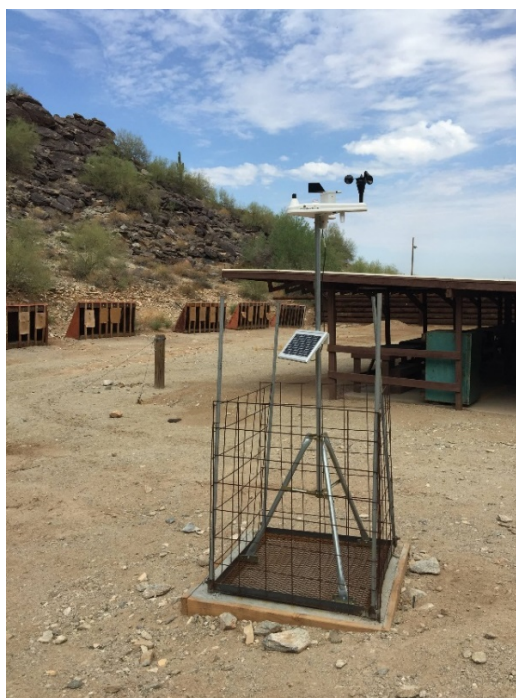
June 29, 2017 Upgradient Weather Hawk installation near the surface water and groundwater monitoring sites. Photo looking northeast.

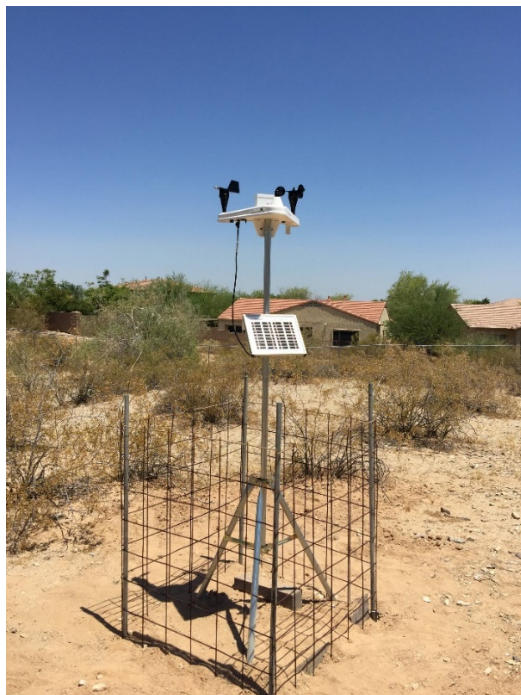
June 29, 2017 Downgradient Weather Hawk installation near the surface water and groundwater monitoring sites. Photo looking northeast.

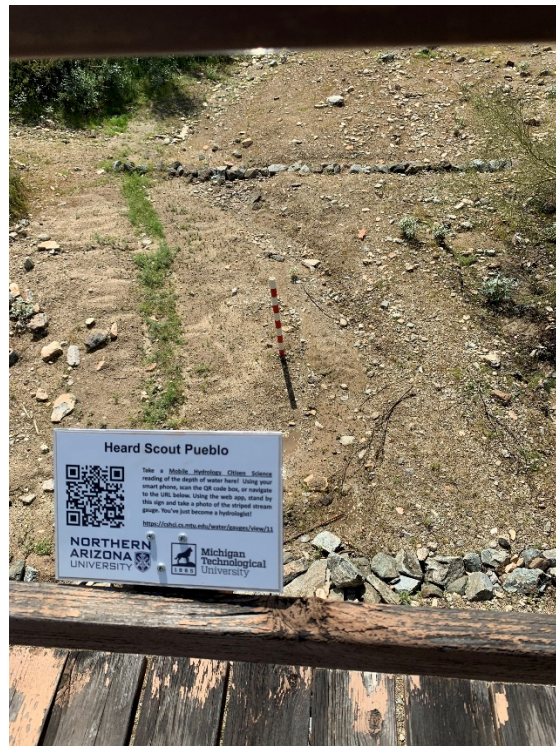
Northern Arizona University Citizen Science Stage, take a photo during stormflow and send it in.

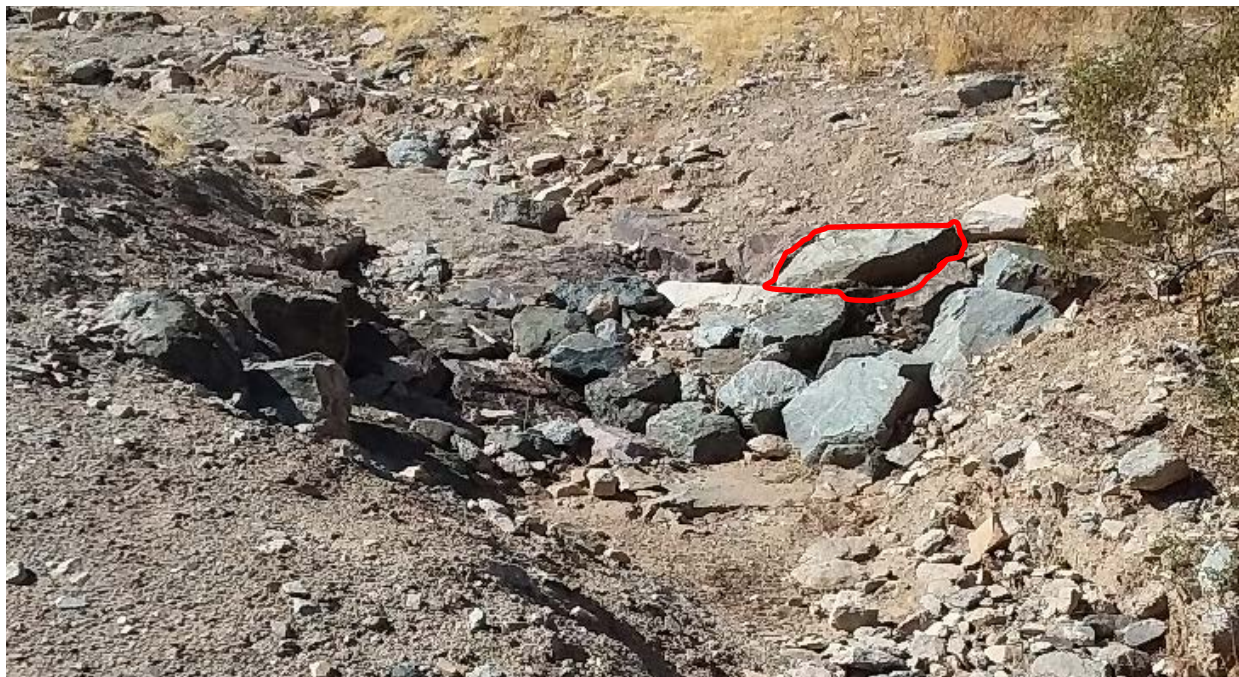
Grade Control Structure #1 Looking Upstream after installation in 2018.

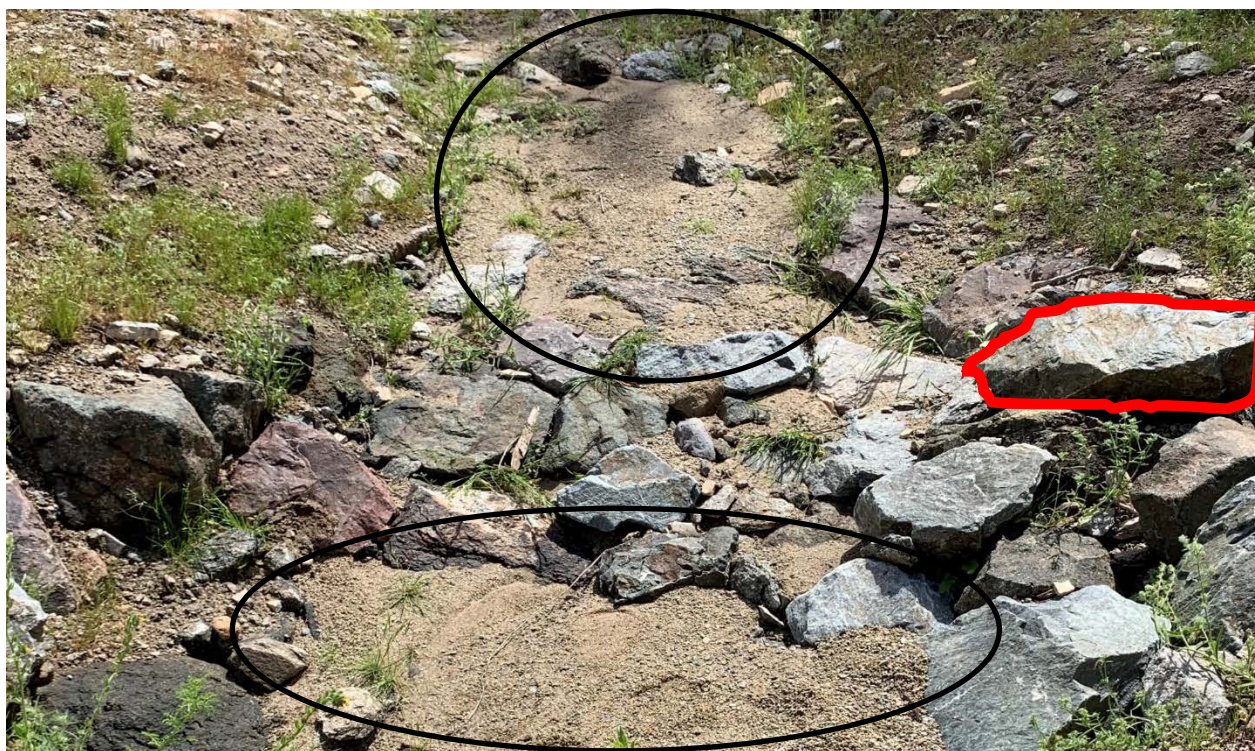
Sedimentation at Grade Control Structure #1 Looking Upstream, March 2020.

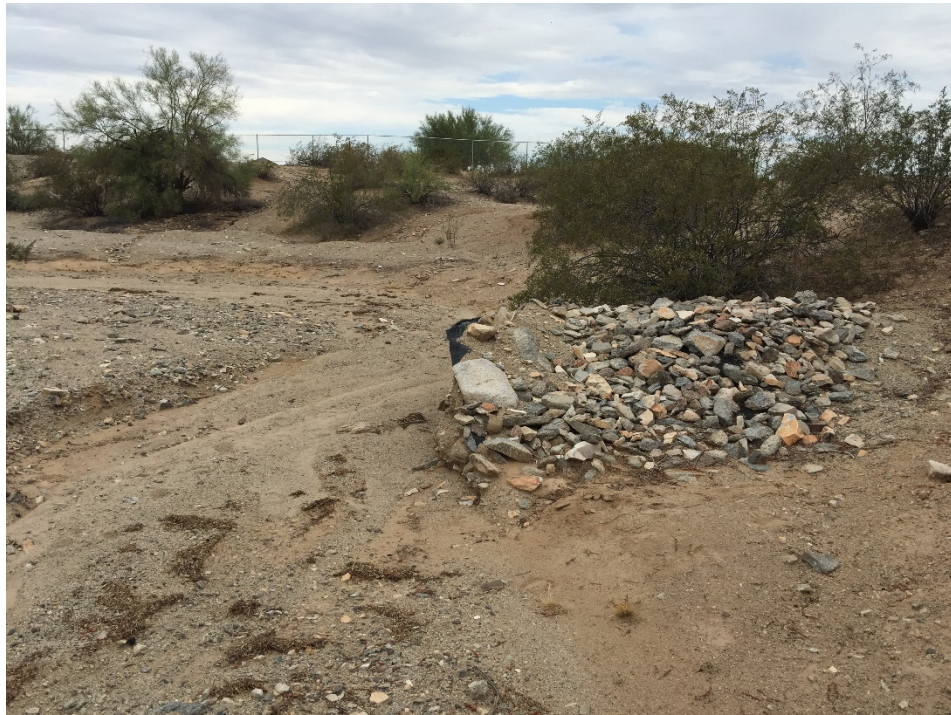
Remnant grade control feature in HSP channel.
