Technical Report No. SRH-2010-12

## **Bighorn Lake-Yellowtail Dam 2007 Sedimentation Survey**

September 2010

**Pick-Sloan Missouri Basin Program, Montana  
Fort Smith, Montana**

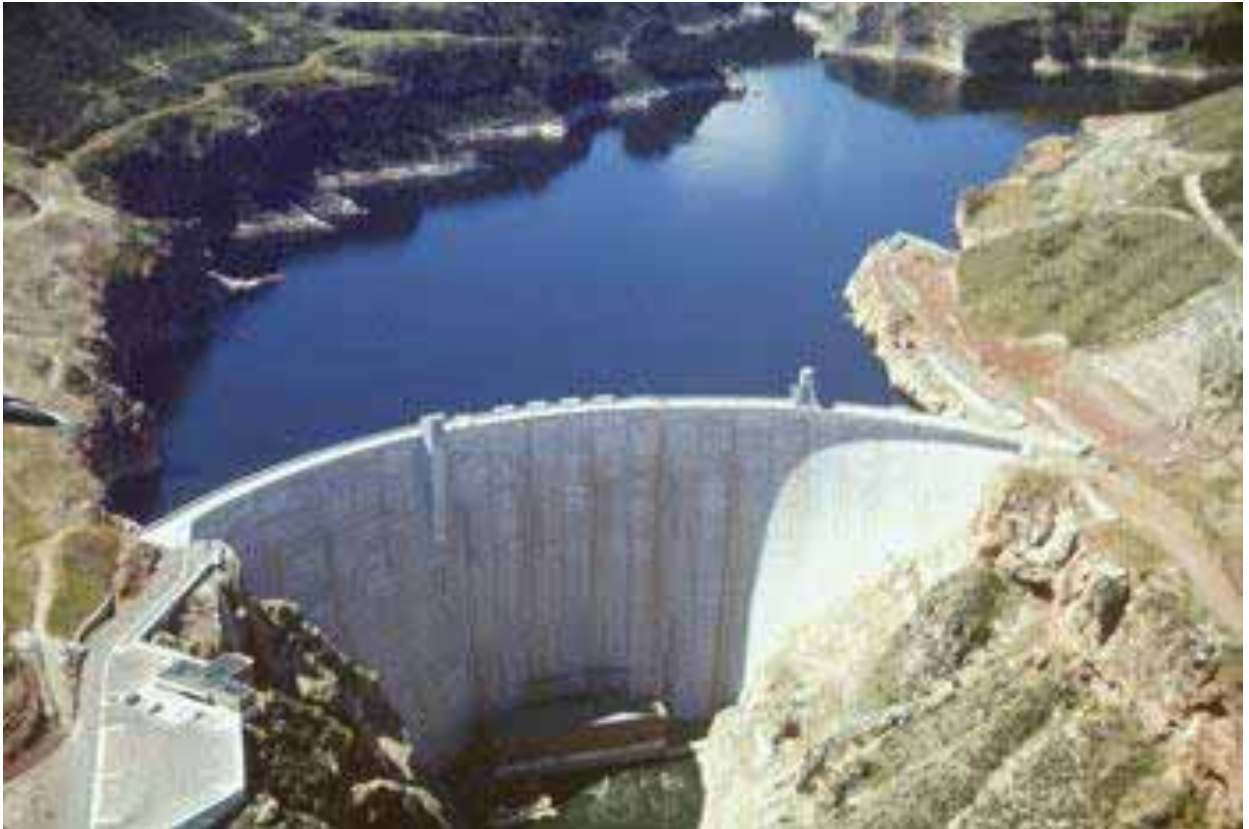
Yellowtail Dam is a concrete thin-arch dam that was constructed between 1961 and 1966 (Figure 2). The dam's dimensions are:

Hydraulic height <sup>1</sup>	494 feet	Dam crest elevation	3,660.0 feet <sup>2</sup>
Structural height	525 feet	Parapet crest elevation	3,664.0
Crest length	1,480.0 feet

**Figure 2 - Downstream Face of Yellowtail Dam.**

The spillway is located in the left abutment of the dam and consists of an unlined inlet channel, an intake structure, a concrete-lined tunnel transition, a concrete-lined tunnel ranging in diameter from 32 to 40.5 feet, and a stilling basin. Discharge through the spillway is controlled by two 25-foot by 64.4 foot radial gates with a total discharge capacity of 92,000 cubic feet per seconds (cfs) at reservoir elevation 3,660.0. The spillway crest elevation is 3,593.0 and when closed, the top gate elevation is 3,657.0.

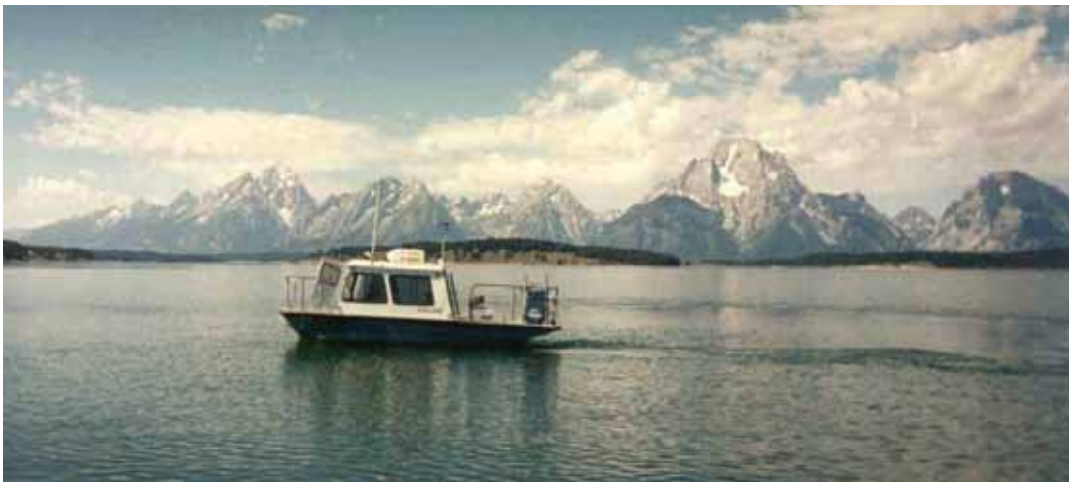
The hydrographic survey equipment was mounted in the cabin of a 24-foot trihull aluminum vessel equipped with twin in-board motors (Figure 4). The hydrographic system included a GPS receiver with a built-in radio, depth sounders, a helmsman display for navigation, a computer, and hydrographic system software for collecting the underwater data. An on-board generator supplied power to all the equipment. The shore equipment that provided DGPS included a second GPS receiver with an external radio. The GPS receiver and antenna were mounted on a survey tripod over a known datum point and a 12-volt battery provided power for the shore unit. The majority of the bathymetric survey was conducted with DGPS provided by a leased commercial service.

**Figure 4 - Survey Vessel With Mounted Instrumentation on Jackson Lake in Wyoming.**

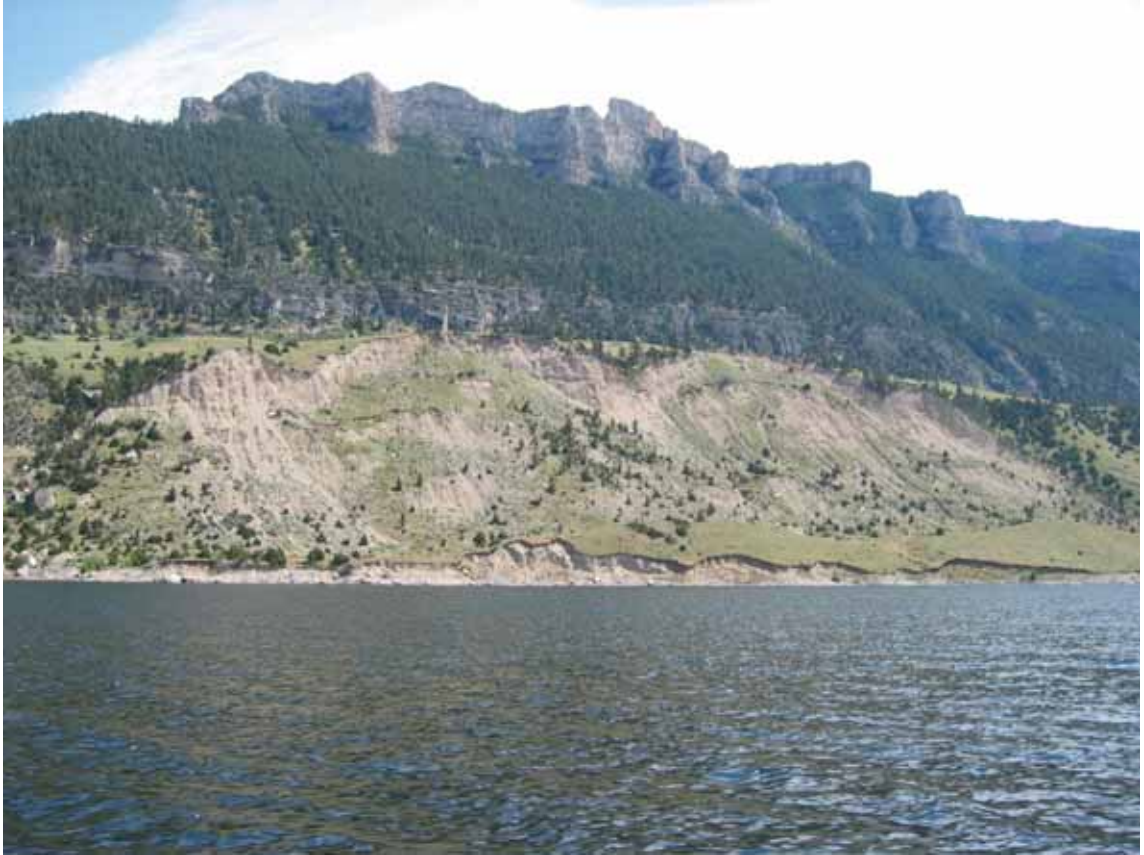
The range line plot comparisons illustrate some interesting results when comparing the original, 1982, 2000 and 2007 surveys. The plots indicate minimal to no change at range line 2 and 2A since the 1982 survey. From the multibeam bottom images a high point or rock slide was located upstream of range line 3A and about 1.7 miles upstream of range line 3, Figures 26 through 28. The slide created a 20-foot high point, measured in 2007, that hindered the density currents from carrying the bottom depositing sediments downstream towards the dam. Changes measured at range line 3 indicate that some sediment has crept over the barrier and deposited downstream with the toe of the deposit about 3,500 feet downstream of range line 3.

**Figure 26 - Bighorn Lake Landslide Area Upstream of Range Line 3A.**
