— BUREAU OF —  
RECLAMATION

Final Report No. ST-2026-24005-02, 8540-2026-16

# Selecting Primers for Cavitation Resistant Coating Systems

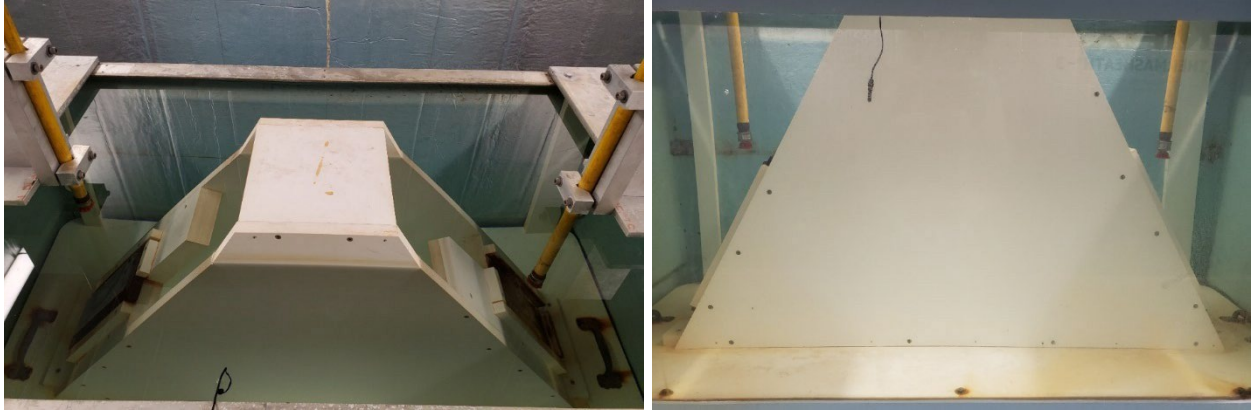
The test set-up is arranged so that two specimens could be tested simultaneously as shown in Figure 2. The test procedure is optimized so that the chosen flows and pressures create light frosting damage to stainless steel 316L and moderate pitting to mild steel, shown in Figure 3. Figure 4 shows minimal pitting to 308/309 stainless steel weld overlay in a 40-hr period of exposure. The testing parameters (listed above) were set to show cavitation damage on mild steel in 16 hrs and measurable damage in 40 hrs of testing, shown in Figure 5.

Figure C- 2. Top view (left) and side view (right) of submerged jet test set-up.

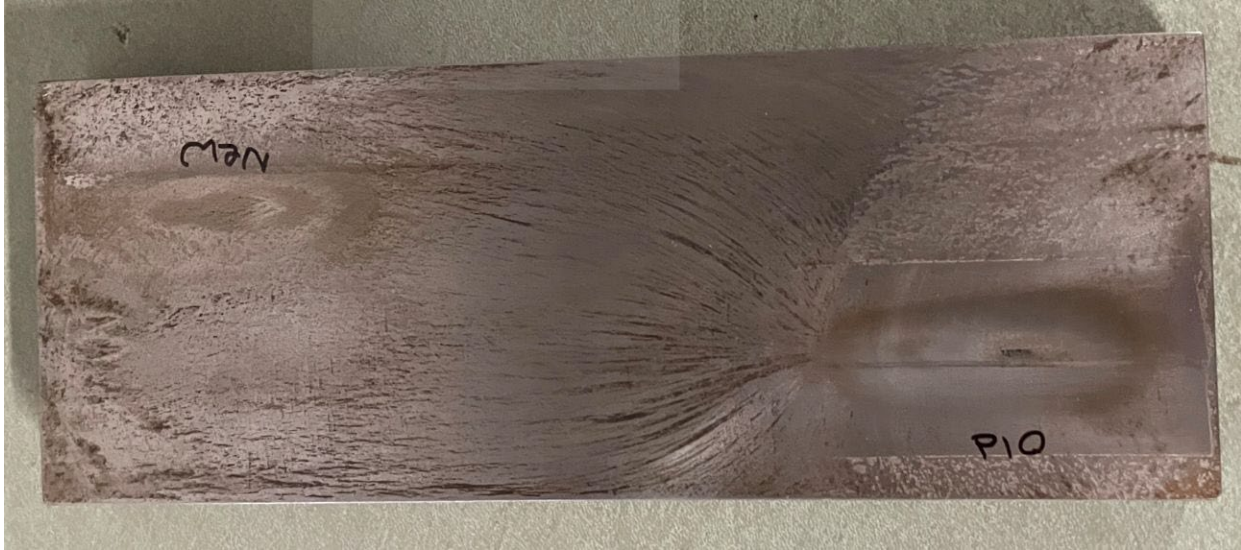
Figure C- 6. Photo of mild steel after 40-hrs of cavitation testing.

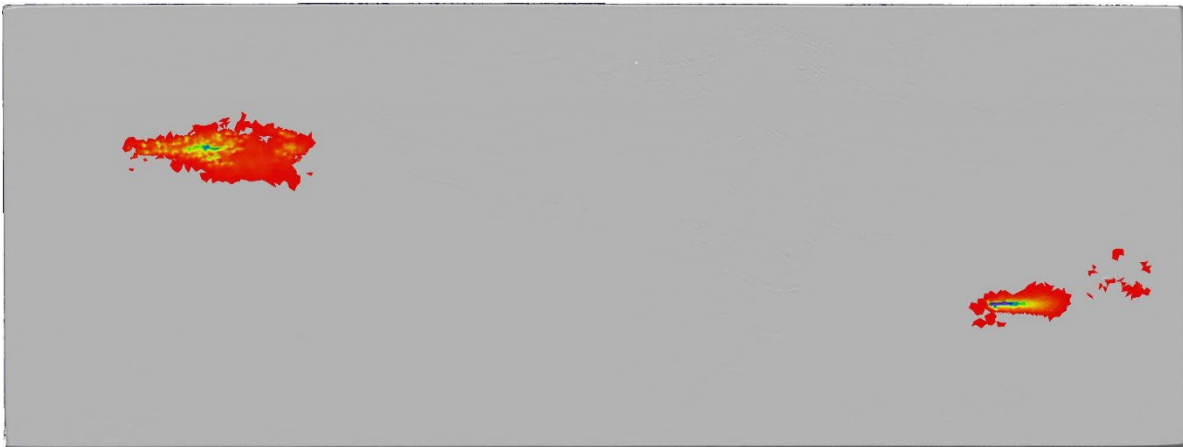
Samples expected to pass the 40-hr test may be tested for long-term durability up to 200 hrs. For detailed analysis, a 3D Faro laser scanner will be used to monitor material loss over time. Figures 6 and 7 show a cavitated sample and the Faro laser scanned that is produced for analysis. Figures 8 and 9 show the analytical capabilities of the Faro laser on cavitated samples.

Figure C- 7. Image of material loss scanned by a 3D Faro Laser
