Investigating Newly Formulated Polysiloxane Coating Systems with Improved Erosion and Impact Properties

Science and Technology Program
Research and Development Office
Final Report No. ST-2024-21019-01
TM 8540-2024-54

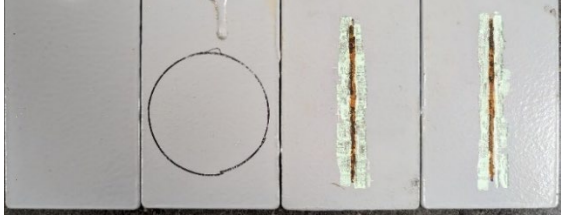
Exposure Type	Specimen Images and Visual Inspection Observations	Rust Creep Result (in)	Score
DI Immersion

<p data-bbox="651 1593 850 1623">No visual defects</p>	0.02	Good

Note: The images for DI immersion, HAR immersion, PRO cyclic, and BOR cyclic represent panels prepared pre-exposure and for EIS and rust creep testing from left to right. The images for QUV and FOG represent a panel prepared pre-exposure, a panel after exposure without a scribe, and a rust creep testing panel from left to right.

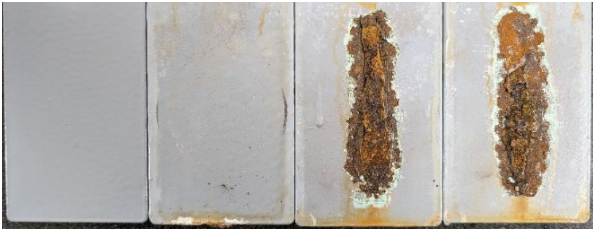
<p data-bbox="647 819 854 846">No visual defects</p>	0.43	Fair
BOR Cyclic

Rust creep testing results for the PRO and BOR panels were fair. Slightly more rust creep on the PRO and BOR panels would have resulted in a poor rating. Rust creep results indicate satisfactory long term corrosion resistance performance.

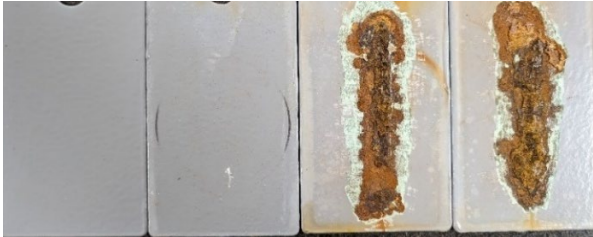
<p data-bbox="647 1125 854 1152">No visual defects</p>	0.46	Fair
QUV Cyclic

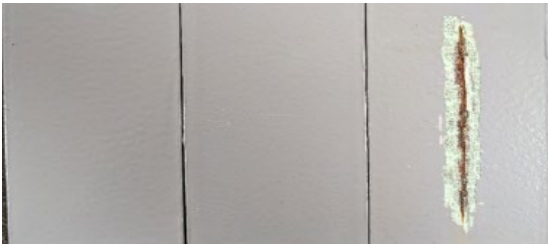
<p data-bbox="647 1438 854 1465">No visual defects</p>	0.00	Excellent
FOG Cyclic

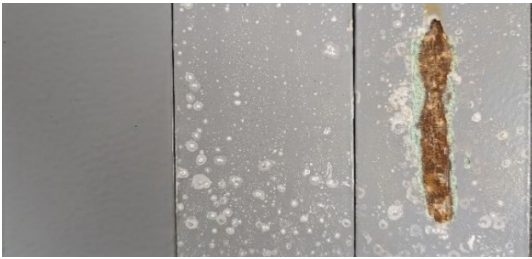
<p data-bbox="480 1759 1024 1787">No visual defects (salt material seen on panel)</p>	0.17	Good

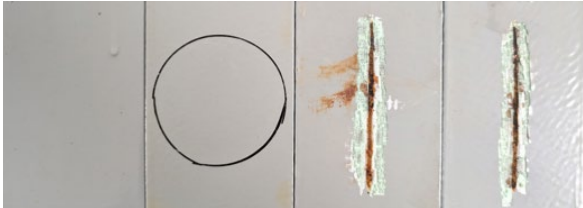
Exposure Type	Specimen Images and Visual Inspection Observations	Rust Creep Result (in)	Score
DI Immersion

<p data-bbox="647 663 852 695">No visual defects</p>	0.08	Good
HAR Immersion

Note: The images for DI immersion, HAR immersion, PRO cyclic, and BOR cyclic represent panels prepared pre-exposure and for EIS and rust creep testing from left to right. The images for QUV and FOG represent a panel prepared pre-exposure, a panel after exposure without a scribe, and a rust creep testing panel from left to right.

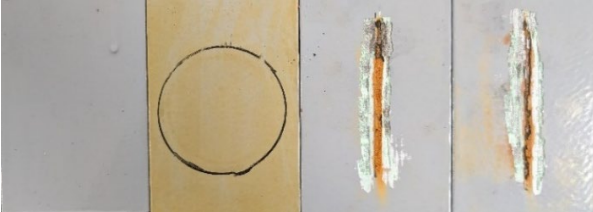
<p data-bbox="647 947 852 978">No visual defects</p>	0.05	Good
PRO Cyclic

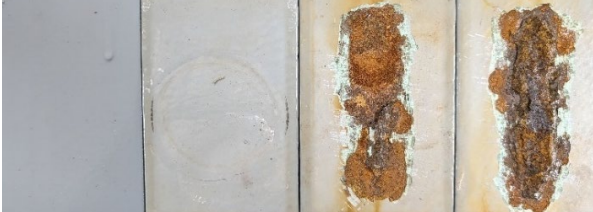
<p data-bbox="647 1234 852 1266">No visual defects</p>	0.55	Poor
BOR Cyclic

Rust creep testing results for the BOR and QUV panels were fair. The rust creep results for the PRO panels were poor, displaying the highest rust creep number of any panel in the test. Rust creep results indicate unsatisfactory long term corrosion resistance performance.

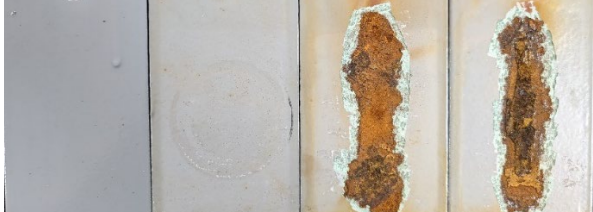
<p data-bbox="647 1522 852 1554">No visual defects</p>	0.39	Fair
QUV Cyclic

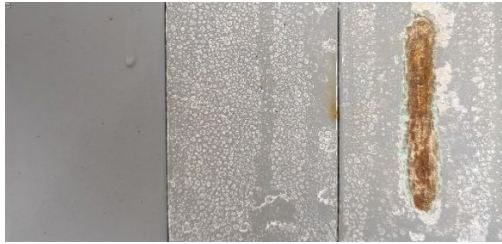
FOG Cyclic

<p>No visual defects (salt material seen on panel)</p>	0.21	Good
Test	Result	Score	
EIS (avg DI & HAR)	6.7 x10 ⁸ ohms @ 0.01 Hz	Good

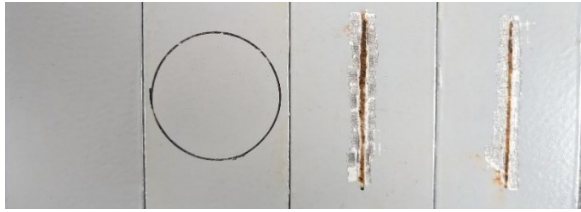
Exposure Type	Specimen Images and Visual Inspection Observations	Rust Creep Result (in)	Score
DI Immersion

<p data-bbox="646 1060 852 1094">No visual defects</p>	0.01	Good
HAR Immersion

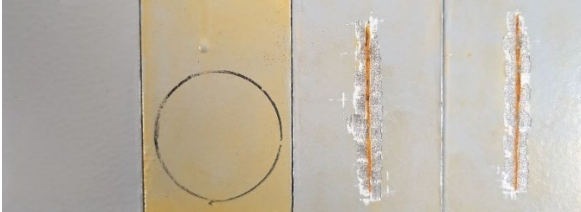
<p data-bbox="646 1339 852 1373">No visual defects</p>	0.01	Good
PRO Cyclic

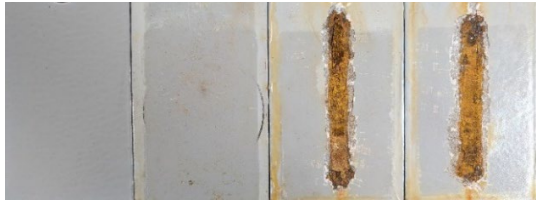
BOR Cyclic

No visual defects	0.23	Good
QUV Cyclic

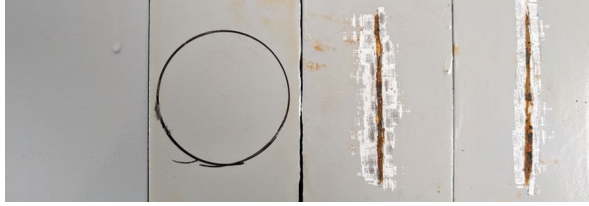
Exposure Type	Specimen Images and Visual Inspection Observations	Rust Creep Result (in)	Score
DI Immersion

<p>No visual defects</p>	0.03	Good
HAR Immersion

Note: The images for DI immersion, HAR immersion, PRO cyclic, and BOR cyclic represent panels prepared pre-exposure and for EIS and rust creep testing from left to right. The images for QUV and FOG represent a panel prepared pre-exposure, a panel after exposure without a scribe, and a rust creep testing panel from left to right.

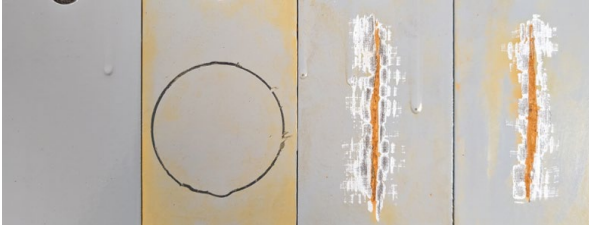
<p>No visual defects</p>	0.02	Good

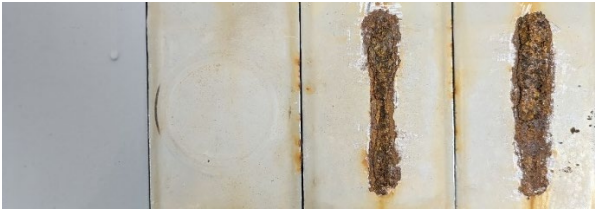
PRO Cyclic

<p>No visual defects</p>	0.27	Fair
BOR Cyclic

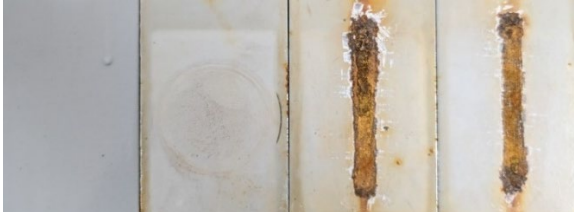
<p>No visual defects</p>	0.19	Fair
QUV Cyclic

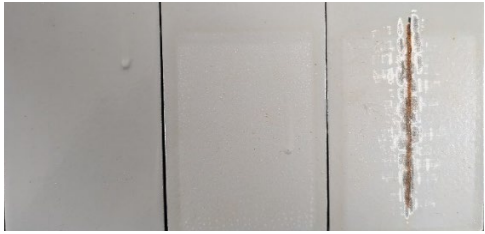
<p>No visual defects</p>	0.01	Fair
FOG Cyclic

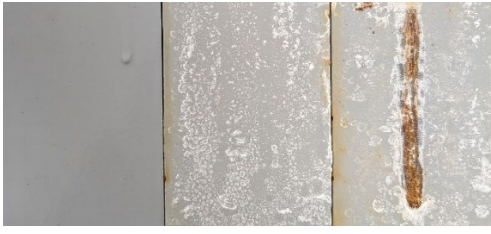
<p>No visual defects (salt material seen on panel)</p>	0.08	Excellent
Test	Result	Score	
EIS (avg DI & HAR)	1.6 x10 ⁹ ohms @ 0.01 Hz	Excellent

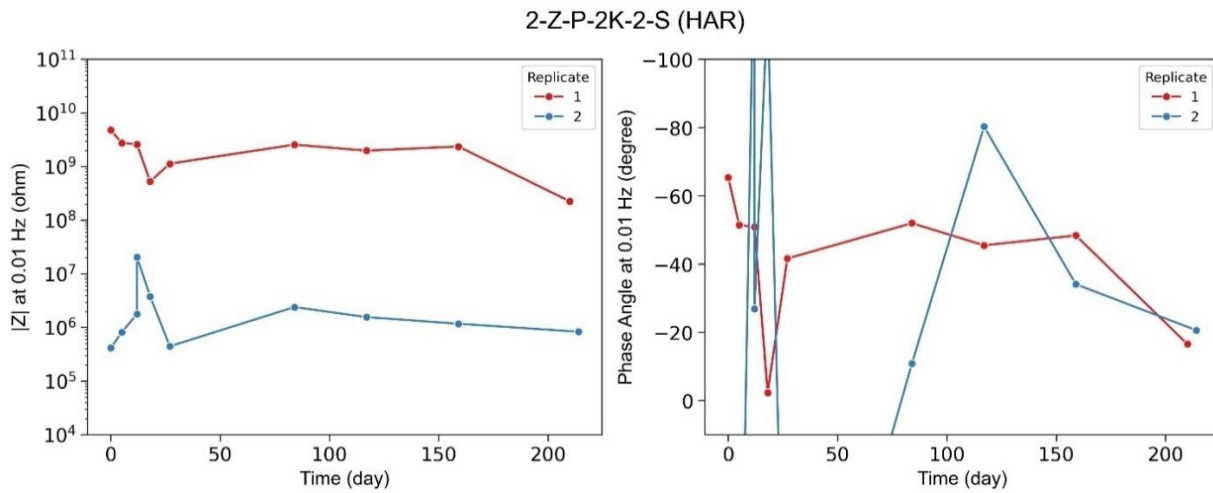
Figure 31: Impedance and phase angle over time (DI panels).

Figure 32: Impedance and phase angle over time (HAR panels).

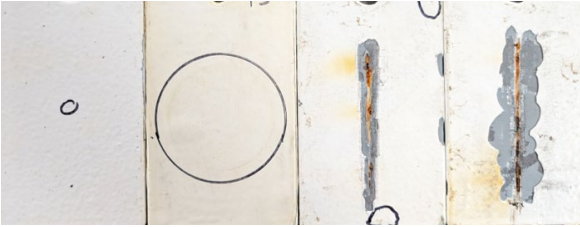
Exposure Type	Specimen Images and Visual Inspection Observations	Rust Creep Result (in)	Score
DI Immersion

<p>Multiple blisters on coating surface</p>	0.01	Poor (Blisters)
HAR Immersion

Note: The images for DI immersion, HAR immersion, PRO cyclic, and BOR cyclic represent panels prepared pre-exposure and for EIS and rust creep testing from left to right. The images for QUV and FOG represent a panel prepared pre-exposure, a panel after exposure without a scribe, and a rust creep testing panel from left to right.

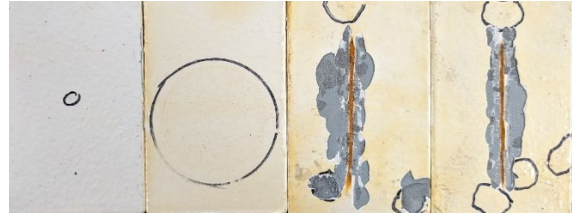
<p>Multiple blisters on coating surface</p>	0.01	Poor (Blisters)
PRO Cyclic

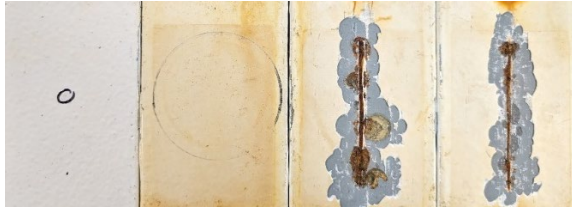
<p>No visual defects</p>	0.12	Excellent
BOR Cyclic

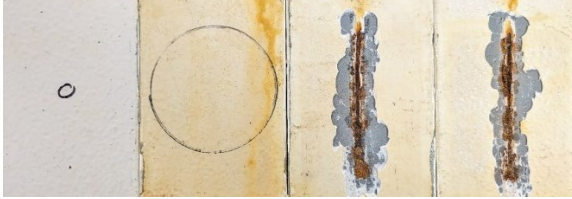
<p>No visual defects</p>	0.12	Excellent

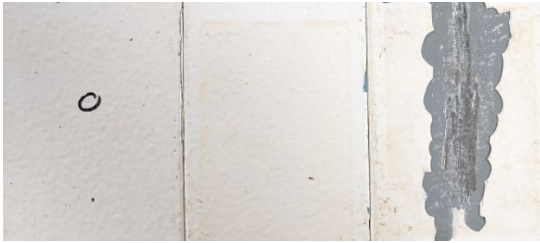
QUV Cyclic

No visual defects	0.00	Excellent
FOG Cyclic

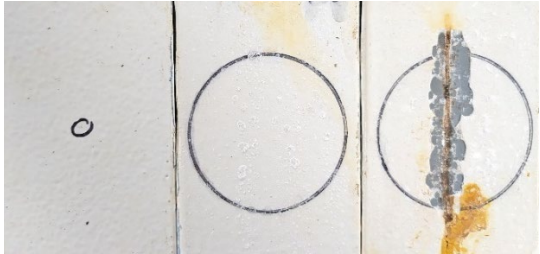
No visual defects (salt material seen on panel)	0.00	Excellent
Test	Result	Score	
EIS (avg DI & HAR)	3.2 x10 ¹⁰ ohms @ 0.01 Hz	Excellent

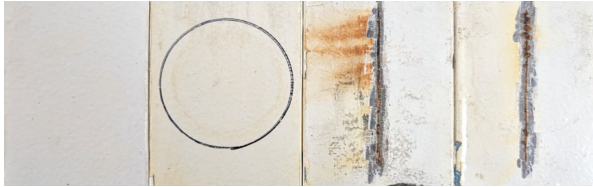
Exposure Type	Specimen Images and Visual Inspection Observations	Rust Creep Result (in)	Score
DI Immersion

<p data-bbox="646 1371 854 1398">No visual defects</p>	0.02	Good
HAR Immersion

Note: The images for DI immersion, HAR immersion, PRO cyclic, and BOR cyclic represent panels prepared pre-exposure and for EIS and rust creep testing from left to right. The images for QUV and FOG represent a panel prepared pre-exposure, a panel after exposure without a scribe, and a rust creep testing panel from left to right.

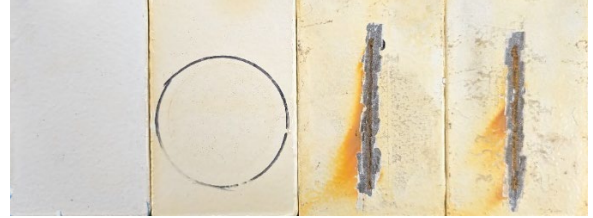
<p data-bbox="646 1656 854 1684">No visual defects</p>	0.01	Good

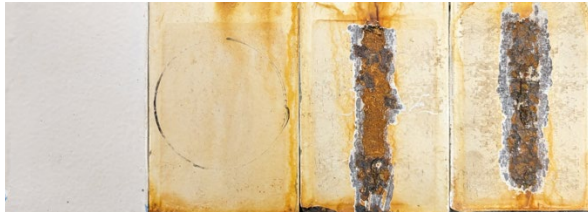
PRO Cyclic

<p>No visual defects</p>	0.26	Fair
BOR Cyclic

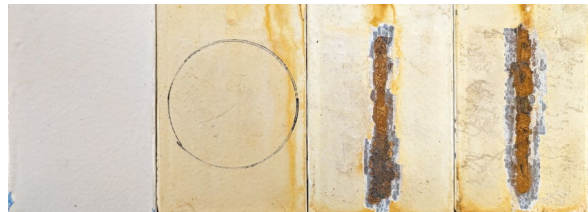
<p>No visual defects</p>	0.18	Good
QUV Cyclic

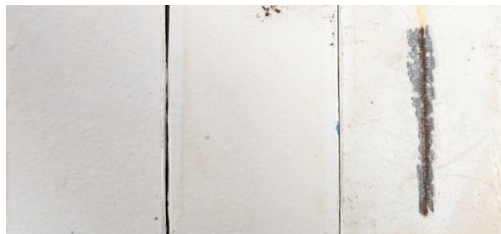
<p>No visual defects</p>	0.00	Excellent
FOG Cyclic

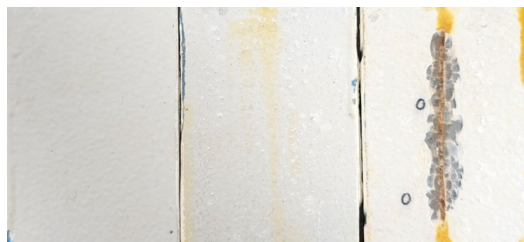
<p>Small imperfection on surface (no blistering)</p>	0.01	Excellent
Test	Result	Score	
EIS (avg DI & HAR)	4.4×10^{10} ohms @ 0.01 Hz	Excellent

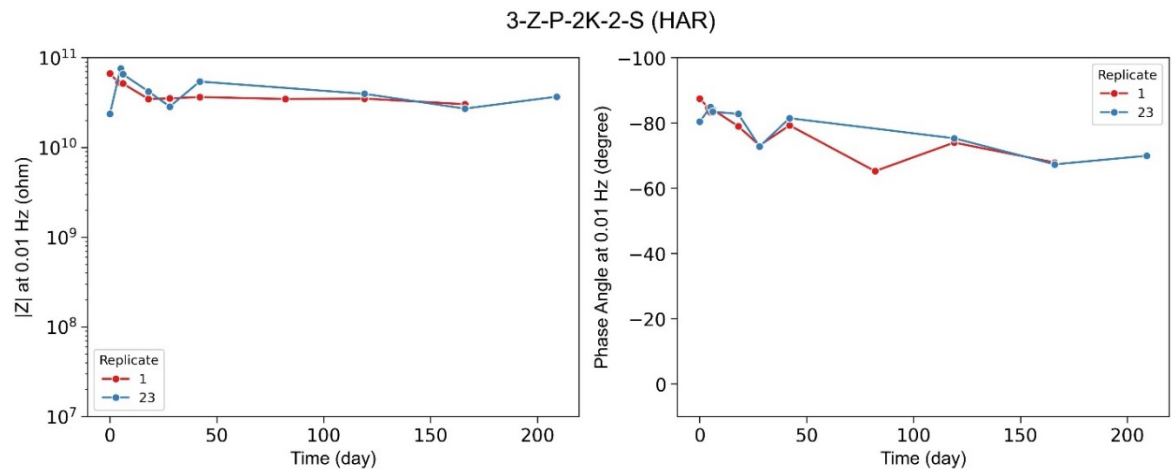
Figure 47: Impedance and phase angle over time (DI panels).

Figure 48: Impedance and phase angle over time (HAR panels).
