Technical Report No. SRH-2013-19

Nambe Falls Reservoir 2013 Bathymetric Survey

**Nambe Falls Dam
New Mexico**

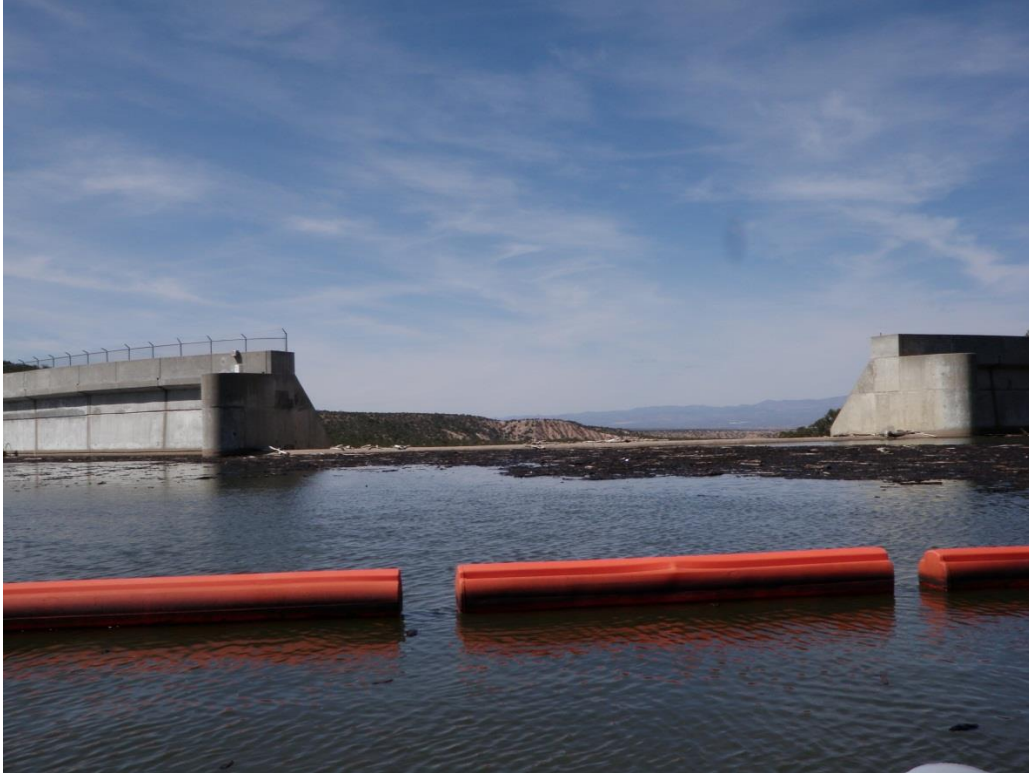
Figure 2 - Nambe Falls spillway, located in the concrete section of Nambe Falls Dam, with spillway crest elevation 6826.6 (NGVD29), March 2013.

The spillway is an uncontrolled overflow section in the center of the concrete arch dam with crest elevation 6826.6 and provides a discharge of 22,500 cubic feet per second (cfs) at maximum reservoir elevation 6839.8, Figure 2. The outlet works are located through the concrete arch dam and consist of two 18-inch-diameter and one 6-inch-diameter conduits. The inlet elevation of the outlets is 6761.5 with a discharge capacity of 107 cfs at reservoir elevation 6826.6. The reservoir is about 3,700 feet in length with an average width of around 690 feet.

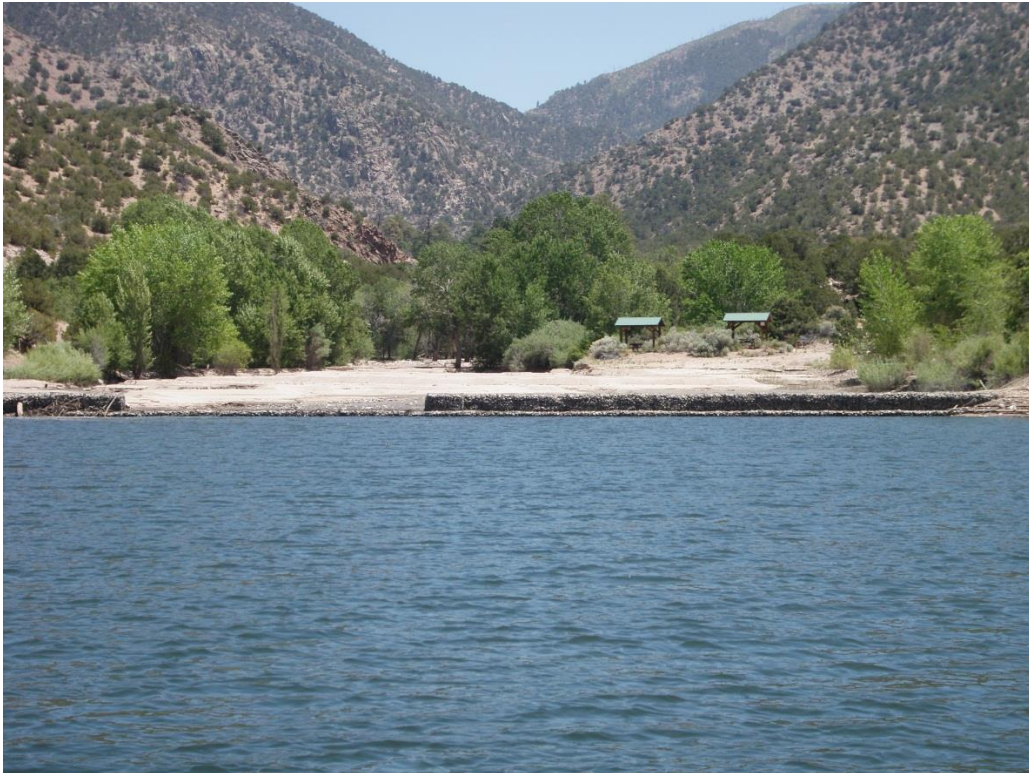
Figure 3 - Nambe Falls Reservoir retaining wall located in upper reservoir, June 2013.

Since the 2004 survey, a retaining wall was constructed in the upper reservoir area in an attempt to trap the sediment inflows, but failed under the stress of the inflows, Figure 3. On February 19, 2009, a U.S. Army Corps of Engineers dive team conducted underwater work at the dam's outlet trash-rack that included a hydrographic survey in the immediate area around the intake. From the developed topographic map it appears the bottom was near elevation 6748 compared to the 6742 elevation measured in 2004.

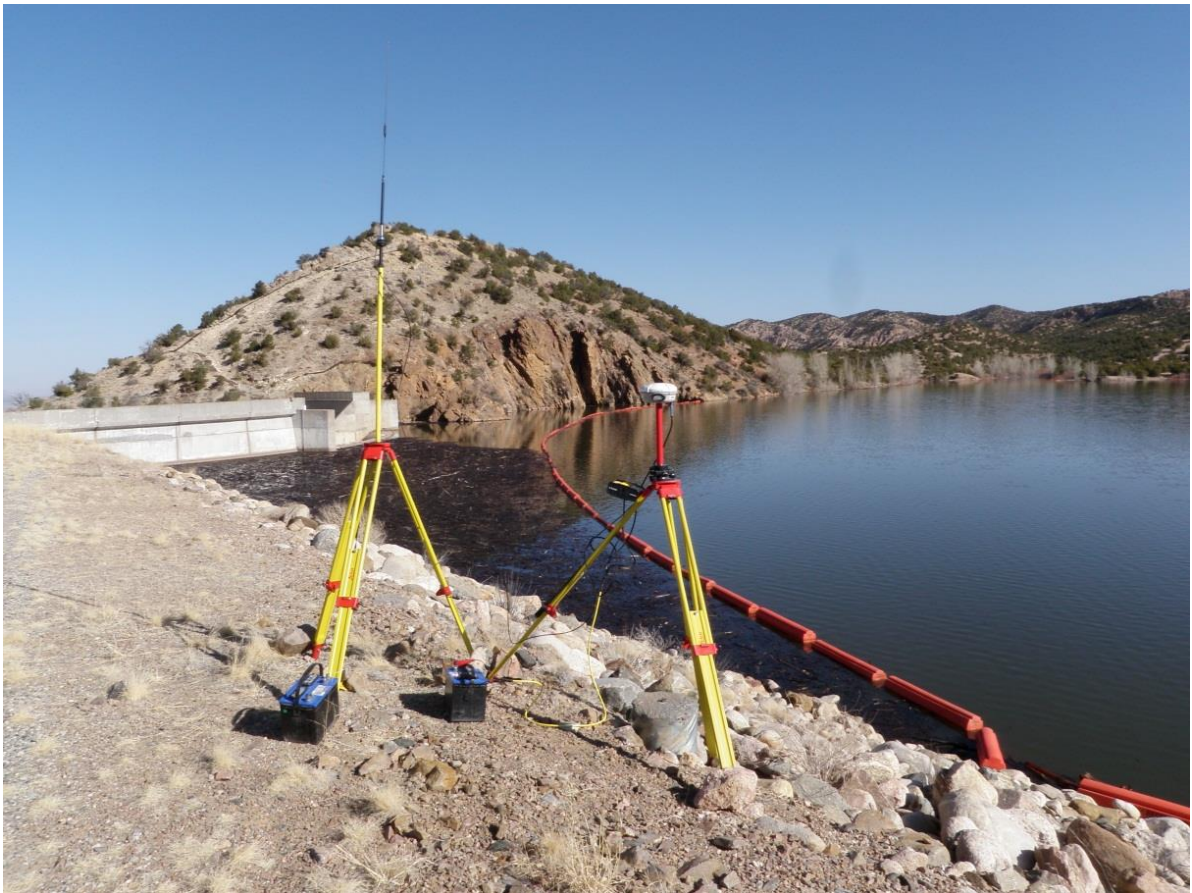
Figure 4 – Base setup over control point "G" located on the earthen portion of Nambe Falls Dam.

For the 2013 survey, the NAD27 and NGVD29 coordinates were converted to the North American Datum of 1983 (NAD83) and NAVD88 using the Corp of Engineers program CORPSCON. The 2013 survey was conducted using the converted coordinates at base station point “G” that measured points “F” and “K.”

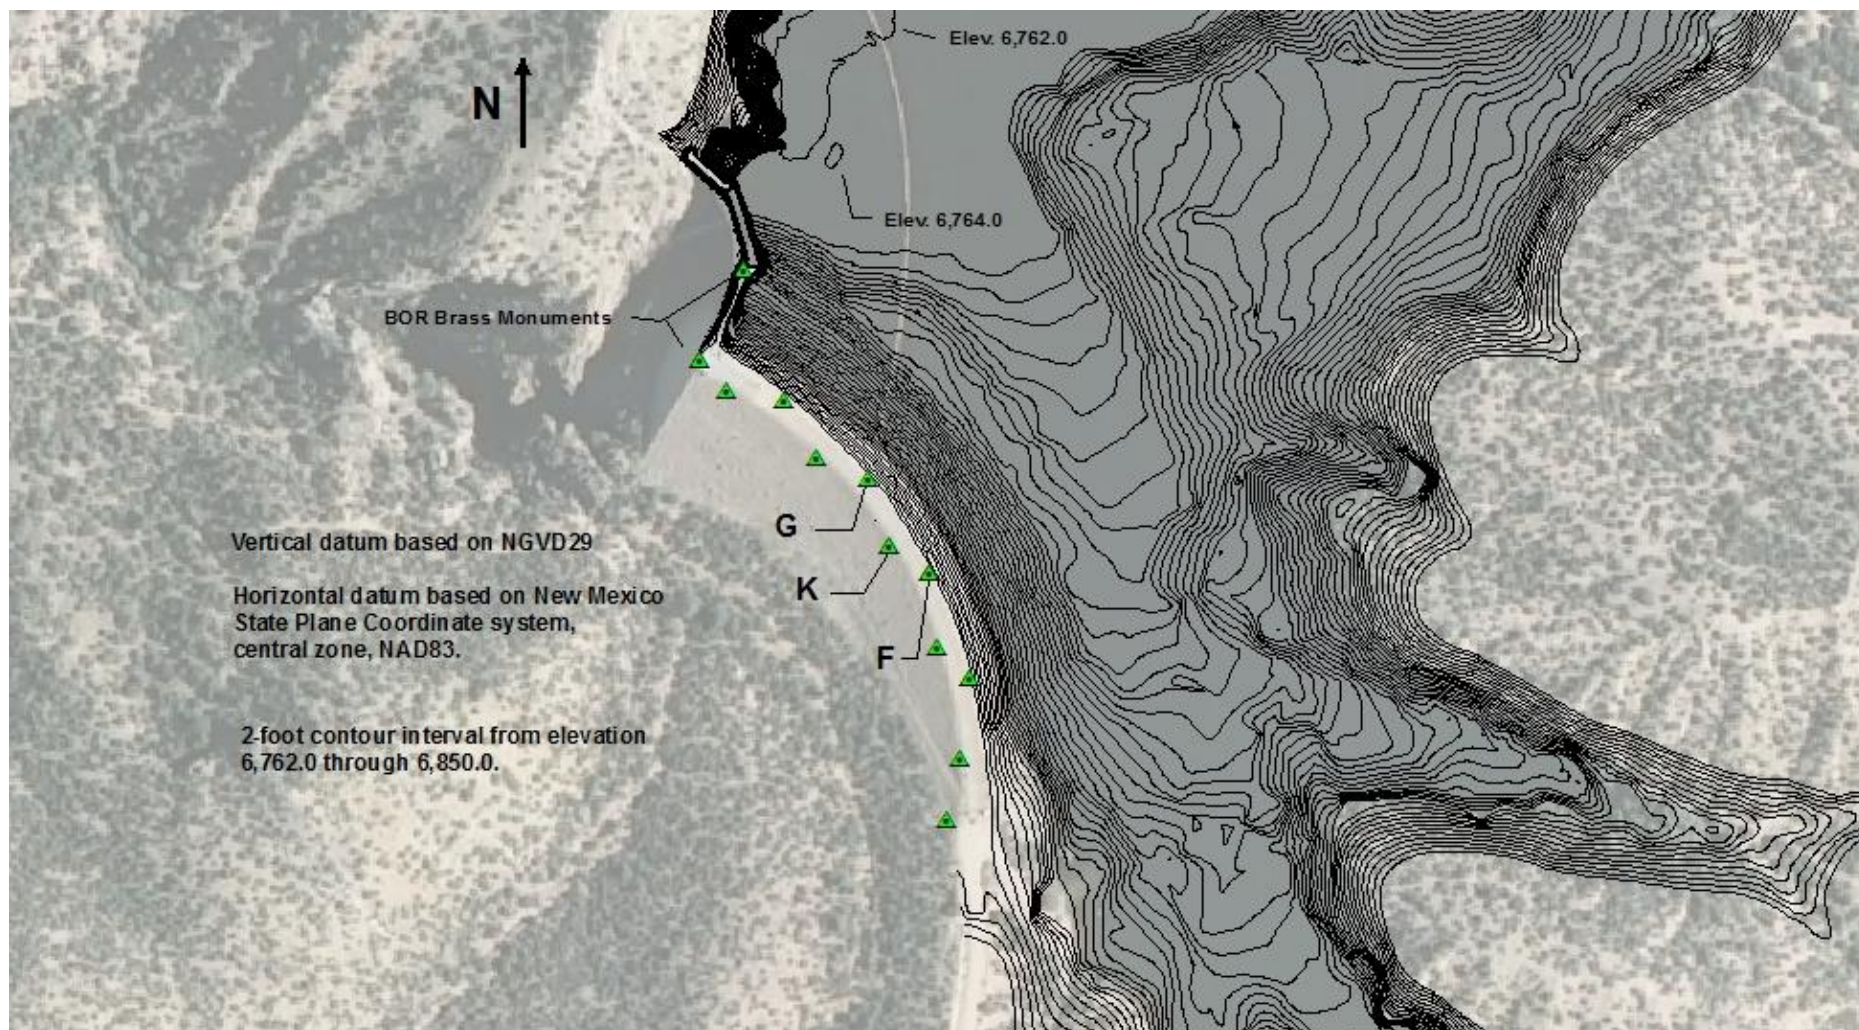
Figure 5 - Nambe Falls Reservoir control points, GPS base set over point “G” (NGVD29).

During the two day March 2013 collection, the base data information was retained at point “G” and submitted to the on-line positioning user service (OPUS). OPUS, operated by the National Geodetic Survey (NGS), allows users to submit GPS data files that are processed with known point data to determine positions relative to the national control network. The OPUS generated coordinates were used to determine position and vertical difference between OPUS generated NAD83/NAVD88 coordinates to the CORPSCON generated NAD83/NAVD88 coordinates at base station “G.” The OPUS computation for both days measured an average positive shift of 5.73 feet “East” and 0.308 feet “North” from the CORPSCON computed coordinates. These east and north computed shifts were applied to all of the data collected by the 2013 survey. The elevation difference was negligible, 0.005 feet, so no correction or shift was applied to the 2013 measured data point elevations except to shift from NAVD88 to NGVD29.

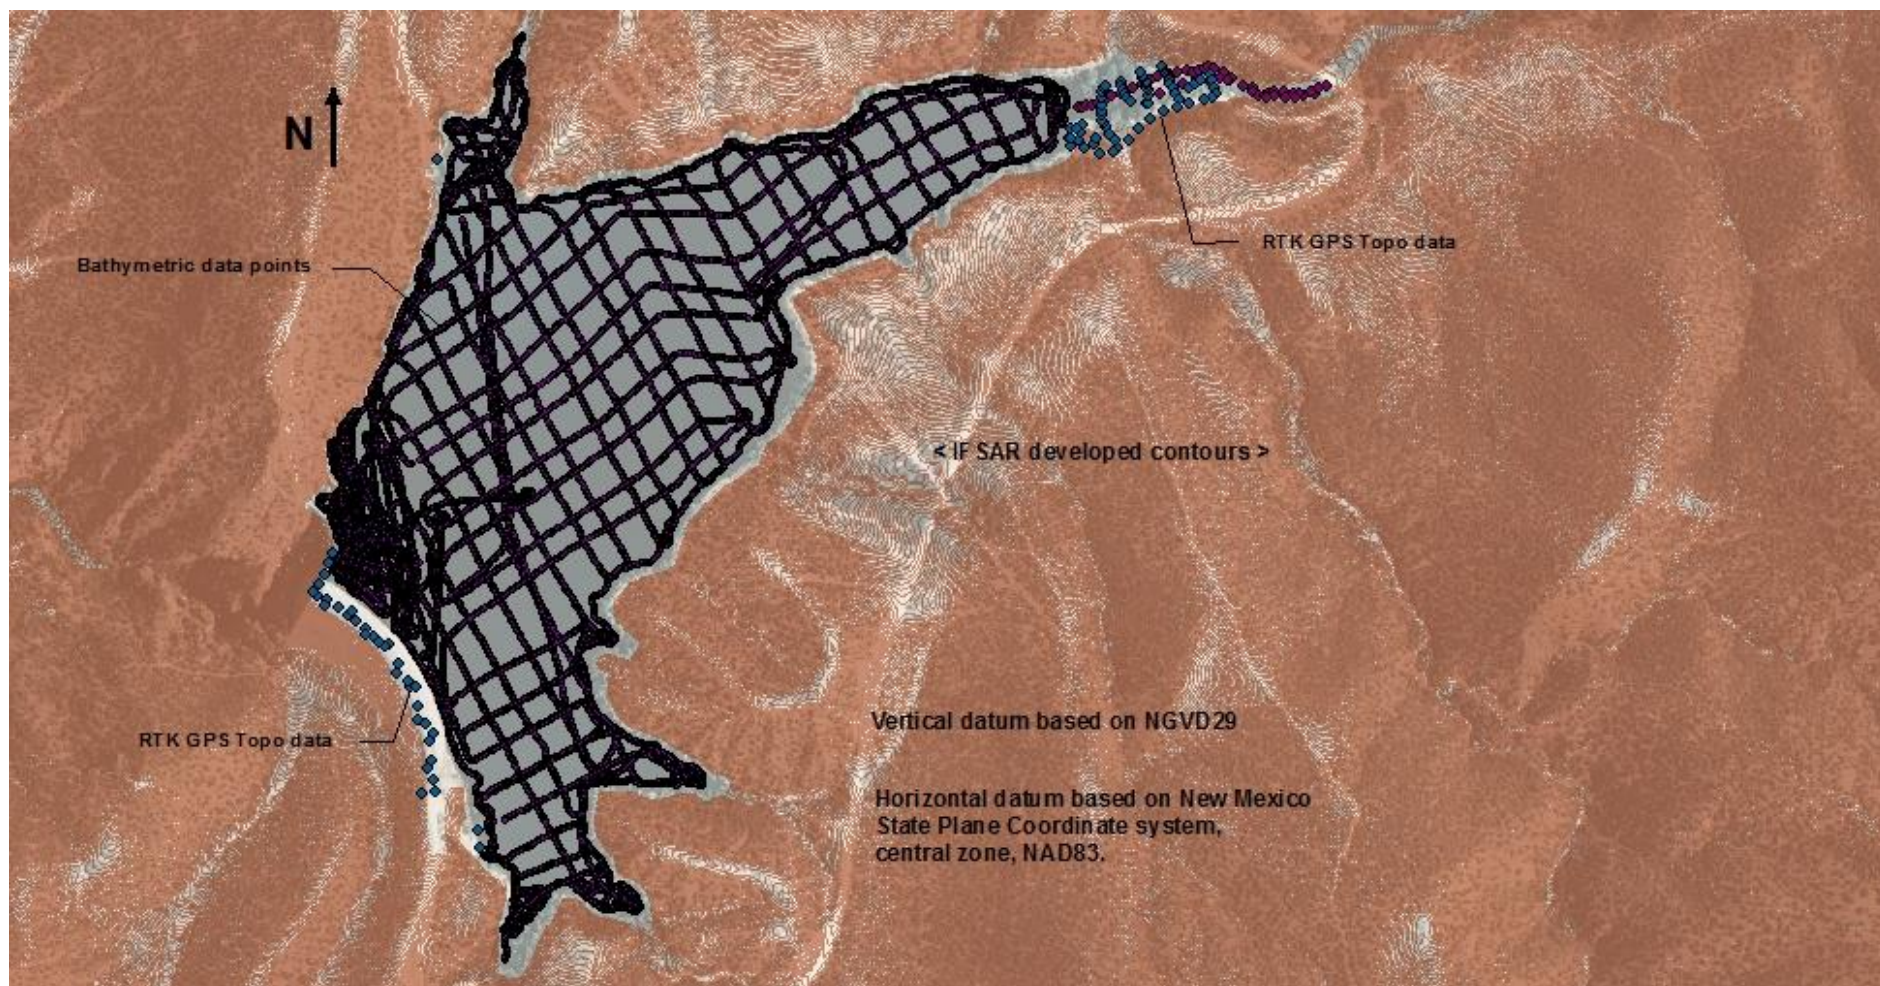
Figure 7 - Nambe Falls Reservoir 2013 data coverages.

The depth data was calibrated by adjusting the speed of sound through the water column, which can vary with density, salinity, temperature, turbidity, and other conditions. The crew returned in June of 2013 to confirm the soundings from the March survey since the results found the dead pool had all but silted in. The depth sounder in March produced a digital analog chart of the measured depths. These charts were analyzed during post-processing; when the charted depths indicated a difference from the computer recorded bottom depths, the data files were modified. Additional information on collection and analysis procedures is outlined in Chapter 9 of the *Erosion and Sedimentation Manual* (Ferrari and Collins, 2006). Final processing of the March 2013 data resulted in 17,272 points, Figure 7.

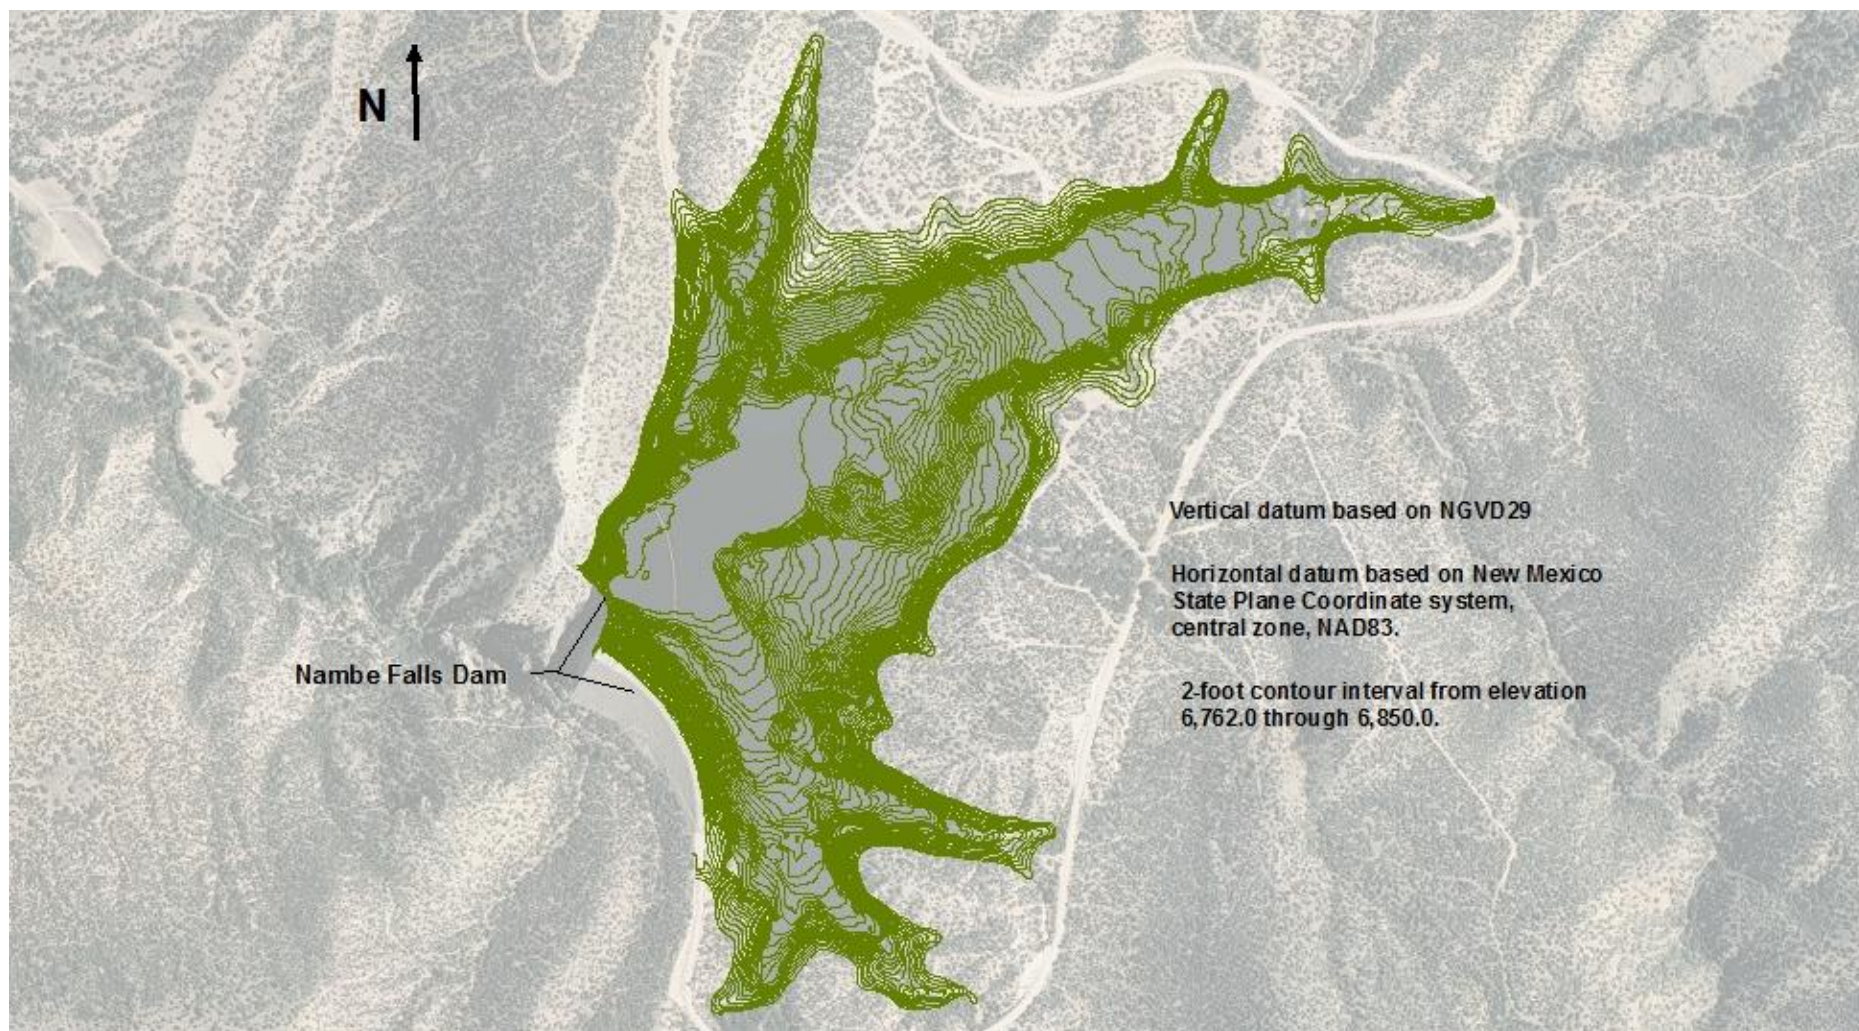
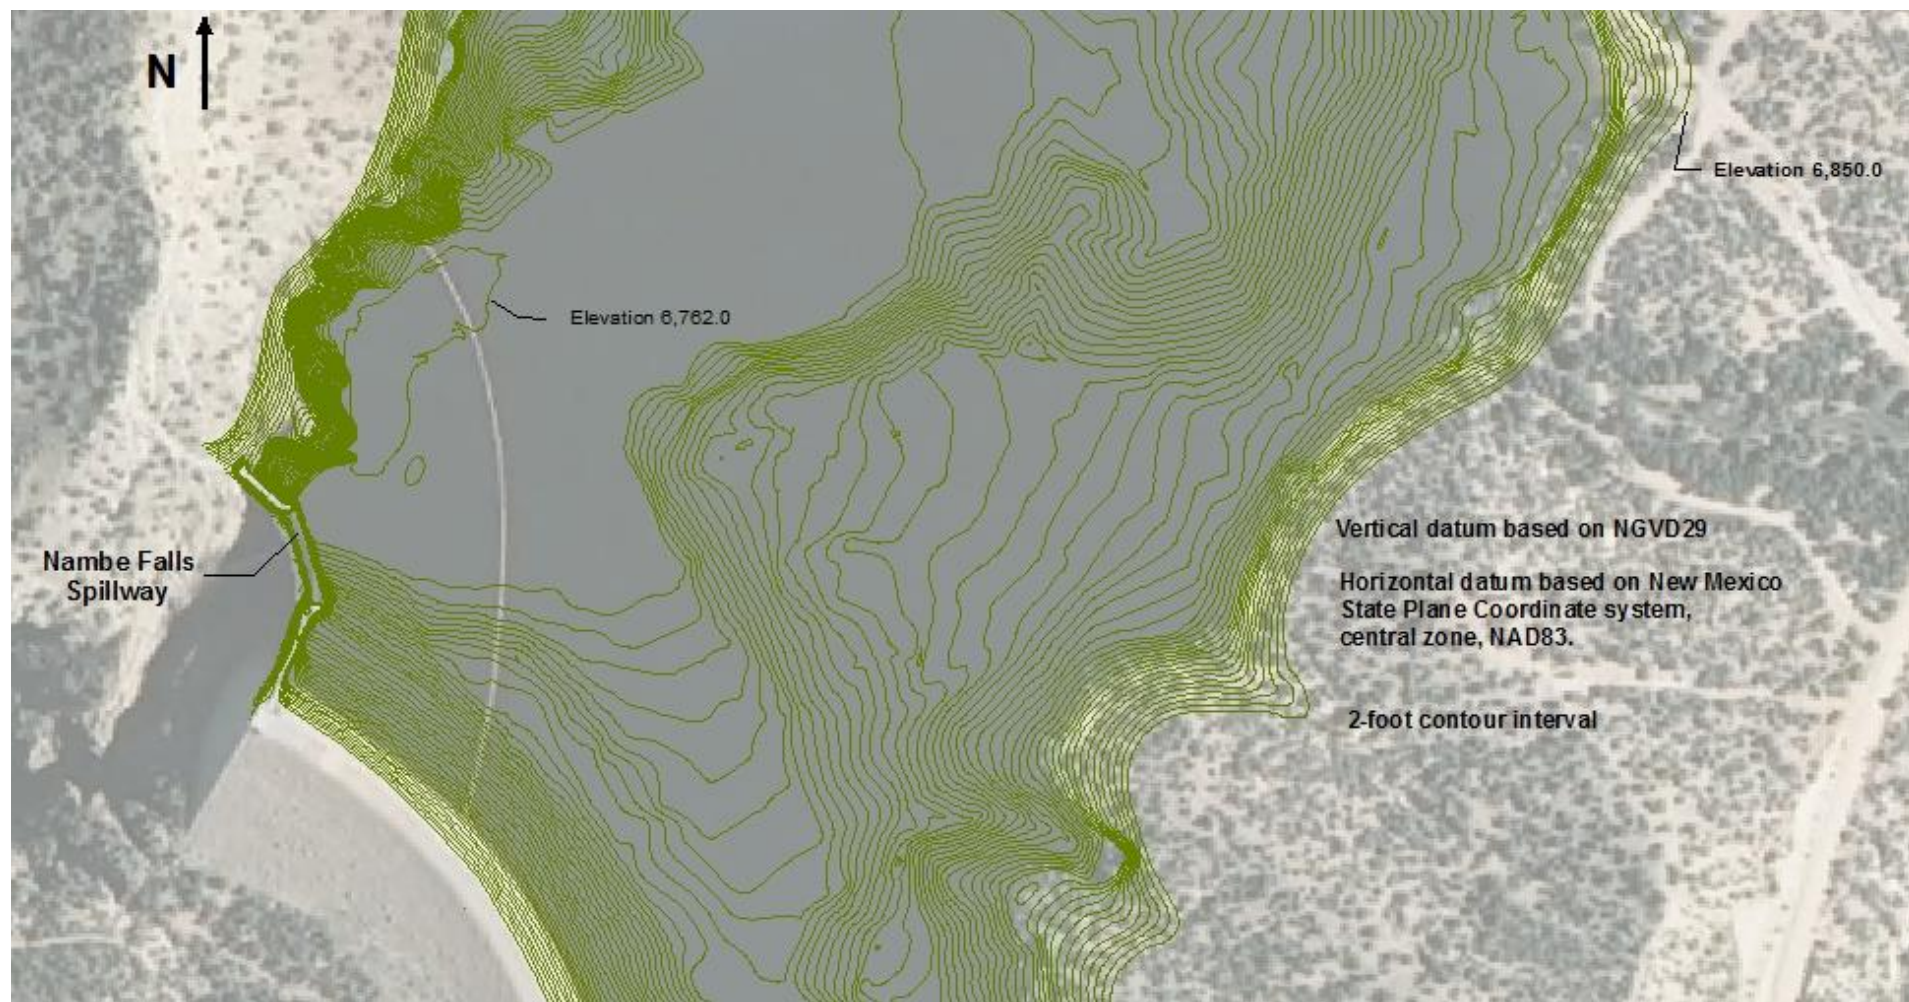
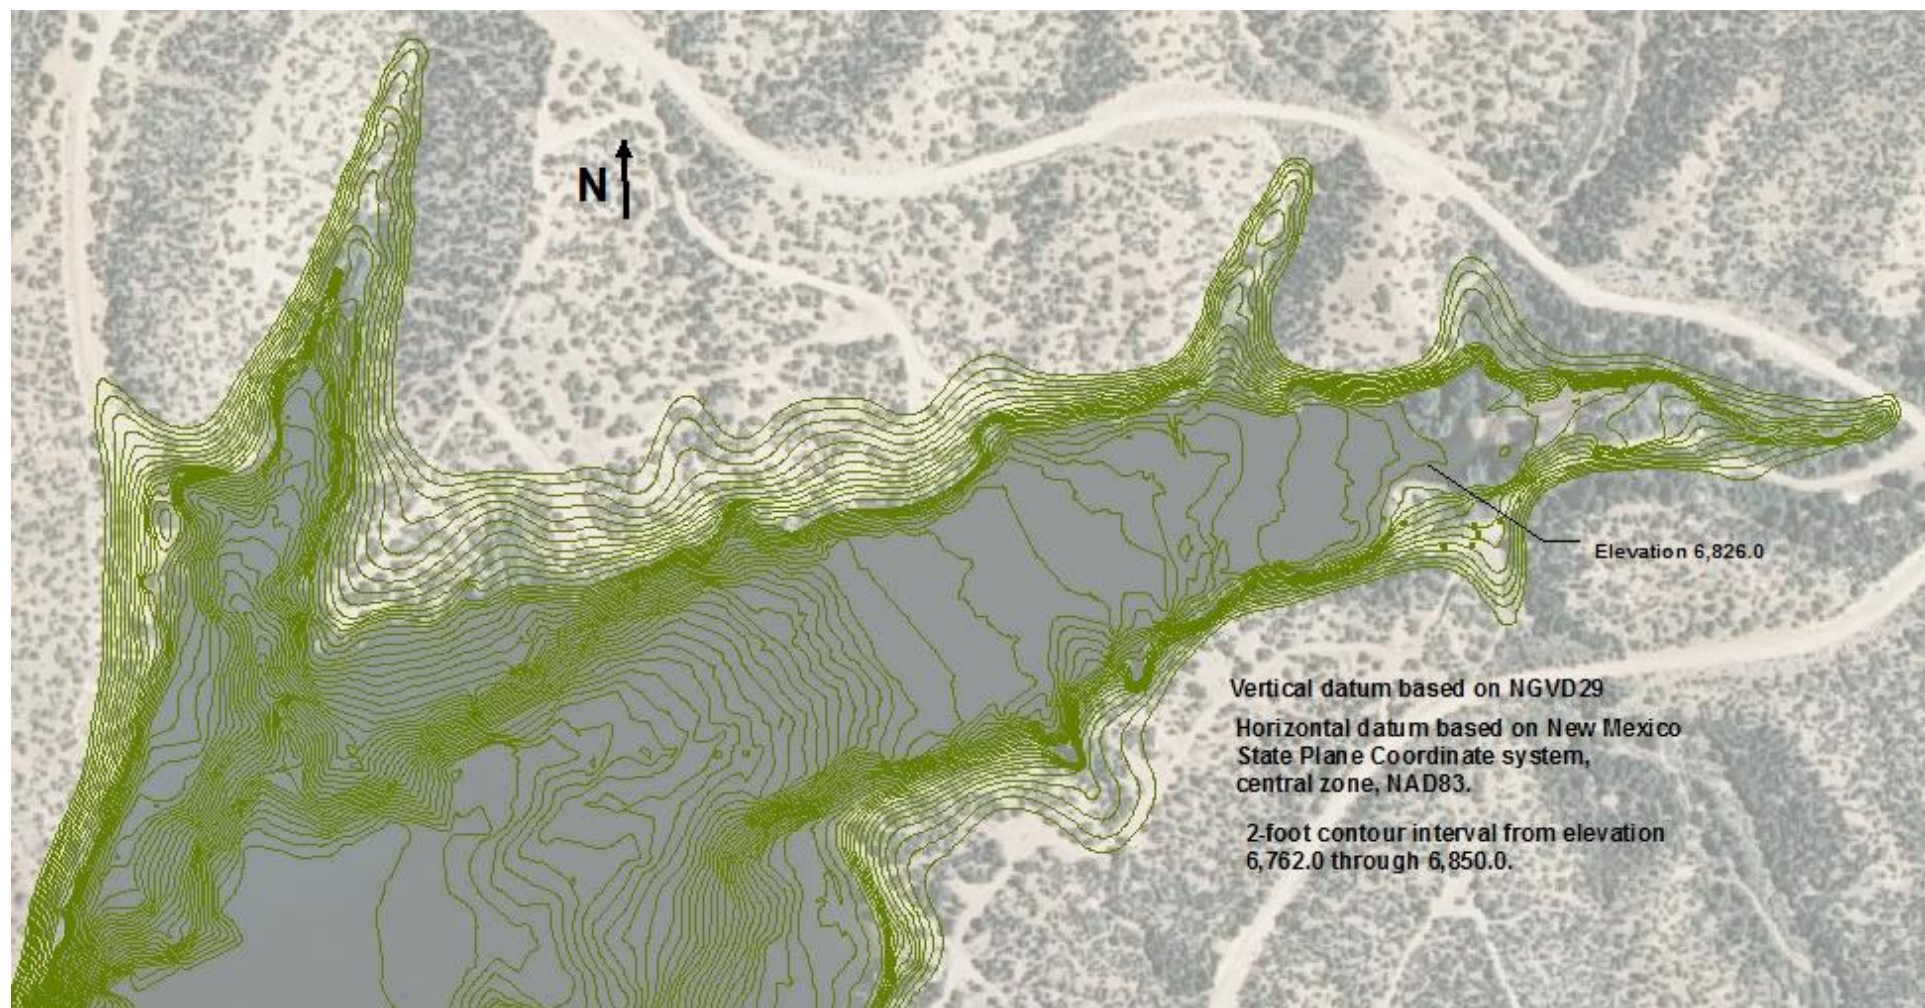
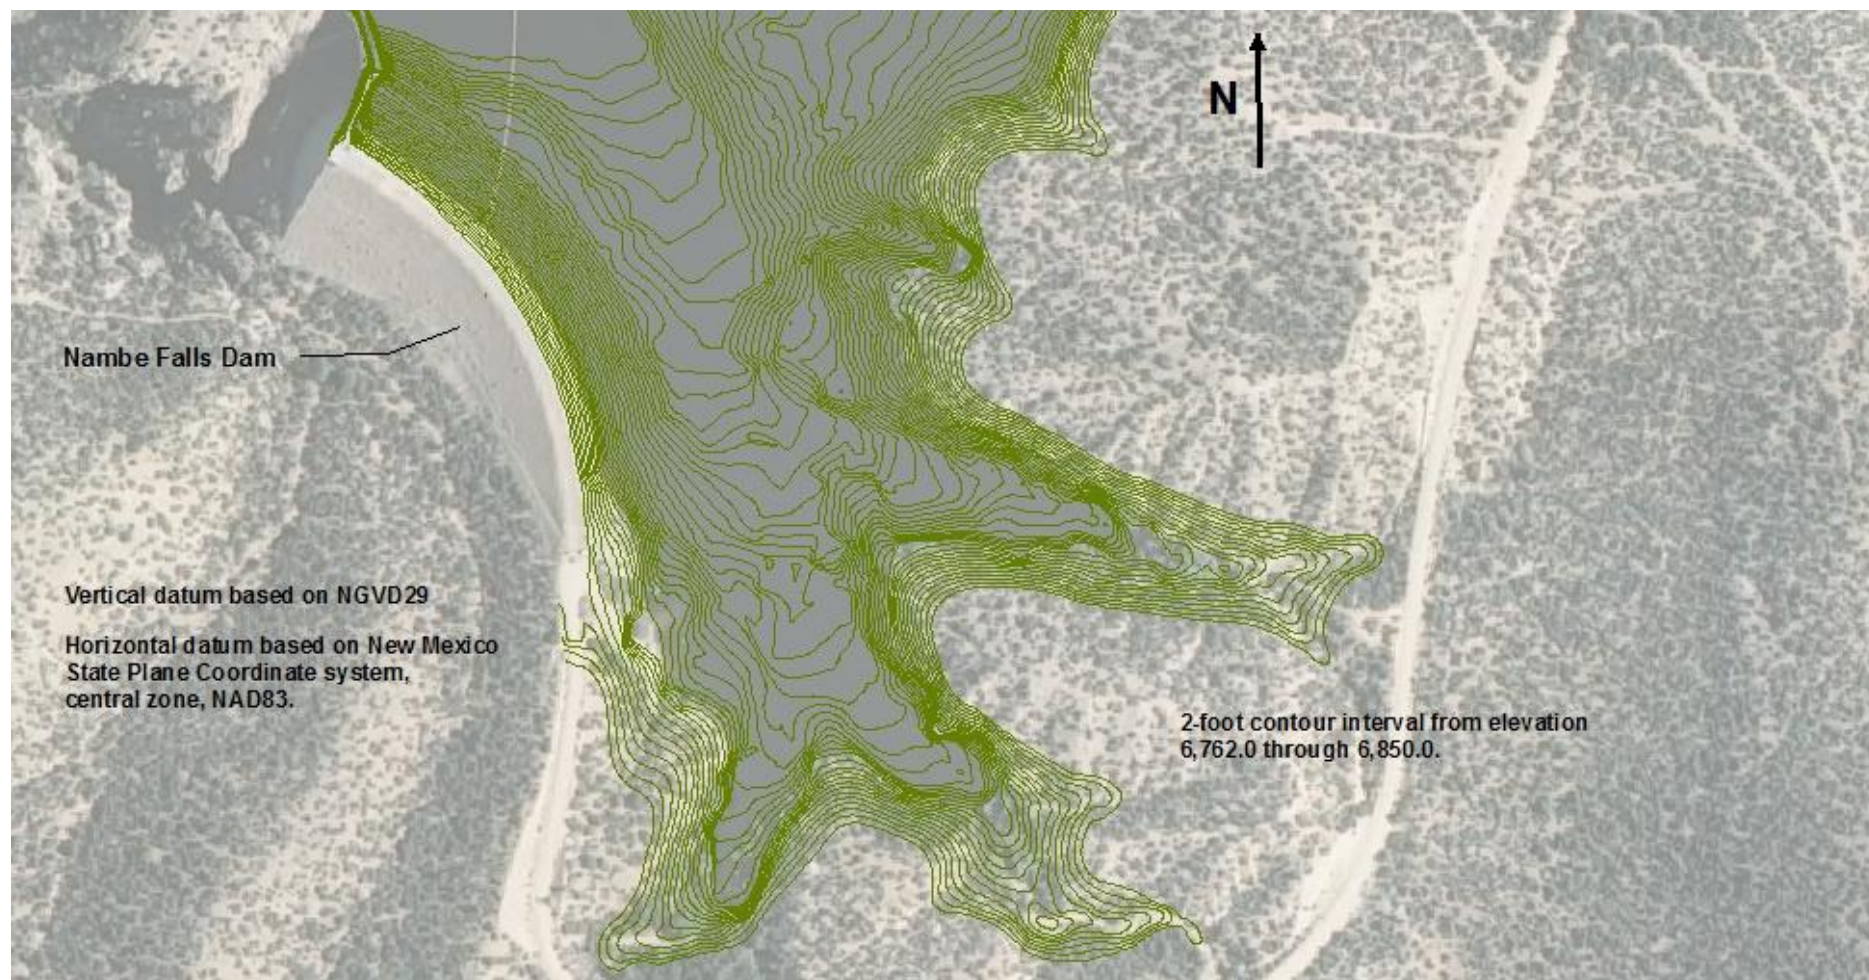
Figure 8 - Nambe Falls Reservoir 2013 contours, NGVD29 (map 1 of 4).

Figure 9 - Nambe Falls Reservoir 2013 contours, NGVD29 (map 2 of 4).

Figure 10 - Nambe Falls Reservoir 2013 contours, NGVD29 (map 3 of 4).

Figure 11 - Nambe Falls Reservoir 2013 contours, NGVD29 (map 4 of 4).

The linear interpolation and CONTOUR commands were used to interpolate contours from the Nambe Falls Reservoir TIN. The surface areas of the enclosed contour polygons at 1-foot increments were computed for elevation 6761.0 and above. The reservoir contour topography at 2-foot intervals is presented in Figures 8 through 11 from elevation 6762.0 and above.

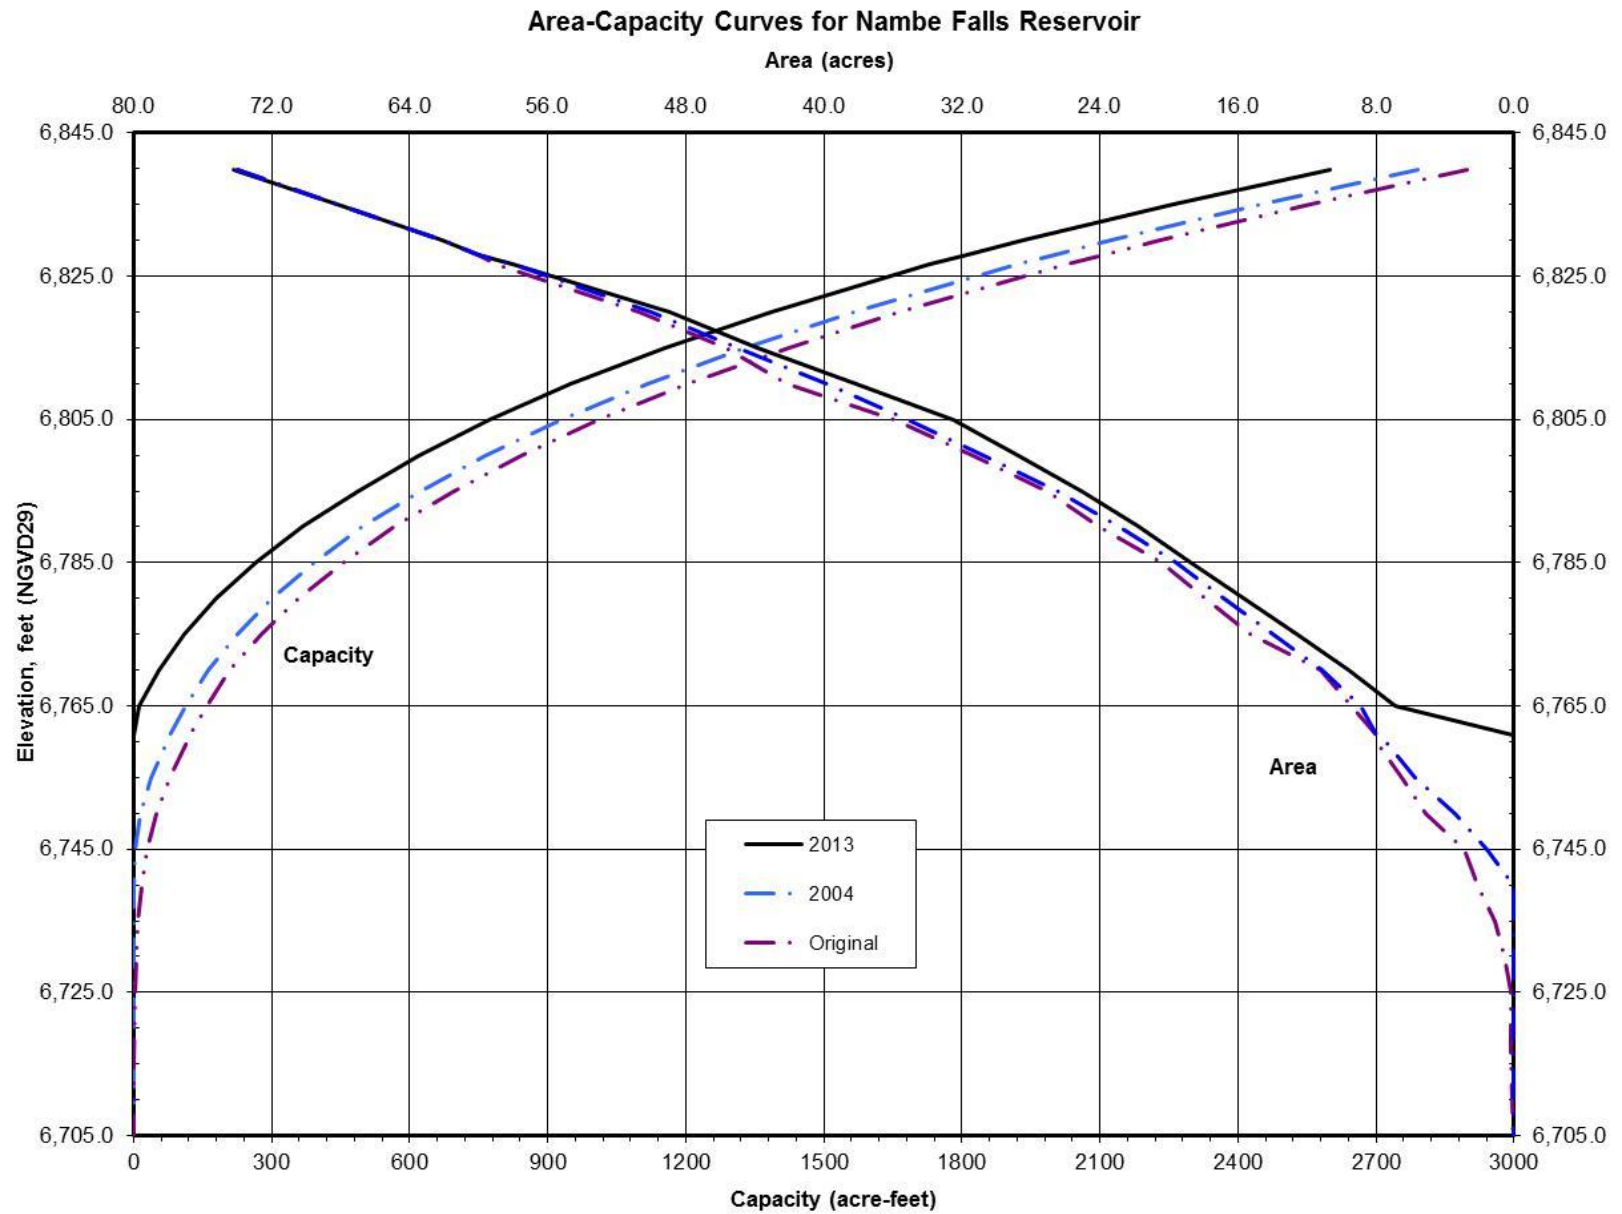
Figure 12 - Nambe Falls Reservoir area and capacity plots.

Figure 12 is a plot comparison of the surface areas and capacities of the reservoir's original, 2004, and 2013 survey results. For calculating the 2004 and 2013 sediment accumulation, the original capacities were recomputed using *ACAP85* that was also used to compute the 2004 and 2013 capacities. Since dam closure in 1976, the measured total volume change at reservoir elevation 6826.6 was 106 acre-feet in 2004 and 297 acre-feet in 2013. The 2013 estimated average annual rate of capacity lost for the 37-year operation period was 8.0 acre-feet per year. The 2013 storage loss in terms of percent of original storage capacity was 14.6 percent at elevation 6826.6.

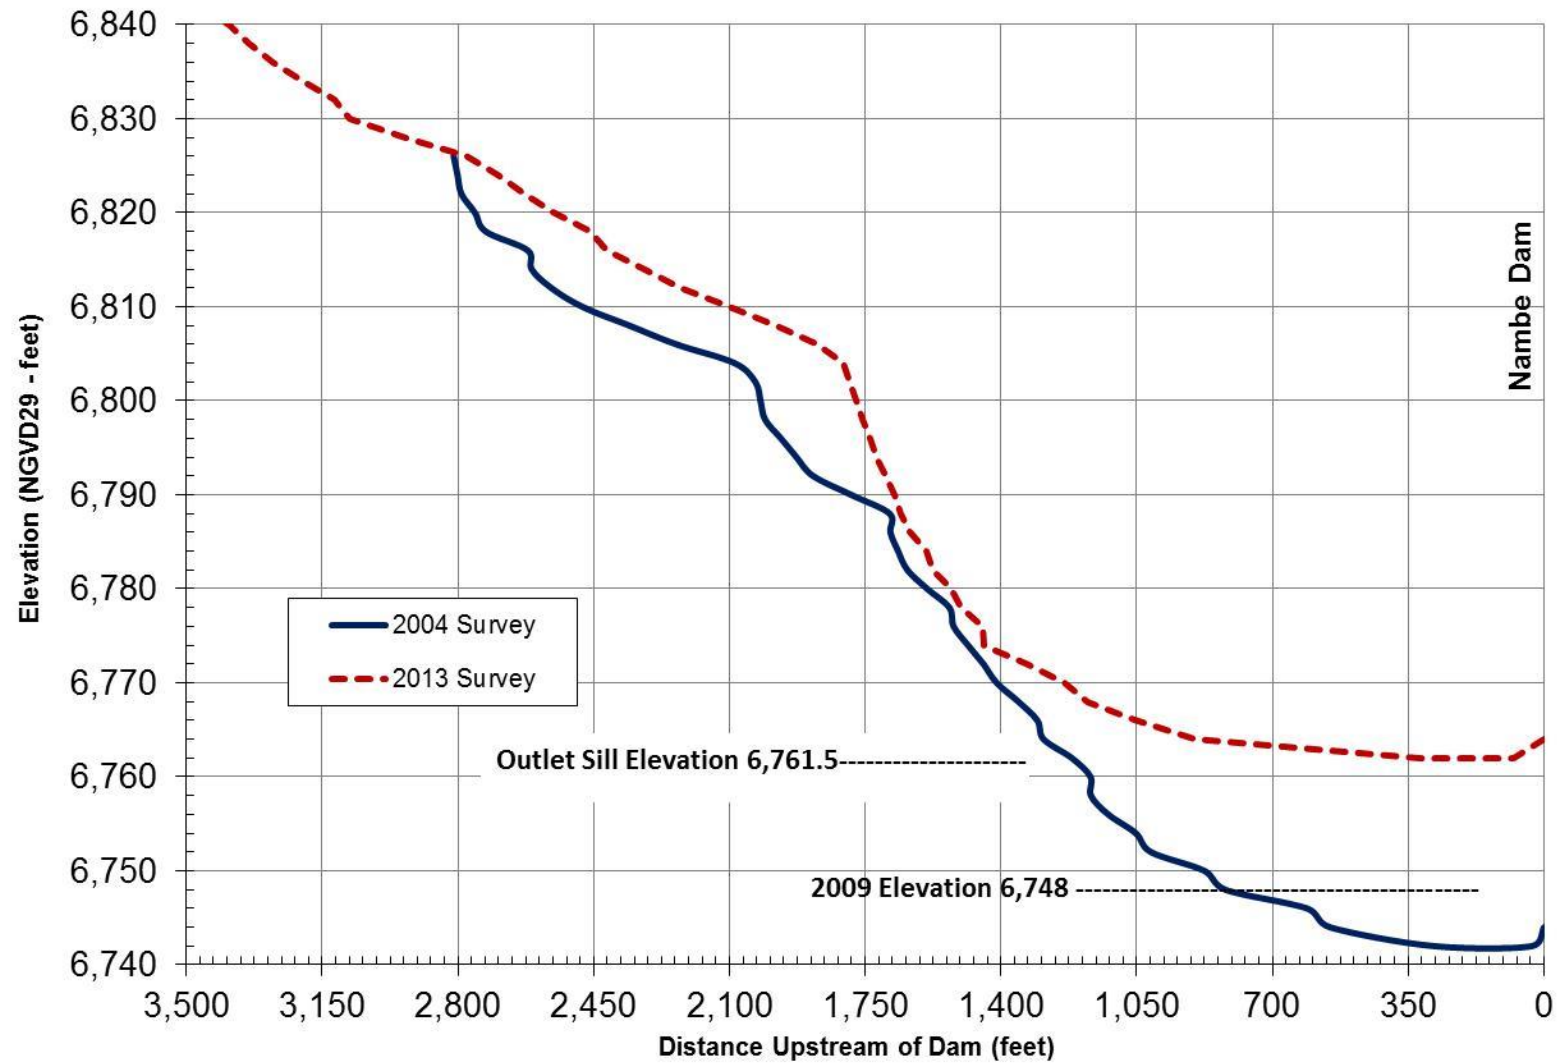
Nambe Reservoir Longitudinal Profiles 2004 and 2013 Comparison

Figure 13 - Longitudinal profile of the Rio Nambe from the dam upstream.

To illustrate the present reservoir bottom and change over time, the reservoir thalweg profile was plotted from the dam to the upper reservoir area for the 2004 and 2013 conditions, Figure 13. The original profile was not available, but it appears that starting at the dam the original thalweg was below elevation 6700. The original capacity at elevation 6710.0 was only 0.1 acres, meaning it didn't take much to fill in this area with sediment. For the 2004 and 2013 longitudinal profiles the thalweg was cut through the developed 2-foot topographic contours from each study with the 2004 contours being used to develop the thalweg alignment starting from the dam and continuing upstream of the Rio Nambe. The 2004 plot ended at elevation 6826.0 using available data while the 2013 plot extended to elevation 6842.0 using the collected RTK GPS topography data.

The 2013 thalweg started near elevation 6764.0 at the dam and dropped to elevation 6762.0 through the developed contours. The 2013 minimum bottom data elevation was around elevation 6761.6 compared to the outlet sill elevation of 6761.5 and the reservoir's dead pool elevation of 6761.9. The collected March 2013 data, spot checked in June 2013, confirmed that the original dead pool area is currently silted in.

The 2013 thalweg shows the majority of the sediment deposition occurring near the dam since 2004 and then slopes upstream to the top of a typically developed sediment delta near elevation 6774. The 2013 top of the pivot point of the delta is

near elevation 6804, which is near the average annual minimum reservoir elevation for the available years of reservoir operations (Table 1). The 2004 plot doesn't show a typical sediment delta formation that was surveyed near reservoir elevation 6803. It must be noted that prior to the 2004 survey the reservoir was much lower in elevation for an extended period due to limited runoff, and land excavation was conducted to move the delta. Some of this material was removed from the reservoir area, but the 2004 survey observed where some of the sediment and other material were placed into large slash piles within the normal reservoir pool. Soon after the 2004 survey the reservoir did fill and spill and it's assumed these slash piles were never removed.

The 2013 plot illustrates the present condition of the reservoir and how the sediment deposition and inflows are impacting the inlet of the outlet works. The plots show nearly 20 feet of sediment deposition at the dam since the 2004 survey and around 14 feet of deposition since the 2009 dive team survey. The 2013 plot also illustrates that sediment inflows have settled in the upper reservoir area where the upper sediment delta has formed and a failed retaining wall was constructed. Sediments have flushed downstream from this formed delta, filling the original dead pool zone and above. With no dead pool area much of the future sediment inflow will deposit throughout the reservoir with small portions being flushed downstream through the outlet works when in operation.
