— BUREAU OF —
RECLAMATION

Final Report No. ST-2024-21045-02 (86-68320-2025-16)

Detection of Voids Behind Spillway, Conduits, Canals, Tunnels, and Siphons – Report 2 of 3 on Void Causes, Detection, and Repair

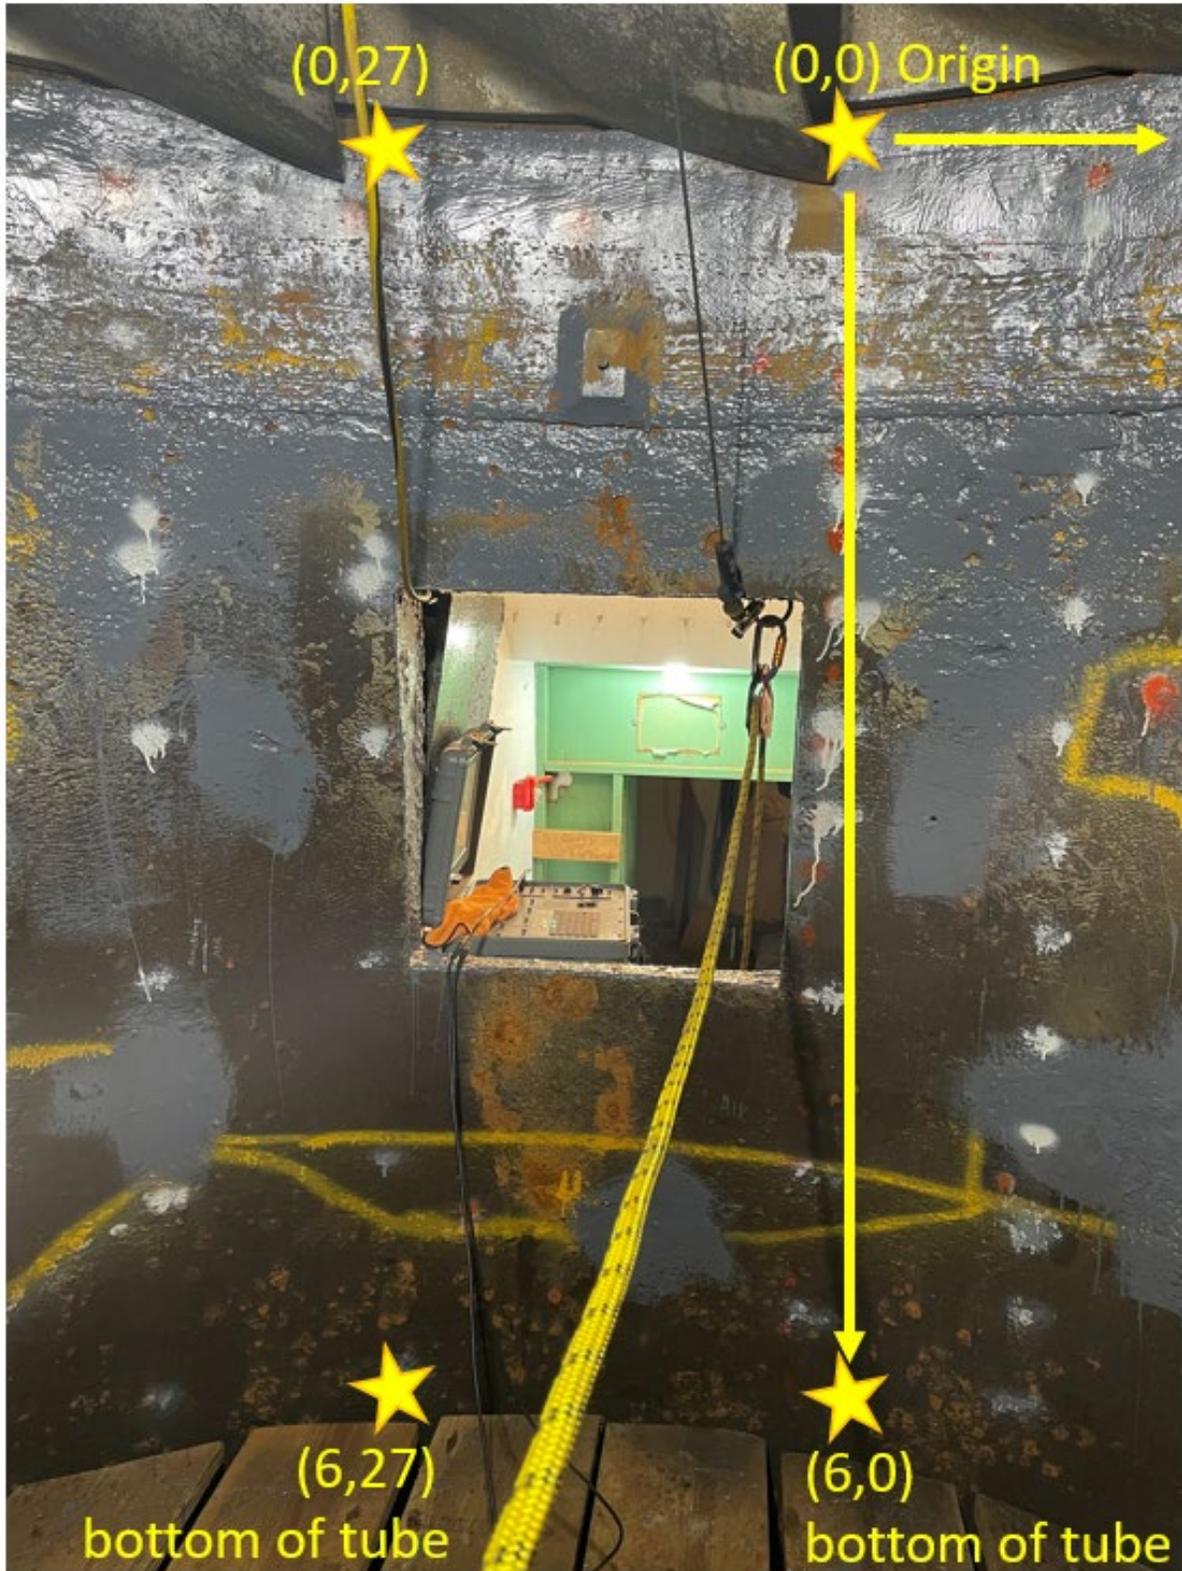
Figure 1.—Photo of 6 ft tall by 27 ft wide 2-D grid corner points (indicated with yellow stars) starting above the top right corner of the tube entrance and extending to the right for 27 ft in the horizontal direction.

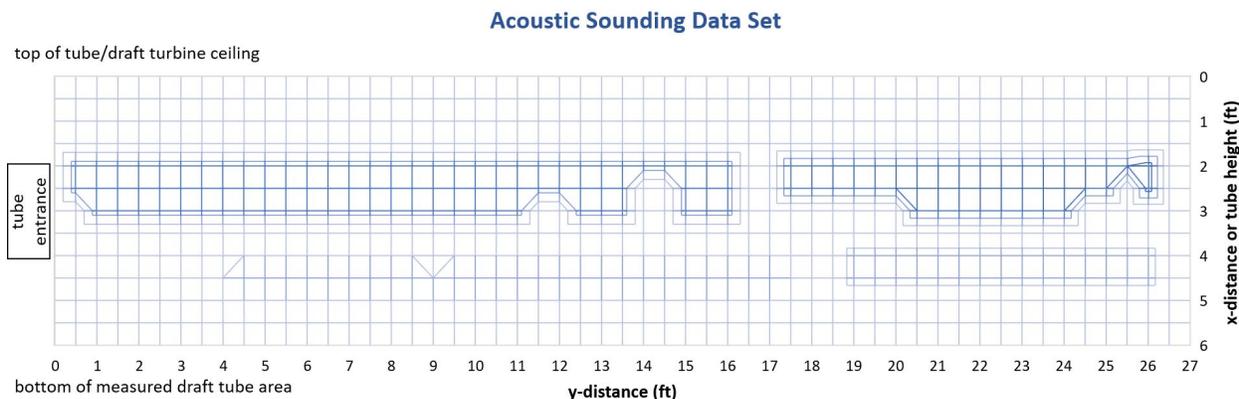
Figure 3.—2-D plot of acoustic sounding data set collected by Westin Joy and interpreted by Sarah Rupert for data visualization. Areas enclosed in polygons between $x = 2$ ft and $x = 3$ ft represent areas with suspected decoupling and voids behind the steel liner.

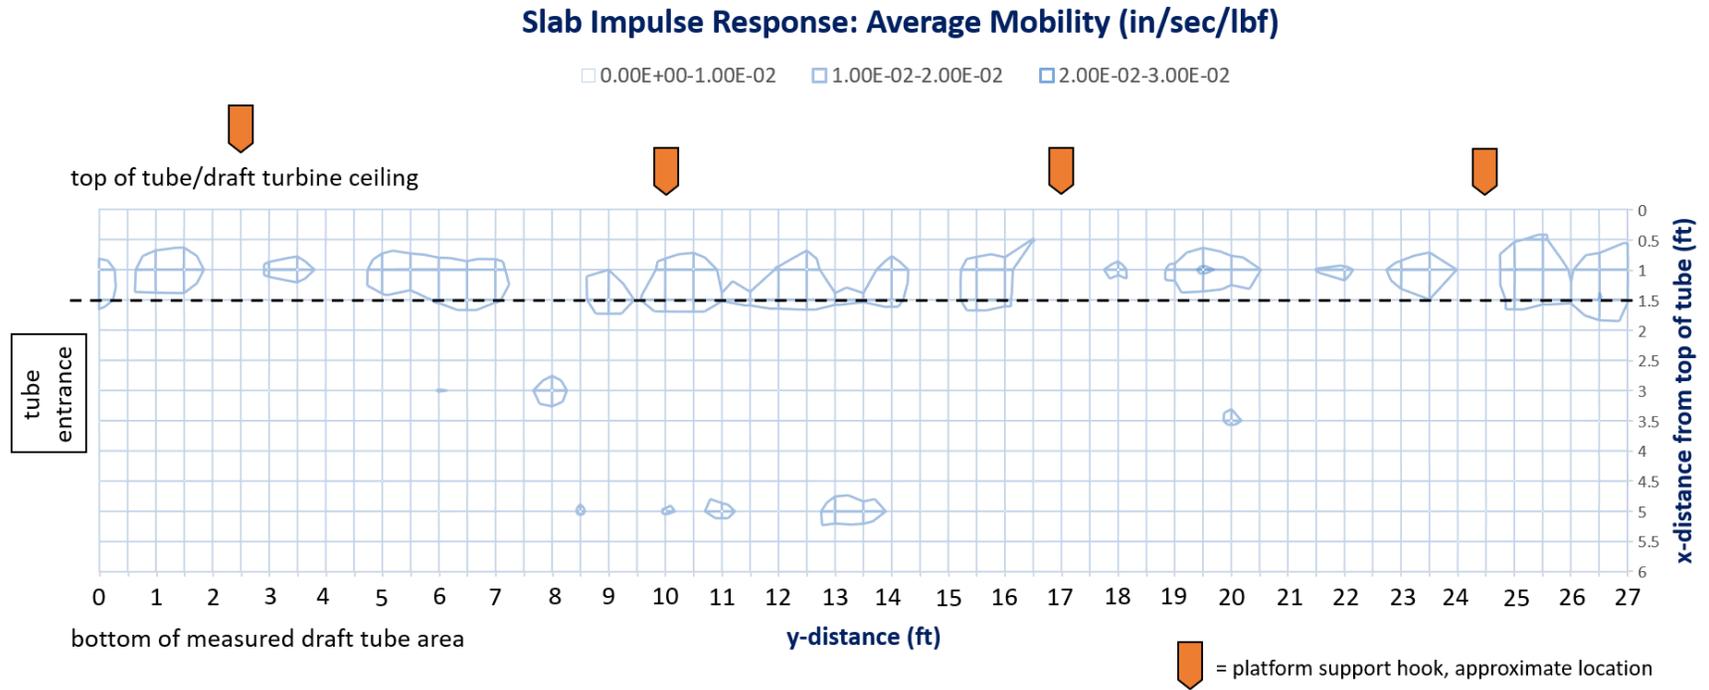
Figure 4.—2-D plot of slab impulse response average mobility measurements from the 2022 survey in Glendo Draft Tube No. 2. Blue polygons indicate areas that possess higher average mobility, suggesting the presence of delamination in these areas. The orange arrows indicate the location of platform support hooks. The horizontal dashed line indicates the upper section of the wall where grouting repairs were planned to be performed (i.e., $x=1.5$ ft).

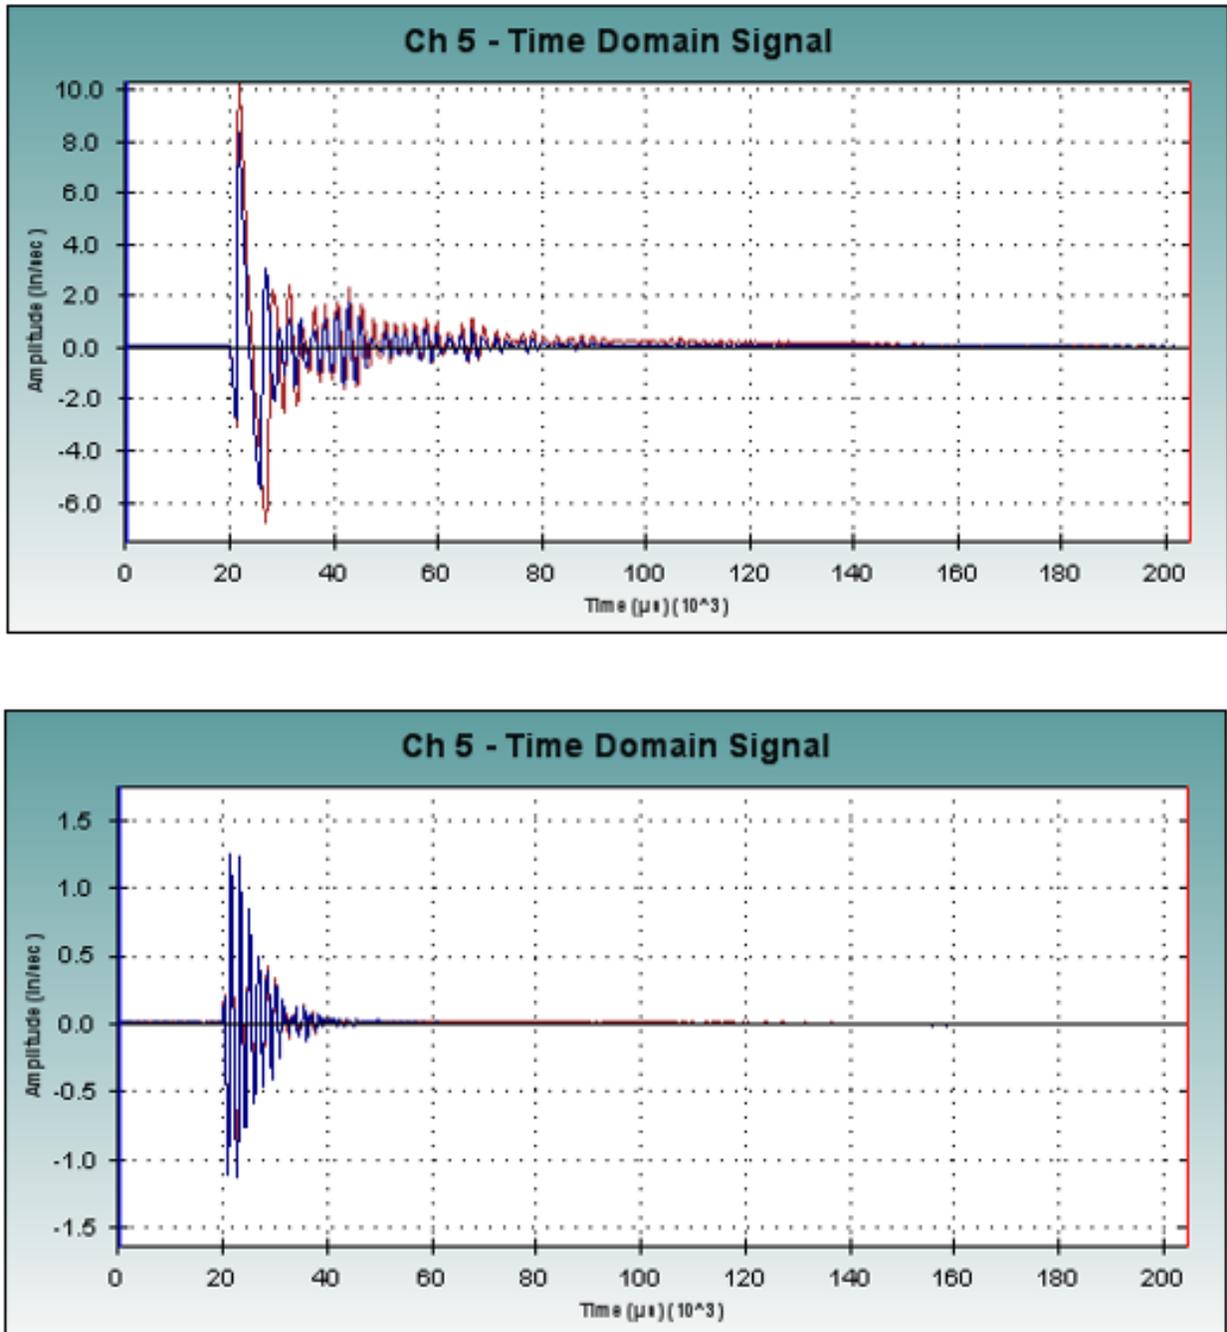
Figure 5.—Example of (top) a 2022 measurement with poor sub-liner support from [1.5, 9] and (bottom) a 2022 measurement with good sub-liner support from [5.5, 19.5]. The poorly supported area is characterized by the high-amplitude signal compared to the well supported area that exhibits a low-amplitude signal.

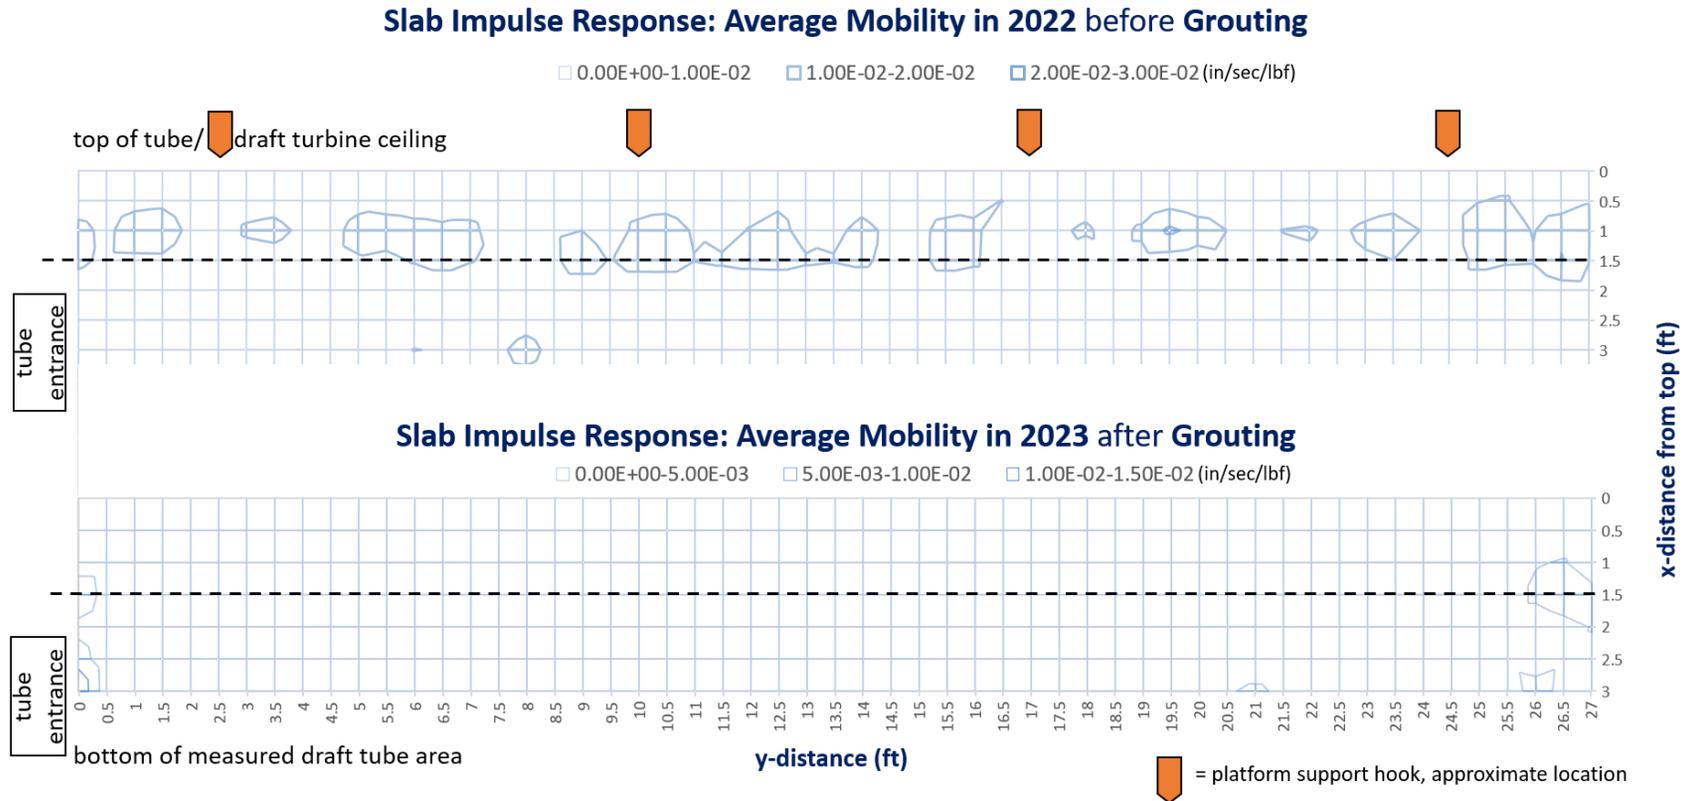
Figure 6.—2-D plots of slab impulse response average mobility measurements from the (top) 2022 survey and (bottom) 2023 survey in Glendo Draft Tube No. 2. Blue polygons indicate areas that possess higher average mobility, suggesting the presence of delamination in these areas. The orange arrows indicate the location of platform support hooks. The horizontal dashed line at [x = 1.5 ft] indicates the height on the wall where grouting repairs were planned and executed.

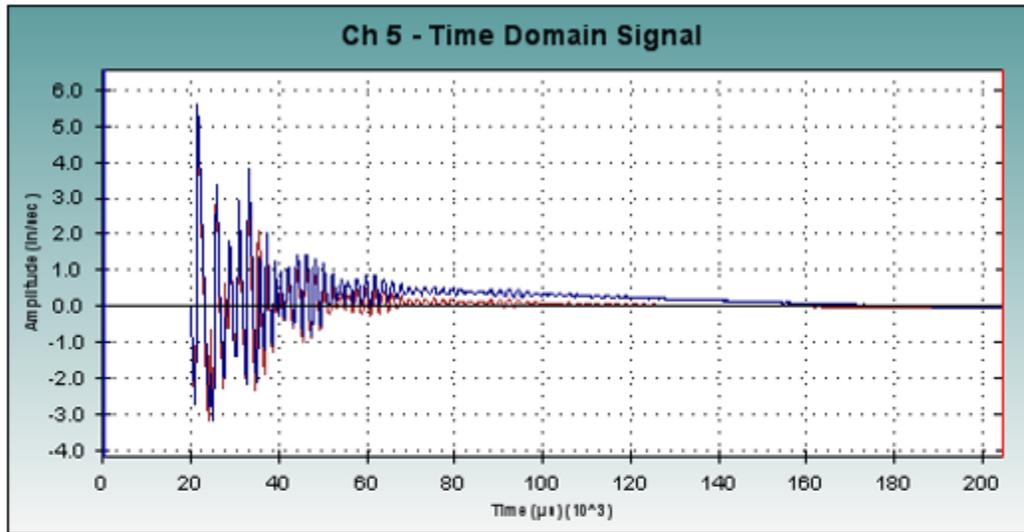
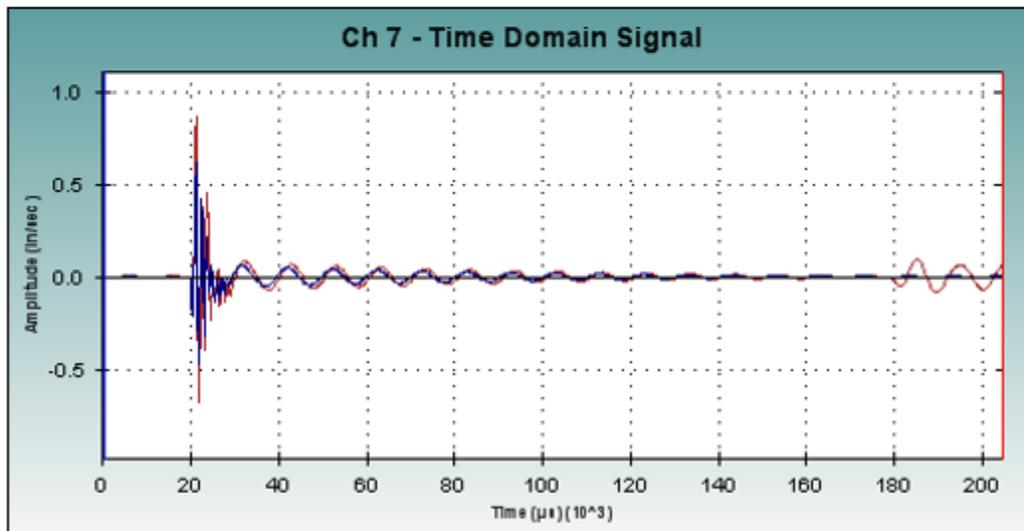
Figure 7.—Measurement from [1, 6] (top) before the grouting repair in 2022 and (bottom) after the grouting repair in 2023. Note how the amplitude of the time domain signal decreased from a maximum of 5.5 in/sec to less than 1 in/sec, indicating better support between the steel liner and concrete.

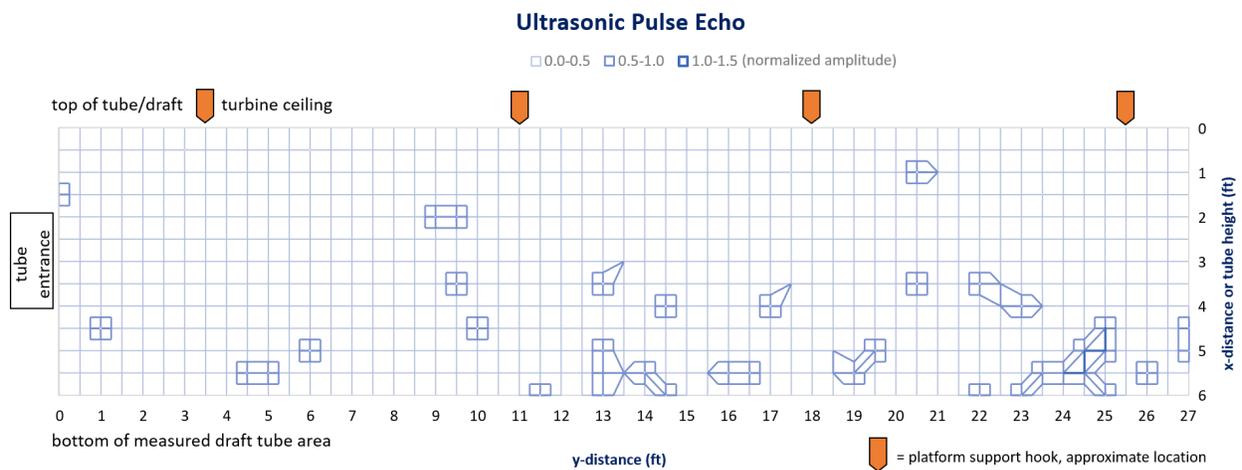
Figure 8.—2-D plot of interpreted UPE results. Areas enclosed in blue polygons represent areas where a higher-amplitude reflections were interpreted.

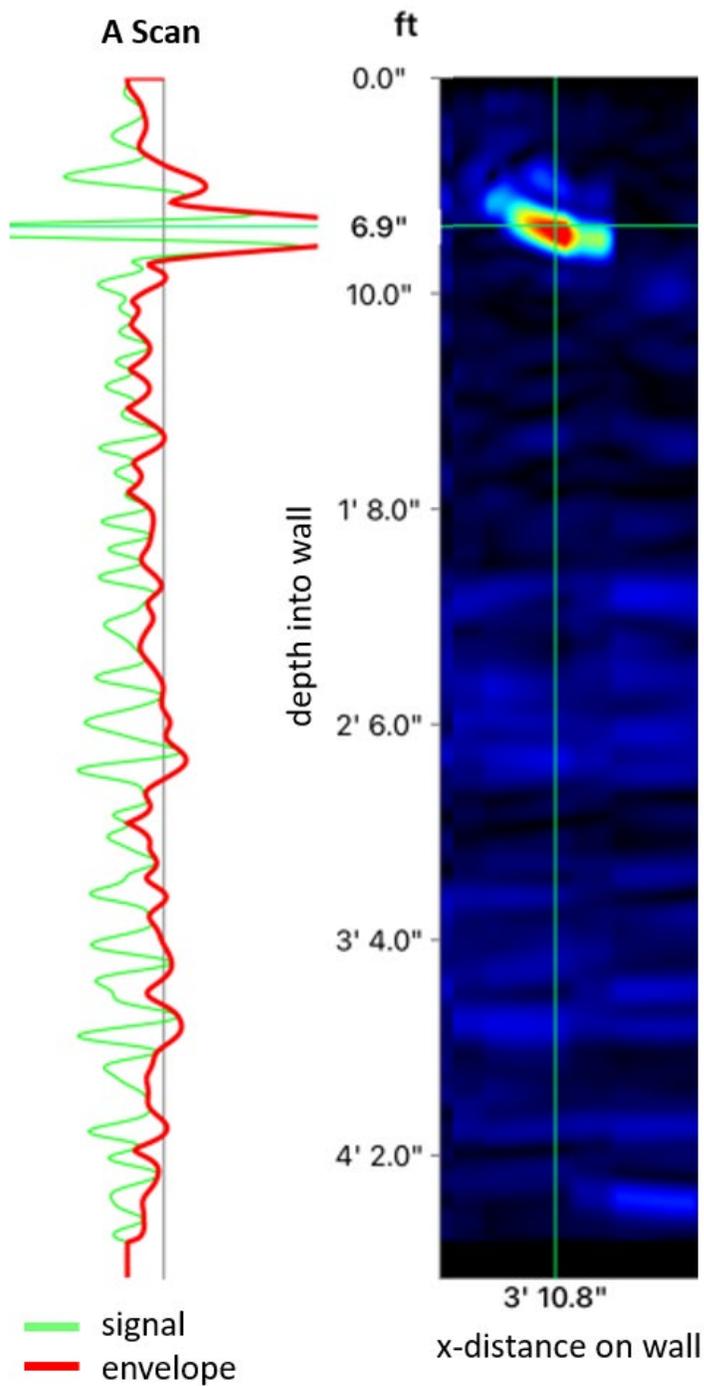
Figure 9.—Example UPE sounding from the 2022 survey. (Left) A-Scan signal where the 1-D trace signal amplitude is shown in green and the signal envelope is shown in red. (Right) Multiple 1-D traces can be viewed as a 2-D color plot where warmer colors represent higher-amplitude reflections and cooler colors represent low-amplitude to no reflection.

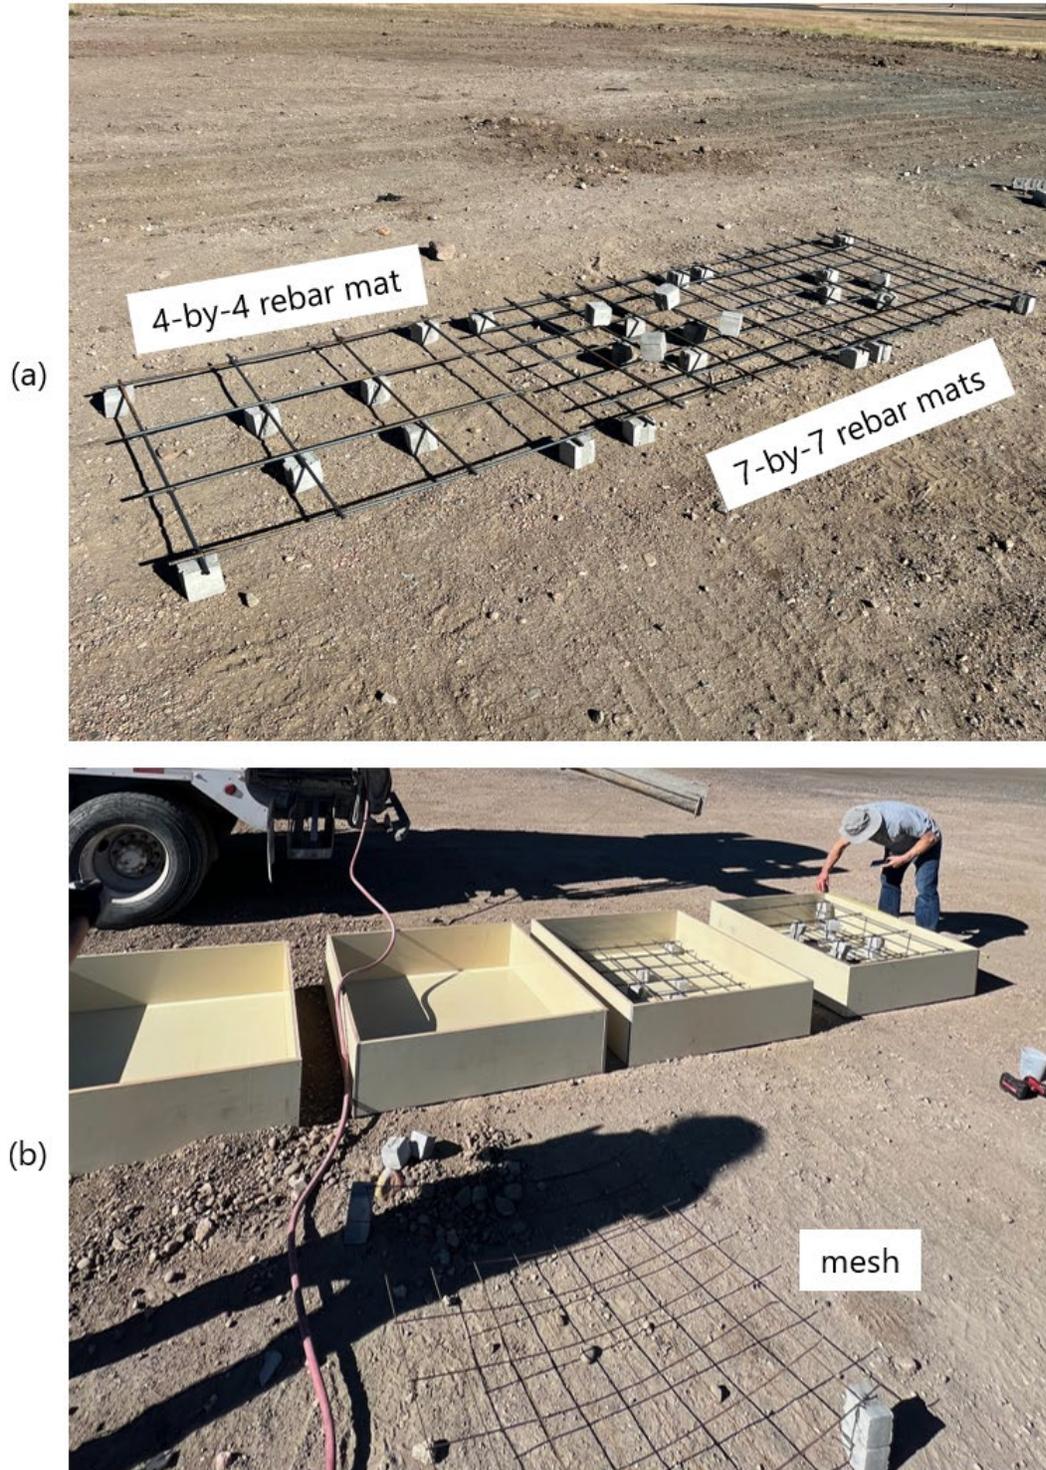
Figure 10.—(a) Photo of the four-by-four and seven-by-seven rebar mat reinforcements. (b) Photo of the wooden boxes used to form the concrete slabs with reinforcement materials. The rebar mats are placed in the boxes, the mesh is shown at the bottom of the image. Photos courtesy of Caleb Nickel (Civil Engineer/8530).

The outdoor experiment consisted of four concrete slabs produced in-house by TSC Civil Engineer, Caleb Nickel (8530). Each slab was made of 4000psi concrete with $\frac{3}{4}$ -inch maximum aggregate. Slab 1/N contained no reinforcement (N), Slab 2/M contained a single layer of mesh (M), Slab 3/SM contained a single rebar mat (SM), and Slab 4/DM contained a double rebar mat (DM). The single mat consisted of a seven-by-seven No.3 rebar layer at the base of the slab (figure 10a). The double mat was comprised of a seven-by-seven No.3 rebar layer at the base of the slab and a four-by-four No.3 rebar layer toward the top of the slab (Figure 10a). The mesh had 6-inch square spacing between wires (figure 10b).

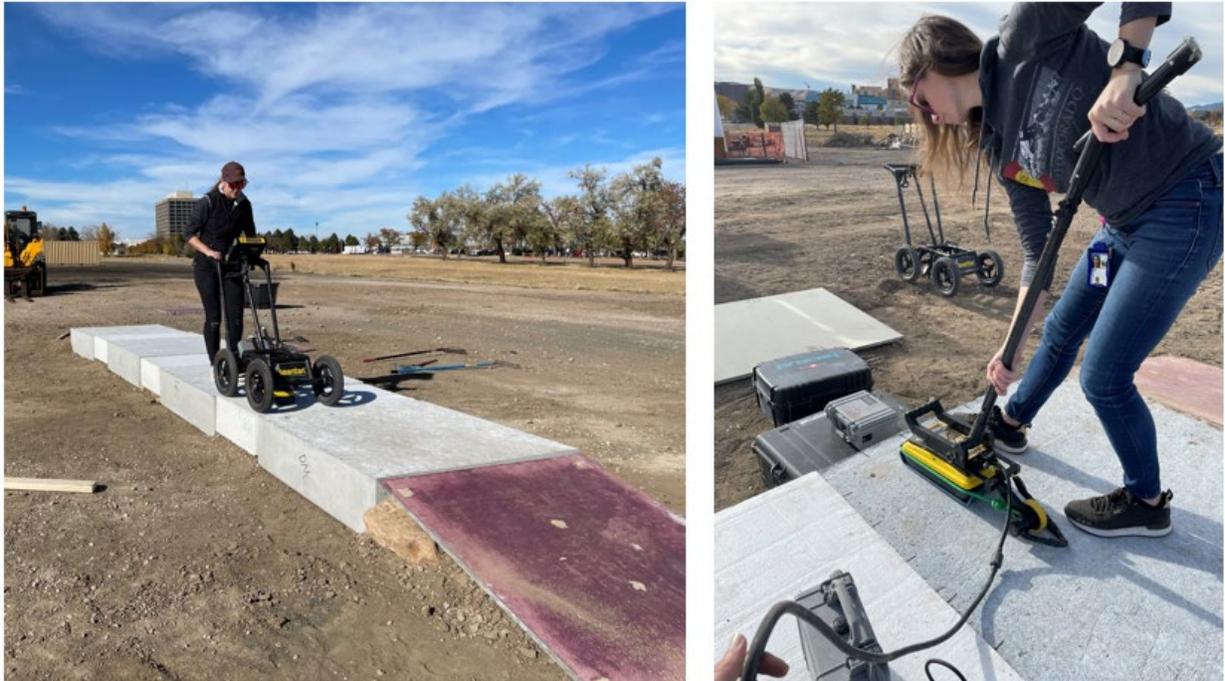
Figure 11.—Photos of GPR data collection at the Denver Federal Center using a (left) cart-based system and (right) handle attachment. Each system has a built-in odometer wheel to track distance surveyed.

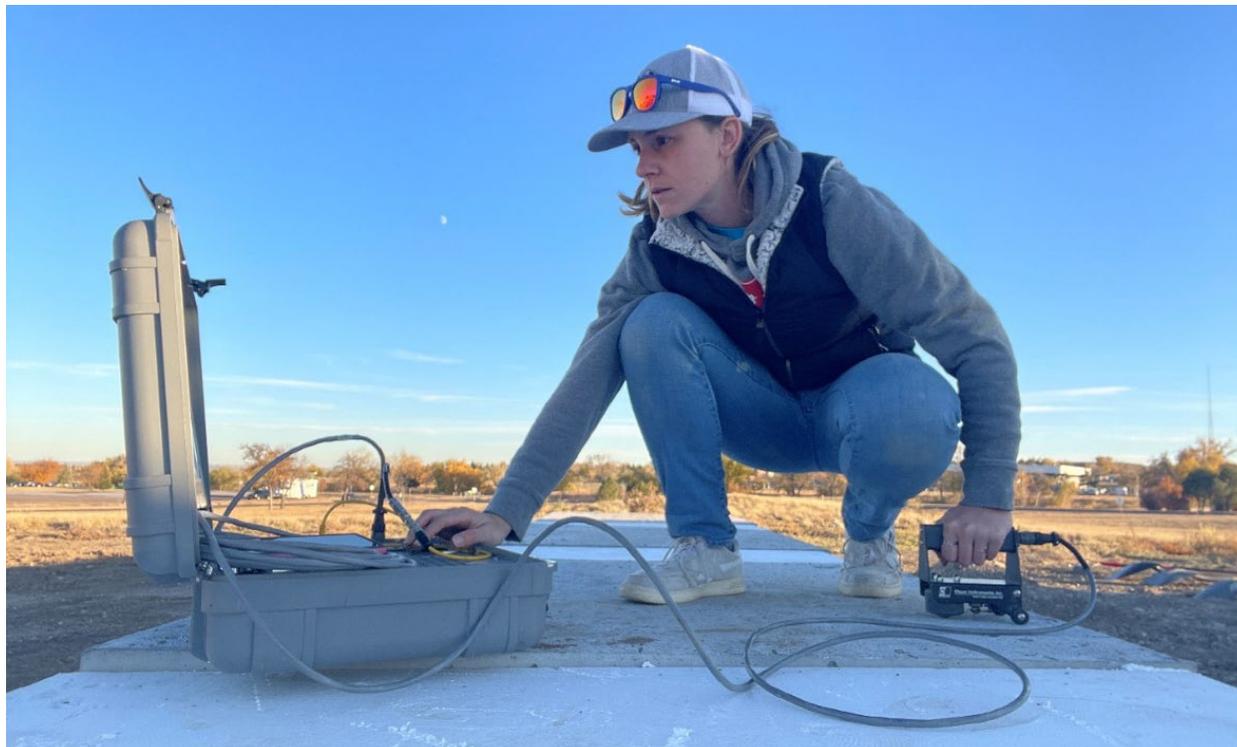
Figure 12.—Photo of Impact Echo data collection on the experimental slabs. The grey box (left) is the laptop and datalogger which attaches to the IE instrument (right).

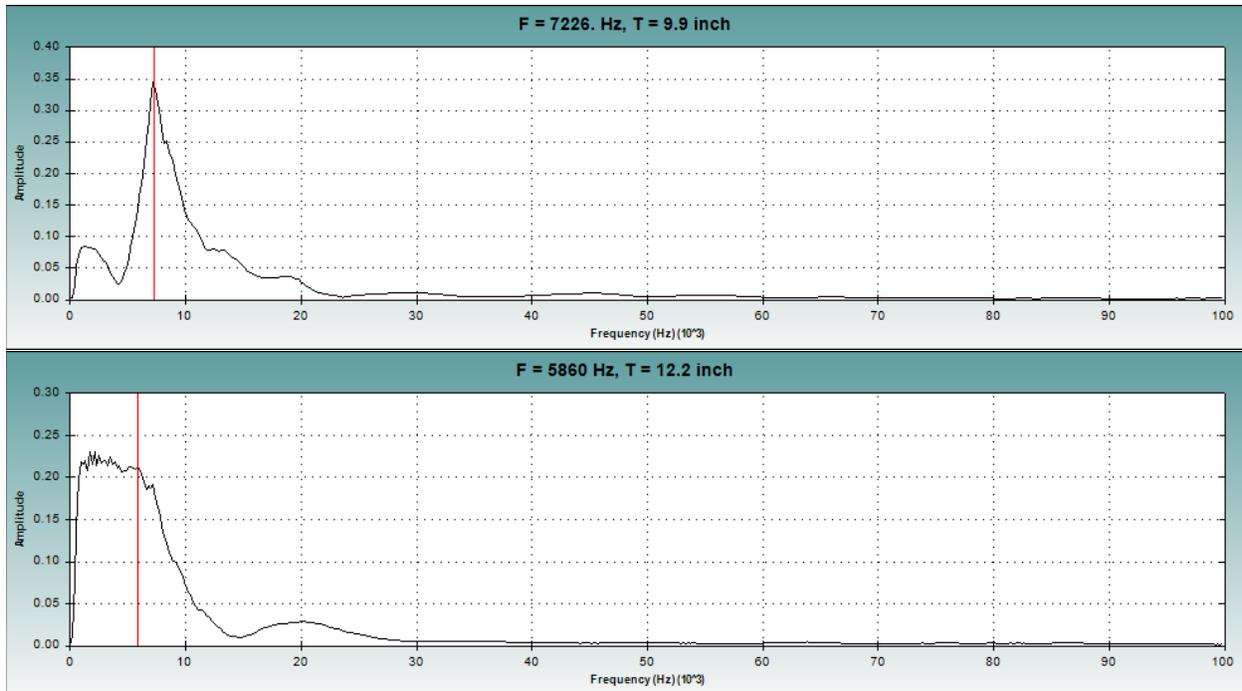
Figure 13.—Impact Echo (IE) amplitude versus frequency plots with automatically estimated peak frequencies (vertical red lines) and corresponding depth to a deeper reflection boundary. Top image displays a sharp spike in amplitude, representing the materials’ resonance frequency with a corresponding depth estimation. Bottom image displays a poorly defined range of high-amplitude signals, likely due to deformations in the measured concrete layer.

The shape of the observed peak frequency can be used to evaluate the condition of a material boundary. For example, a sharp, high-amplitude peak (figure 13, top) is often indicative of competent material that is well-supported by a deeper material. If the peak broadens or deteriorates (figure 13, bottom), it is likely the result of deformation within the survey material. These features can be associated with honeycombing or poorly cemented aggregate within a concrete subsurface.

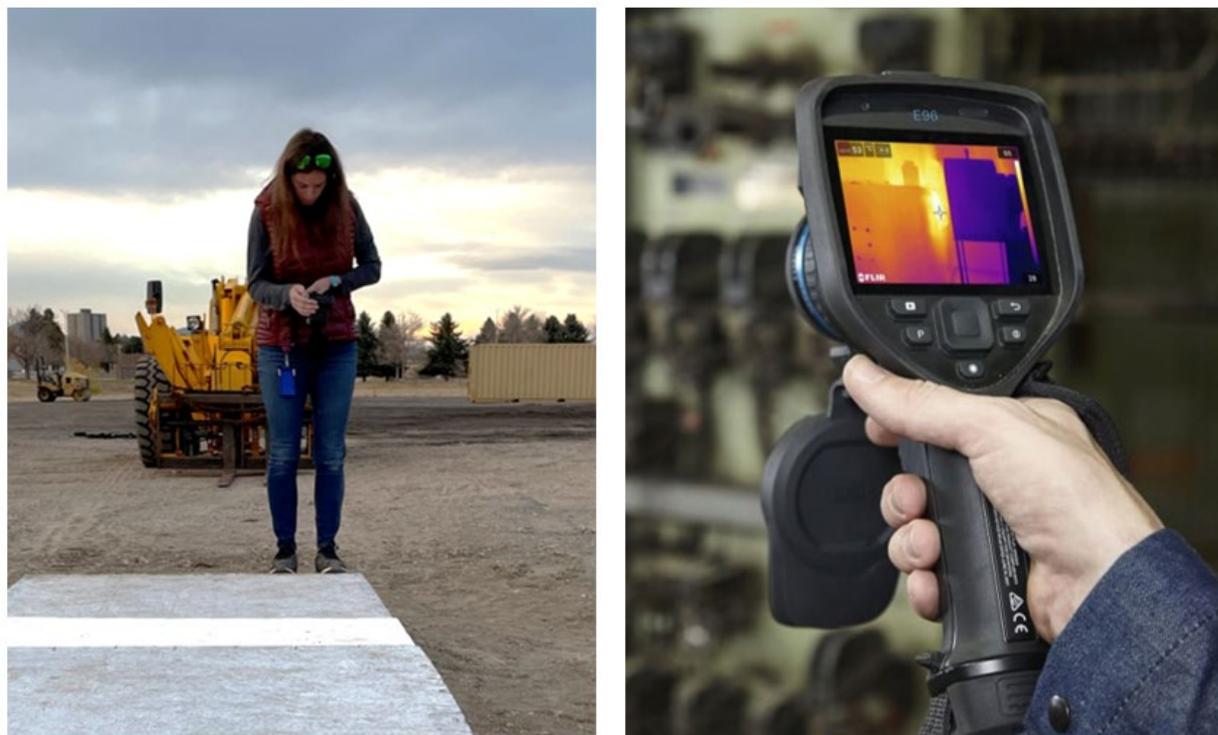
Figure 14.—(Left) Photo of geophysicist Miriam Johnston using the FLIR during one of the outdoor experiments. (Right) Image of the FLIR E96 handheld system, courtesy of manufacturer website (T. Equipment).

A FLIR, or forward-looking infrared camera, E96 Advanced Thermal Imager (figure 14) is a non-contact device that uses thermal imaging to detect and generate images based on the presence of heat rather than visible light. These thermal signals (i.e., radiation) are emitted by all objects that are warmer more than absolute zero and are considered invisible to the human eye. A FLIR camera is mostly used to identify changes in heat, the warmer the object, the more thermal energy it will emit. For this investigation, heat variations of interest can be related to the presence of moisture, ice, and exposed material surfaces (e.g., voids).

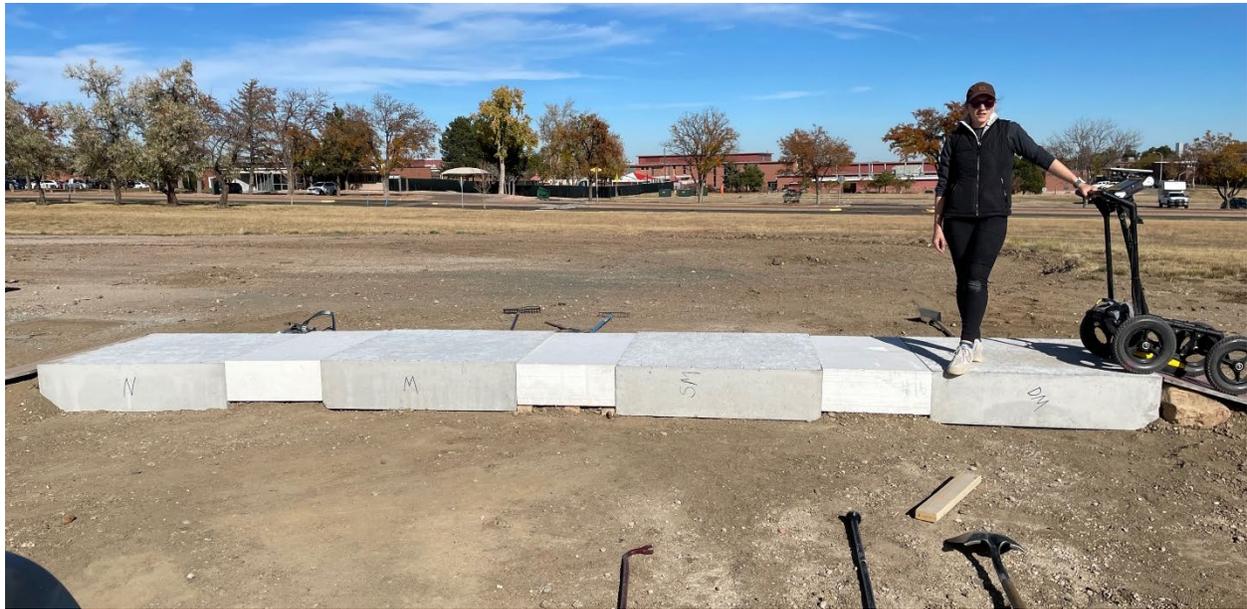
Figure 15.—Photo of field experiments showing each of the four concrete slabs. Slab 1 had no reinforcement (N), Slab 2 had a mesh reinforcement (M), Slab 3 had a single rebar mat (SM), and Slab 4 had a double rebar mat (DM).

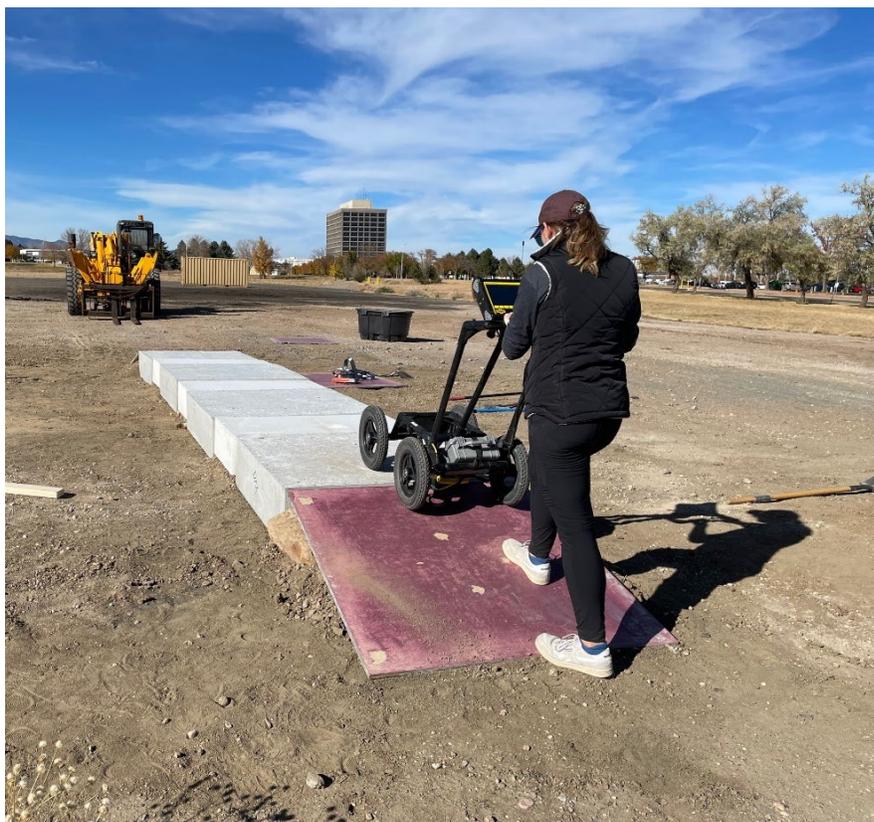
Figure 16.—Photo of ramp construction on each end of survey area to aid GPR surveying.

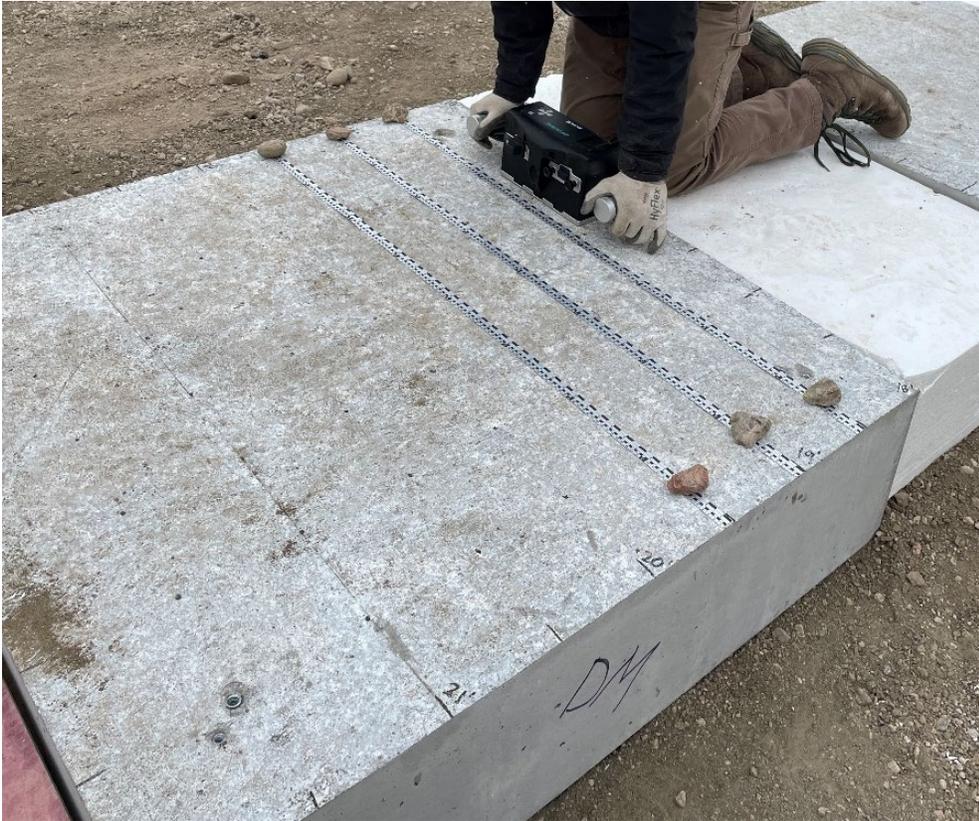
Figure 17.—Photo of concrete blocks with survey grid marked along the edges to indicate total distance along the survey grid. This photo shows block 4 marked from $x=18$ to 22ft.

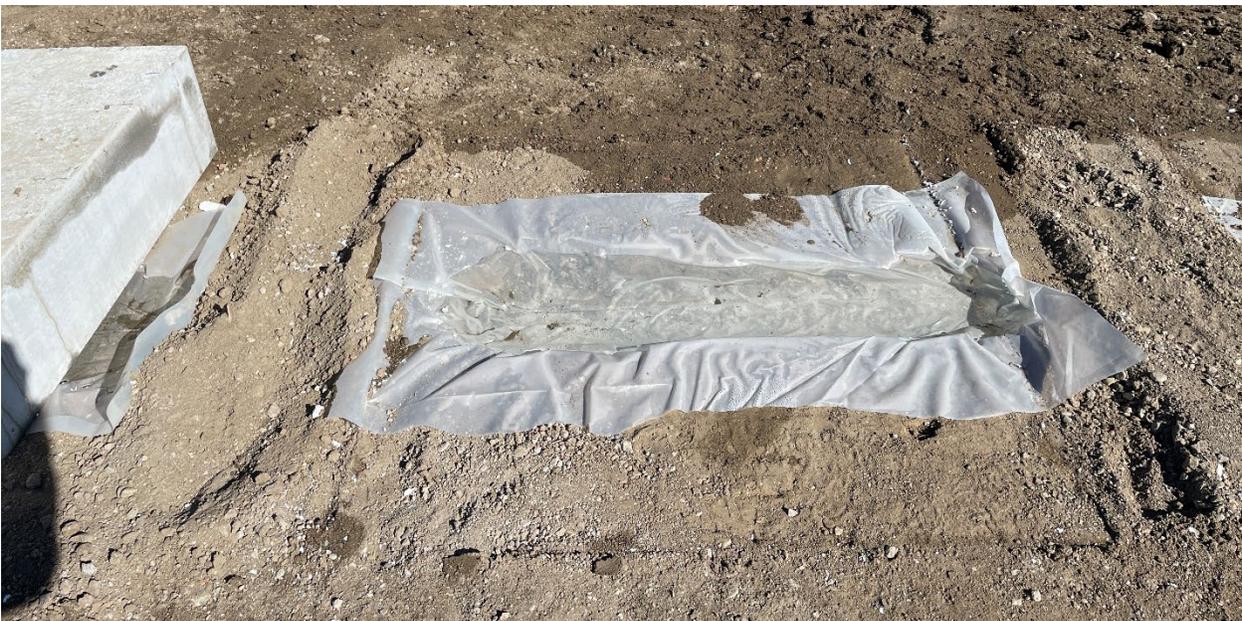
Figure 18.—Photo of longitudinal tunnel hand dug under the long axis of the experimental setup. A layer of visqueen plastic film was used to prevent the added water from draining during surveys.

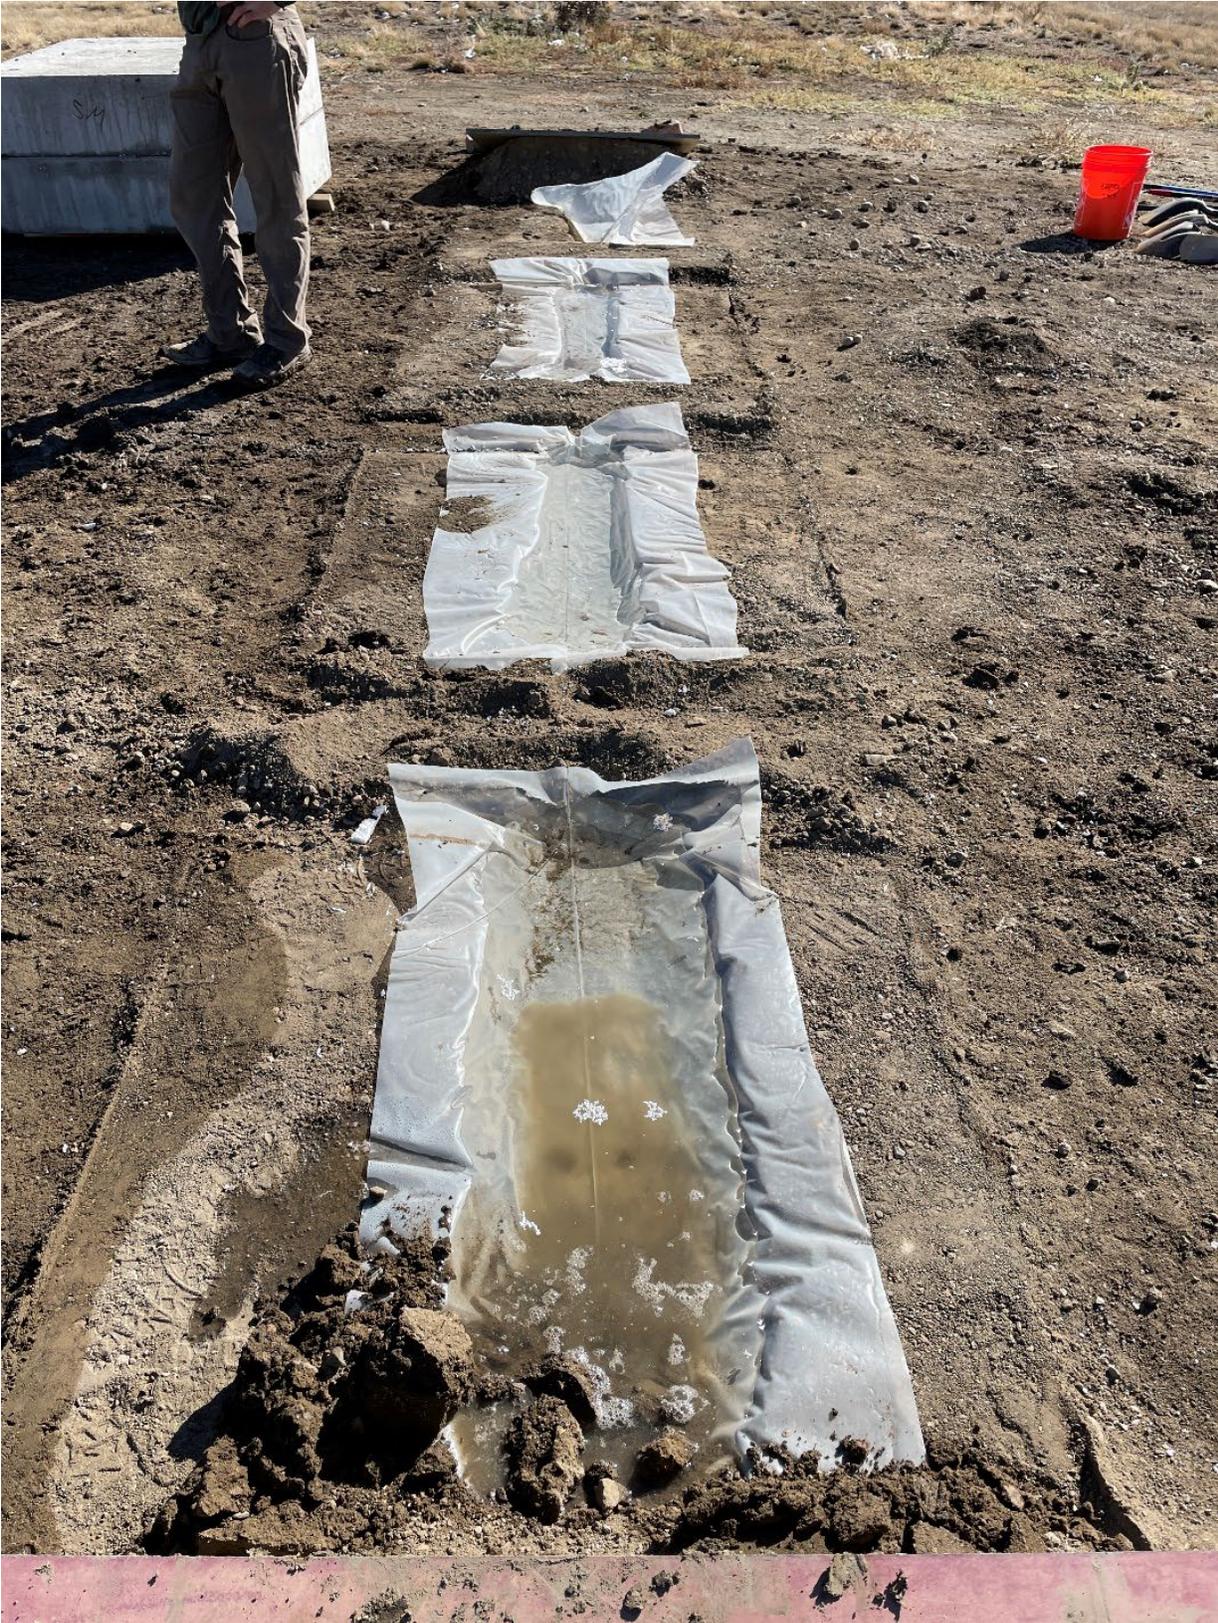
Figure 19.—Photo of water-filled visqueen films that were placed under each of the four concrete slabs.

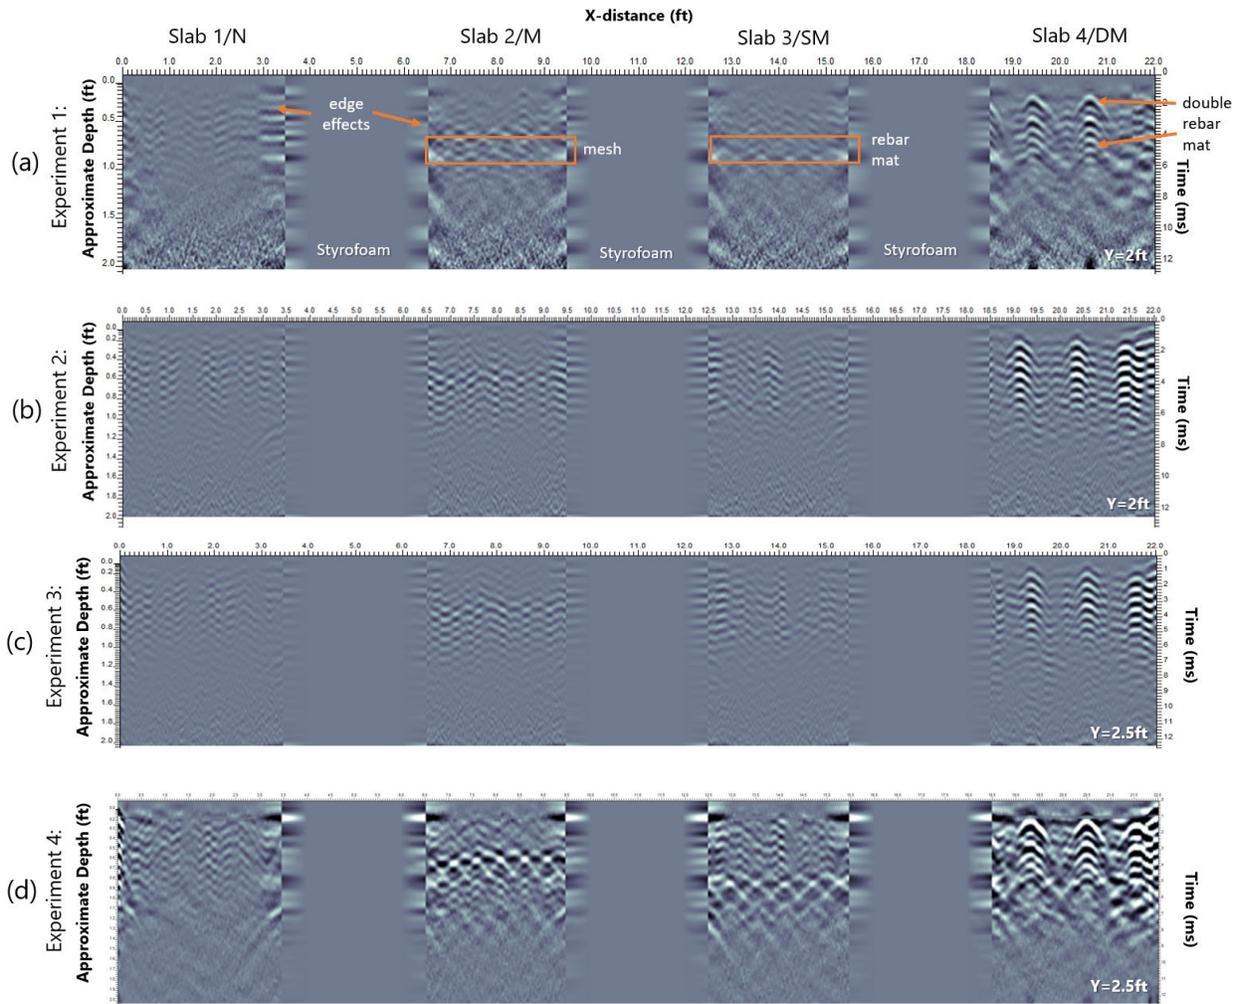
Figure 20.—X-axis (long-axis) GPR profiles across the centerline of each experimental setup. Each profile includes all four concrete test slabs with varying types of reinforcement separated by a Styrofoam block. For reference, the locations of each reinforcement are indicated in Experiment 1.
