— BUREAU OF —
RECLAMATION

Final Report No. ST-2024-21045-02 (86-68320-2025-16)

Detection of Voids Behind Spillway, Conduits, Canals, Tunnels, and Siphons – Report 2 of 3 on Void Causes, Detection, and Repair

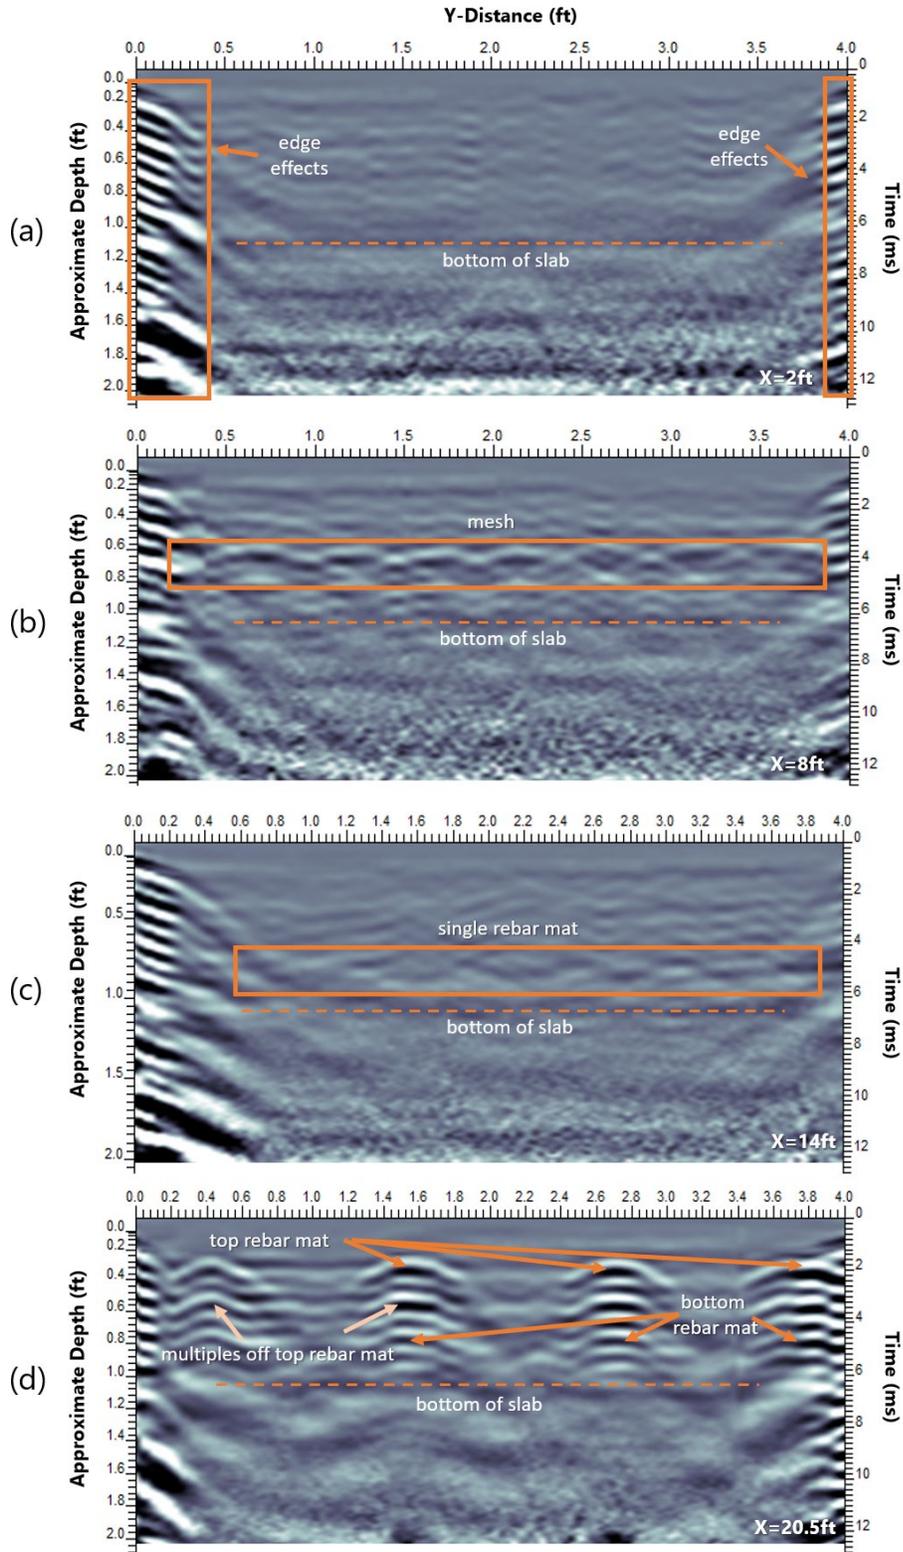
Figure 21.—Y-axis (short axis) GPR profiles across each concrete slab in Experiment 1; no void is present in this setup. The locations of each reinforcement and interpreted bottom of each slab are indicated in each profile.

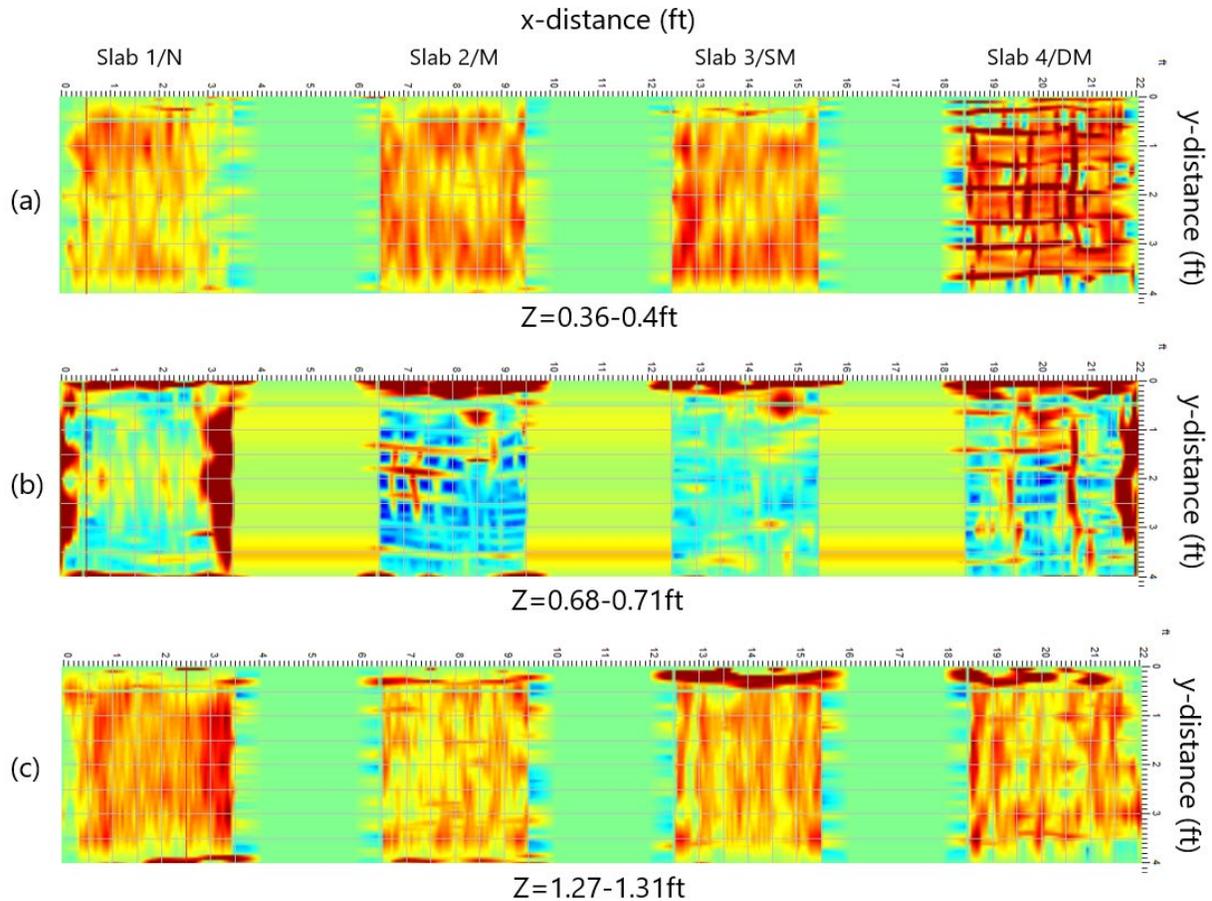
Figure 22.—Depth slices (plan-view profiles) from Experiment 1. Each depth slice includes all four concrete test slabs with varying types of reinforcement separated by a Styrofoam block. (a) The upper rebar mat is observed in slab 4 at 0.38 ft depth. (b) the wire mesh and rebar mats are observed at approximately 0.7 ft depth. (c) the bottom of the slab is at approximately 1.2 ft depth.

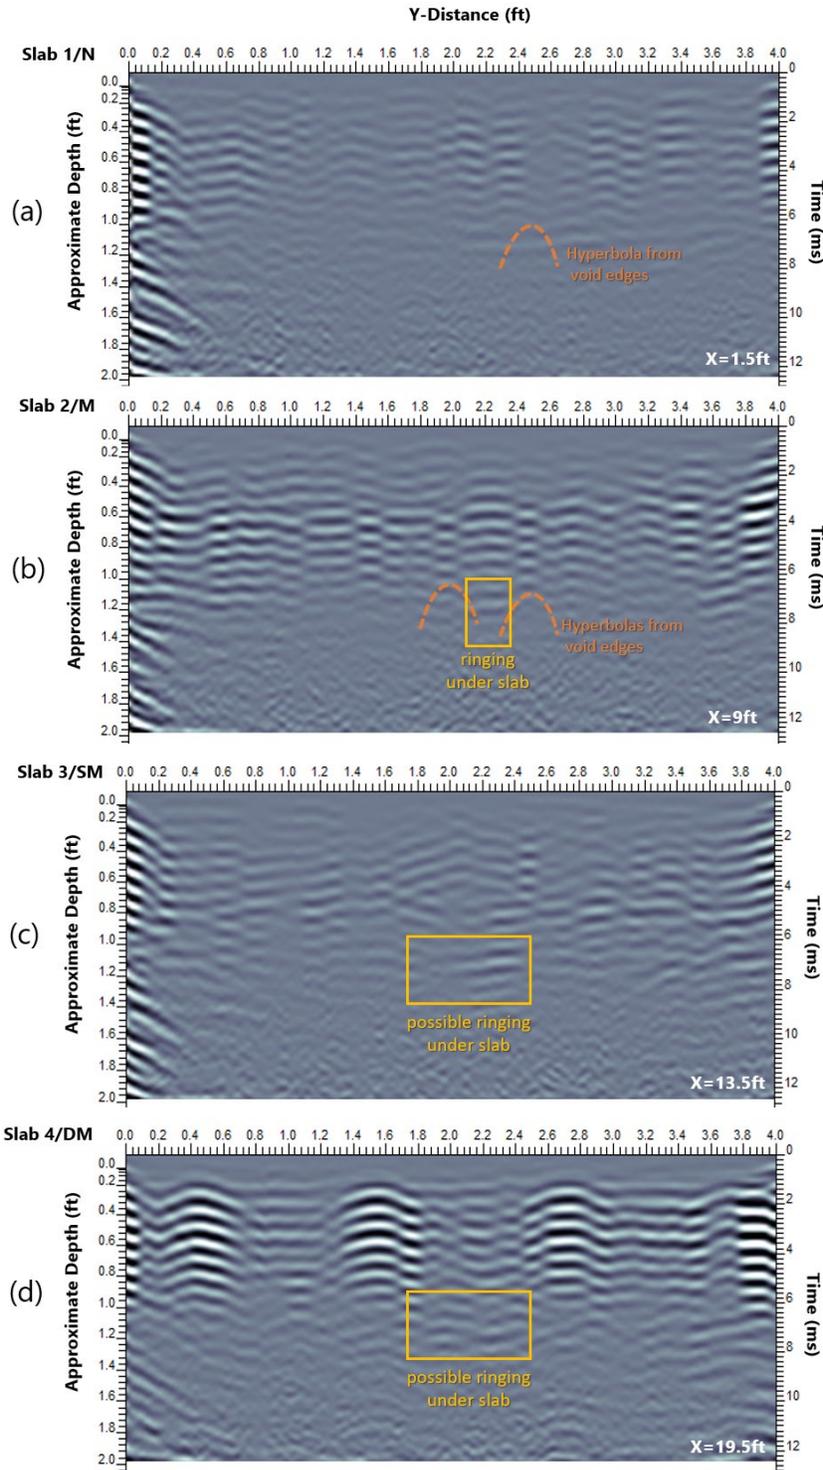
Figure 23.—Y-axis (short axis) GPR profiles across each concrete slab in Experiment 2 with an air-filled void; the void centerline is at approximately $y = 2$ ft. Evidence of the void are interpreted in each profile as either hyperbolas from the lateral edges of the void or ringing beneath the concrete slab.

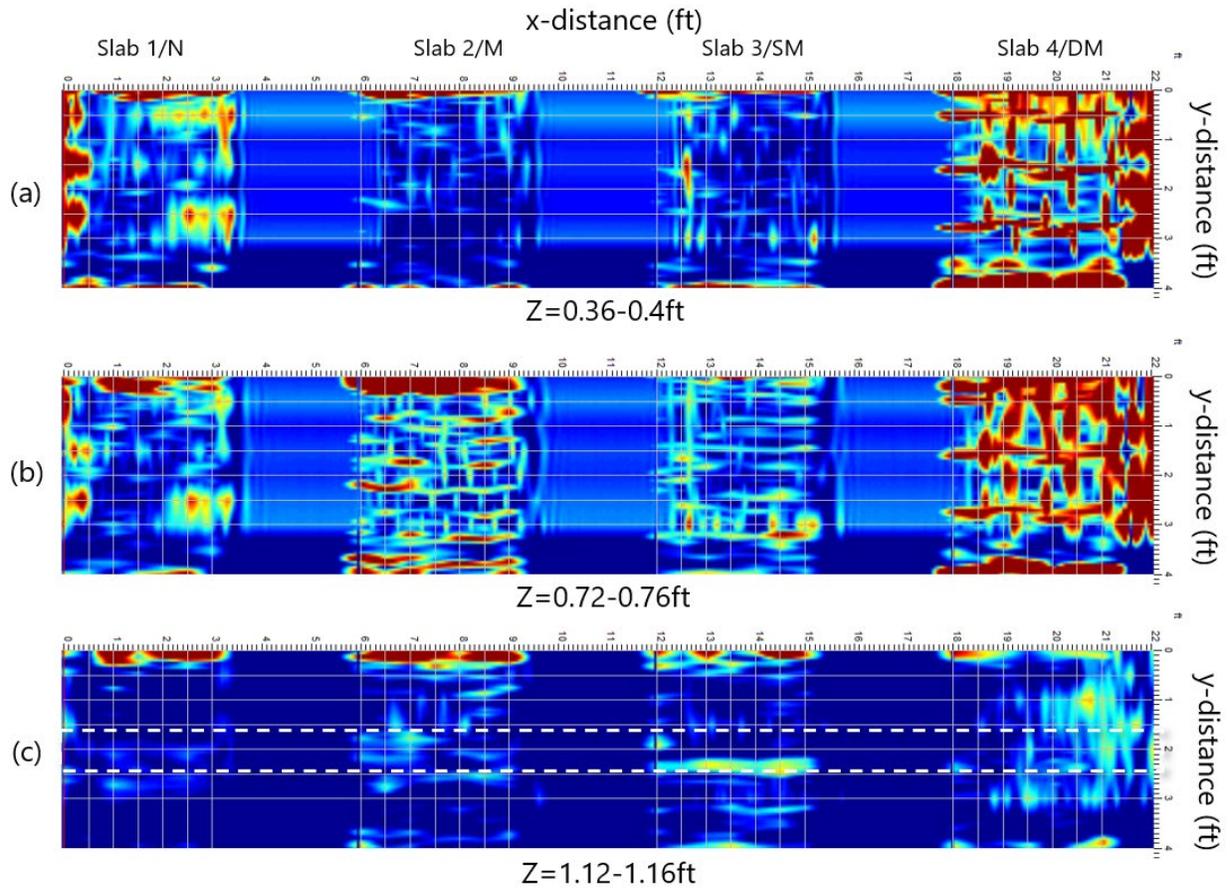
Figure 24.—Depth slices (plan-view profiles) from Experiment 2. Each depth slice includes all four concrete test slabs with varying types of reinforcement separated by a Styrofoam block. (a) The upper rebar mat is observed in Slab 4/DM at 0.36 ft depth. (b) the wire mesh and rebar mats are observed at approximately 0.72 ft depth. (c) the bottom of the slab is at approximately 1.2 ft depth. A longitudinal feature is observed below Slab 3/SM in the approximate location as the air-filled void.

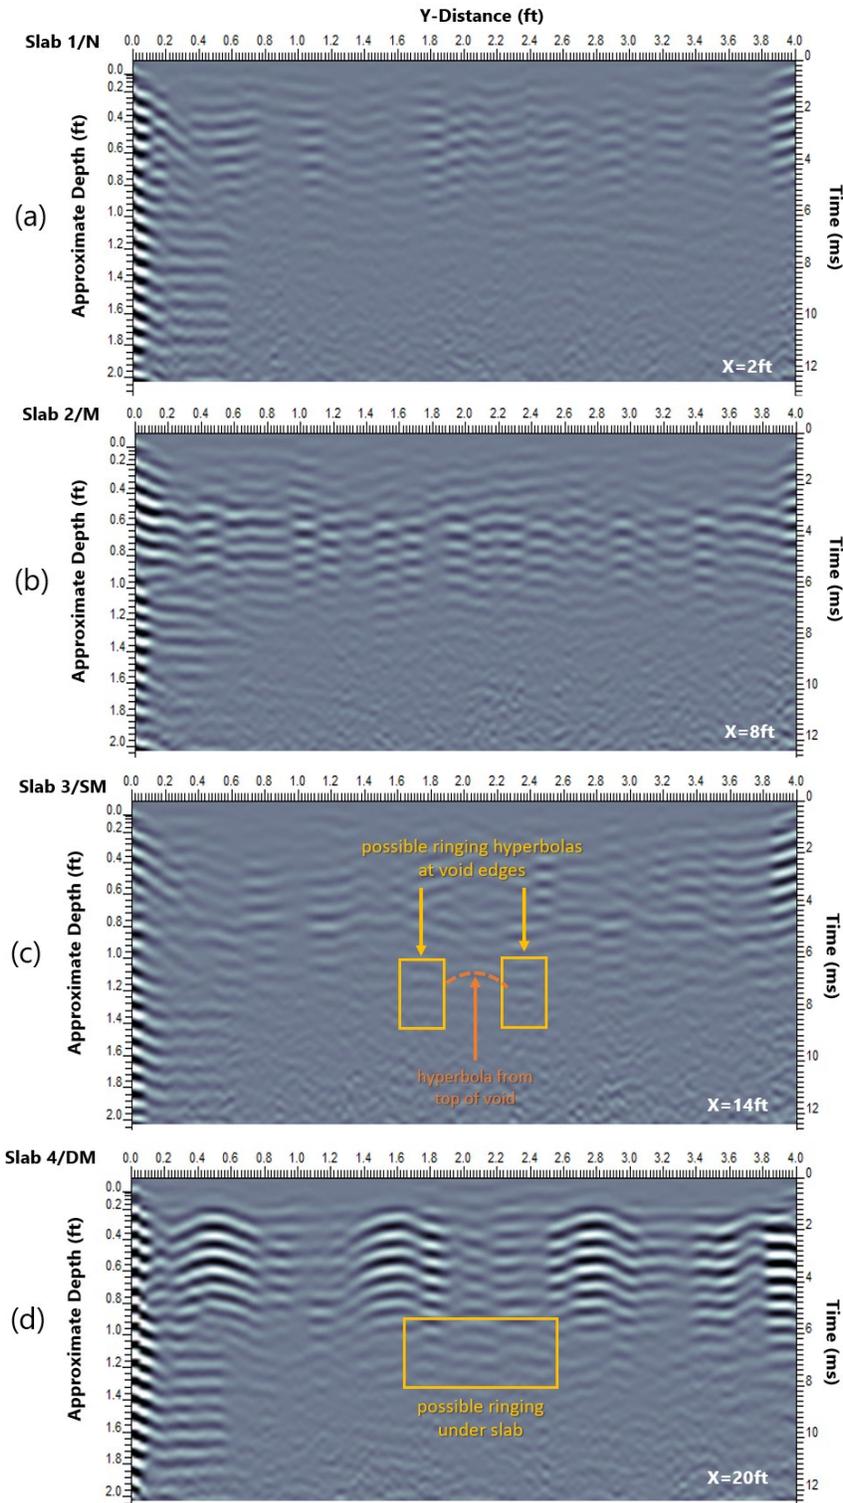
Figure 25.—Y-axis (short axis) GPR profiles across each concrete slab in Experiment 3 with a water-filled void; the void centerline is at approximately $y = 2$ ft. Evidence of the void are interpreted below Slab 3/SM and Slab 4/DM as either hyperbolas or ringing beneath the concrete slab.

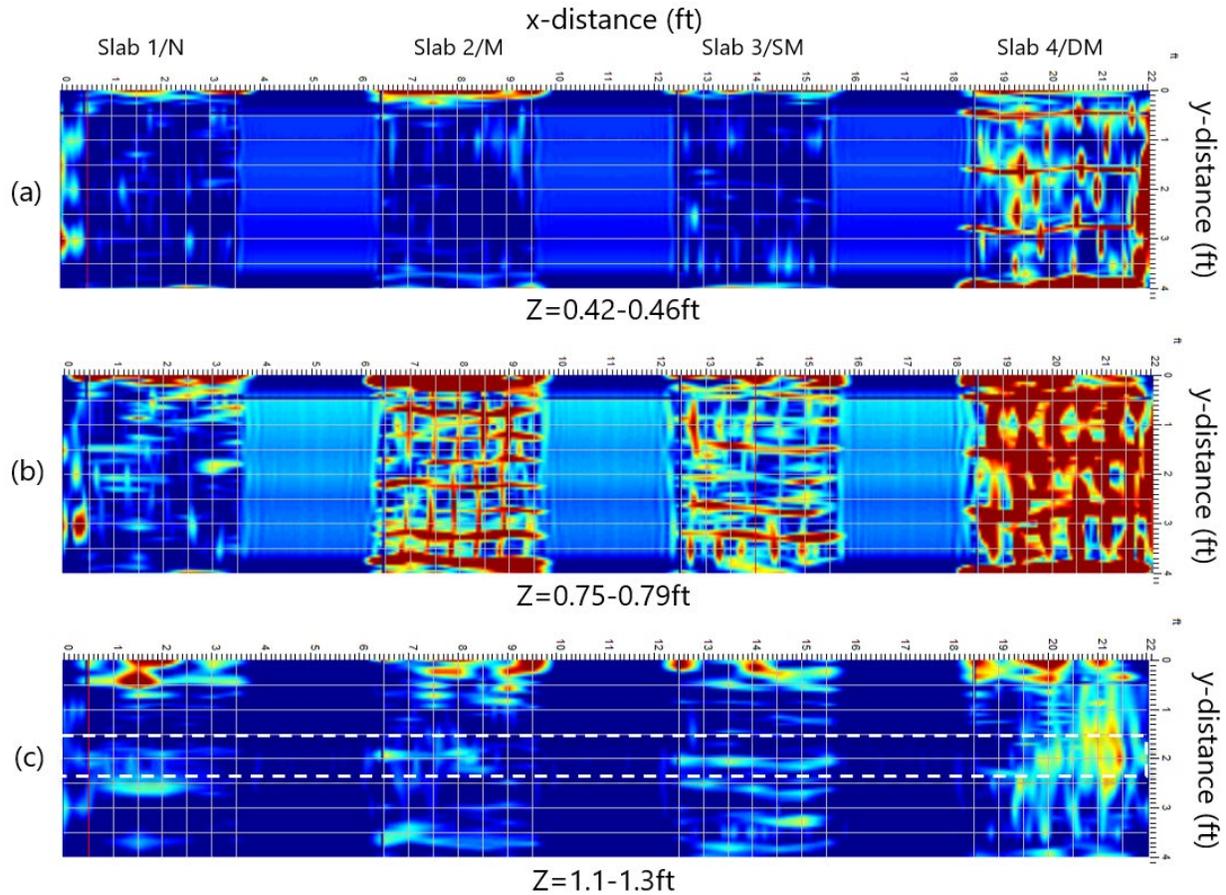
Figure 26.—Depth slices (plan-view profiles) from Experiment 3. Each depth slice includes all four concrete test slabs with varying types of reinforcement separated by a Styrofoam block. (a) The upper rebar mat is observed in Slab 4/DM at 0.42ft depth. (b) the wire mesh and rebar mats are observed at approximately 0.75ft depth. (c) the bottom of the slab is at approximately 1.2ft depth. A low-amplitude longitudinal feature is observed below Slab 2/M and Slab 3/SM in the approximate location as the water-filled void.

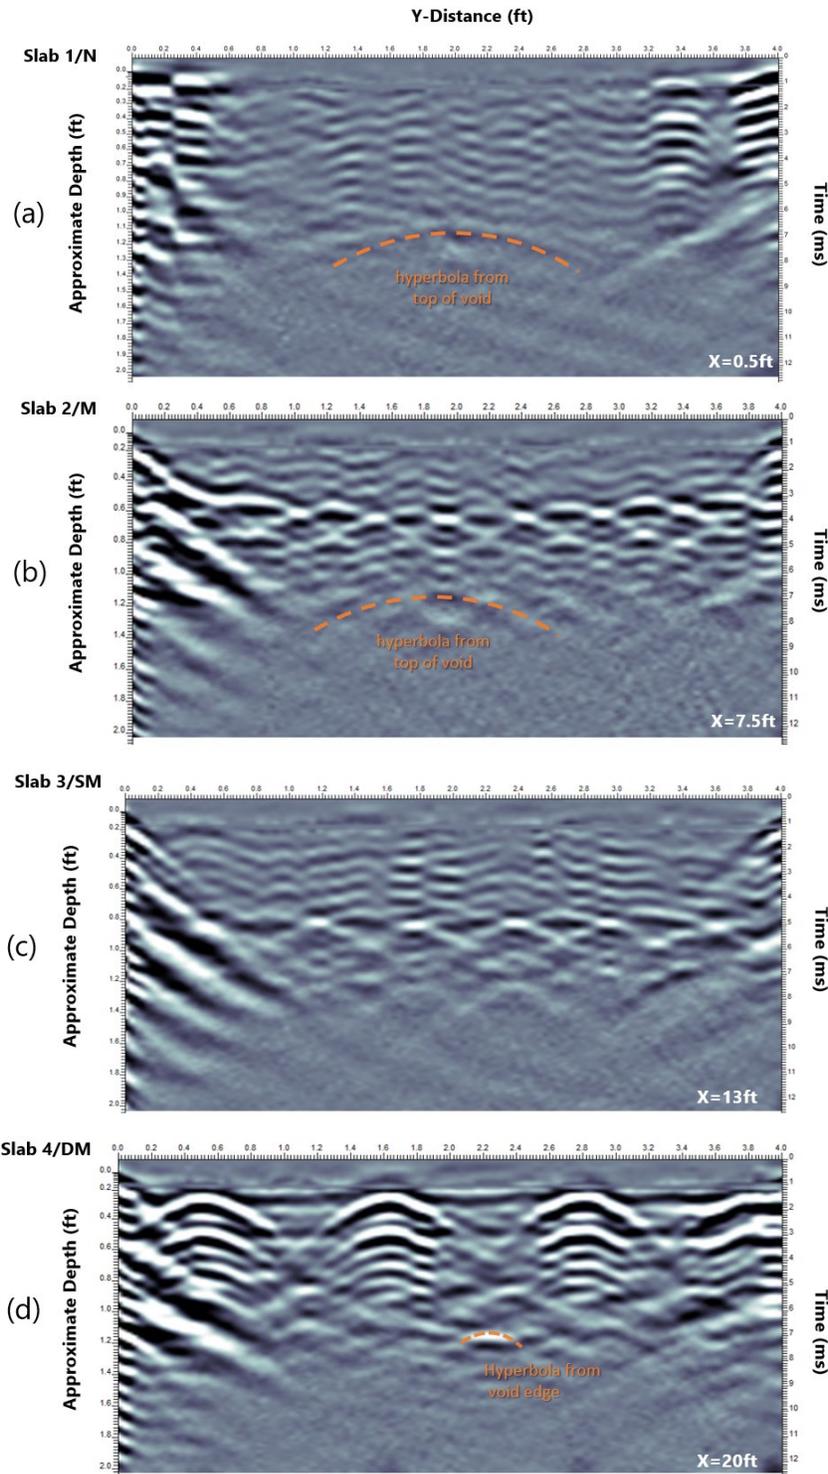
Figure 27.—Y-axis (short axis) GPR profiles across each concrete slab in Experiment 4 with a partially frozen water-filled void; the void centerline is at approximately $y = 2$ ft. Evidence of the void are interpreted in Slabs 1/N, 2/M, and 4/DM as hyperbolas from either the top of the void or the lateral edges of the void.

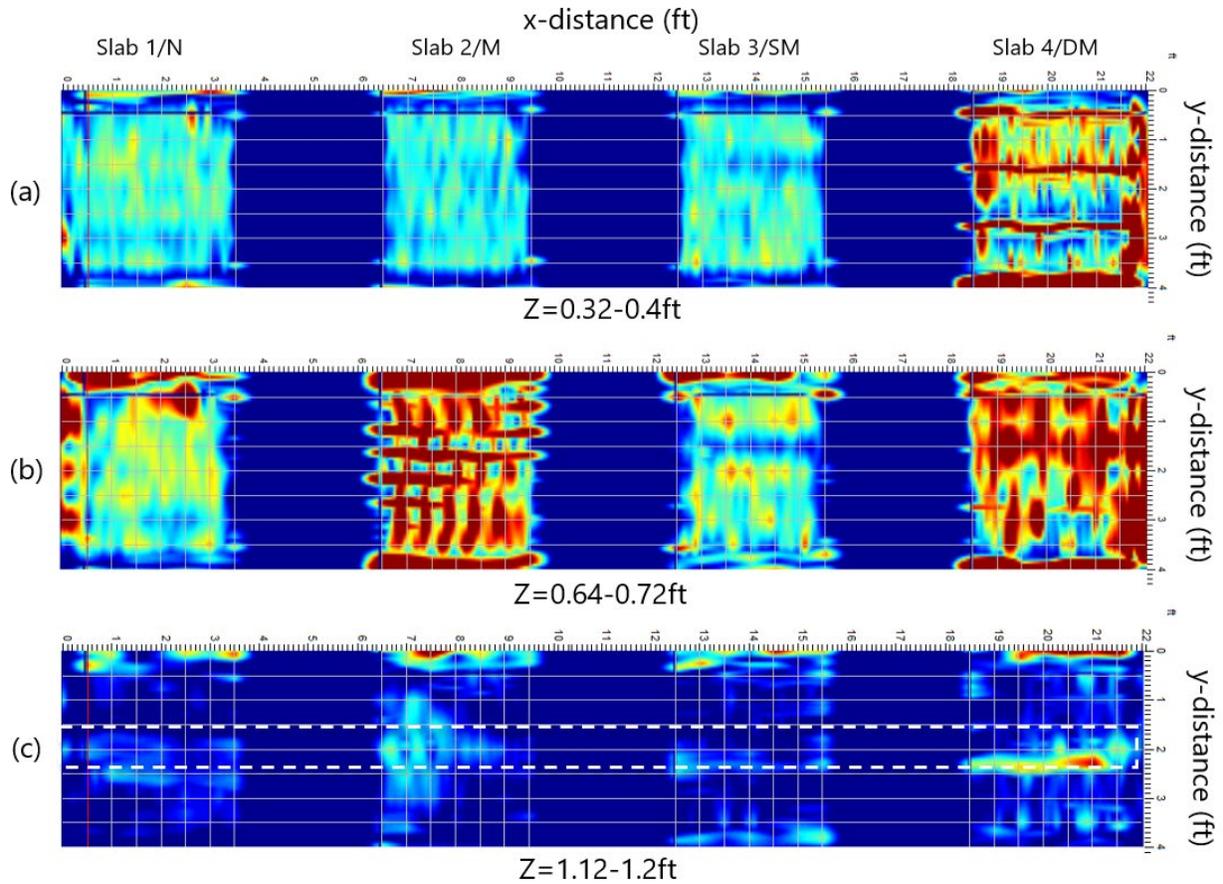
Figure 28.—Depth slices (plan-view profiles) from Experiment 4. Each depth slice includes all four concrete test slabs with varying types of reinforcement separated by a Styrofoam block. (a) The upper rebar mat is observed in Slab 4/DM at 0.36 ft depth. (b) the wire mesh and rebar mats are observed at approximately 0.7 ft depth. (c) the bottom of the slab is at approximately 1.15 ft depth. A longitudinal feature is observed below Slab 4/DM in the approximate location as the partially frozen water-filled void.

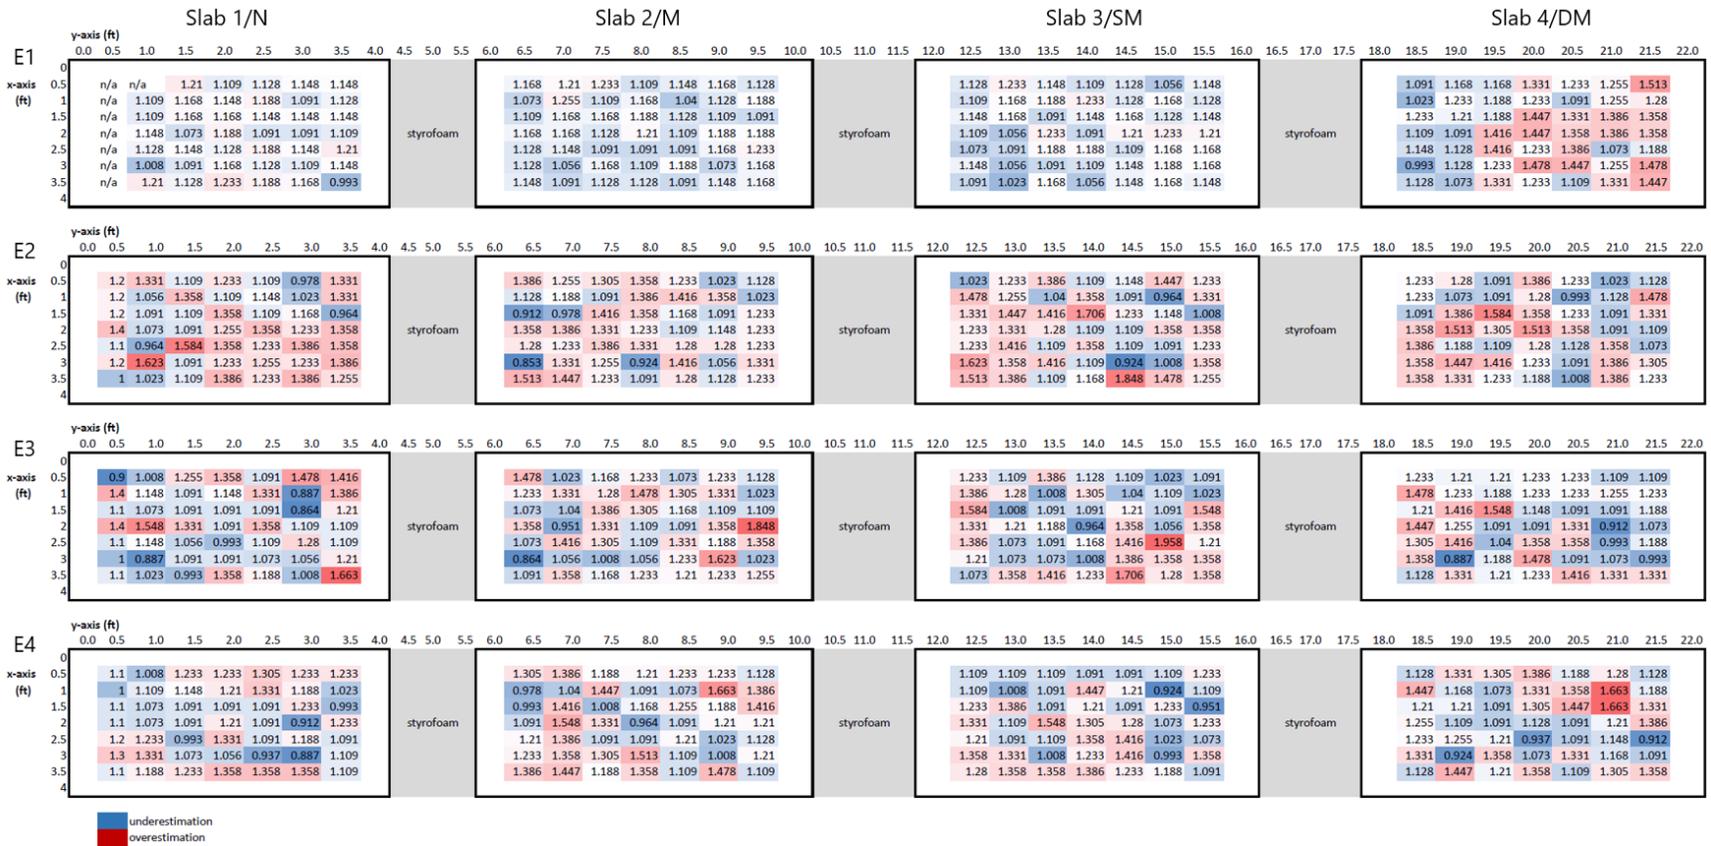
Figure 29.—IE results for each experiment and each slab. Warmer (redder) colors represent larger slab thickness estimates and cooler (bluer) colors represent smaller, or thinner, slab thickness estimates.

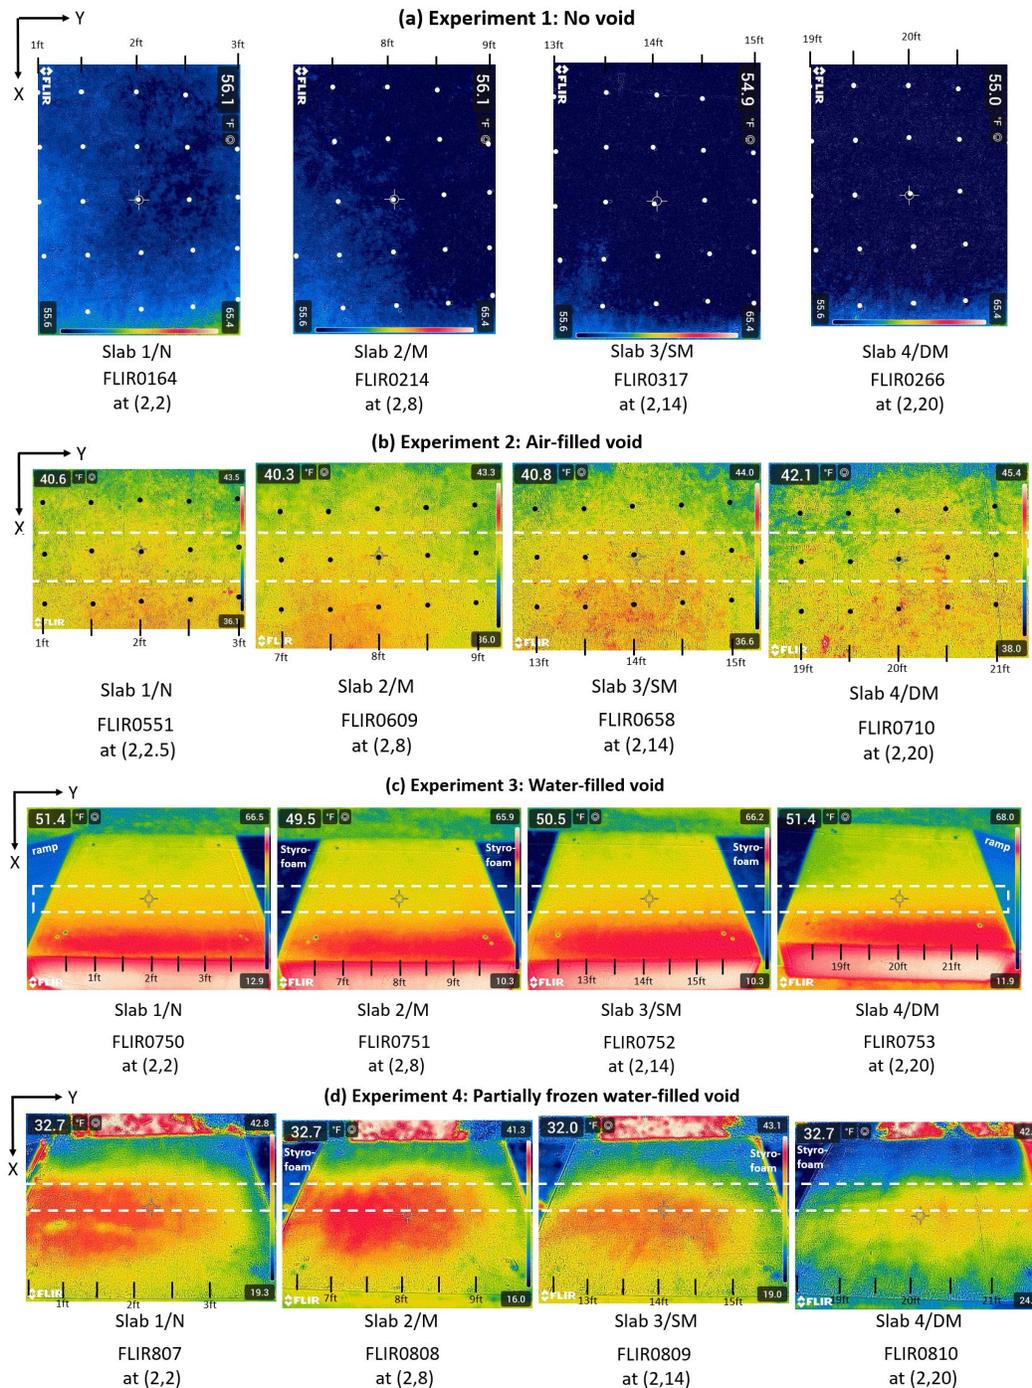
Figure 30.—(a) – (d) FLIR images of each slab for each experiment. An approximate grid and scale are overlaid on each FLIR image. The white dashed rectangle is drawn to indicate the approximate location of the subslab longitudinal void. N refers to no void, M refers to mesh reinforcement, SM refers to single rebar mat, and DM refers to double rebar mat. Temperature scales are listed on the right side of each image.

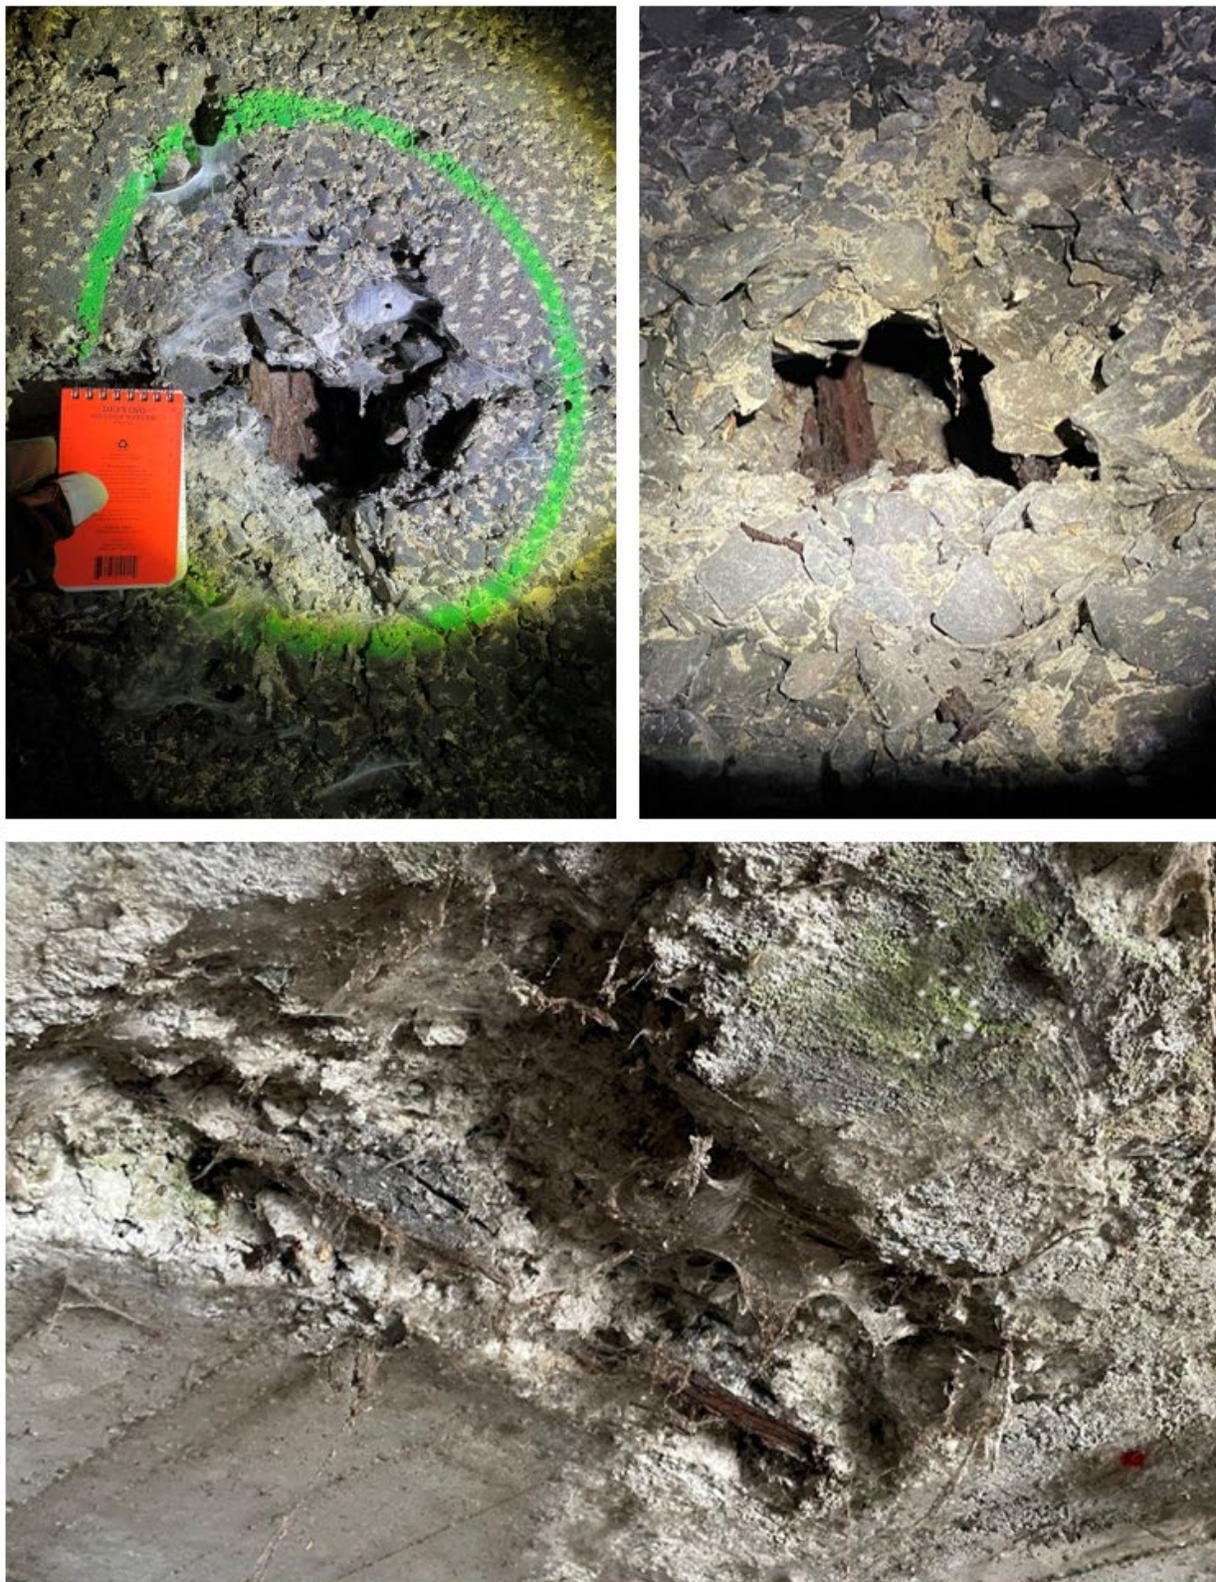
Figure 31.—Photos of exposed timber reinforcement and varying degrees of concrete deterioration observed in A Canal Tunnel during data collection.

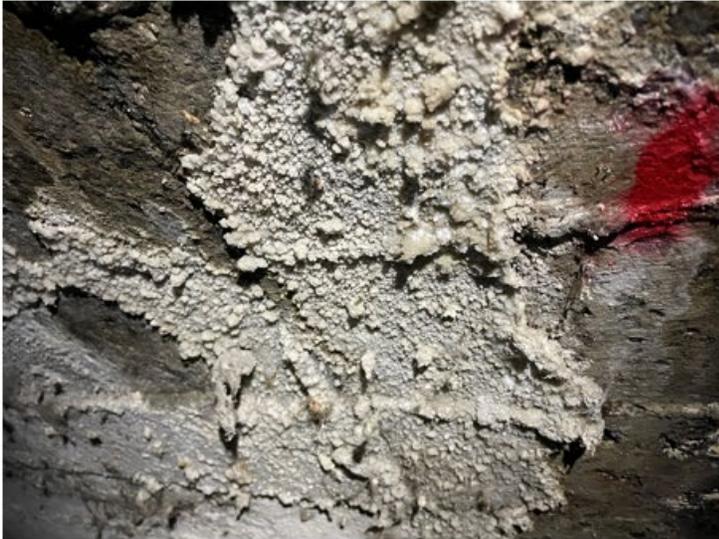
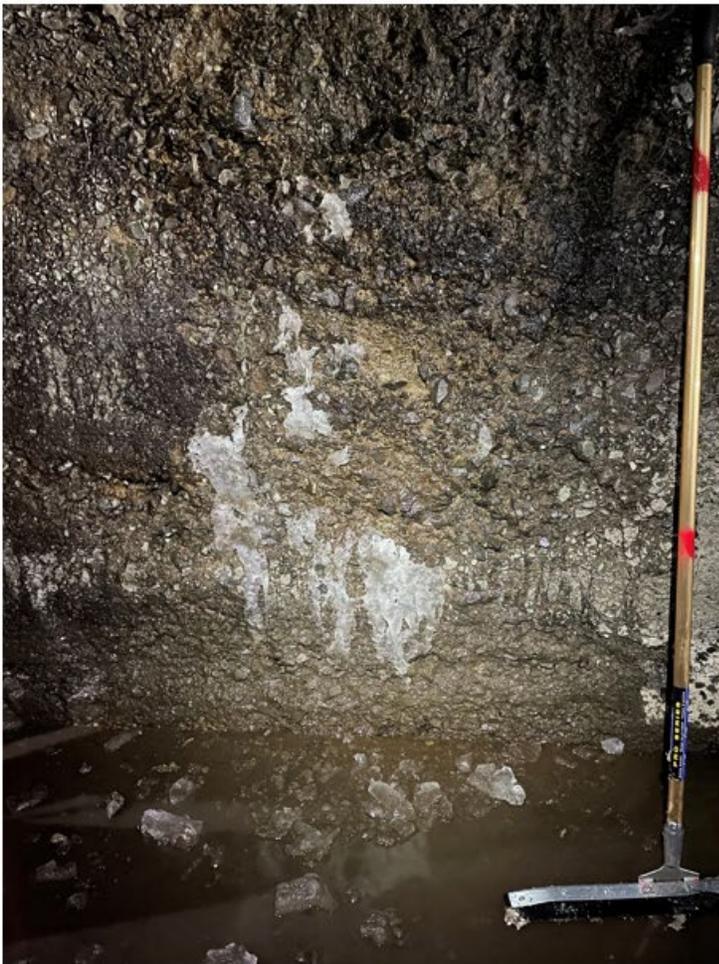
Figure 32.—Photos of tunnel conditions showing uneven concrete surface (top) and icy walls (bottom) due to the deterioration of the concrete.

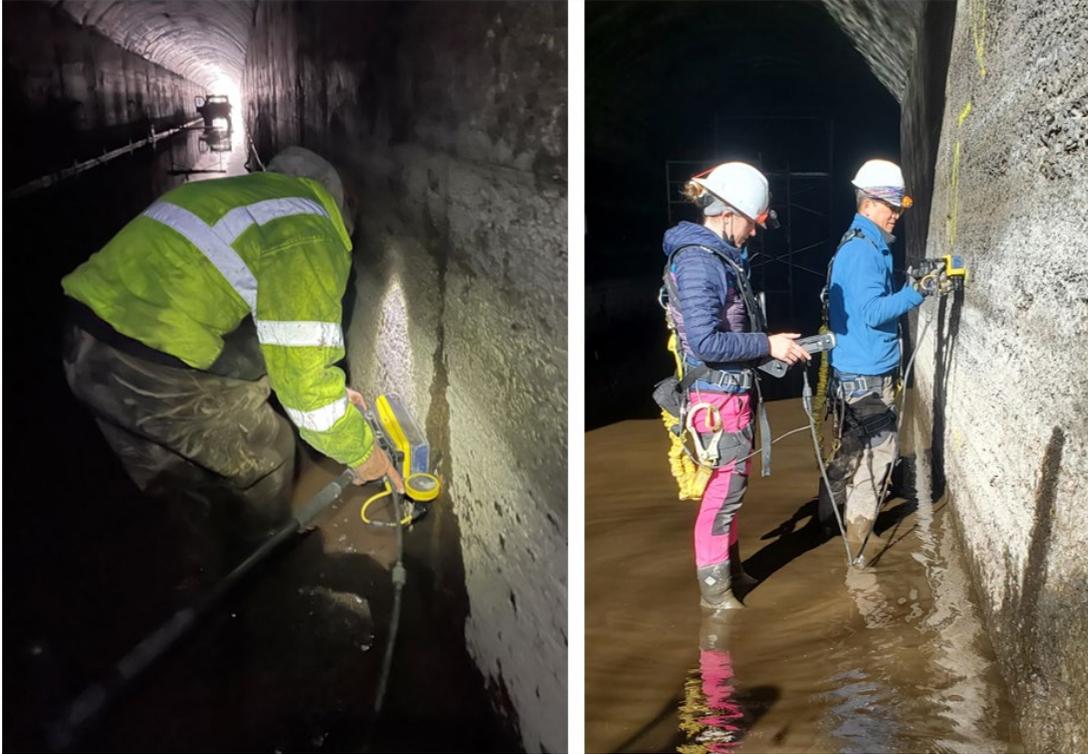
Figure 33.—Photos of Reclamation personnel performing GPR surveys on the tunnel walls.

Fixed-offset cart-based GPR line data (2-D data) were collected using a Sensors and Software Inc. Noggin SmartHandle™ GPR system with a 1000MHz antenna (figure 33). The irrigation tunnel consists of 11 ft-tall vertical walls and a nearly 4ft-tall crown. Survey lines were oriented along the tunnel's long axis in the east-west (upstream-downstream) direction across the north wall (left embankment), south wall (right embankment) and tunnel crown. Surveys were performed with caution due to the environmental conditions inside the tunnel. Standing water was present in many sections and walls were often wet, covered in ice, or overrun with cobwebs (figure 33, figure 34). Geophysical surveys were performed under a confined space permit with personnel positioned on both sides of the tunnel throughout the duration of each workday.

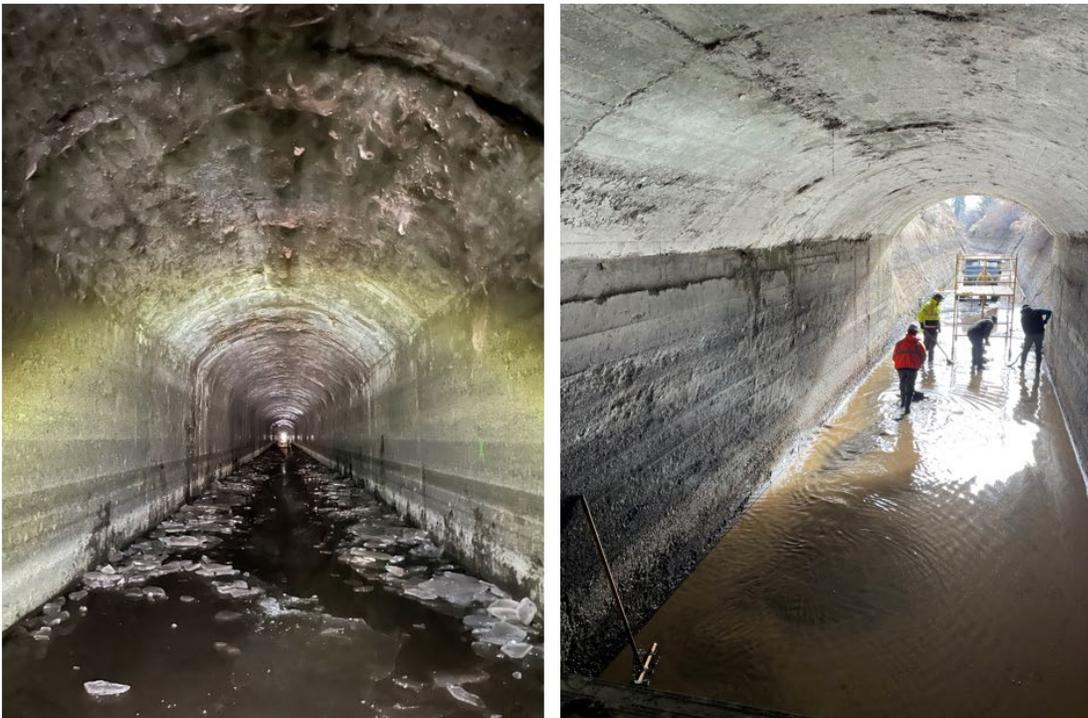
Figure 34.—Photos of tunnel conditions showing cobwebs across ceiling with broken up icy floor (left) and deepening standing water (right).

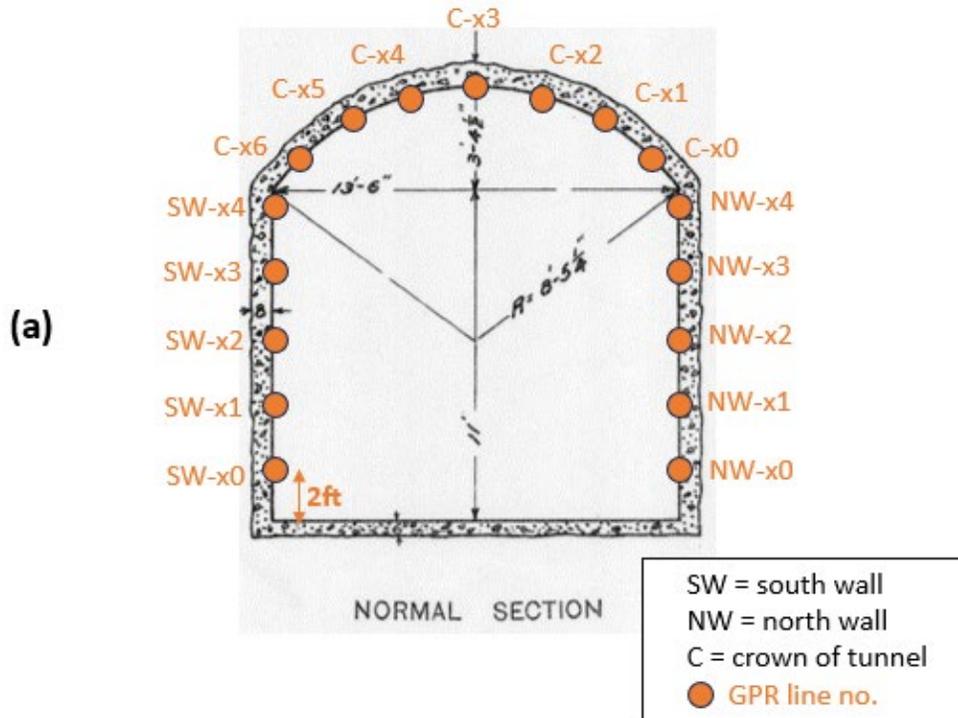
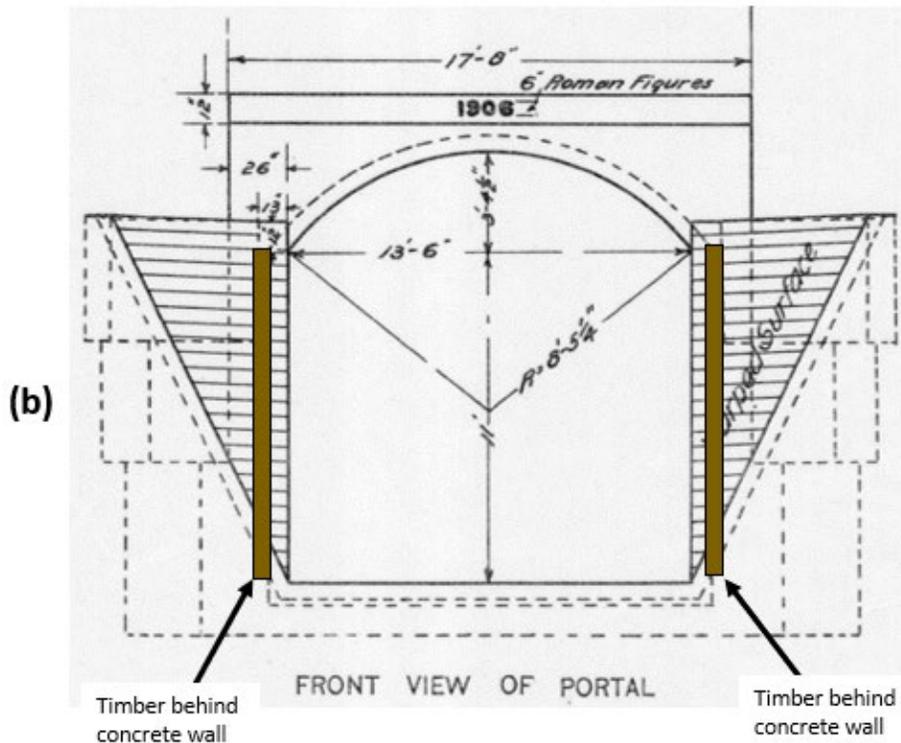
Figure 35.—(a) GPR survey line locations (orange) in A Canal Tunnel. (b) Schematic of A Canal Tunnel showing approximate locations of timber supports with respect to the sloped canal embankment walls. Figures are modified from Drawing No. 12-201-1766.

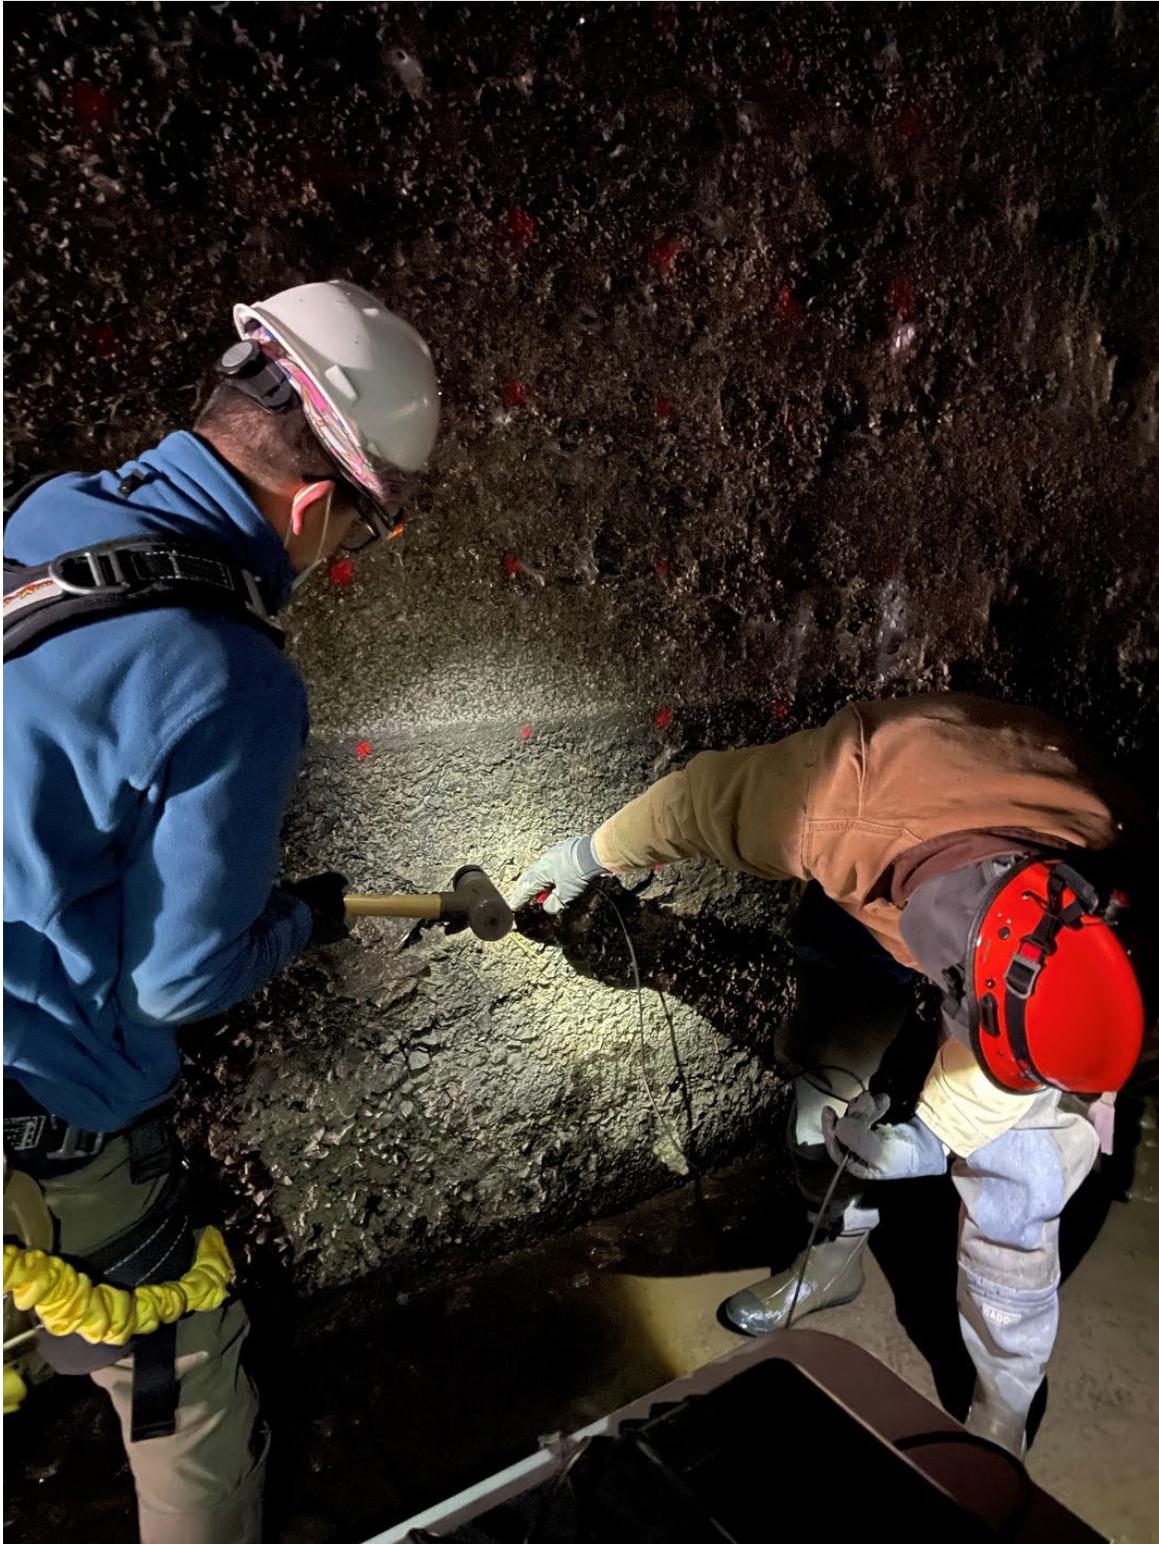
Figure 36.—Photo of Reclamation personnel performing one of the slab-impulse response surveys within A Canal.

Four slab impulse response survey grids were also performed in three sections of A Canal (figure 36). These sections include sections 11, 18, and 22 and were selected based on visual evidence of surface cracking and voids on and through the concrete wall. The grid locations and geometries for all SIR surveys are summarized in table 7.

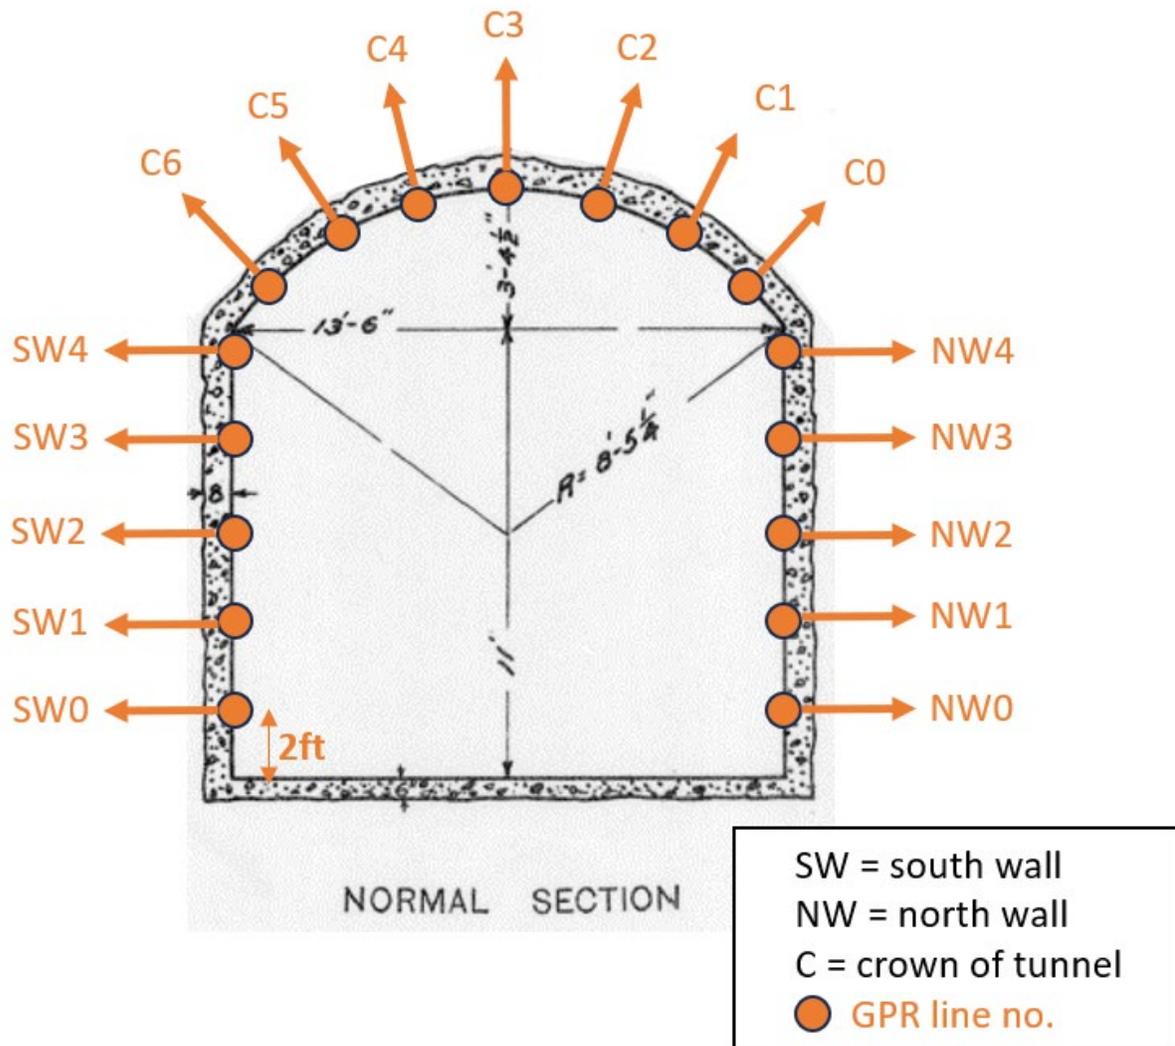
Figure 37.—GPR line names and each profile's depth orientation. Each orange arrow illustrates how depth projects into the subsurface behind the tunnel wall.
