— BUREAU OF —
RECLAMATION

Final Report No. ST-2024-21045-02 (86-68320-2025-16)

Detection of Voids Behind Spillway, Conduits, Canals, Tunnels, and Siphons – Report 2 of 3 on Void Causes, Detection, and Repair

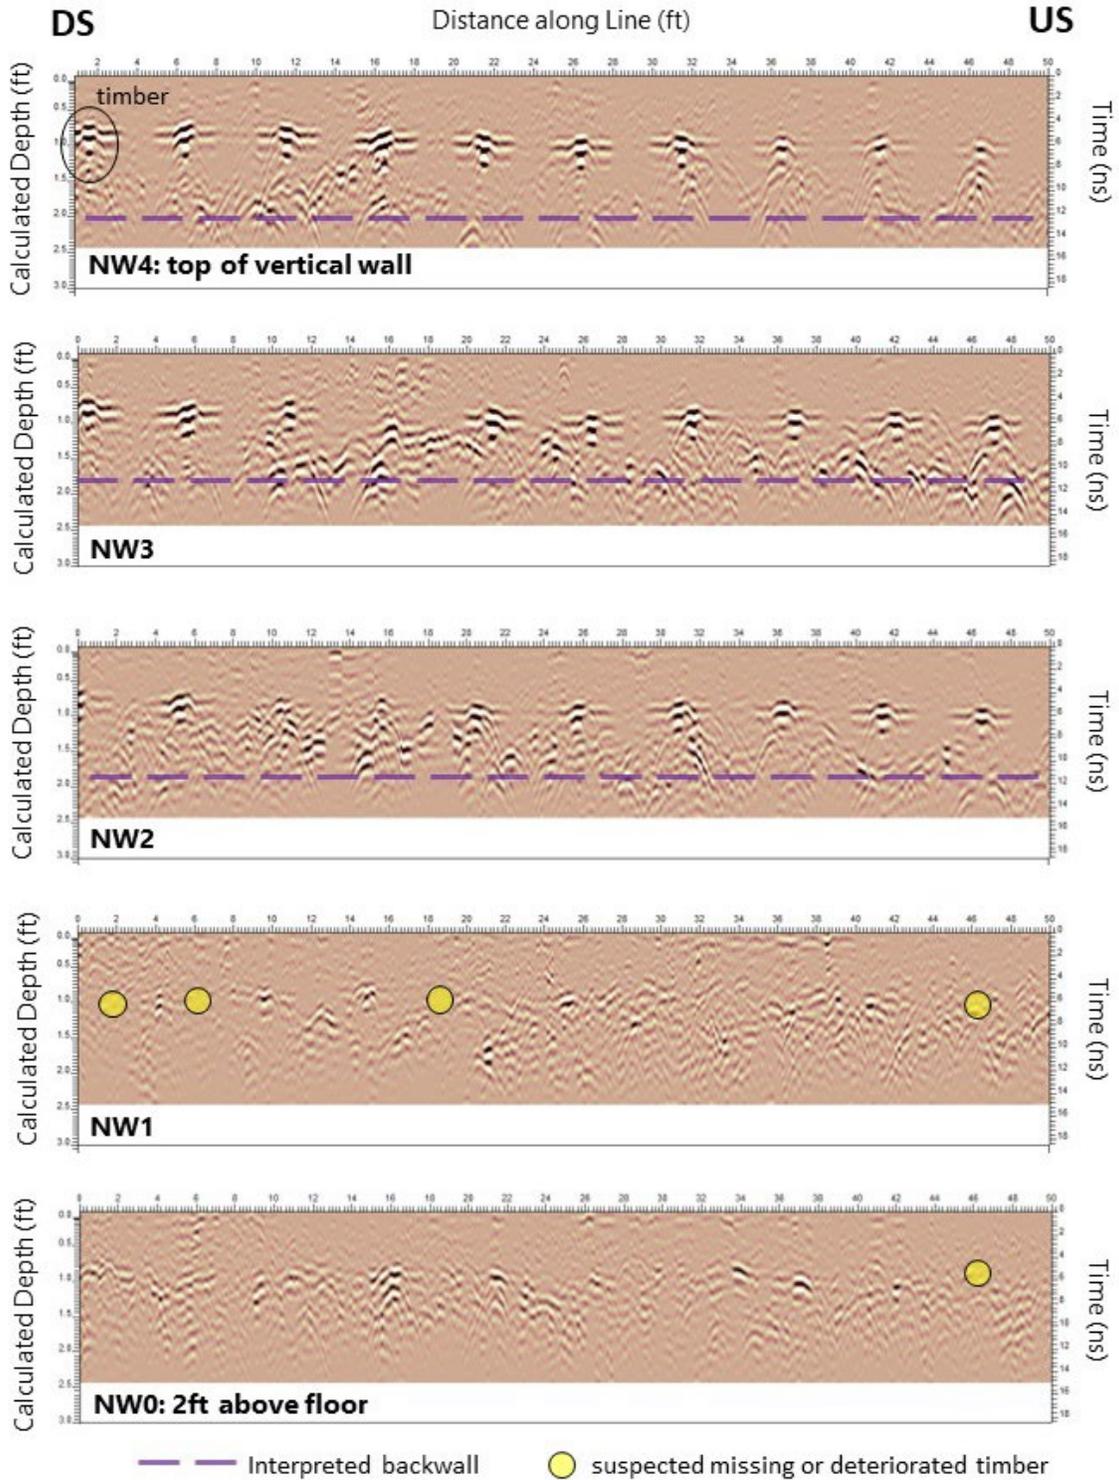
Section 11, North Wall

Figure 38.—GPR profiles from Tunnel Section 11 along the North wall. Each line has 2 ft vertical separation from the bottom of the wall (NW0) to the top of the vertical wall (NW4).

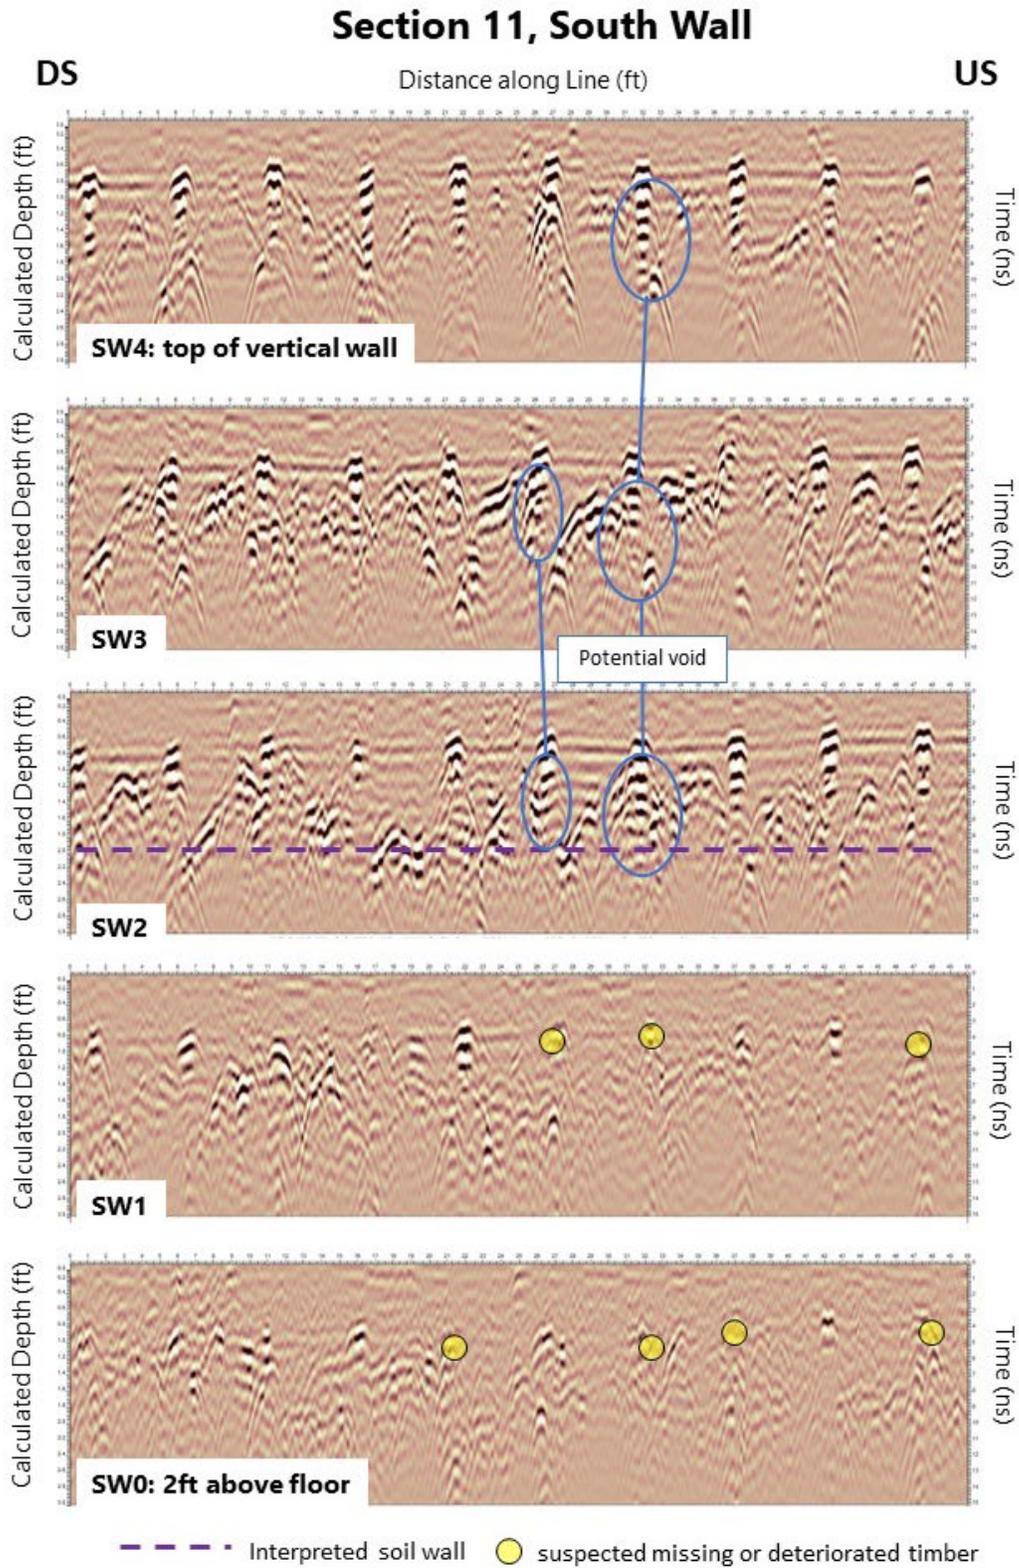
Figure 39.—GPR profiles from Tunnel Section 11 along the South wall. Each line has 2ft vertical separation.

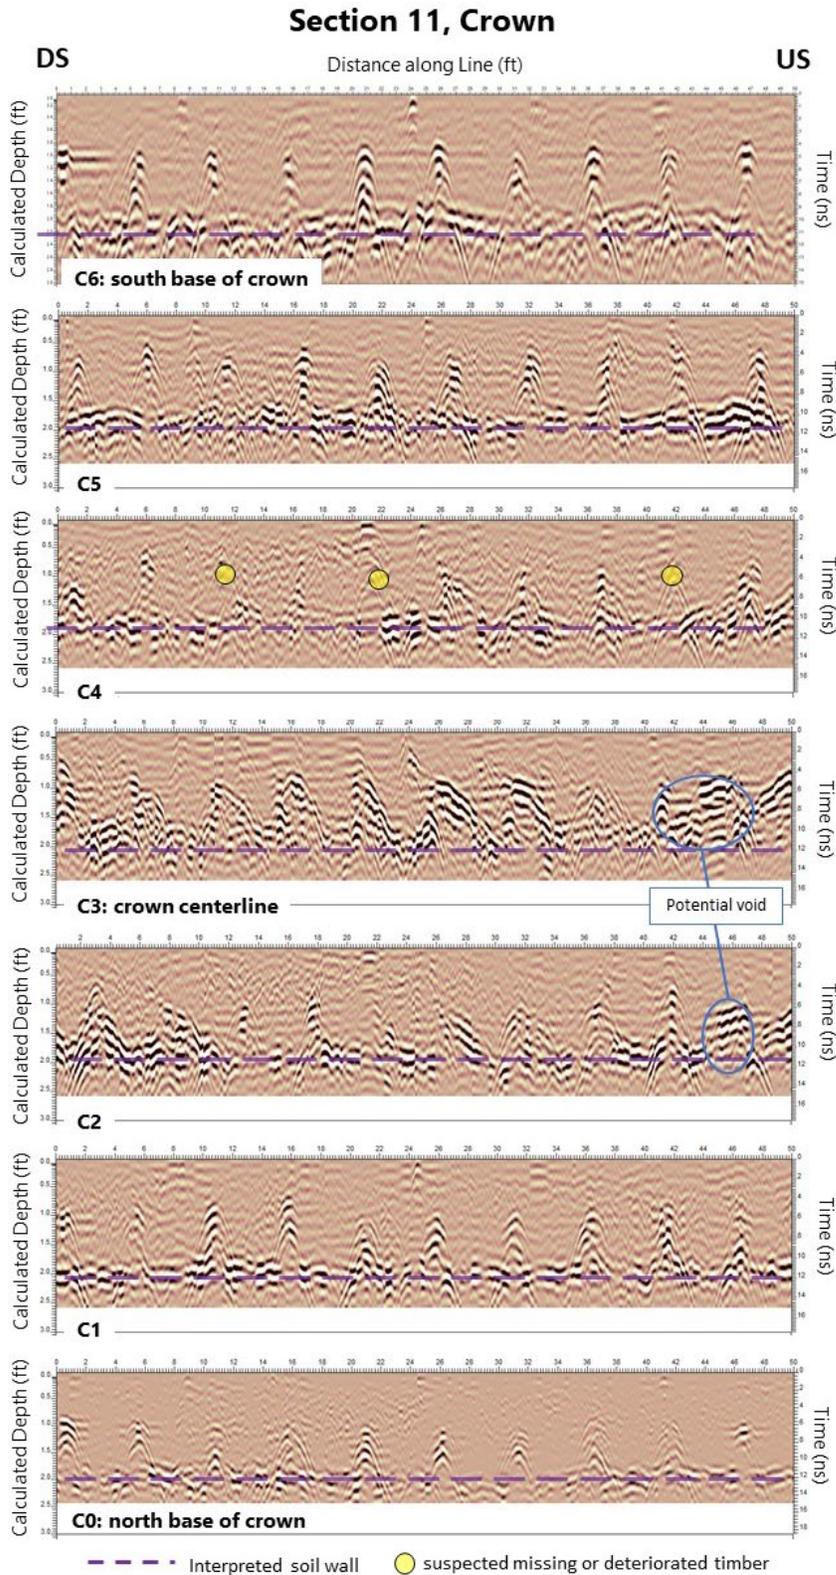
Figure 40.—GPR profiles from Tunnel Section 11 along the crown. Each line has 2 ft vertical separation.

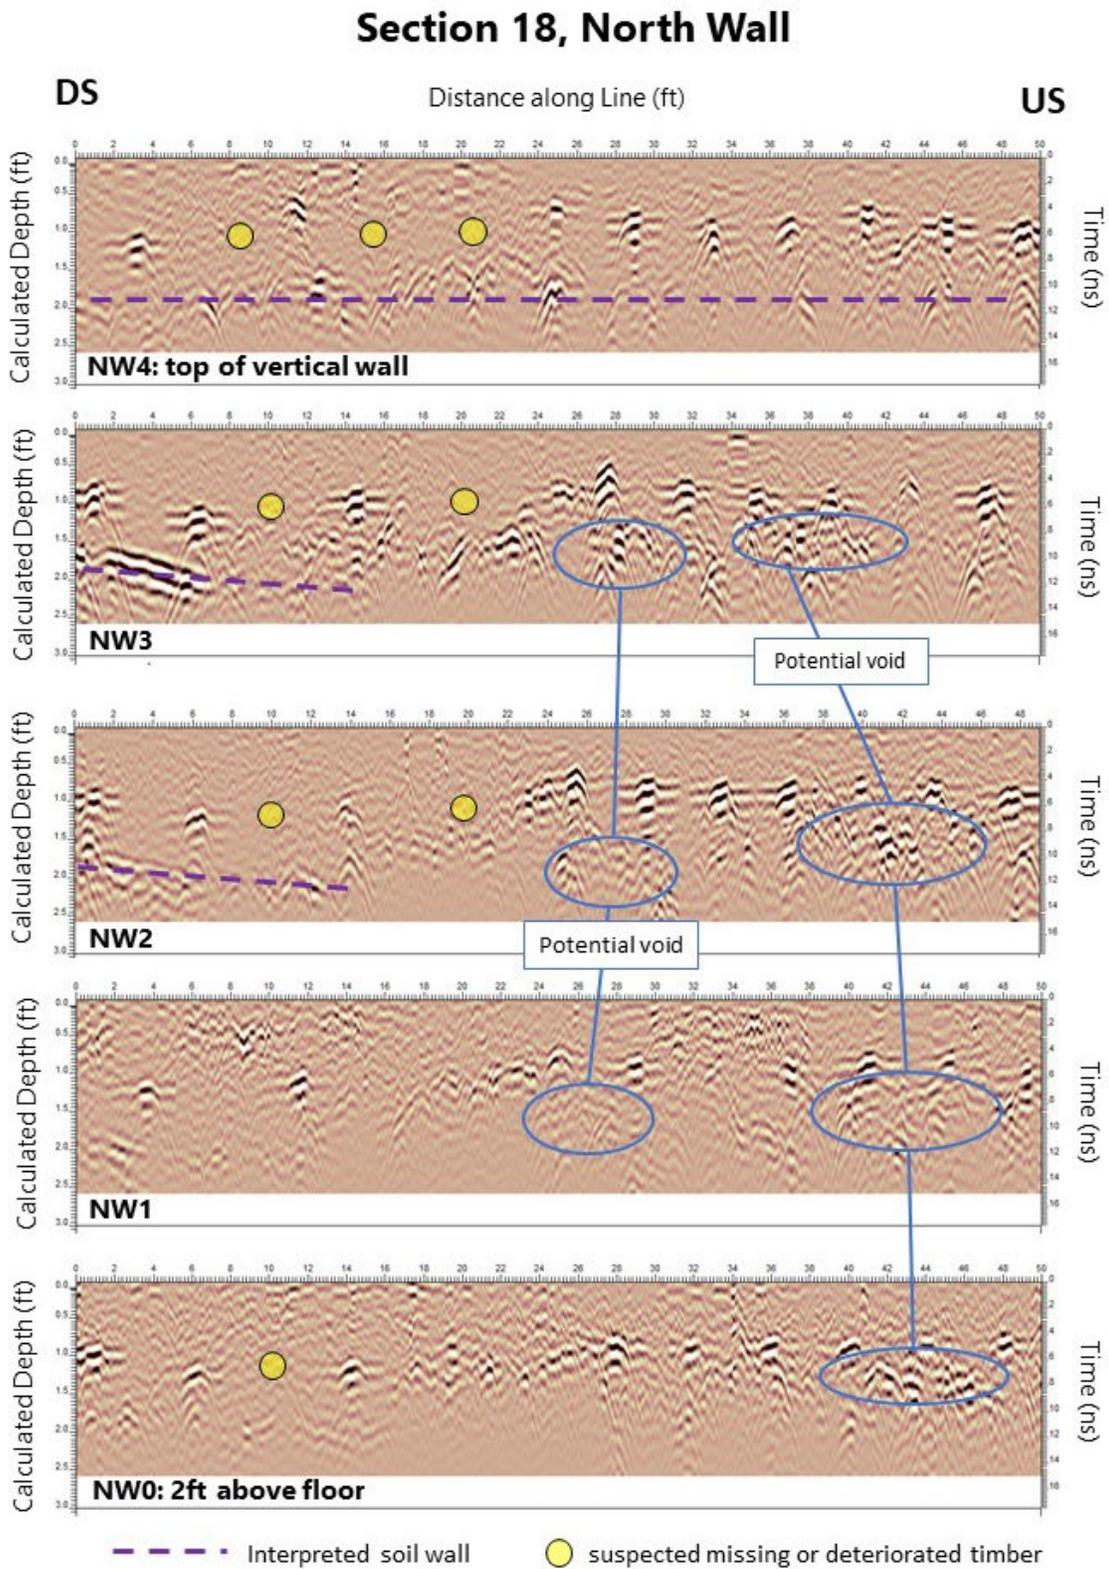
Figure 41.—GPR profiles from Tunnel Section 18 along the North wall. Each line has 2 ft vertical separation.

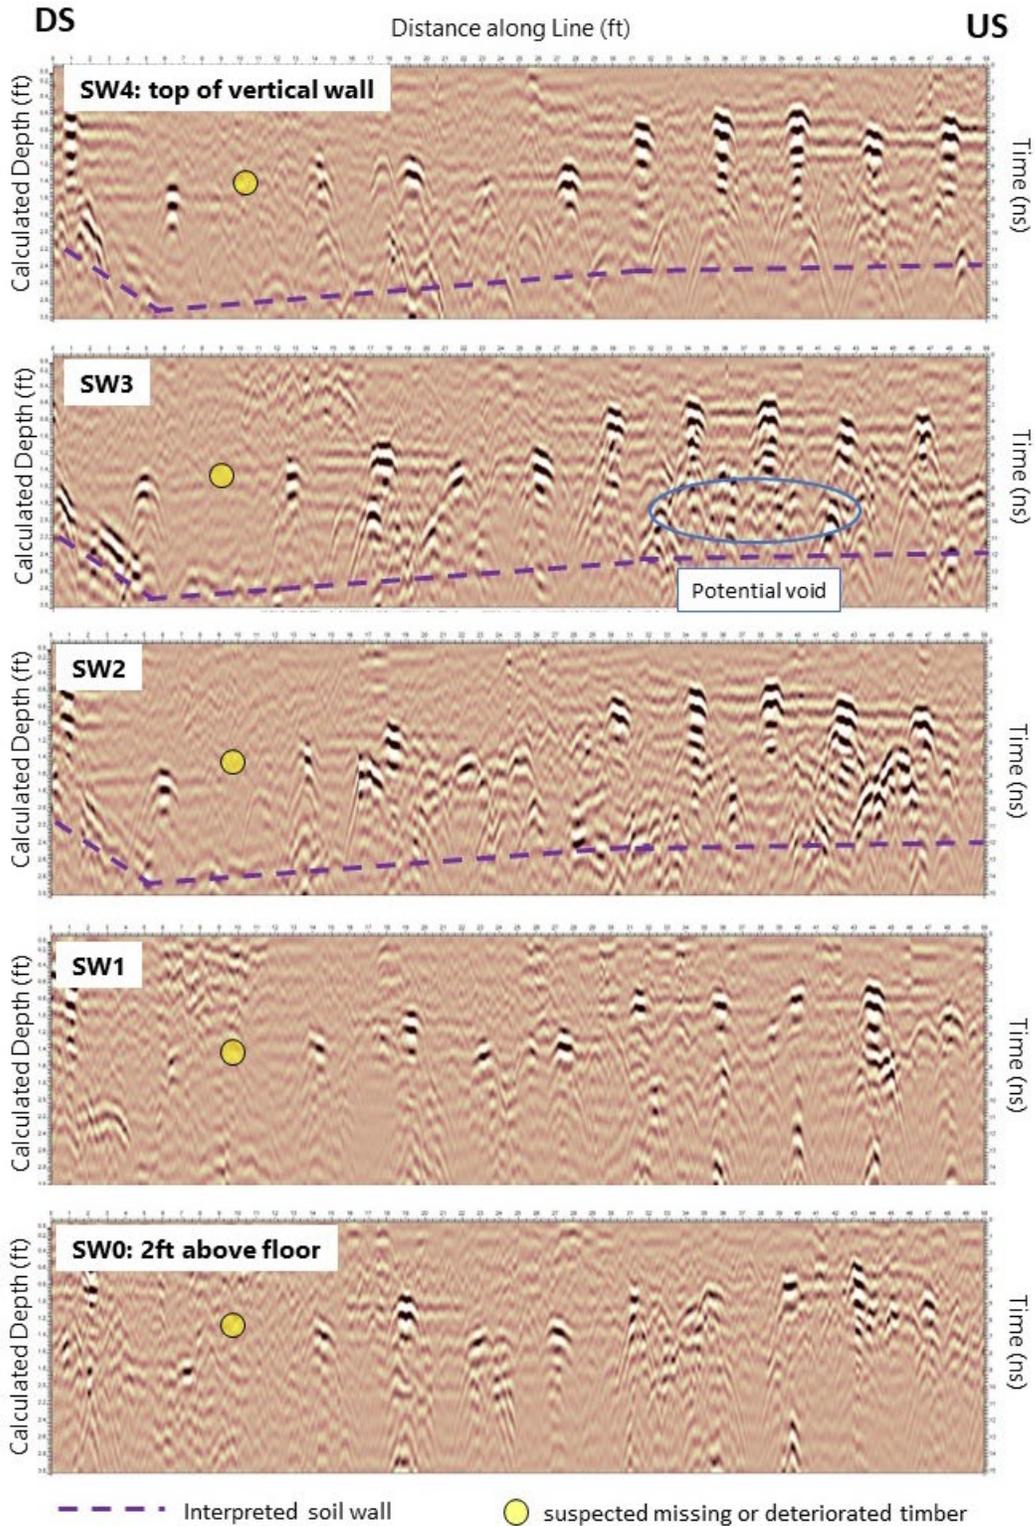
Section 18, South Wall

Figure 42.—GPR profiles from Tunnel Section 18 along the South wall. Each line has 2 ft vertical separation.

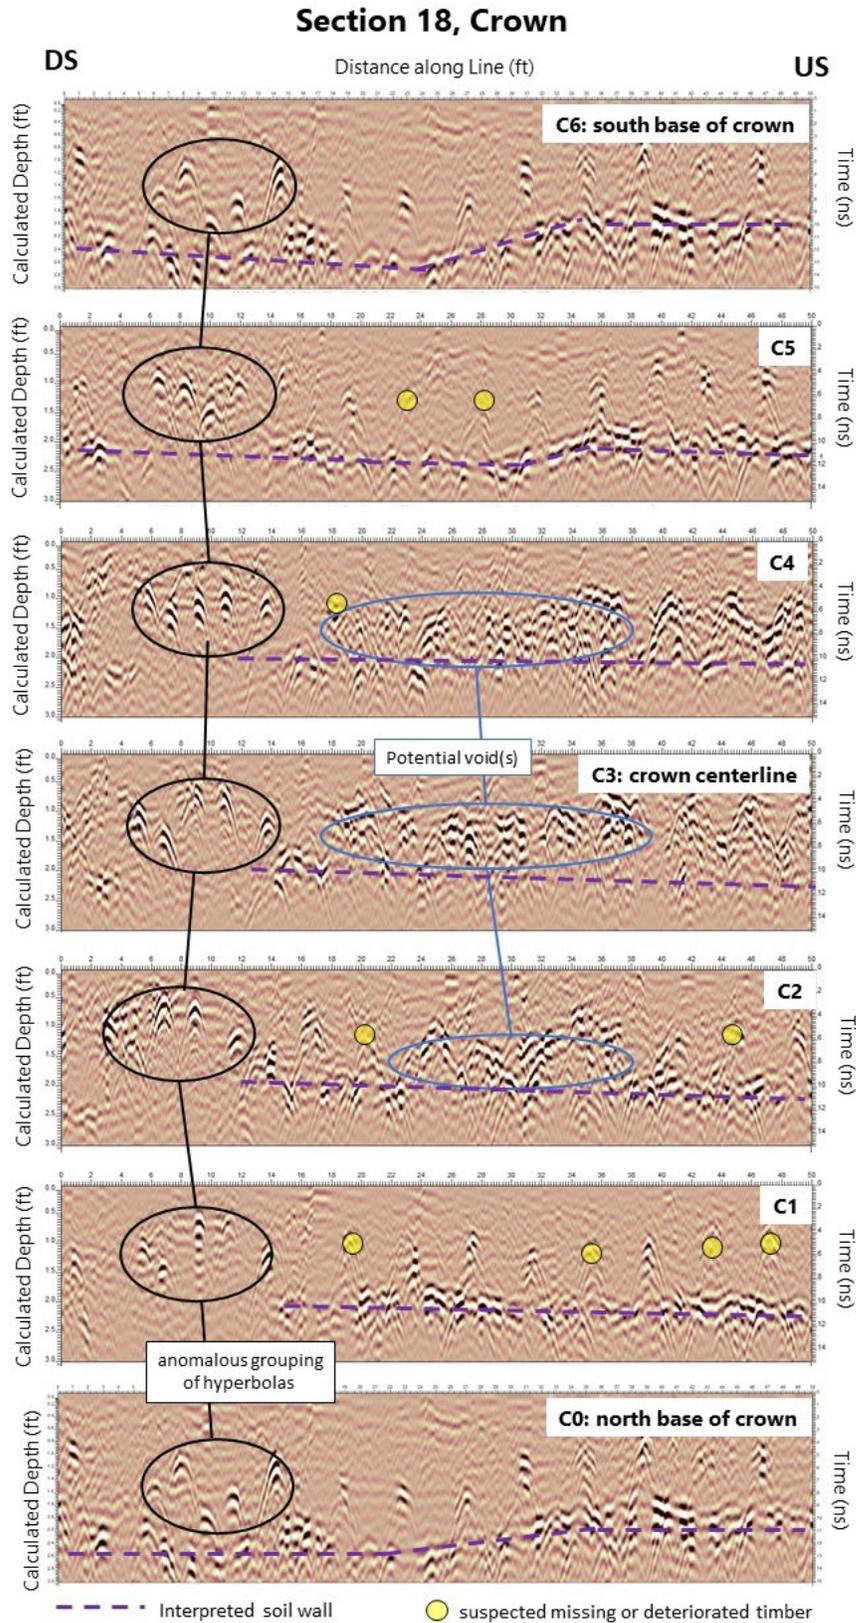
Figure 43.—GPR profiles from Tunnel Section 18 along the crown. Each line has 2 ft vertical separation.

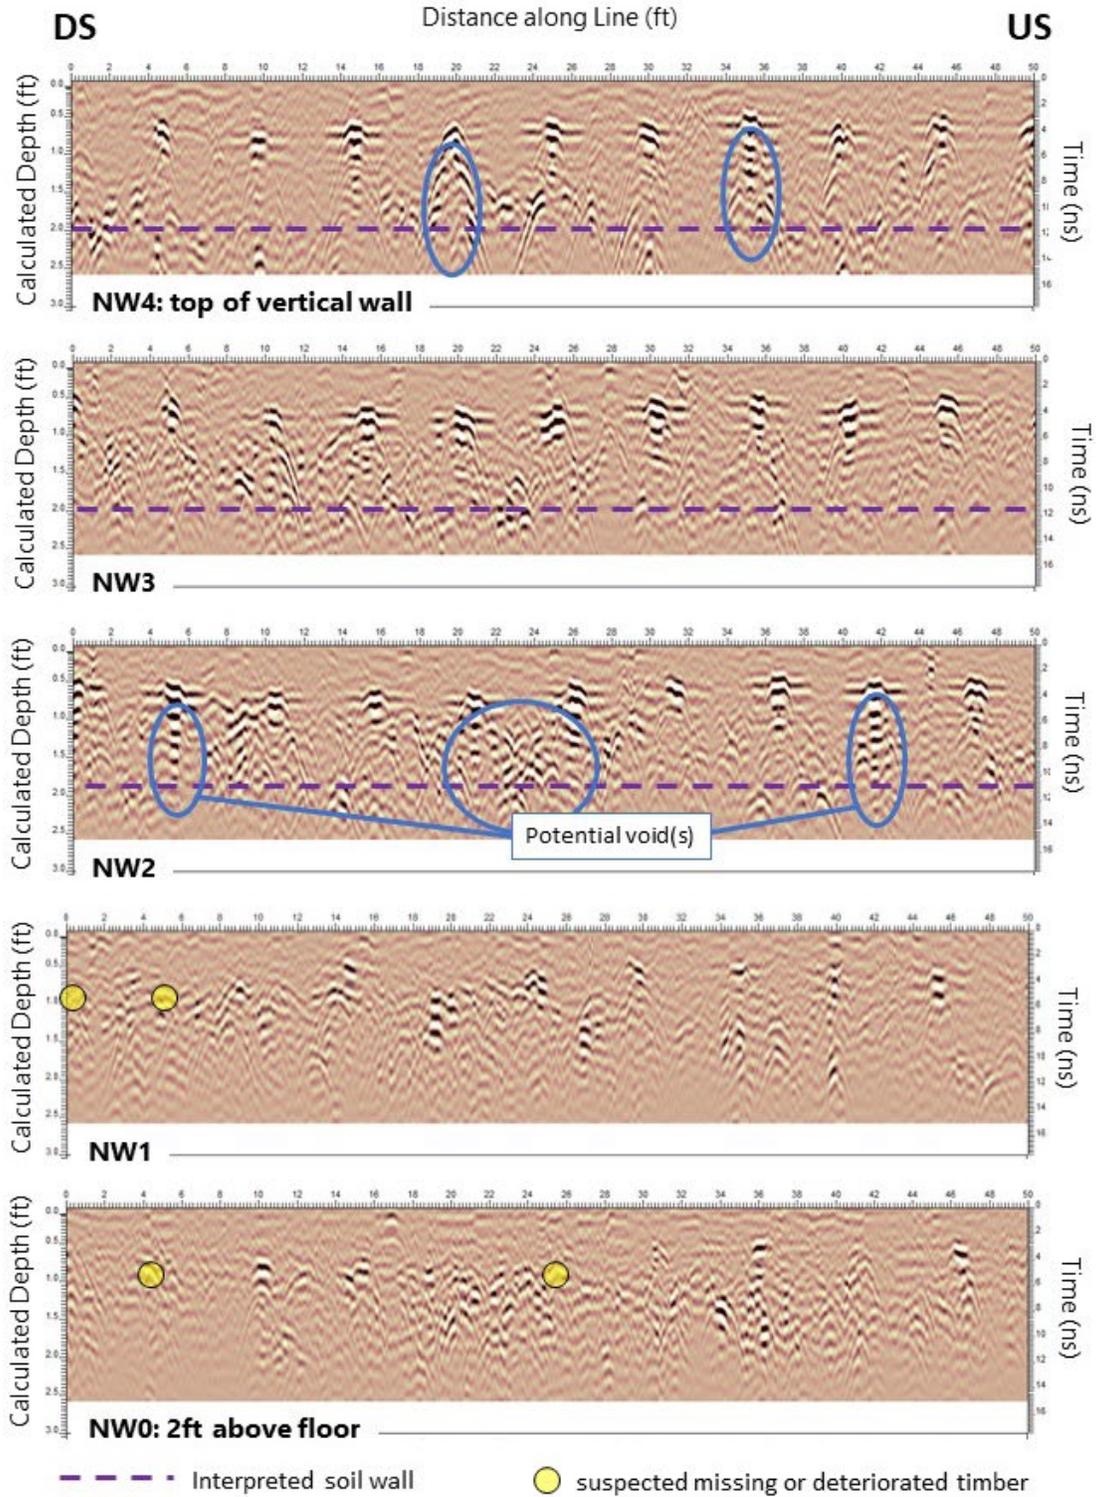
Figure 44.—GPR profiles from Tunnel Section 22 along the North wall. Each line has 2 ft vertical separation.

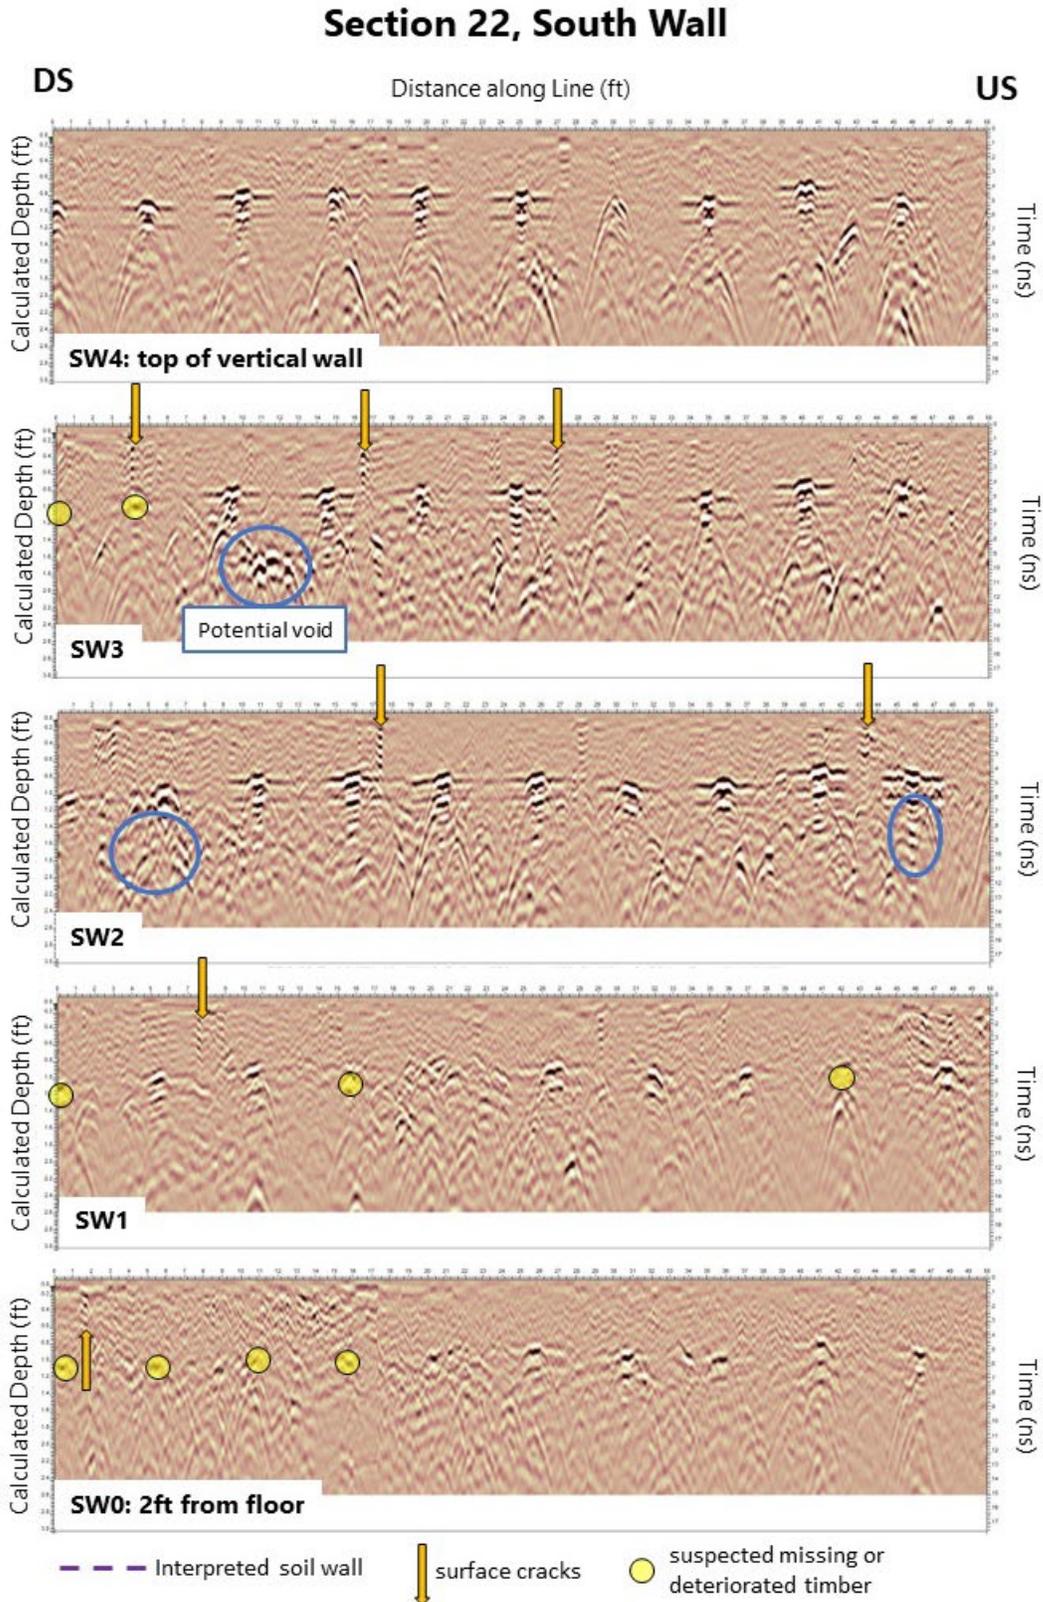
Figure 45.—GPR profiles from Tunnel Section 22 along the South wall. Each line has 2 ft vertical separation.

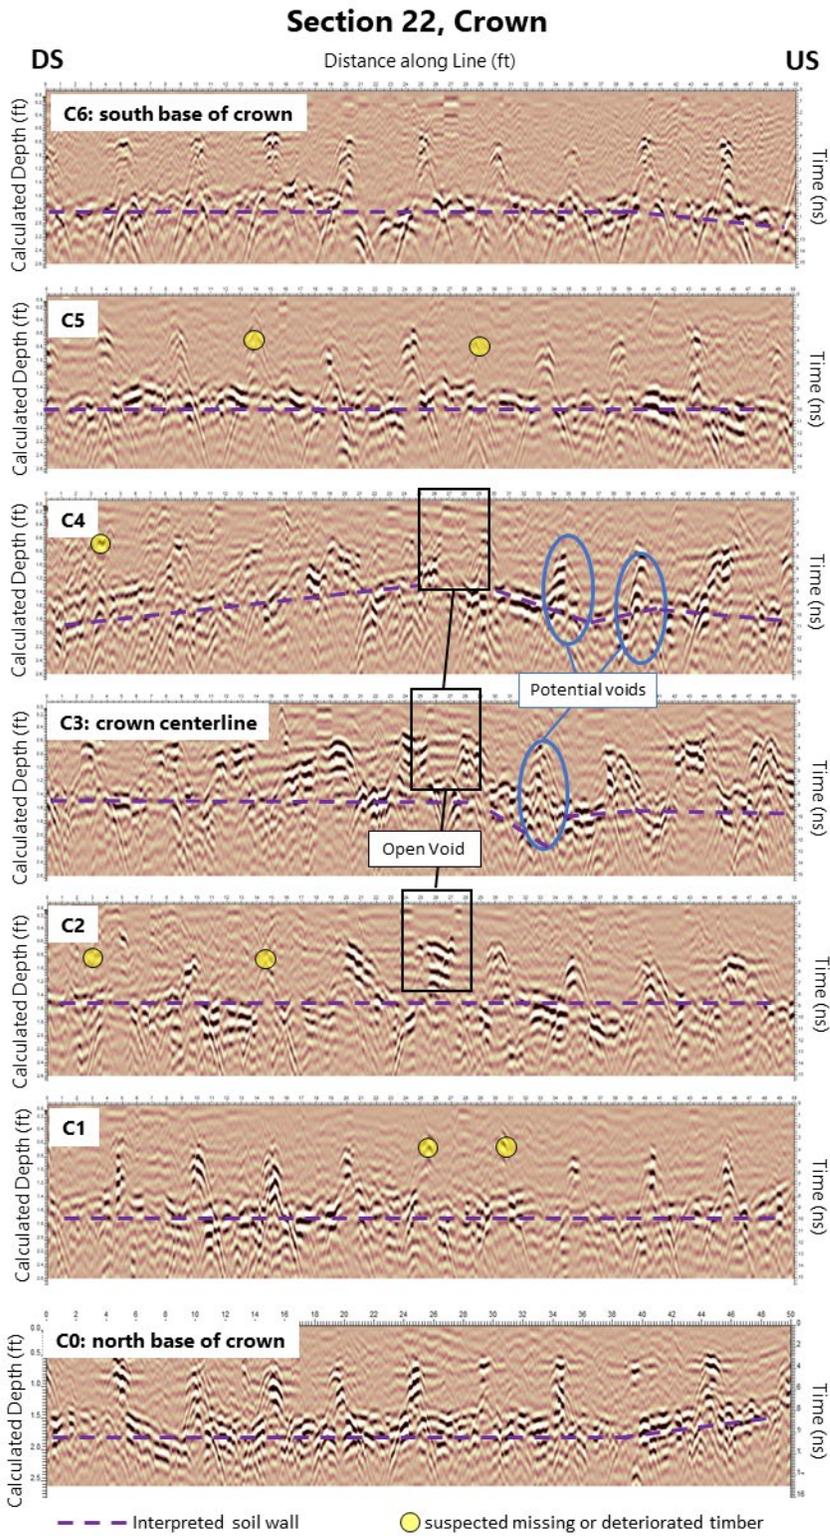
Figure 46.—GPR profiles from Tunnel Section 22 along the crown. Each line has 2 ft vertical separation.

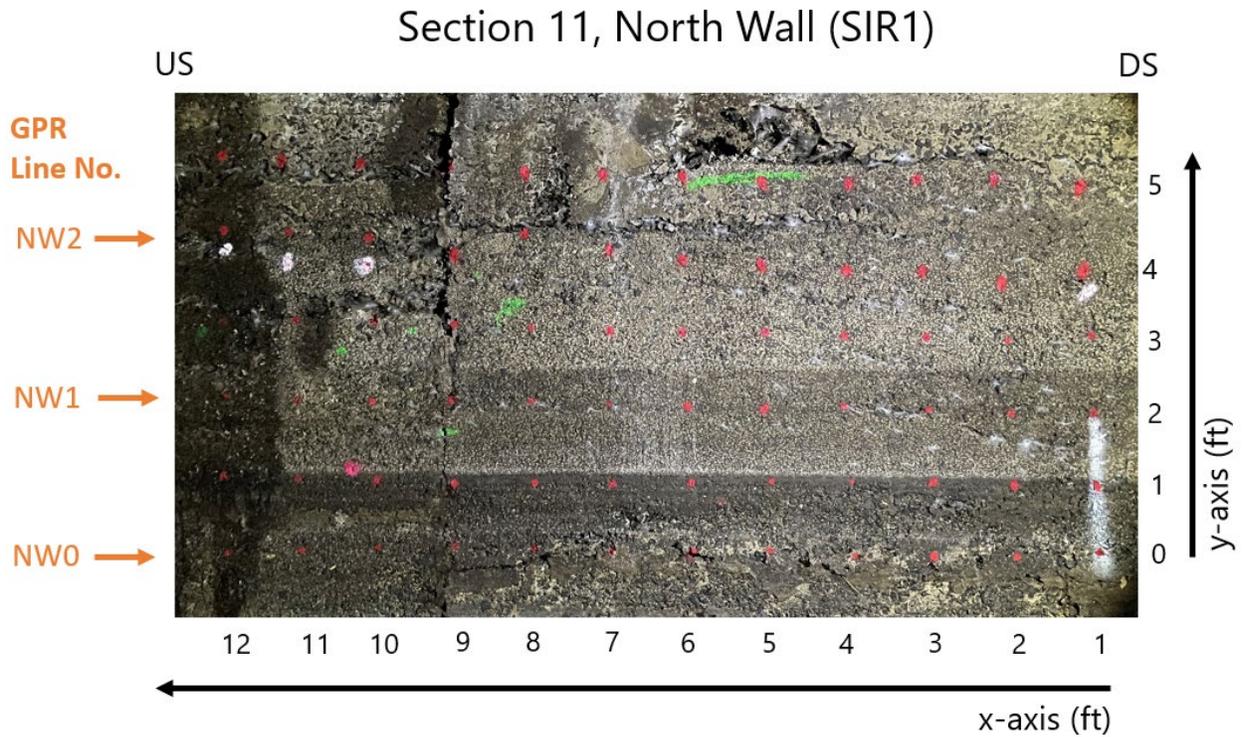
Figure 47.—Photo of SIR1 grid area consisting of a 5 ft by 12 ft grid with measurements every 1 ft. This area possesses noticeable surface cracks along $x = 9$ ft and $y = 5$ ft. $x=0$ ft accidentally not included in photo.

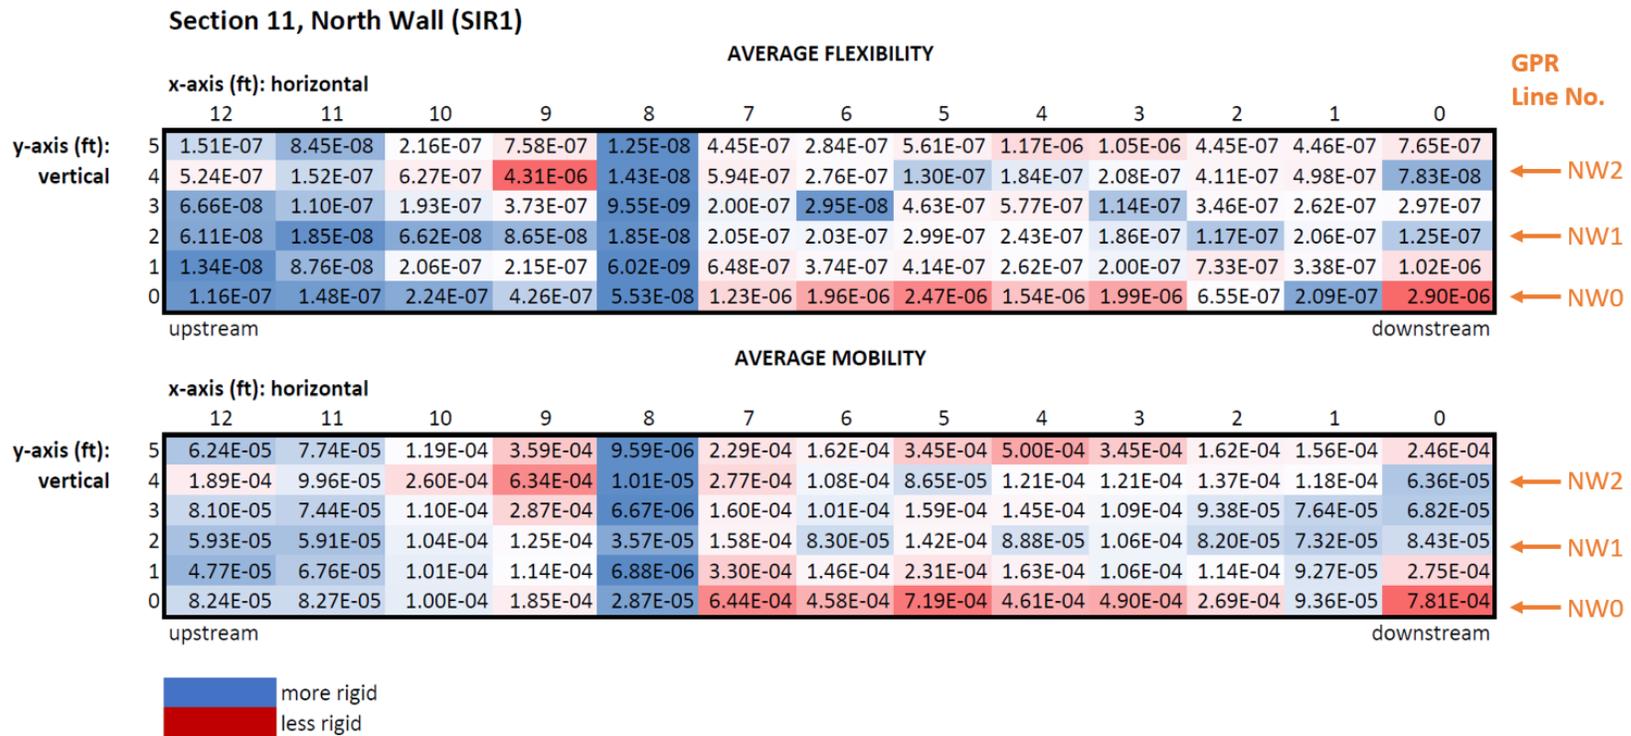
Figure 48.—SIR1 results from the North Wall of Section 11 where more rigid areas are colored in blue and less rigid areas are colored in red.

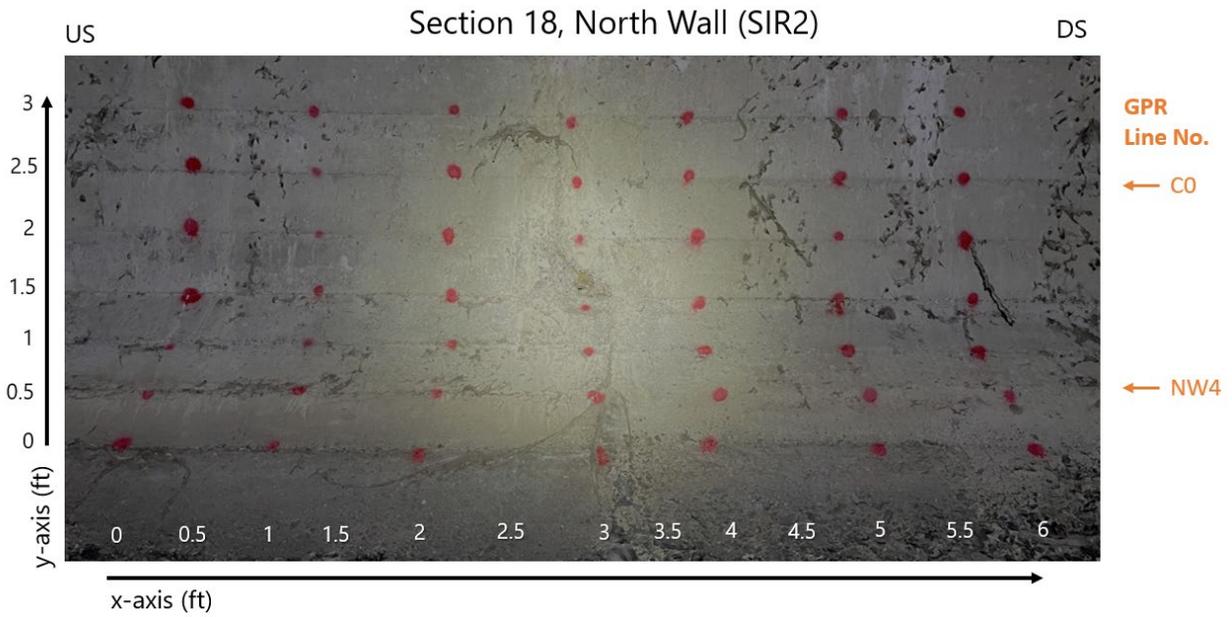
Figure 49.—Photo of SIR2 grid area consisting of a 3 ft by 6 ft grid and measurements every 0.5 ft.

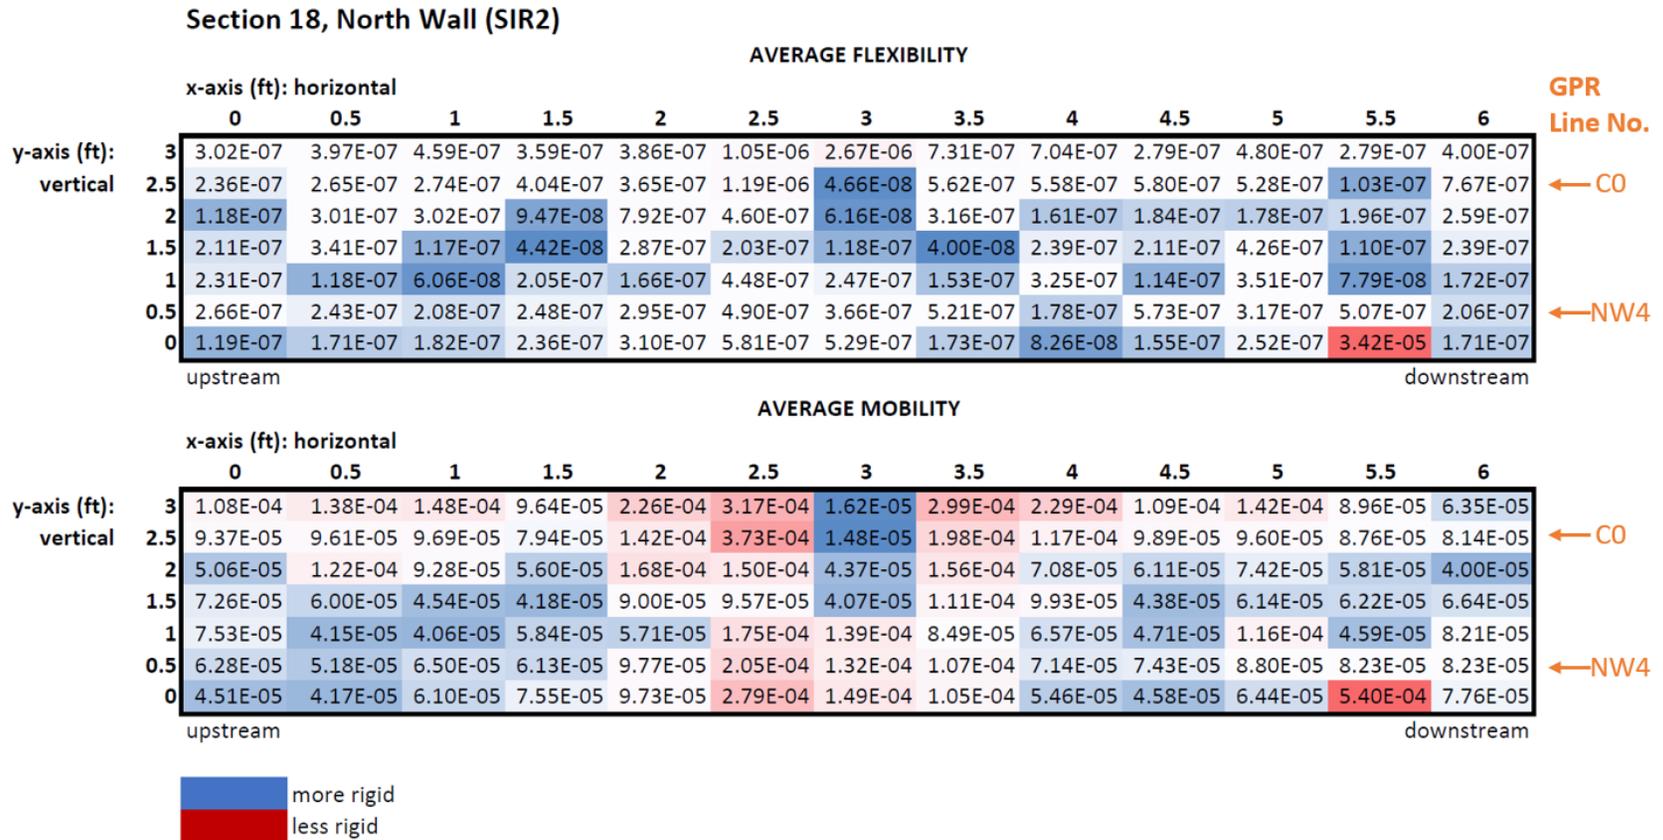
Figure 50.—SIR2 results from the North Wall of Section 18 where more rigid areas are colored in blue and less rigid areas are colored in red. This grid overlaps with portions of GPR Lines C0 and NW4 in this tunnel section.

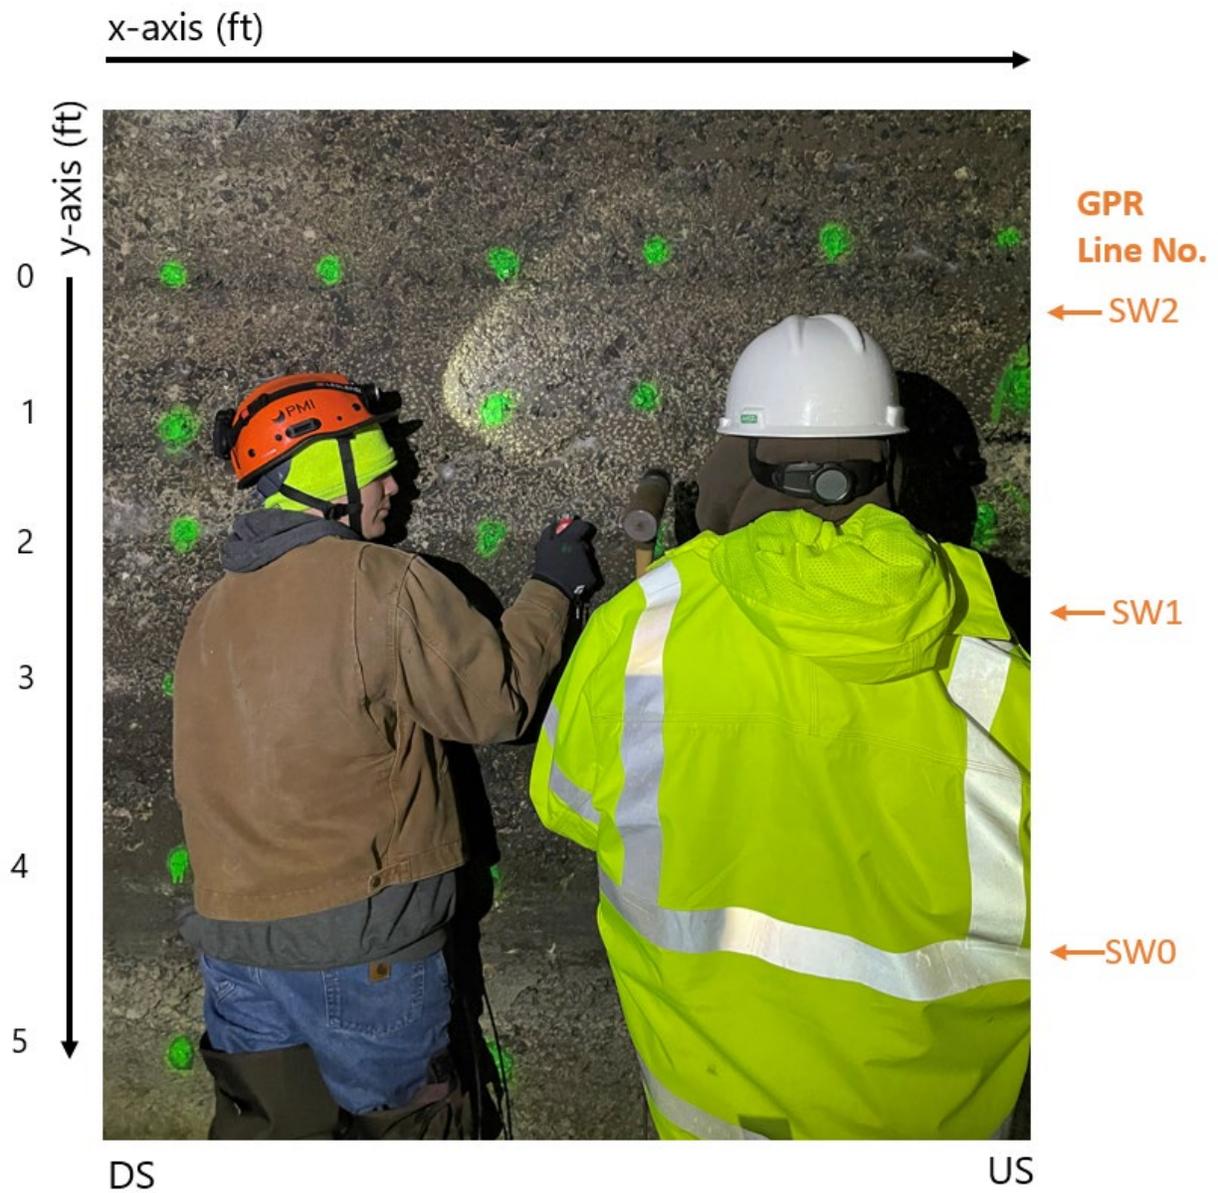
Figure 51.—Photo of SIR3 survey grid area consisting of a 5 ft by 9 ft wide grid with measurements every 0.5 ft.

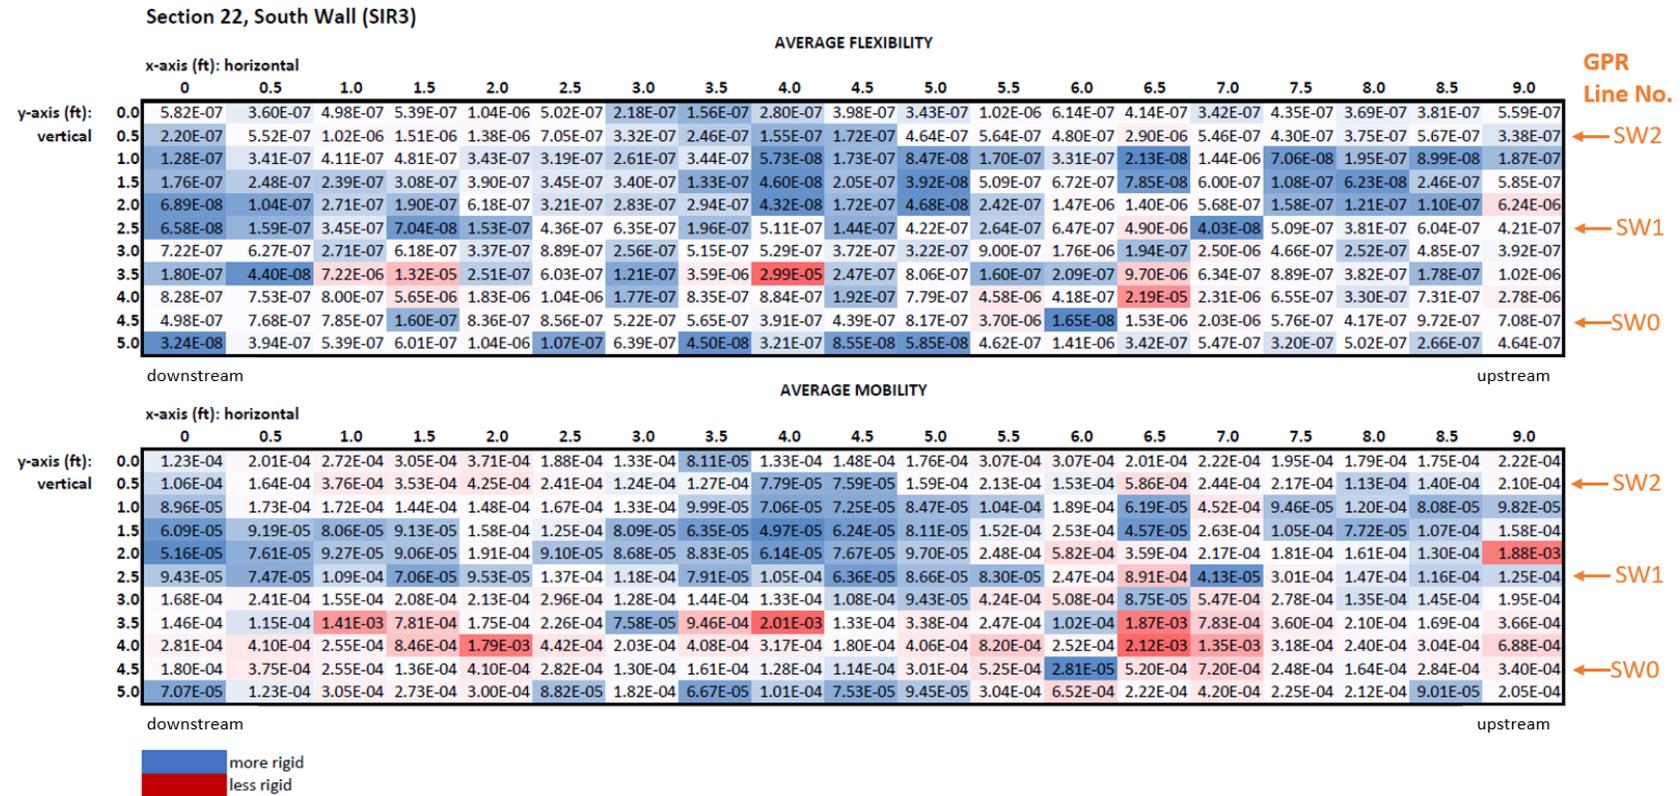
Figure 52.—SIR3 results from the South Wall of Section 22 where more rigid areas are colored in blue and less rigid areas are colored in red.

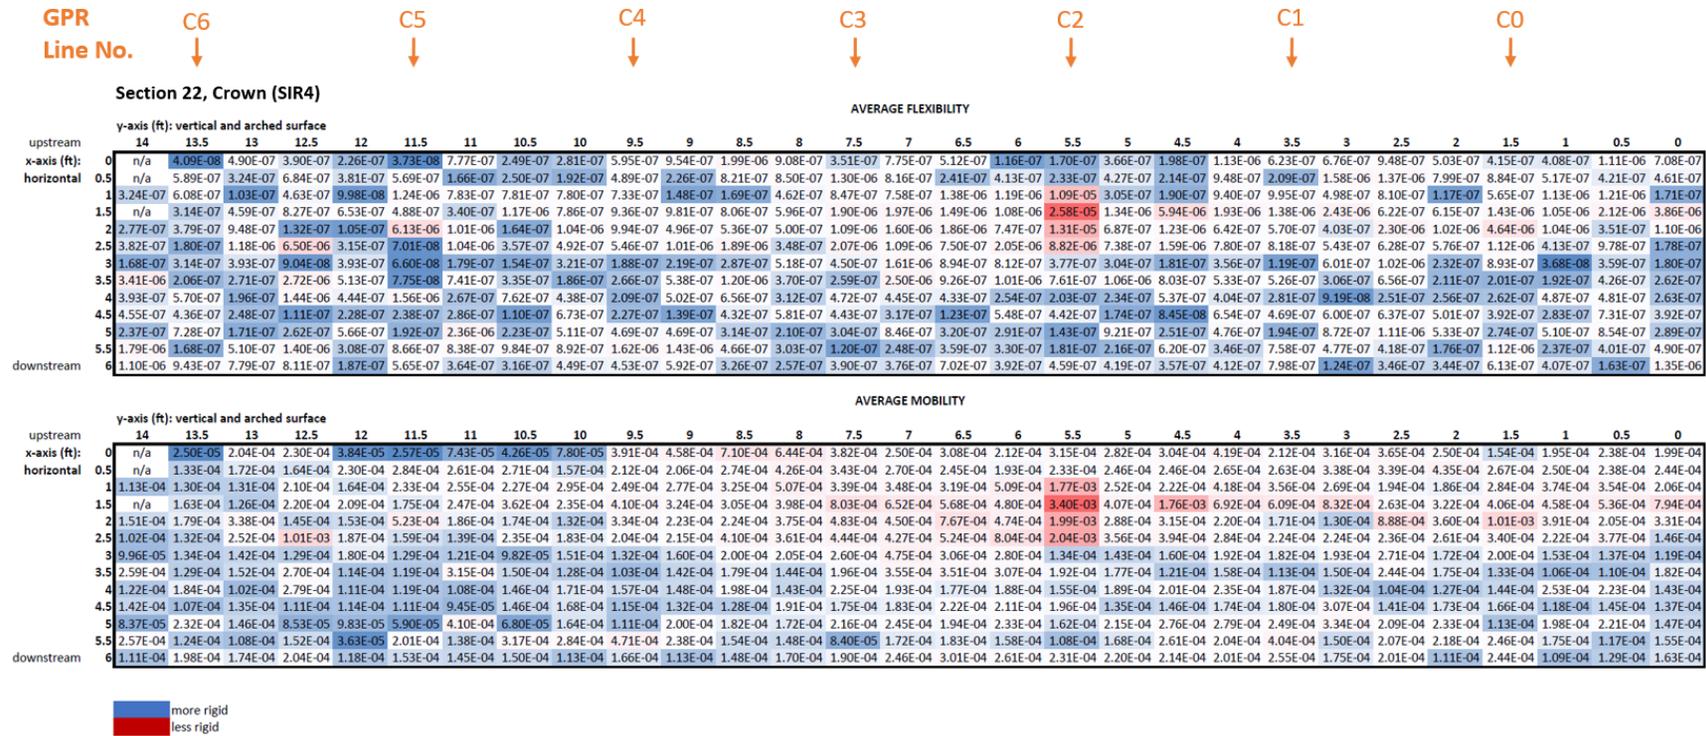
Figure 53.—SIR4 results from Section 22 with GPR line locations labeled across the grid. More rigid areas are colored in blue and less rigid areas are colored in red.
