Nathaniel “Nat” Washington Power Plant G21 Turbine Runner Cavitation Resistant Coating Field Trial

Interim Report No. ST-2023-20024-02

Technical Memorandum No. 8540-2023-12

**Columbia Basin Project, Washington
Columbia-Pacific Northwest Region**

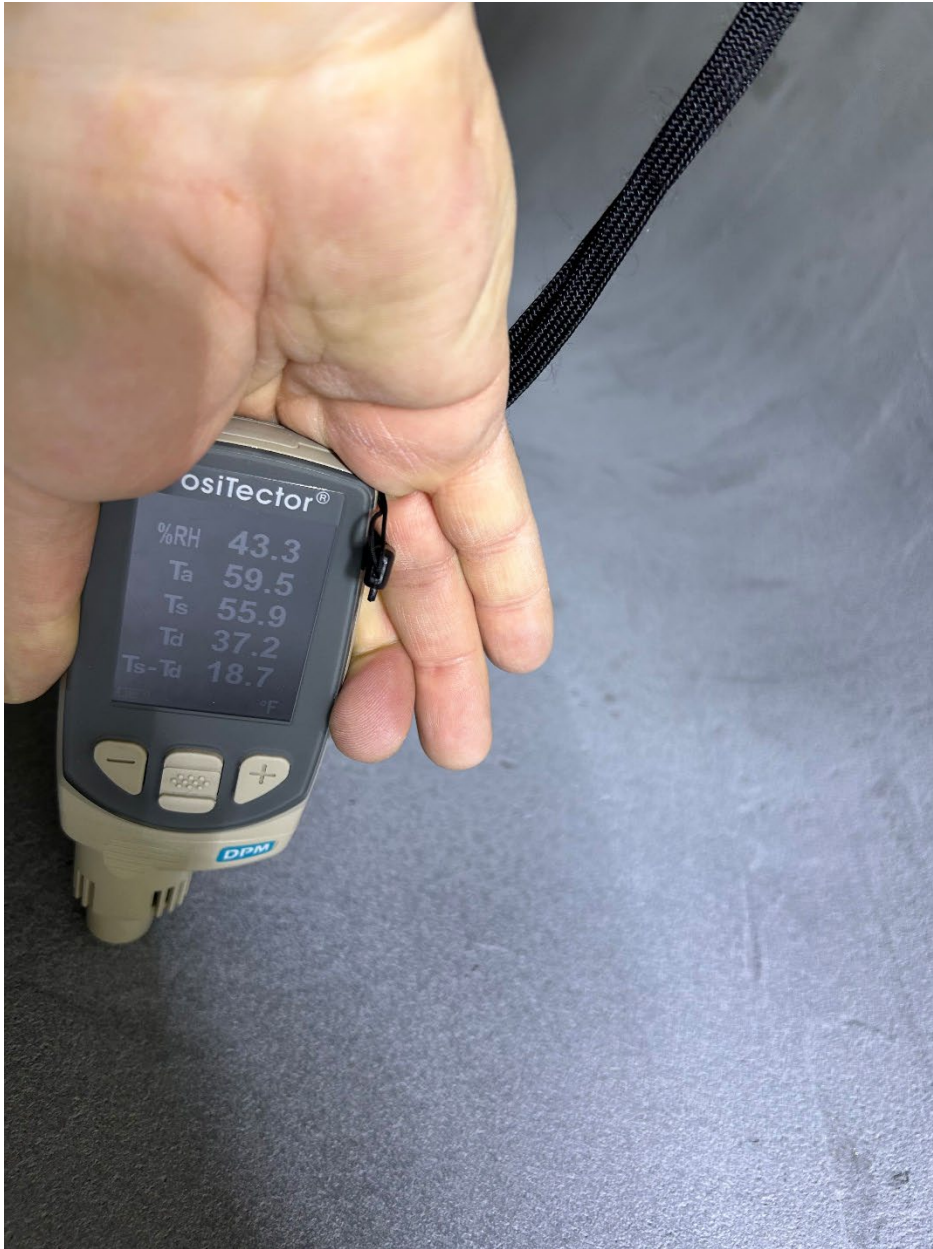
The team completed the application of adhesive to Blade 13 between 9:30 a.m. and 11:00 a.m. on February 7. Environmental conditions were measured in degrees Fahrenheit (F) before the application and are documented in Table 2 and shown in Figure 3. A thin layer of adhesive was brush-applied to the roughened ceramic-filled epoxy surface. As seen in Figure 4, each employee wore full personal protective equipment (PPE) and isocyanate exposure monitoring equipment; see Section 4. Exposure Assessment During Field Trial for details.

Figure 3.—Measurement of environmental conditions on Blade 13 prior to the application of adhesive.

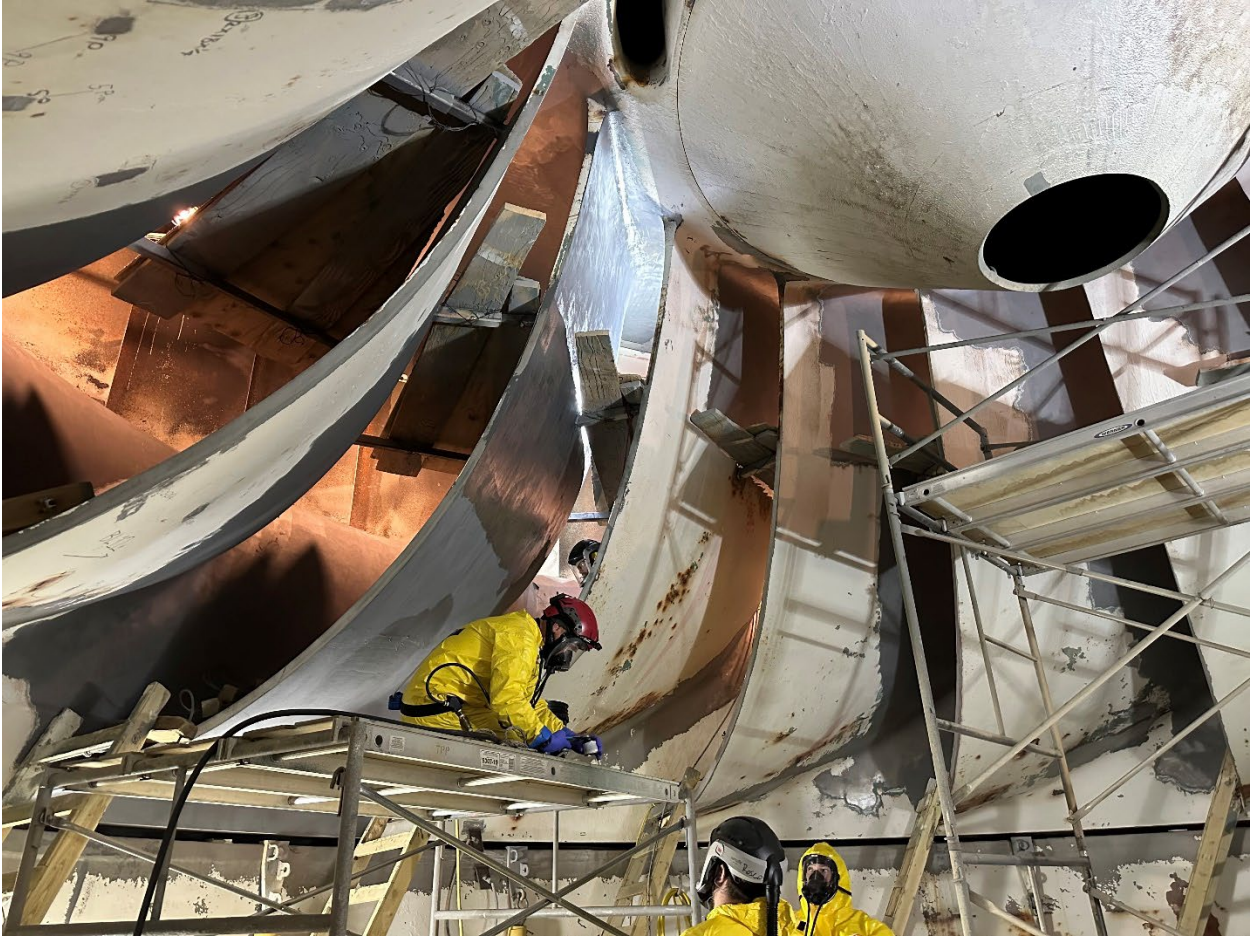
Figure 4.—The team applies adhesive to Blade 13.

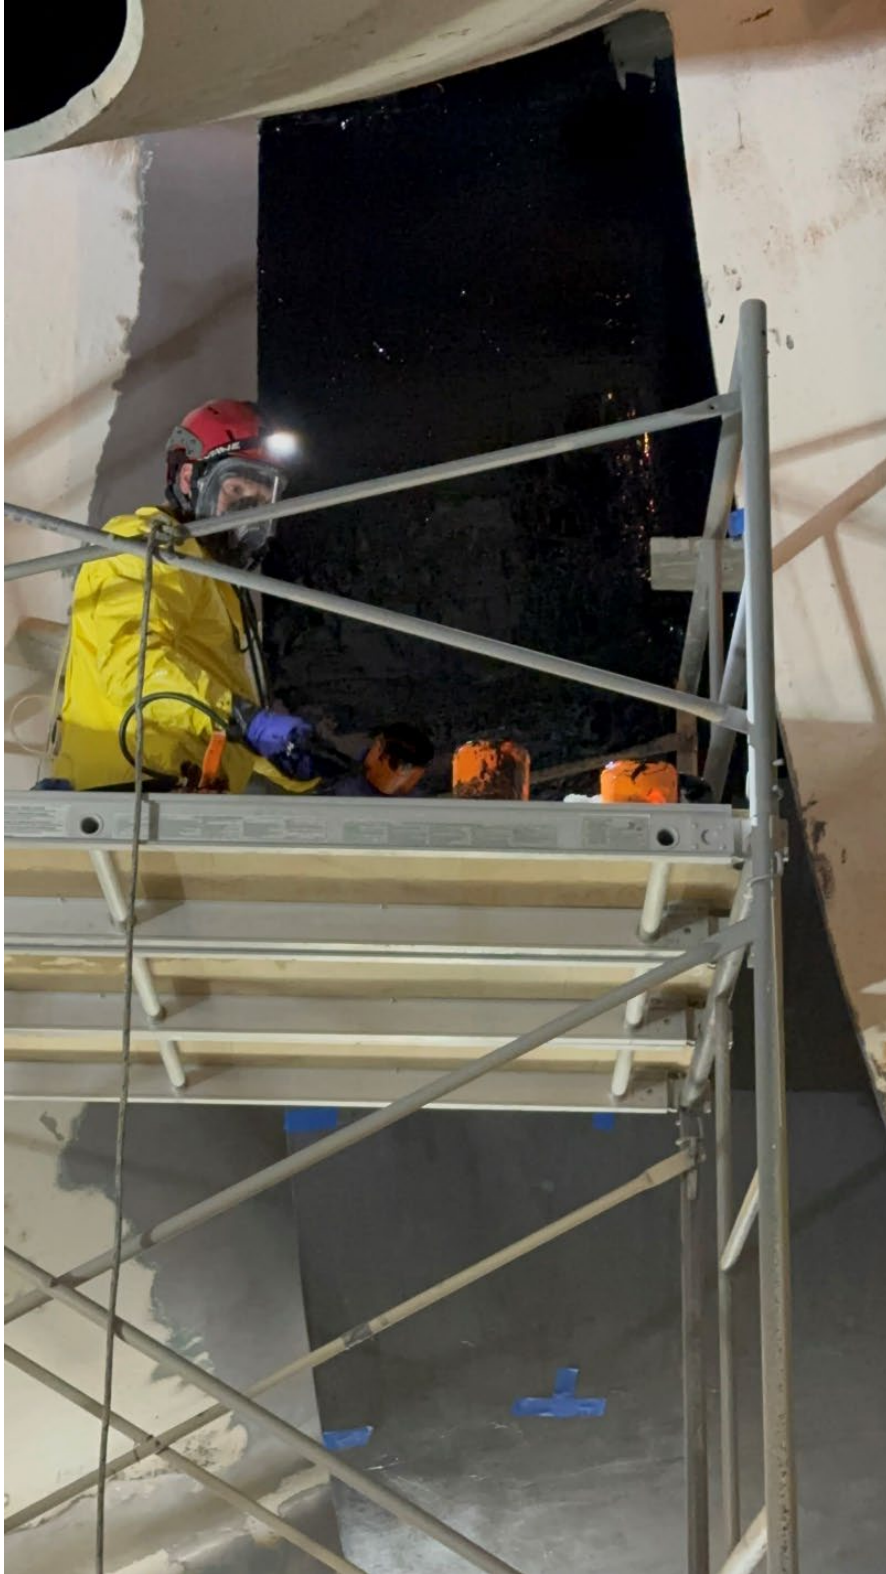
PE1 is a two-component polyurethane with a 13-minute pot life. Each PE1 kit was mixed by hand for about three minutes, then troweled onto the adhesive coated surface. Application of PE1 to Blade 13 occurred between 2:00 p.m. and 5:30 p.m. As shown in Figure 5, each employee wore full PPE and isocyanate exposure monitoring equipment.

Figure 5.—Application of PE1 to Blade 13.

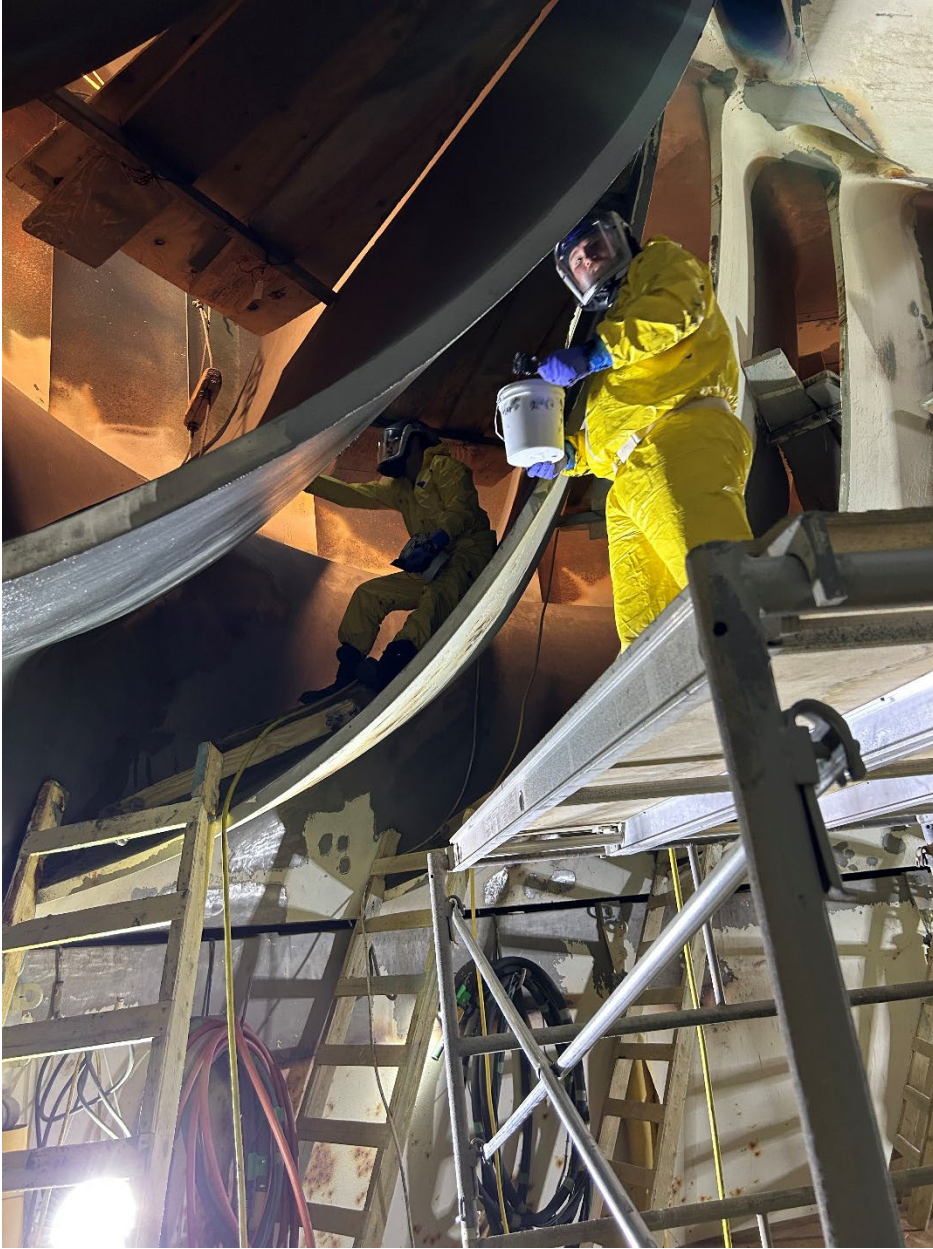
Since the ambient temperature was still below 65F, heated welding blankets were used to keep the PE2 components between 75–85F. The heated materials were kept near the draft tube door during application. The heat lowered the viscosity of both components and they mixed easily. The team mixed two kits at a time for about 2 minutes each. When the material started to thicken, the mixed coating materials were handed to the three applicators, as seen in Figure 7. Each batch of two kits covered about 12 sq ft. The team used 36 one-pound kits to cover a total of 210 sq ft. PE2 application was completed by 12:00 p.m. on February 9.

Figure 7.—Application of PE2 to Blade 7.
