Shasta Dam Unit 5 Penstock – Historic Linings Field Test Site

Science and Technology Program
Research and Development Office
Interim Report No. ST-2022-22024-01
Technical Memorandum No. 8540-2023-42

Interim Report ST-2023-22024-01

Technical Memorandum No. 8540-2023-42

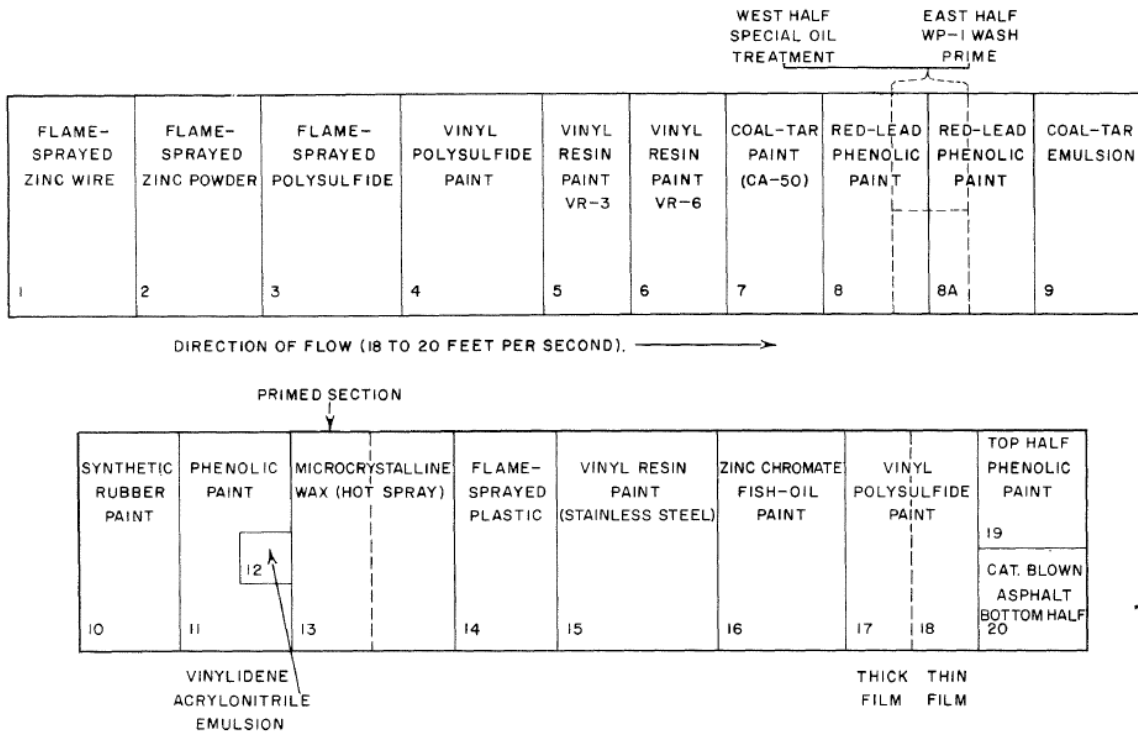
Figure 1. Test section layout in 1949, a total of 160 ft length

The Shasta Dam Unit 5 Penstock field trial evaluated 26 different experimental linings applied in a 160-foot (ft) section, shown in Figure 1. Vinyl and many of the other test linings were developed during or directly after World War II and had minimal service history in 1949. Figure 1 shows the test section layout as it was recorded in 1949. The test sections were inspected in 1957 and 1964. After eight years eight linings had an A rating, eight linings had a B rating, two linings had a C rating, and eight linings had a D rating [1]. The 15-year inspection found that seven linings remained an A rating, and four were a B rating. Class A or B rating: flame-sprayed polysulfide in section 3, two vinyl linings (VR3 and VR6) in sections 5 and 6; coal tar cutback (CA-50) in section 7; two phenolic red lead paints with and without two primer treatments (six total variations) in sections 8 and 8a, and a catalytic blown asphalt in section 20 [2]. Note that Section 8 contained zinc chromate and zinc oxide pigments in addition to red lead and Section 8A was lined with phenolic red lead, the report did not state that it was the Federal Standard TT-P-86a Type IV red lead. The lead-based paints were also sectioned off for a direct to metal application, oil-based primer section and a vinyl wash primer section.
