Leak Repair Demonstrations for Pressurized Mechanical Systems

Science and Technology Program
Research and Development Office
Final Report No. ST-2023-20074-01
8540-2023-78

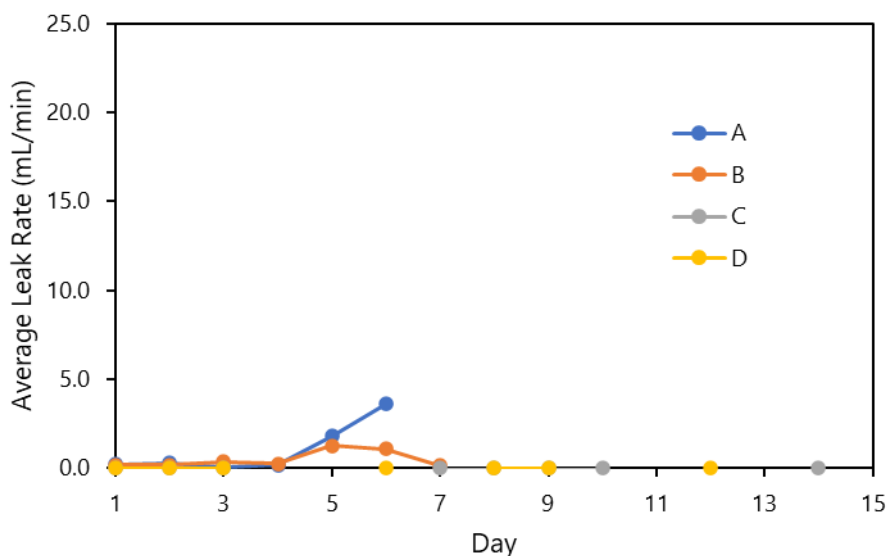
Figure 9.—Results from Weeping Trials for Products A, B, C, and D.

Note that a result of 0 mL/min leakage indicates negligible leakage, either due to zero leakage or due to the water evaporating more quickly than it was being collected.

For the weeping trial, Product A was applied while the system was depressurized due to a miscommunication with the applicator. This does not follow the intent of testing, which was to determine how the repair products would perform when applied to a pressurized, actively leaking system. However, even with a more ideal application than the other products, Product A still had the worst performance during the weeping tests. As shown in Figure 9, after Day 4, Product A had an increasing amount of leakage.

Similar to Product A, Product B was mistakenly applied while the system was depressurized. As shown in Figure 9, water leakage was initially stopped, then allowed through the repair, and then stopped again.

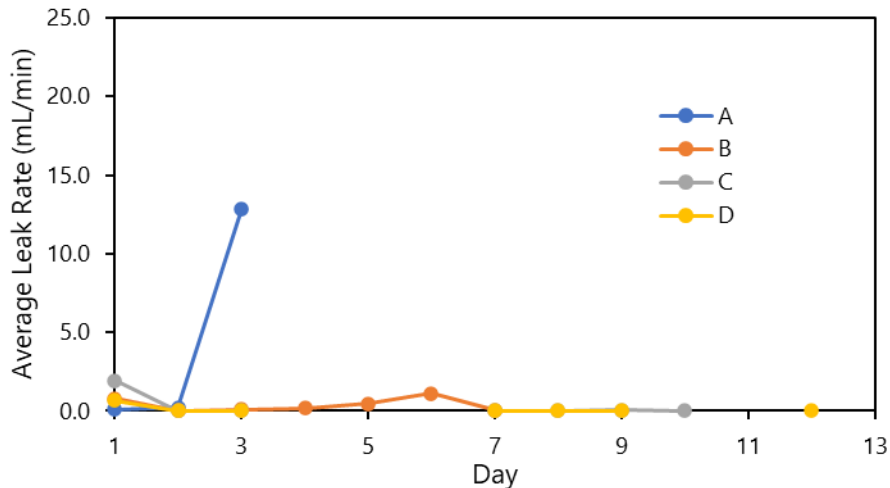
Figure 12.—Results from Intermediate Trials for Products A, B, C, and D.

Note that a result of 0 mL/min leakage indicates negligible leakage, either due to zero leakage or due to the water evaporating more quickly than it was being collected.

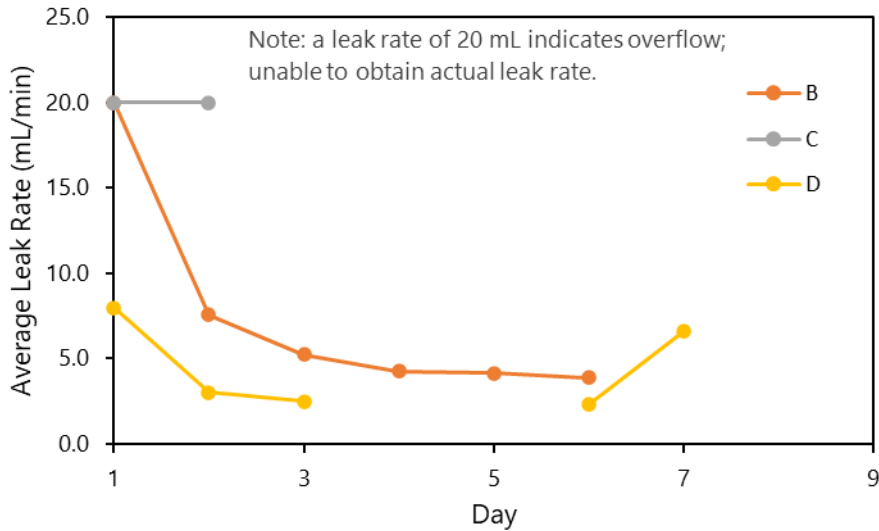
Figure 14.—Results from Spraying Trials for Products B, C, and D.

Note that a result of 20 mL/min leakage indicates an overflow of the measurement bucket, meaning that the true leak rate was unable to be obtained. See section 2.1.1 for more information.

On the first day, the wrap immediately failed and the measurement bucket overflowed. However, the test was continued to see if the repair product would further cure or expand and reduce leakage as it had in previous trials. As shown in Figure 14, this did occur, but the pressure vessel continued to leak at a greater level than in the weeping and intermediate trials. This indicates that the repair product could be used as a temporary means of slowing (but not completely stopping) water leakage, and only for short periods of time.

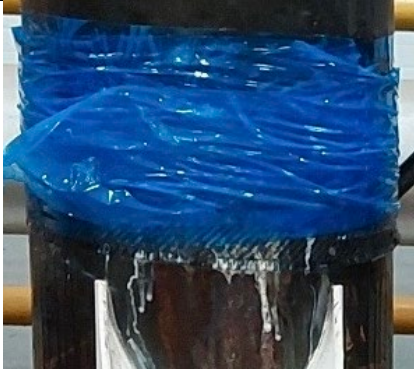
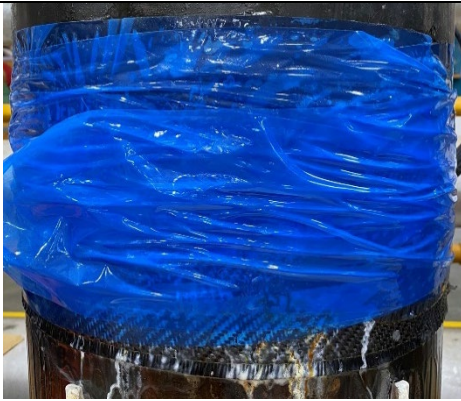
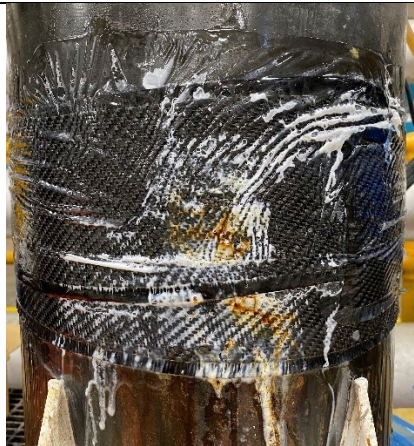
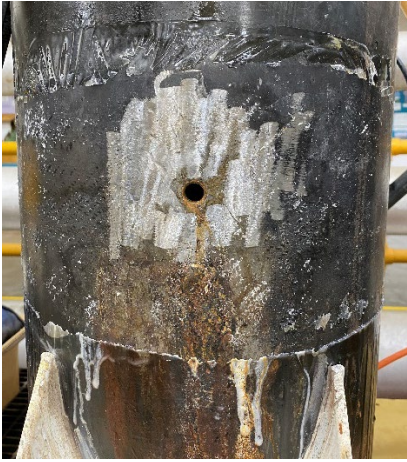
E, Weeping Trial 1

After compression film removal

After full product removal

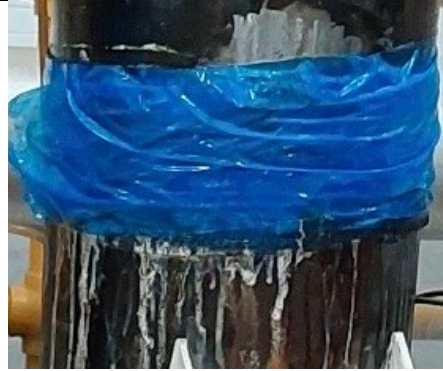
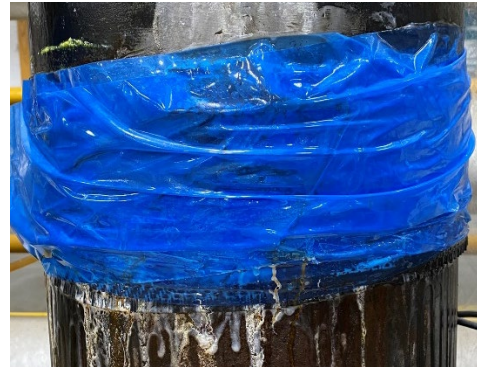
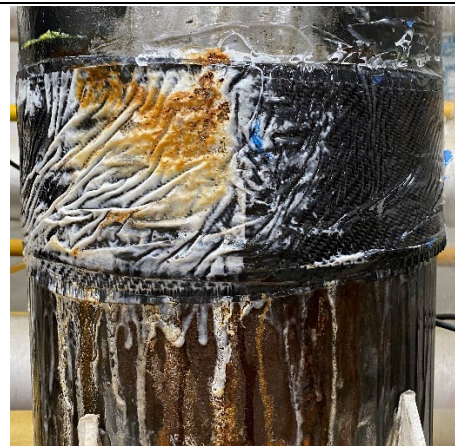
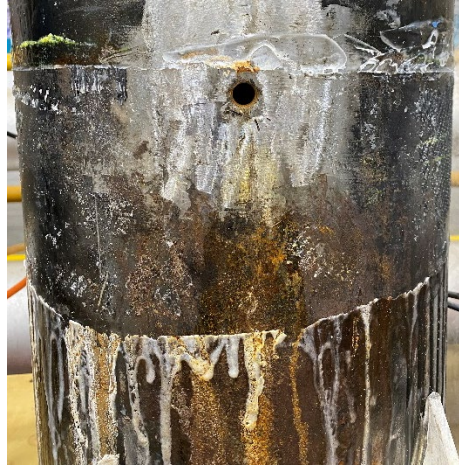
E, Weeping Trial 2

After compression film removal

After full product removal
