— BUREAU OF —
RECLAMATION

Development and Field Research on Next Generation Coatings for Mussel Mitigation on Infrastructure

Science and Technology Program
Research and Development Office
Final Report No. ST-2021-19196-01
Technical Memorandum No. 8540-2022-56

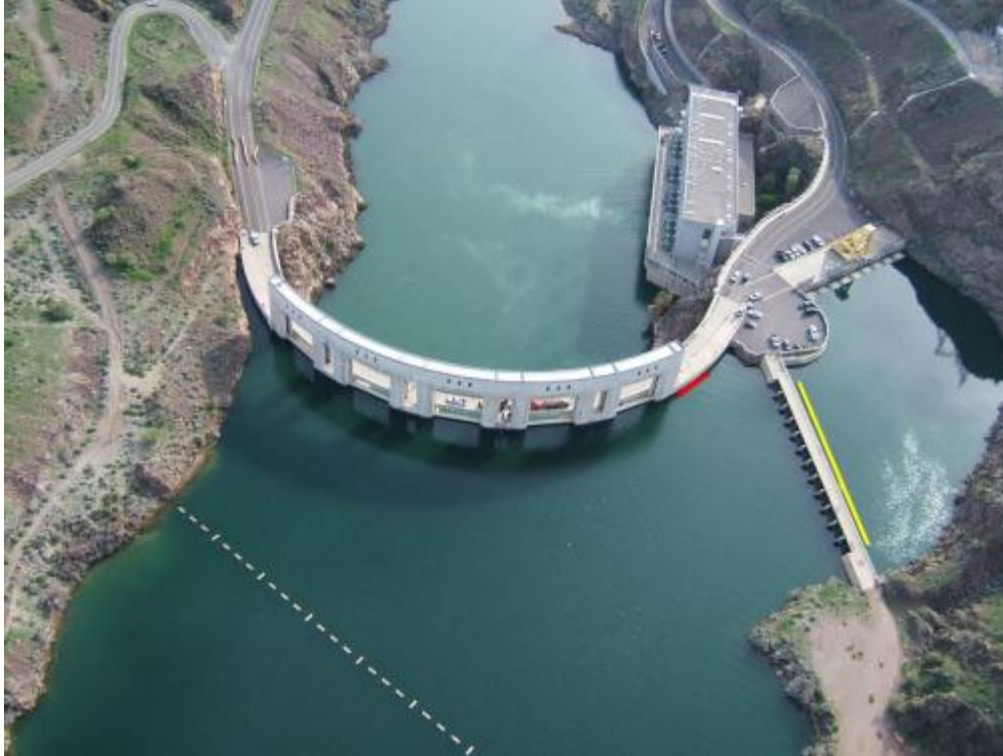
Figure 1: Ariel view of Parker Dam. Yellow line is the flowing water test location downstream of the trashracks. Red line is location of quasi-static water flow testing on the side of the dam.

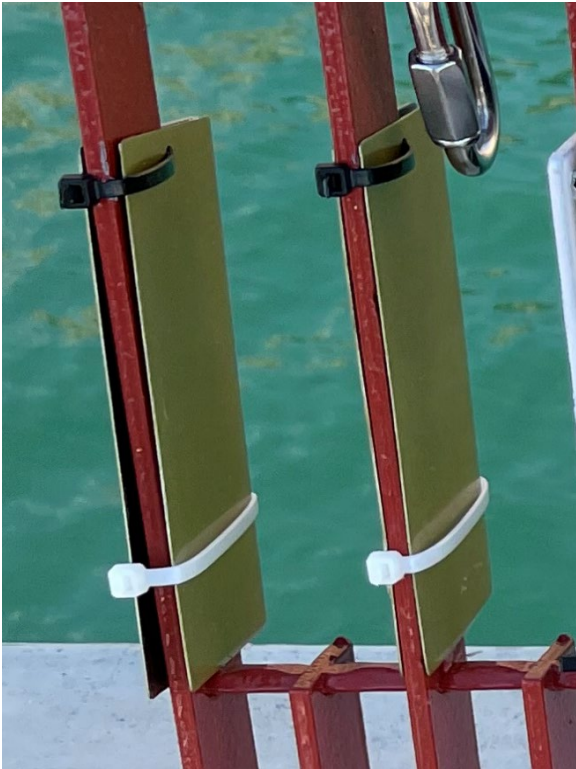
Figure 2: Popspeed panels on experimental rack for dynamic testing prior to January 2022 installation.

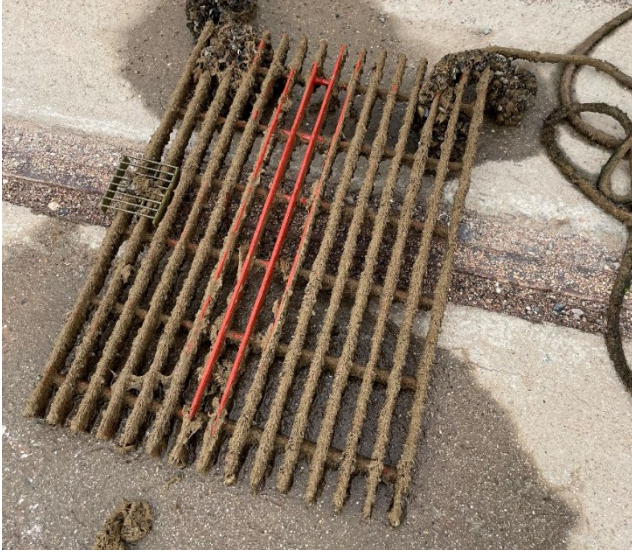
Figure 6: Jotun Repulse during July 2022 inspection with accumulation of colonial hydroid on surface of grate.

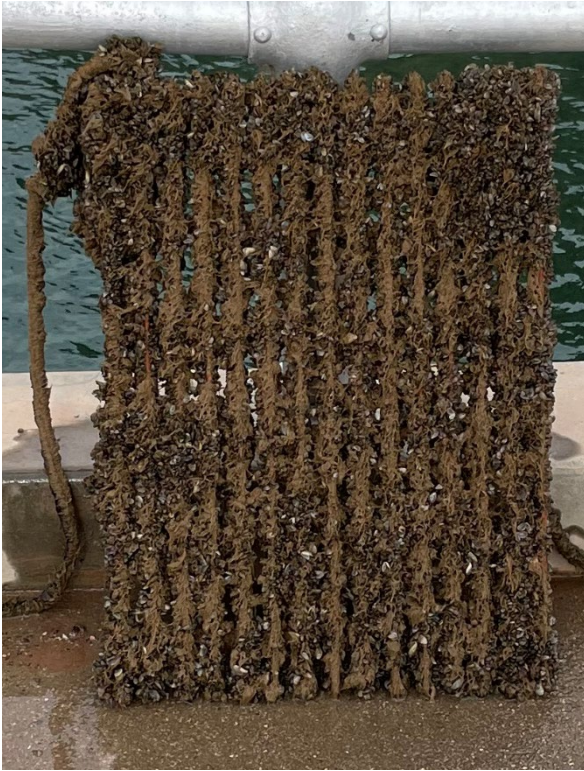
Figure 10: Jotun Sealion Resilient during July 2022 inspection with large amounts of colonial hydroid and mussel fouling.

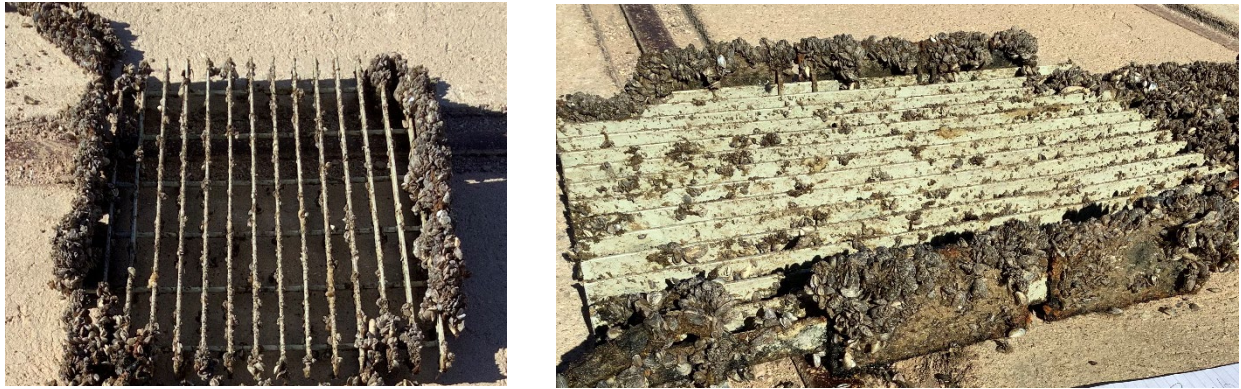
Figure 16: Top and side view of Silicone Solutions F-23 during January 2022 inspection.

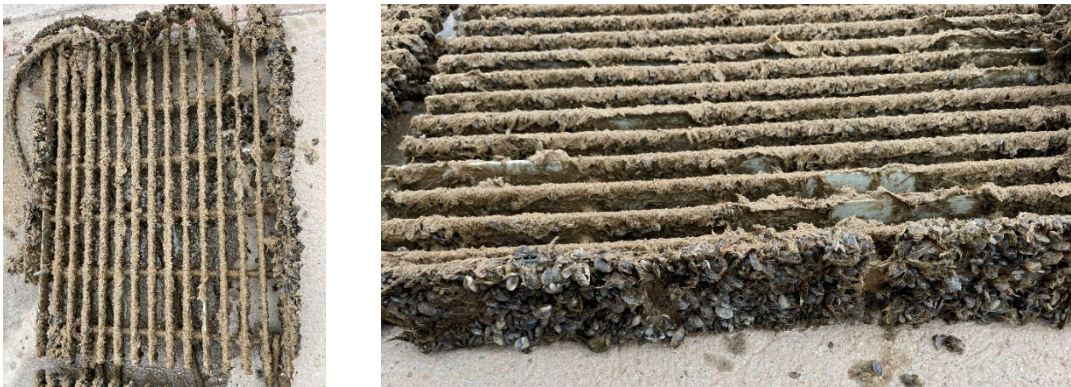
Figure 17: Top and side view of Silicone Solutions F-23 during July 2022 inspection. Minimal fouling of mussels but covered with

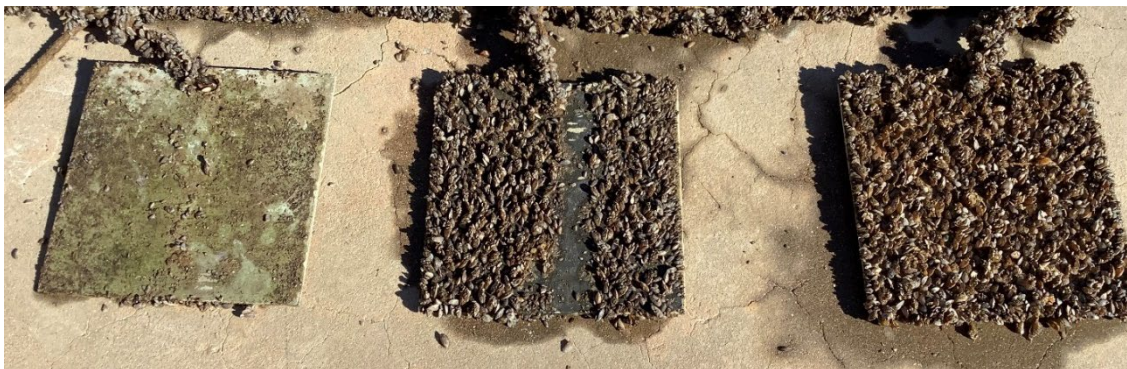
Figure 18: Silicone Solutions static test plates: F-23 (left), SS3000 (middle), and 5000A (right).

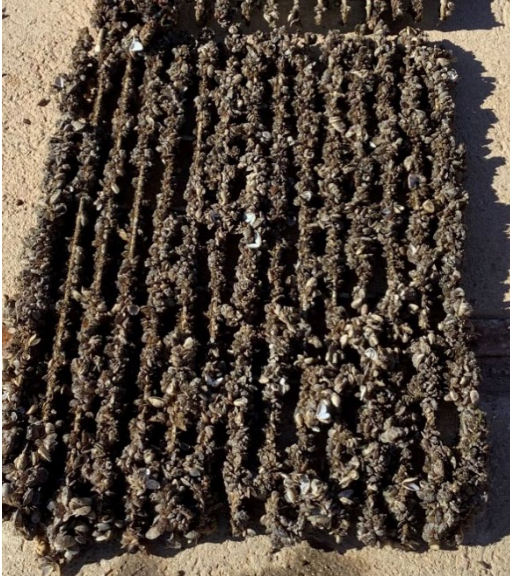
During the January 2022 inspection the second product from Silicone Solutions, 5000A was approximately 85% fouled, seen in Figure 19, and required a light force to clean. In static testing product 5000A also had similar results with 95% of the surface fouled and a light force was required to remove the mussels. This suggests the coating is beginning to lose some of its foul release properties. The dynamic test grate was approximately 25% fouled with mussels and 100% covered with the colonial hydroid during the July 2022 inspection, Figure 20. The grate did require a light force to remove the mussels, further supporting the claim that the coating is losing its foul-release properties. In static testing the plate was 95% fouled with mussels and required a light force to clean.

Figure 19: 5000A dynamic test grate during heavily fouled with mussels during January 2022 inspection.

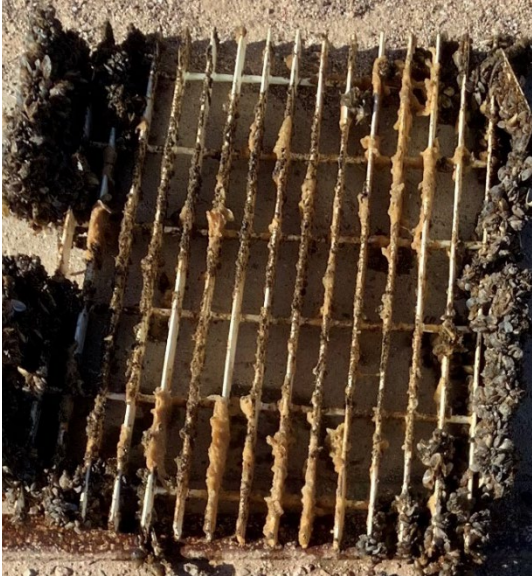
Figure 21: NuSil 9707 test grate during January 2022 inspection. Grate is fouled with sponge organism but no mussels.

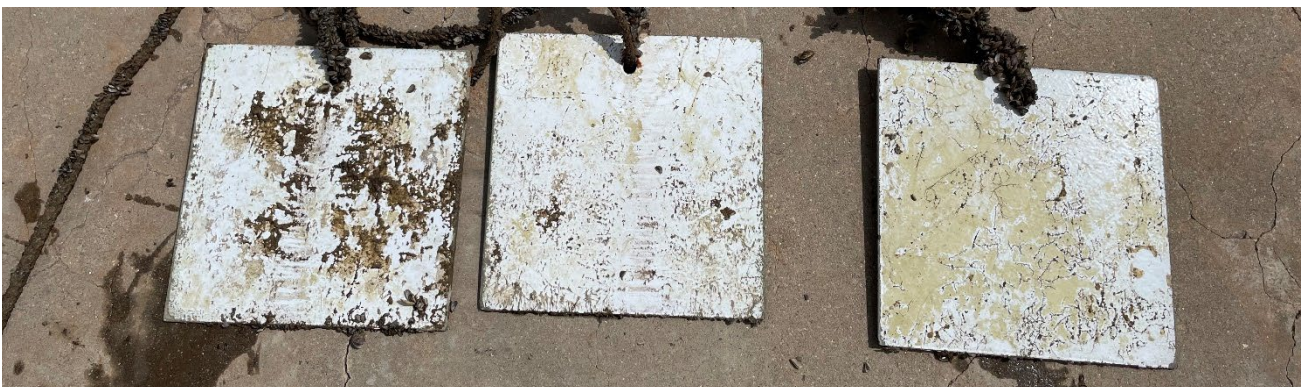
Figure 28: Static test plates Sigmaglidle 890. Little fouling from sponge organism and no mussel attachment.

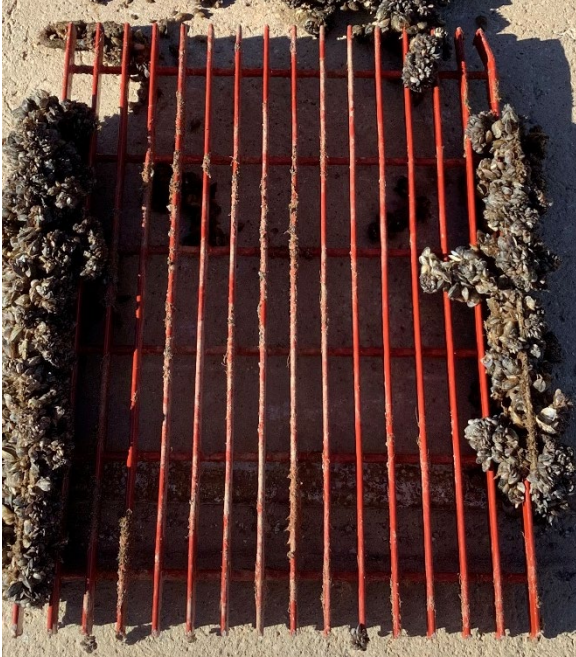
Figure 31: Sigmaglide 1290 after 1.5 years in flowing water during January 2022 inspection.

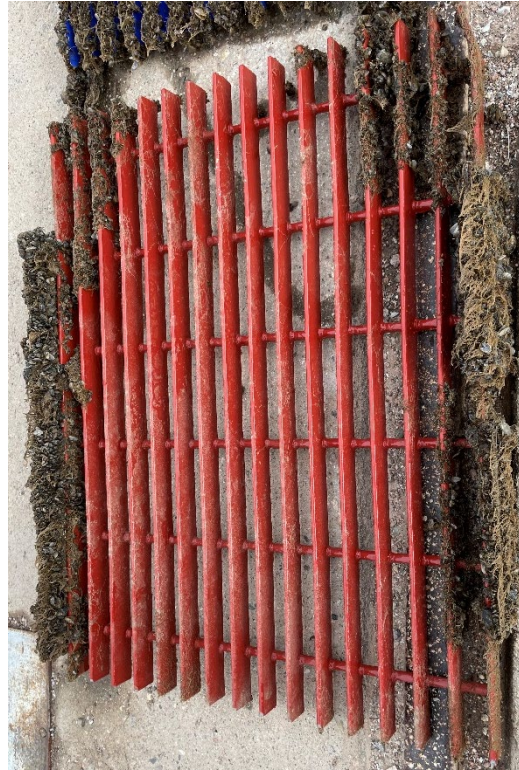
Figure 32: Sigmaglide 1290 dynamic test grate after 2 years in field testing during July 2022 inspection.

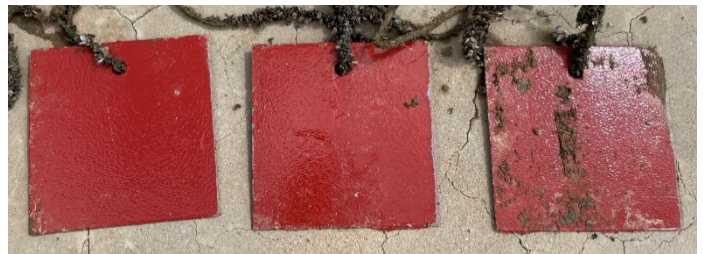
Sigmaglide 1290, installed in July 2019, had good results through to the July 2022 inspection. The dynamic test grate did not have any fouling during the January and July 2022 inspections as Figure 31 and Figure 32 show. The static test plates also had the same results with no fouling present during both 2022 inspections. Figure 33 and Figure 34 show the static test plates and some early-stage damage to the coating can be observed at the edges.

Figure 34: Sigmaglide 1290 static plates after 2 years of testing. There is no mussel fouling.

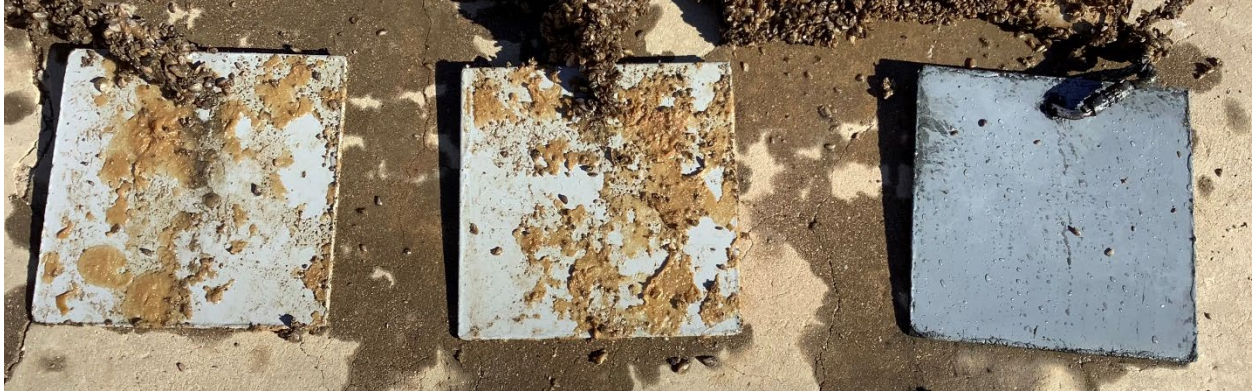
Figure 42: Intersleek 1425 quasi-static test panels with two panels being slightly fouled with sponge organism during January 2022 inspection.

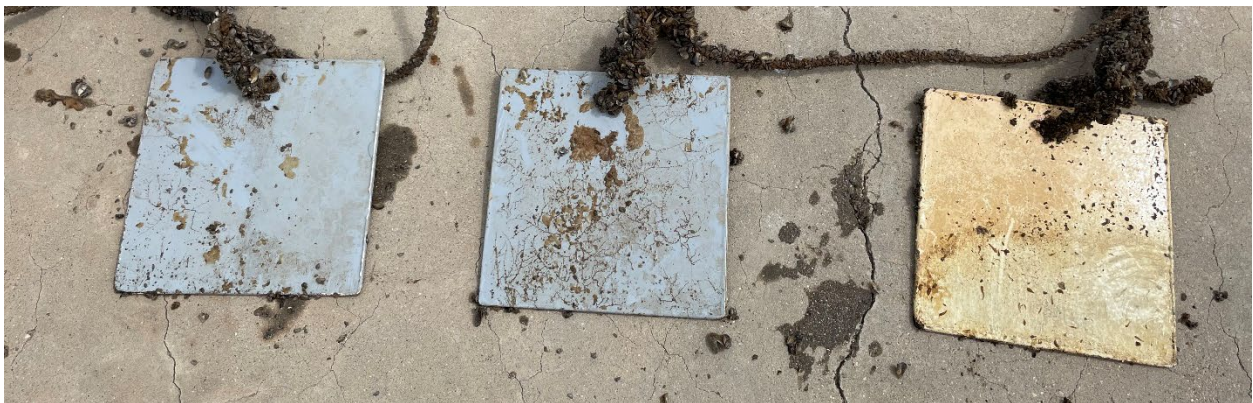
Figure 43: Intersleek 1425 quasi-static test plates. No mussel fouling and small amounts of sponge and hydroid present during July 2022 inspection.

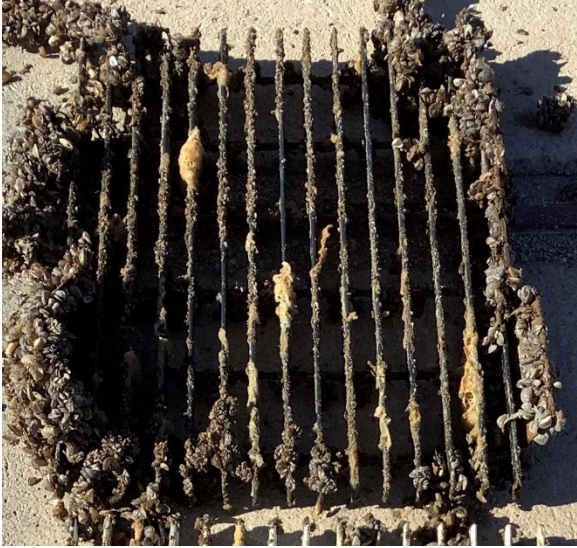
Figure 44: BioClean flowing water test grate during January 2022 inspection. Light fouling of sponge organism and mussels.

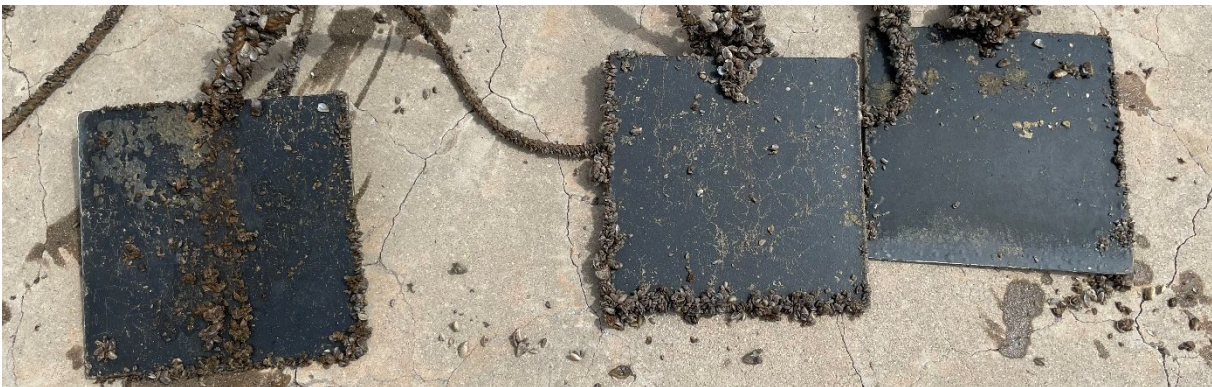
Figure 46: BioClean static test plates during July 2022 inspection.

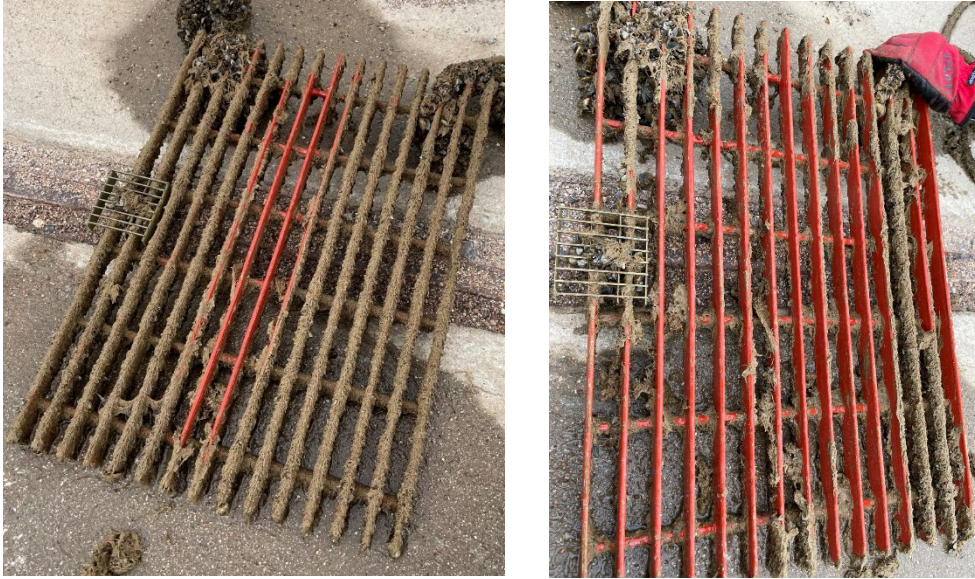
Figure 51: Hempel X3 dynamic test grate, covered in colonial hydroid, before and after cleaning during July 2022 inspection.

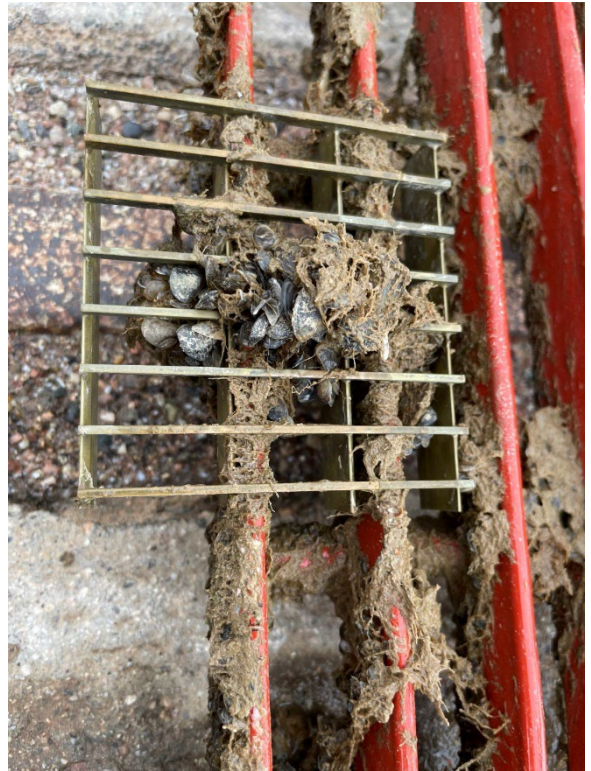
Figure 55: Z-Alloy fish screen at July 2022 inspection. All fouling is on zip-tie securing the sample.

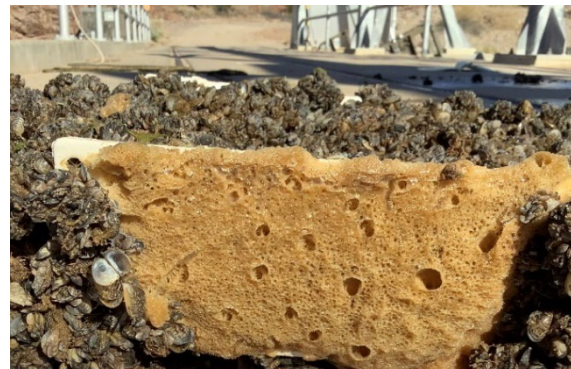
Figure 57: NDSU 8 in flowing conditions during January 2022 covered in sponge organism.

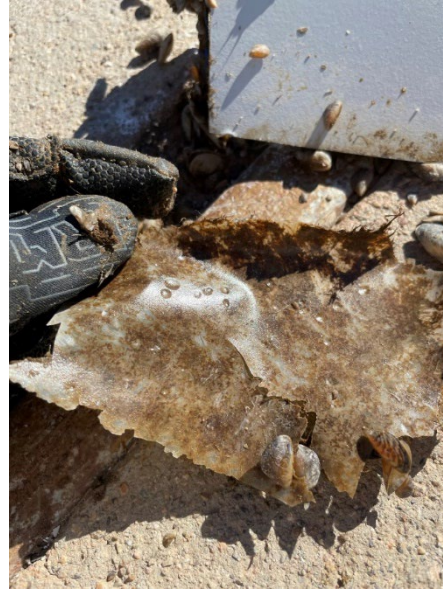
NDSU 8, C20, and C4-20% had the best results in flowing water testing. These formulations had little to no fouling and were easily cleaned. Figure 56 through Figure 59 show the dynamic panels for NDSU 8 and NDSU 9 formulations. NDSU 8 had blisters form and NDSU 9 is damaged with some of the topcoat missing. The other noticeable observation during the January 2022 inspection was a large section of topcoat on NDSU 3 had delaminated in as a single piece shown in Figure 60 through Figure 62.

Figure 62: Delaminated topcoat from NDSU 3. Blisters can be seen in the film.

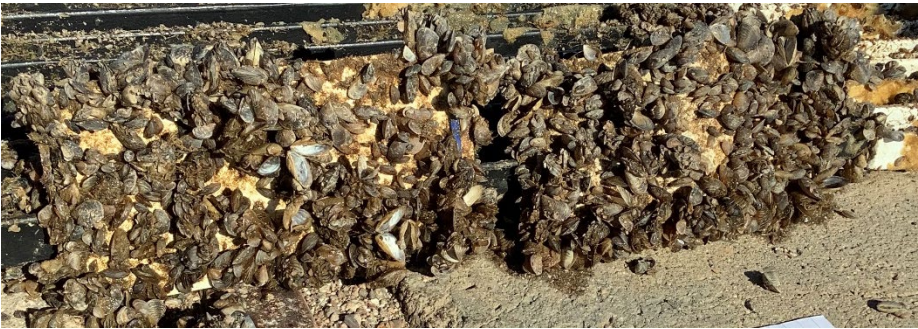
Figure 63: NDSU 1 dynamic testing results January 2022 inspection.

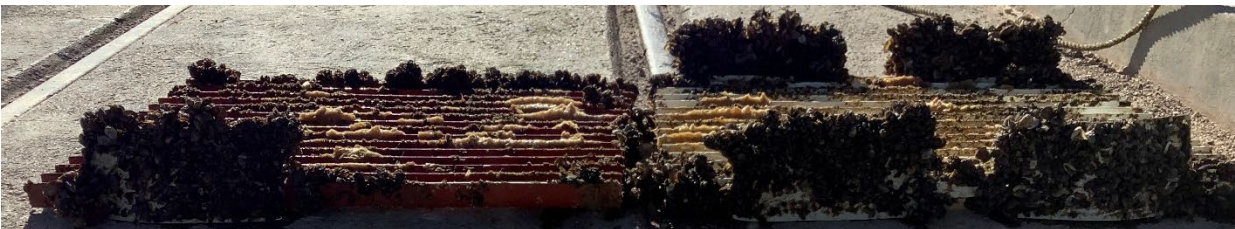
Figure 64: NDSU 7 (left), NDSU 5 (middle), and NDSU 4 (right) in dynamic testing conditions. NDSU 6 was lost during testing and one panel of NDSU 7 was lost also.

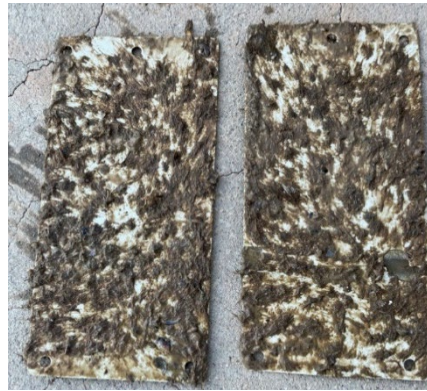
Figure 68: NDSU 1 static panels after being cleaned.

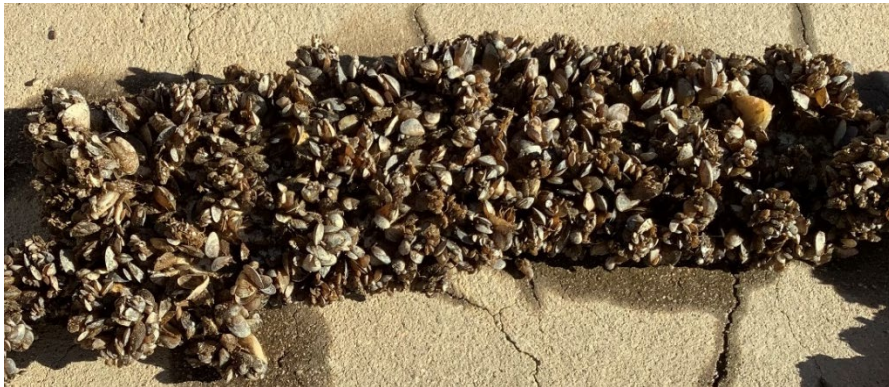
Figure 69: NDSU 3 static test panel completely fouled January 2022 inspection.

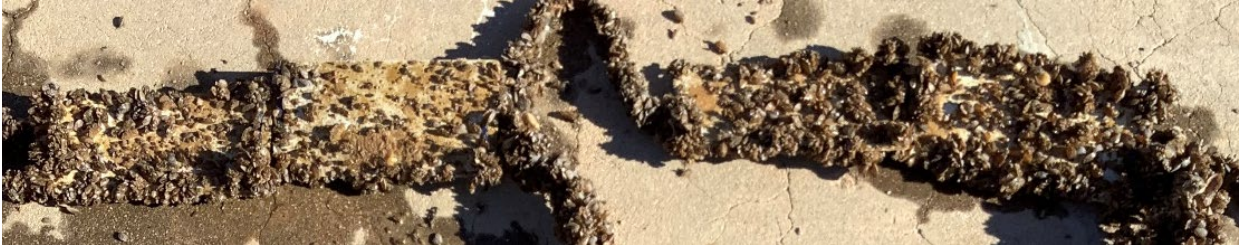
Figure 70: NDSU 4 (left two panels) and NDSU 5 (right two panels) in static testing conditions January 2022 inspection.

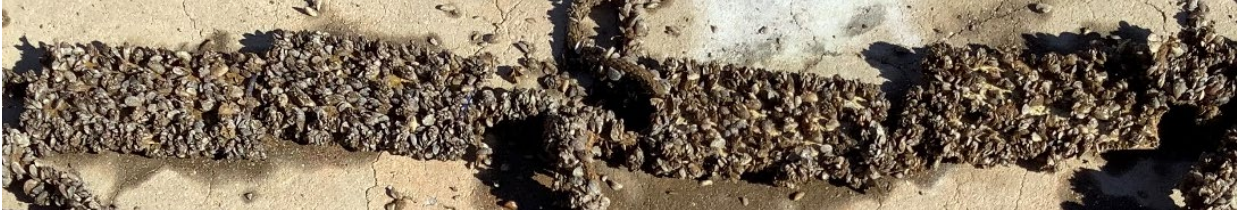
Figure 71: NDSU 6 (left two panels) and NDSU 7 (right two panels) in static conditions January 2022 inspection.

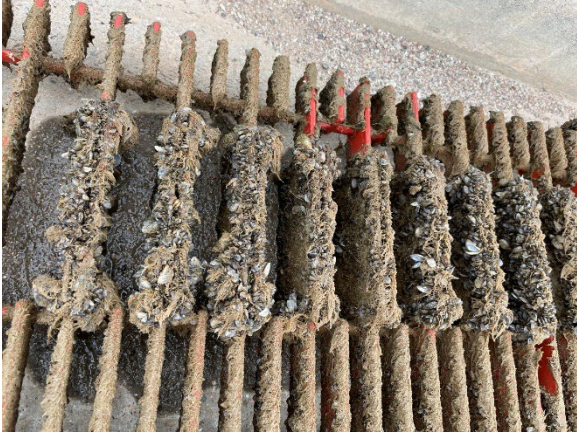
Figure 73: From left to right Formulation A, B, and C with various degrees of fouling during July 2022 inspection.

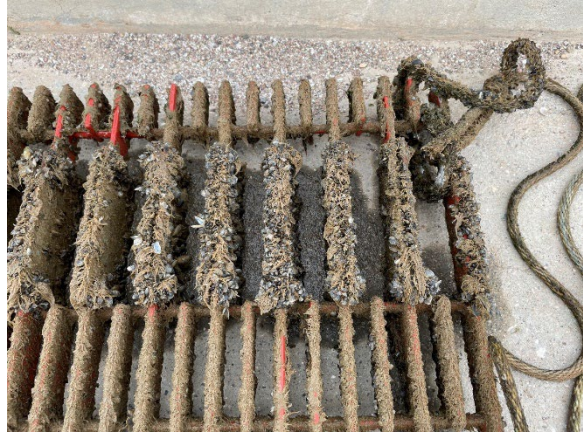
Figure 74: From left to right formulations B, C, and D with different degrees of fouling during July 2022 inspection.

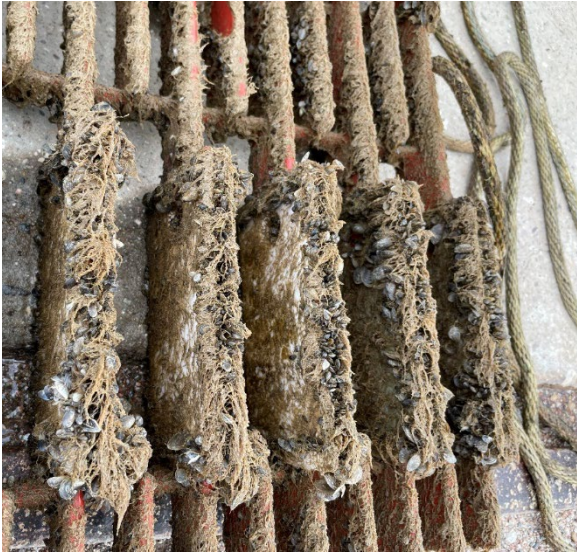
Figure 75: Formulation E (left) and formulation G (right) prior to cleaning of mussels during July 2022 inspection.

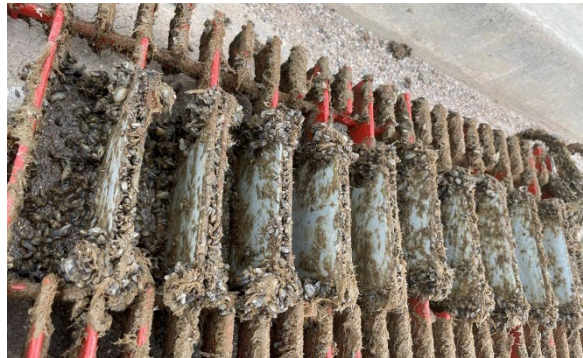
Figure 76: From left to right Formulation A, B, and C with various degrees of fouling during July 2022 inspection.

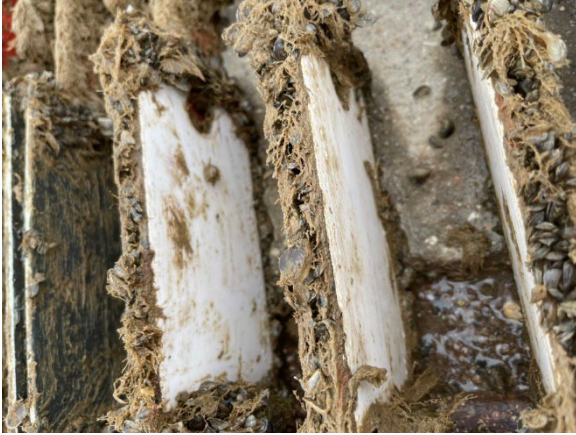
During the July 2022 inspection, Formulation E continued to have the best performance out of the experimental systems from Adaptive Surface Technologies. This formulation prevented most fouling, and any fouling present was easily cleaned. Formulation E and all other formulations had blisters form around the edges indicating application defects or the coating has poor barrier properties and corrosion prevention. All formulations, except Formulation E, allowed for mussel fouling to occur to varying degrees ranging from 15% up to 100% of the surface being fouled. System B was the only other formulation that was easily cleaned. The other systems, A, C, D, G, and F, all lost some of their foul release properties from the previous inspection and did require a light force to remove the mussels. Two panels from each system were removed from testing and were shipped back to Adaptive Surface Technologies for internal evaluation. Three panels from each set remained in testing for another data point collection. Figure 72 through Figure 87 show the formulations in and after removal from testing.

Figure 77: Formulation E after cleaning during July 2022 inspection.

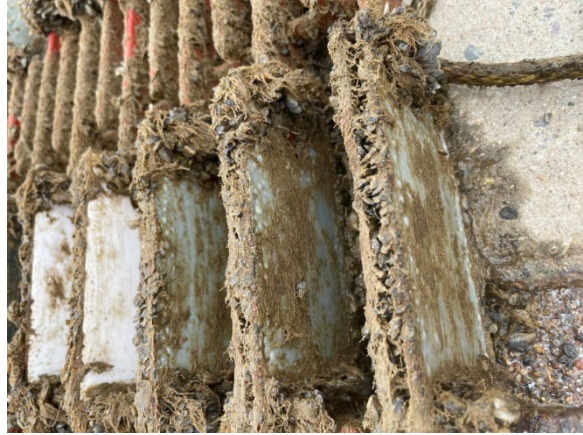
Figure 78: Formulation E and G after cleaning during July 2022 inspection.

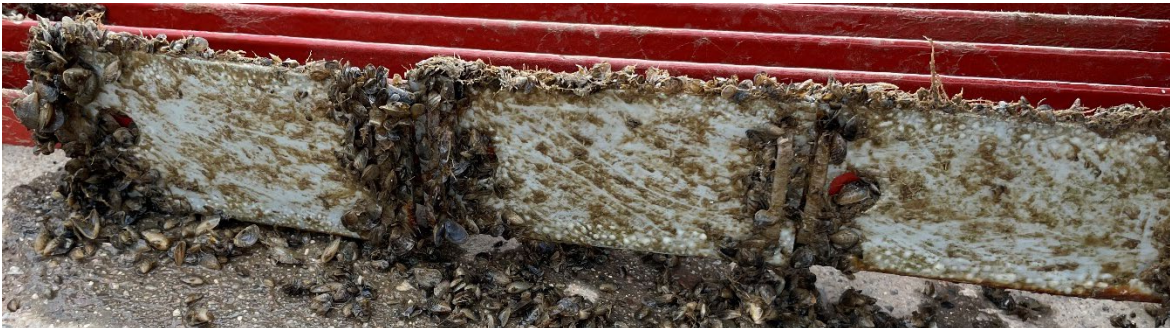
Figure 80: Formulation F panels after cleaning during July 2022 inspection.

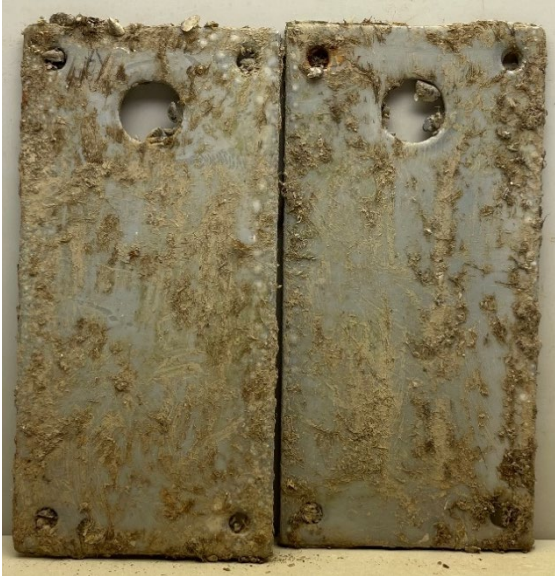
Figure 81: Adaptive Surface Technologies' Formulation A after removal from testing.

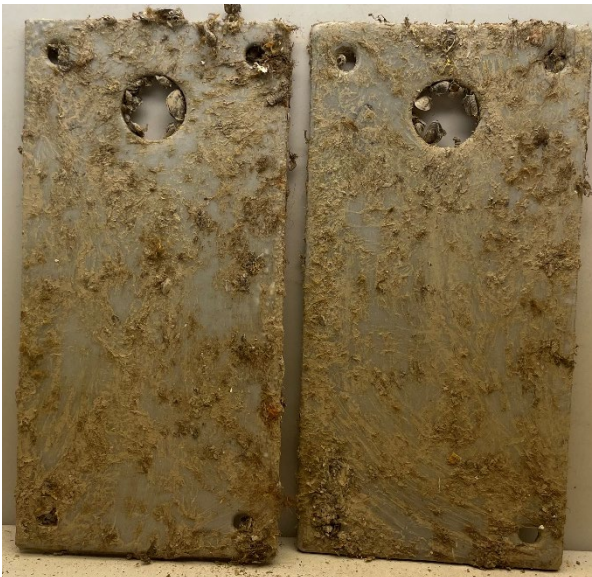
Figure 83: Adaptive Surface Technologies' Formulation C after removal from testing.

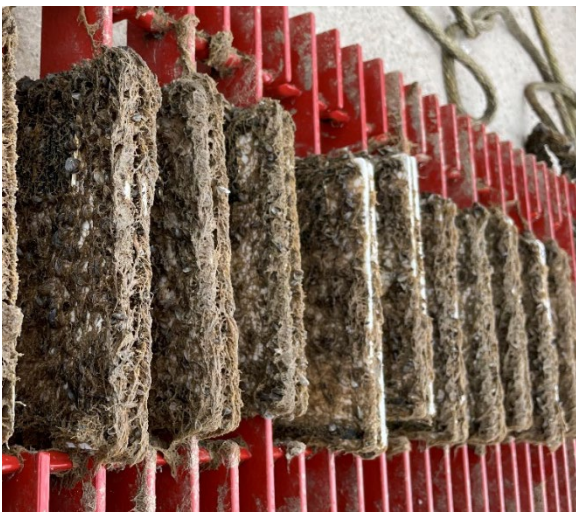
Figure 89: PNNL panels on experimental rack after approximately 6 months of testing. Minor mussel fouling and some buildup of colonial hydroid.

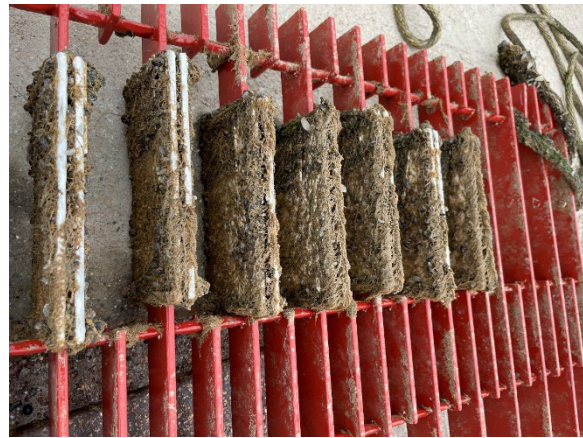
Figure 90: PNNL panels on experimental rack after approximately 6 months of testing. Minor mussel fouling and some buildup of colonial hydroid. Formulations 3 through 10 (left to right).

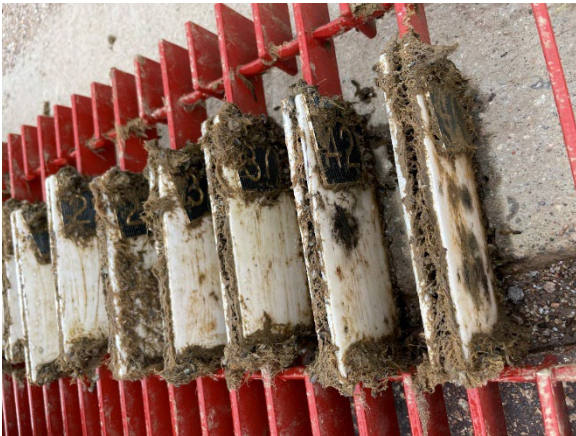
Figure 91: Panels after cleaning. Some of the black spots can be seen on the two right panels, 40 and 42.

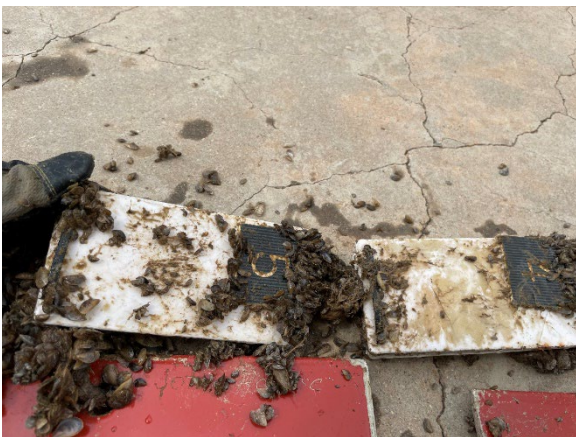
Figure 95: Formulation 1 panels in static testing. Less than 5% fouled with mussels and some sponge organism build up.

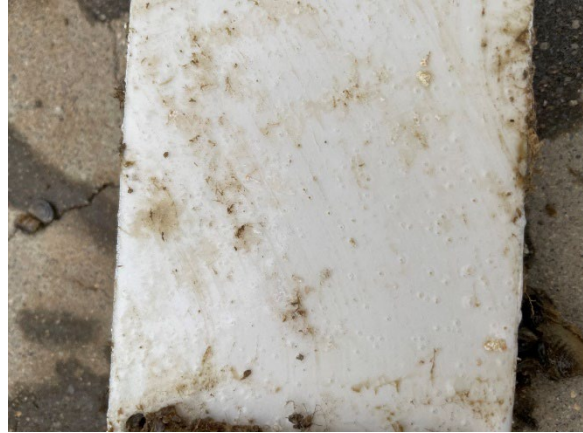
Figure 98: Closeup of formulation 3 surface showing blistering and air bubbles in coating.

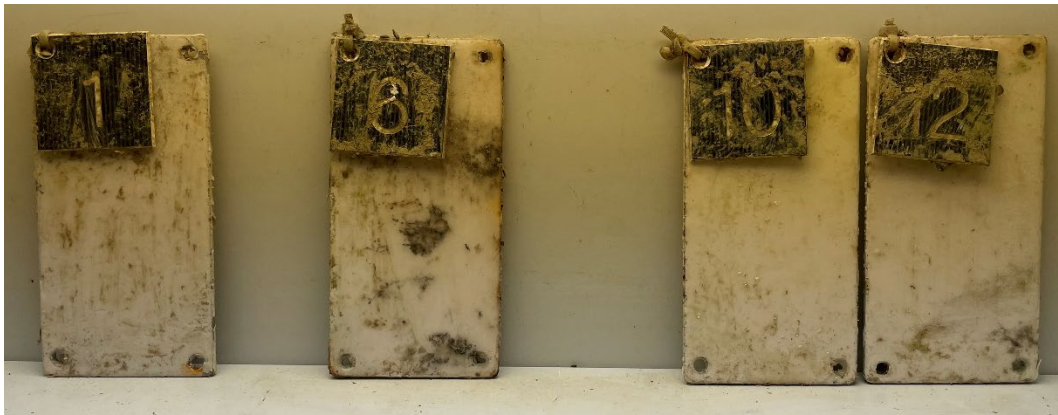
Figure 99: PNNL Formulations 1 (coupon 1), 2 (coupon 6), and 3 (coupon 10 and 12) coupons that were removed from testing.

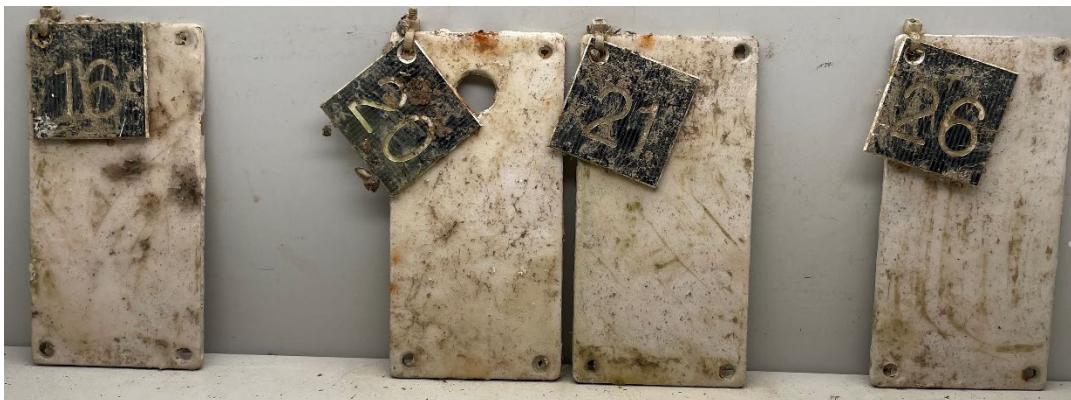
Figure 100: PNNL formulations 4 (coupon 16), 5 (coupon 20 and 21), and 6 (coupon 26) coupons that were removed from testing.

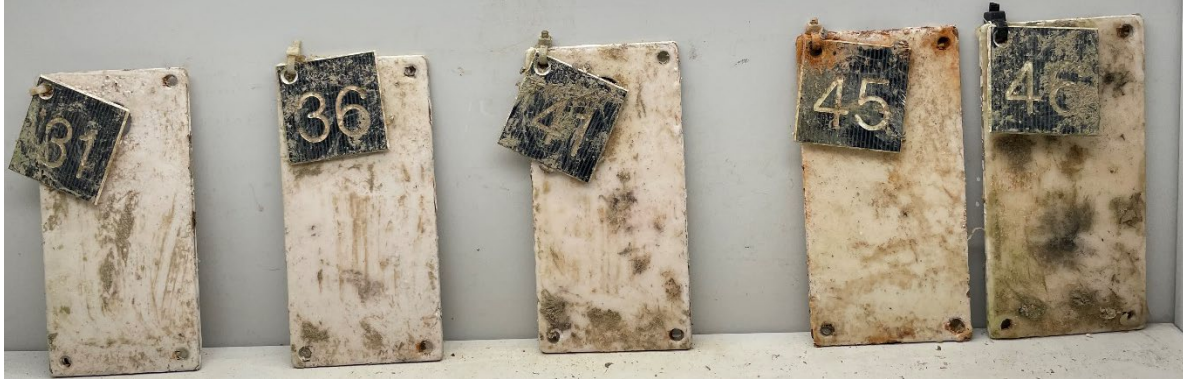
Figure 101: PNNL formulations 7 (coupon 31), 8 (coupon 36), 9 (coupon 41) and 10 (coupon 45 and 46) coupons that were removed from testing.

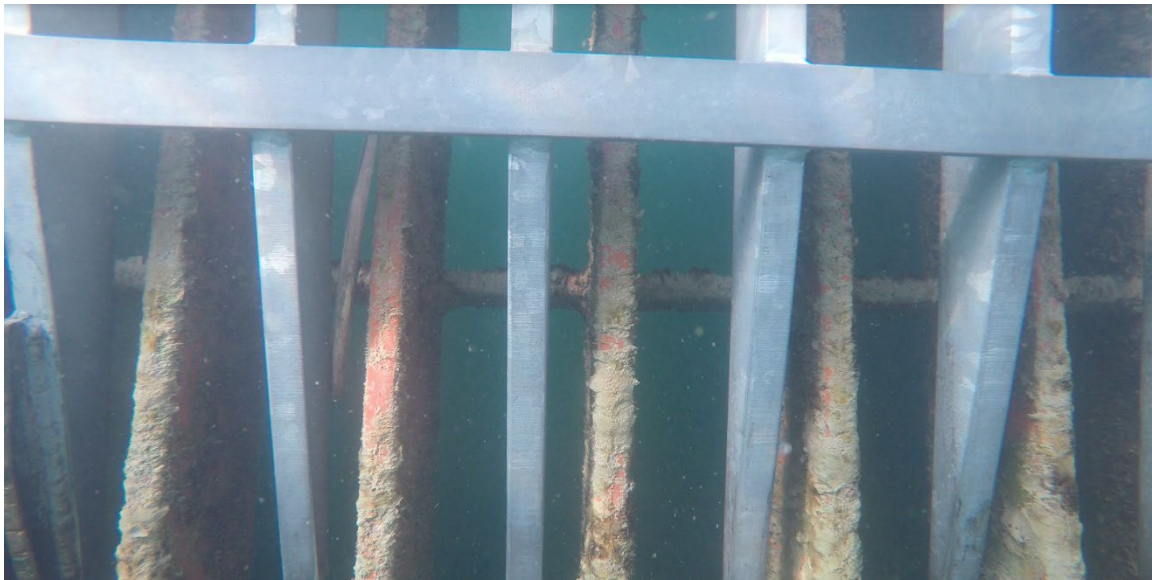
After nine years of service, all four coatings appeared to have lost a small amount of their foul-release properties and allowing the accumulation of hydroids. However, all four coatings are still preventing the fouling of mussels to the trashrack. Sigmaglide 890 appears to have retained its foul release properties the best, compared to the other coatings on the scale-up project, with no mussel fouling and minimal accumulation of algae which Figure 104 shows. The bottom of the trashrack was damaged where the Sigmaglide 890 was once located and corrosion is occurring as shown in Figure 105. Both Sher-release and Intersleek 970 appeared to have the same performance with no

Figure 104: Sigmaglide 890 on trashrack. Coating is in good condition.
