Uplift Pressure and Flow through Open Offset Joints in Spillway Chutes

**Science and Technology Program
Research and Development Office
Final Report ST-2021-19170-01**

**Technology Development Program
Dam Safety Office, Dam Safety and Infrastructure
Final Report DSO-2021-08**

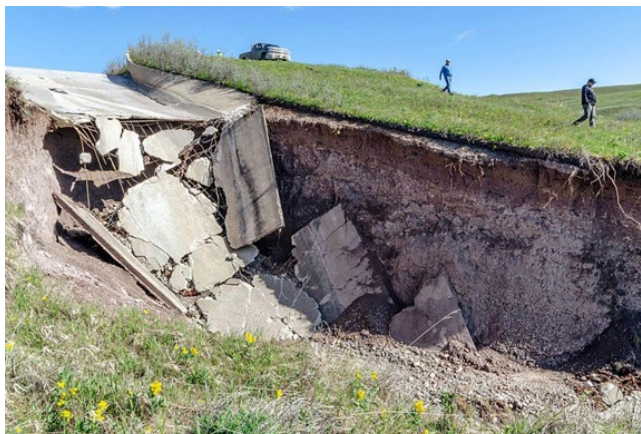
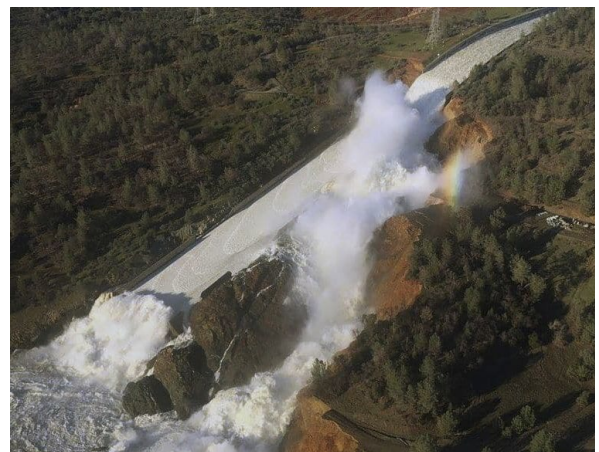
Cover photos show chute failures at the fifth drop structure of the St. Mary Canal on Reclamation's Milk River Project (Montana) in 2020, and Oroville Dam (California) in 2017.

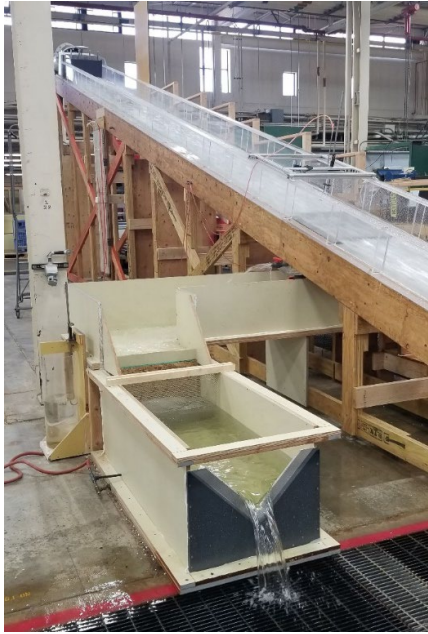
Figure 1. — Spillway uplift research flume.

The flow conditions above the joint are measured using a 1.32-mm (0.052-inch) diameter Pitot tube that allows the velocity to be determined at any point above the floor of the flume, just upstream from the simulated joint. Velocity profiles are measured for each test condition to define the boundary layer properties near the joint and to obtain an estimate of the flow depth. This estimate is made by fitting a power curve function to the velocity data. This function also allows indirect calculation of the effective flow depth, which is also checked against a depth estimate obtained from a down-looking acoustic sensor. Testing can be performed with mean velocities ranging from 3.5 to 8.8 m/s (11.5 to 29 ft/s). Channel Reynolds numbers range from about 3.4×10^5 to 5.4×10^6 , which should be sufficient to make results independent of friction-related scale effects. Flow conditions for the testing performed thus far have been non-aerated to slightly aerated. Measurements of air concentration have not been made at this time. Figures 1 through 5 show several views of the test facility. Figure 6 shows the joint configuration and the important joint dimensions. Tested gap widths, s , varied from 2.49 to 37.6 mm and offset heights, b , varied from 3.45 to 22.4 mm. The thickness of the joint in the direction normal to the chute slope was 156 mm for all tests before the flow entered the larger 75-mm wide chamber beneath the joint.

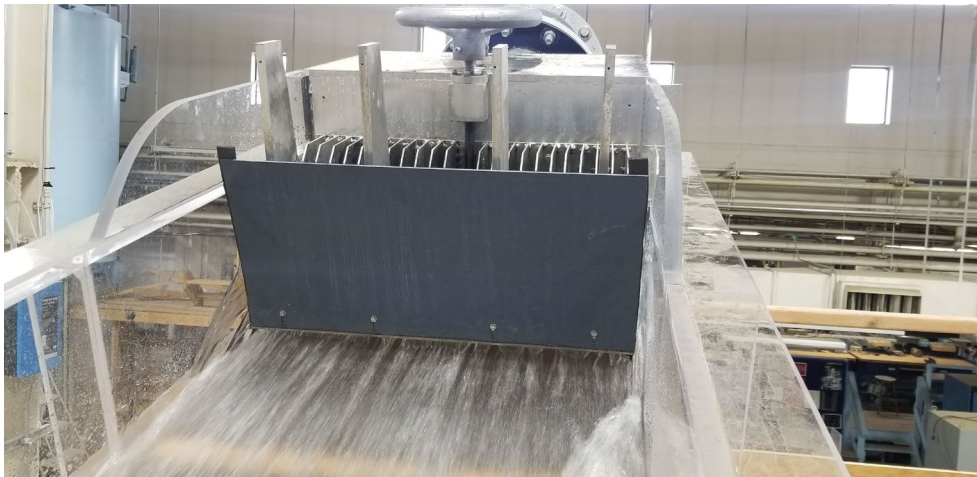
Figure 2. — A jet box regulates the depth and velocity of incoming flow.

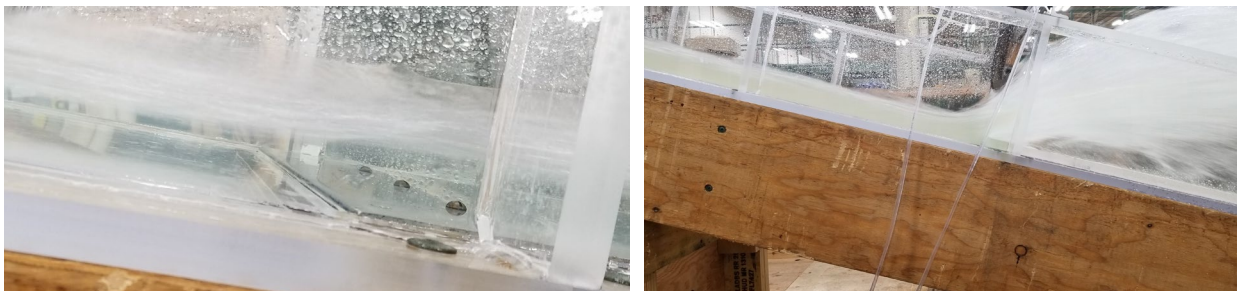
Figure 3. — Flow attached to the flume floor as it flows over a small-height offset (left); Flow launched or detached from the floor by a large-height offset (right).

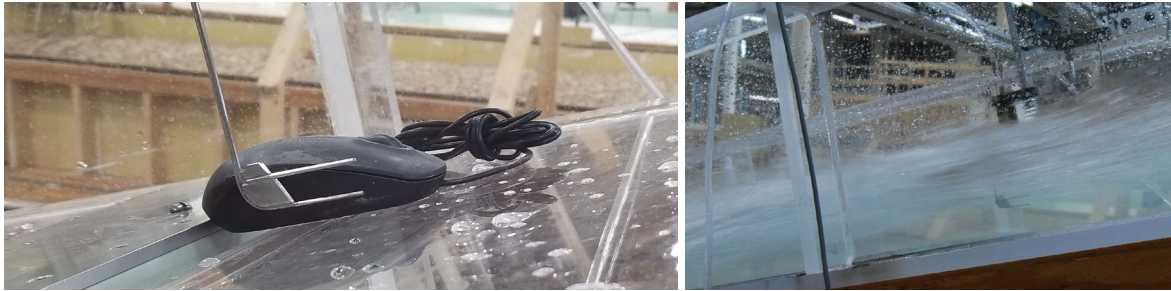
Figure 4. — Pitot tube used to measure spillway chute velocity profile.

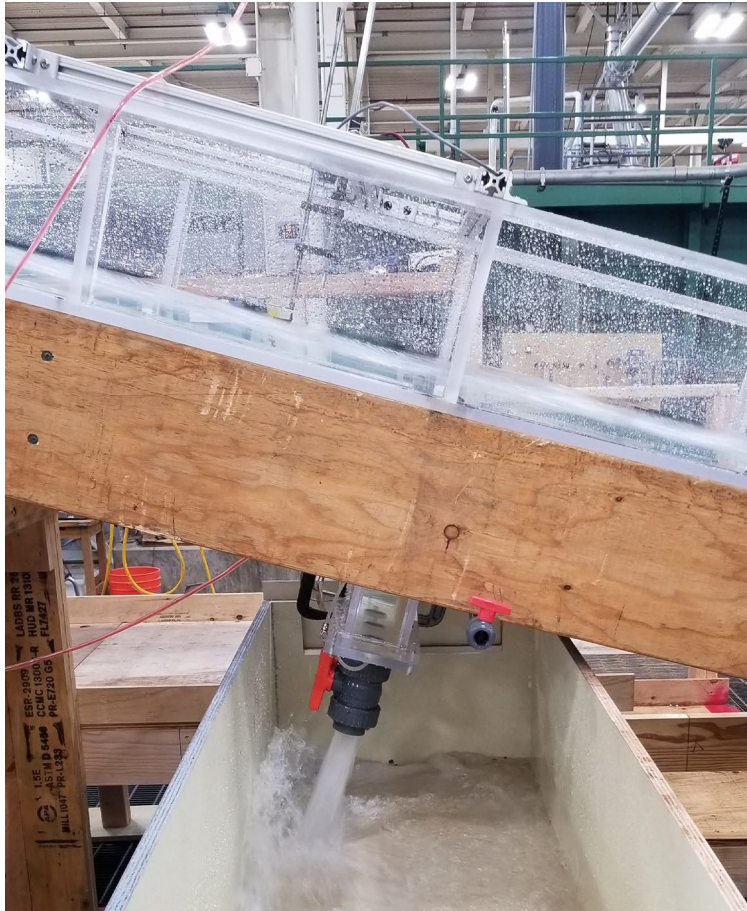
Figure 5. — Flow exiting the flume through the simulated joint during testing of a partially vented condition. Several valves regulate the back-pressure and control the flow out of the chamber below the joint.

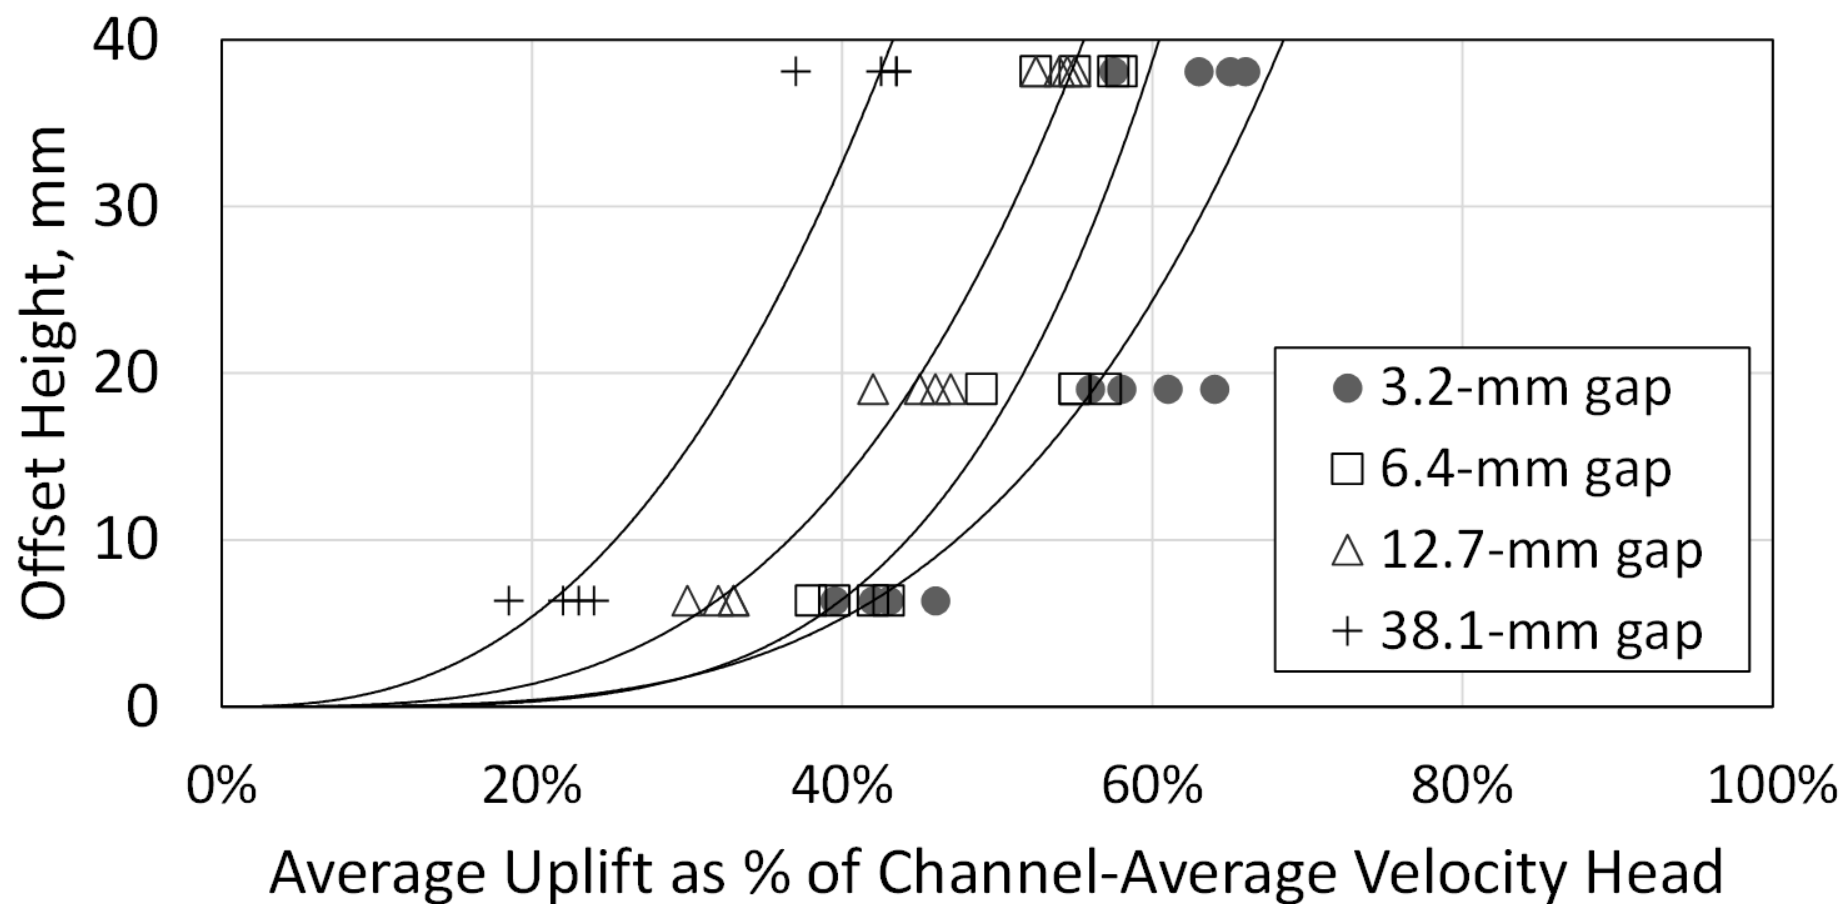
Figure 3. — Johnson (1976) data on uplift pressures in sealed offset joints, as originally presented in the form of percentages of the channel-average velocity head versus offset height. Power curve trend lines for each gap width are for illustration only; Johnson (1976) drew individual curves by hand through the data points for each gap width and velocity setting.

Figure 3 shows the Johnson (1976) measurements of average uplift pressures in a format that is condensed, but similar to the way they were first presented by Johnson. Uplift pressures are made dimensionless by expressing them as a percentage of the channel-average velocity head. Johnson originally showed data for each gap width on a separate plot, with individual hand-drawn curves passing through the data points collected at each velocity setting. In this condensed presentation Figure 3 shows power curves through the data for each gap width to illustrate general trends in the data. Johnson's observations highlighted previously are apparent, especially the significant increase in uplift pressure as the width of the joint gap was reduced. Although the data are not included here, trends in the 95-percent maximum uplift pressure data were similar, with the 95-percent maximum uplift typically being about 1.15 to 1.40 times the average uplift.

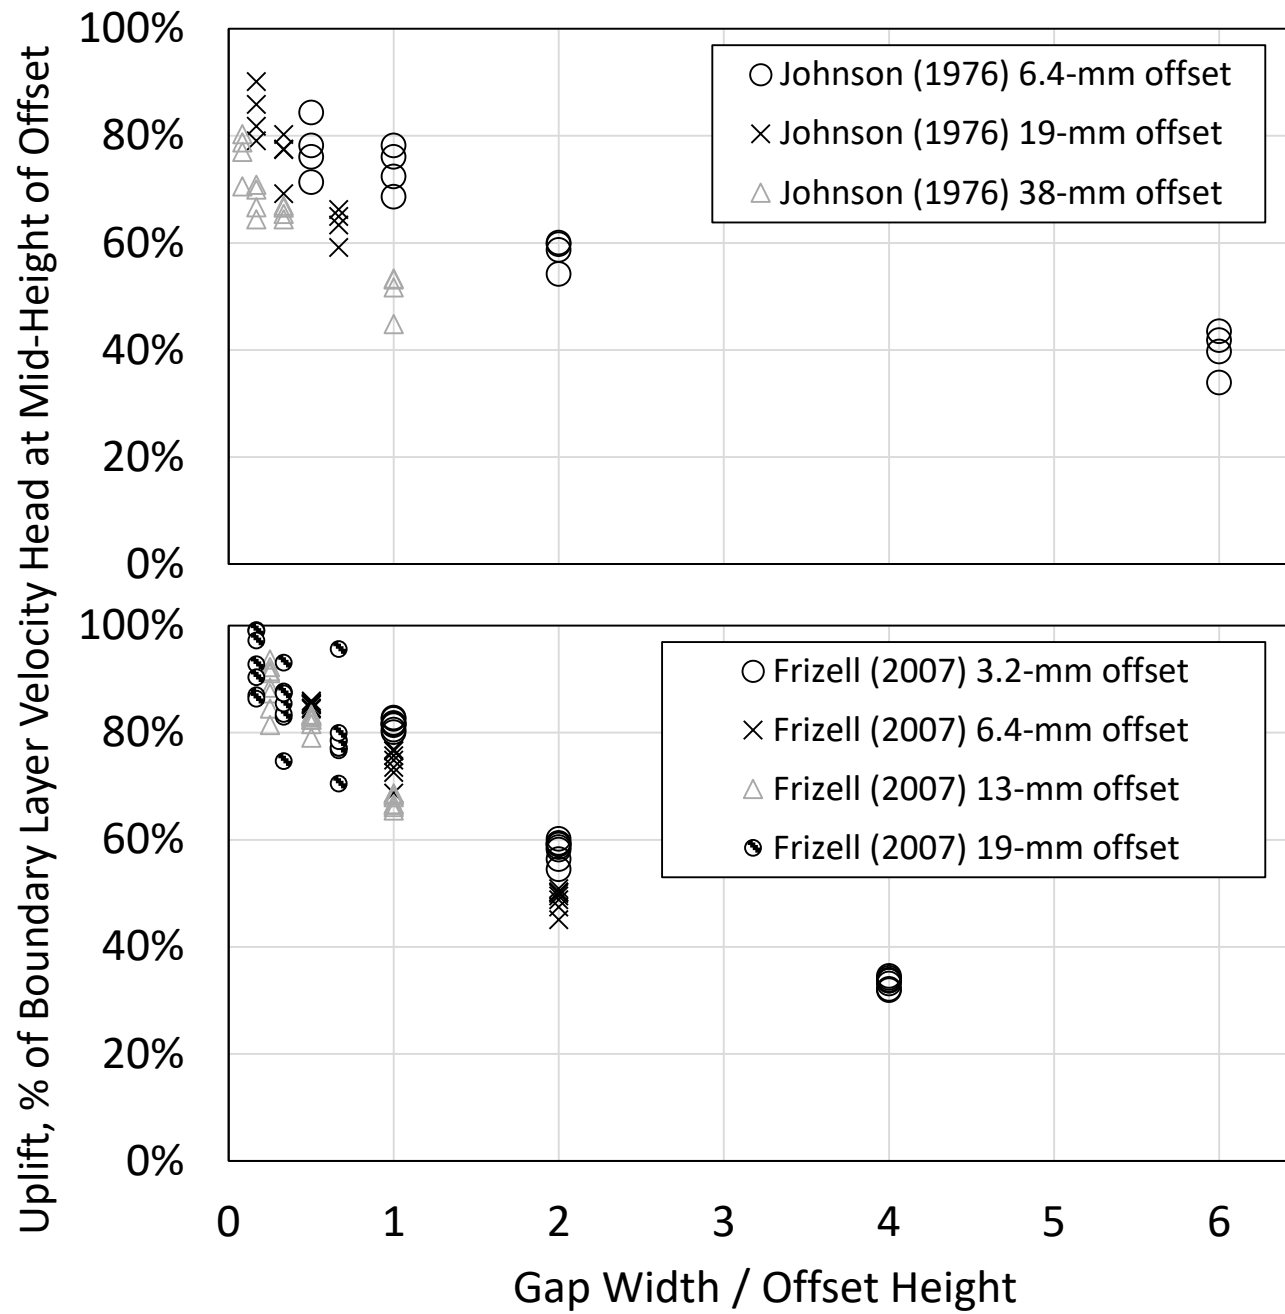
Figure 7. — Uplift pressure head as a percentage of boundary layer velocity head related to joint geometry.
