# Repair of Voids Behind Spillways, Conduits, Canals, Tunnels, and Siphons

Science and Technology Program  
Research and Development Office  
Final Report No. ST-2024-21045-03  
8550-2024-12

Report 3 of 3 on Void Causes, Detection, and Repair

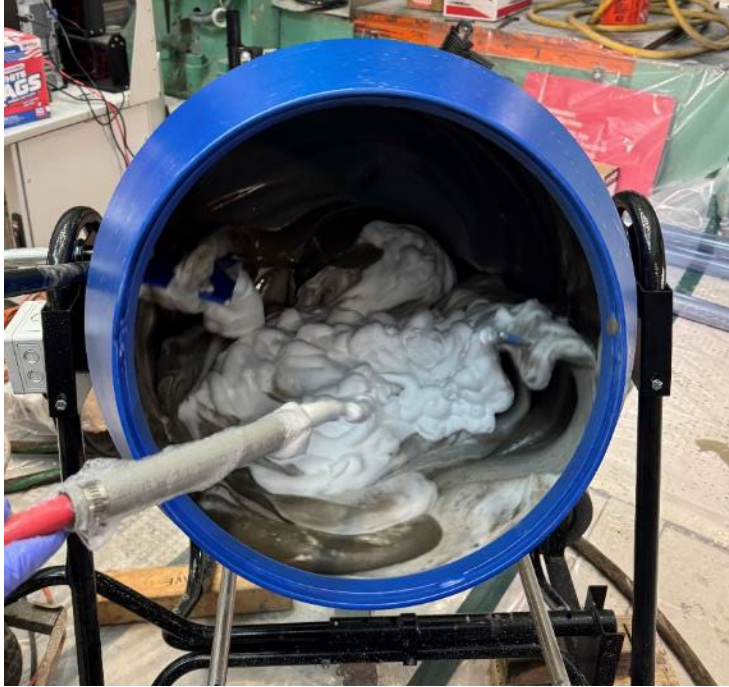
Photograph 1.—Addition of foam to cementitious grout in mixing drum.

All PLDCC was mixed and cast on the same day. The grout utilized consisted of 100-percent cement mixed with water at a 0.50 water/cementitious (w/c) ratio. Foam utilized to create the PLDCC was AQUAERiX manufactured by Aerix Industries. The foam and grout were mixed at 3:1 (75% foam) with a foam density of 2.5 pcf to achieve a target PLDCC plastic density of approximately 30 pcf. The 24-foot vertical set-up was filled last with all remaining PLDCC material, resulting in filling only to approximately 19ft. Photograph 1 through Photograph 6 show general set-up and pumping operations.

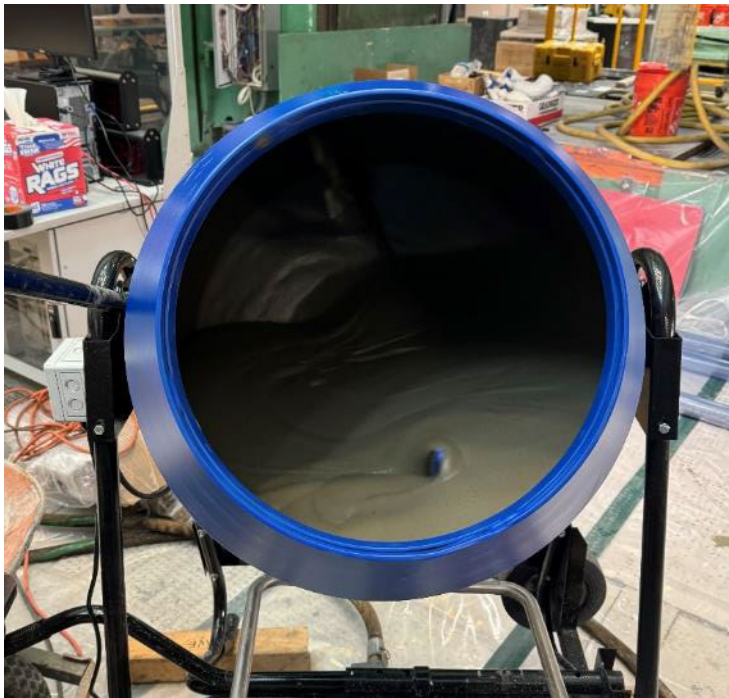
Photograph 2.—Fully mixed PLDCC in drum mixer.

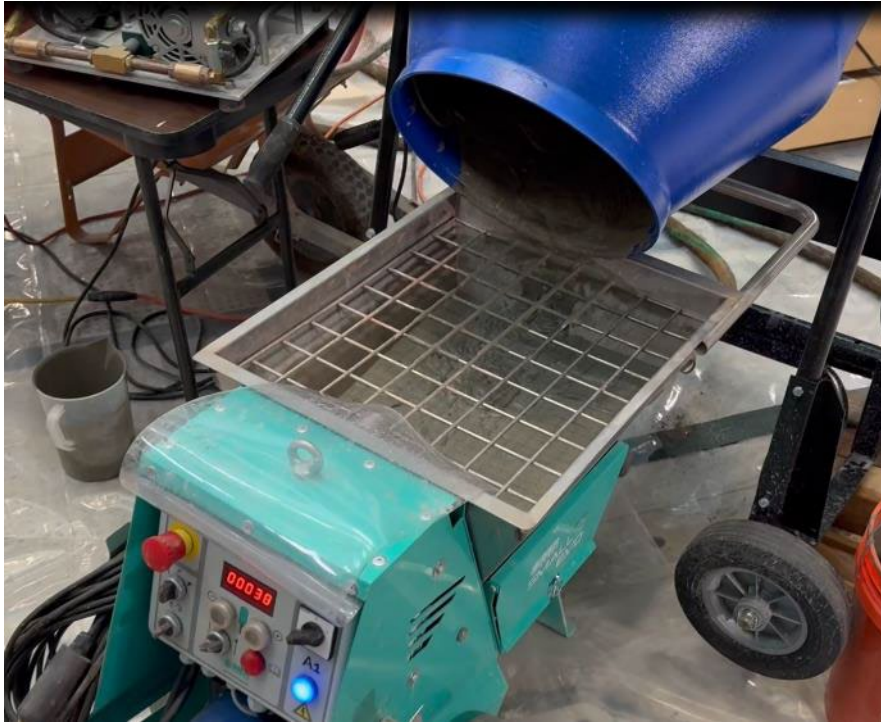
Photograph 3.—PLDCC transferred from drum mixer to grout pump.

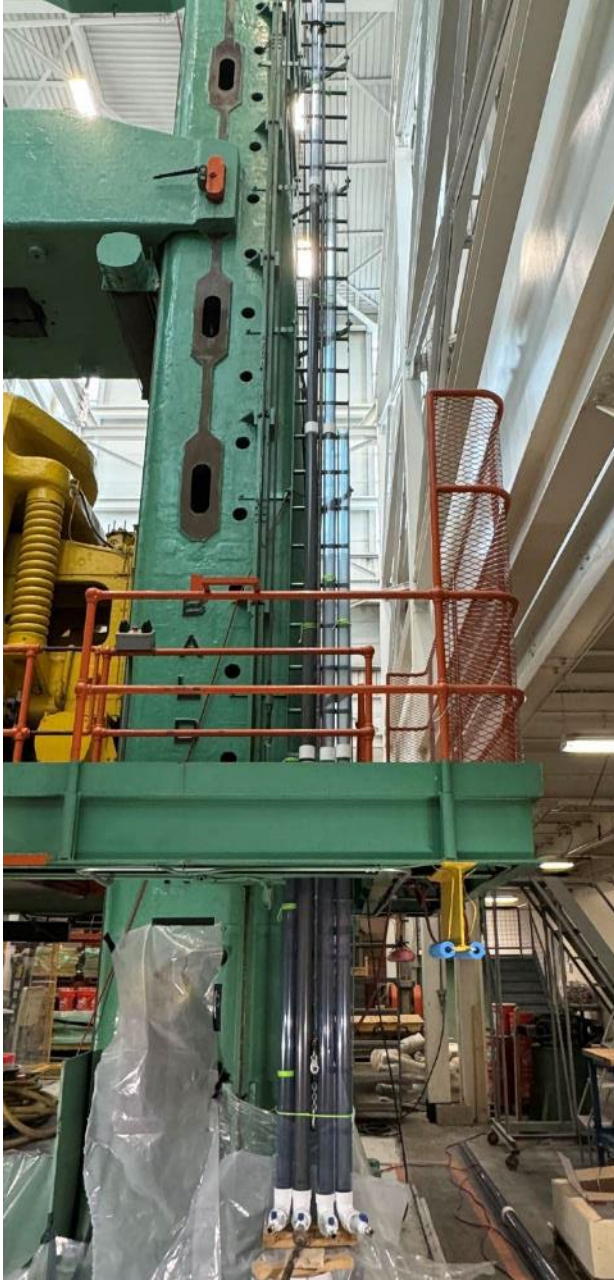
Photograph 4.—PLDCC test set-ups with vertical pipes attached to permanent ladder.

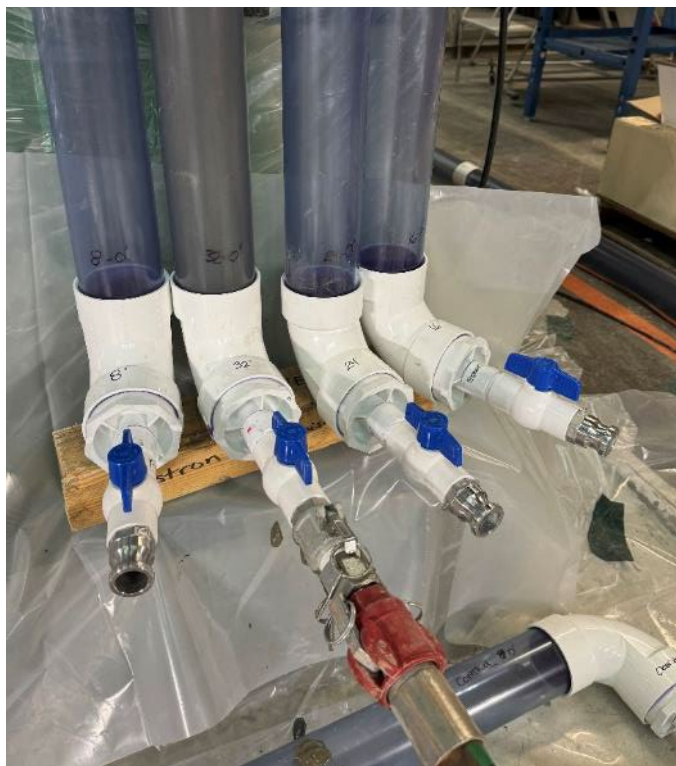
Photograph 5.—PLDCC pumping into vertical 32-foot set-up.

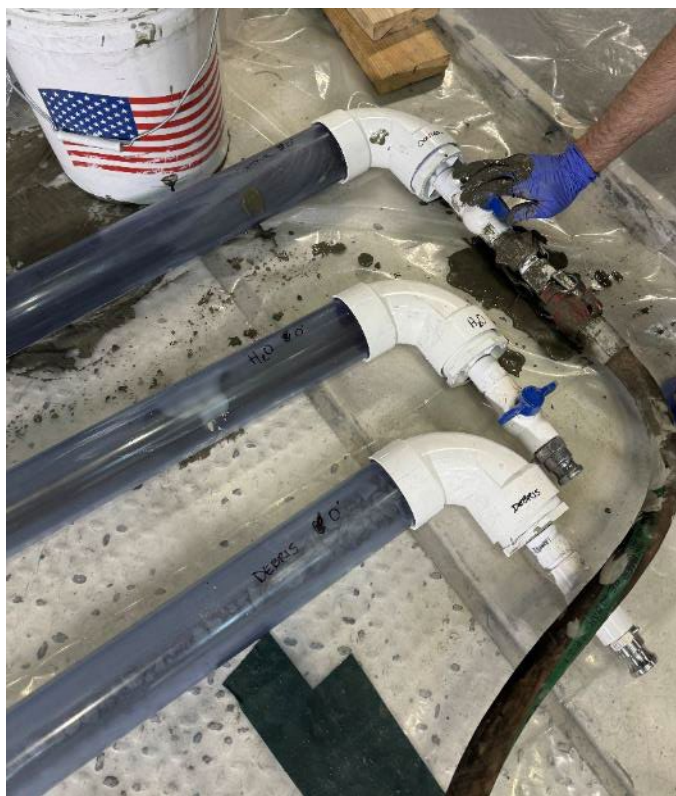
Photograph 6.—PLDCC pumping into horizontal 8-foot set-ups.

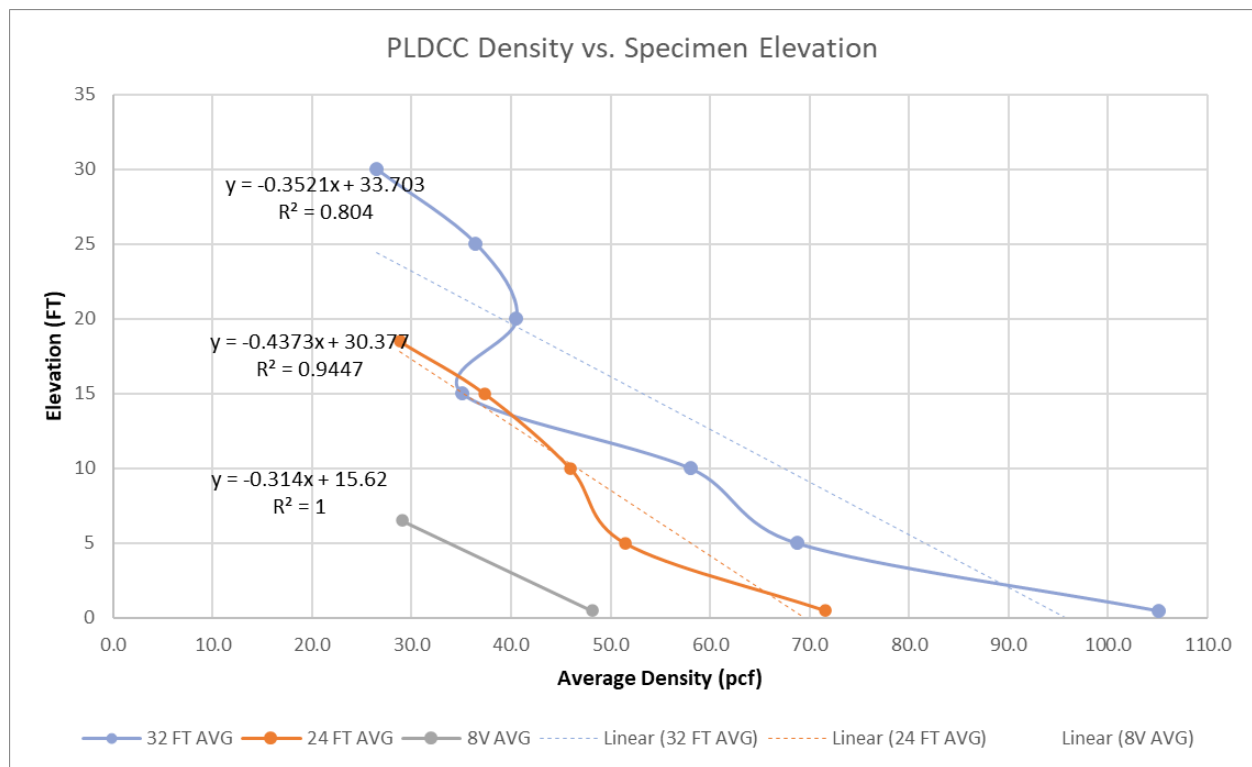
Figure 1.—Average PLDCC specimen density vs. elevation.

Test results for the PLDCC are presented in Table 1 through Table 5 and Figure 1 and Figure 2.

Sample ID	Specimen ID	Elevation (ft)	Average Dry Density (pcf)
32 FT	32-0.5	0.5	105.1
	32-5	5.0	68.8
	32-10	10.0	58.0
	32-15	15.0	35.1
	32-20	20.0	40.5
	32-25	25.0	36.5
	32-30	30.0	26.4
24 FT	24-0.5	0.5	71.6
	24-5	5.0	51.5
	24-10	10.0	46.0
	24-15	15.0	37.4
	24-18.5	18.5	28.8
8 FT Vertical	8V-0.5	0.5	48.2
	8V-6.5	6.5	29.0

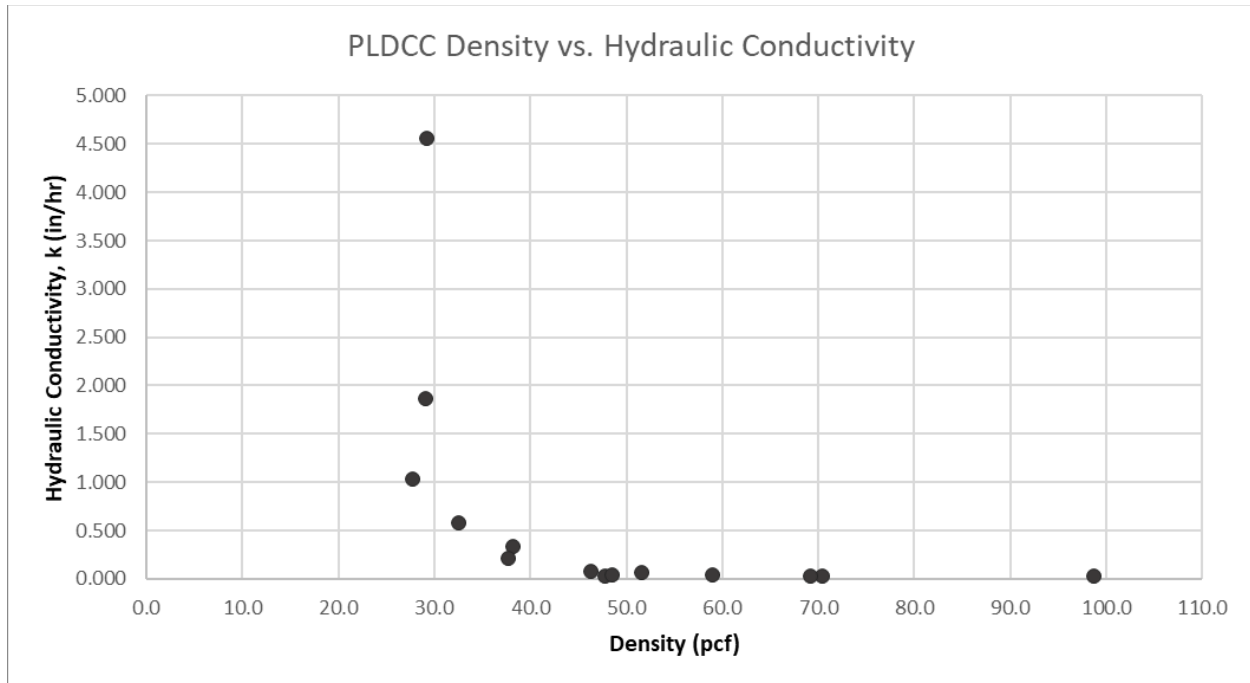
Figure 2.—PLDCC Density vs. Hydraulic Conductivity.

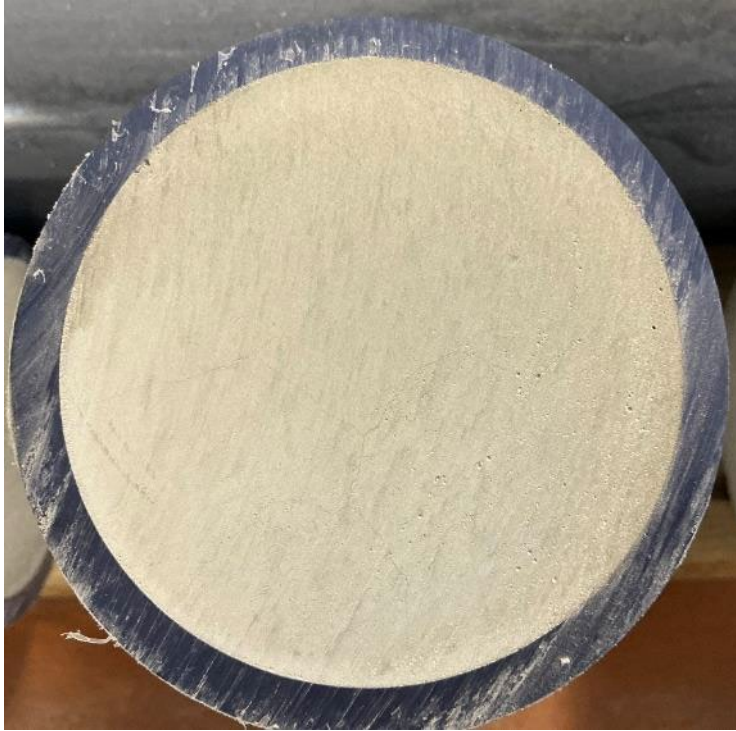
Photograph 8.—Section of 32-0.5 specimen with little to no voids visible indicating high density, low porosity.

- Change in density and porosity was apparent from the lowest sample, 32-0.5 (Photograph 7) to the highest sample, 32-30 (Photograph 8).
- Varying densities from 15 ft to 25 ft; specimens 32-15, 32-20, and 32-25, this corresponds to stopping and restarting of pumping operations at approximately 15 ft.

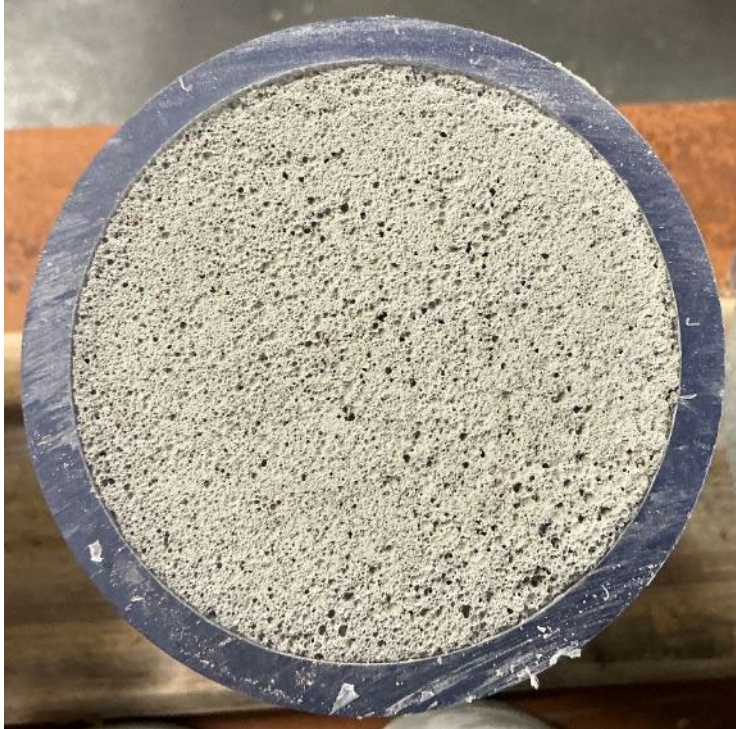
Photograph 9.—Section of 32-30 specimen with voids visible indicating low density, high porosity.

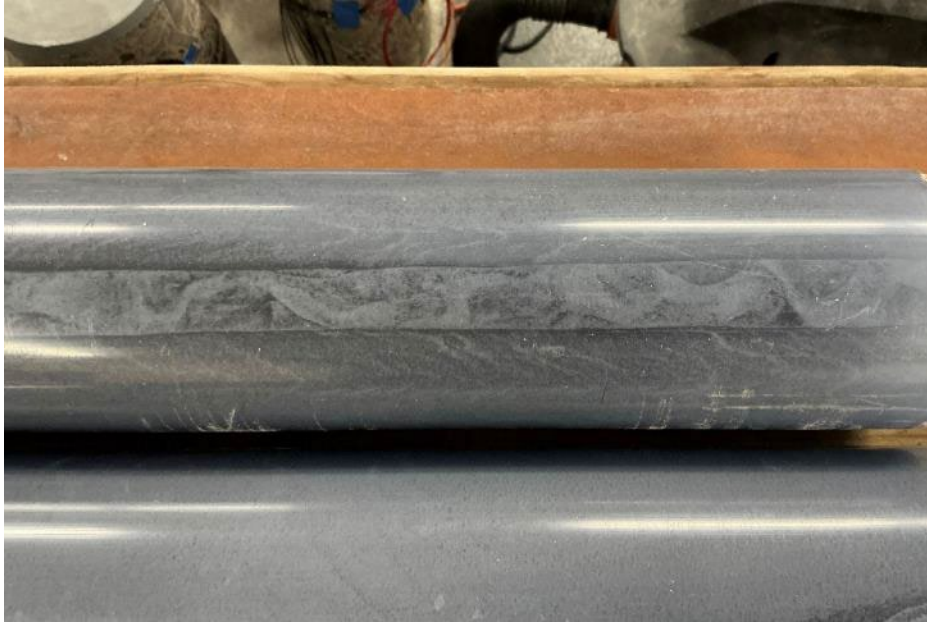
Photograph 10.—Portion of sample 32 with color variation in the vicinity of specimens 32-15 and 32-20.

- Color variation within pipe (Photograph 9) from 15ft to 20 ft indicates non-uniform flow during pumping; this corresponds to stopping and restarting of pumping operations at approximately 15 ft.

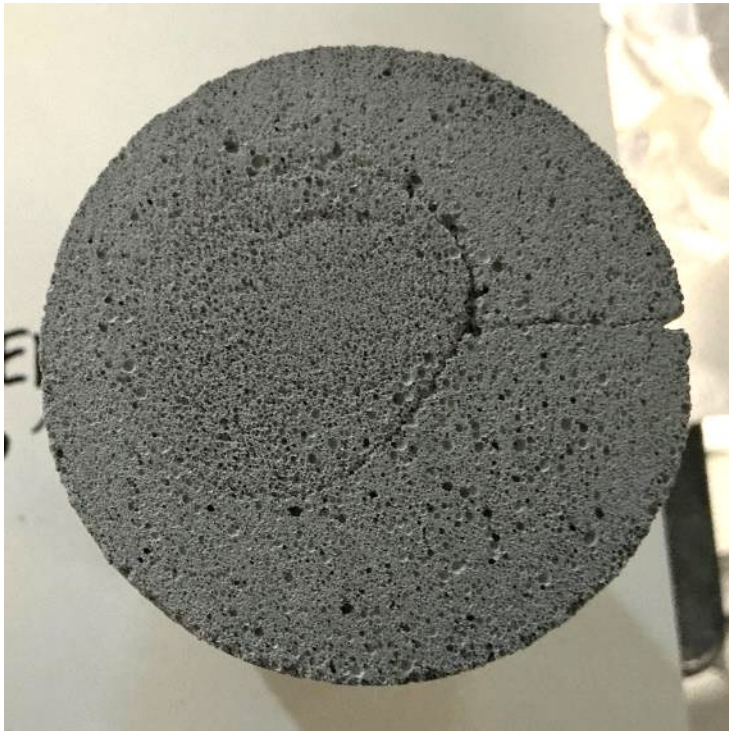
Photograph 11.—Strength specimen 32-20 indicating non-homogenous section and "lift lines".

- Compressive strength samples 32-15 and 32-20 appeared to have non-homogenous sections approximating lift lines when viewed prior to testing (Photograph 10). After testing, the failures occurred on a plane in alignment with the non-homogenous sections (Photograph 11 and Photograph 12); this corresponds to stopping and restarting of pumping operations at approximately 15 ft.

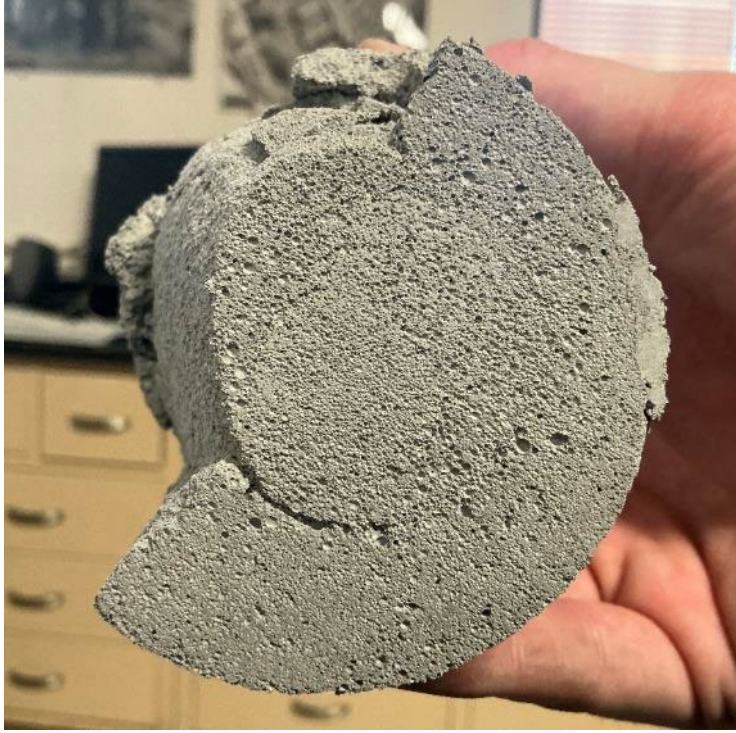
Photograph 12.—Strength specimen 32-20 after testing with failure occurring at “lift lines”.

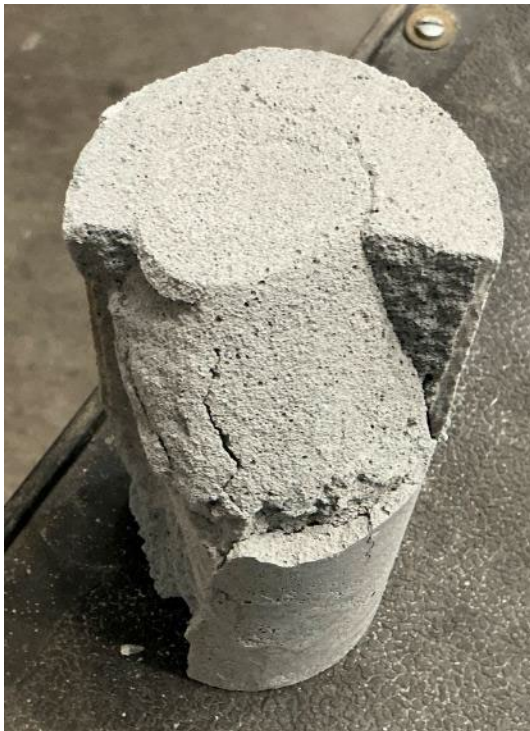
Photograph 13.—Strength specimen 32-20 after testing with failure occurring at “lift lines”.

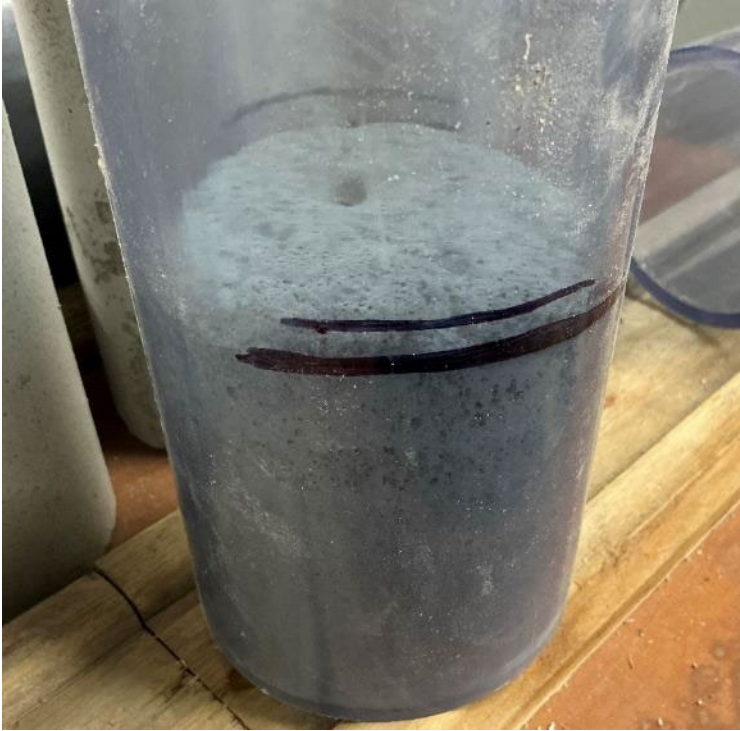
Photograph 14.—Non-collapsed upper extents of 32-foot set-up, approximate elevation 31ft.

- Upon final curing, the uppermost extents of the PLDCC did not appear to condense or collapse (Photograph 13).

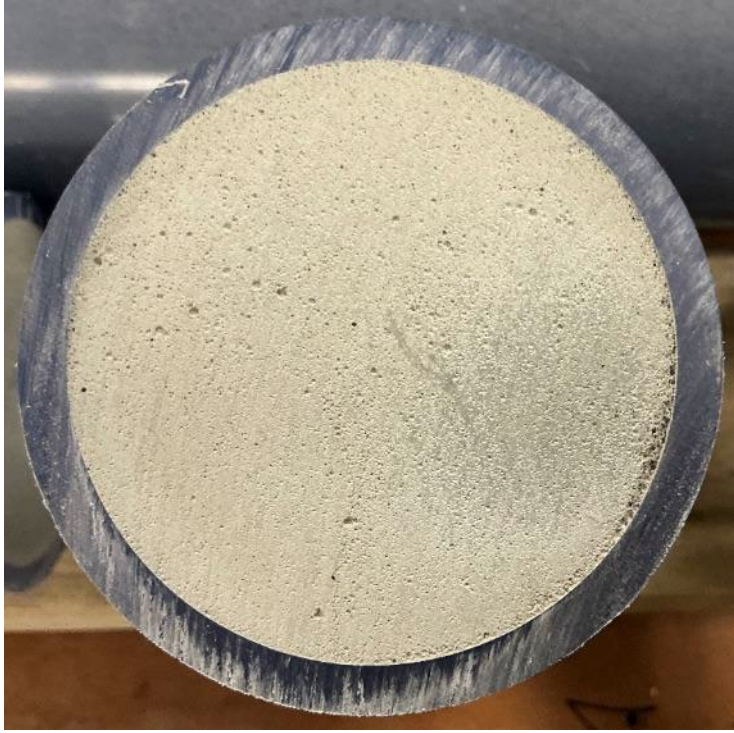
Photograph 15.—Section of 24-0.5 specimen with little to no voids visible indicating high density, low porosity.

- This sample was placed in one batch with all remaining material; placement was made to approximately 20 ft.
- Change in density was apparent from the lowest sample, 24-0.5 (Photograph 14) to the highest sample, 24-18.5 (Photograph 15).
- Upon final curing, the uppermost extents of the PLDCC did not appear to condense or collapse (Photograph 16).

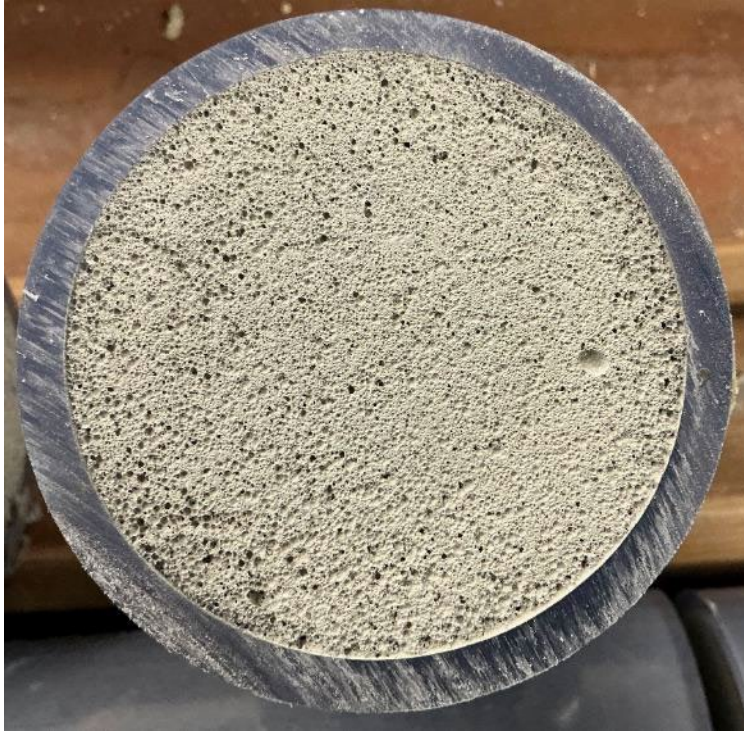
Photograph 16.—Section of 24-18.5 specimen with voids visible indicating low density, high porosity.

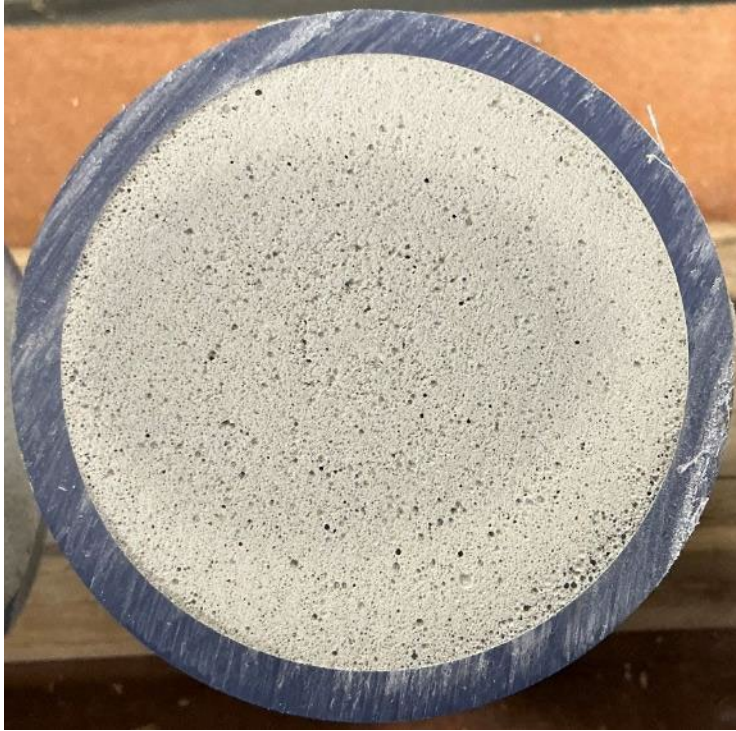
Photograph 18.—Section of 8-0.5 specimen with fewer voids indicating higher density, lower porosity.

- This sample was placed in one batch with all remaining material; placement was made to approximately 7.5 ft.
- Change in density was apparent from the lowest sample, 8-0.5 (Photograph 17) to the highest sample, 8-6.5 (Photograph 18).
- Upon final curing, the uppermost extents of the PLDCC appeared to condense or collapse approximately 2 in (Photograph 19).

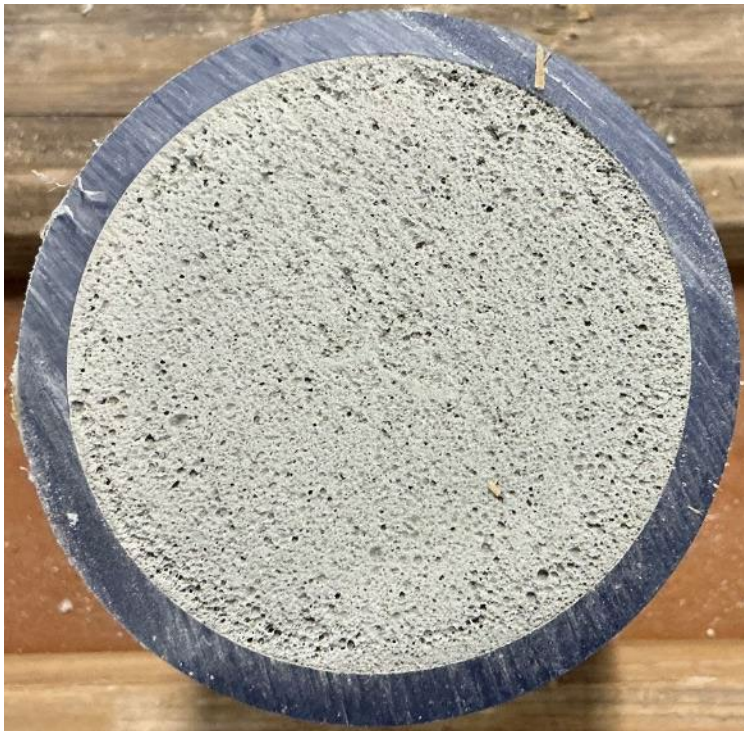
Photograph 19.—Section of 8-6.5 specimen with greater voids indicating lower density, higher porosity.

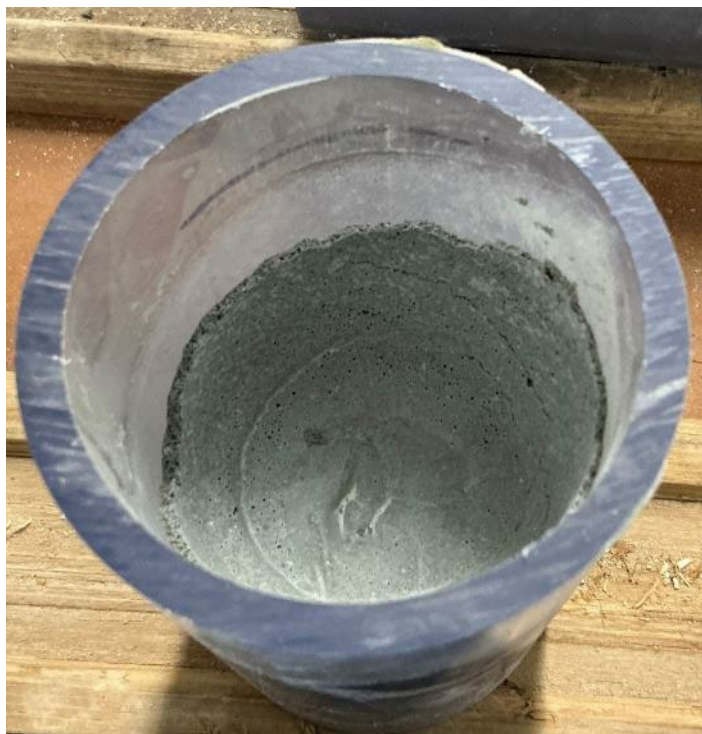
Photograph 20.—Collapsed upper extents of 8-foot set-up, approximate elevation 7ft.

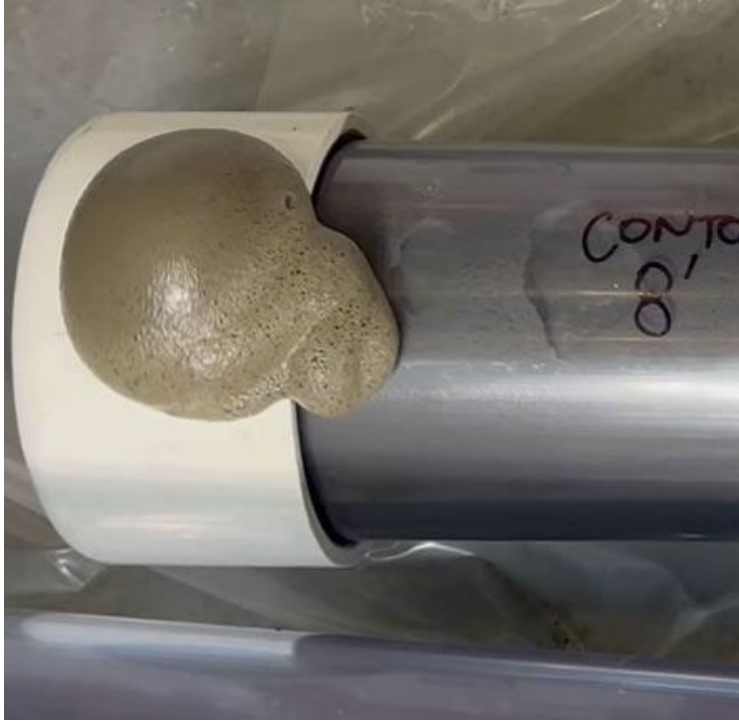
Photograph 21.—PLDCC discharging from vent hole of 8-foot horizontal-empty sample.

- This sample was placed in one batch with all remaining material; placement was made until PLDCC was discharging from the vent hole at the end of the pipe (Photograph 20).
- Upon curing, it was noted that the density varied from the top of the specimens to the bottom, i.e. vertically through the 3 in pipe cross section.
  - An air void was present at the top and the specimens were notably more dense and generally free of foam air voids at the bottom (Photograph 21).

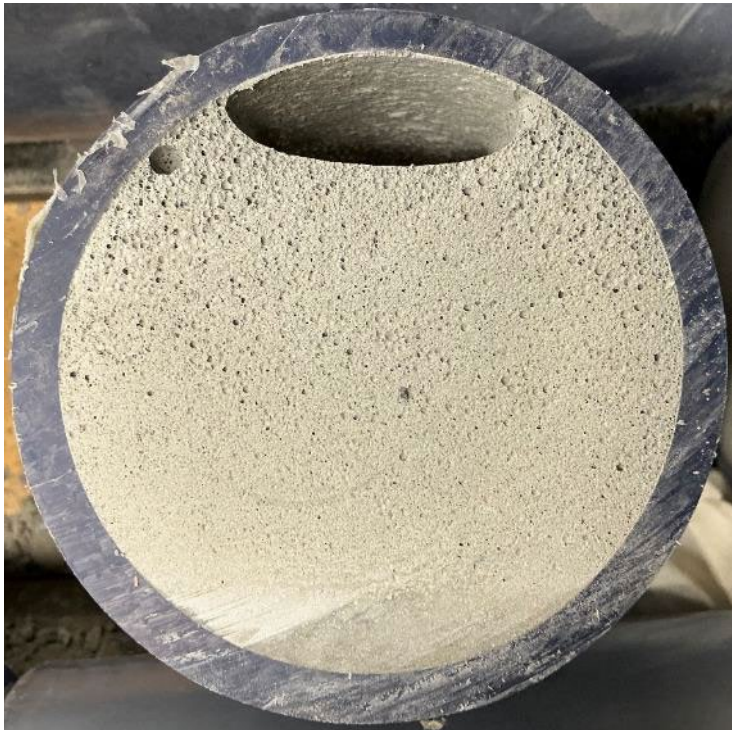
Photograph 22.—PLDCC specimen from 8-foot horizontal-empty, with air void and lower density at top, and higher density at bottom.

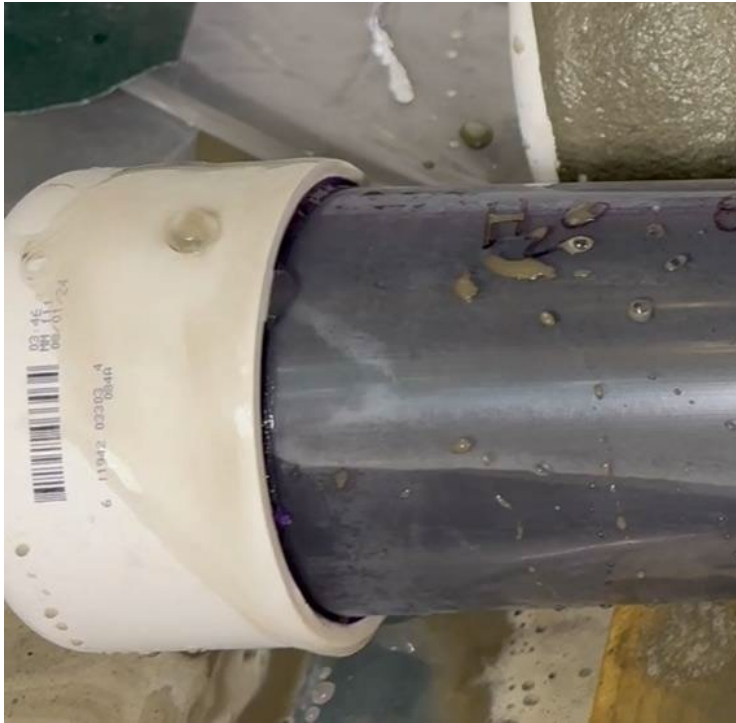
Photograph 23.—Clean water discharging from vent hole during placement of PLDCC.

- This sample was placed in one batch with all remaining material; placement was made until PLDCC was discharging from the vent hole at the end of the pipe. During placement, clean water was discharged from the vent hole (Photograph 22).

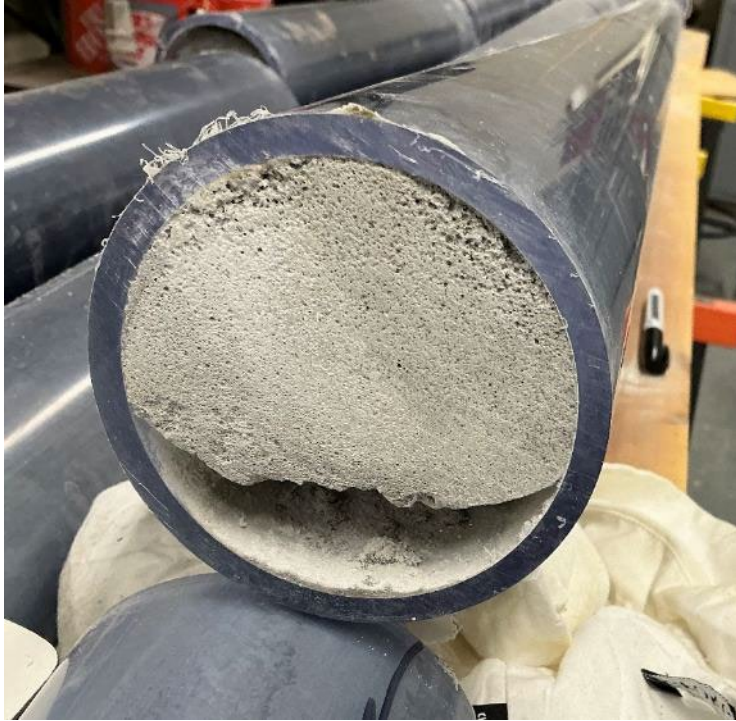
Photograph 24.—PLDCC specimen from 8-foot horizontal-water, with water-filled void at bottom pipe at vent end.

- Near the vent end, water was present in the sample and came out during specimen cutting. After draining of the water, a void was present on the bottom of the 8-6.5 specimens (Photograph 23). The specimens displayed a slightly higher density immediately above the void filled with water with decreasing density toward the top.

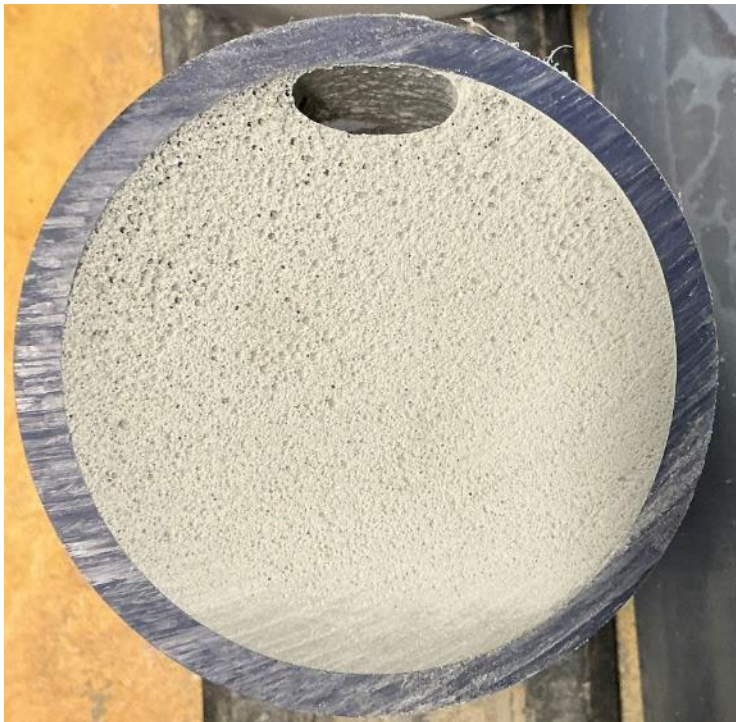
Photograph 25.—PLDCC specimen from 8-foot horizontal-water, with air void and lower density at top, and higher density at bottom.

- Near the pump end, an air void was present at the top and the specimens were notably more dense and generally free of foam air voids at the bottom (Photograph 24).

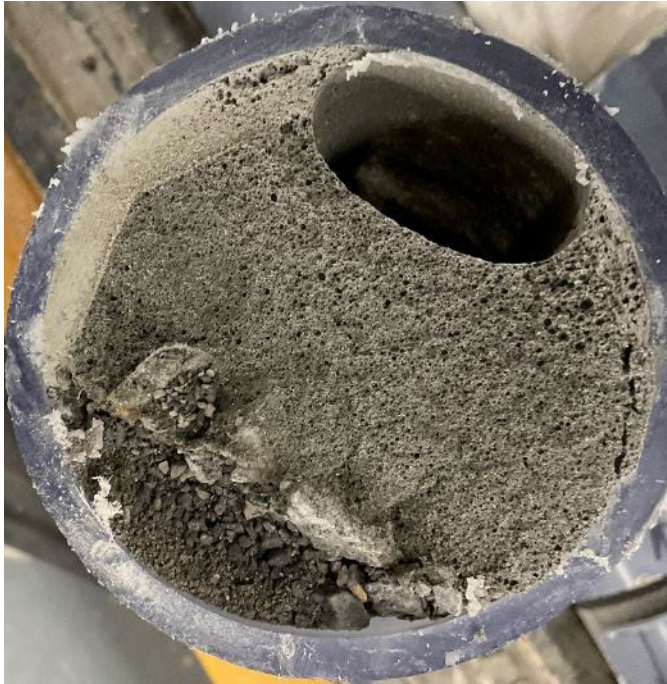
Photograph 26.—PLDCC specimen from 8-foot horizontal-debris, with air void and lower density at top, and partially encapsulated coarse and fine aggregate debris at bottom.

- This sample was placed in one batch with all remaining material; placement was made until PLDCC was discharging from the vent hole at the end of the pipe.
- Upon curing, it was noted that the encapsulated limited amounts of rock and sand debris (Photograph 25). Areas of rock and sand remained unbound (Photograph 26); unbound debris appeared most common at locations where greater quantities of debris were initially present.

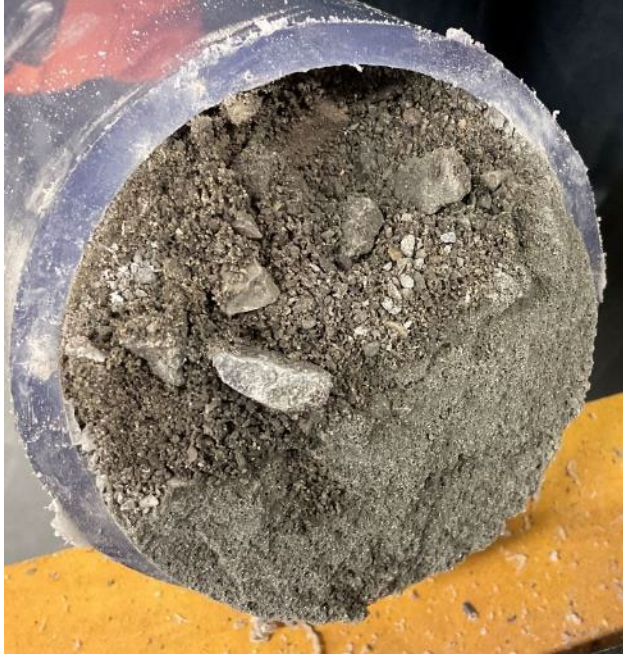
Photograph 27.—PLDCC specimen from 8-foot horizontal-debris, with unbound coarse and fine aggregate debris material.
