Tiber Reservoir – Lake Elwell 2002 Survey

U.S. Department of the Interior Bureau of Reclamation Technical Service Center Denver, Colorado

September 2005

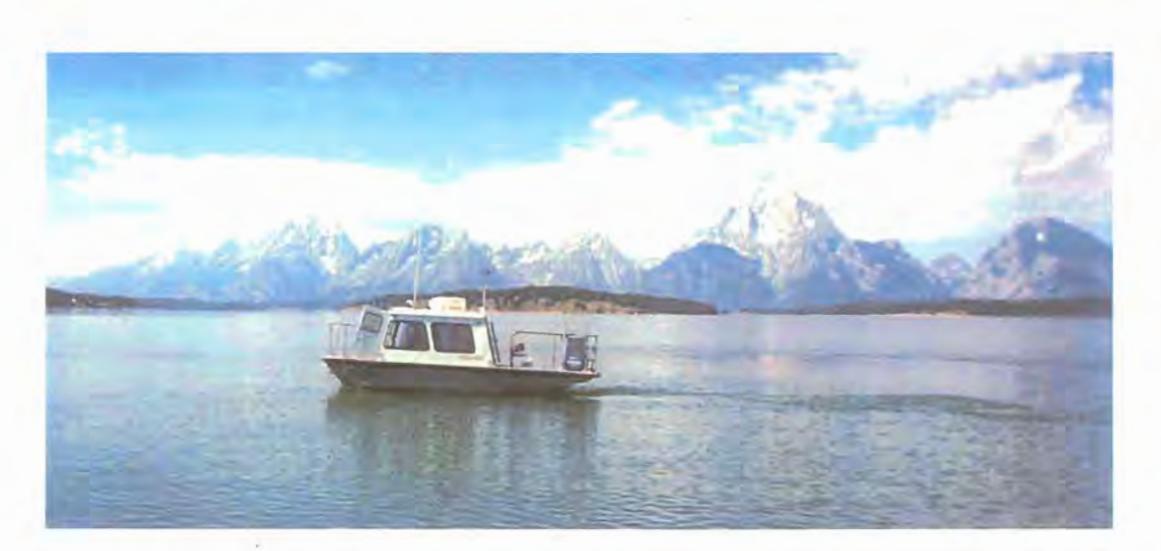
Figure 4 - Survey vessel with mounted hydrographic equipment on Jackson Lake in Wyoming

The hydrographic survey equipment was mounted in the cabin of a 24-foot trihull aluminum vessel equipped with twin in-board motors (figure 4). The hydrographic system included a GPS receiver with a built-in radio, a depth sounder, a helmsman display for navigation, a computer, and hydrographic system software for collecting the underwater data. An on-board generator supplied power to all the equipment. The shore equipment included a second GPS receiver with an external radio. The GPS receiver and antenna were mounted on a survey tripod over a known datum point and a 12-volt battery provided the power for the shore unit.

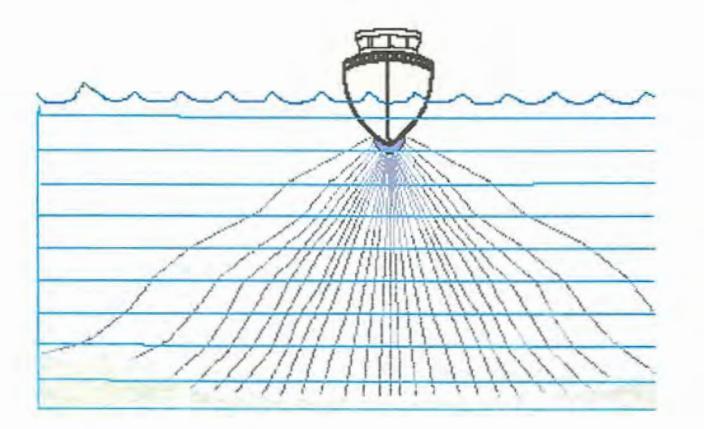
Figure 5 – Multibeam collection system

In 2001, the Sedimentation and River Hydraulics Group began utilizing an integrated multibeam hydrographic survey system. The system consists of a single transducer mounted on the center bow or forward portion of the boat. From the single transducer a fan array of narrow beams generate a detailed cross section of bottom geometry as the survey vessel passes over the areas to be mapped. The system transmits 80 separate 1-1/2 degree slant beams resulting in a 120-degree swath from the transducer. The 200 kHz high-resolution multibeam echosounder system measured the relative water depth across the wide swath perpendicular to the vessel's track. Figure 5 illuminates the swath of the sea floor that is about 3.5 times as wide as the water depth below the transducer.

The multibeam system is composed of several instruments that are all in constant communication with a central on-board notebook computer. The components include the RTK GPS for

positioning; a motion reference unit to measure the heave, pitch, and roll of the survey vessel; a gyro to measure the yaw or vessel attitude; and a velocity meter to measure the speed of sound of the reservoir water column. With the proper calibration, the data processing software utilizes all the incoming information to provide an accurate detailed x, y, z data set of the lake bottom.

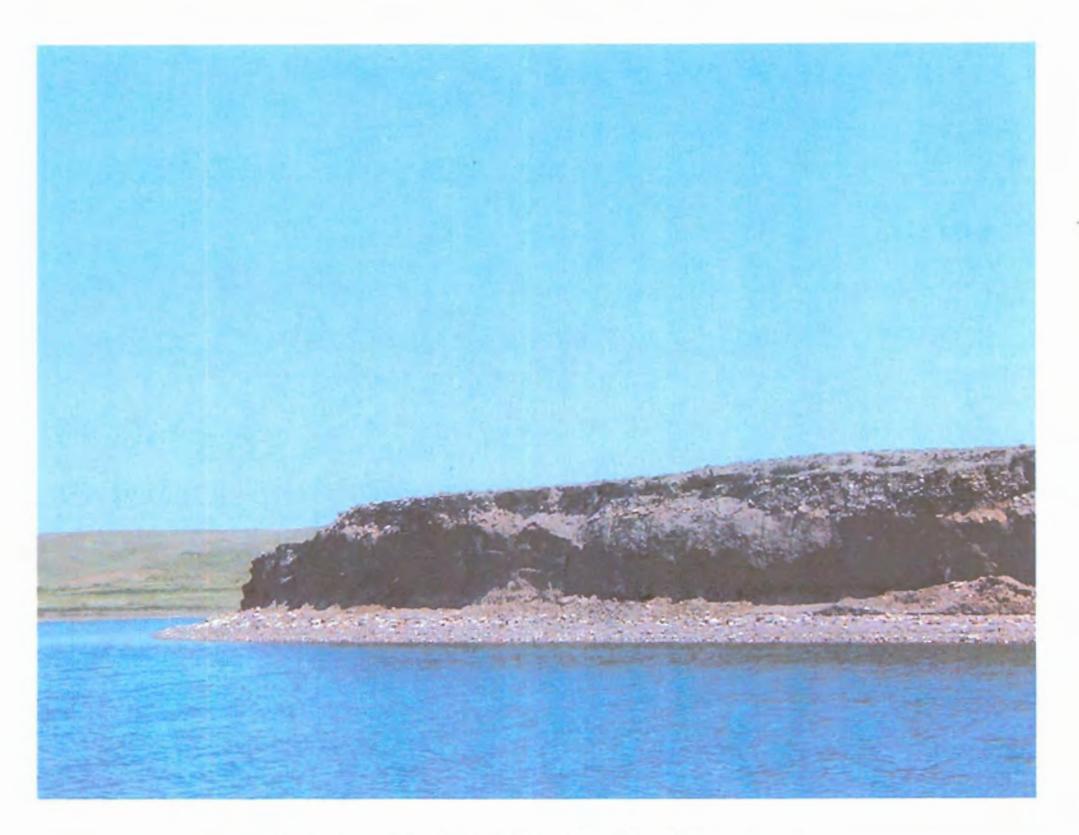
Figure 6 - Eroded Material Forming a Shelf.

The 2002 underwater survey revealed extensive shoreline erosion throughout the reservoir area. During collection, the GPS boat positions were found to be at times outside the digitized USGS quad contour locations indicating the boat was on solid ground. These USGS quad contours were developed from aerial photography flown in the 1960's and at times, the position of the boat was tens of feet outside their boundary. In addition, during the 2002 survey a major windstorm occurred and the crew witnessed vertical sections of the shoreline collapsing into the reservoir for days after. Even with the extensive shore erosion that has occurred since dam closure, the survey vessel was able to hug the vertical banks in deep water conditions where previous shore material had collapsed into the reservoir. It appears that over time the collapsed material is washed further into the reservoir by the wave action, similar to ocean waves smoothing the beaches. This is possible because the material dissipates in the water and consists of little to no rock or large cobble. Following are views showing the shoreline erosion and its affect on the reservoir, figure 6 through 9, from photographs taken by Sharon Nuanes in 2002.

The above photographs show several different stages of the shoreline erosion along the Tiber Reservoir banks. If the erosion occurred only below the reservoir high water mark, the total volume of the reservoir would not be greatly affected. In this case, however, the gain in surface area and resulting volume in the upper reservoir elevation zone is offset by the loss of surface area and volume in the lower elevations of the reservoir. The eroded upper elevation shoreline deposits in the lower elevations of the reservoir. The photographs show the large amount of shore erosion above the maximum reservoir elevation, meaning that a portion of the loss of the original total reservoir volume is due to the above reservoir shoreline erosion along with the incoming river sediments. The only means to accurately measure the extent of the shoreline erosion would be by an above water aerial survey.

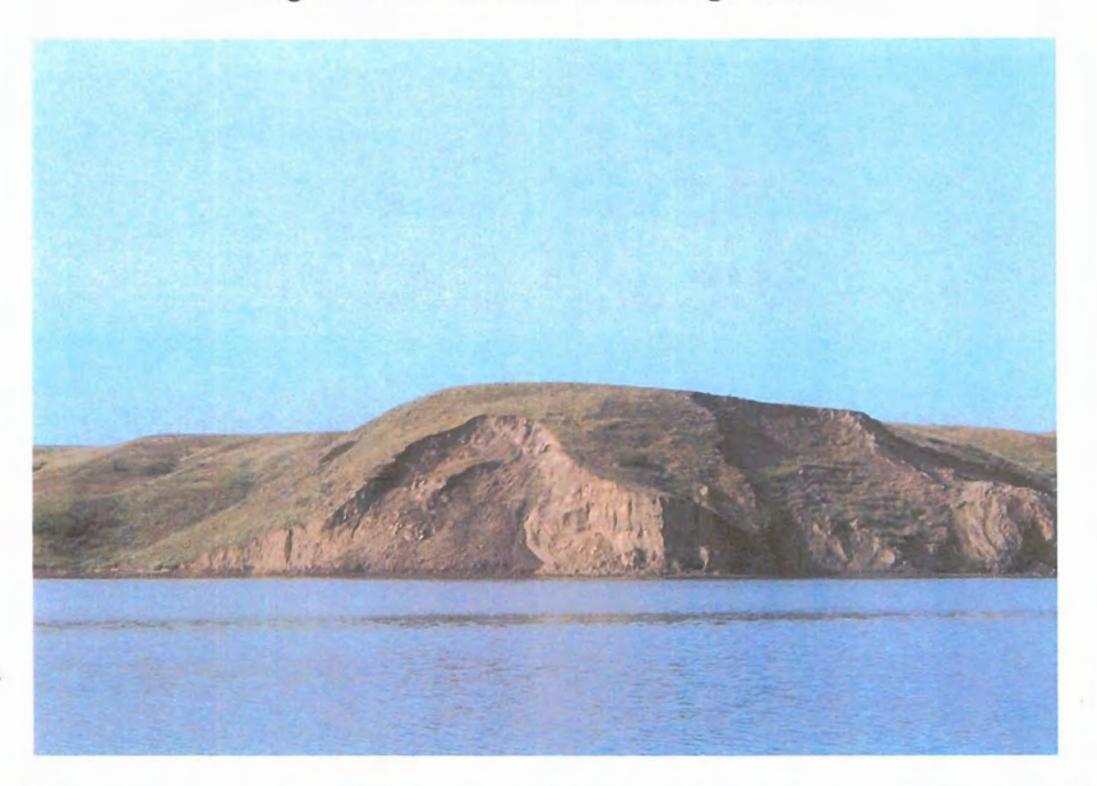
Figure 7 – Large Areas of Erosion Occurring Above the Reservoir Maximum Water Surface.

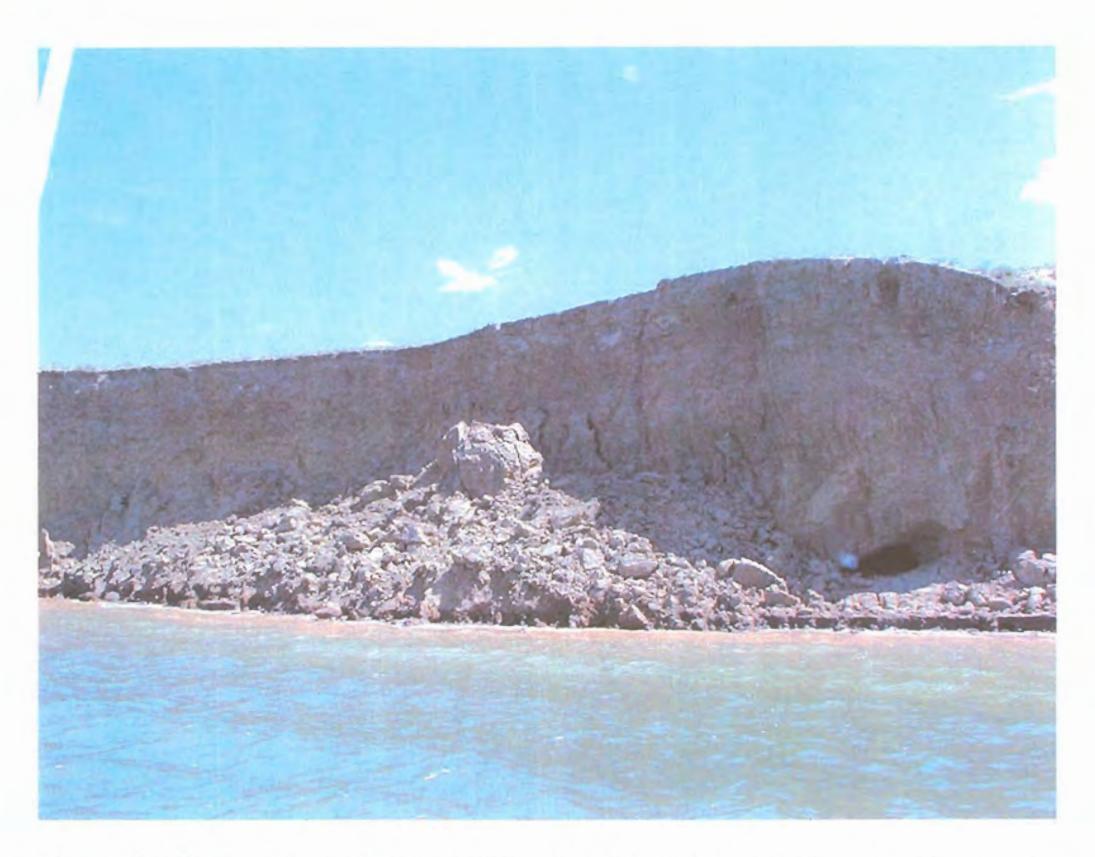
Figure 8 - Recent Eroded Material That Has Not Moved Further Into Reservoir.

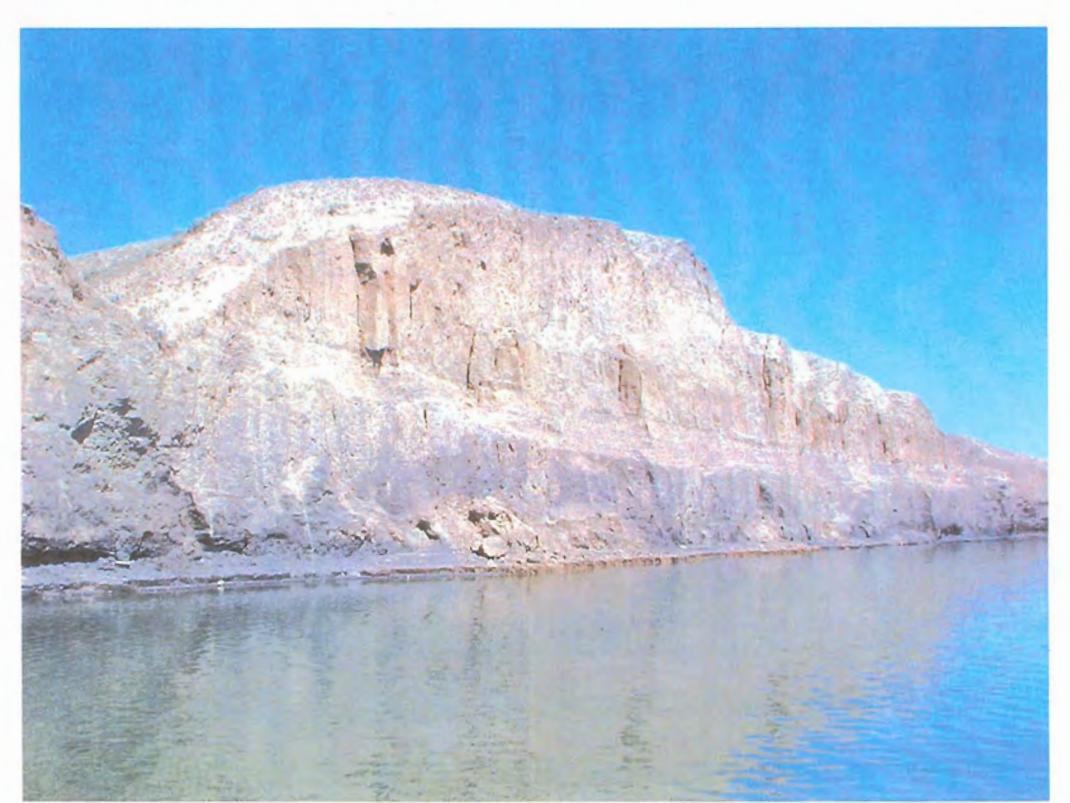
Figure 9 – Eroded Bank Where the Eroded Material Has Deposited Below the Water Line.
