Science and Technology Final Report No. ST-2024-22039  
Dam Safety Final Report No. DSO-2024-03

# Boundary Layer Effects on Hydraulic Jacking in Spillway Chutes

Research and Development Office

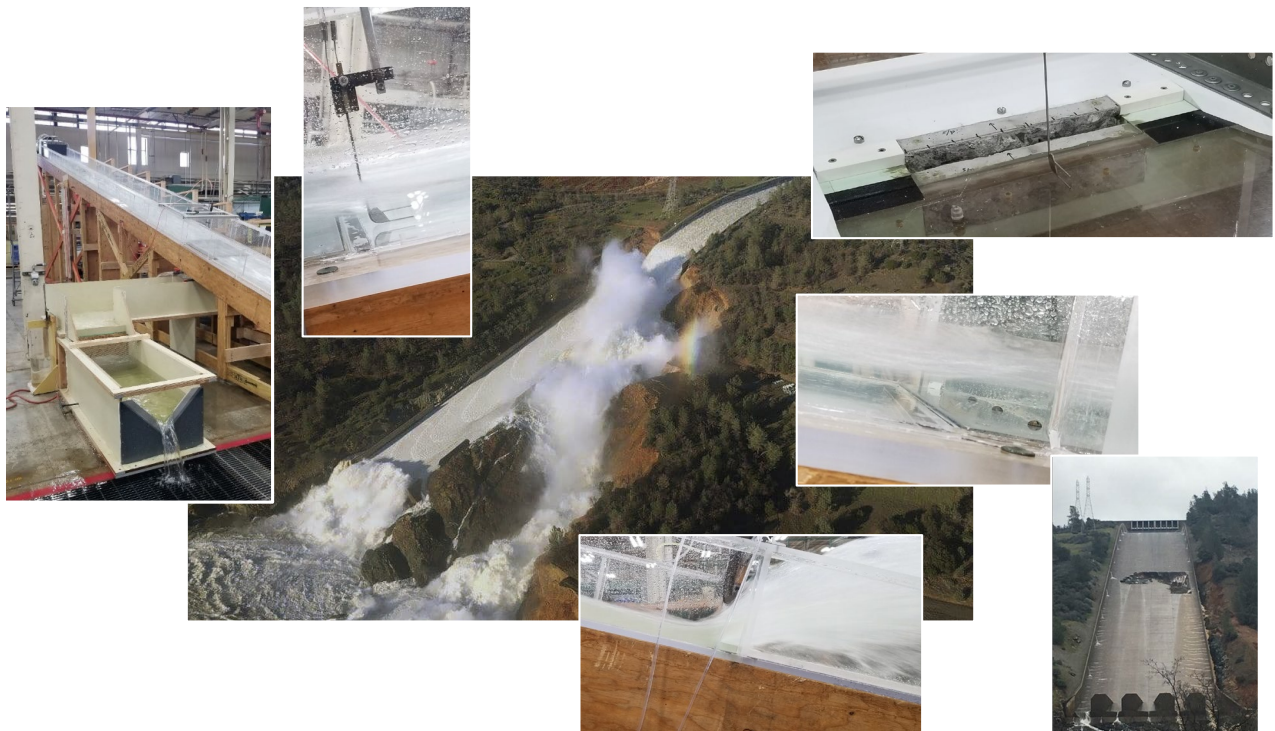
**Cover Image** – The center and bottom-right photos show the Oroville Dam spillway failure in 2017 (California Department of Water Resources). All other photos depict laboratory testing conducted in Reclamation's Hydraulics Laboratory (Tony Wahl / Bureau of Reclamation).

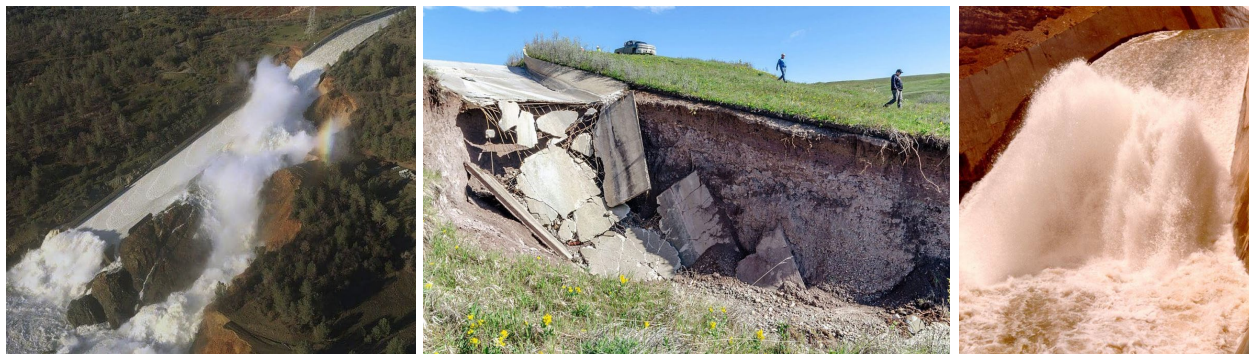
Figure 1. — Hydraulic jacking failures from left to right at Oroville Dam, California (2017), St. Mary Canal Drop #5, Montana (2020), and Big Sandy Dam, Wyoming (1983).

Hydraulic jacking failures have always been a concern for spillways and other high-speed waterways. Concrete chutes develop cracks and must necessarily be constructed with various joints, all of which are prone to displacement over time that can create offsets into the flow. Some specific causes for offsets are expansive or contractive soils, consolidation or frost heave, and damage to concrete surfaces (e.g., spalls) adjacent to a joint. Hydraulic jacking can occur when the flow strikes such an offset and is brought suddenly to rest, similar to a pedestrian tripping on a sidewalk crack. The localized stoppage of flow at the offset creates dangerously high pressures that can be injected into the foundation if cracks or joints are open to allow water penetration. Open joints may exist in older spillways that were not constructed with waterstops, or in newer spillways due to misinstallation or failure of waterstops. When high pressure water penetrates through cracks or open joints and pressurizes large areas of the foundation, the result can be an explosive jacking failure since any lifting of the slab amplifies the flow stagnation effect. Flow into the foundation can also lead to erosion beneath the slab that destabilizes the structure and allows high pressures to be applied to larger expanses of the slab.

Modern spillways incorporate multiple layers of protection against hydraulic jacking. Keyed and heavily reinforced joints are meant to prevent the development of offsets, while waterstops within joints are meant to prevent water intrusion (both pressure and flow). Older structures that might lack some of these modern features still have multiple layers of protection, including the weight (thickness) of the slab itself, anchors to hold the slab down, and subsurface drains meant to reduce the buildup of pressure. When offsets are known to exist in a spillway, corrective measures may include grinding and beveling to reduce or eliminate them. Unfortunately, the design of anchors, drains, and related features requires knowledge of the pressure forces created by flow stagnation, the quantity of water that can be injected into an opening, and the modification of uplift and flow that comes from remedial measures. The catastrophic failure of the spillway at Oroville Dam (California) in 2017 showed that the capacity of anchors and drains can be exceeded.
