Investigating the Need for Corrosion Protection of Steel Reinforcements in Concrete at Reclamation

Science and Technology Program
Research and Development Office
Final Report No. ST-2024-24002-01
Technical Memorandum No. 8540-2024-45

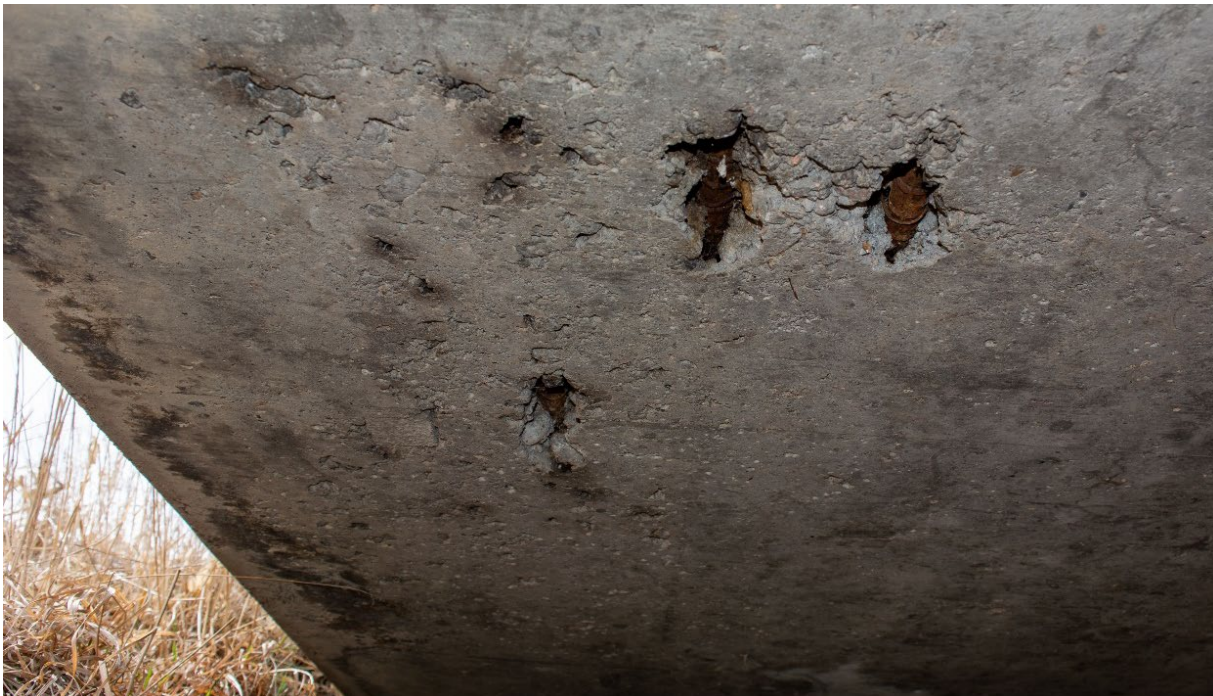
Cover photograph: Exposed reinforcing steel on the underside of a concrete bridge structure (Photo credit: Reclamation).

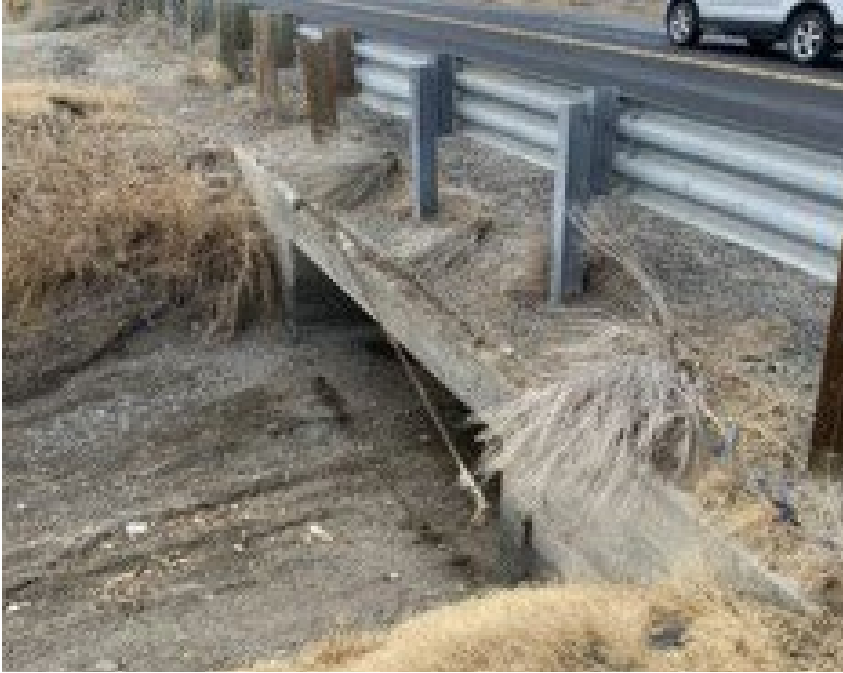
Figure A-1.—Exposed rebar along a bridge crossing over a canal. The bridge is a roadway that has deicing salts applied in the winter. It has not required previous repairs and it is unknown whether concrete corrosion caused the initial concrete deterioration.

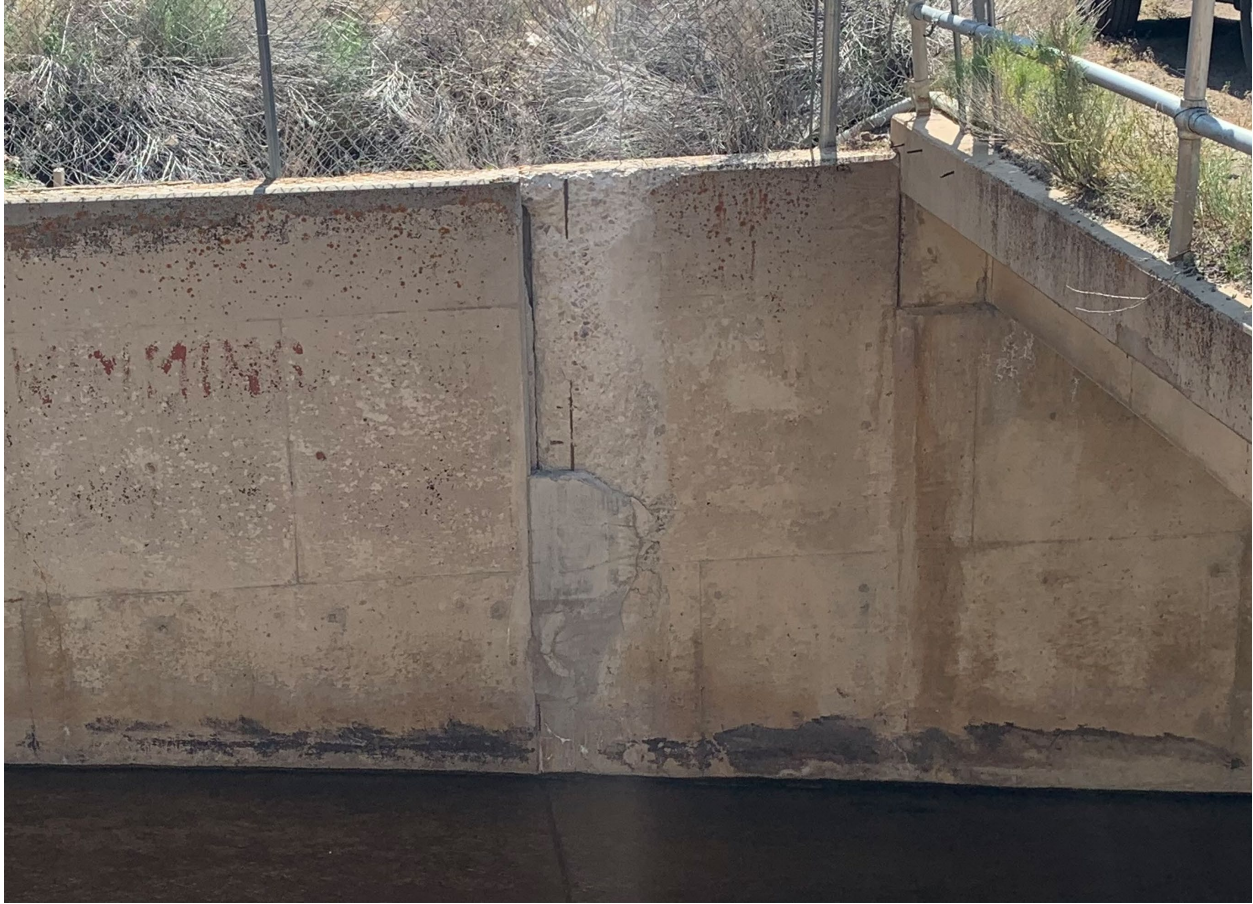
Figure A-2.—Deteriorated concrete with exposed reinforcing steel that has required multiple repairs at the same location. The suspected cause is ASR and subsequent freeze-thaw. Notes on other structures from the same region: roadways that are treated with deicing salts in the winter have not experienced major spalling or delamination, just minor cracking and a few popouts.

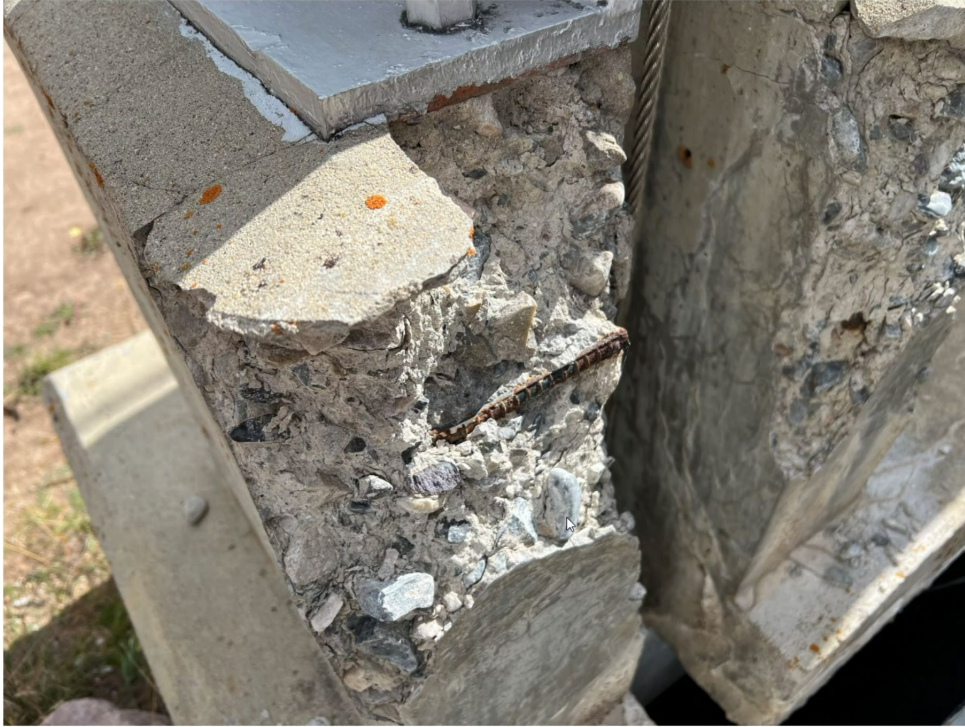
Figure A-3.—Spalling pedestal with exposed reinforcing steel. The initial cause of the concrete deterioration is unknown.

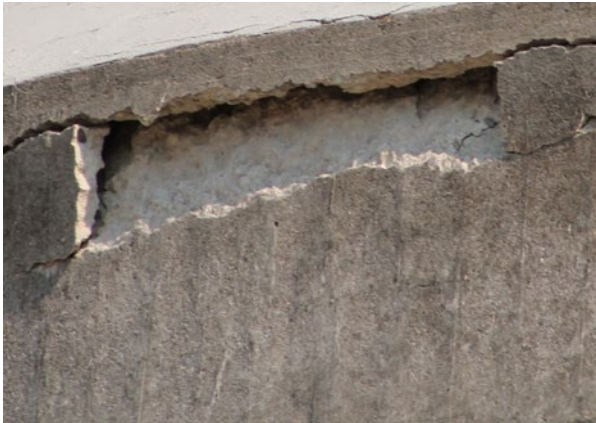
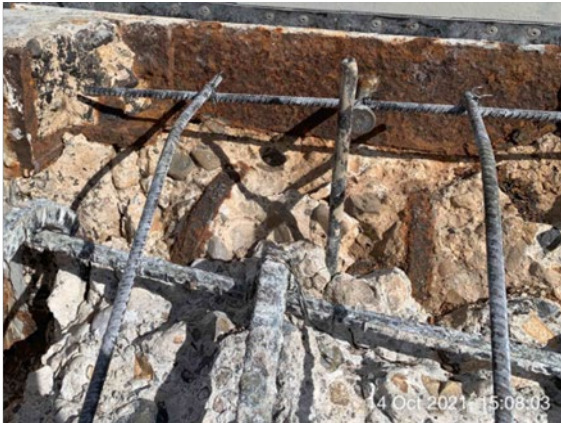
Figure A-4.—This structure has documented issues with ASR. Left: deteriorated concrete due to ASR. Right: Old concrete removed from around reinforcing steel prior to repair.

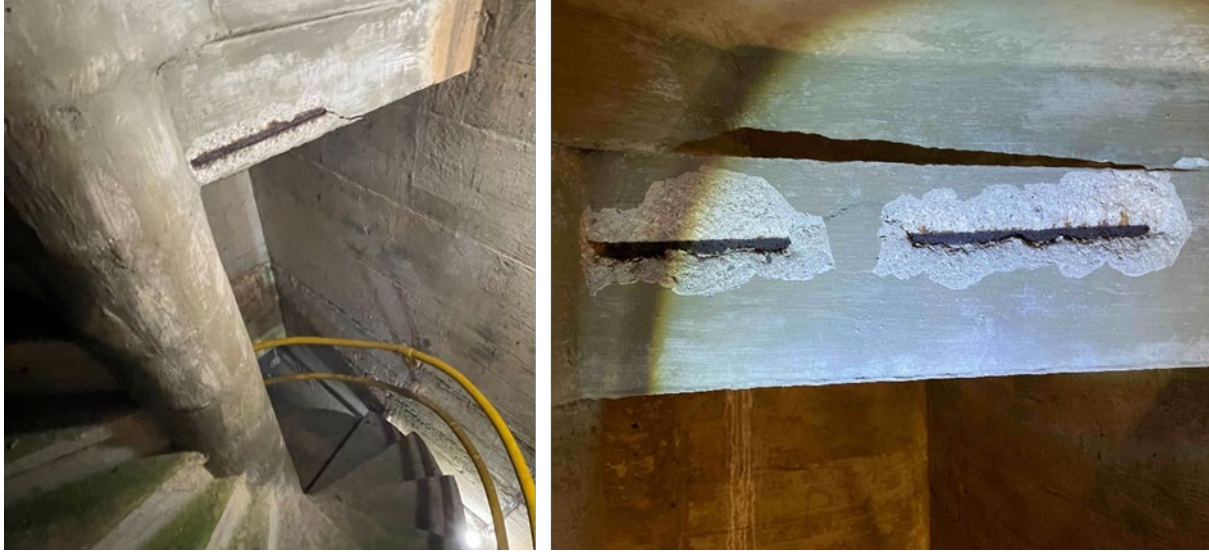
Figure A-5.—Spalling and exposed rebar on underside of stair treads on the spiral staircase between the upper and middle galleries. Rebar corrosion and concrete damage likely due to inadequate cover.

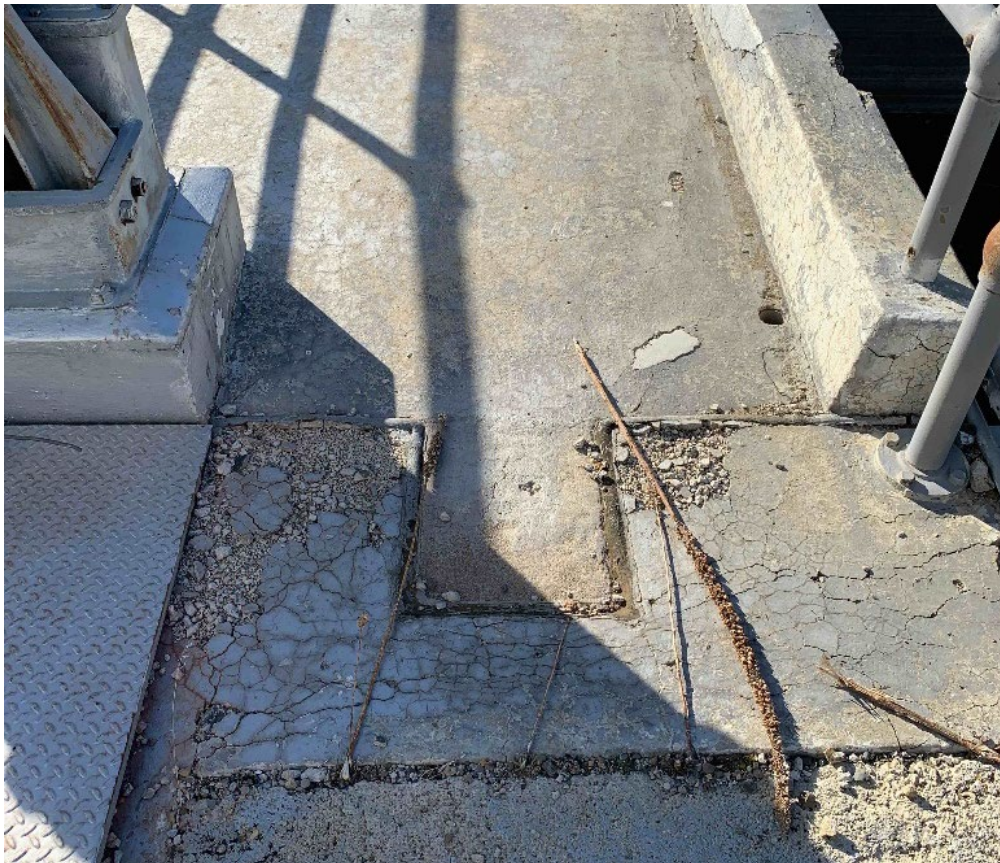
Figure A-6.—Deteriorated concrete on a walkway.

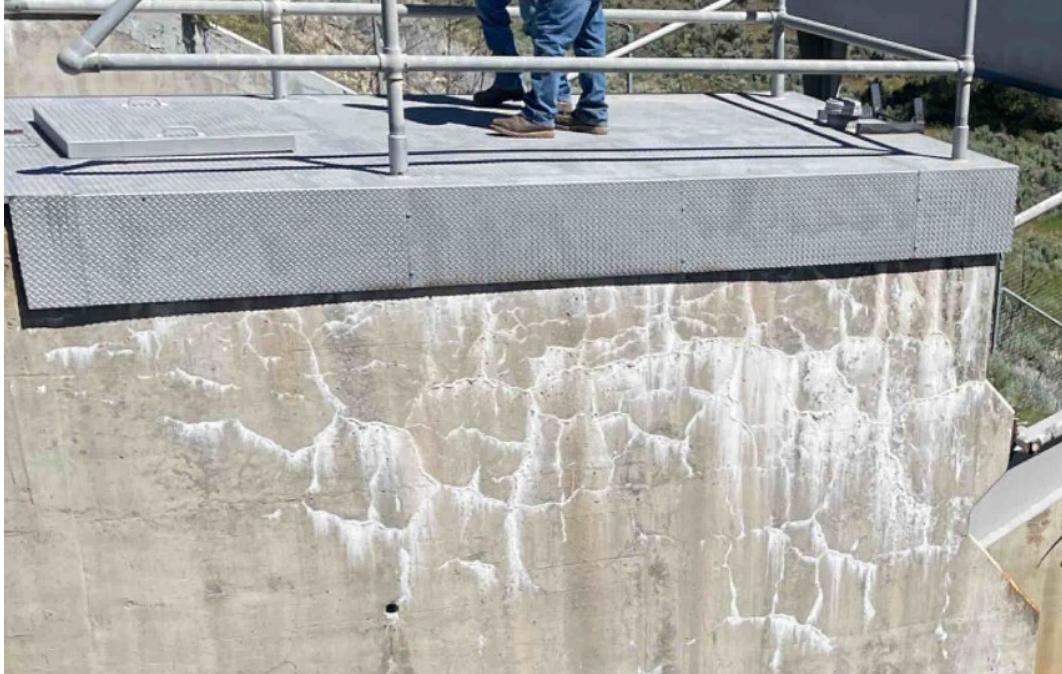
Figure A-7.—Concrete damage, possibly due to ASR. Generally, no corrosion staining is visible, except some possible corrosion staining at the wall on the lower right corner of the image.

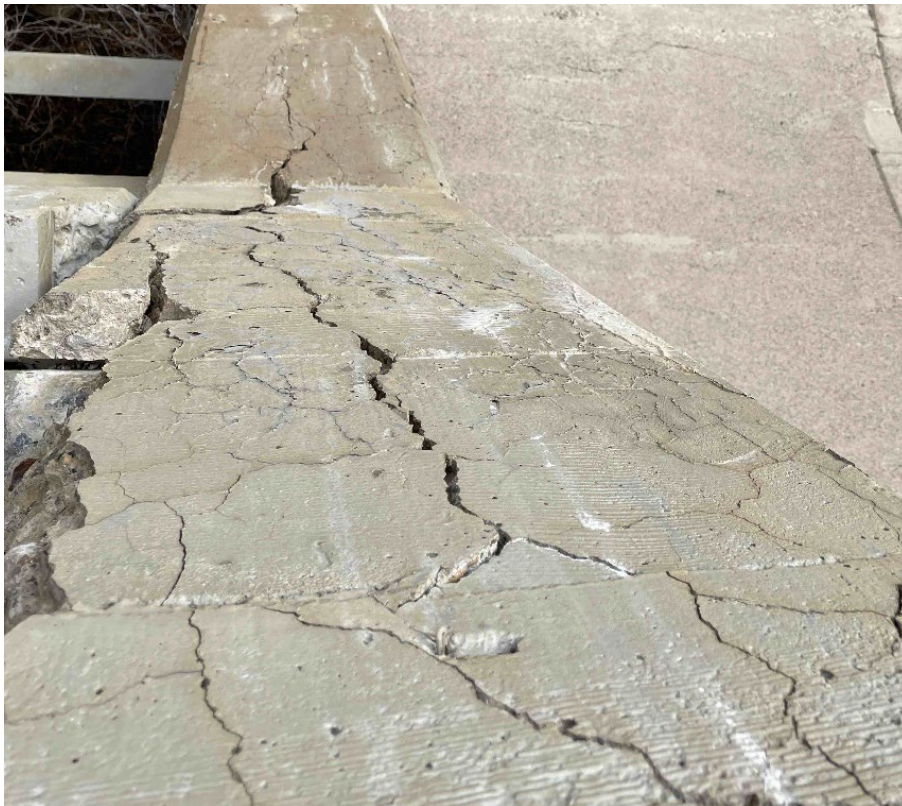
Figure A-8.—Cracking along a parapet wall due to freezing and thawing.

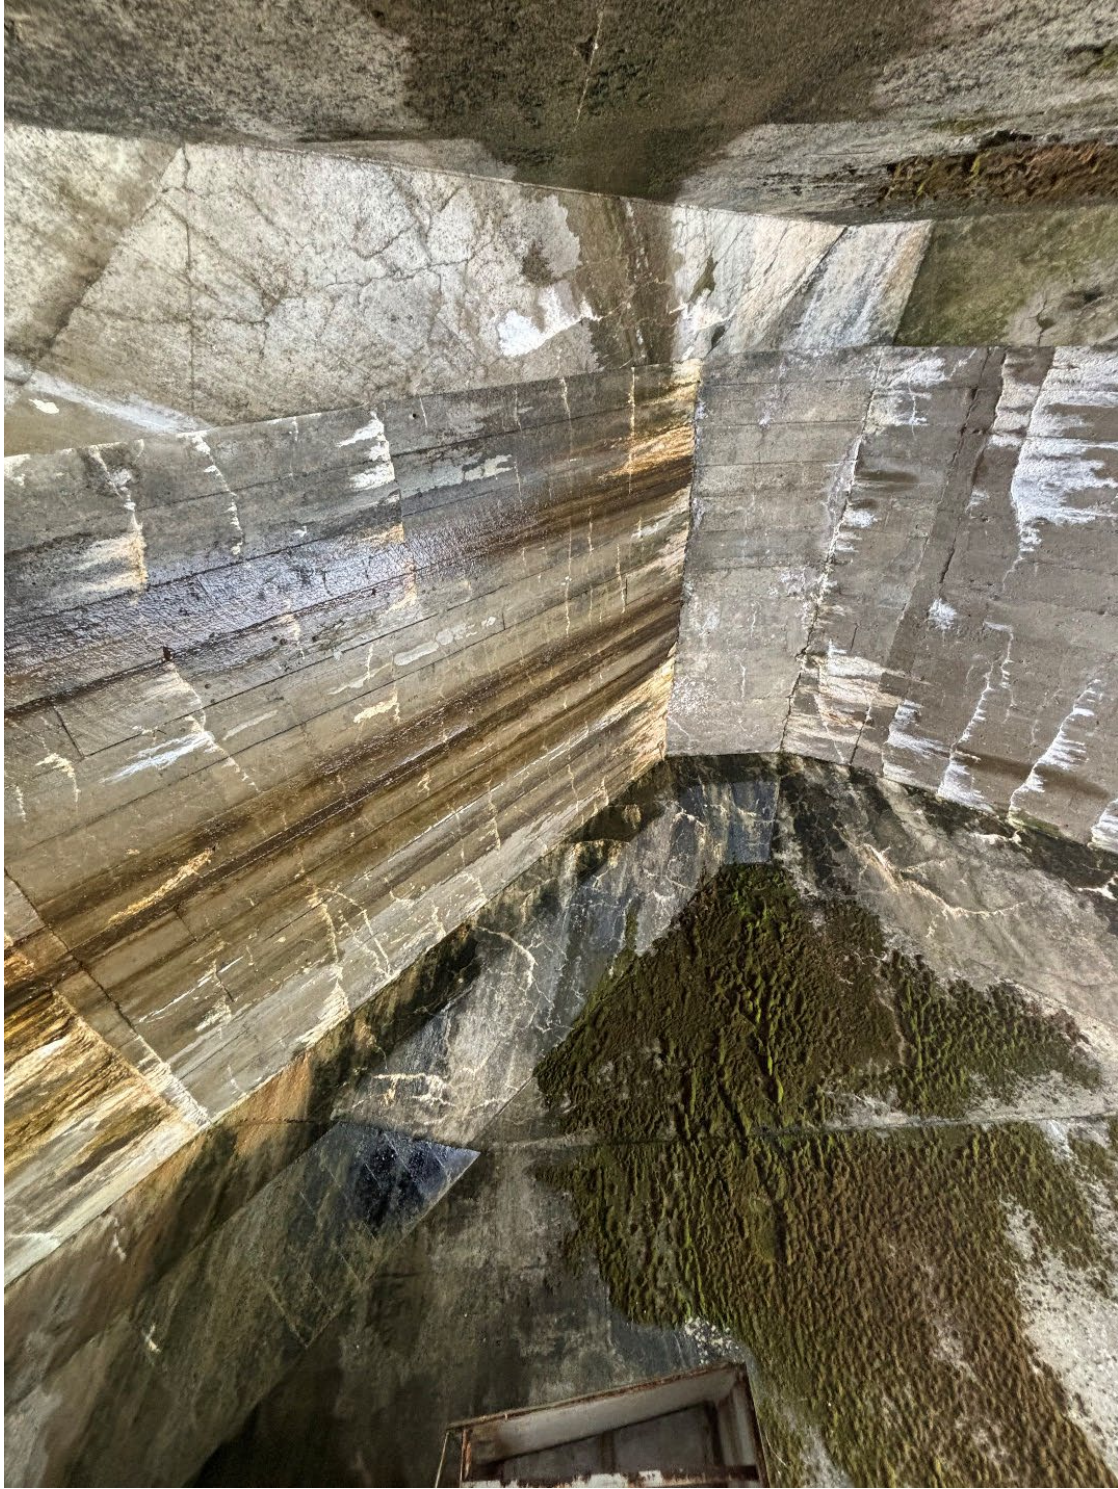
Figure A-9.— Concrete slabs exhibiting widespread horizontal cracking with relatively narrow widths. The source of the cracking is likely due to freezing and thawing.

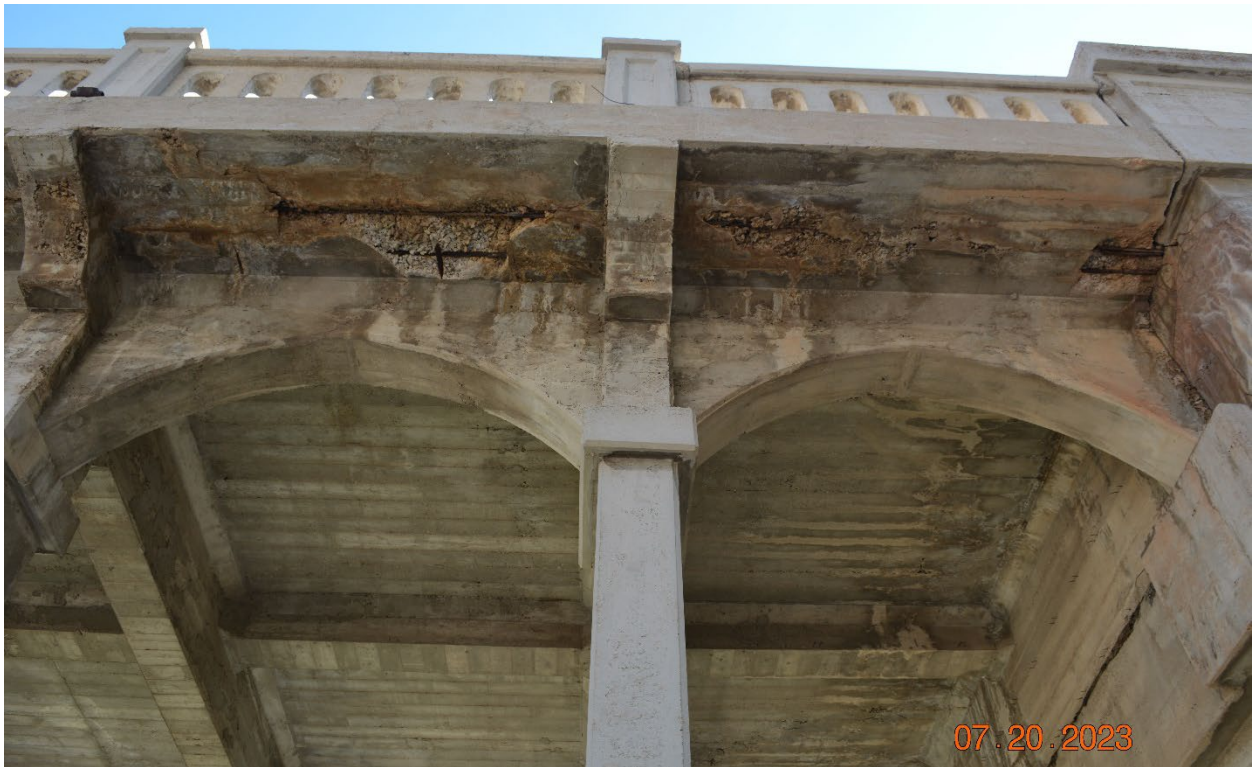
Figure B-1.—Type 1 bridge. Location noted as having deterioration, cracking, efflorescence, rust staining, spall, and exposed rebar with corrosion.

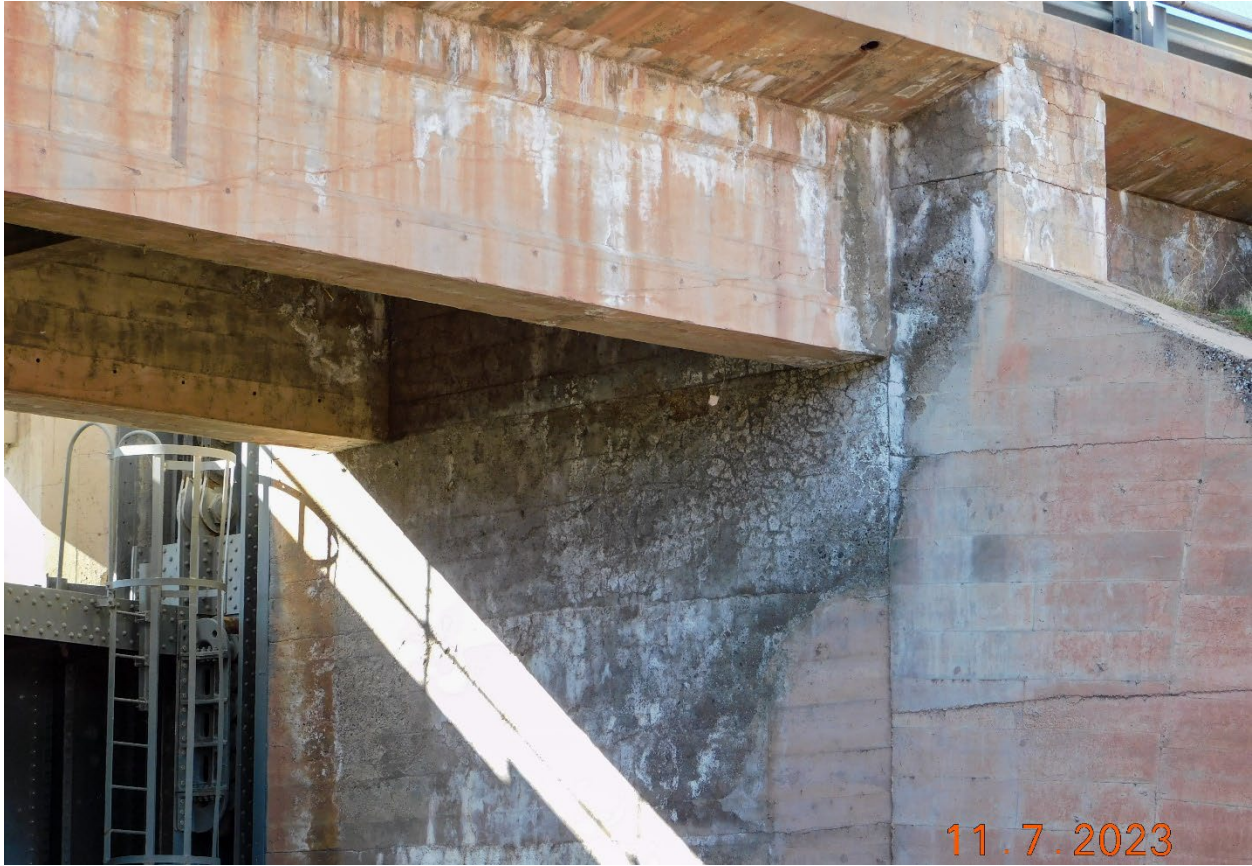
Figure B-2.—Type 1 bridge. Location noted as having deterioration, cracking, efflorescence, spall, and water staining. Corrosion was not noted as an issue.

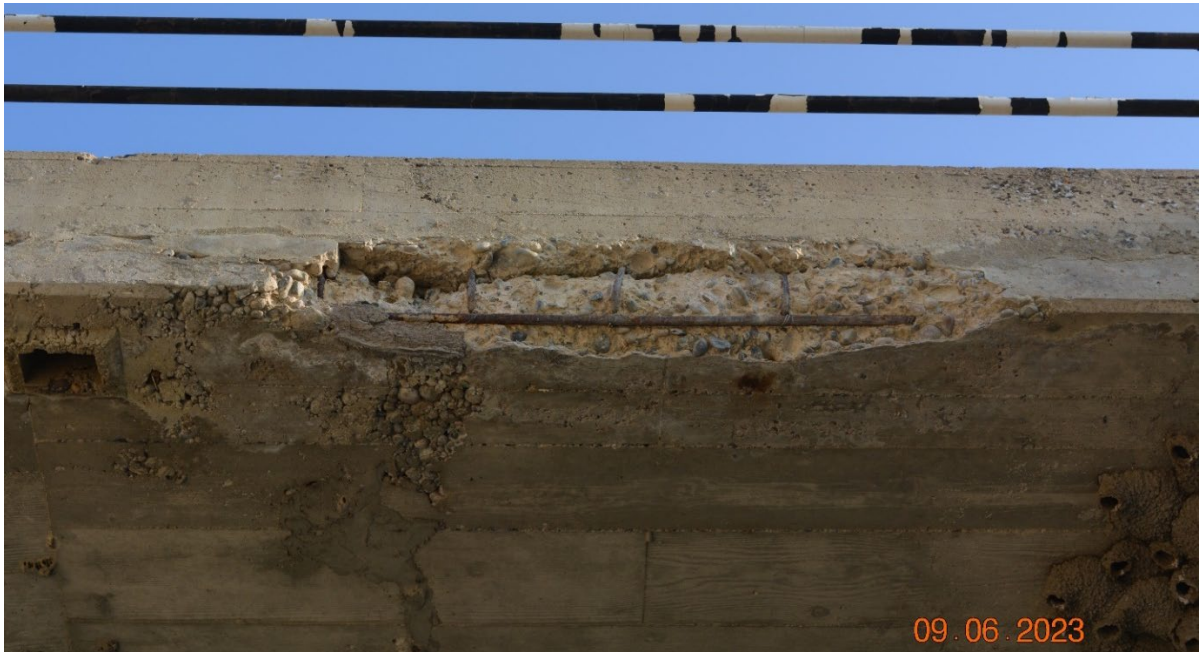
Figure B-3.—Type 1 bridge. Location noted as having cracking, spalling, and one instance of exposed rebar. Corrosion is not explicitly mentioned in inspection reports.

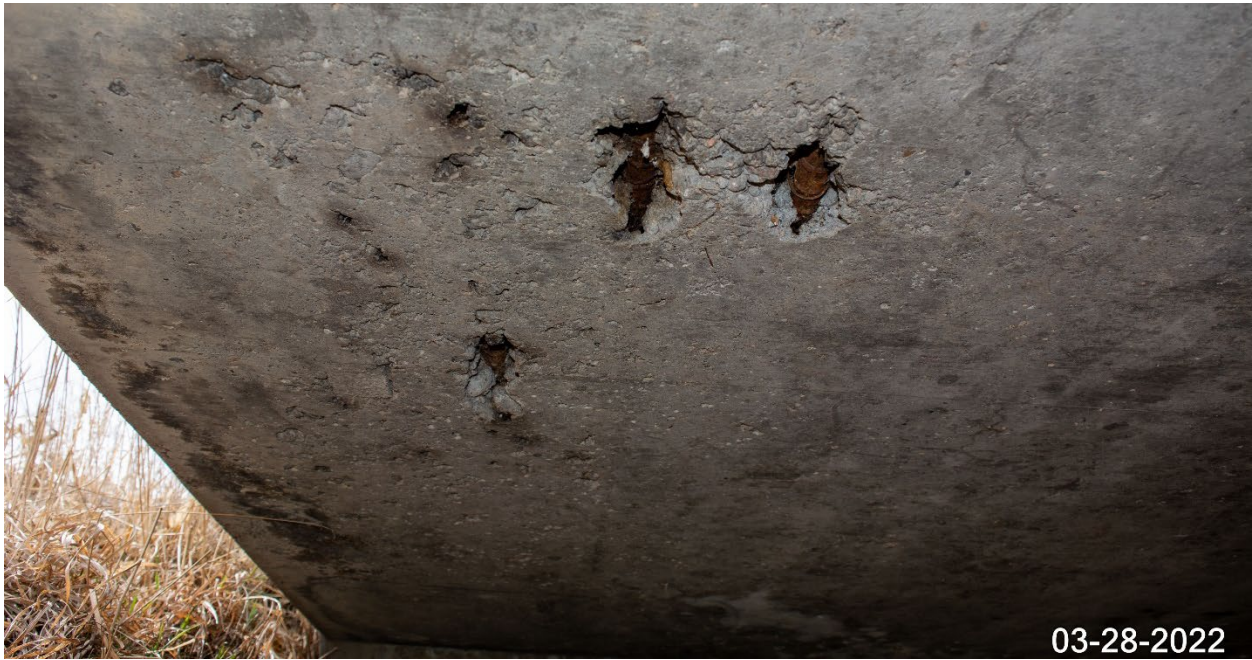
Figure B-4.—Type 1 bridge. Location noted as having exposed rebar. Corrosion is not explicitly mentioned in the inspection reports, but the rebar corrosion and concrete damage may be due to inadequate cover.
