Technical Report No. SRH-2011-15

Heron Reservoir 2010 Bathymetric Survey

**Heron Dam
Chama, New Mexico**

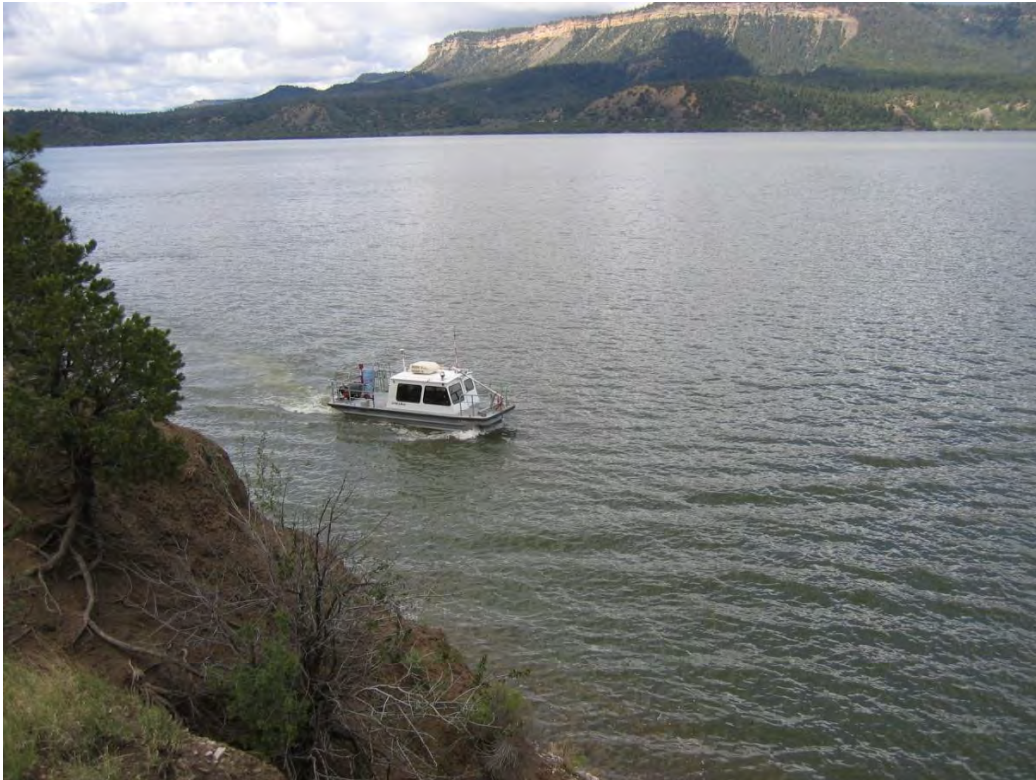
Figure 2 - Survey vessel with mounted instrumentation on El Vado Reservoir, New Mexico.

The bathymetric survey equipment was mounted in the cabin of a 24-foot trihull aluminum vessel equipped with twin in-board motors (Figure 2). The hydrographic system included a GPS receiver with a built-in radio, single and multibeam depth sounders, helmsman display for navigation, computer, and

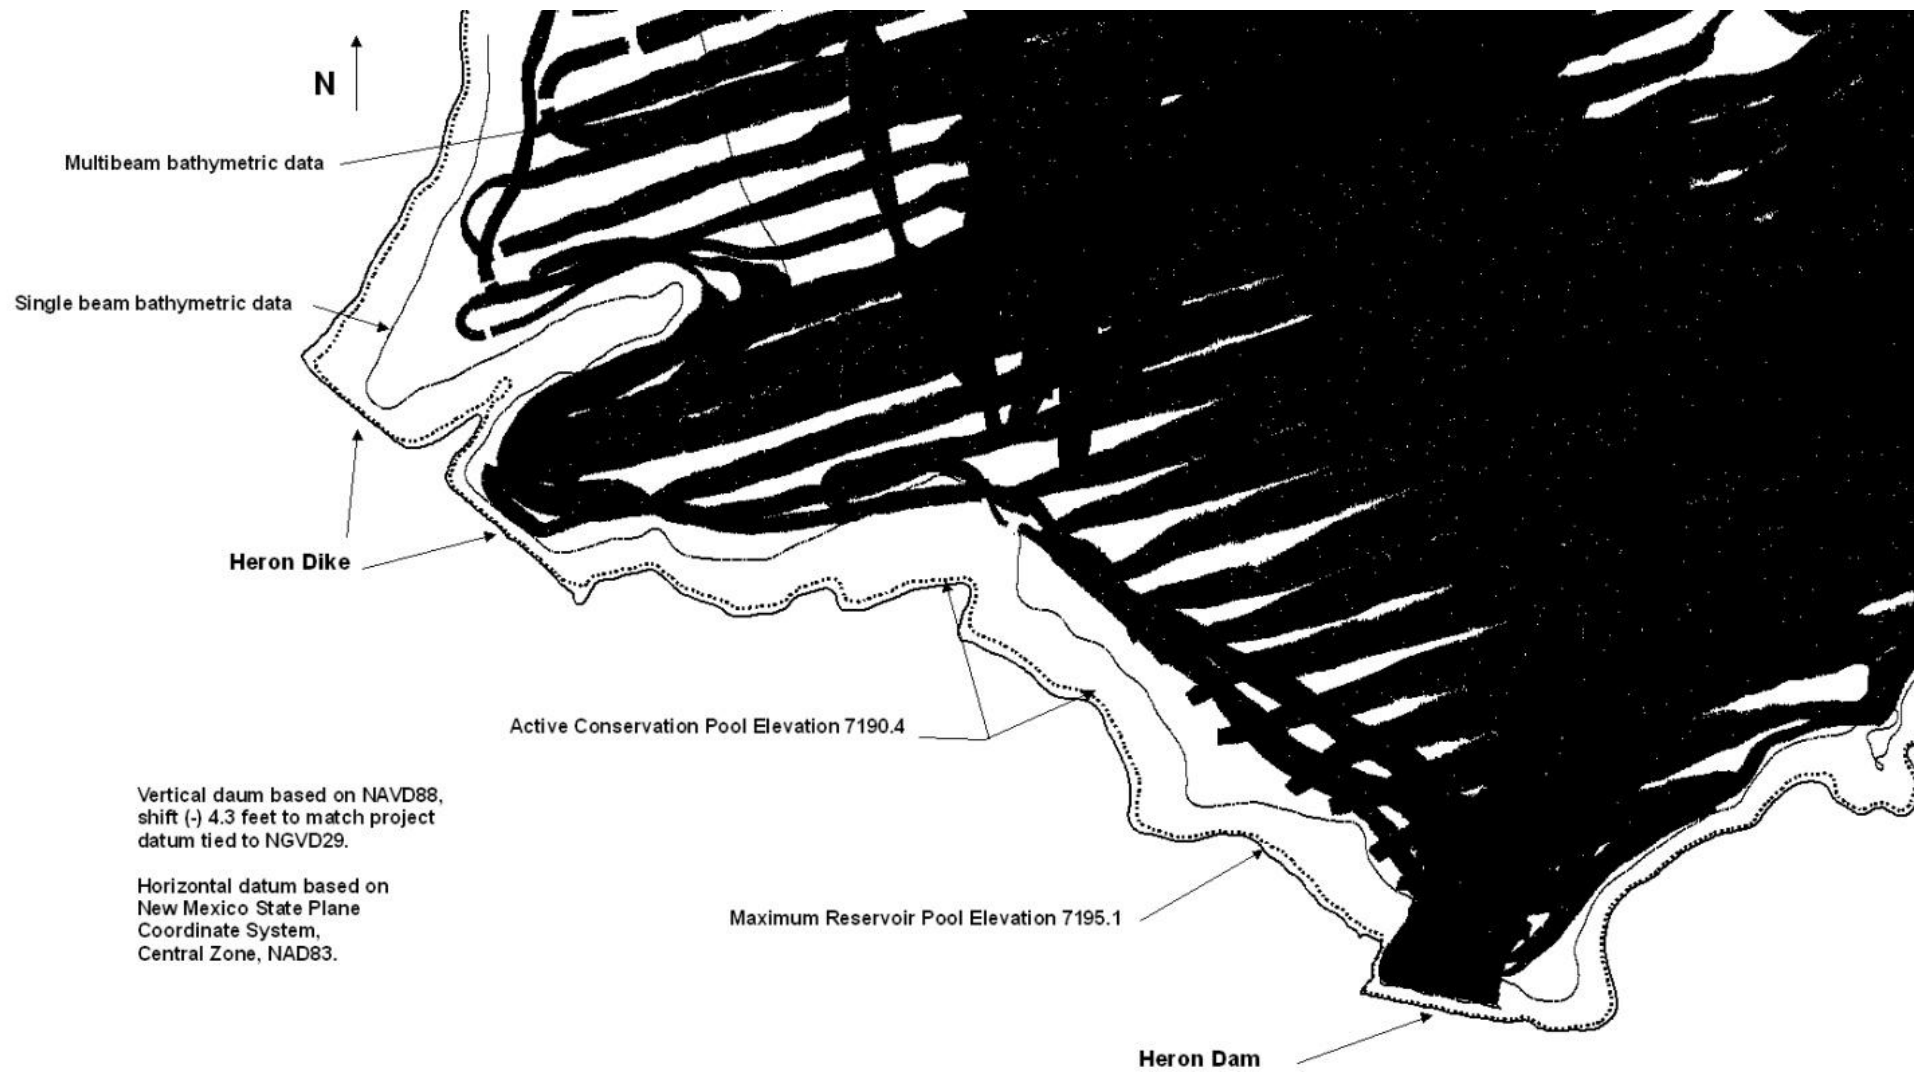
Figure 4 - Heron Reservoir bathymetric data points (NAVD88).

Figures 4 and 5 show portions of the reservoir areas covered by the multibeam and single beam collection systems. The underwater collected data was processed using the hydrographic system software that was also used during the data collection. The analysis applied all measurements such as vessel location and corrections for the roll, pitch, and yaw effects. The other corrections included applying the sound velocity through the reservoir water column and converting all depth data points to elevations using the measured water surface elevation at the time of collection. To make it more manageable, the massive amount of multibeam data was filtered into 5-foot cells or grids of the reservoir area surveyed by the multibeam system. The multibeam data was combined with the single beam data to produce the x,y,z data set used for Heron Reservoir map development. Additional information on general bathymetric data collection and analysis procedures can be found in *Engineering and Design: Hydrographic Surveying* (Corps of Engineers, January 2002) and *Reservoir Survey and Data Analysis* (Ferrari and Collins, 2006).

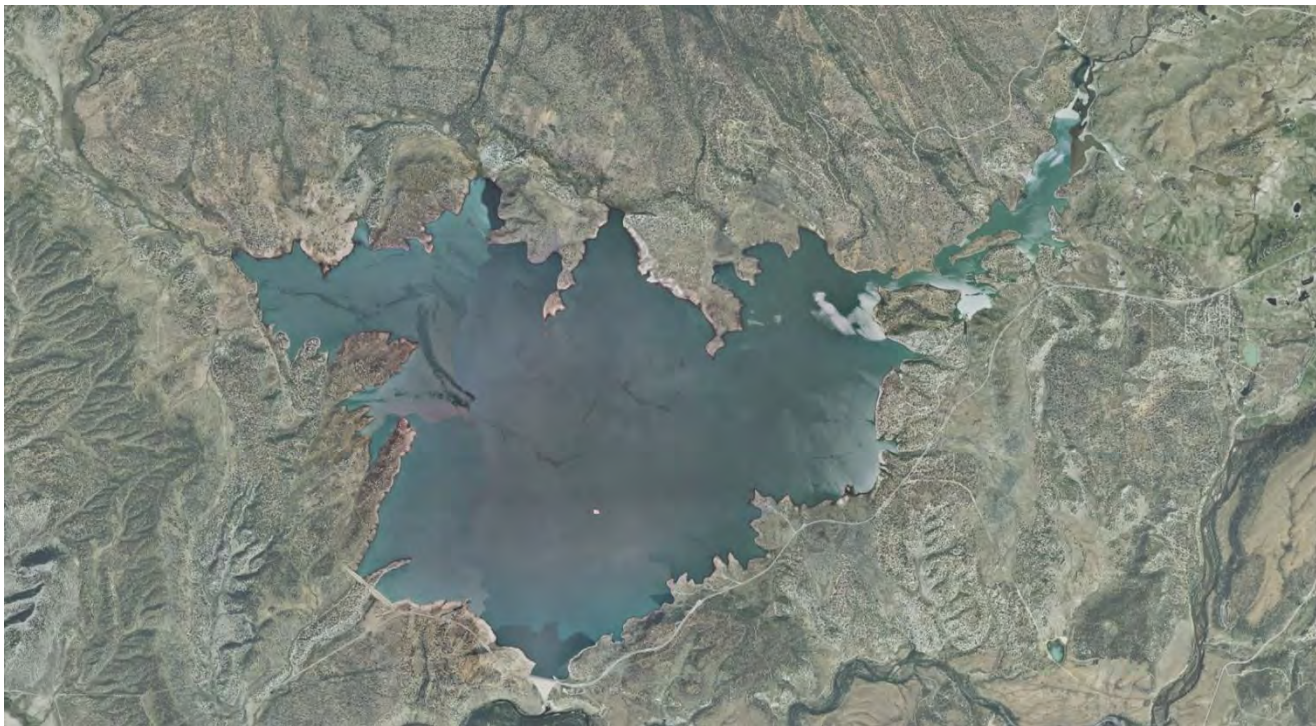
Figure 6 - Aerial image of Heron Reservoir flown in 2009 (USDA, 2010).

During the analysis, orthographic aerial images collected in 2009 near water surface elevation 7,174 (NGVD29); or 7,178.3 (NAVD88); was downloaded from the USDA data web site (USDA, 2010). The majority of reservoir's water edge covered by the aerial that was flown at elevation 7,174.0 was near the same elevation as the 2010 bathymetric collection. This allowed a reservoir contour to be developed that enclosed the bathymetric data by digitizing the water's edge from the aerial image, Figure 6.
