— BUREAU OF —
RECLAMATION

Development and Field Research on Next Generation Coatings for Mussel Mitigation on Infrastructure

Science and Technology Program
Research and Development Office
Final Report No. ST-2021-19196-01
Technical Memorandum No. 8540-2022-56

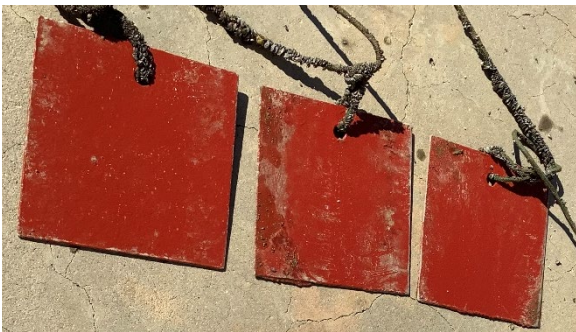
Figure 33: Sigmaglide 1290 after 1.5 years in quasi-static water conditions.

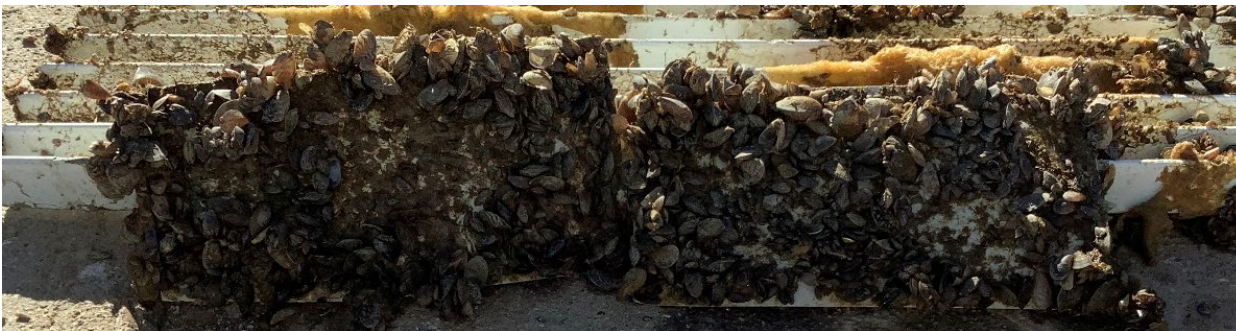
Figure 60: NDSU 3 (left) and NDSU 2 (right) in dynamic testing conditions January 2022 inspection.

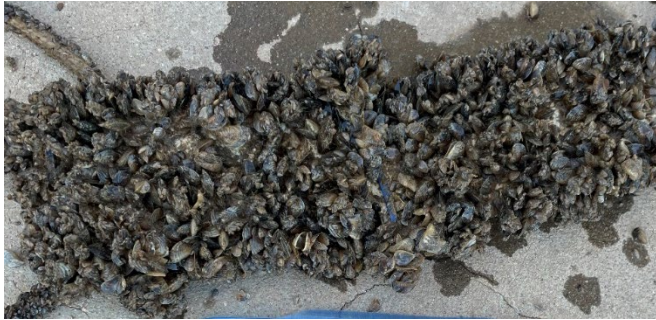
Figure 67: NDSU 1 static panels.

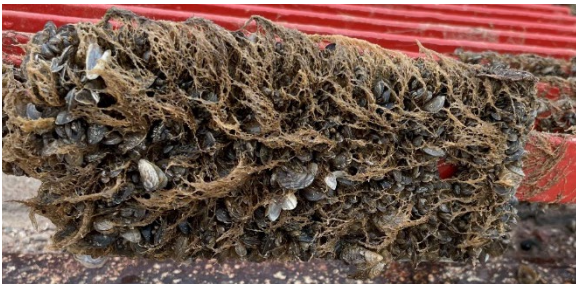
Figure 79: Formulation F during July 2022 inspection.

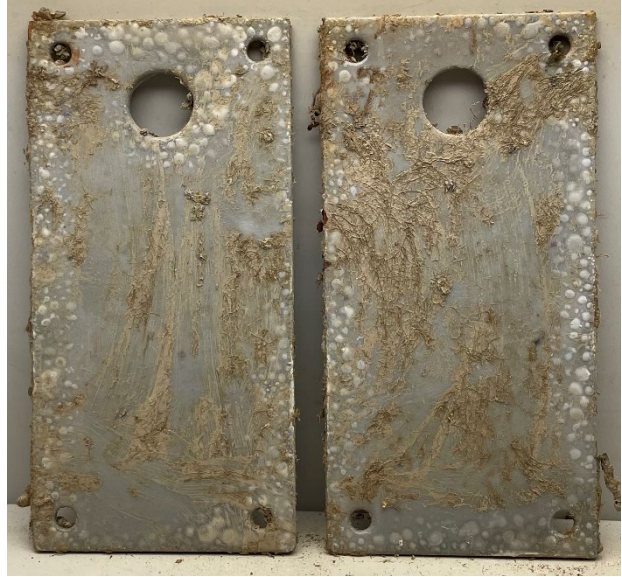
Figure 82: Adaptive Surface Technologies' Formulation B after removal from testing.

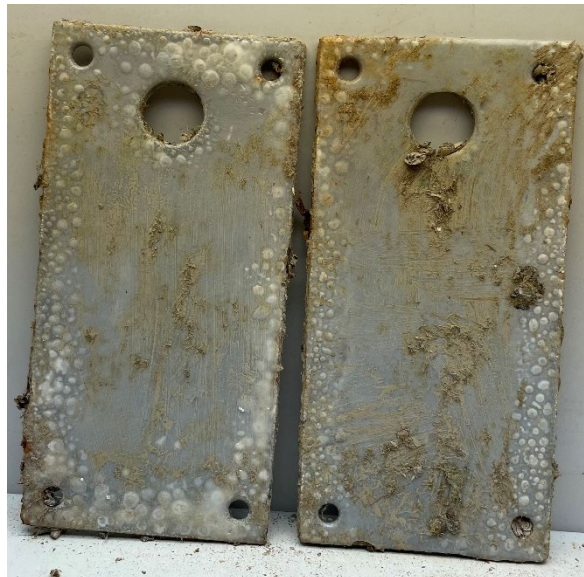
Figure 84: Adaptive Surface Technologies' Formulation D after removal from testing.

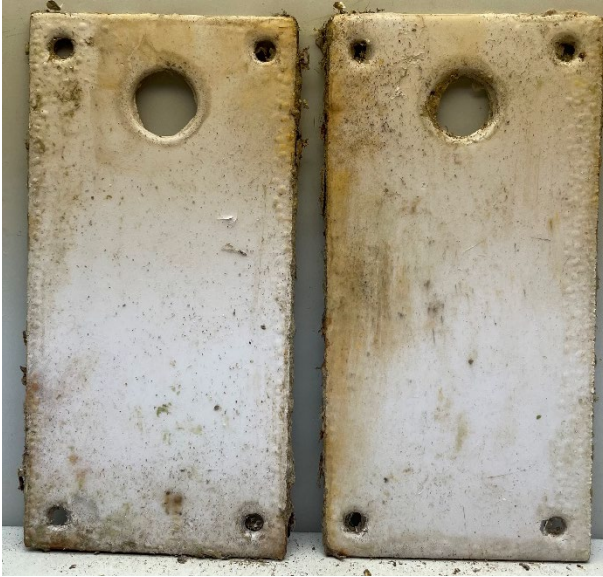
Figure 85: Adaptive Surface Technologies' Formulation E after removal from testing.

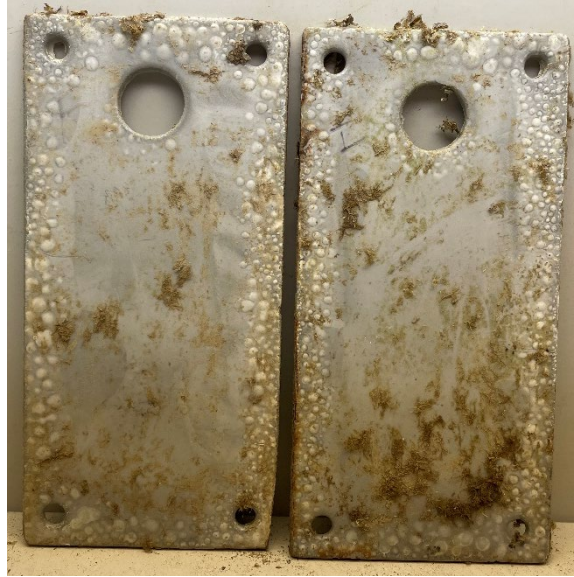
Figure 86: Adaptive Surface Technologies' Formulation F after removal from testing.

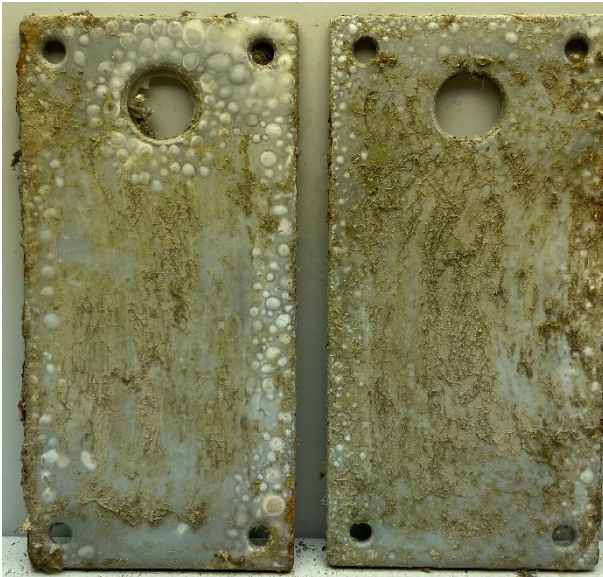
Figure 87: Adaptive Surface Technologies' Formulation G after removal from testing.

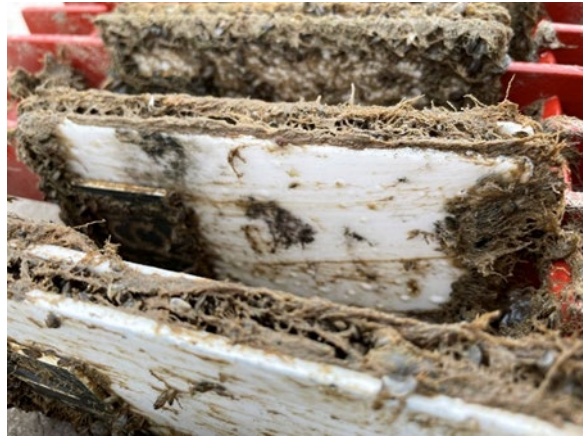
Figure 92: Close up view of PNNL formulation 2 showing blisters on panels.

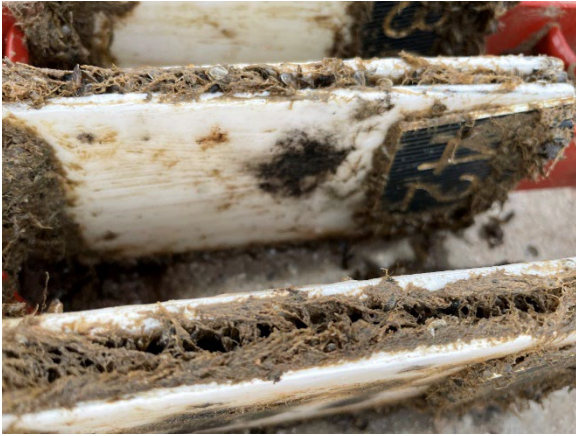
Figure 93: Closeup view of black spot on panel 42 from PNNL.

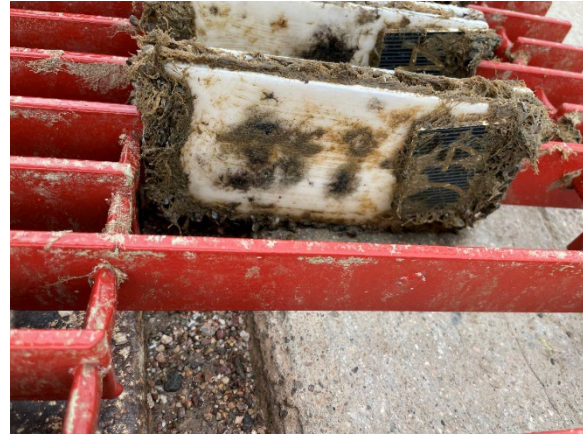
Figure 94: Close up view of panel 40 with black spots.

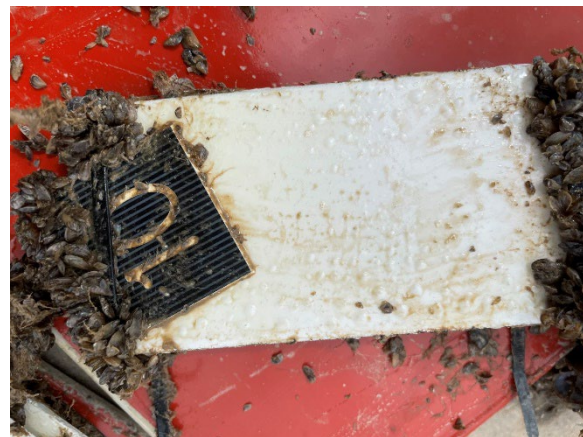
Figure 96: Formulation 2 in static testing with no fouling but blisters on surface.

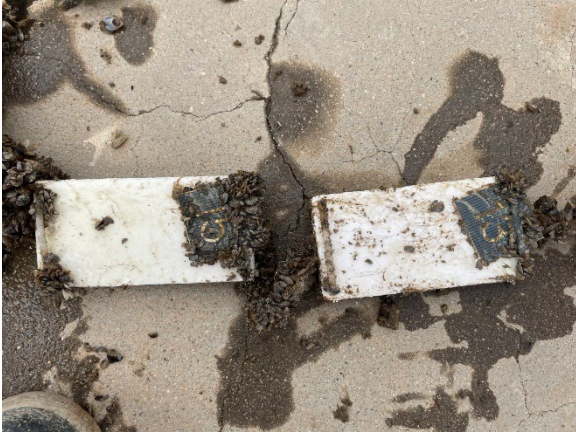
Figure 97: Formulation 3 in static testing with no fouling.
